LAND WEST OF BRETCH HILL (FIELD 3), BANBURY, OXFORDSHIRE

ARCHAEOLOGICAL EVALUATION

PLANNING REF. 13/00444/OUT

October 2018

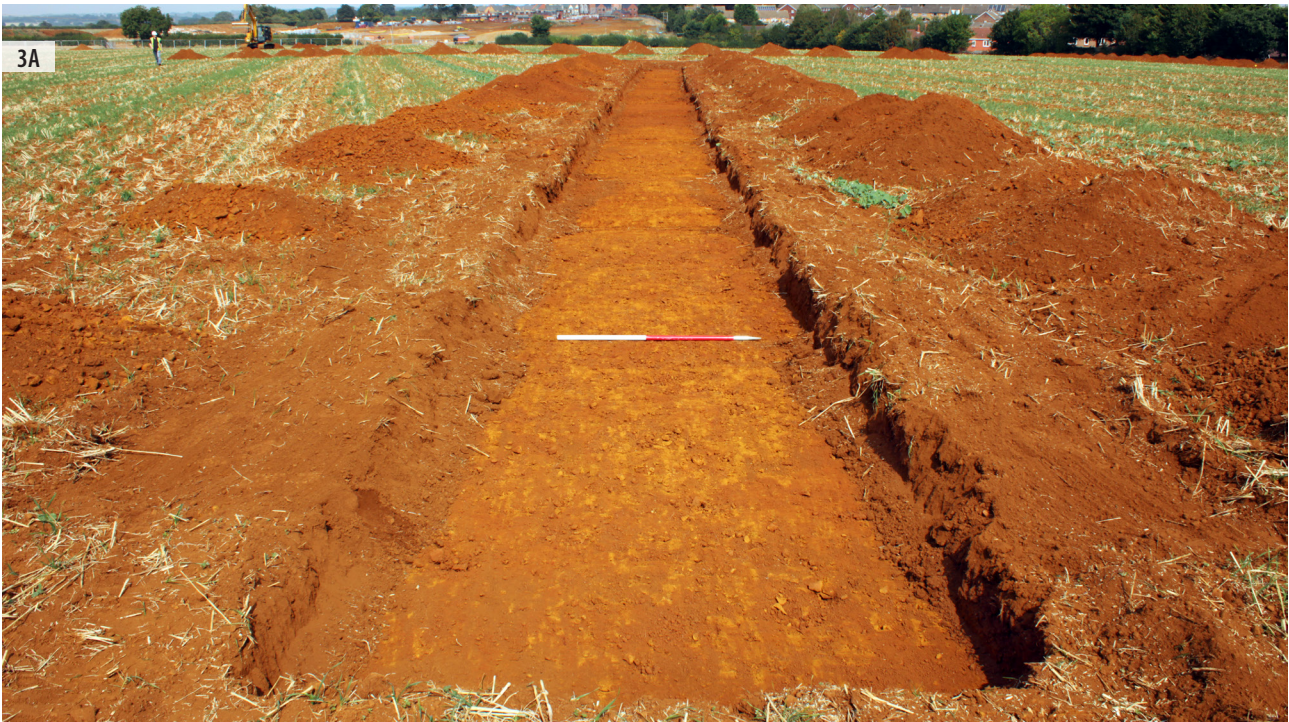
ILLUS 3A South facing shot of Trench 36 representative section of Trench 37

The natural substrate was exposed at a depth of 0.27m BGL, sealed by remnants of a shallow subsoil and in turn by plough-soil.

Two parallel linear anomalies were identified by geophysical survey, respecting an east to west alignment. The northern anomaly produced a high magnitude response indicative of a soil-fill from a buried ditch.

No evidence of negative cut features was encountered.

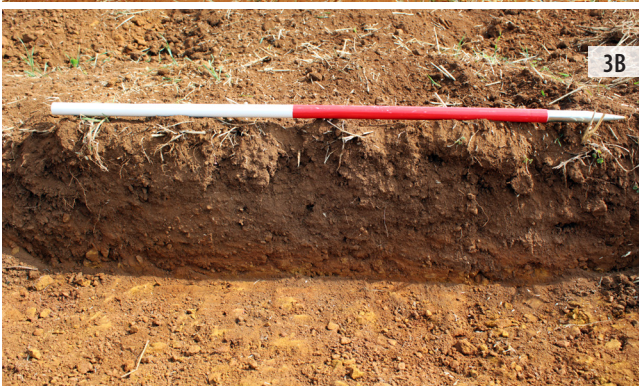
ILLUS 3B West facing representative section of Trench 36

CONTEXT	DESCRIPTION	*D BGL (M)
3601	Topsoil: Medium red brown sandy silty loam with few sub-rounded limestone and ironstone (0–0.04). Clean plough soil.	0.21
3602	Subsoil: Medium red brown sandy silt with few sub-rounded sandstone and ironstone (0–0.03).	0.06
3603	Natural: Medium yellow brown sandy clay 'brash' Iron stone.	N/A

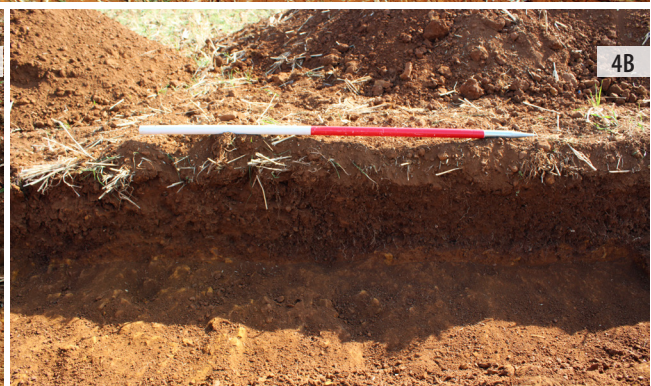
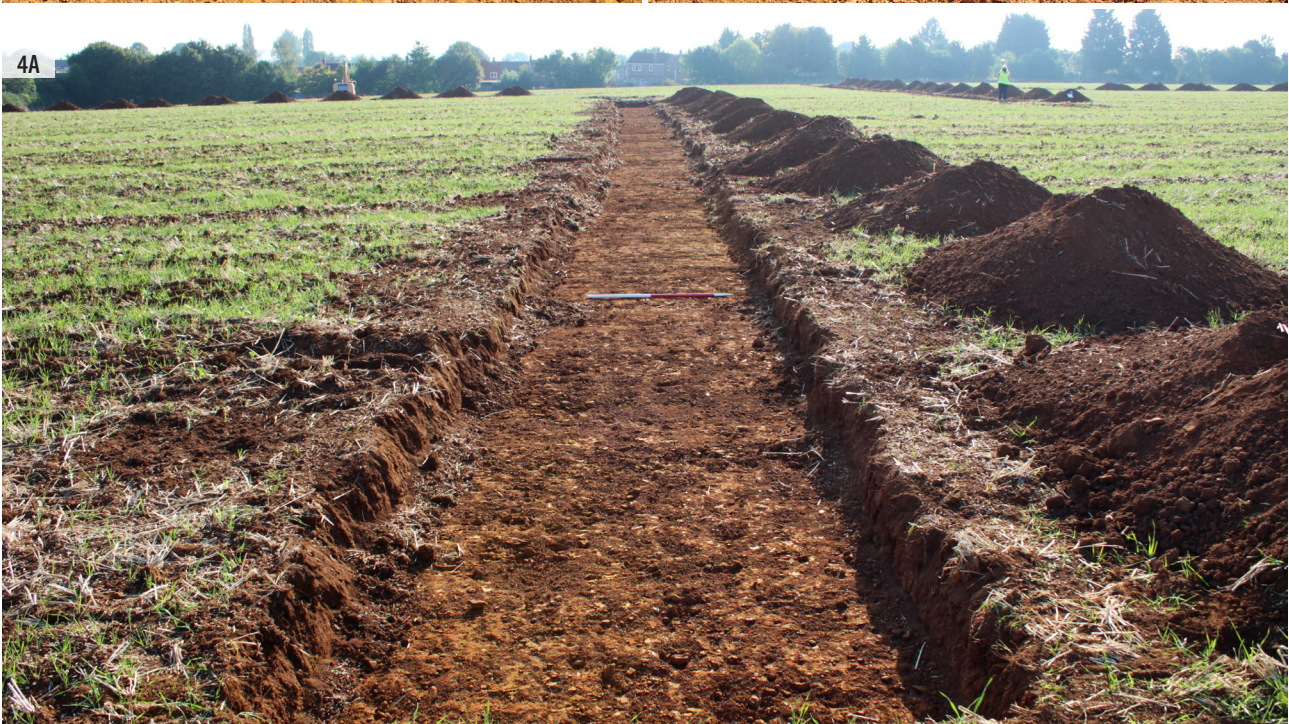
ILLUS 4A East facing shot of Trench 37

The natural substrate was exposed at a depth of 0.28m BGL, sealed by plough-soil. A shallow linear feature [3703] was encountered, aligned north to south measuring 0.72m in width and 0.08m in depth. It contained a single dark grey brown sandy silt deposit and no material culture.

This feature correlates with geophysical survey results.

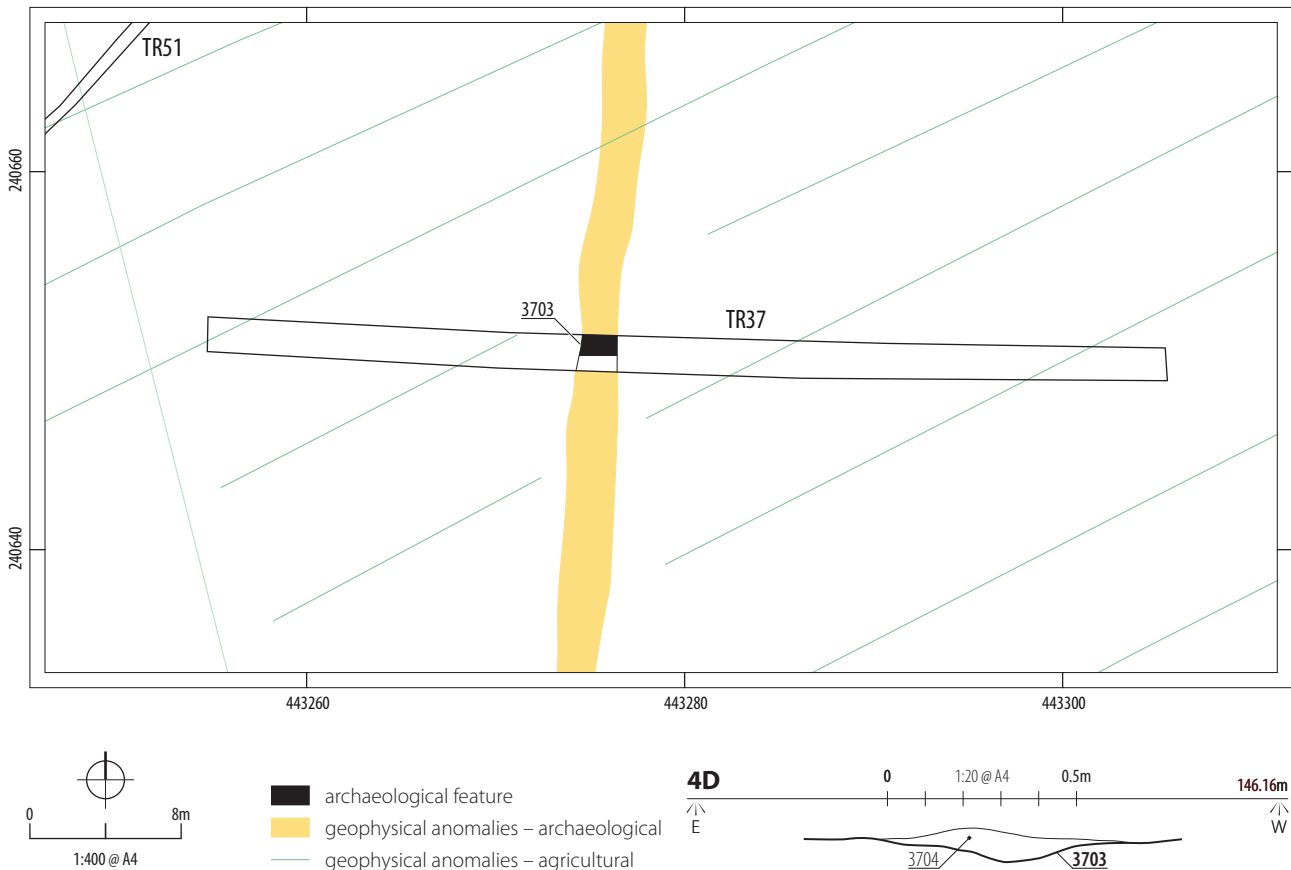
ILLUS 4C Plan of Trench 37 ILLUS 4D North facing section of ditch [3703]

SUMMARY		
Linear ditch exposed, N/S aligned. Poorly preserved. Visible in section, not in plan. Respects geophysical anomaly. Plough scars noted, N/S aligned.

The geophysical survey identified positive trends indicative of negative/buried features below the present ground level. The cause of these trends was not identified during the field evaluation except for the shallow remains of a ditch recorded in Trench 37. The presence of this feature and its preservation suggest that the geophysical survey had potentially identified ephemeral remnants of features at the base of the plough-soil which had not been visible in the underlying substrate. This is either as a result of intensive land management limiting the preservation of these features or the features did not cut into the underlying geology sufficiently to be recorded.

The field evaluation recorded a single undated linear ditch related to a potential field system. This feature had been identified by geophysical survey, forming a curving feature continuing to the north (Field 2).

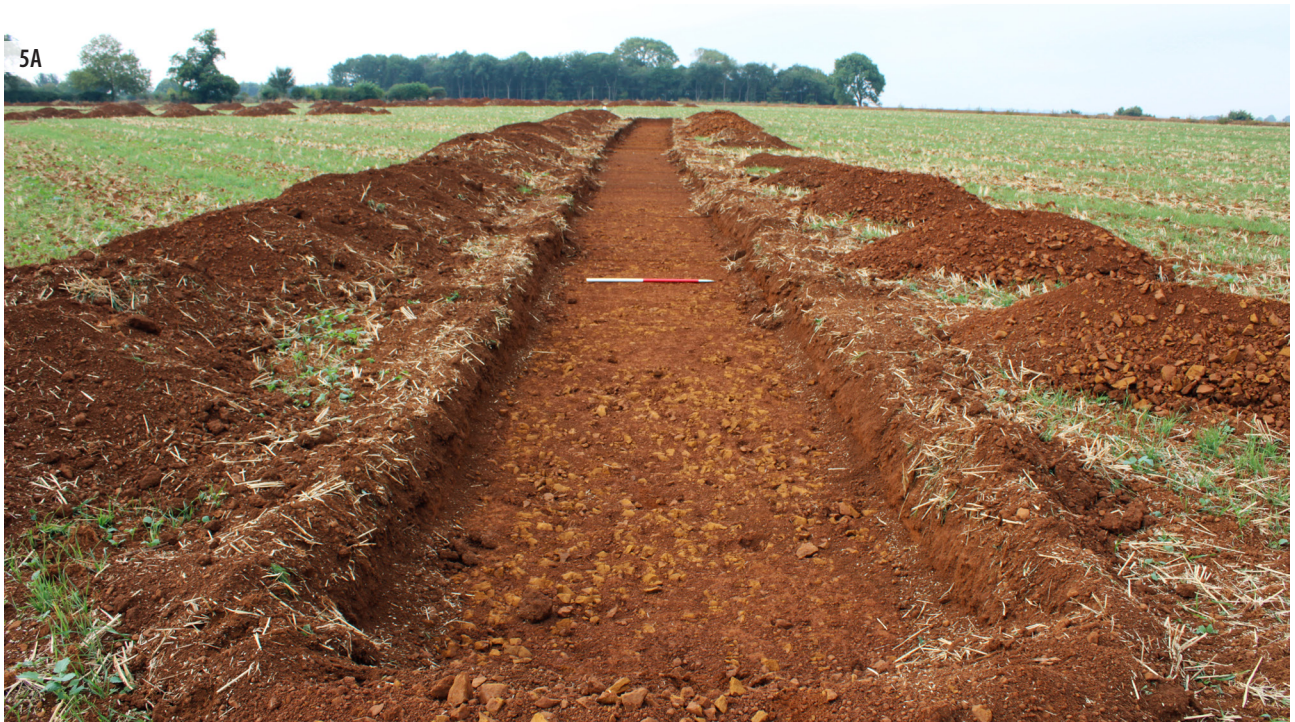
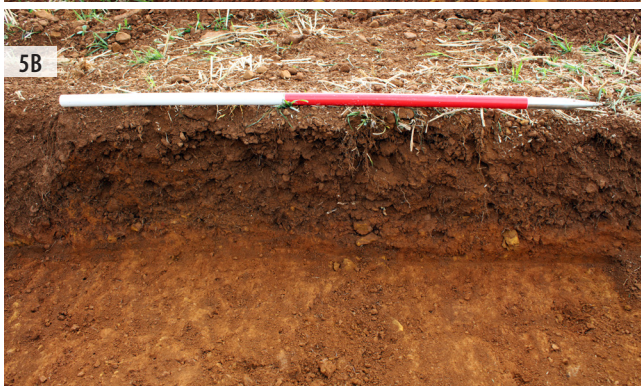
ILLUS 5A South-west facing shot of Trench 40 **ILLUS 5B** South-east facing representative section of Trench 40 **ILLUS 6A** South-west facing shot of Trench 42 **ILLUS 6B** South-east facing representative section of Trench 42

The natural substrate was exposed between depths of 0.21–0.32m BGL, sealed by plough-soil.

A linear anomaly was identified by geophysical results, interpreted as potential pit alignment.

No evidence for negative cut features was encountered.

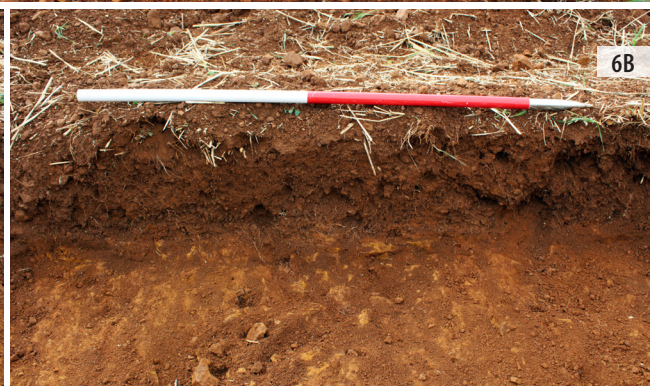
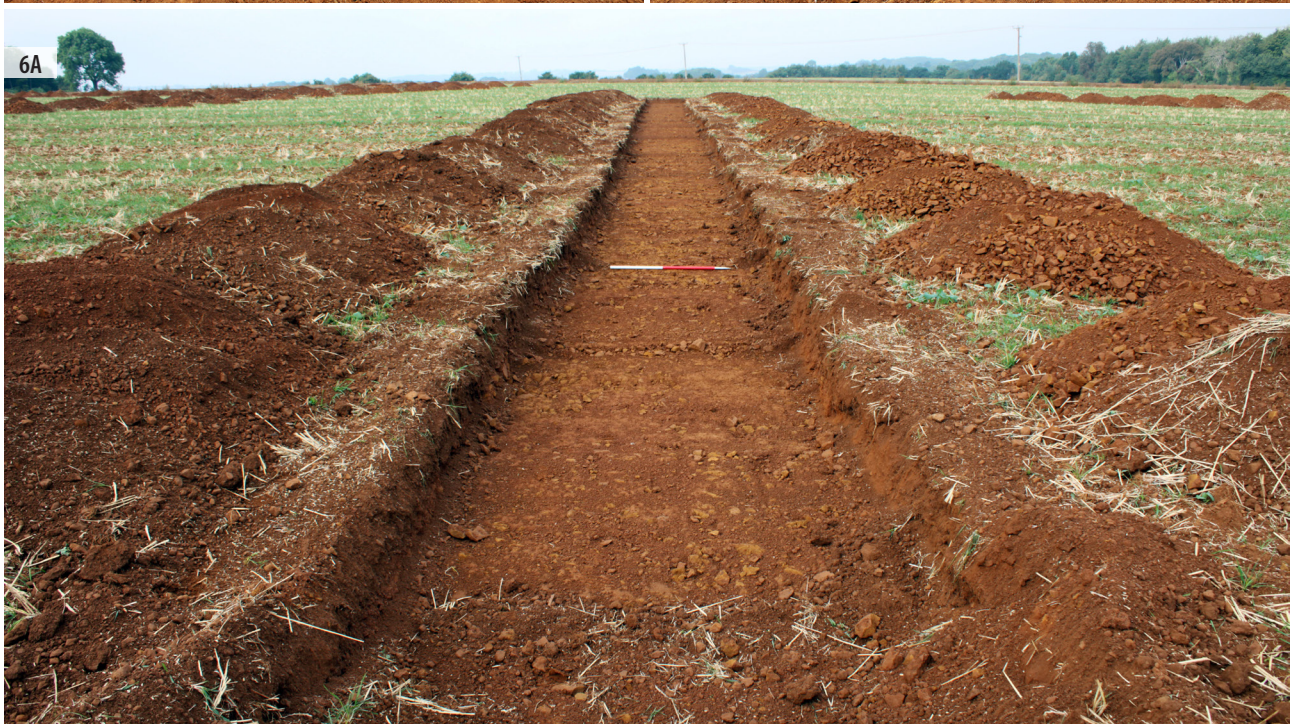
The natural substrate was exposed between depths of 0.18–0.22m BGL, sealed by plough-soil.

Two fragmented circular features were identified by geophysical survey results, interpreted as potential ploughed-out barrows.

No evidence of negative cut features was encountered.

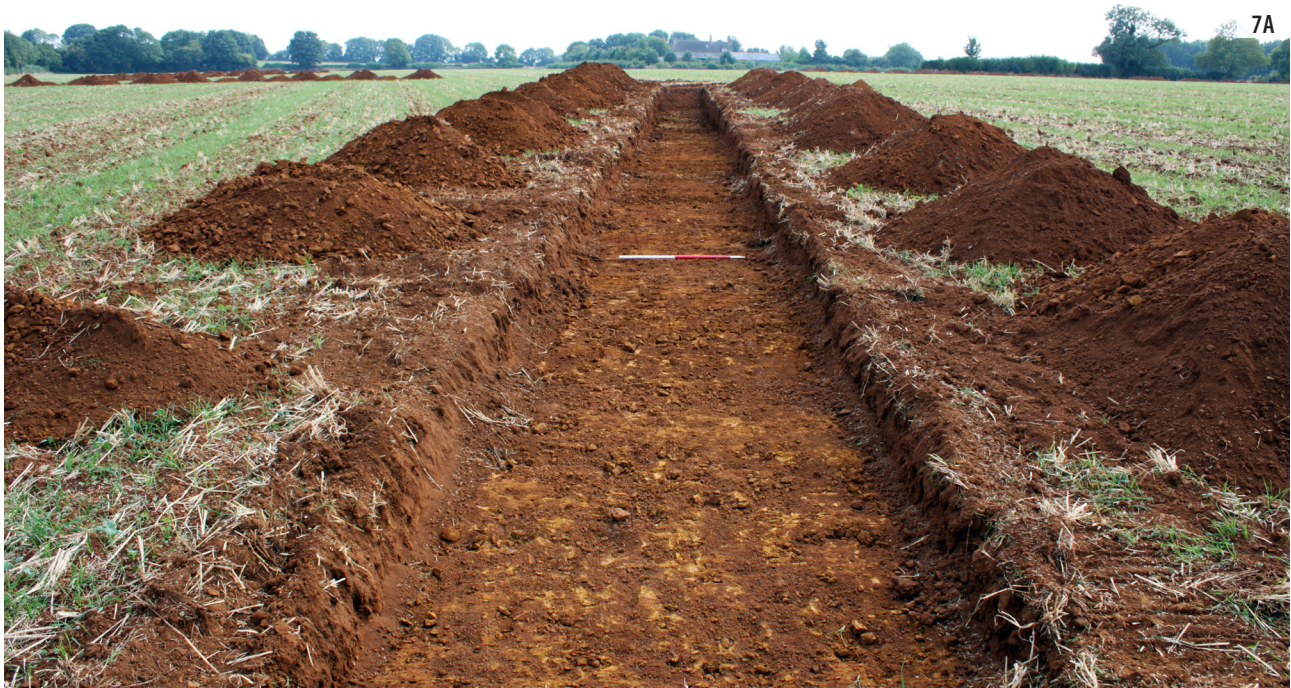
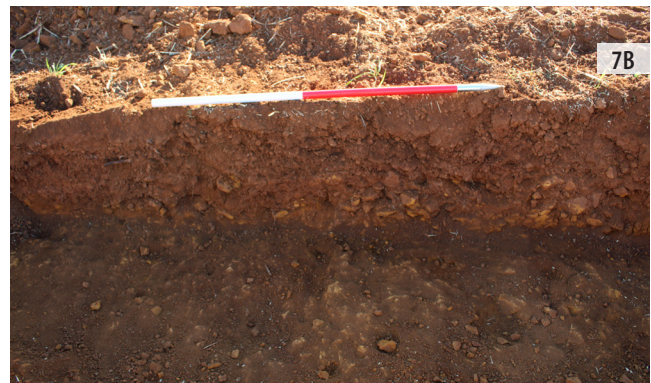
ILLUS 7A South facing shot of Trench 43 **ILLUS 7B** West facing representative section of Trench 43

No archaeological features encountered. Excavated into the geology on the southern extent with the excavator to test the level.

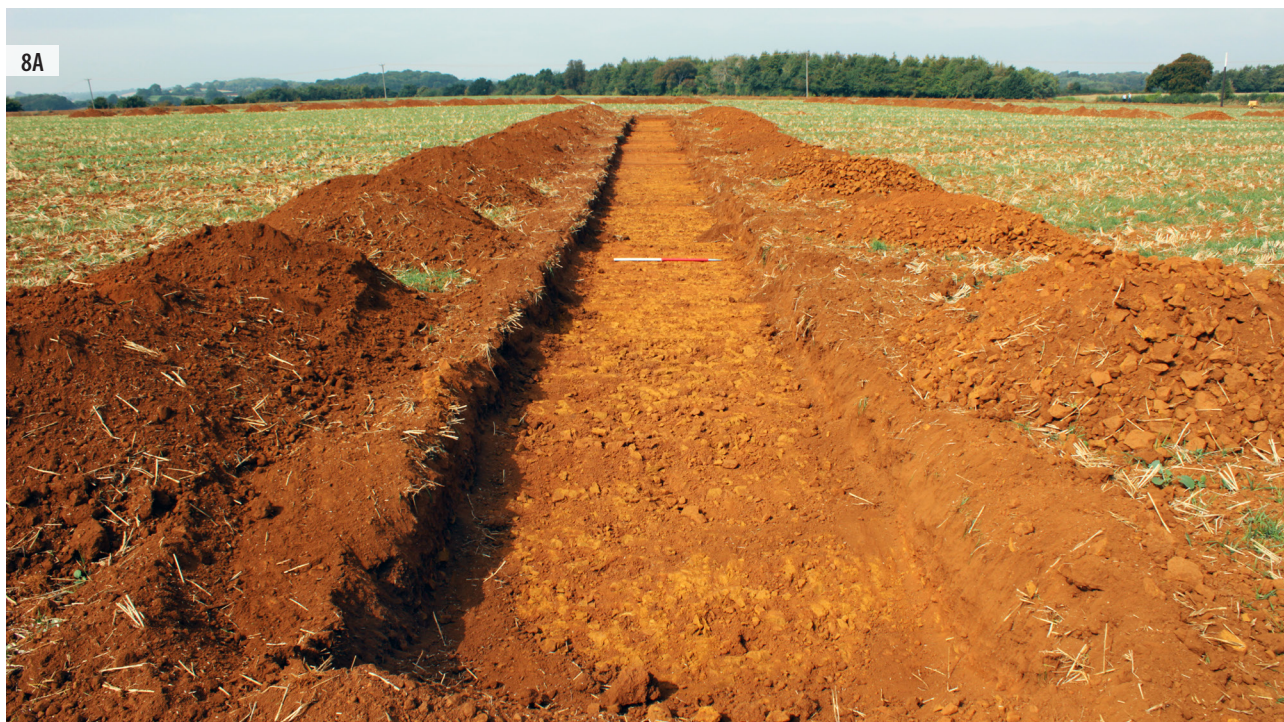
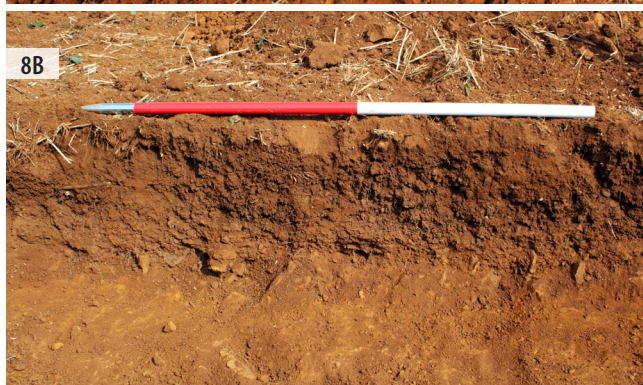
ILLUS 8A North-west facing shot of Trench 48 **ILLUS 8B** South-east facing representative section of Trench 48

The natural substrate was exposed at a depth of 0.28m BGL, sealed by plough-soil.

Two linear anomalies were identified by geophysical survey results, indicative of soil-fill from a buried ditch.

No evidence of negative cut features was encountered.
