Clifford Road, Princes Risborough, Buckinghamshire

Archaeological Watching Brief

Prepared on behalf of Red Kite Housing

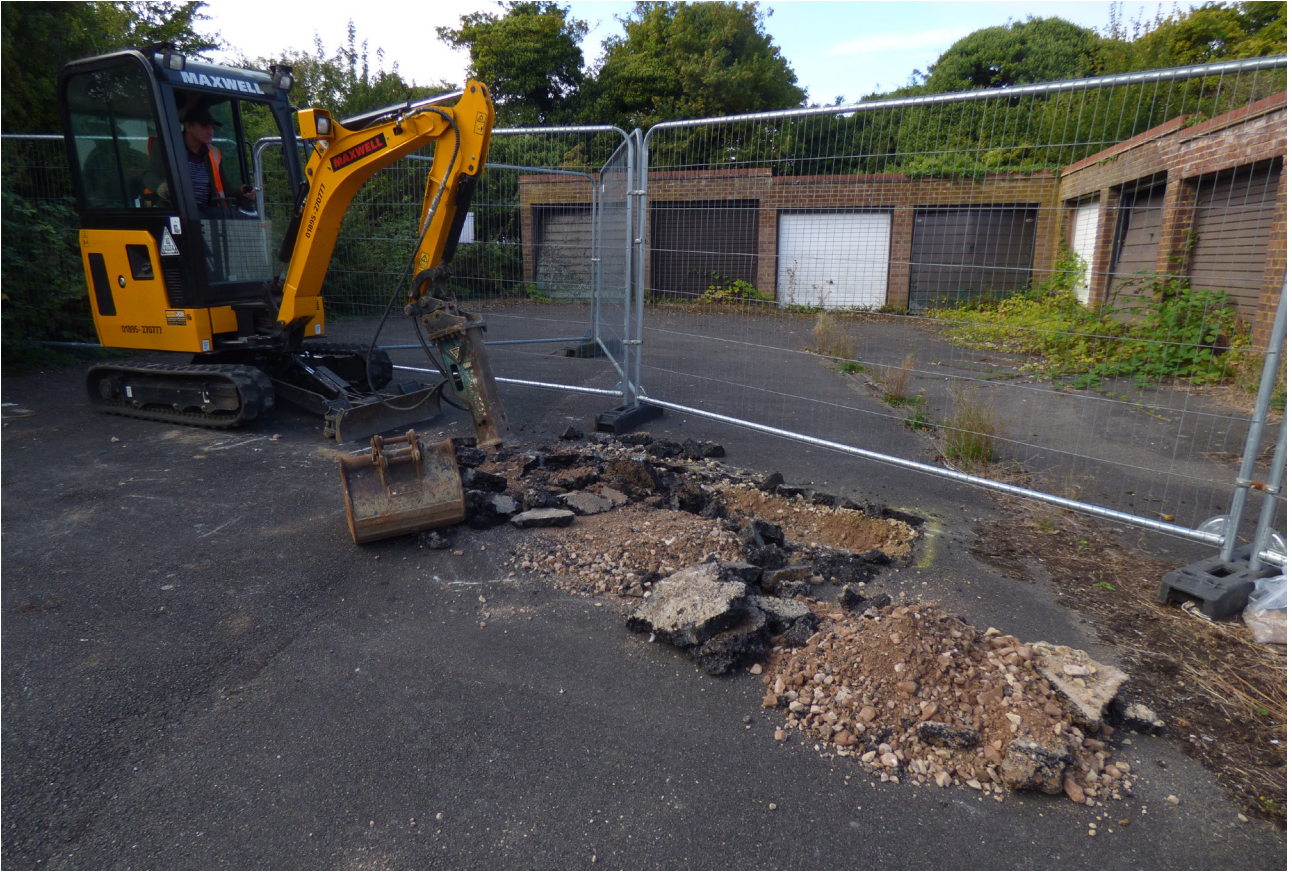
ILLUS 2 Trial Pit 4 during excavation, looking south

Monitoring of the excavation of Trial pit 4 revealed no archaeological finds or features. The top layer (401) was very compact dark grey/black modern asphalt and was 0.08m thick. This overlays 0.12m of compact mid brownish pink silty gravel made ground (402), which would have been bedding for the asphalt. The made ground overlays a 0.11m thick layer of friable mid greyish brown silty clay subsoil (403), with occasional sub angular stones, which sits on top of the natural geological chalk deposit forming part of the Zig Zag chalk formation (404), and was found at 0.31m below present ground level. As part of the infiltration testing, the trial pit was dug down 0.4m into the natural chalk. The trial pit also revealed part of a modern drain [405], appearing to run on a northeast-southwest axis, cutting the subsoil (403), and covered by the made ground (402). The modern drain was filled with very compact light grey brown gravel (406), which was not excavated. The trial pit was extended slightly to the southeast in order to avoid impacting the drain. The final trial pit dimensions were 2.6m long, by 0.6m wide, and 0.71m deep.
