**City Centre Opportunity Site South (CCOS South), Victoria Street, St
Albans**

Archaeological Excavation

**Archaeological Excavation City Centre Opportunity Site South (CCOS South), Victoria Street, St Albans:
Assessment and Archive Report**

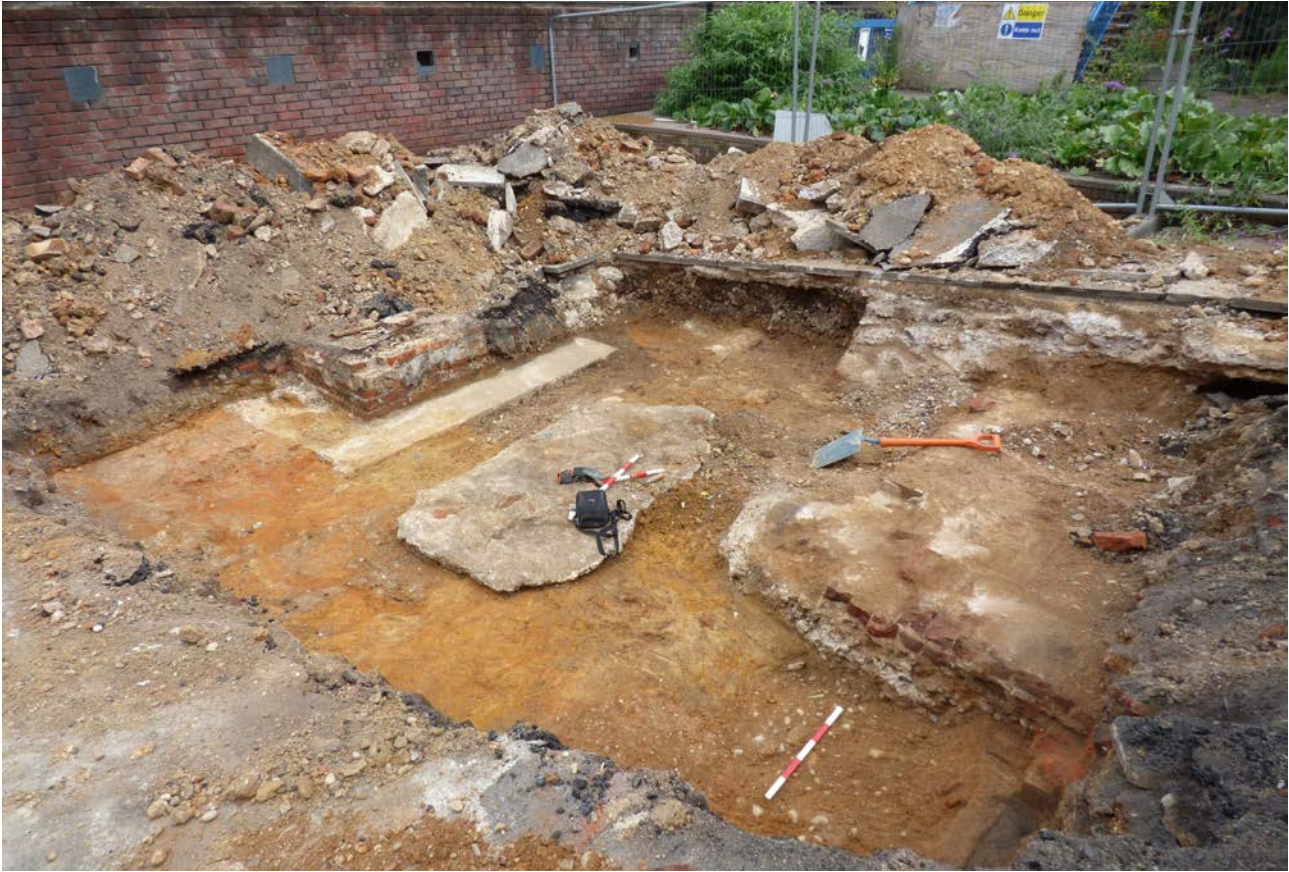
ILLUS 3 North-east facing working shot of site

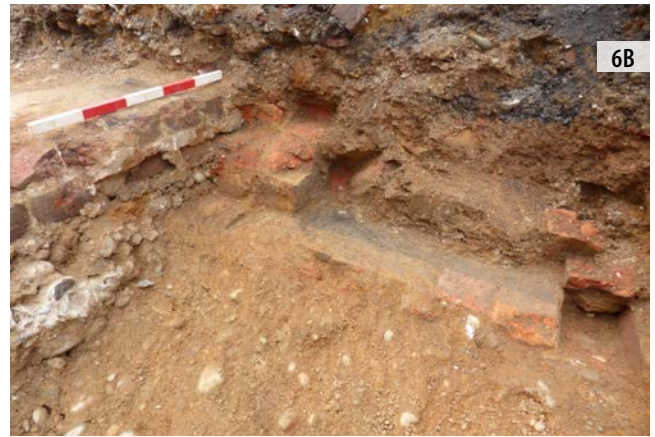
ILLUS 6 A North facing elevation drawing of Structure [10031] **B** South facing photograph of Structures [10031 and 10027]

Phase 1 is comprised of a late nineteenth century coal storage structure [10031]. The structure was 0.92m below ground level (BGL). It was 1.04m wide, 0.50m in height and projected 0.28m out of the south-west L.O.E (Illus 5 and 6).

[10031] comprised the remains of two walls [10043, 10044] abutting a blackened brick floor [10031]. The bricks from floor surface [10031] were 223 x 111 x 65mm in dimension and consisted of an orange fabric. They were frogged and had no makers mark. The floor was constructed upon an 0.08m deep aggregate and sand sub-base layer (10041) in cut [10030]. A single fill composed of demolition debris (10039) was located within the structure (Illus 6b). Small find SF 1, a small clamp of unidentified use was recovered from (10039).

Contemporary with the oven were the remains of the concrete foundations [10028] and brickwork footings [10019, 10022, 10027] that projected from the south L.O.E (Illus 7-A). The foundation cut [10033] truncated nineteenth century structure [20031] (Illus 6-A). The concrete and brickwork [10019] abutted this structure (Illus 6-B).

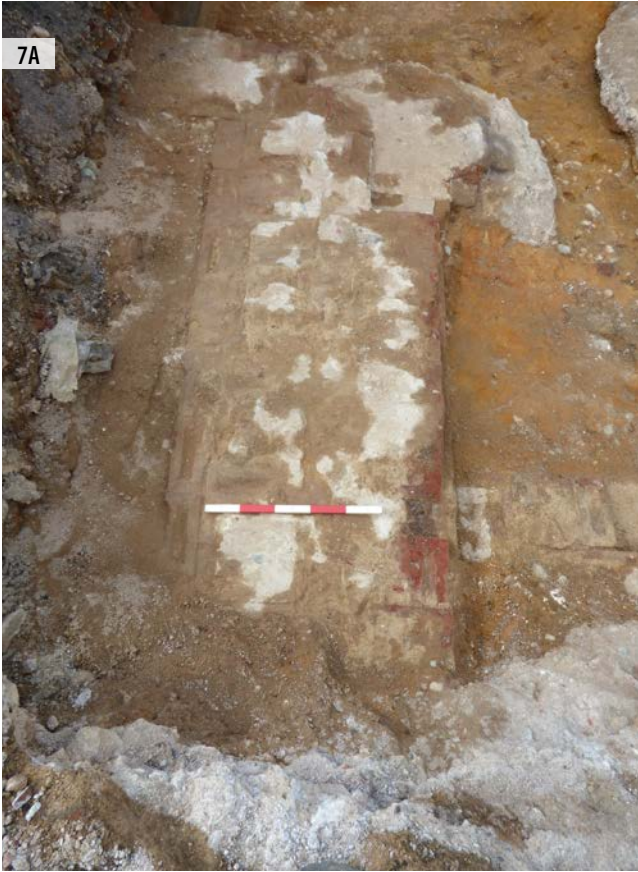
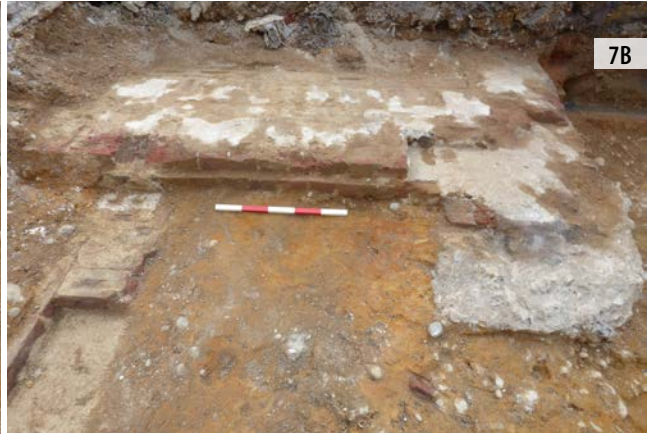
ILLUS 7 A West facing photograph of Structure [10027] **B** South facing photograph of Structure [10027]

The brickwork footings [10027, 10019] formed a corner foundation positioned upon concrete [10028]. [10027] was 0.83m in width and formed the footings of a load bearing wall. Wall [10022] extended north-east from [10027] and formed the upper courses of wall [10037], joining these two contemporary structures (Illus 7-B, 8-A). Packing deposits of concrete (10038), aggregates (10032) and re-deposited geological substrate (10024) secured the structure foundations.

The bricks from [10022] and [10027] were composed of a dark red fabric, 230 x 105 x 67mm. They were machine-made, frogged bricks with no maker's marks.

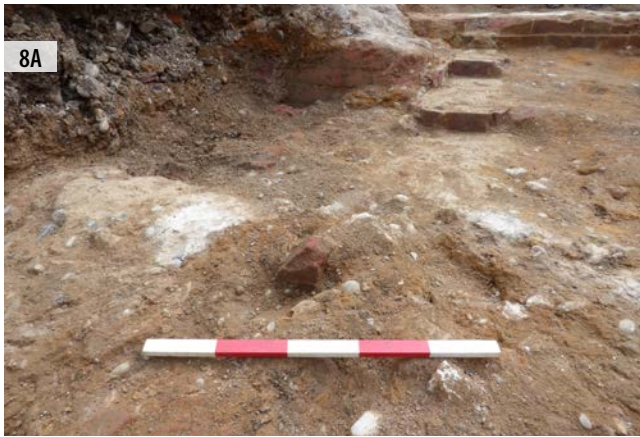
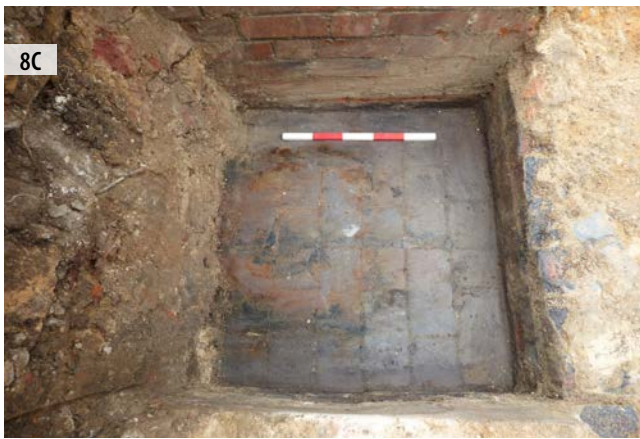
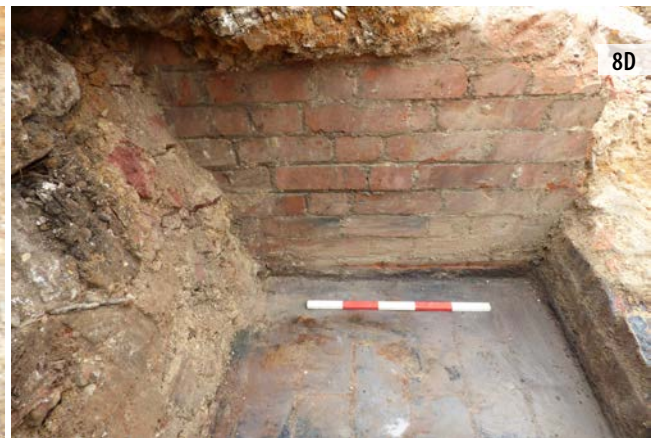
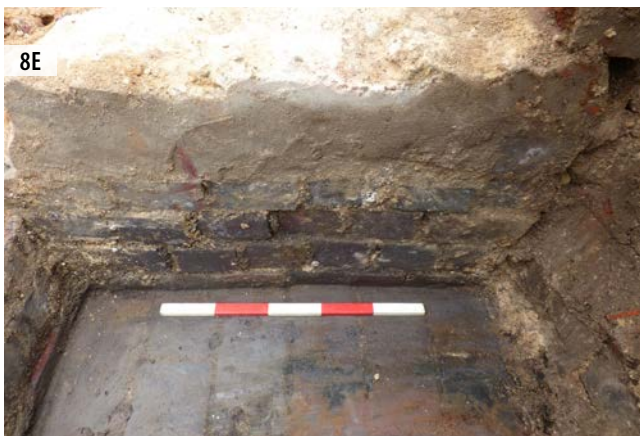
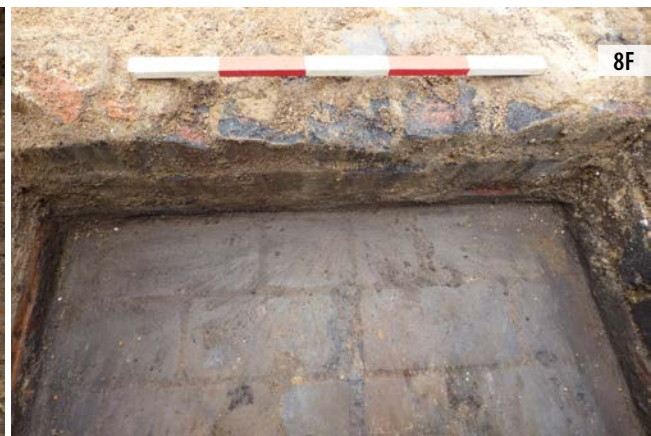
ILLUS 8 A South-east facing pre-excitation photograph of Structure [10042] **B** Plan of Structure [10042] **C** Plan photograph of Structure [10042] **D** South facing elevation photograph of [10023] **E** North facing elevation photograph of [10008] **F** West facing elevation photograph of [10037]

The remains of a heat effected brick floor [10042] and abutting walls [10008, 10023, 10037] projected out of the east L.O.E (Illus 8-A). The oven structure measured 1.40m length and 1.08m in width, at a depth of 1.09m BGL. Concrete (10018, 10038) abutted walls [10008, 10037]. These formed packing deposits that supported the structural foundations.

Walls [10008 and 10037] (Illus 8-E and 8-F) also evidenced heat damage. Wall [10023] was not heat damaged, It is likely that that this wall had been lined. Circular markings on the brick floor [10042] evidenced oxidisation from heated metal (Illus 8-C).

The oven structure contained two fills (10045, 10021). A black fill (10045) was sampled at its base. It had visibly stained the base of walls [10023 and 10037] and was contemporary with the structure.

[10042] was an oven used for industrial activity. It was contemporary with [10027] and associated with the rear building shown on the 1898 (Illus 4-A) OS Map. The buildings was demolished in preparation for construction of the Police station that commenced in 1963.

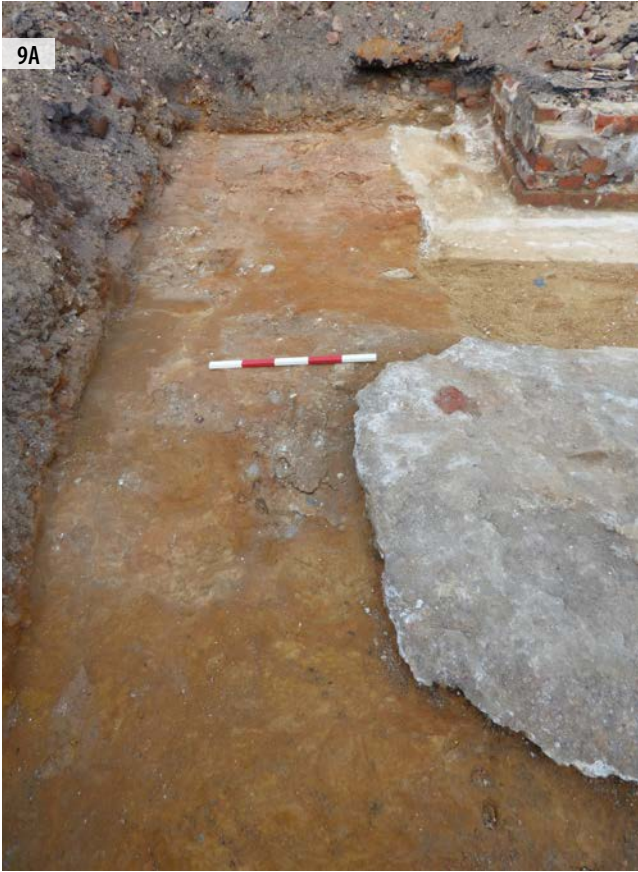
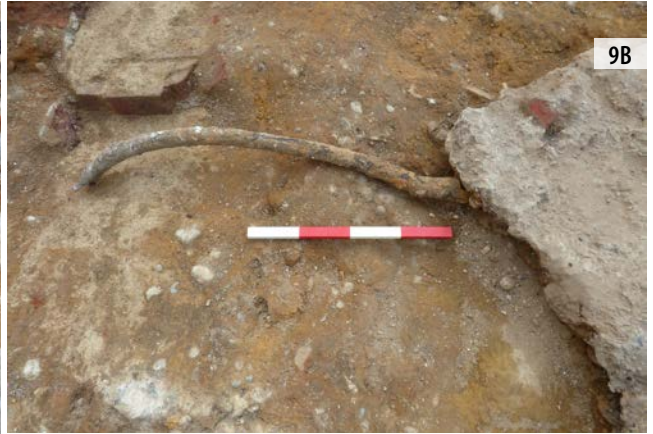
ILLUS 9 A North facing photograph of Structure [10017] foundations **B** South facing photograph of steel re-enforcement of Structure [10017]

An angular construction cut [10013, 10014, 10016], basal remains of red brick and lime mortar footings (10015) and compacted lime mortar foundation [10017] form the remains of a structure that protruded from the north L.O.E and extended into the centre of the site (Illus 9-A). A plain rounded steel reinforcement rod (SF 3, Illus 9-B) protruded from the east of [10017], it formed a foundation anchor, connected to wall [10022].

Originally recorded during trial trenching of the DA, the compacted lime mortar foundation [10017] was evidenced to extend northwards, within cut [10014] (James 2018), only the basal remains (10015) of the northern element of this structure survived at the time of excavation.

Whilst map evidence suggests that this structure could have mid-eighteenth century origins, the use of steel re-enforcement did not come into practice until the late nineteenth century. It is likely that these foundations were the base of a crude, rear yard structure associated with the late nineteenth century buildings.
