LIVERPOOL CITY CENTRE CONNECTIVITY, PHASE 2

ARCHAEOLOGICAL TRIAL TRENCHING
PLANNING REF. 17F/2628

commissioned by Amey PLC

October 2017

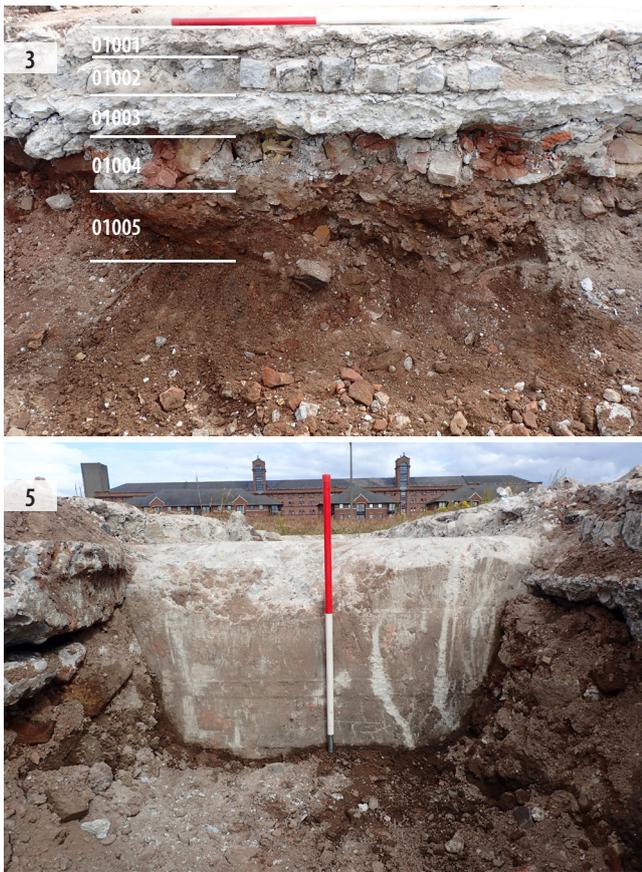
ILLUS 3 Trench 1 representative section **ILLUS 4** Trench 1 looking east towards concrete structure (01006) **ILLUS 5** Trench 1 detail of concrete structure (01006)

In Trench 1 a single course of granite setts, (01002), lay underneath the concrete surface at a depth of 0.1–0.22m below ground level. The setts were rectangular in shape and appear to form a surface similar to those seen in Trenches 2 and 3. No bonding agent was visible but it appeared that in places concrete (01001) had ‘seeped’

into gaps between individual setts suggesting the floor was not in good condition. Beneath (01002) was concrete surface (01003), found at a depth of 0.22–0.43m. This may have been a foundation or base for (01002), however, it is more likely that it was an earlier dock surface which was repurposed as a base for the sett floor surface. The rest of Trench 1 comprised of two made ground deposits, (01004) and (01005). Context (01004) consisted of a mixture of sandstone and red brick rubble at a depth of 0.43–0.68m. Context (01005) was a mixed brownish grey red sand deposit with clay patches and occasion sandstone and brick rubble inclusions. This was excavated to a maximum depth of 1.09m. In the eastern end of the trench a large cast concrete structure (01006) was found. Excavation of the western end of the trench revealed it was 0.91m thick as excavated and, along with suggestions that the structure was related to a sewerage system, meant that excavation stopped when it was uncovered. Structure (01006) measured 7.5m in length and extended north, south and east outside the limit of excavation. Both (1001) and (1002) extended over it. A lip was cast into the concrete possibly for a manhole cover. Two nearby manholes, to the north and south respectively, were also noted.

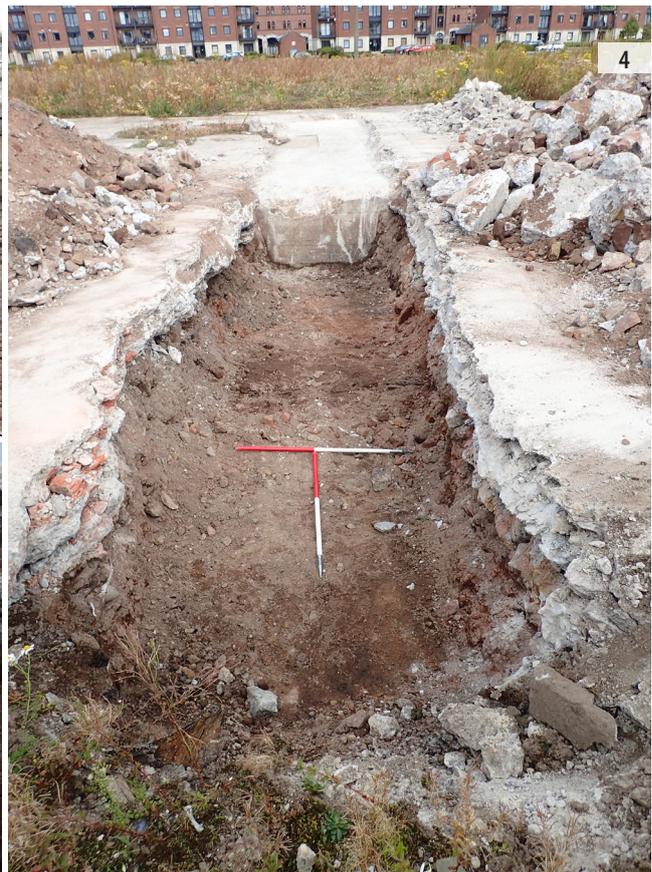
The archaeological trial trenching revealed a sequence of made ground deposits used to either build the original 19th century docks or related to the 20th century redevelopment. Trench 1 did not expose the presence of the dock wall, however a large cast concrete structure, (01006), was found. The date and function of this structure is unknown and would require further investigation. In Trench 2 the remains of the original sea/dock wall were found in the form of large worked sandstone blocks (02005). In addition to this the trench revealed sandstone sett flooring, bituminous surfaces and red brick walls which may be associated with dock structures such as the West Waterloo Warehouse or later dock buildings. Trench 3 did not reveal the dock wall which may be the result of relocating it due to health and safety and logistical reasons. A small redbrick and sandstone structure, (03006) and (03007), was uncovered

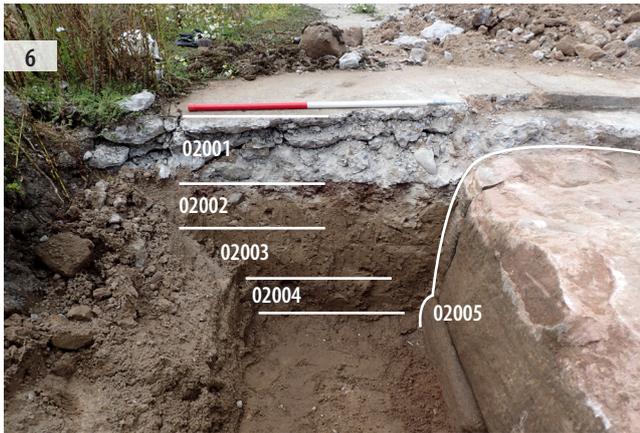
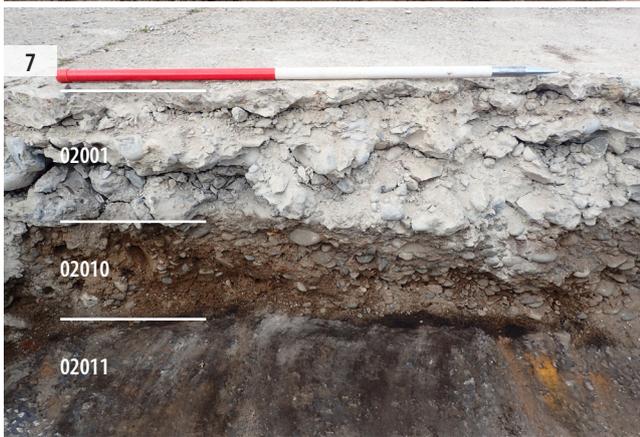
ILLUS 6 Trench 2 representative section (western end) **ILLUS 7** Trench 2 representative section (eastern end) **ILLUS 8** Trench 2 looking east towards Waterloo Dock with 19th century dock wall (02005) in foreground **ILLUS 9** Trench 2 detail of 19th century dock wall (02005) looking east

century redevelopment. This consisted of made ground deposits (02002), (02003) and (02004) each of which butted (02005). Context (02002) was a thin band of red sandy clay rubble at a depth of 0.3–0.4m. Below this lay (02003) at a depth of 0.4–0.84m which consisted of a light yellow brown sand. It was soft and friable and contained occasional small rounded stone inclusions. Finally, (02004), a mixed mid grey yellow brown clay sand deposit was uncovered at a depth of 0.84–1m.

Between (02005) and (02009) lie two patches of truncated sandstone sett flooring (02006) to the west and (02008) in the east, both covered by (02001) concrete surface. It is likely that these are the same but have been robbed out in the past. The blocks are generally rectangular in shape and no bonding agent is visible. These floor surfaces were bedded on to made ground deposit (02007) which consisted of a red sandy rubble.

To the east of red brick wall (02009) the stratigraphy changes and simplifies. Beneath (02001) lay (02010) at a depth of 0.36 – 0.63m. This consists of a loose grey brown sandy deposit with highly frequent medium to large well rounded pebbles and appears to be a deliberate backfill. It sits on a bituminous floor surface (02011) which was hard and compact. Its function is unknown but it sloped from west to east towards the dock perhaps to aid loading of cargo on to ships. This surface did not continue under 02009 but seemed to stop just short of it.

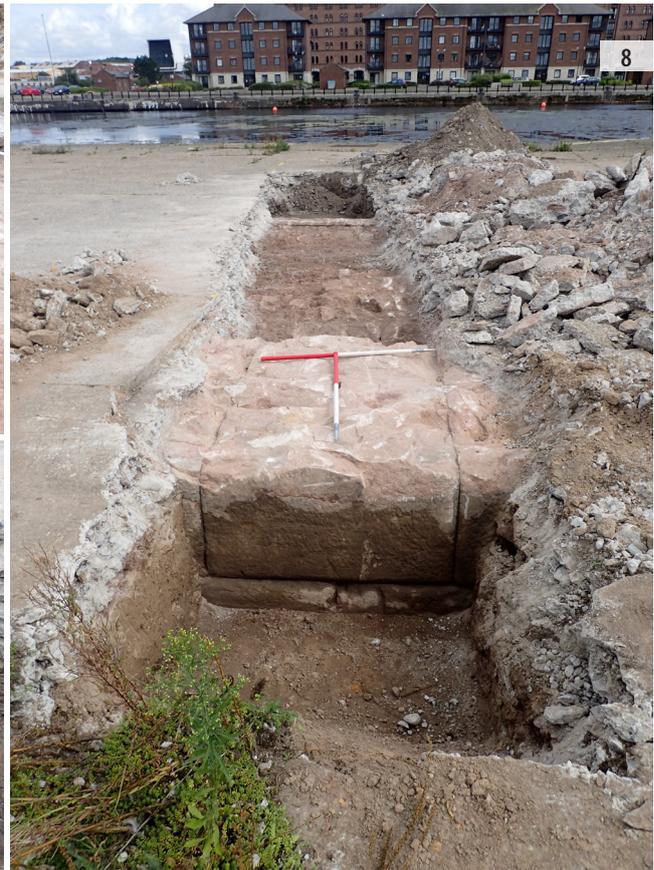
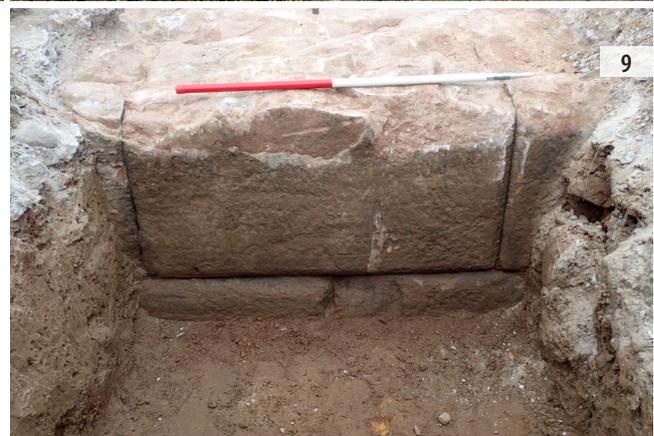
The dock wall itself consisted of large pinkish red sandstone blocks (02005). It was found at a depth of 0.3m and was excavated to 1.06m. Two courses of the wall were uncovered and it extended across the width of the trench and measured 1.88m in width. One block was fully exposed and measured 1.88m x 1.25m x 0.6m. The joints between the blocks were barely visible but an unknown fine black sandy substance could be seen. The top of the wall featured

evidence of fixings of some sort. A small rectangular fixing of unknown function can be seen in the middle of the fully exposed block. Along the joints of the blocks two diamond shaped features can be seen, possibly consisting of mortar and used to fix the blocks together.

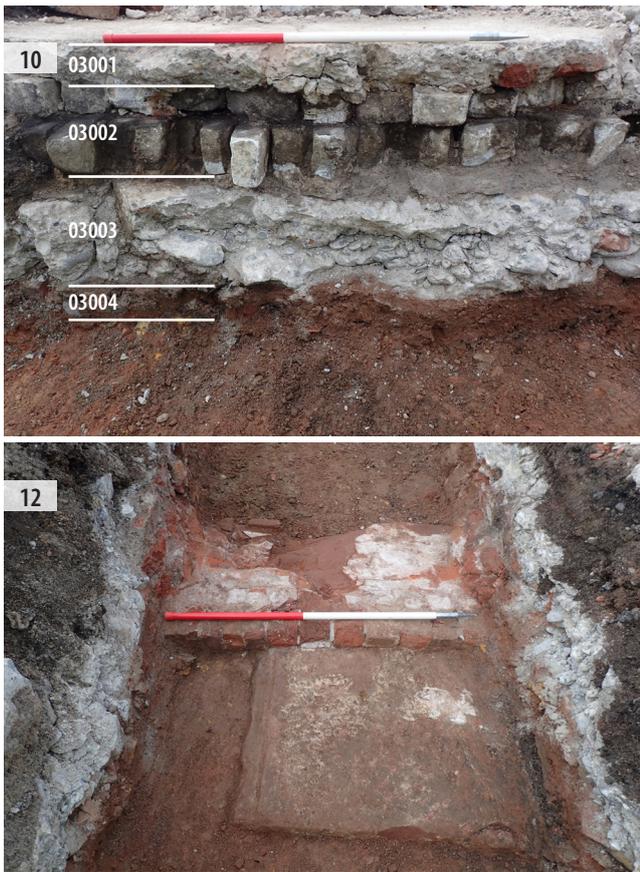
ILLUS 10 Trench 3 representative section **ILLUS 11** Trench 3 looking west towards wall and possible structure **ILLUS 12** Trench 3 detail of wall and possible structure

Trench 3 also had a granite sett dock floor surface (03002) under the concrete. A total of two courses were uncovered at a depth of 0.14–0.45m. The upper course was laid in stretcher with the bottom laid in rollock coursing. A light brown hard and compact sand based mortar was visible. Beneath this an earlier concrete surface, (03003), was uncovered at a depth of 0.45–0.75m. The rest of the trench comprised two made ground deposits (03004) and (03005). Deposit (03004) consisted of a pinkish red clay sand with frequent medium sized sandstone fragments found at a depth of 0.5–1.02m. Beneath this lay (03005) which was a mid-brown sandy clay with rare sandstone fragment and charcoal fleck inclusions at a depth of 1.02–1.19m. Towards the middle of the trench, under (03003), a red brick

wall (03006) and sandstone structure (03007) were found. Wall (03006) consisted of four surviving courses of red brick at a depth of 0.73m, aligned north to south and bonded with a grey cement like mortar. No frogging or stamp was visible but the bricks measured 0.23m x 0.11m x 0.08m in size. This wall rested on a sandstone base which comprised of either one large block or two smaller ones. Mortar, similar to that bonding (03006), was found on the surface of the sandstone. The limitations of the trial trenching makes interpretation of these features difficult, however it is likely these features represent a foundation and lower wall remains of an unknown structure.

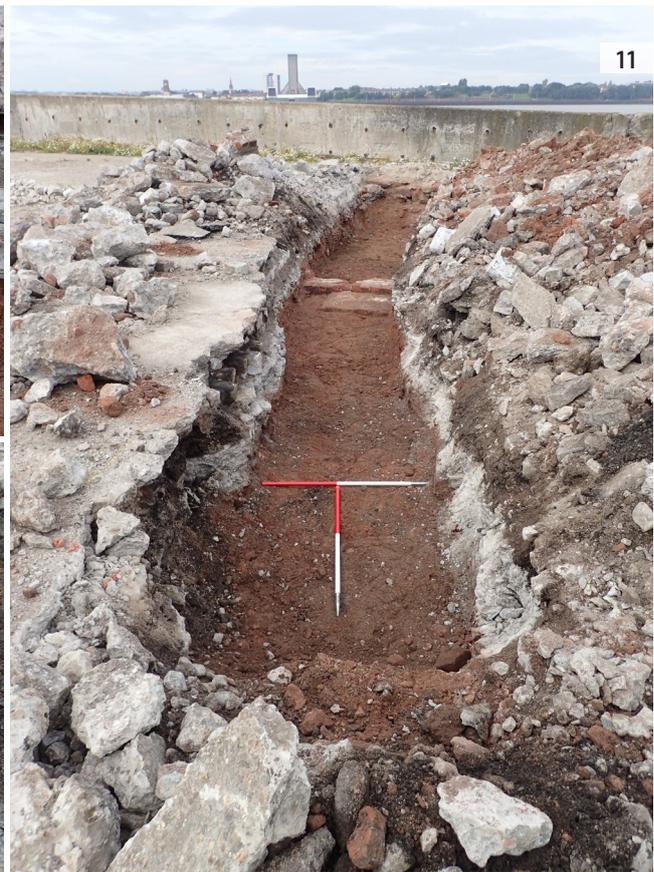
and possibly represent the wall and foundation of dock related buildings. The excavations have revealed both the dock wall and associated structural remains of unknown function and date. Further excavation would be required to provide greater information for the accurate interpretation of the archaeology observed. On the basis of the trial trenching, the proposed construction of the Liverpool City Centre Connectivity, Phase 2 will impact on all the uncovered heritage assets.
