LAND EAST OF THE A417, MAIN ROAD, OVERTON, GLOUCESTERSHIRE

ARCHAEOLOGICAL TRIAL TRENCH EVALUATION

PLANNING REF. 18/01162/FUL

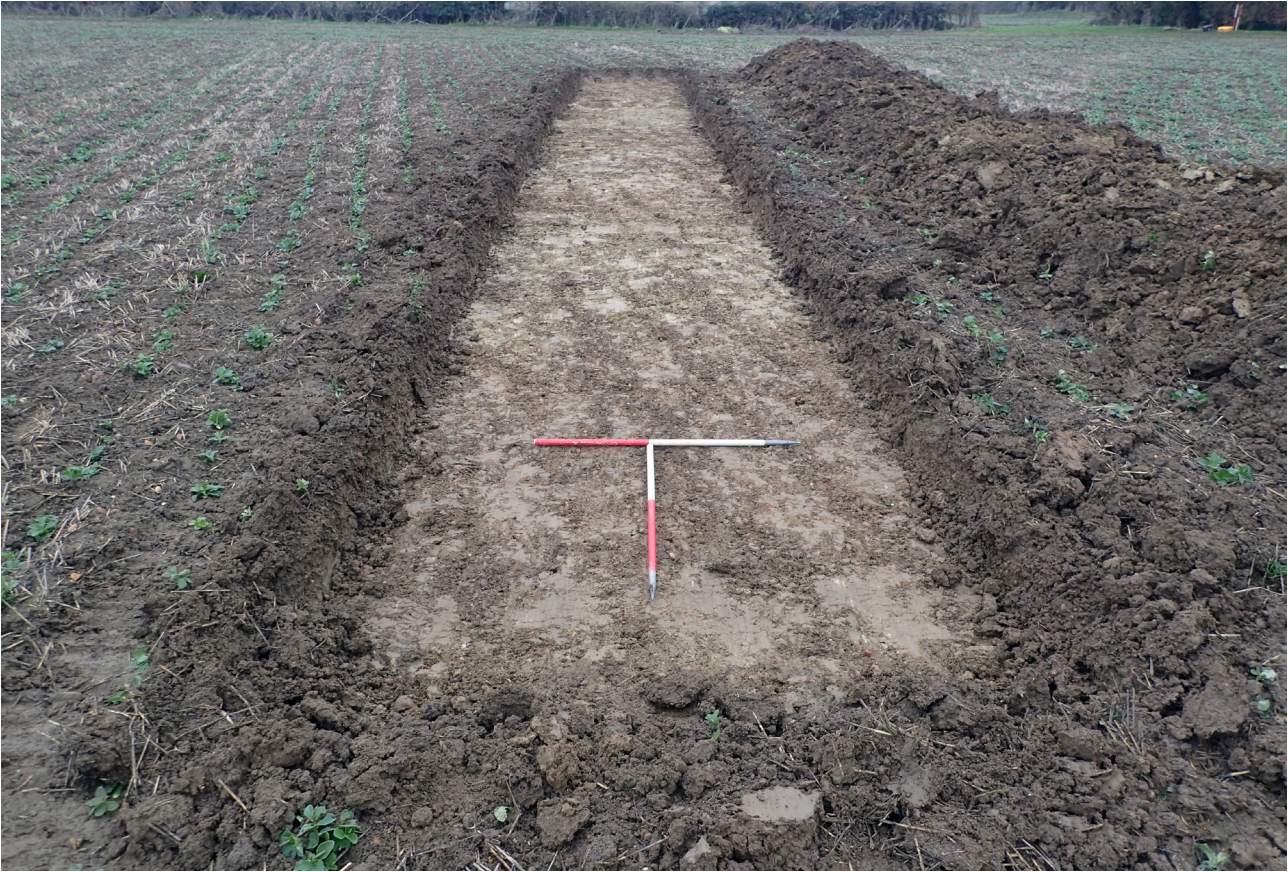
ILLUS 3 Trench 1, looking north

CONTEXT	DESCRIPTION	*D BGL (M)
00101	Topsoil: Mid grey brown silty clay, firm and friable. Light and rooting, occasional small CBM inclusions, occasional small charcoal flecks and frequent small sub angular stones.	0-0.35
00102	Natural: Mid orange red brown silty clay with occasional patches of a yellow grey gravel of mudstone and degraded limestone. Frequent small to medium sub angular stones.	0.35+

SUMMARY
No archaeological features were present. Two land drains orientated north west to south east were found.

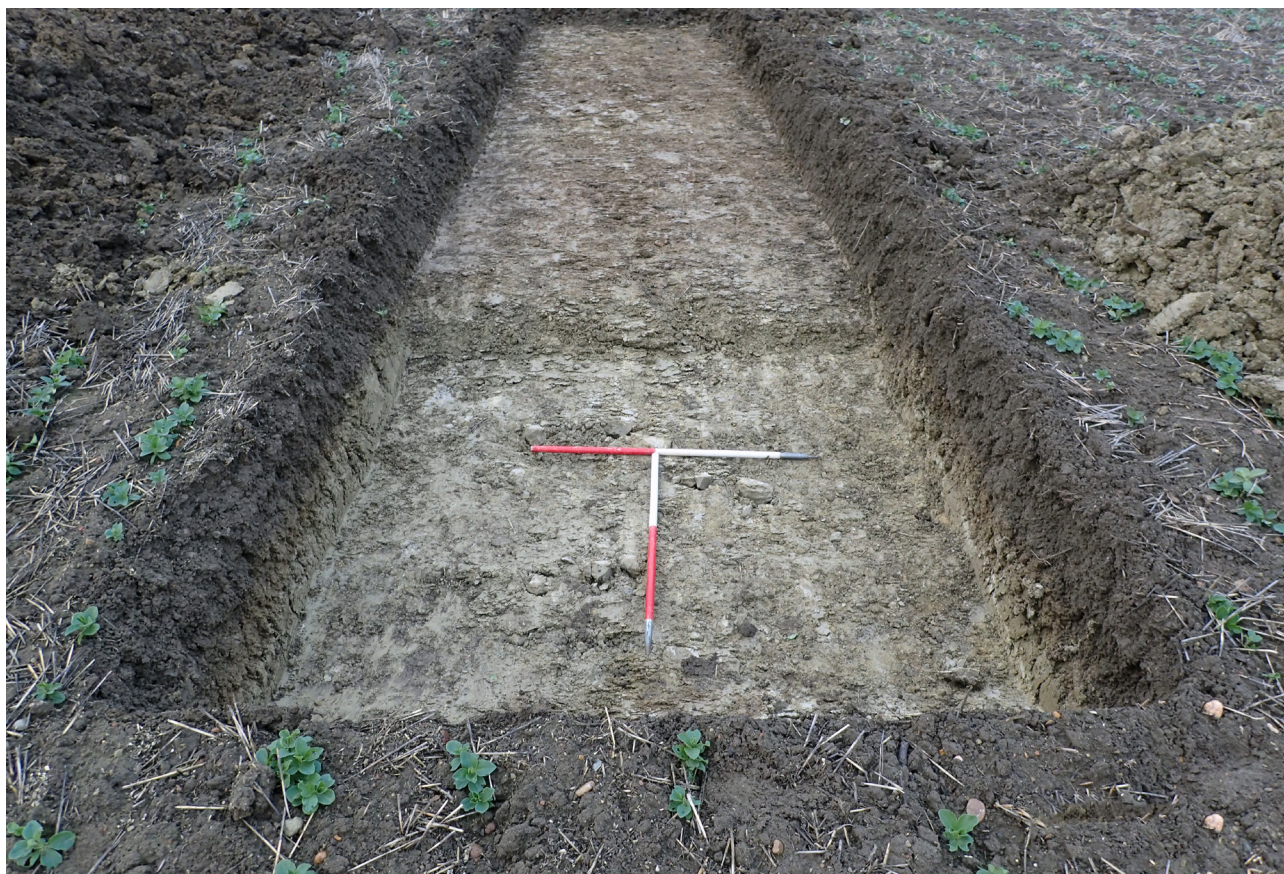
ILLUS 4 Trench 6, looking north

Trench 6 also contained a glacial deposit uncovered by a sondage excavated in the southern end of the trench to test the natural deposits. It consisted of a mid-grey yellow clay with degraded limestone fragments and was excavated to a depth of 0.59m BGL.

CONTEXT	DESCRIPTION	*D BGL (M)
00601	Topsoil: Mid grey brown silty clay, firm and friable. Light and rooting, occasional small CBM inclusions, occasional small charcoal flecks and frequent small sub angular stones.	0-0.32
00602	Natural: Mid orange red brown silty clay with occasional patches of a yellow grey gravel of mudstone and degraded limestone. Frequent small to medium sub angular stones.	0.32-0.47
00603	Glacial Clay: Mid grey yellow clay. Very firm and compact. Frequent small to large degraded limestone fragments. Found only in the sondage at the south of the trench.	0.47-0.59+

No archaeological features were present. A sondage was excavated in the southern end of the trench to test the natural deposits.
