LAND AT HUGGATE WOLD FARM EAST RIDING OF YORKSHIRE

ARCHAEOLOGICAL TRIAL TRENCHING EVALUATION

PLANNING REF. DC/19/2842/PLF

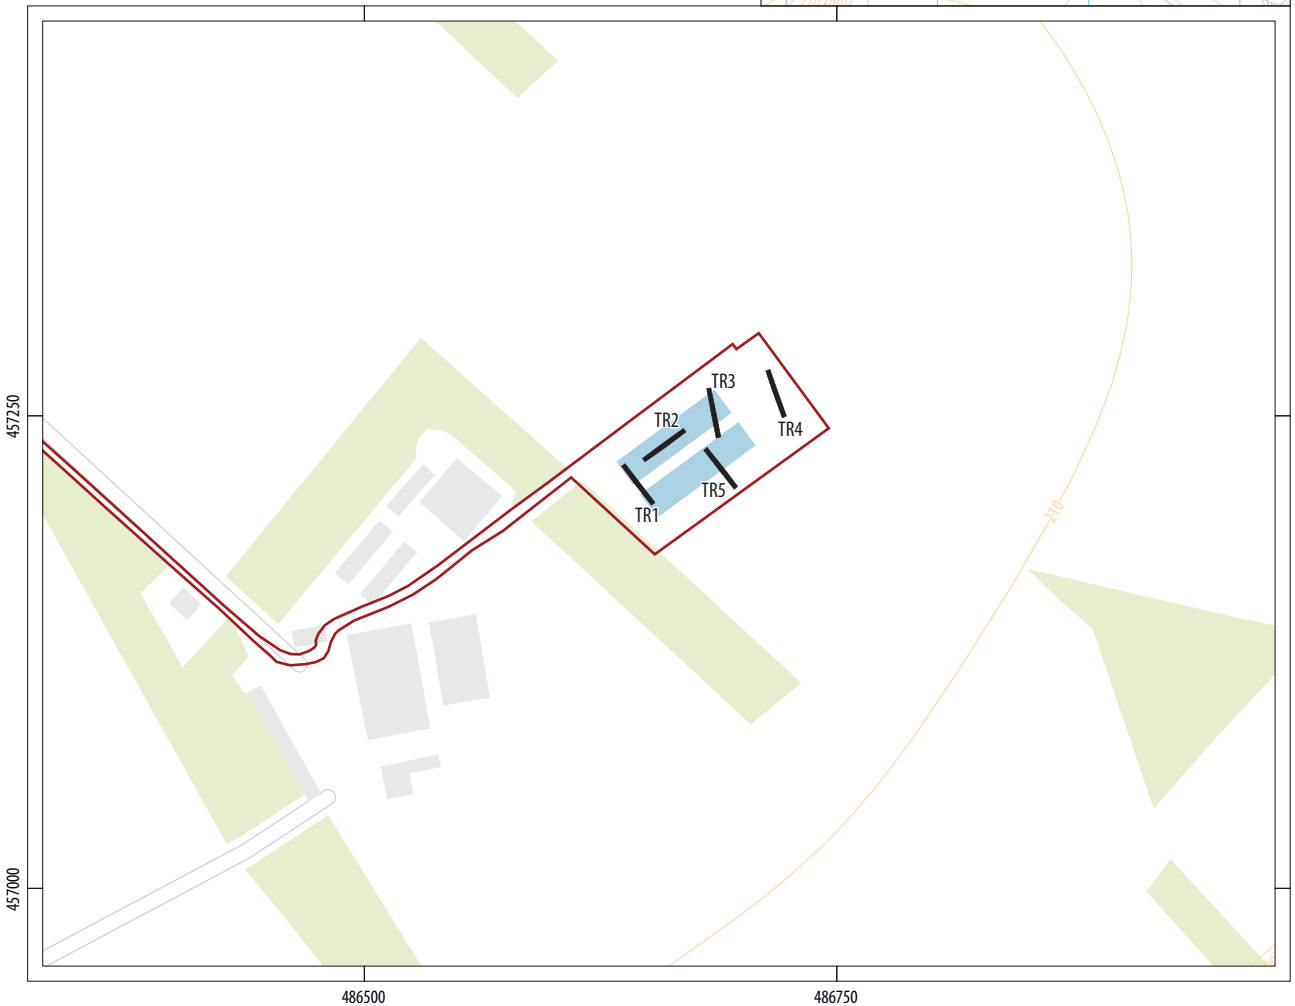
ILLUS 1 Site location

application area proposed development footprint
trench location

Five trenches were excavated, each measuring 25m x 2m (Illus 2). Four trenches were set out in accordance with the agreed layout plan in the WSI although Trench 3 was relocated approximately 2m south of the proposed position in order to avoid damaging an existing track.

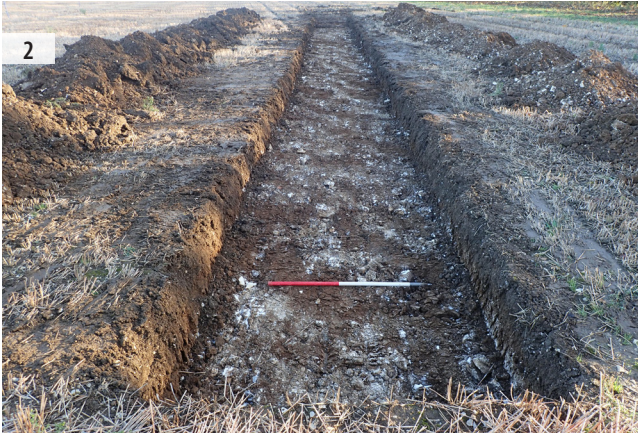
ILLUS 2 Trench 1 looking south-east **ILLUS 3** Trench 4 looking west; natural fissuring in chalk bedrock

The trial trenching evaluation confirmed the presence of scars on the natural deposits resulting from modern ploughing (Illus 2). No archaeological features or deposits were present in any of the trenches. Naturally occurring fissures in the chalk bedrock correlate with the fragmented linear anomaly identified by the geophysical survey, thus confirming its results. No further archaeological work is anticipated.
