THE BROOKE HOTEL, BROOKE ROAD WEST, CROSBY, SEFTON, MERSEYSIDE

ARCHAEOLOGICAL EVALUATION & BUILDING RECORDING

PLANNING REF. DC/2020/02174 & DC/2020/01396

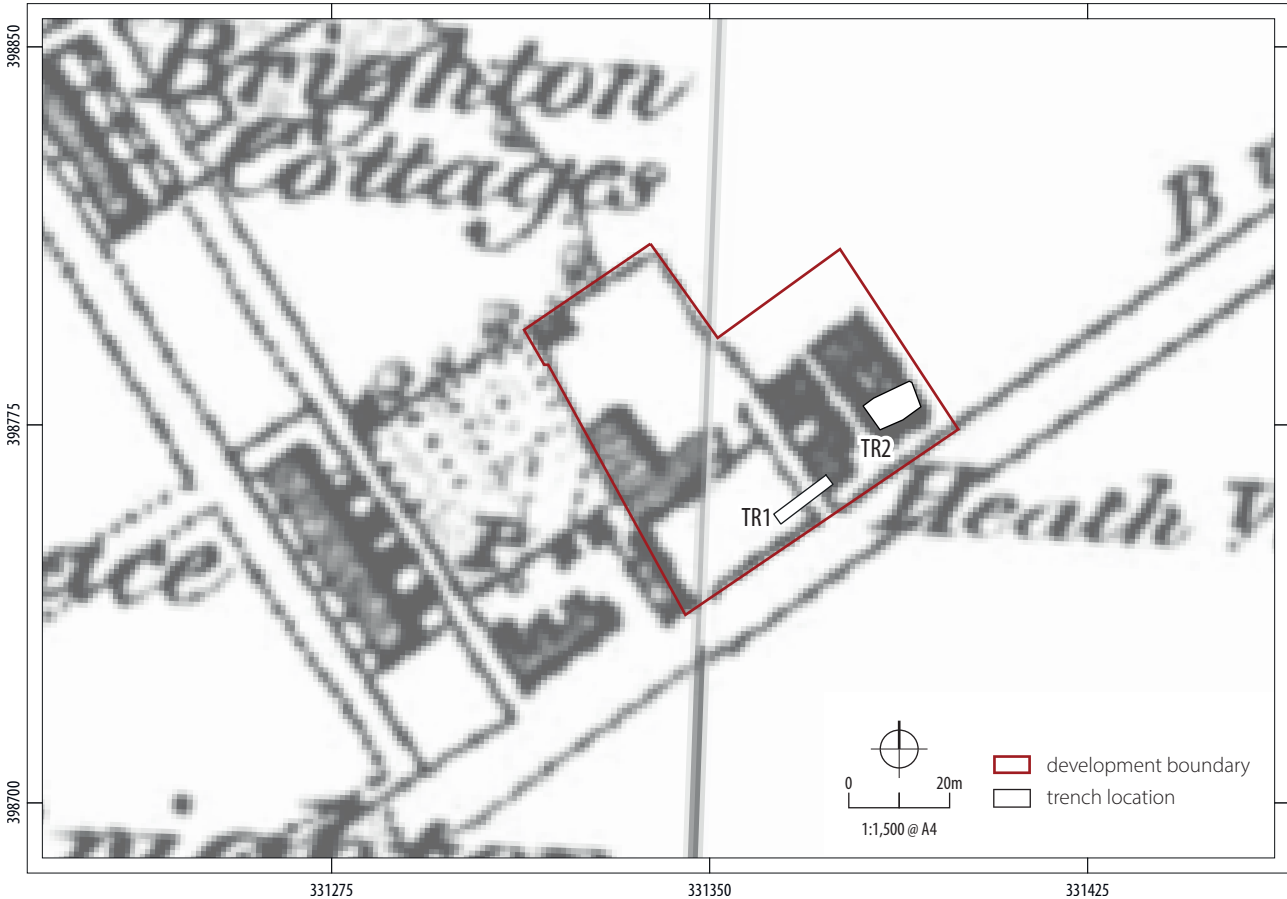
ILLUS 4 Part of the First Edition OS 6 in to the mile survey published 1850 ILLUS 5 Part of the Waterloo and Seaforth Sewer Plan dated 1857

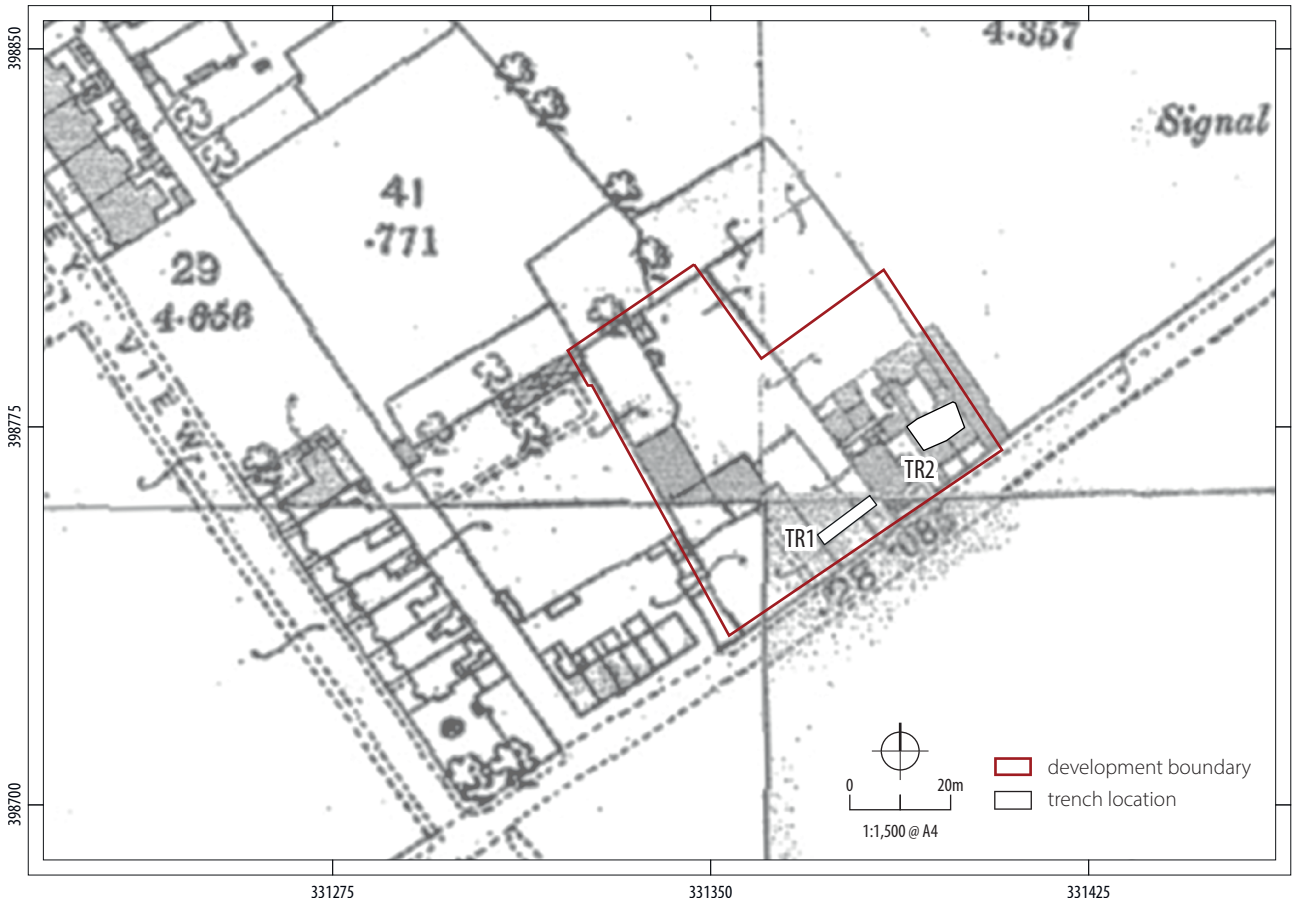
ILLUS 6 Part of the First Edition OS 25 to the mile survey published in 1893 ILLUS 7 Part of the 25 inch to the mile survey published in 1908

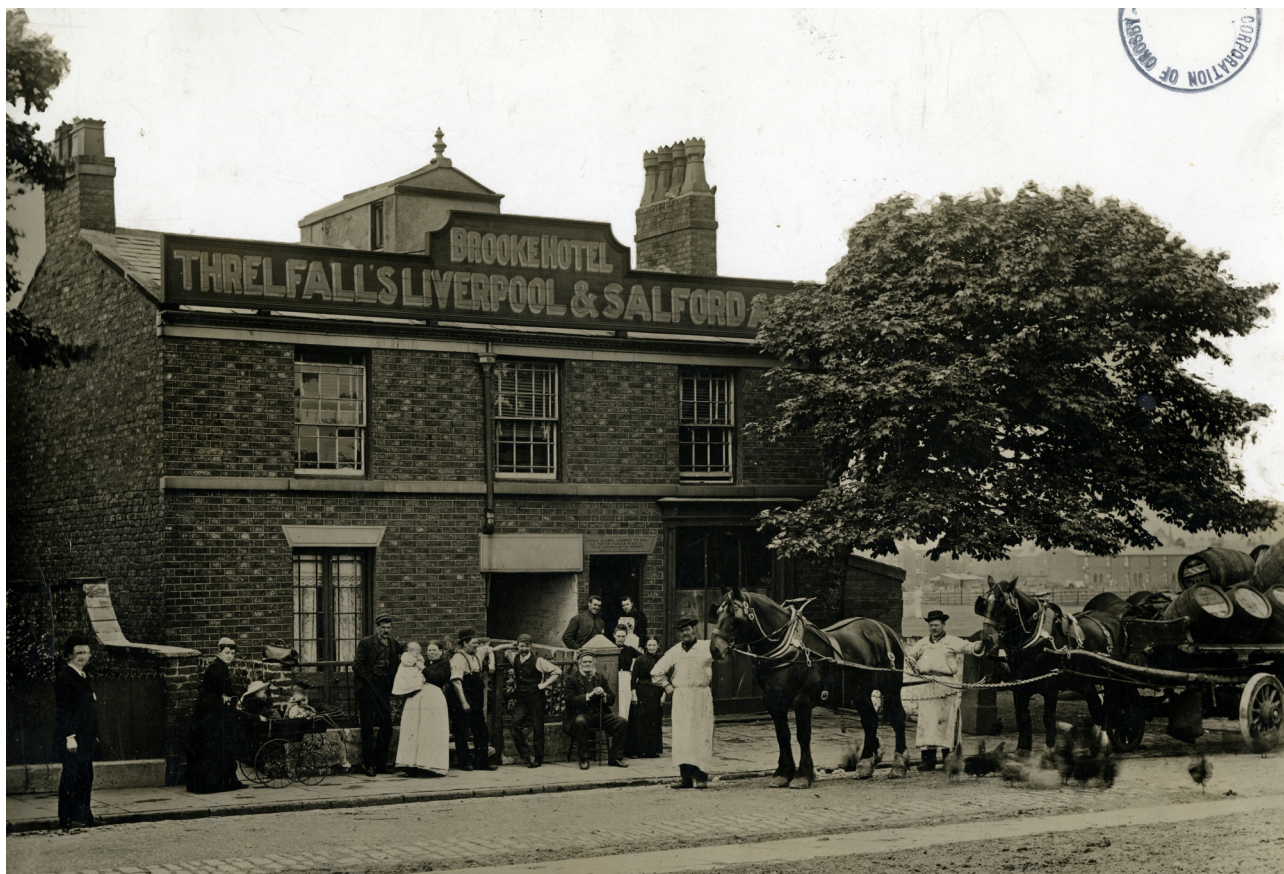
An undated photograph in Sefton Archives (Illus 9) is described in the catalogue entry as being of the 'Brooke Hotel', Brooke Road'. The form of the building is however quite different to that of the hotel constructed in the 1920s and currently standing on the site. It was a two storey building of two bays with a low, single pitch, roof. The frontage was pierced by two entrances which perhaps equate to the gap between the two blocks depicted on historic mapping. A large sign read 'Brooke Hotel Threlfall's Liverpool and Salford A[obscured]'. The people stood in front of the hotel are dressed in clothing typical of the late 19th or early 20th century. In the absence of other identifying features it is possible that the image is of a different location, though the building is consistent in size with that shown on 19th and early 20th century mapping and the surrounding landscape of fields visible in the background is consistent with the landscape depicted on contemporary mapping, so it is considered likely that this is an image of the predecessor to the pub constructed in the 1920s.

ILLUS 9 Photograph of the Brooke Hotel c 1900
 © copyright Sefton Libraries 2014–2021, all rights reserved (PhotoID SS_HL3)

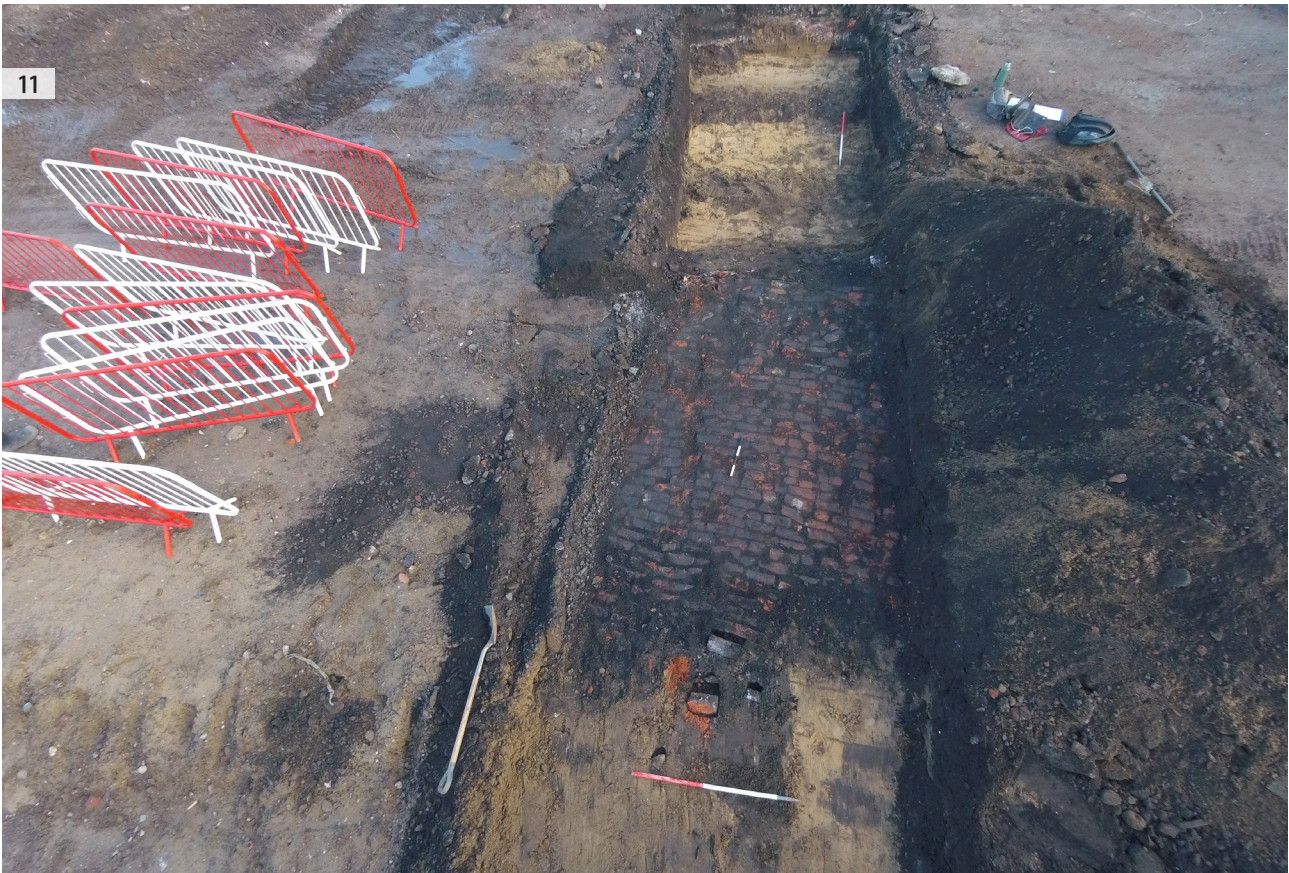
distance of 4.00m. This was constructed in hand-made unfrosted brick on a bed of lime mortar and was perhaps a yard surface associated with one of the outbuildings depicted on the 1844 Tithe Map. It had formerly extended to the west but had been removed during construction of a piling mat in that area prior to receipt of the condition (communication from client). Following recording this was excavated by machine which exposed underlying deposits of windblown sand.

To the west of these was an area of crudely constructed brick paving (Context 3) which covered the whole of the trench surface for a

ILLUS 11 View of Trench 1 looking east. Context 3 is in the foreground ILLUS 12 View of Trench 2 looking west. Context 4 is in the foreground

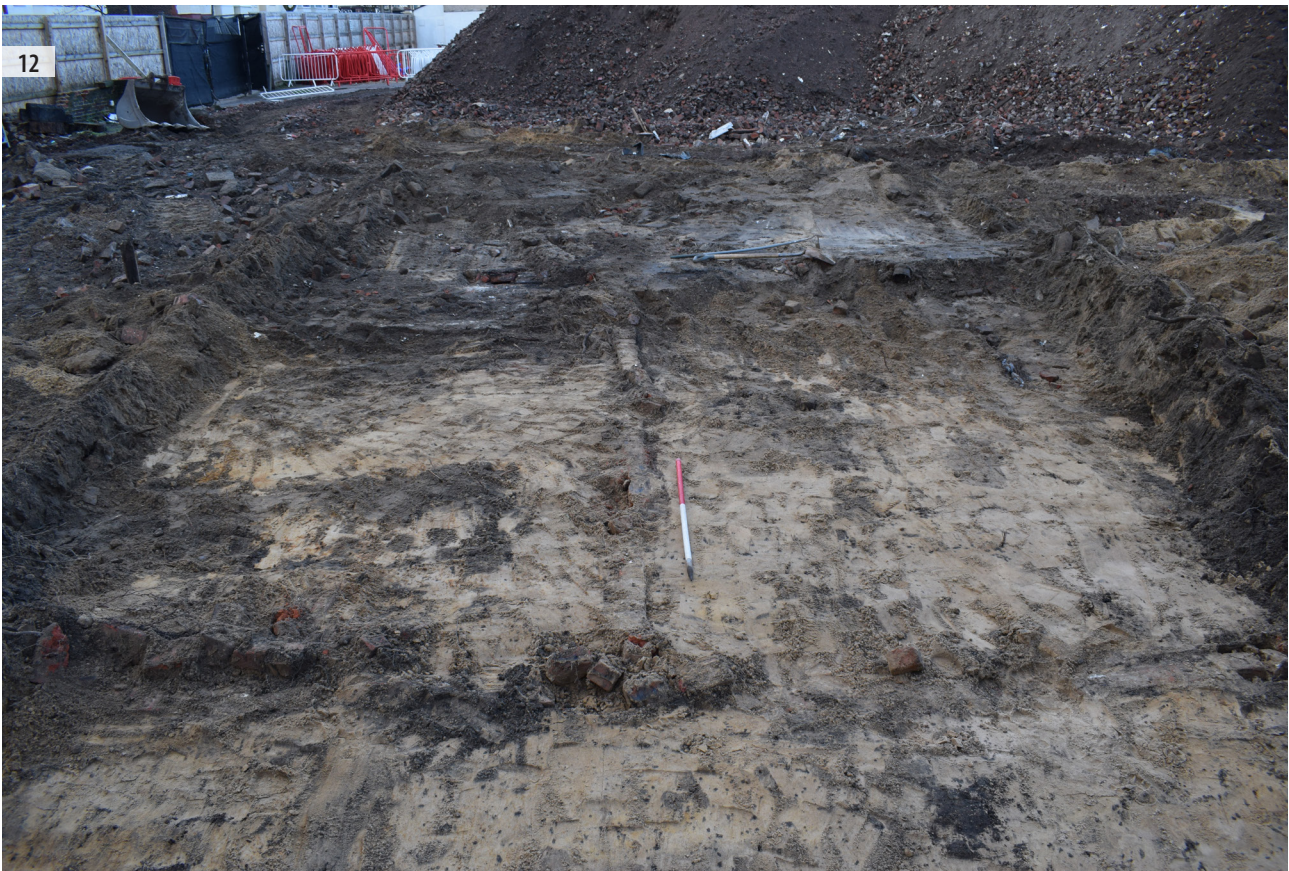
Trench 2 measured 5x10m and was situated to the east of the Brooke Hotel (Illus 10). The earliest deposits were two walls, Context 4 was aligned north-south and was bonded at its mid-point by Context 5 which was aligned east-west and truncated at its western end by the east wall of the Brooke Hotel (Illus 12). Both walls were constructed in locally produced hand-made unfrosted red-brick and bonded with lime mortar. Both consisted of a single skin of bricks and survived to a depth of 2-3 courses (c 210mm). Two short sections excavated across the walls found a single fragment of clay tobacco pipe stem and a fragment of transfer printed earthenware dating to the 19th century.

No internal or external surfaces associated with these walls survived, small areas of darker material within the footprint of the structure were rapidly excavated by hand and shown to contain fragments of brick, lime mortar and Welsh roofing slate. These deposits are not described in detail but are considered to be related to demolition of the structure in the 1920s.

Contexts 4 and 5 are interpreted as the foundations to the cottages depicted on the 1844 Tithe Map.

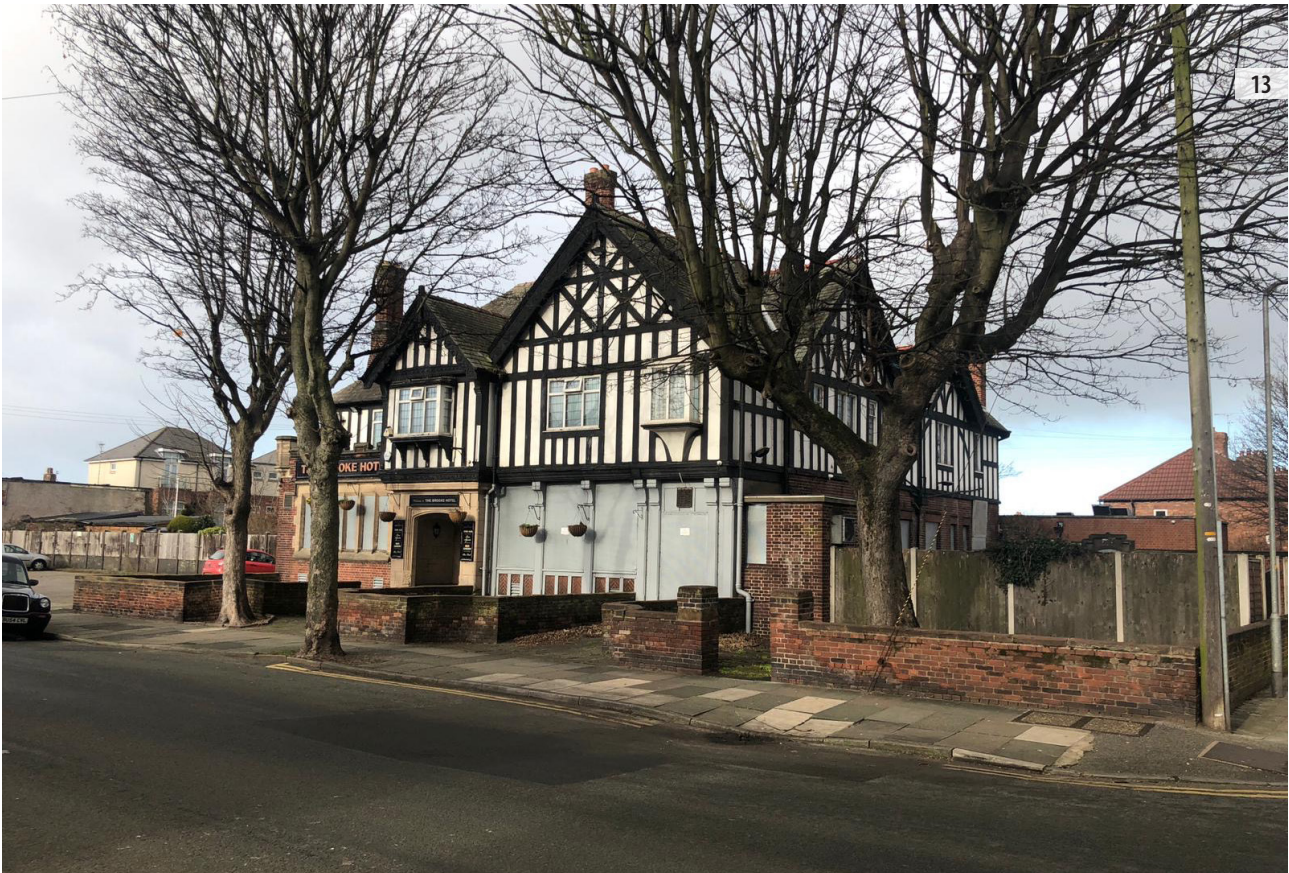
The Brooke Hotel was a two storey, purpose built, public house in 20th century Tudor Revival style (a type often referred to as 'Brewer's Tudor'). The principal elevation fronted south onto Brooke Road West and on the ground floor was a mix of brickwork, and fake timber framing with brick noggin. The door was framed in neatly dressed stone and there were stone mullioned windows at the west end of the elevation (Illus 13). The roof was clad in Westmorland slate (R Burns, pers comm) though this had been removed prior to the commencement of this project.

ILLUS 13 Front (south) and east facing elevations of the Brooke Hotel
ILLUS 14 Signage above front door of the Brooke Hotel

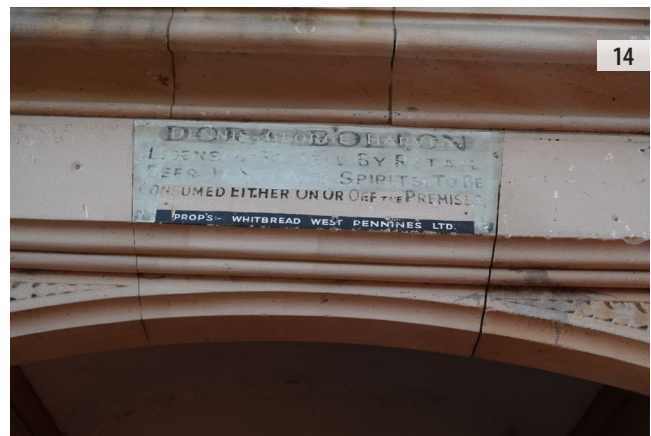
Above the front door a painted sign showed that the hotel had been owned by Whitbread West Pennines Ltd (Illus 14) who were presumably the original builders of the hotel.

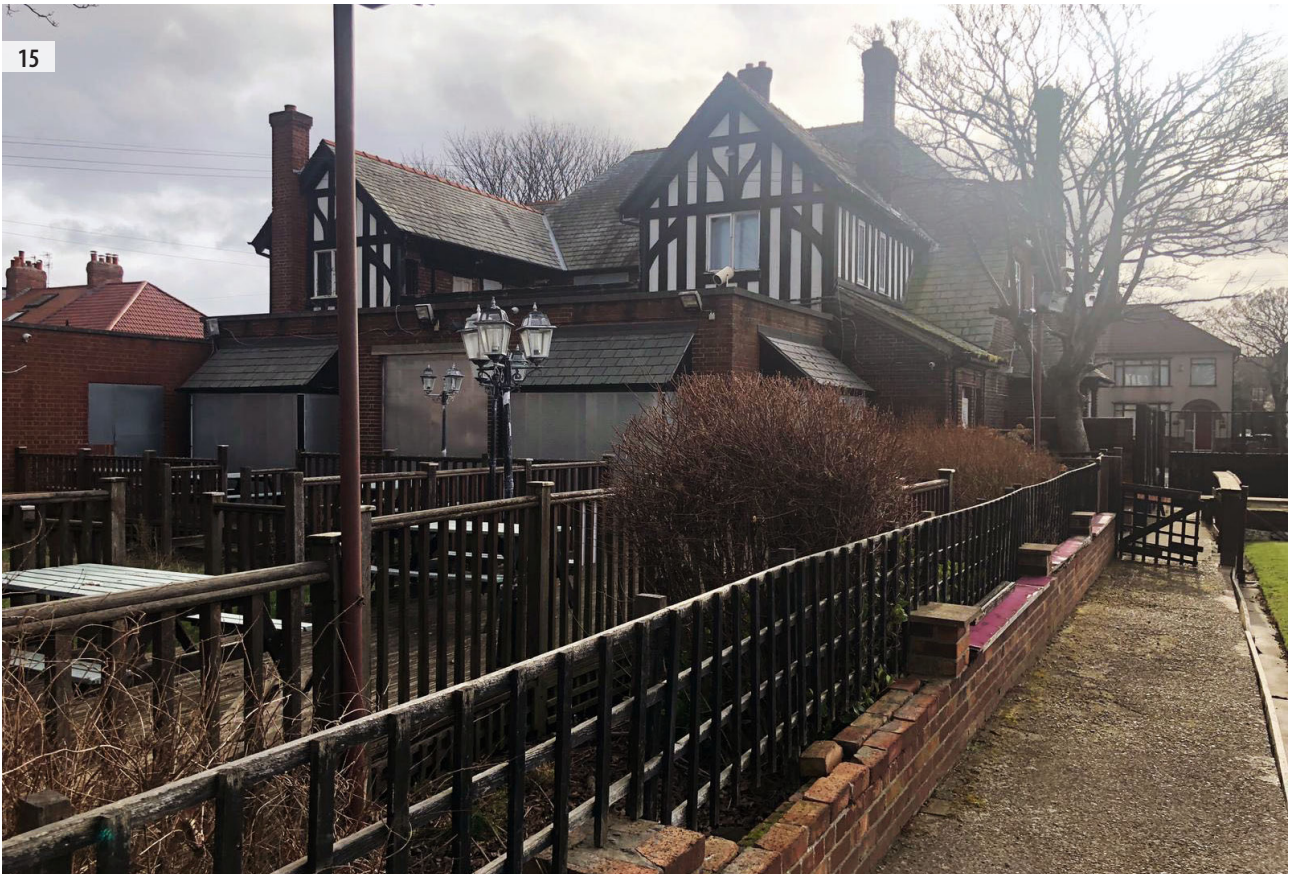
The other elevations were more plainly constructed but also featured mock timber framing above a brick faced ground floor (Illus 15).

ILLUS 15 Rear elevation of the Brooke Hotel ILLUS 16 Internal fireplace ILLUS 17 Internal fireplace

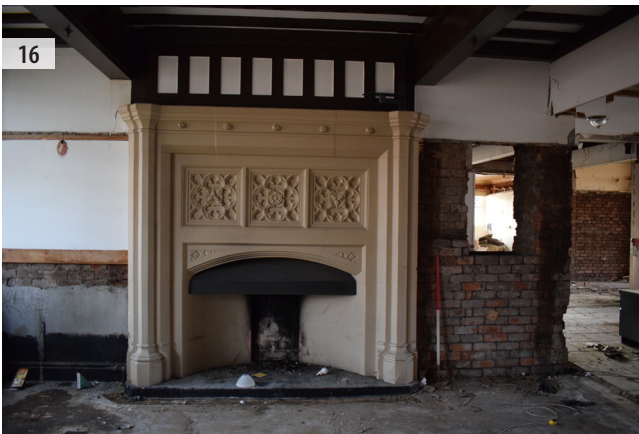
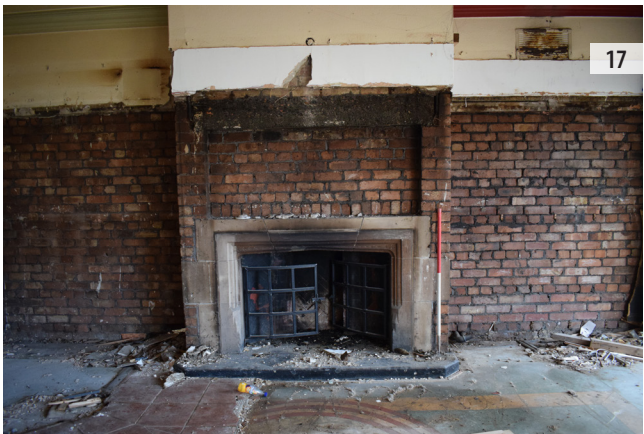
Internally few original features survived. At ground floor level internal walls had been removed, probably in the late 20th century to create a single bar area. Two stone fireplaces were the only significant features (Illus 16 and 17). At first floor level there was an external balcony area between the two side wings, again probably created in the late 20th century. No internal fixtures or fittings survived.
