WEST END GARAGE BEDLINGTON NORTHUMBERLAND

REPORT OF ARCHAEOLOGICAL MONITORING AND RECORDING

BRP 08/02b

March 2012

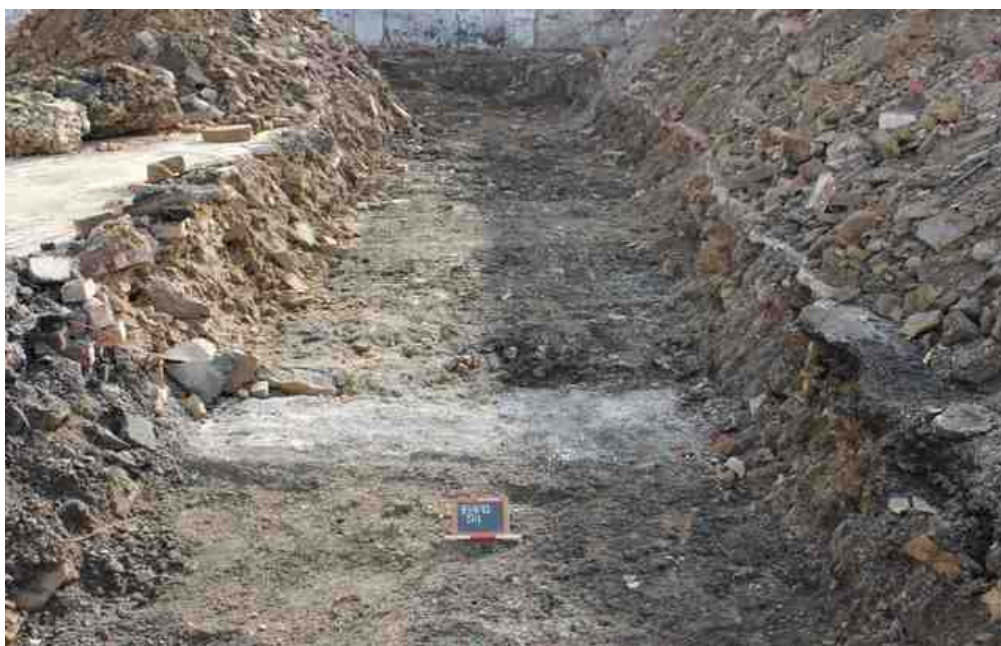
- 6.0.1 The foundation trenches were excavated by machine under continuous archaeological monitoring. Brick and stone rubble, almost certainly derived from modern building works, was encountered to the full depth of the foundation trenches (Plate 1). At the southern end of the site evidence of cut bedrock was present (Plate 2), suggesting that the underlying bedrock had been quarried away in places. No archaeological stratigraphy of any significance was encountered within the area of the foundation trenches.

Plate 1: Construction trench excavated through bricks and stone rubble , facing south

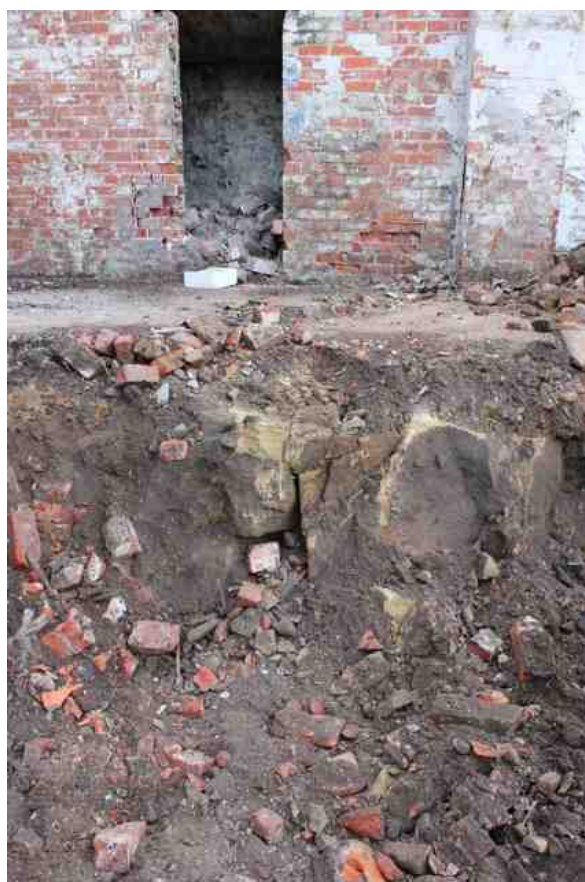
- 7.0.1 Although the location of the site is almost certainly within the boundary of medieval Bedlington the present work has revealed a significant level of disturbance, to a depth of 1m, and some degree of what is likely to be deliberate quarrying, indicating very little likelihood of the survival of medieval stratigraphy in the immediate vicinity.

Plate 2: Possible quarrying, facing south
