CARTERSIDE FARM, ROTHBURY, NORTHUMBERLAND

HISTORIC BUILDING RECORDING

Compiled for Mortgage Guarantee plc by The Bamburgh Research Project: Commercial Projects Section

BRP 13/02b

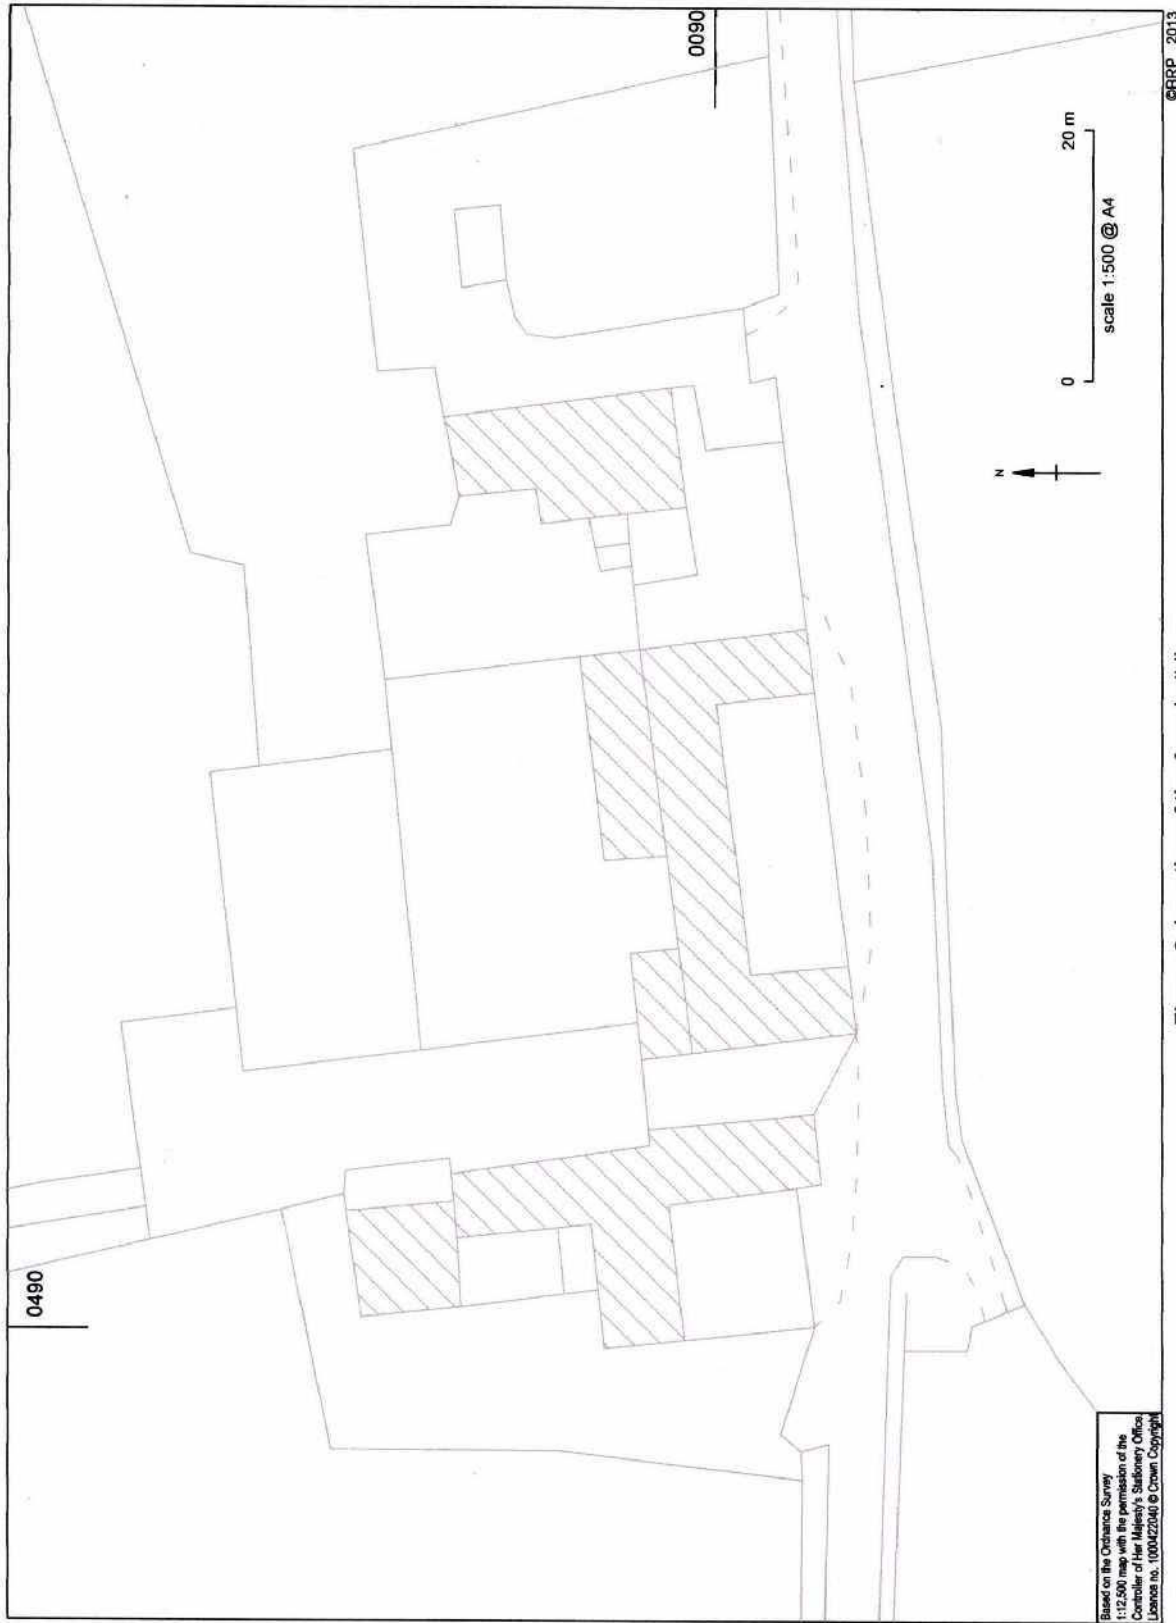
Figure 2 Location of the farm buildings

The farm complex comprises a farm house and two ranges of buildings, the central C-shaped and extending parallel to the road, and the third, T-shaped, on the west side and extending away from the road. The farm occupies 75m east to west and 42m north to south. The buildings themselves slope gently downhill from south to north as they extend away from the road (Figure 2).

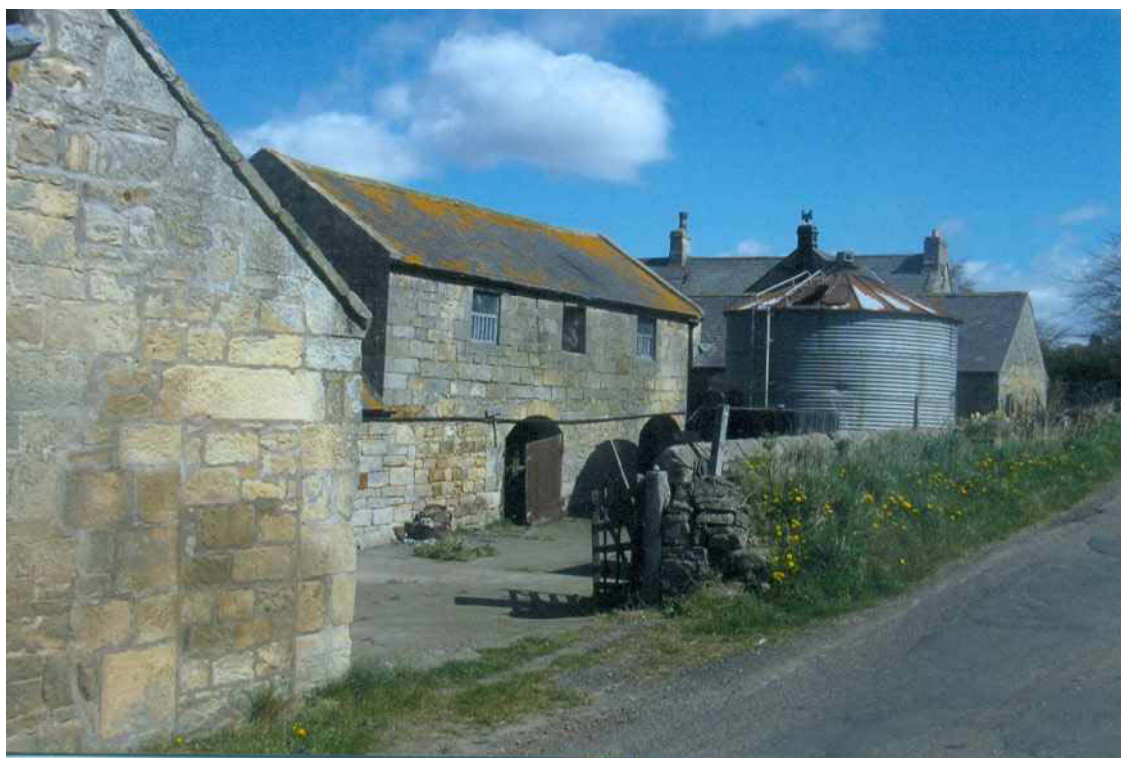
- 5.0.2 The C-shaped range of buildings, in the centre and nearest the road, would appear from both position and form to have formed the heart of the farm complex and to have been the earliest constructed on the site. The east-west range, Room F, is formed from square cut rectangular masonry blocks of varying sizes up to 0.7m wide by 0.25m in height down to small blocks. The structure was irregularly coursed, but formed a build of apparently good quality. It measured 21m by 5.5m and had an upper storey over the eastern half of the structure. A single build with north and south facing doorways in the western single storey element and a series of four archways let into the south wall of the eastern two storey section. Rooms E, G, H and I were a later additions, present by the 1st Edition OS map's compilation, indicating their construction by the first half of the 19th century. The additions were also constructed from square cut blocks but of generally smaller proportions than those of the original build. Rooms E and G formed a north to south range on the east end of F measuring 17m north to south by 5.6m east to west, with G overlapping range F at a width of 8.5m. The range formed by Rooms H and I measured 18m north to south by 5.5m east to west. Two doors led into the east wall of Room E on its south side and a further blocked doorway was present in the south wall, originally leading out to the road (Plate 8). Two doorways were present in the east wall of Room H and no trace of structure J, that joined this range to the farmhouse on the first edition, was visible. A further doorway, facing west and opposite those into Room E, was present. Modestly sized simple square windows were present within the range including a series of three in each long wall of the upper storey element of F (Plates 1 and 2).

Plate 1: Room F from the south-west, two archways were blocked at the time of the development

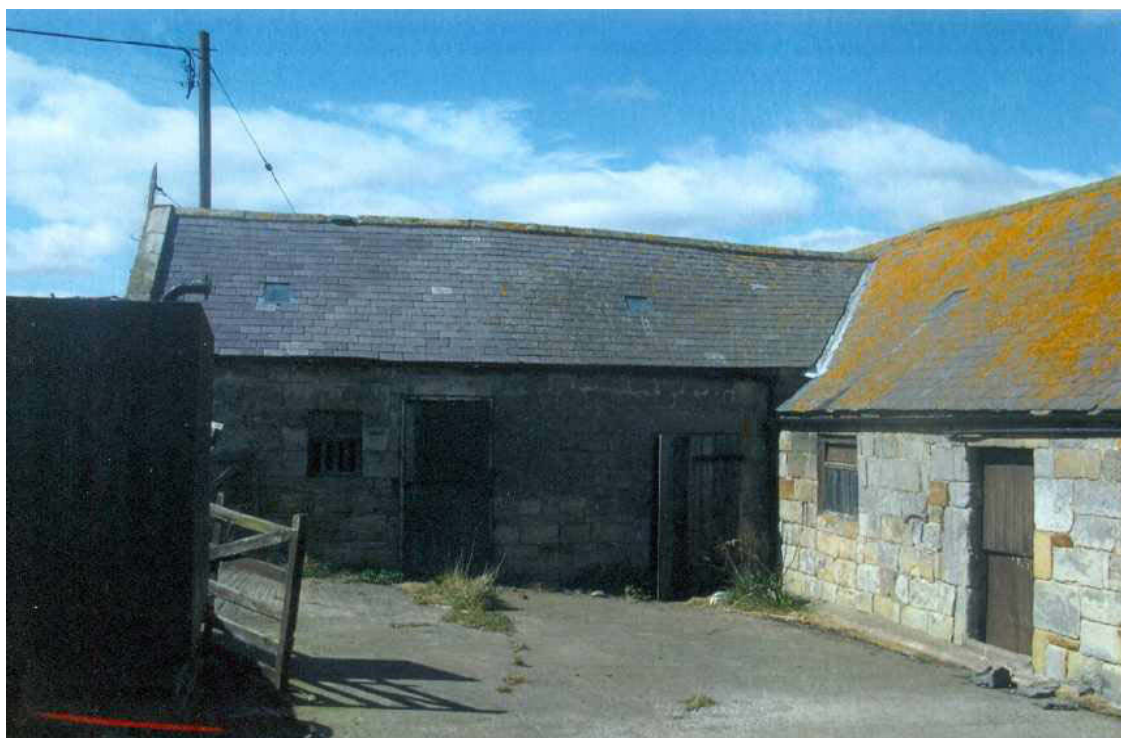
Plate 2: Rooms E and F from the south-east

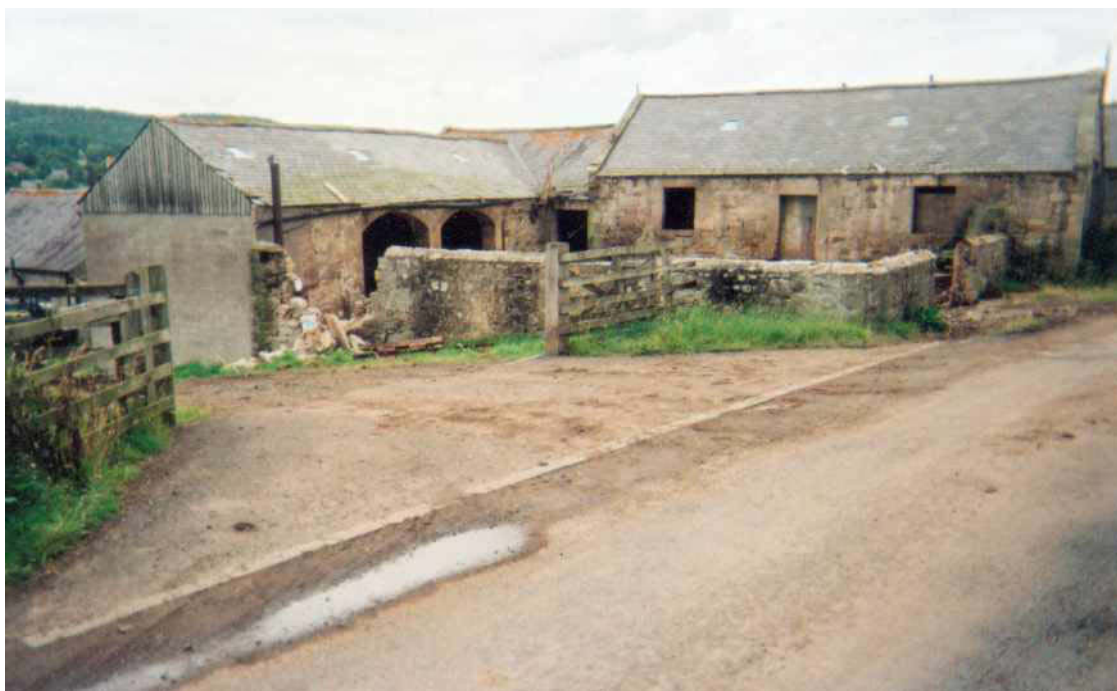
- 5.0.3 Rooms A, B and C formed a T-shaped range extending northwards from the road on the west side of the farm. It was not attached to the C-shaped range being separated by 5.9m. The range measured 29m by 15.6m overall. Room A, measured 11.56m by 5.9m and was adjoined to room B at its north end where a cross-passage, at the south end of B, led through the building. The L-shaped section formed by B and C was offset slightly to the east. B and C are stepped down the slope. This block was 15.6m by 17.6m overall and formed from wings 5.4m wide. Rooms A, B and C appear to have formed a single build, originally, but the preponderance of small and irregular sandstone blocks towards the base of the structure and somewhat larger, but still irregularly coursed blocks higher in the walls may indicate more than one phase of work. That noted, no clear evidence of a phase division was present and it is quite possible that this was just an eccentricity of the build. A door was present in the west wall of Room A and three archways led through the south wall of B. A further archway was present in its east wall with a further three in the east wall of Room C, which formed cart sheds, shelter sheds or a simple storage area. Simple square windows were present in the west wall of Room A but not elsewhere within the range (Plates 3, 4, 5 and 6).

Plate 3: Rooms A and B, from the south-west, one archway is blocked on the south side of Room B

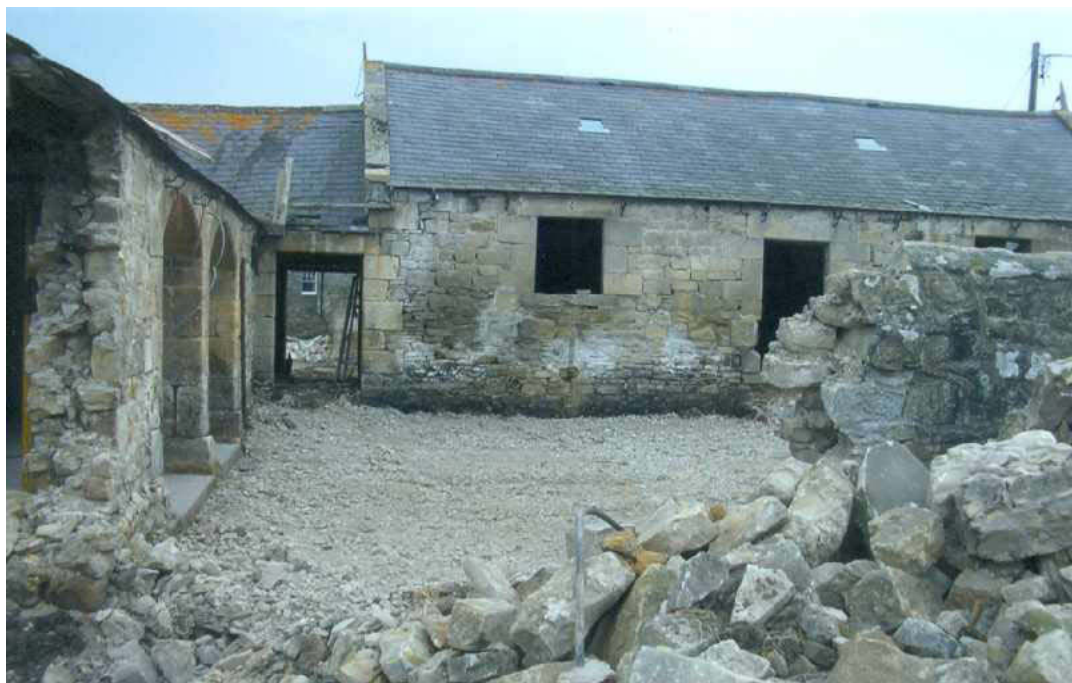
Plate 4: Room B part demolished with the through passageway visible between Rooms A and B, facing east

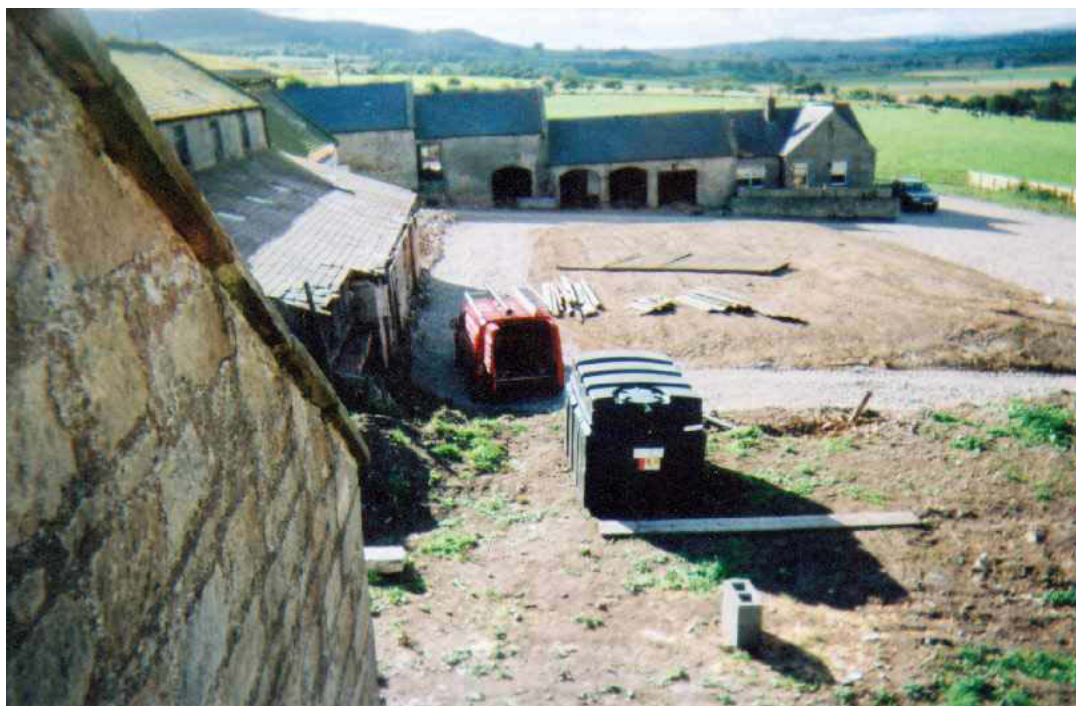
Plate 5: Northern part of the western building range following the demolition of the late 20th century shock sheds, Rooms B, C and D, facing west

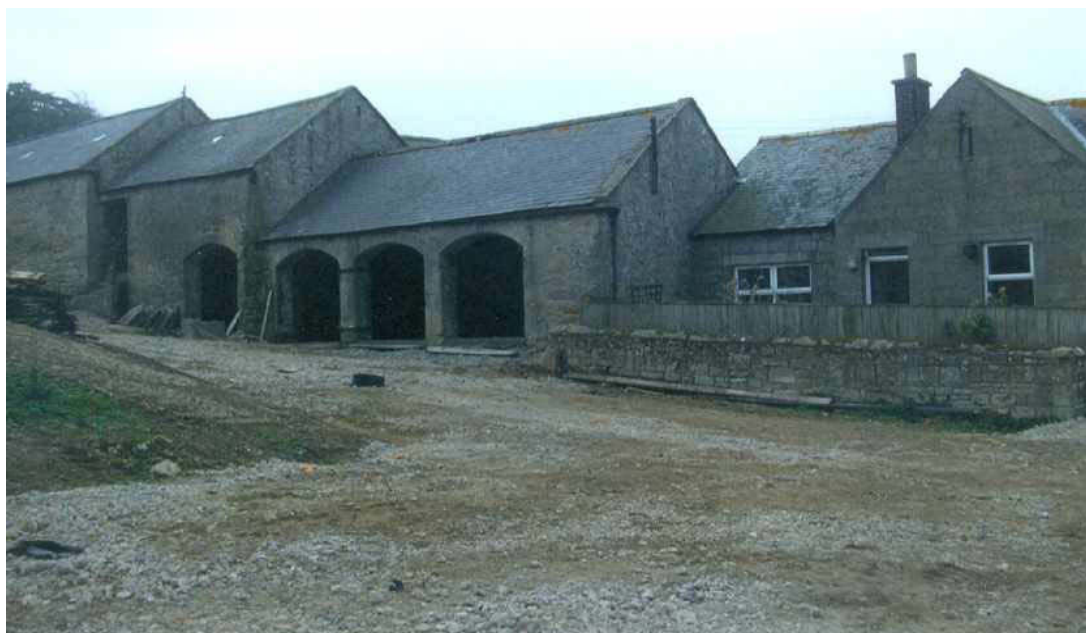
Plate 6: Rooms B, C and D, facing south-west

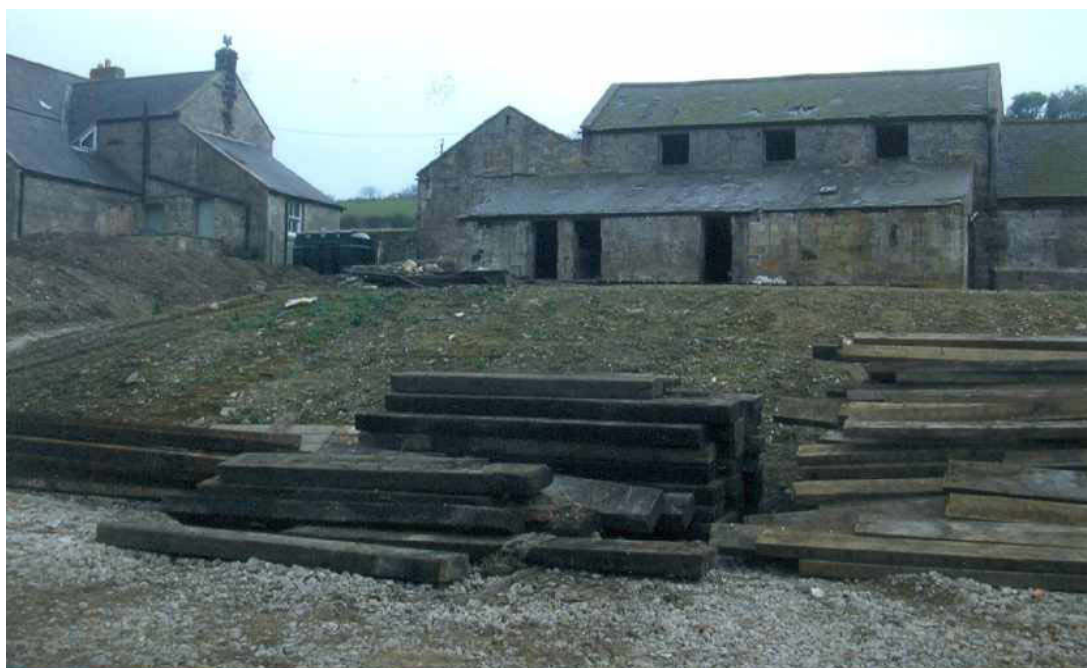
- 5.0.4 An additional Room (L) measuring 4.8m by 4.9, was added to the north side of Room F by the 1920s, from cartographic evidence. It represented a simple lean-to addition to the north side of room F with a large rectangular door taking up much of the west wall. A cottage-like building (Room D) had also been constructed onto the north end of the western range. It measured 9m east to west by 8.3m north to south and was a single phase build of small to medium rectangular, regularly coursed, sandstone blocks. A simple door was set into the east wall and two equally plain windows were present in each of the west, north and east walls (Plate 7).

Plate 7: The north side of Room F with extensions I and L, facing south

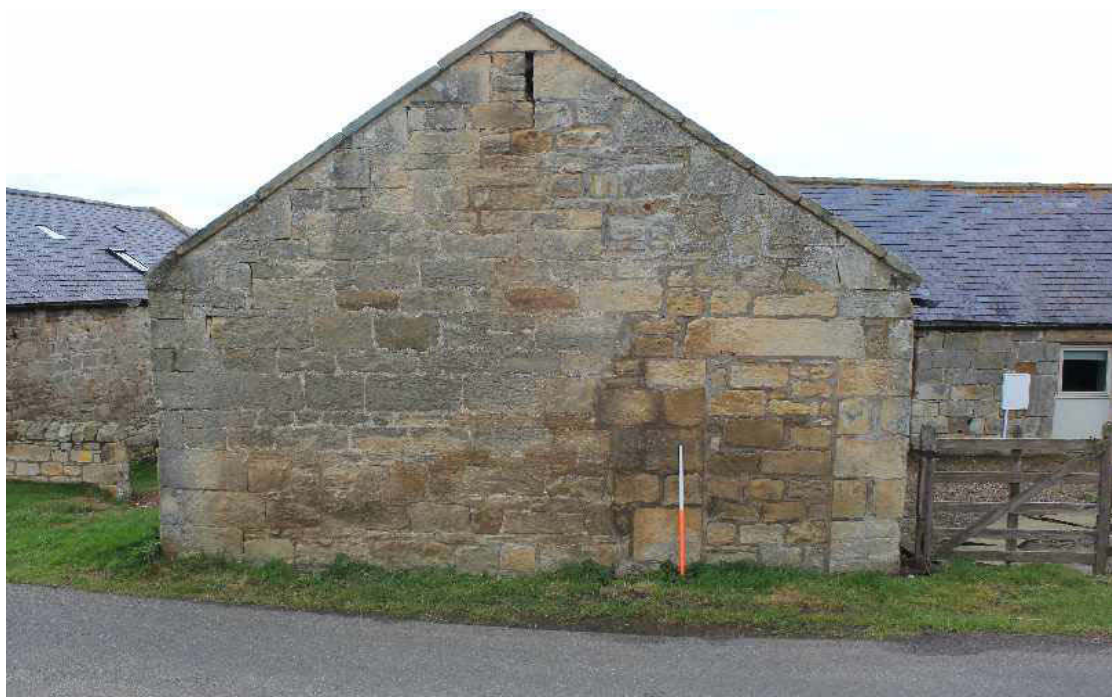
Plate 8: South end of Room E, showing blocked doorway, facing north
