WHITTINGTON MILL NORTHUMBERLAND

HISTORIC BUILDING RECORDING AND ARCHAEOLOGICAL TRIAL TRENCH REPORT

BRP 18/01b

February 2018

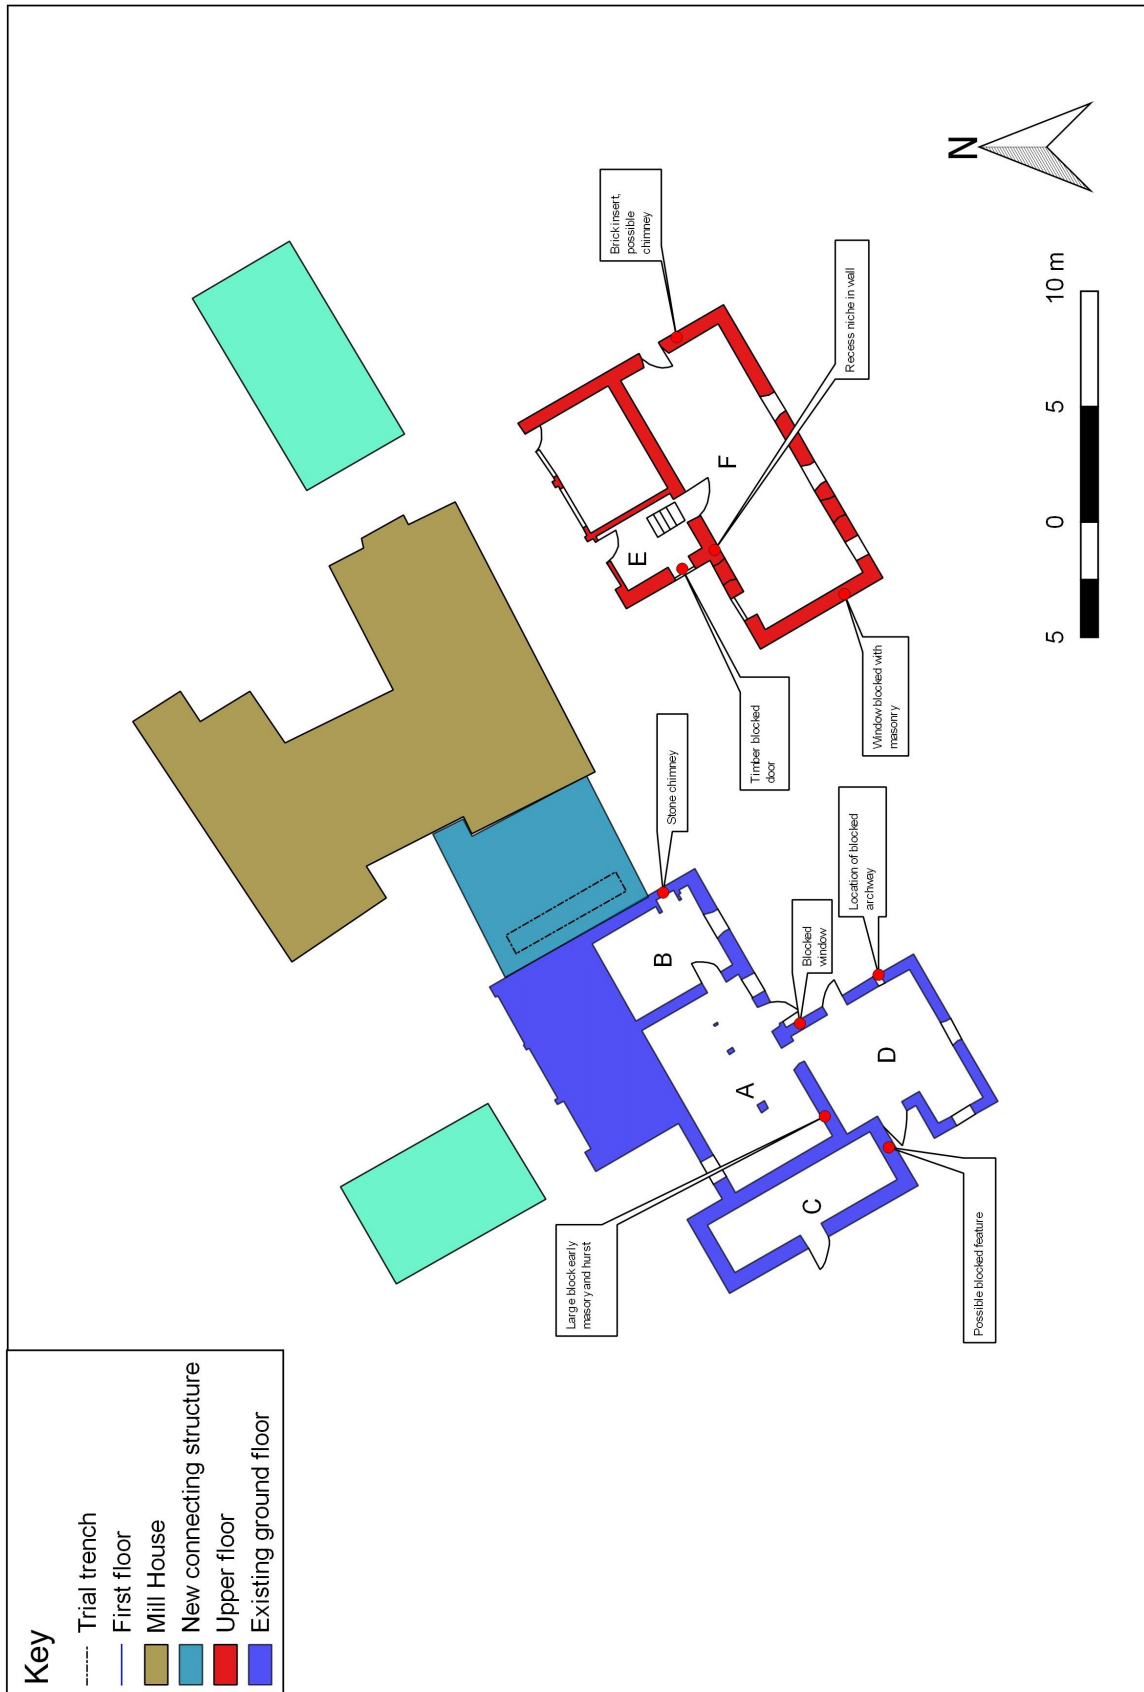
Figure 3 Details of building recording

- 4.0.1 The standing building assessment was undertaken by Graeme Young and Cole Kelly on the 17th January 2018. The mill was a single building formed of a rectangular core with additions. The rooms were recorded in detail and have been delineated by letter codes from A to F on Figure 3 in order to allow for easy reference within the text.

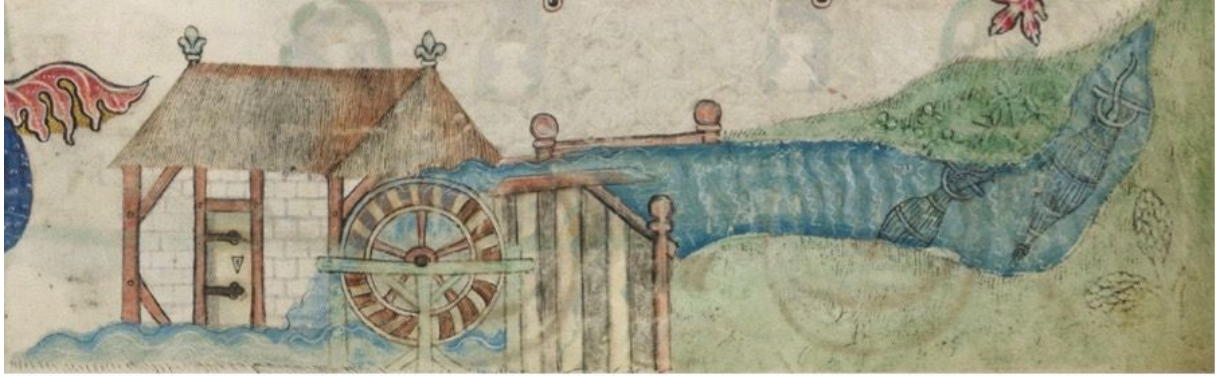
Figure 5: Medieval single storey, stone built, overshot watermill as depicted in the Luttrell Psalter, early 14th century (wikicommons)

- 3.0.5 A number of types of watermill are known from the medieval period. The earliest examples in the British Isles, are early medieval in date, and are horizontal mills. Such mills reached Northumberland in the Middle Saxon period and one is known from Corbridge (Snape 2003). Mills became commonplace by the 11th century, over 6000 are recorded by the Domesday survey, and were increasingly of the vertical wheel type. Vertical wheels were of three types, undershot, the most common, together with overshot and the rare breast shot mills. The undershot mill was the simplest in engineering terms and required only a flowing stream into which the mill-wheel extended and was turned by the flow of the water passing by it. Overshot mills required a head of water as great as the height of the wheel and were more common when modest streams were available as a water source as they utilized gravity to turn the wheel more than the power of the water stream. Given the modest nature of the Bowbridge Burn it is quite conceivable that Whittington Mill was of the overshot type from the medieval period (Figure 5). A breastshot mill is known from Barrowburn in the Coquet Valley and has been dated to the 13th century demonstrating that such technology for gravity fed mills was present in Northumberland from this time (Carlton 2015, 103).

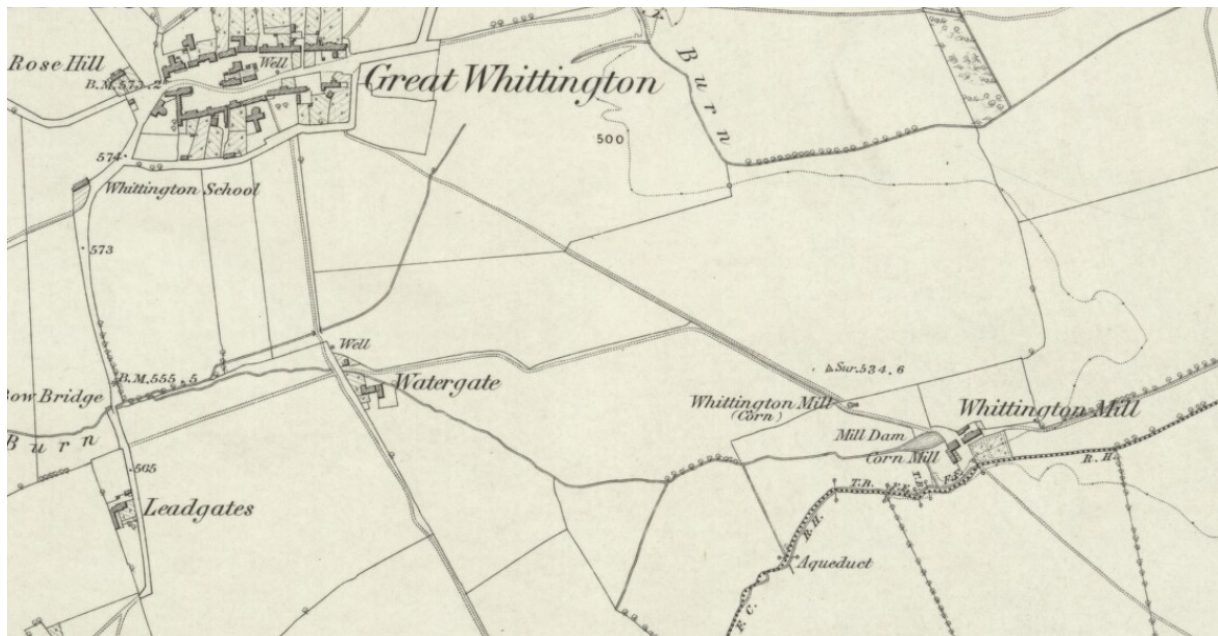
Figure 6: First Edition Ordnance Survey, 6 inch, 1864, depicting mill dam and mill

- 3.0.3 The mill and house are depicted on the 1st Edition Ordnance Survey map of c.1870 (Figure 6). The site of the mill damn and pond is shown immediately to the north of the mill building and stored water from the Bowbridge Burn. The water discharged from the mill wheel would have drained in the Pont. It can be speculated, given the height of the stone wall that still demarks the position of the damn, that in

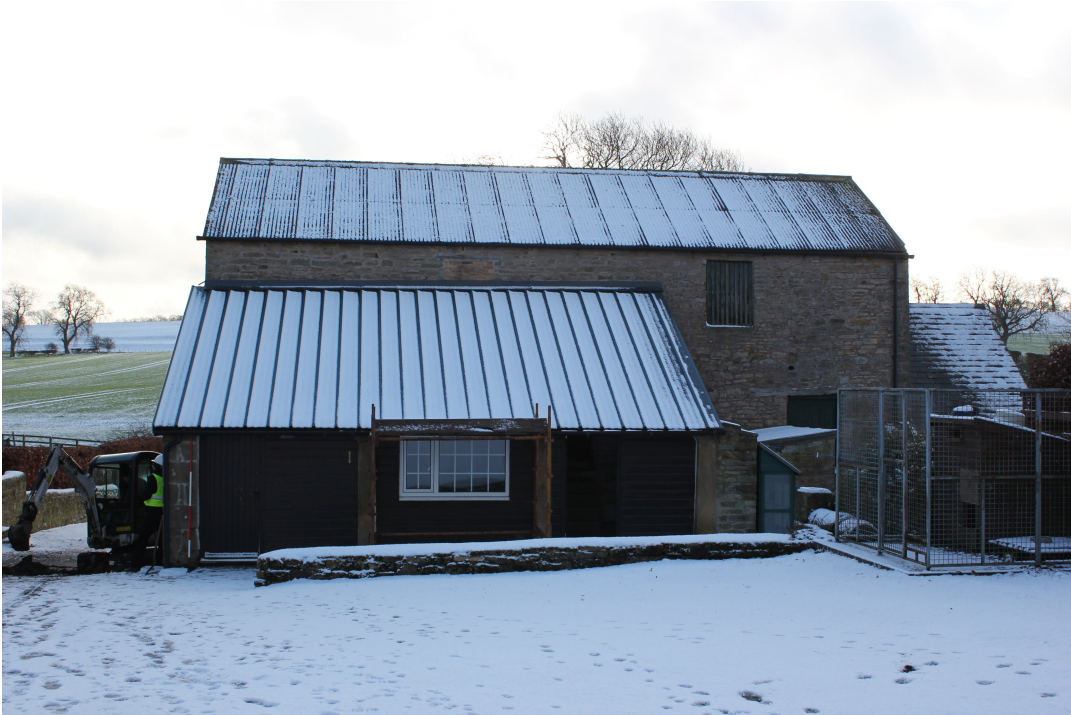
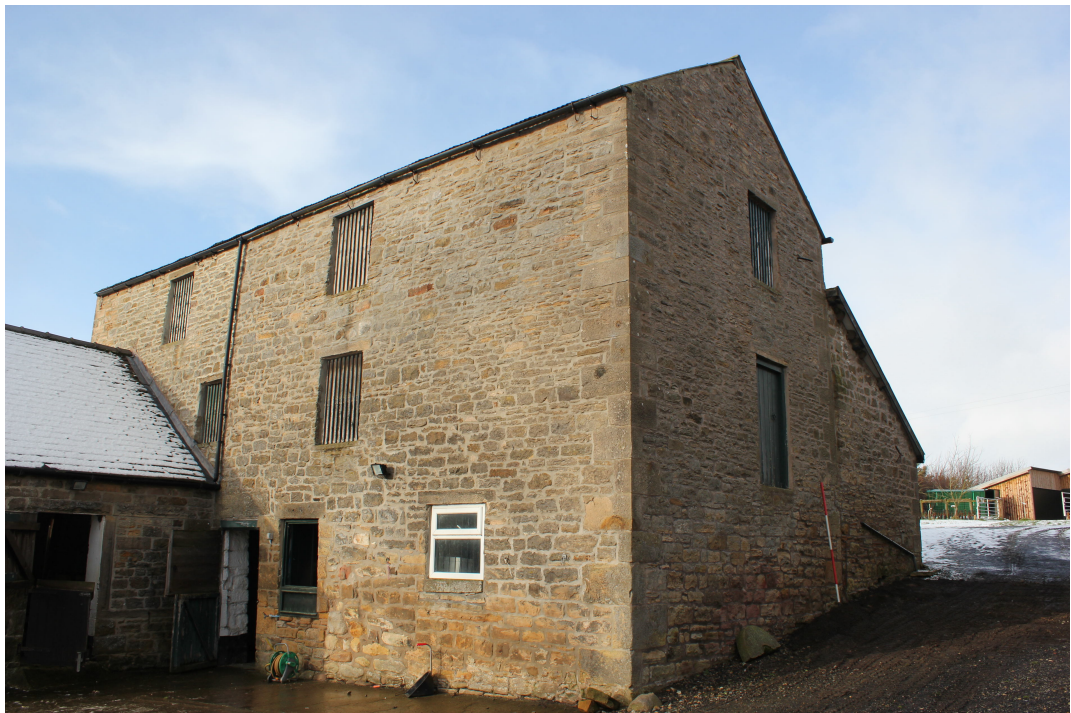
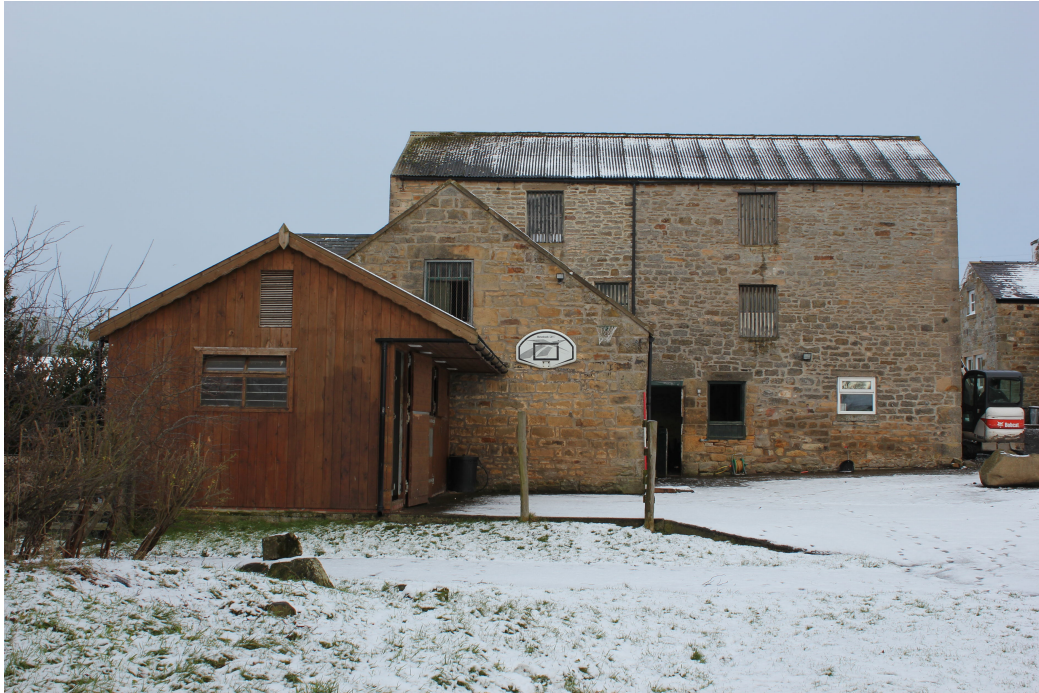
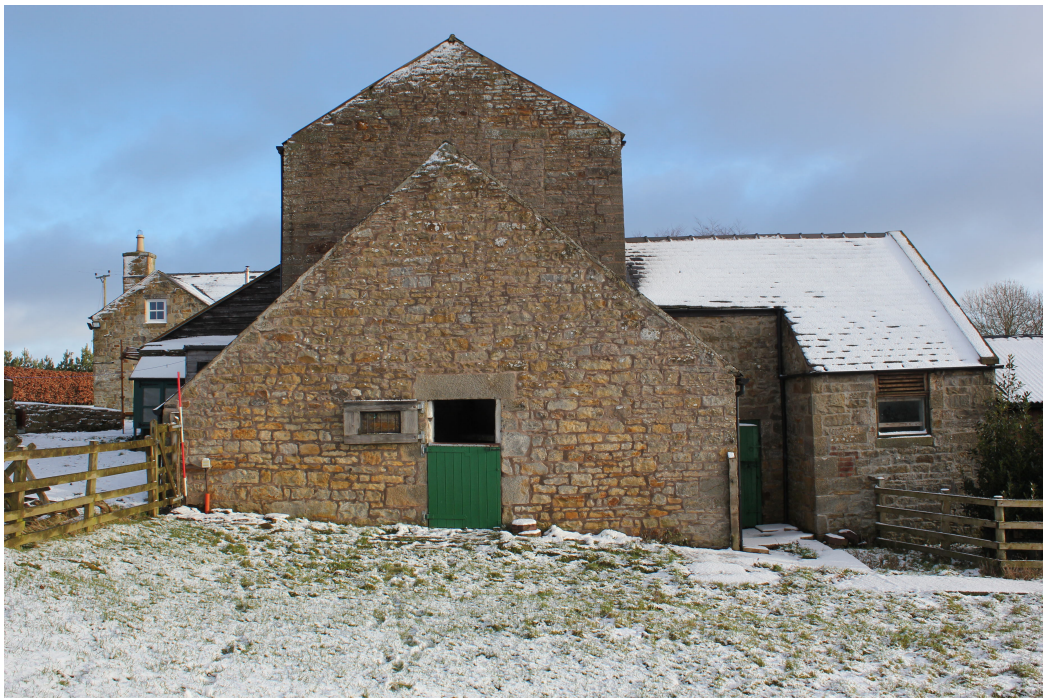
- 4.1.1 The structure of Whittington Mill displays a number of phases of construction, The core of the structure is a rectangle, 6.3m north-south by 13.6m east-west, externally, onto which additions to the north, south and west have been added. The rectangular core of the structure is three storeys high, though the floor of the upper storey is not currently present. The additions to the core building are all of single storey construction, though not on a single level due to the ground sloping down from north to south. It is constructed from a variety of masonry and styles but is mortar bonded throughout. Roofs of the western and southern extensions were pitched and covered with slate, the main roof was of asbestos and the northern extension was of modern metal (Figure 4 and Plates 1- 4).

Plate 1: North elevation of the mill building

Plate 2: South and east elevations of the mill building

Plate 3: South elevation of the mill building

Plate 4: West elevation of the mill building

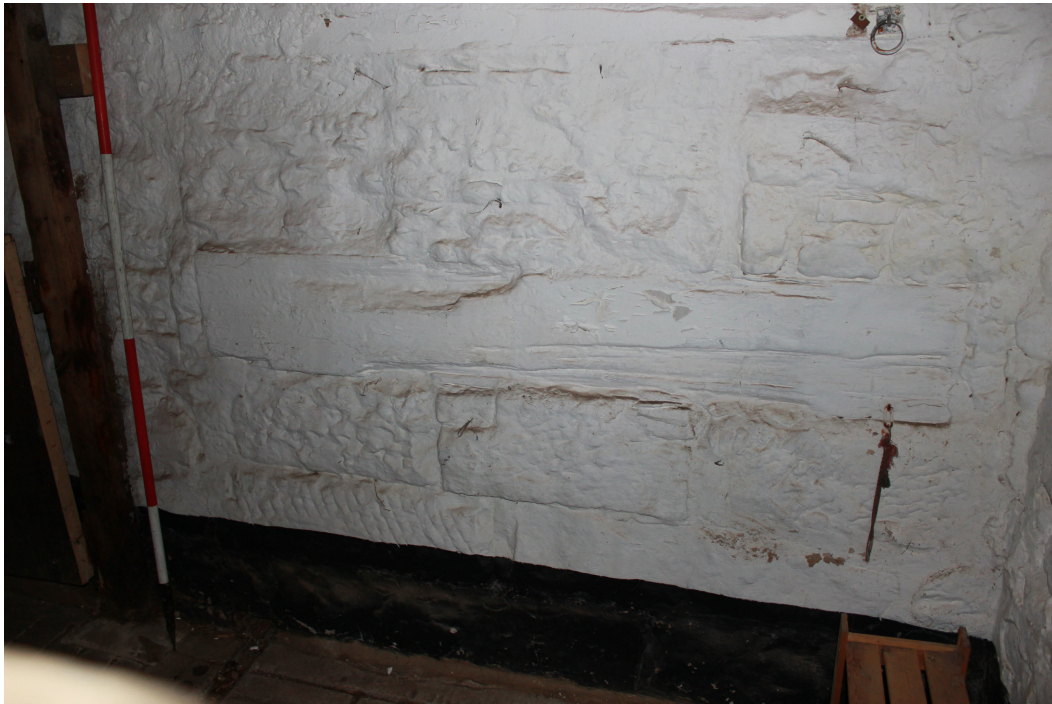
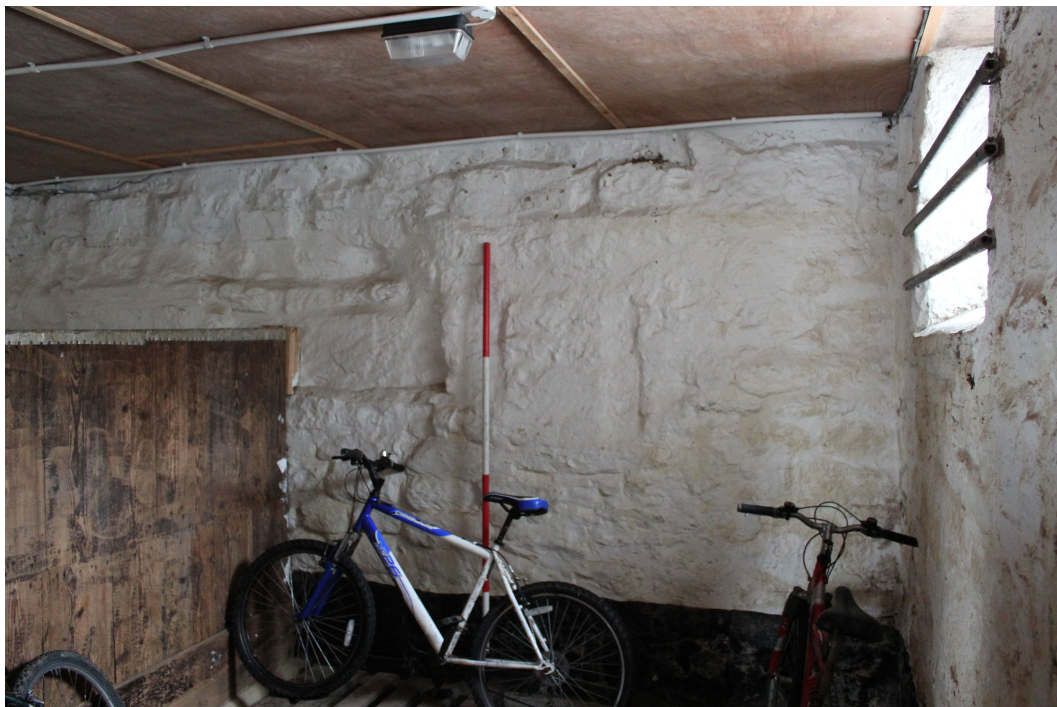
- 4.2.1 The room measured 8m by 5m internally and was the core of the mill structure. At the western extent of the south wall a series of very large square cut masonry blocks formed what is likely to be the earliest part of the mill. These blocks c.0.6m by 0.3m, and with a crude chisel-tooled finish, are the best candidate for surviving elements of the medieval mill. Their finish and scale are consistent with a medieval date, but sadly by no means certainly diagnostic of such a date. Three courses of this masonry survived in this area and other examples were present in the western extent of the north wall as well. A large timber set into the south wall above the masonry, very likely, represented surviving elements of the hurst cradle for the wheel axle and gears to the millstone (Plate 5). Traces of less substantial timbers were also seen inset into the west wall nearby, leaving little doubt, despite the obscuring plaster and whitewash, that these walls, forming the three sides of the western part of the room, represent the core of the early mill structure (Plate 6).

Plate 5: Large chisel tooled masonry blocks and cut timber, south-west corner of Room A

Plate 6: West Wall of Room A with further timber elements

1. The west end of Room A forms the early core of the structure and its large masonry blocks could be of medieval date and would not be inconsistent with 13th century styles.

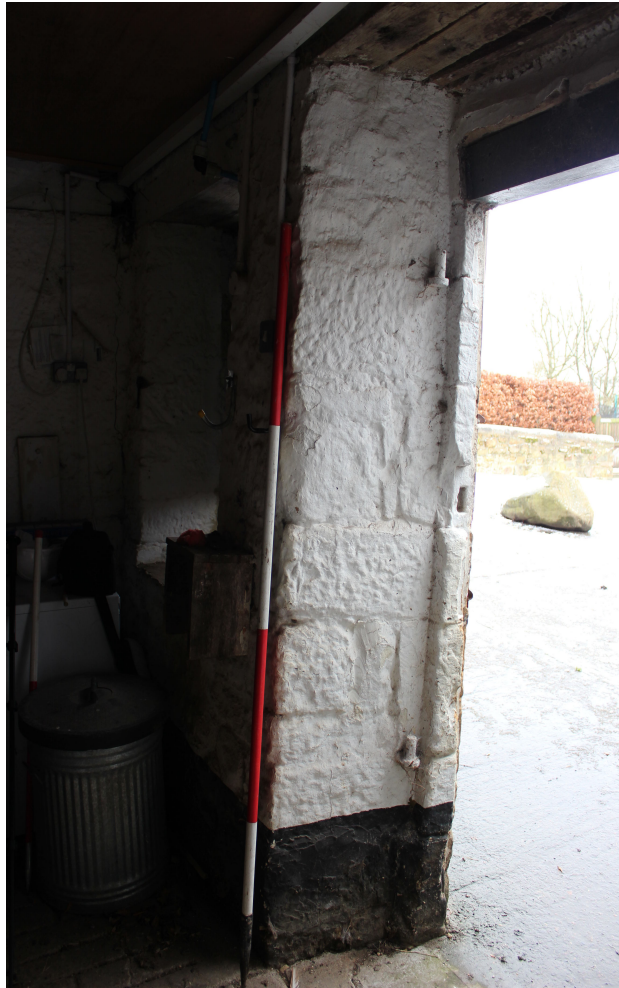
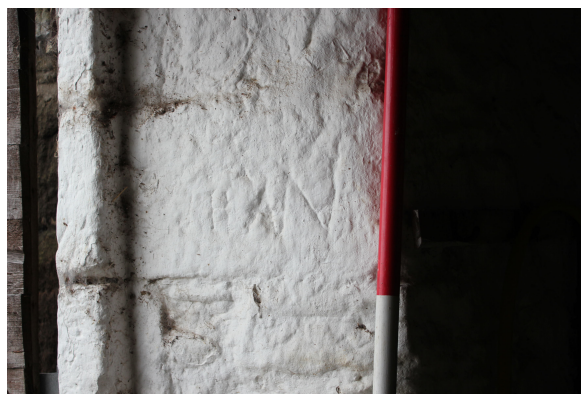
- 4.2.2 The doorway through the south wall was well-built and displayed a chamfer rebate for an inward opening door constructed from large square cut masonry blocks, smaller but similar in style to the early blocks beneath the hurst. The present outward opening split door represented a later replacement for the original, inward opening, door that had hung from iron pins present on the east side of the doorway. A weathered graffiti, that could not be read, was present cut into a block on the west side of the opening (Plates 7 and 8).

Plate 7: Doorway into Room A, facing south-east

Plate 8: Graffiti on opposite side of doorway to Room A, facing south-west

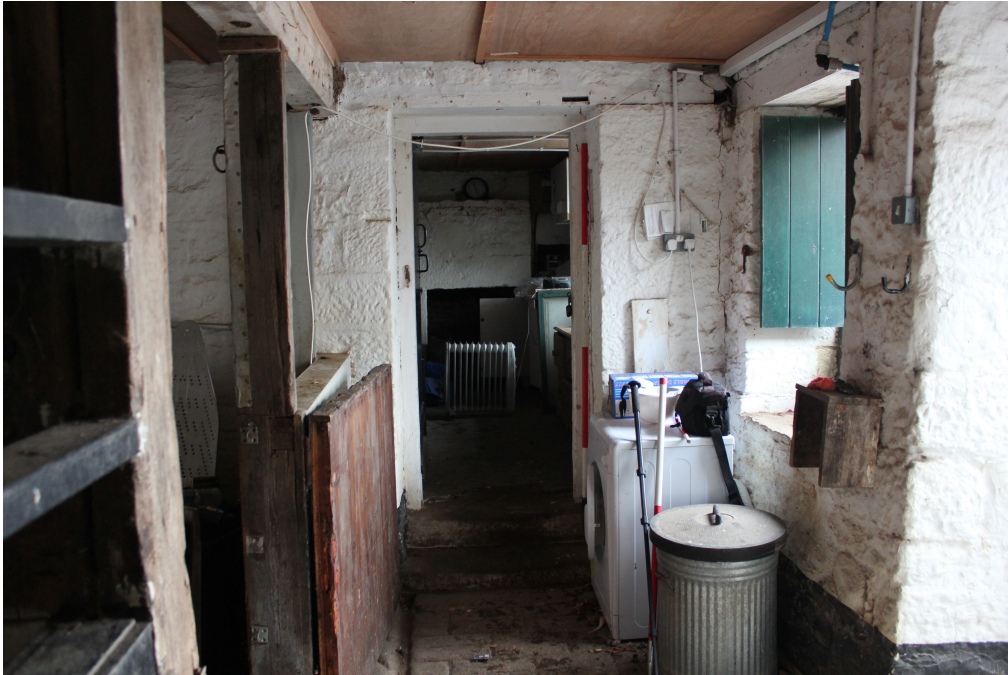
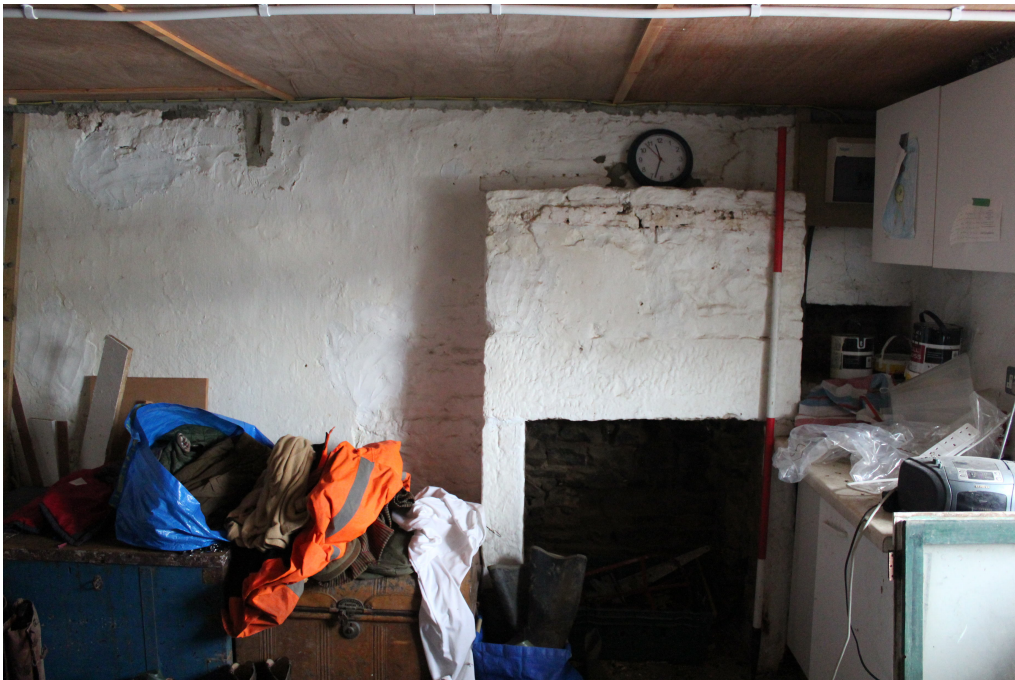
- 4.3.1 The room measured 3.8m east to west by 4.8m north to south. It was entered through a well-made doorway from Room A. Its walls comprised large blocks with a distinctive pecked tooling of apparently post-medieval character. No large and potentially early masonry blocks were apparent from the internal surfaces nor was any such material apparent from the external walls. Some of the lower courses did have a square cut regularity that was indicative of more than one build phase to this end of the structure. This view was further reinforced by a distinctive colour differential between some of the lowest courses in the south wall, being of a yellow sandstone, and the upper part of the lower storey and upper storeys, being constructed of a pinkish sandstone. The only feature of note within the room was the presence of a substantial fireplace set in the south side of the east wall (Plates 9 and 10).

Plate 9: Doorway between Rooms A and B, facing east

Plate 10: Fireplace within Room B, facing east

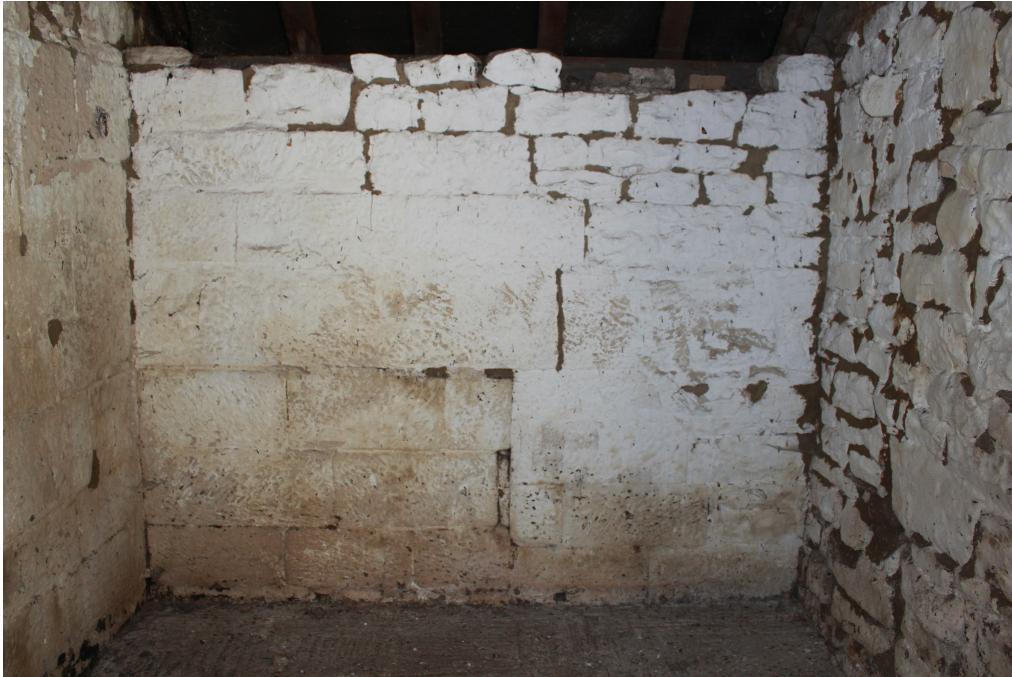
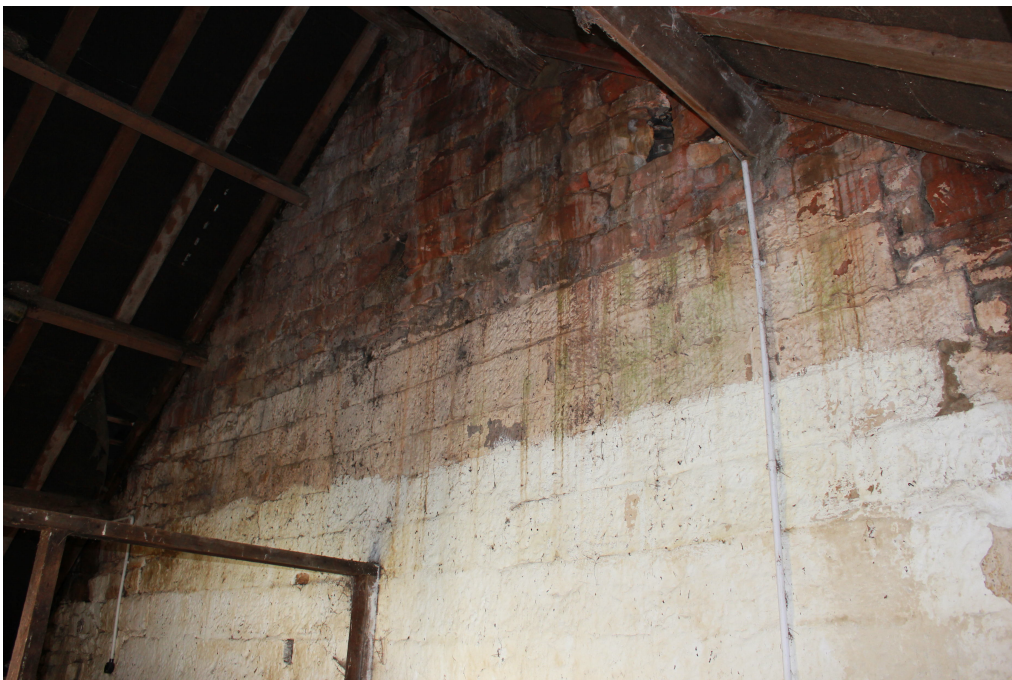
- 4.4.1 Room C measured 8m by 2.4m and clearly contained two phases of build. The main part of the east wall comprised large, regularly coursed, square cut masonry blocks, as did some elements of the south wall, and the remaining elements were of a later cruder build with smaller blocks and irregularly coursed. These were clearly the later element as a butt joint was present between the north and east walls, showing this wall of Room C to be an add on to Room A. There were indications within the early build of the south wall that a blocked feature was present (Plate 11) and this appeared to be mirrored on the exterior wall, though here it appeared to be a blocked

doorway and the masonry was of small irregular blocks similar to the later west and north walls.

- 4.4.2 The large, square cut regularly coursed blocks that formed the base of the east wall are almost certainly elements of the Room A structure. The basal blocks were of similar scale to those seen immediately inside at the base of Room A, and although the block sizes diminished further up the wall they exhibited the same chisel tooling throughout. This is likely the best indication of the form of the primary build of the mill. It is significant that they stopped at a consistent line, some 3m above ground level, indicating that the original mill structure was of a single storey, or that the upper element was of timber (Plate 12). No clear trace of where timbers leading to the hurst on the far side of this wall would have penetrated was present, but a coal storage bin may well cover the critical spot. It was also clear on examination that this regular masonry turned a right angle at the south end of the room suggestive that some small elements of the south wall of Room C may well have been a part of the primary build.

Plate 11 South wall of Room C showing blocked feature

Plate 12 East wall of Room C, showing possible early roof line between large early blocks and later smaller irregularly coursed blocks

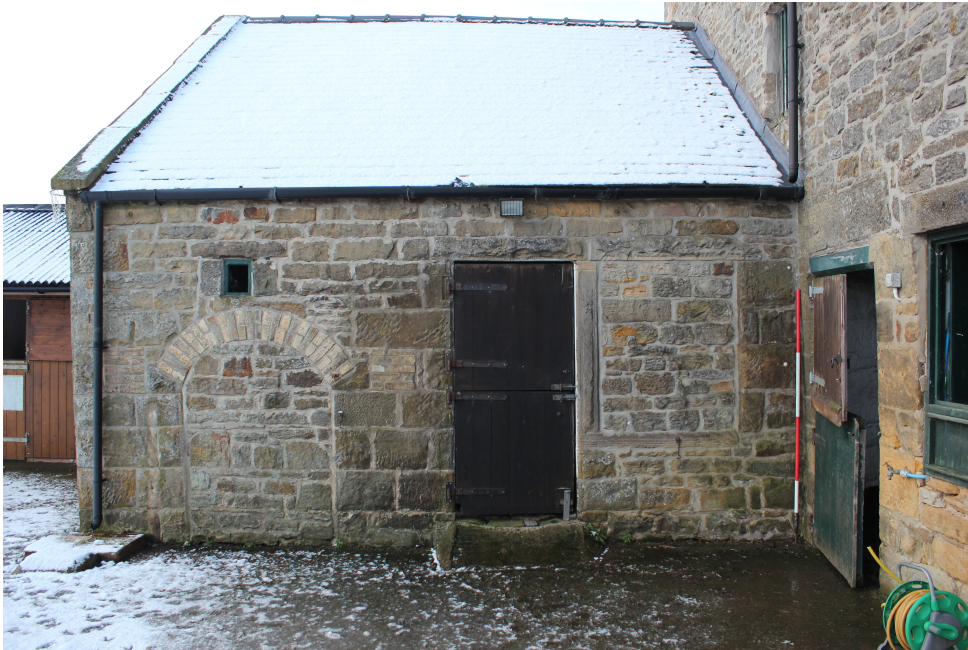
- 4.5.1 The room represented a south-east extension to the core building represented by Room A. L-shaped in plan and measuring 5.8m north-west to south-east and 6.4m south-west to north-east, internally. It is clear that there are at least two main phases of construction; a lower phase, clearly visible in the exterior north-west wall, comprised larger square cut regular blocks of masonry compared to the upper construction. This lower build could represent the continuation of the early phase seen in Room A, or more likely, an additional early phase. It was only really apparent in this one wall, so no clear indication survives as to whether the early phase structure was also L-shaped or even of a similar scale. A low arched opening some 1.7m high was present in this wall. The larger early masonry blocks gave the impression of respecting this opening making it potentially an original feature. The voussoirs of the arch were formed of mould cast bricks of likely 19th century date, suggesting that either the opening was a later addition, despite indications, or that the voussoirs had been replaced at a latter date. Two square opening were present, blocked by similar bricks, either side of the springing of the arch and a small rectangular opening was present above the arch and offset to the south. The arched opening had been blocked by masonry of a character similar to the upper build of the room as had a window to the north of the doorway in the north-east facing wall (Plate 13).

- 4.5.2 The impression was clearly that alterations, probably representing a change of function for this room had occurred at least once. The south-west wall appeared to be a single build of irregular roughly squared uncoursed masonry that very likely was not contemporary in phase to the upper part of the north-east wall, which was more regular in form and coursing and composed of smaller but squared masonry blocks. This together with numerous examples of in-filled areas with broadly 19th century bricks suggested that at least three phases of use/build were present and potentially more.

Plate 13 East wall of Room D, showing blocked arch and at least two phases of masonry

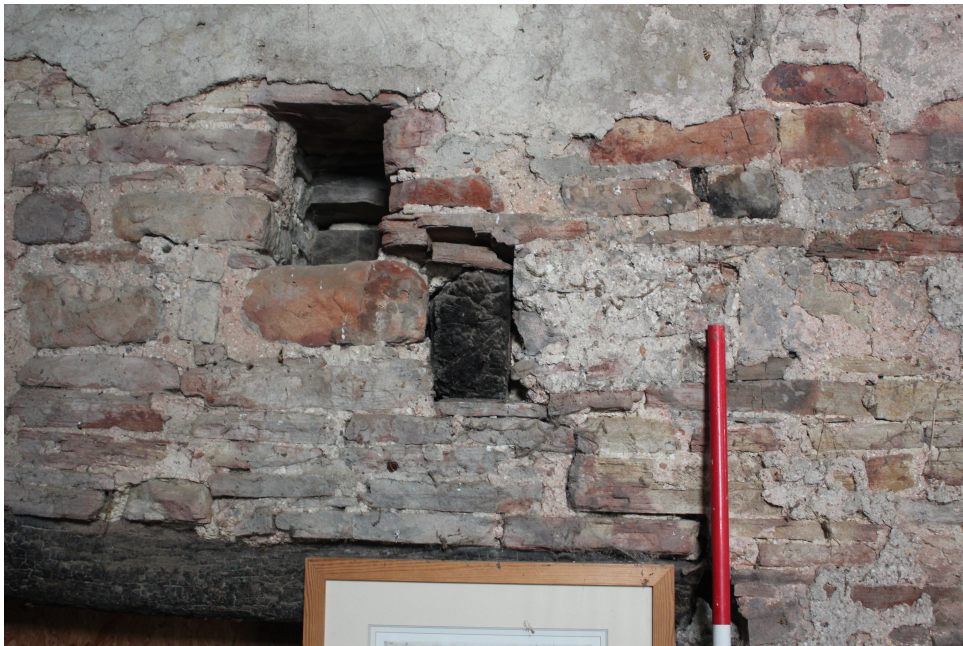
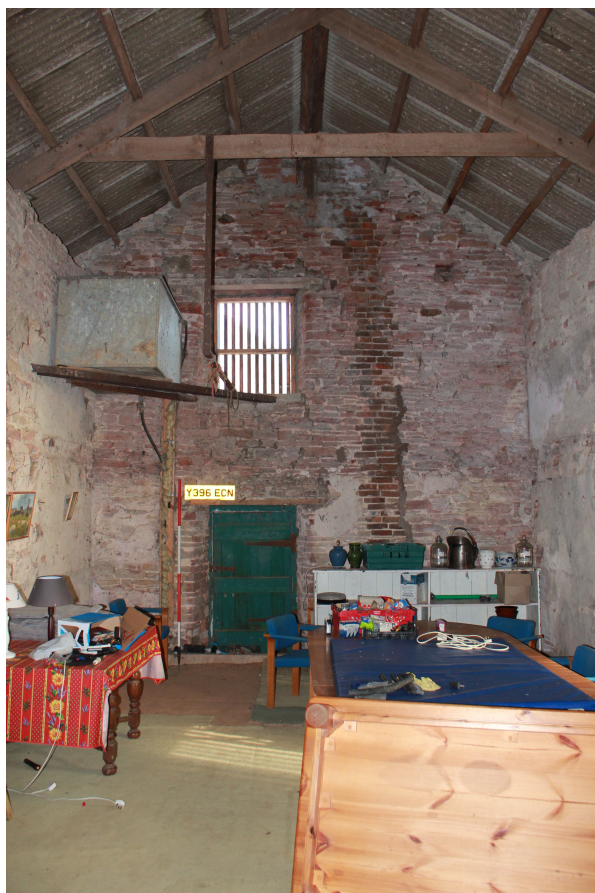
- 4.7.1 The room is reached from a short flight of stairs up to a door at the west end of the north wall. The room measured 12.5m east-west by 4.8m north-south and was constructed from a mixture of squared and irregular masonry blocks, mostly of small to medium size, that were irregularly coursed. The build of the upper two storeys appeared to be relatively homogeneous inside and out, suggesting a single phase, with some patching in brick in places internally. The level of the floor for the upper storey could be reconstructed from timber sockets set into the walls at about 2m in height above the surviving floor. They were present in the north and south walls but not in the east and west. In the main the supporting timbers were modest in size other than a matching pair of sockets close to the west end of the building which were for a much larger timber, clearly intended to be more load bearing (Plate 14).

Plate 14 Wooden floor joist and niche, Room F, north wall, west end

Plate 15 East wall of Room F, showing chimney patch

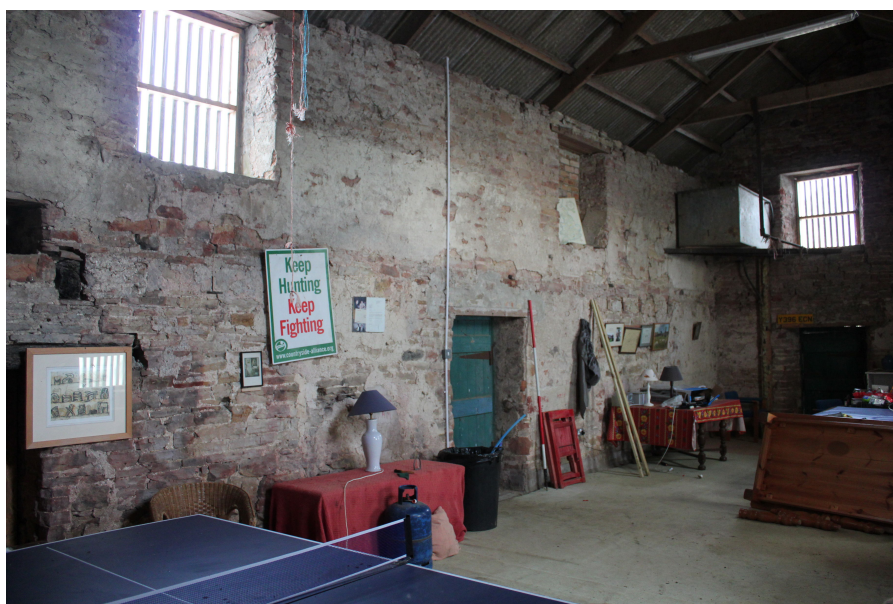
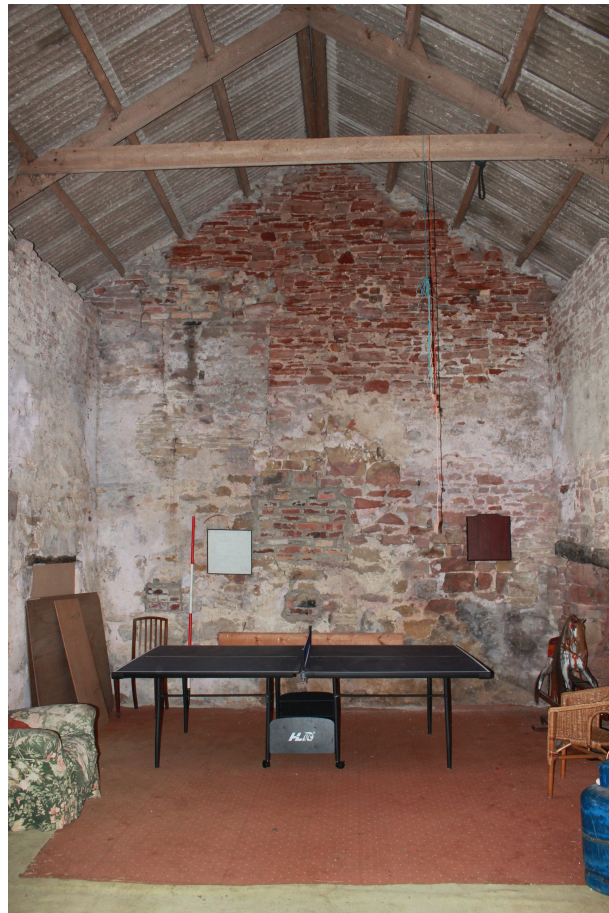
- 4.7.2 A short door, blocked by timber, was present at the west end of the north wall, some 1.5m high. Above this and just above the missing upper floor level a small niche was set into the wall, measuring some 30cm high by 20cm wide. A boarded up window high in the wall was sited between this and the doorway to light the upper floor. A second, bricked up, top floor window was also present located centrally, high in the wall. A shallow curved recess, extending from floor level, 1m high and 40cm wide, was present between the blocked door and the access door. Its purpose was unclear. The east wall contained a timber door at first floor level and a window above it for the second storey. A consistent vertical patch of bricks, c. 0.4m wide, extended up the full height of the wall from floor level just to the south of the door, sloping slightly to the north as it ascended. The bricks were somewhat shallow in depth compared to modern standards and are likely 18th century in date, though potentially re-used. It seems likely that this represents the chimney for the Room B fireplace inserted into the wall, or a patch put in place when it was removed (Plate 15). Four windows were present in the south wall, two for each of the upper storeys. A further boarded up short door, 1.5m high, was present at the west end opposite the short door in the north wall. The west wall contained two bricked up niches, 1m above ground level and each c 30cm square, in the centre and south side of the wall. A window, blocked with stone, was traced high on the south side and would have lit the upper, second floor (Plates 16 and 17).

Plate 16 North wall of Room F

Plate 17 West wall of Room F

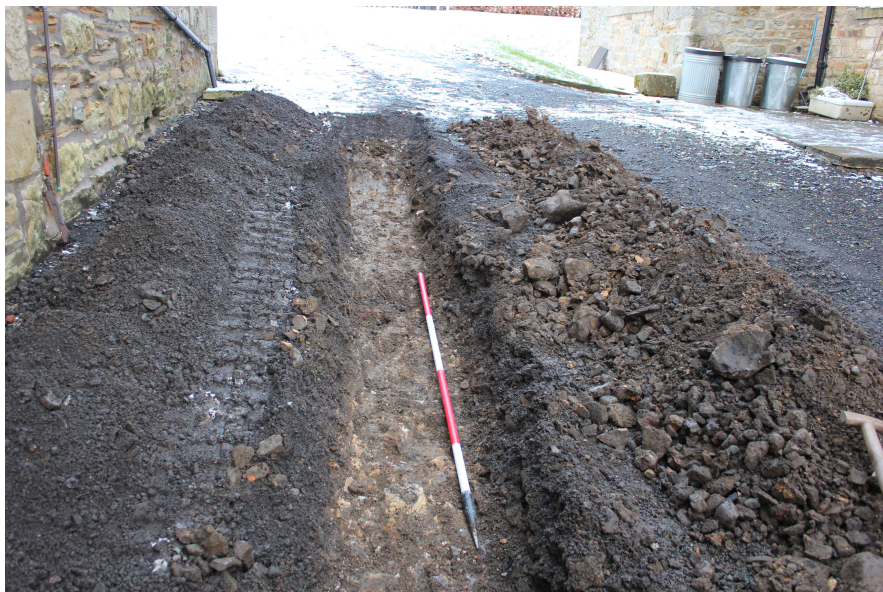
- 6.0.1 The original intent for the archaeological mitigation was for monitoring to be undertaken during the groundworks associated with the construction of the connecting building. This was altered during the preparation phase of the WSI following consultation between Beke Projects, the Assistant County Archaeologist and the archaeological consultant in order to allow for a modest trial trench to demonstrate if there was any archaeological potential in the area of the connecting structure. Excavation of a simple trial trench measuring 4m by 0.8m on a north south alignment, to the immediate east of the mill building, revealed a sterile boulder clay beneath a thin cobble surface that was itself sealed by modern gravel. There were no finds or any indication of occupation such as charcoal in any of the layers. All indications were that the area had no archaeological potential (Plate 18).

Plate 18 Trial trench, facing north
