BAMBURGH RESEARCH PROJECT

BAMBURGH HALL ESTATE OFFICE NORTHUMBERLAND

HISTORIC BUILDING RECORDING AND ARCHAEOLOGICAL MONITORING REPORT

BRP 19/05b

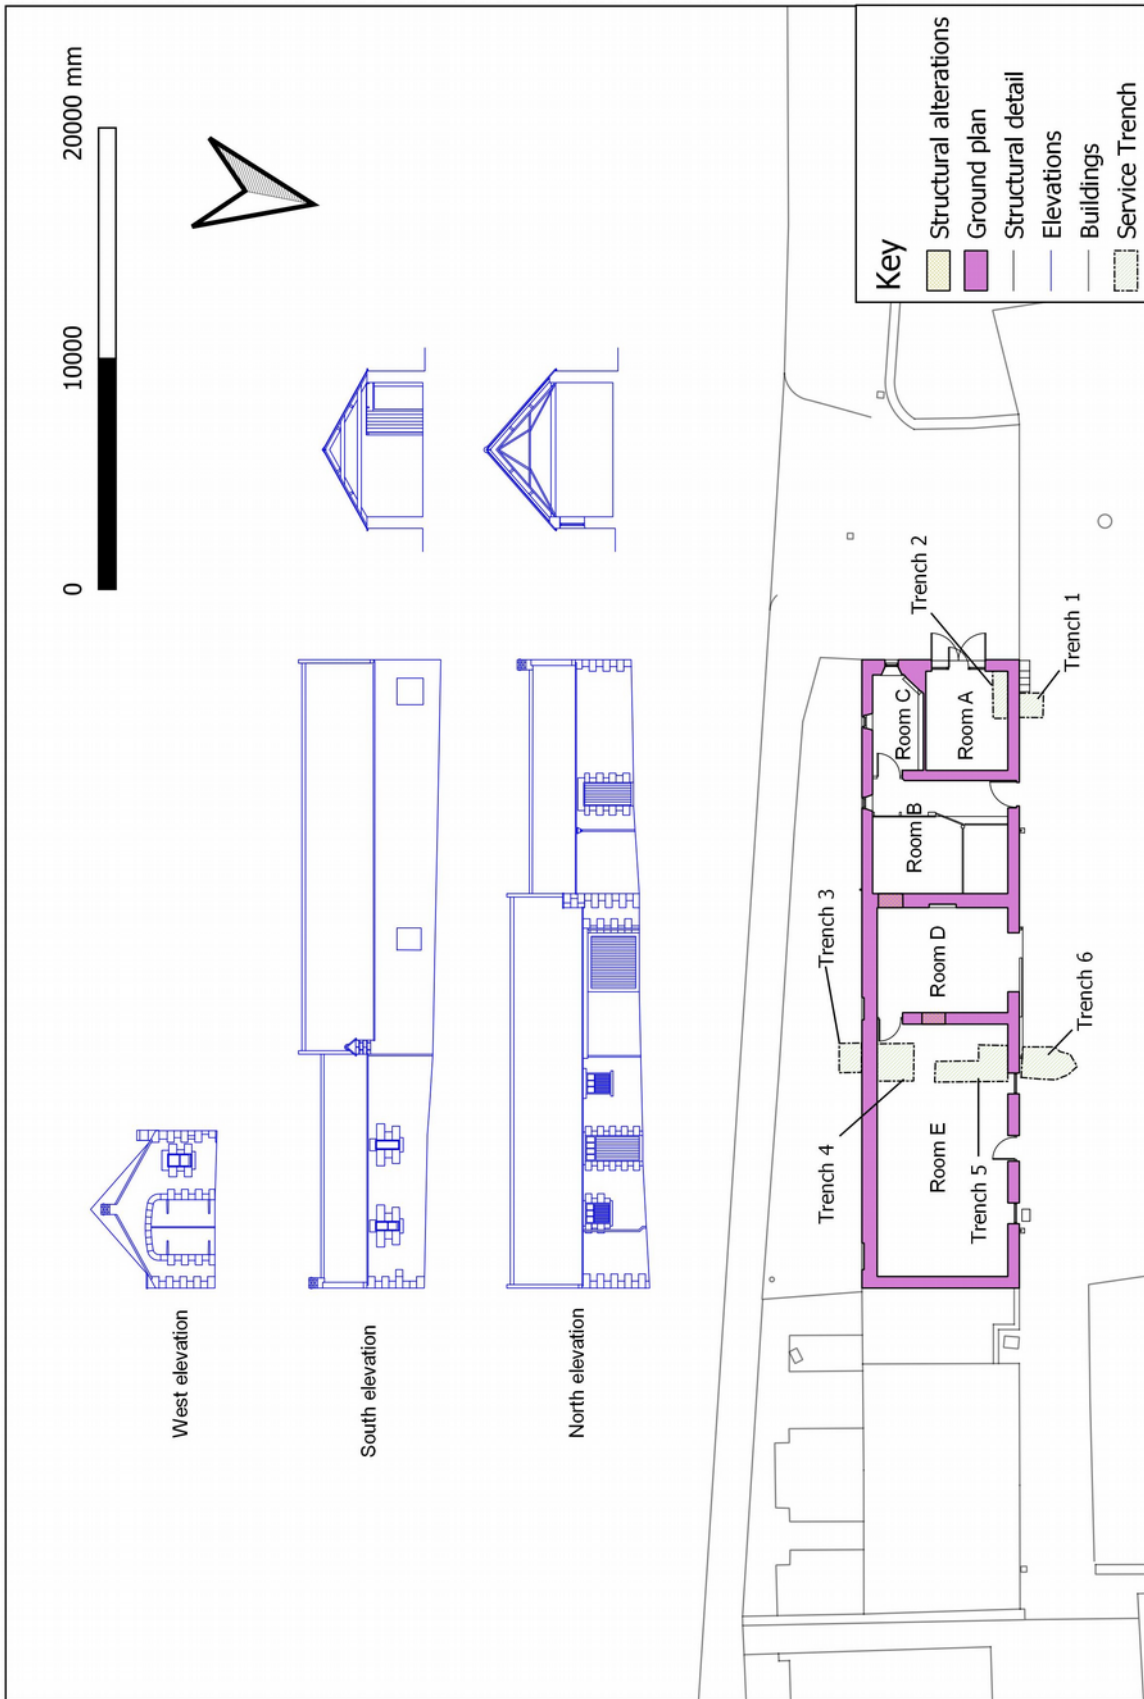
Figure 4: building plans, sections and trench layout

earlier element being the eastern range. This was rectangular and measured 17.1m east to west by 6.8m north to south, externally, onto which to the west a further, smaller, range was added. This addition measured 10.1m east to west and was also 6.8m north to south externally. Where it could be observed the walls for this smaller element butt jointed onto the east range. The roof of the western range was ridged red ceramic tiles and the eastern range slate with a somewhat shallower angle of pitch (Figure 4 and Plate 1).

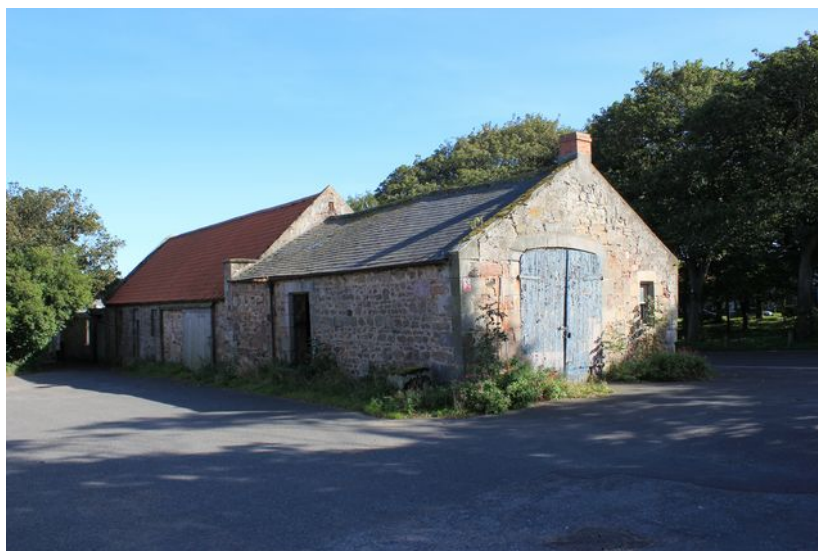
Plate 1: the building range facing south-west

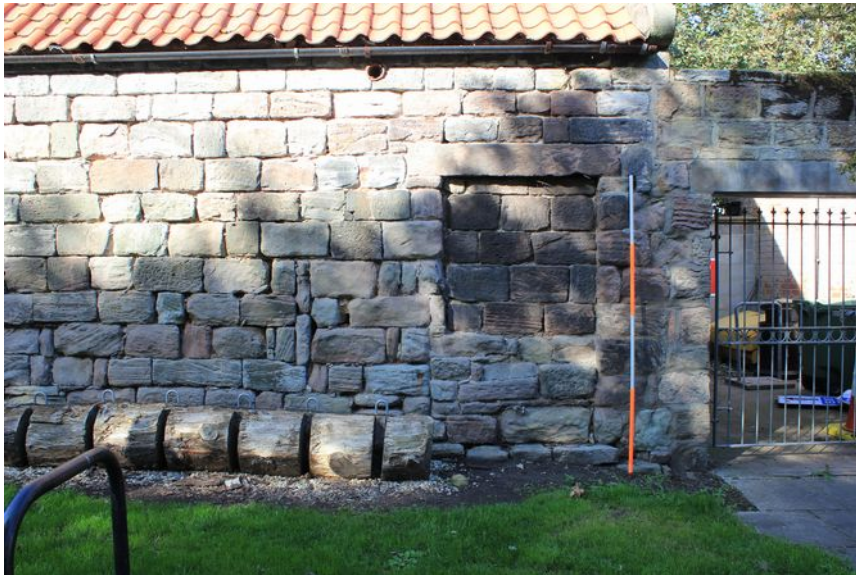
- 3.1.2 The exterior wall on the south side of the west range facing the road has distinctive large squared masonry blocks, different from the rest of the structure, indicating an intent for this public facing wall to be more impressive than the others. This appears to be confirmed by the fact that the interior face of this wall does not show such large square blocks and that only the outer face was constructed in this fashion. There is a blocked window at the east end of this wall facing the street and a vertical discontinuity that might represent a blocked doorway centrally. Neither of these features are visible on the interior face of the wall though, casting such interpretation into some doubt (Plate 2).

Plate 2: blocked window at the east end of the north facing exterior wall

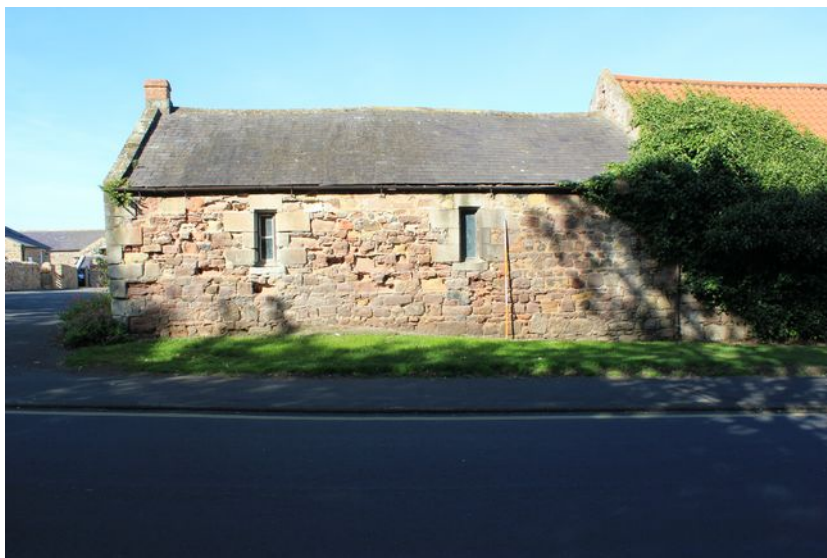
- 3.1.3 The smaller, west, range has two evenly spaced small vertical windows in the south facing wall and a third to the south of a substantial pair of double doors in the west facing wall. The north facing wall contains a second standard sized door. Although the wall is weathered and patched there are no clear indications of phases of build. The stones around the windows and doors are much less weathered but it seems likely that this is a case of renovation and replacement rather than re-build (Plate 3).

Plate 3: the western range of the buildings, facing north

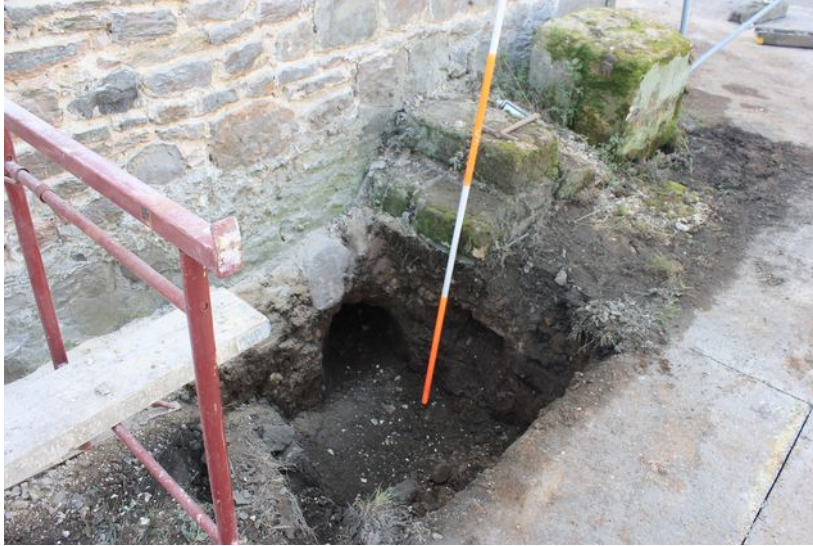
- 3.1.5 There is a stone step for mounting a horse on the ground immediately adjacent to the north wall at the west end of the full range, close to the small door that leads to the stalls (within Room B) and tack room (Room C) (Plate 4). This represents the only notable external feature not immediately part of the build.

Plate 4: the stone steps at the south-west corner of the west range, facing west

4.1.1 The trench was excavated immediately outside of the north wall of the west range adjacent to the stone steps to identify an exiting electrical line that is to be connected to the new development. It was excavated to a depth of 0.7m below ground level and through a mixed somewhat disturbed deposit of dark grey-brown sandy silt soil with clay patches that appeared to represent a depth of buried soil sealed by the farm yard surface and somewhat disturbed in this area by the construction of the building (Plate 4).

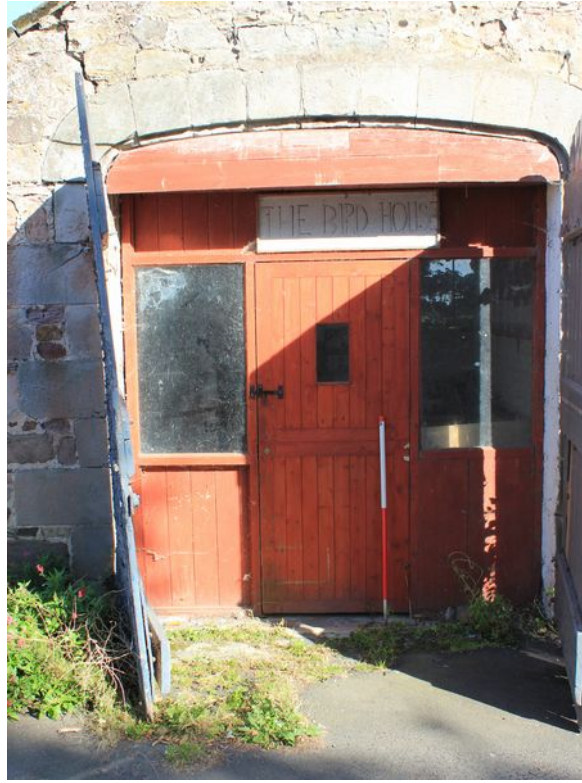
- 3.2.1 The room measured 4.3m east to west by 3.5m north to south internally and was at the western end of the later smaller range accessed through the west, external wall, through a pair of timber double doors, 2.3m wide that led immediately to a timber partition with a door and windows that had clearly been added at a later date. The internal room was plain and displayed no built in features and was lit only through the door as no windows were present (Plate 5).

Plate 5: the double doors and inner door of Room A, facing east

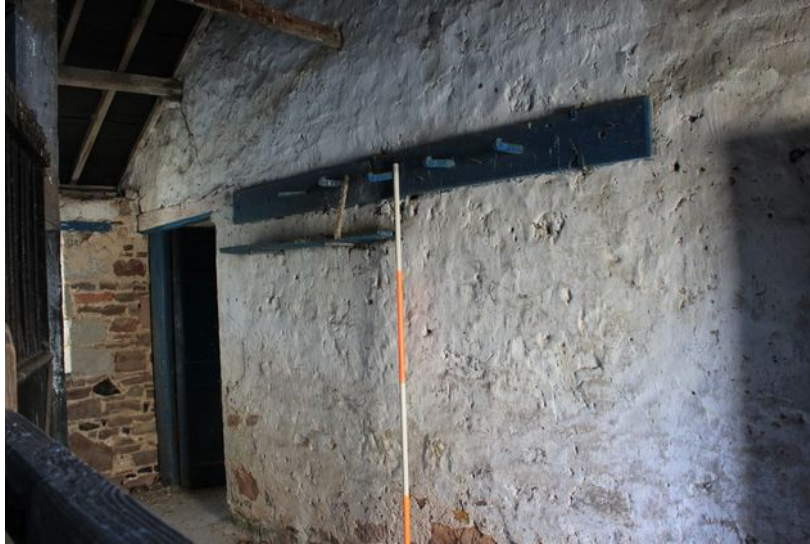
- 3.3.1 The room measured 5m east to west by 5.8m north to south. It was entered through a well-made doorway through its south wall. The room contains a number of timber fittings. A line of wooden pegs set in a plank on the west wall formed clothes hooks (Plate 6). The eastern part of the room was divided by a wooden partition with a one third element at the north side with a wooden hay manger fixed to the wall. The remaining two thirds part of the room had a further set of wooden and metal mangers on the wooden partition at the west side and traces on the south wall where a horse stall appears to have been present and removed (Plates 7). The north wall as it reached the east wall clearly seems to represent a butt joint and is the best evidence that the west range is the later build phase.

Plate 6: west wall of Room B facing south-west

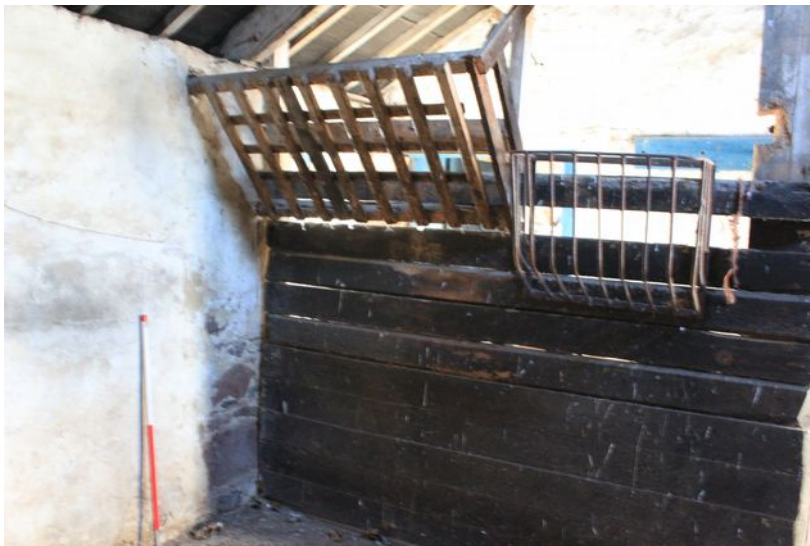
Plate 7: the wooden partition and the two mangers, facing south-west

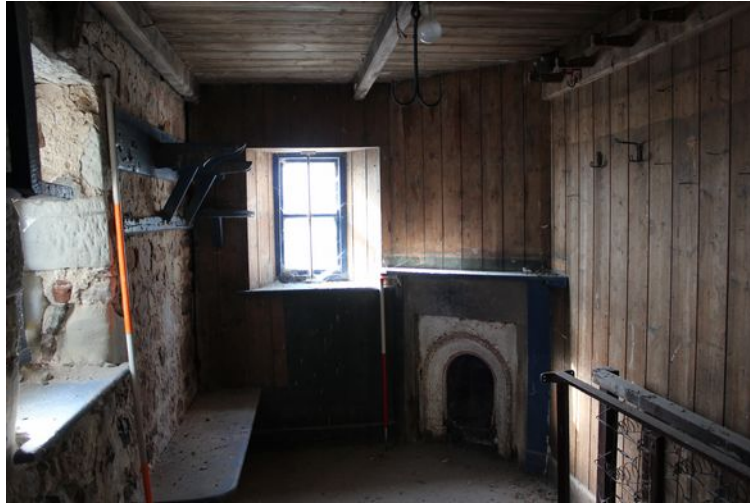
- 3.4.1 The room was a small anti-chamber entered from Room B and measured 4.1m east to west by 2.15m north to south, divided from Room A by a timber partition. A small fireplace is set in the north-west corner of the west wall. The room was last used as a tack room with timber fittings for saddles and numerous hooks for other items on the south wall with a bench beneath set against the wall. The room was lit by two small windows one in the south and the second in the western wall (Plate 8).

Plate 8: Room B with fireplace and wall fittings, facing west

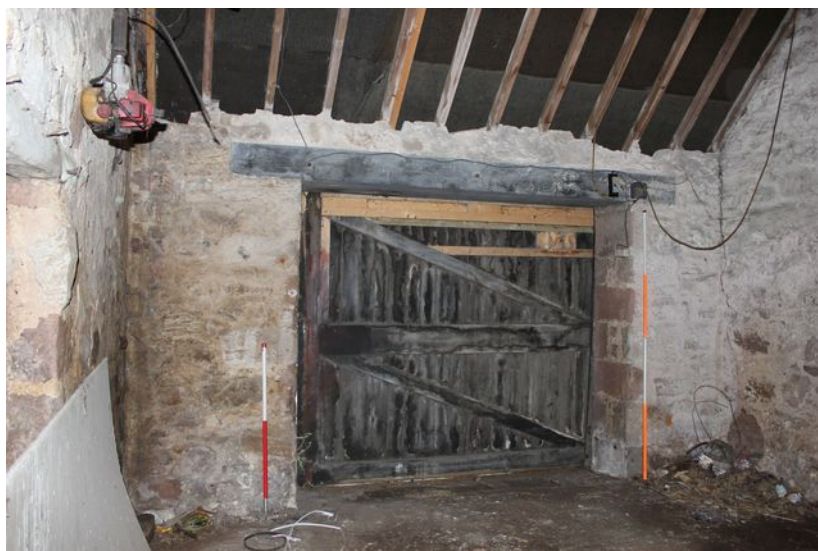
- 3.5.1 The room represented the western part of the eastern building range with the higher roof line and as a likely earlier build does not have any direct connections with the western range. The room, 4.5m wide east to west by 5.5m north to south and is entered by a large timber sliding door, some 2.56m wide (Plate 9). A recessed niche, some 20cm deep, was present centrally in the western wall with the appearance of a blocked window. The corresponding blocking was not immediately obvious on this wall seen in Room B, but there was a long stone set in the wall that could have been a lintel, which does suggest that a blocked window is probably the best interpretation. Assuming the build order deduced is correct then the window may well have been blocked at the time of the construction of the west range (Plate 10). The room was otherwise plain and not lit by a window and a single door led from Room D to Room E.

Plate 9: the double door leading from Room D, facing north

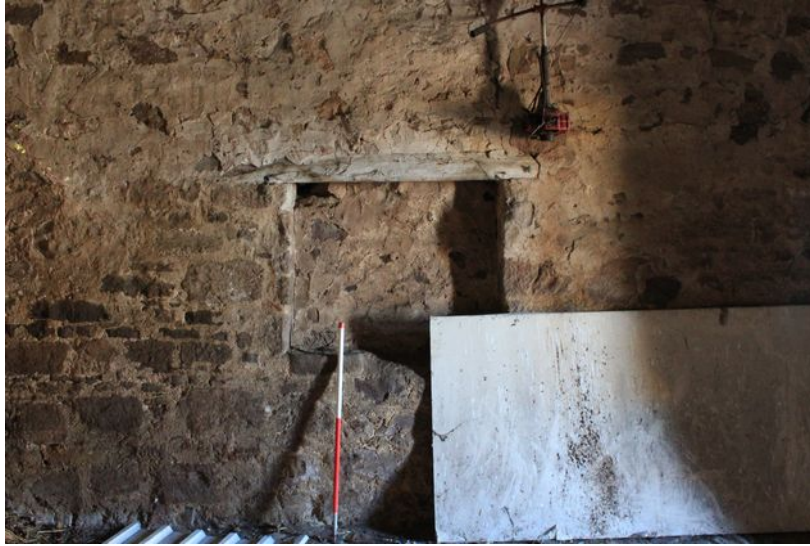
Plate 10: blocked window feature in the west wall of Room D, facing west

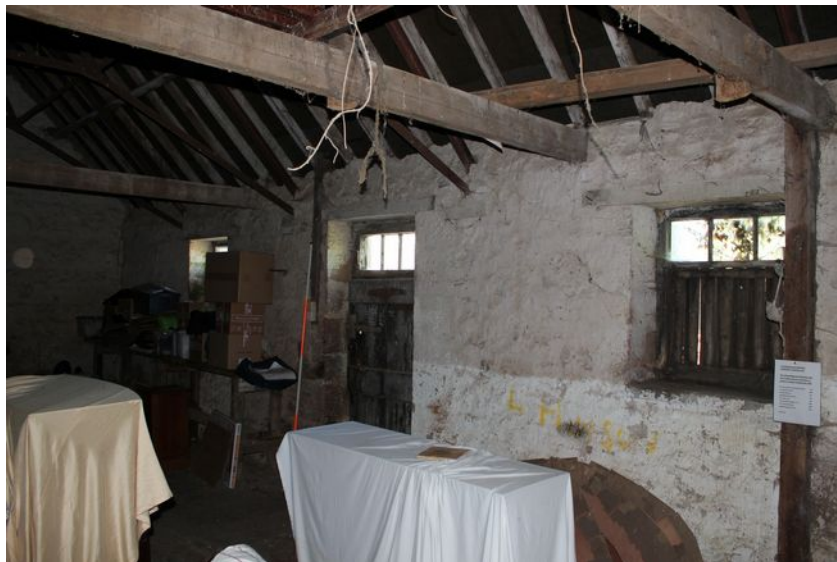
- 3.6.1 Room E was entered from outside by a door located centrally within the north facing wall flanked by two square windows on either side and inside from a door to Room D. The room was relatively plain with few fittings apparent, beyond a scarcement running the length of the east wall some 1.8m above floor level (Plates 11 and 12).

Plate 11: Room E south wall showing windows and door, facing north-west

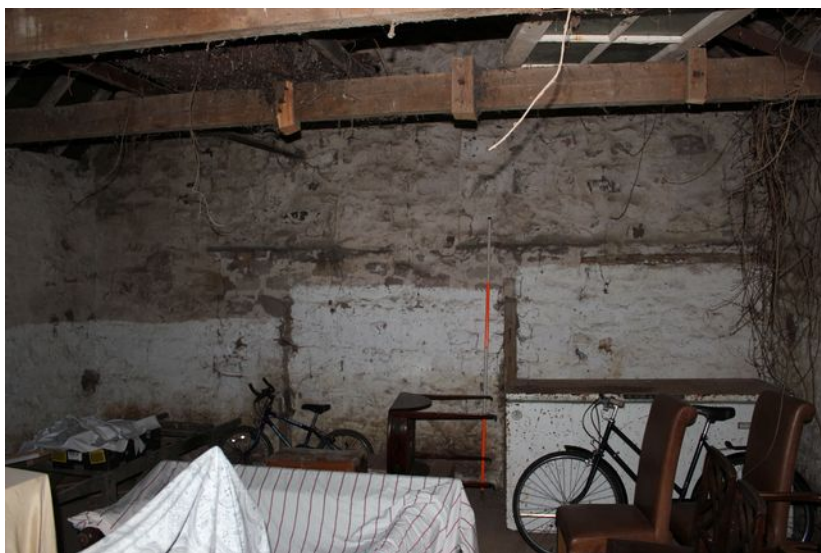
Plate 12: east wall of Room E showing scarcement, facing east

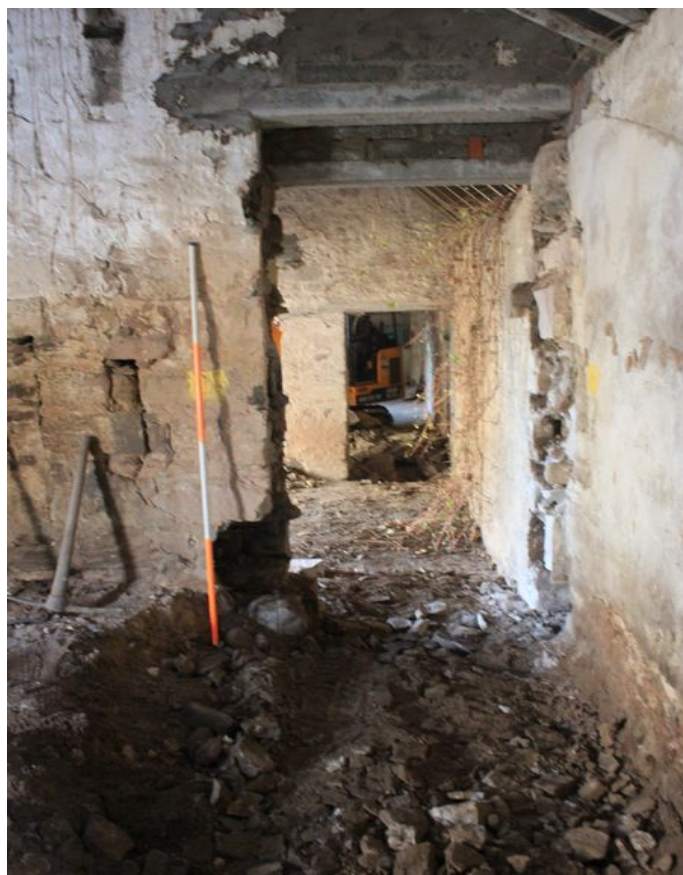
Plate 13: cut through for new doorway between Rooms B and D, facing east

3.8.1 A new internal doorway was cut between Room B and D, at the south end of the wall. The corresponding doorway in the eastern wall of Room D leading to Room E was blocked and a new slightly wider doorway cut more centrally in the wall. New internal partitions, plumbing and flooring is to be constructed and laid but did not involve any substantial alterations to the main fabric of the building (Plate 13).

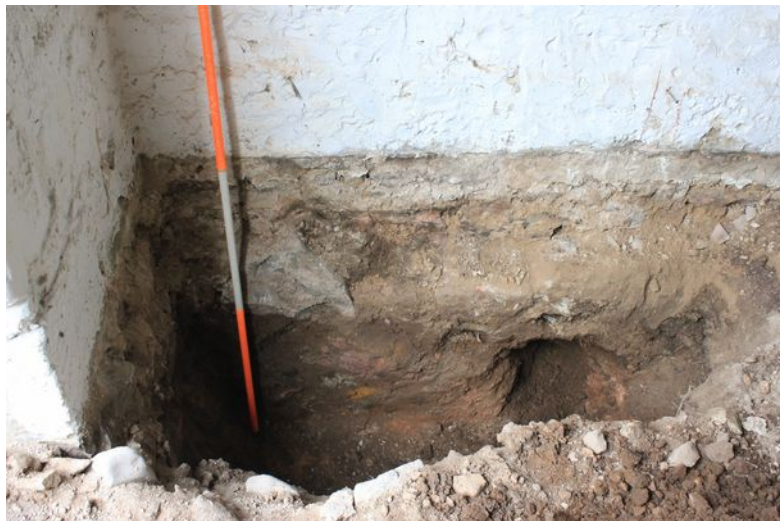
4.2.1 The trench was excavated within the structure to connect with the external Trench 1 beneath the wall foundation in order to allow for the electrical cable to be extended to the north-west corner internally where a new junction box is to be fitted. The trench extended at its deepest point to 1m below ground level and revealed a dark red-brown sandy silt and clay layer. At the base of the trench a homogeneous red-brown sandy silt was revealed, which is thought to represent subsoil in the area (Plate 14).

Plate 14: Trench 2 within Room A, facing north

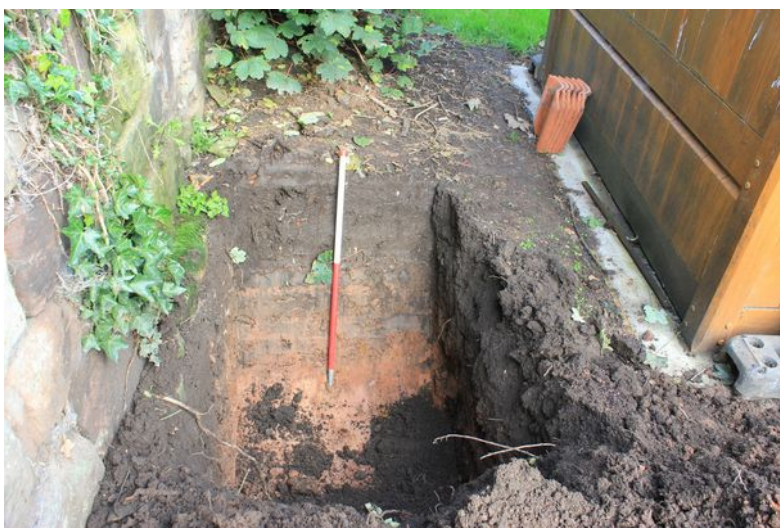
4.3.1 Trench 3 was excavated on the south side of the east range to locate the Northumbrian Water mains pipe and allow for an extension of this service into the building. The trench was excavated to a depth of 1m with the lower 0.6m cut through a red-brown clay silt subsoil above which a dark-grey brown 0.4m topsoil was present. The south section of the trench showed disturbed soil to its full depth and this must represent the backfill of the existing water pipe, though this was not revealed within the trench at this time (Plate 15).

Plate 15: Trench 3. looking east

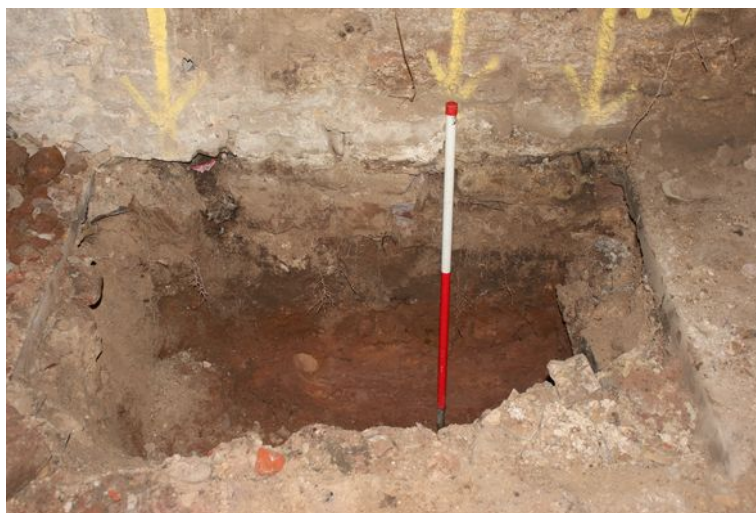
- 4.4.1 Trench 4 was sited adjacent to the south wall internally within the building to facilitate the connection of the water main beneath the wall. It was excavated to 0.9m below ground level and mostly through a red-brown clay subsoil identical to that seen outside the building. The upper 0.3m to 0.4m was a mixed yellow-brown bedding layer beneath the building floor (Plate 16).

Plate 16: Trench 4, facing south

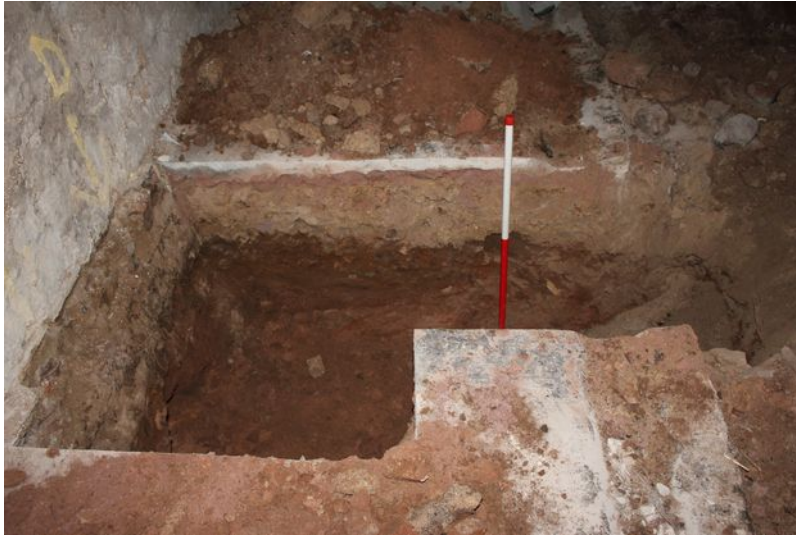
- 4.5.1 Trench 5 extended from the northern internal wall opposite Trench 4, with a narrower extension towards Trench 4 to allow for the water pipe to be laid to the area where the new bathroom and kitchen are to be installed on the north side of the building. It was excavated to 0.8m below ground level and mostly through a red-brown clay subsoil identical to that seen outside the building. The upper 0.3m was a mixed yellow-brown bedding layer beneath the building floor (Plate 17).

Plate 17: Trench 5, facing east

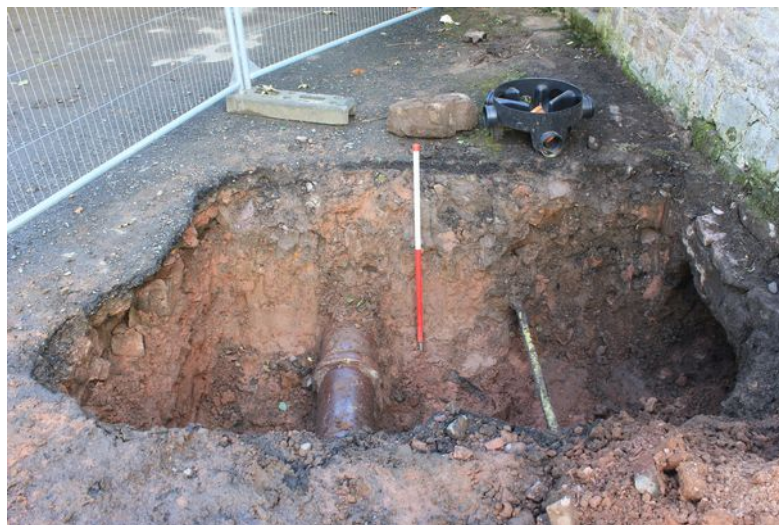
- 4.6.1 The existing waste water sewer pipe runs parallel to the building range outside on the north side and the final trench was sited immediately outside the building opposite the interior trenches to locate this and to establish a waste water connection and to provide space to install a new inspection chamber and hatch. The trench was excavated to a depth of 0.8m and other than the tarmac yard surface and its cobble predecessor the full depth was through a red-brown clay silt subsoil. The existing sewer pipe was revealed in the northern half of the trench within a narrow cutting (Plate 18).

Plate 18: Trench 6 with existing sewer pipe, facing east
