BAMBURGH RESEARCH PROJECT
TRIAL TRENCH EVALUATION
AND HISTORIC BUILDING INVESTIGATION
LORD CREWE ARMS HOTEL
BLANCHLAND
NORTHUMBERLAND

ARCHAEOLOGICAL TRIAL TRENCHING AND BUILDING
INVESTIGATION REPORT

Compiled on behalf of The Lord Crewe's Charity by the Bamburgh Research Project: Commercial Projects Section

BRP 20/03b

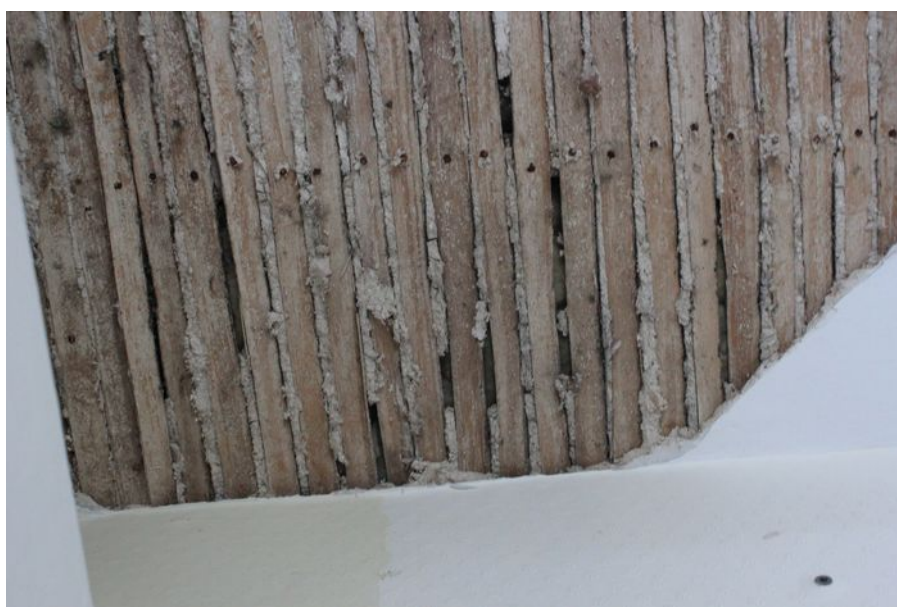
updates to services, fire safety, ventilation and lighting to the first floor as well and all of this work has the potential to impact on the first floor ceiling. Inspection of the ceilings of the first floor shows some of the tie beams and roof timbers, that are clearly part of an old roof structure do extend below the ceiling level into the rooms. Impact on these should clearly be avoided where at all possible. The general ceiling area is of a uniform smooth surface, however, in one area within the hallway at the top of the stairs to the side of Room E some of this modern plasterboard has fallen to reveal small timber laths and traces of older plaster beneath it. This appears to represent an earlier ceiling later covered but there is no indication that this earlier ceiling material is of particularly great age (Plate 7).

Plate 7: Earlier laths and plaster seen beneath the modern plaster board, hall ceiling first floor, facing west

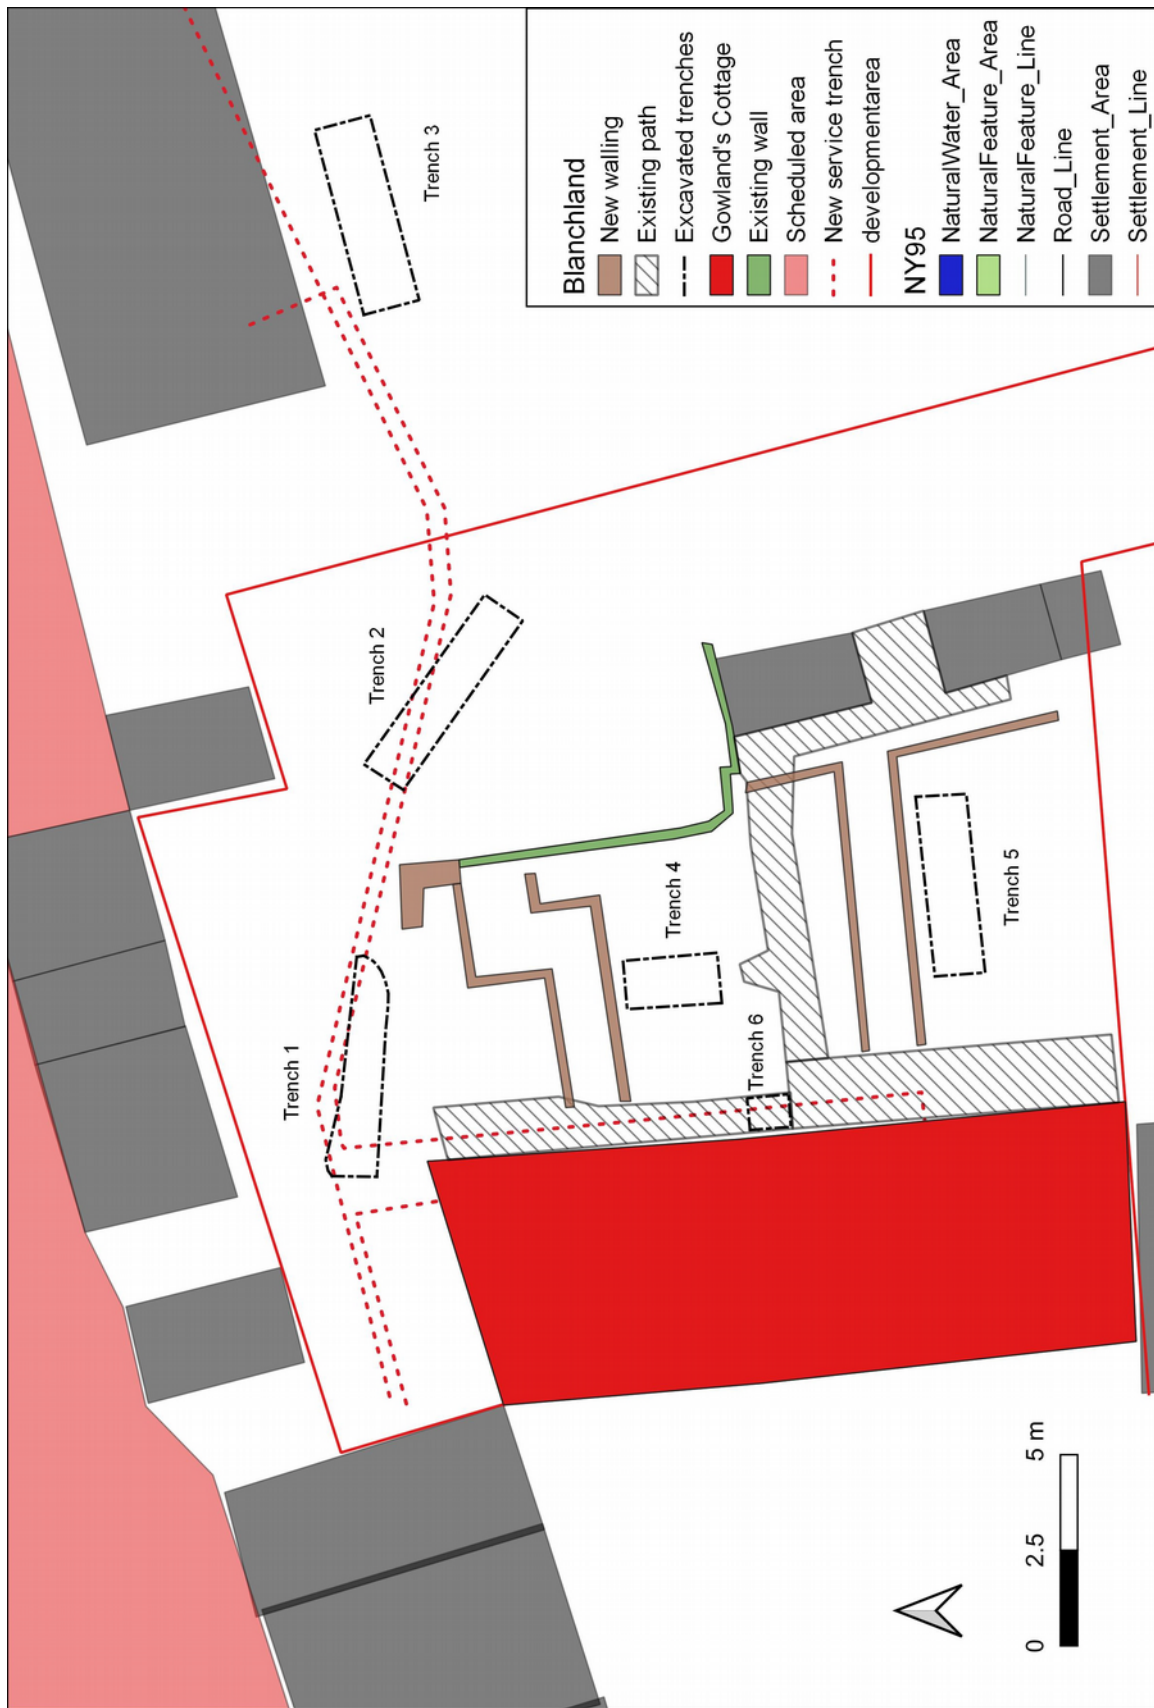
Figure 4: The site area showing the proposed new structures and trial trench location

- 2.2.1 The building investigation will evaluate the archaeological potential and significance of the buildings in the development area and will include in some instances stripping of modern materials and coverings to expose at risk elements of the ancient structure (shown by label on Figure 4). As the stripping and investigation will involve a degree of disturbance of the fabric of a historic building, it is important that it is extensive enough to provide sufficient information to inform the consent but no more than is needed. It is proposed therefore that a meeting will be undertaken on site with the appropriate contractors to provide the detailed information required with particular reference to and the WSI suitably updated:

- The proposed spiral staircase that is intended must be demonstrated to impact only on 19th century elements. In this case the timbers appear to be sawn timber contrasting with the axe/adze dressed timber main beams. Stripping of paint over two sections of the impacted timbers should confirm their later date, but if it is not the case then dendrochronology dates will be taken to prove this. In addition the stripping will expose the ceiling elements between the beams to aid in confirming its date of construction (Plate 1 and Figure 4).

removal (and will be required for the development) to establish this should not be problematic (Plate 2 and Figure 4).

- As with the ground floor there will be a requirement to demonstrate that the ceiling is not impacted by the development and that any services, fire safety, ventilation and lighting will need to avoid impact. If such impact appears necessary then dendrochronology dates will need to be taken to fully understand the potential impact and so that informed decisions can be made.
- The north wall of the proposed Bedroom 4 is substantial and may be therefore be medieval. There is a proposal to recess an area of the wall to form a cupboard. This area is on the opposite side of an existent cupboard and require paint stripping within the cupboard and plaster stripping on the opposite side to confirm the date and if this structure could represent an older entrance (Plate 3 and Figure 4).

4.2.1 The building investigation will evaluate the archaeological potential and significance of the buildings in the development area and will include in some instances stripping of modern materials and coverings to expose at risk elements of the ancient structure (shown by label on Figure 4). As the stripping and investigation will involve a degree of disturbance of the fabric of a historic building, it is important that it is extensive enough to provide sufficient information to inform the consent but no more than is needed. It is proposed therefore that a meeting will be undertaken on site with the appropriate contractors to provide the detailed information required with particular reference to and the WSI suitably updated:

- The proposed spiral staircase that is intended must be demonstrated to impact only on 19th century elements. In this case the timbers appear to be sawn timber contrasting with the axe/adze dressed timber main beams. Stripping of paint over two sections of the impacted timbers should confirm their later date, but if it is not the case then dendrochronology dates will be taken to prove this. In addition the stripping will expose the ceiling elements between the beams to aid in confirming its date of construction (Plate 1 and Figure 4).

- The proposed ground floor en-suite to Bedroom 3 at the southern end of the property extends into an existing cupboard to the east of the fireplace in which the original walls and ceiling are not visible. As a result it needs to be demonstrated that no large and early beam is present there as one is present to the west of the fireplace. In addition the south-east exterior wall is not square and so it is important to establish that no early fabric is present here to be impacted. This would require the removal of the cupboard and false ceiling within it and exposure of the stone at the back wall of the cupboard. The complete structure appears to be of relatively late date and so total removal (and will be required for the development) to establish this should not be problematic (Plate 2 and Figure 4).

- As with the ground floor there will be a requirement to demonstrate that the ceiling is not impacted by the development and that any services, fire safety, ventilation and lighting will need to avoid impact. If such impact appears necessary then dendrochronology dates will need to be taken to fully understand the potential impact and so that informed decisions can be made.
- The north wall of the proposed Bedroom 4 is substantial and may be therefore be medieval. There is a proposal to recess an area of the wall to form a cupboard. This area is on the opposite side of an existent cupboard and require paint stripping within the cupboard and plaster stripping on the opposite side to confirm the date and if this structure could represent an older entrance (Plate 3 and Figure 4).

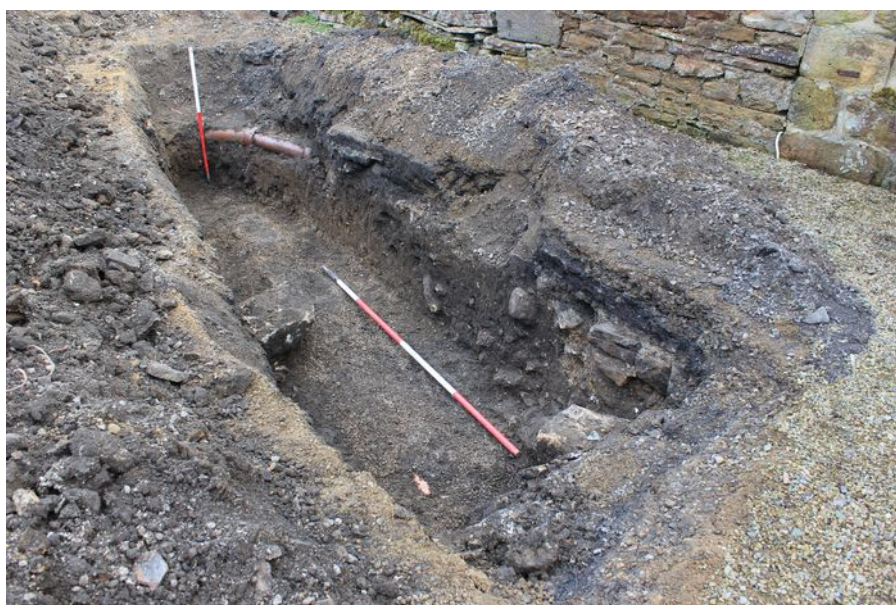
4.1.1 Subsoil (**119**) that comprised a medium yellow-brown silty clay was seen at the base if the trench 1.13m below ground level (236.72m OD). A very disturbed sandstone wall (**111**) was present cut into subsoil in the south-west corner of the trench. It survives partially intact, disturbed by a number of features but appears to have been constructed on a rubble foundation on which square cut dressed sandstone blocks had been laid. It was silt bonded and may have been partially robbed. It survived up

to 0.4m in height and was sealed by a soil layer (**110**), a stony very dark brown clay silt over which a less stony layer of grey-brown silty clay was present (**109**), further covered by a thin layer of dark near black silt (**106**). This was in turn cut by a pit (**104**) that contained a layer of sandstone rubble (**103**) and a medium yellow-brown sandy silt (**102**) (Figure 5 and Plates 8 and 9).

- 4.1.2 The trench contained three service trenches. The largest of these (**114**) extended along the trench on an east to west alignment and contained a gravel fill (**113**) and had truncated wall **111**. This was cut on its north side by a further service trench (**116**) that contained a narrow metal pipe and also cut at the east end of the trench by a service cut (**108**) for a soil pipe that extended across the trench on a south-east to north-west alignment. The services were sealed by topsoil (**101**), two paving slabs (**105**) and this in turn sealed by gravel (**100**) that formed the hard standing in the area.

Plate 9: Trench 1 showing the fragmentary stone wall truncated by the service trench and rubble filled pit, facing south-east

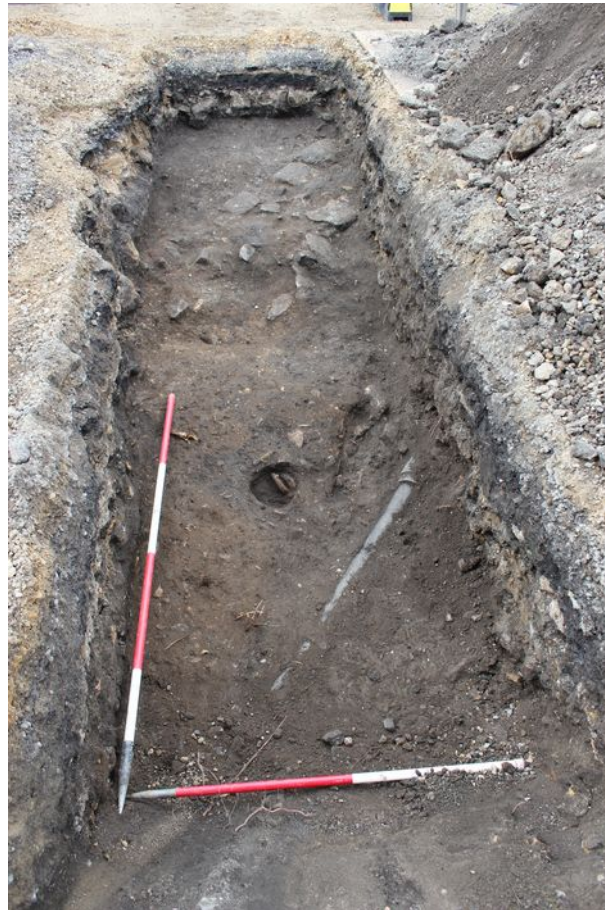
- 4.2.1 Subsoil (**215**) was seen at the base of the trench and comprised a red-brown silty clay with some stones. It lay between 0.7m and 1.0m below ground level (232.32m and 232.04m OD) and was cut by a stone wall (**210**) at the west end of the trench that may have been contained within a rather ephemeral shallow cut (**212**). The wall survived only one course high, was formed from two faces of square cut medium sized sandstone blocks with a rubble core. It was silt bonded and was disturbed at the south end where it appeared to have been robbed out as it did not extend to the section (Figure 5 and Plate 10).

- 4.2.2 The wall and subsoil was sealed by a layer (**209**) of dark grey-brown stony sandy silt which in turn was covered by a grey-brown sandy silt with pebbles (**208**). At the east end of the trench these layers were overlain by a stony dark silt layer (**207**) and a stony mortar spread (**206**) and a dark grey-brown stony layer (**205**) that also contained a substantial mortar content. Both layers had the appearance of being derived from demolition rather than being in any way structural. In addition a number of masonry blocks within the west end of these layers, and the central part of the section, are in the correct place to represent rubble from the robbing of wall **210**. Two mortar layers (**204** and **203**), separated by a thin silt lens were present in the east part of the trench sealing layer **208**. It was unclear if these layers represent a crudely laid mortar surface or a dump deposit. They were sealed by a layer of very dark grey-brown silt (**202**) with a substantial stone content. The trench was covered by a pebble surface (**200**) laid on a thin silt layer (**201**).

Plate 10: Trench 2 showing the partially surviving stone wall and intrusive service, facing north-west

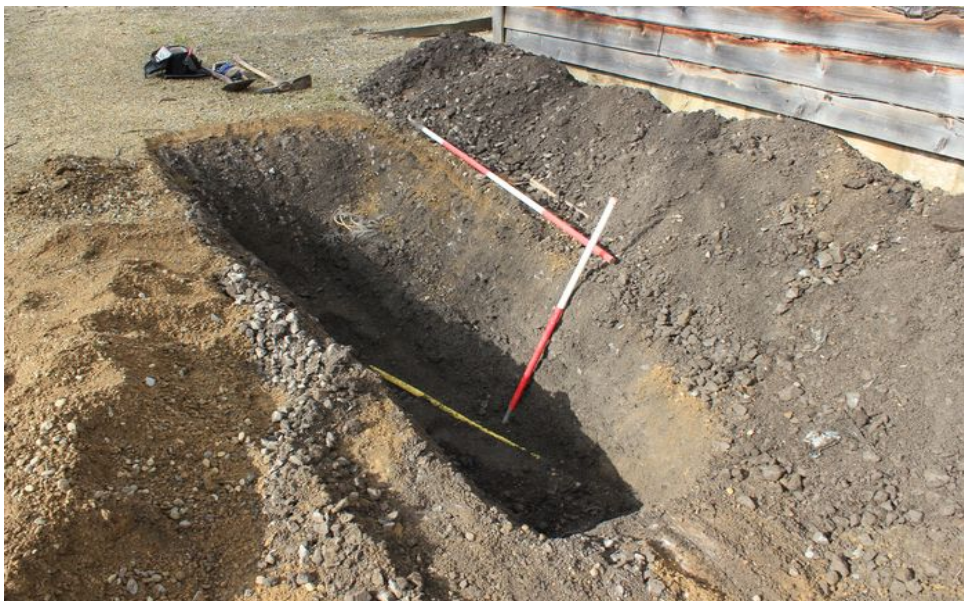
Plate 11: Trench 3 containing made-up ground and modern service, facing north-west

- 4.3.1 Trench 3 revealed the presence of a service pipe within its cut (**303**) that appeared to be cut into a made-up ground (**301**). The service pipe was sealed by the pebble hard standing layer (**300**) that formed the ground surface (Figure 5 and Plate 11).

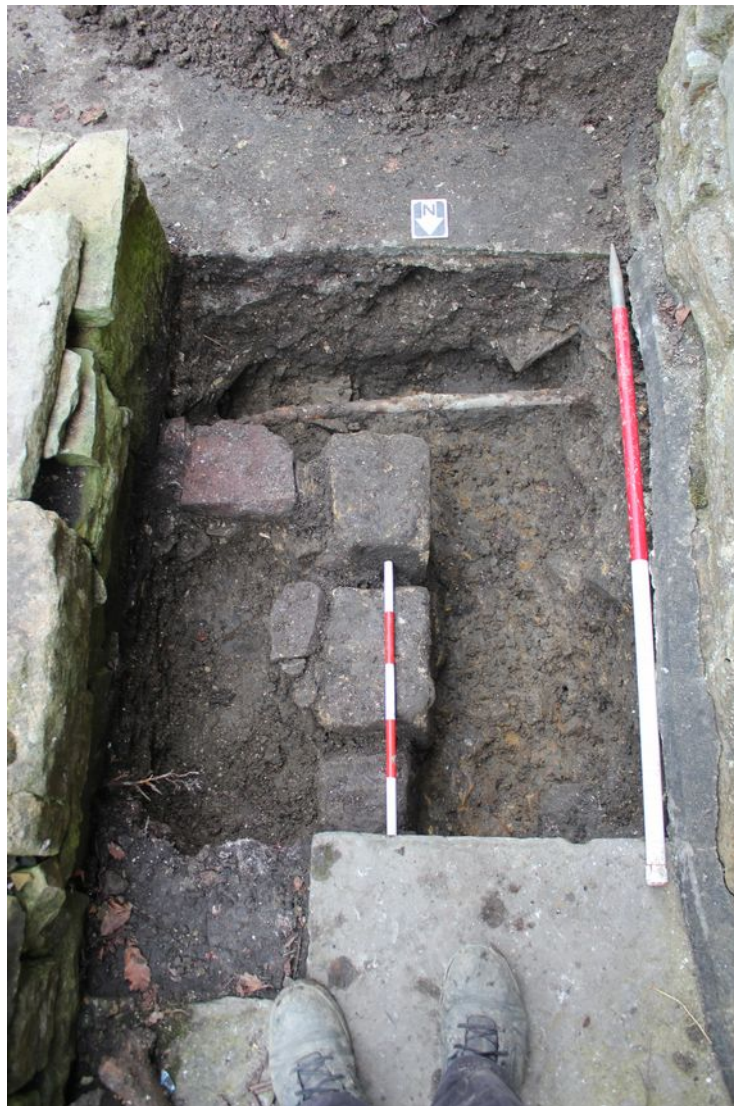
- 4.6.1 Subsoil (**606**) was seen at the base of the trench 0.45m below ground level and was the same yellow-brown clay with some stone seen in Trenches 4 and 5. A single course, and single thickness, stone right-angled linear (**602**) that may have been a very crude wall was seen on a north to south alignment set on the subsoil and covered by a soil layer (**601**), a dark grey-brown silt with some clay and stone content. The feature was of unknown date but had the appearance of being a garden feature. At the south end of the trench two or three small split sandstone flags (**603**) were seen to lie on the subsoil to the south of the wall. A water service pipe (cut **604** and fill **605**) had been cut in at the south end of the trench above the level of the slabs. The trench was covered by pavement slabs (**600**) that formed the ground surface (Figure 5 and Plate 14).

Plate 14: Trench 6 showing the stub wall (602), facing south
