# **BAMBURGH RESEARCH PROJECT**

## **INSTALLATION OF AN ELECTRICITY CABLE AT HOTSPUR STREET AND BONDGATE WITHOUT, ALNWICK, NORTHUMBERLAND**

### **REPORT OF ARCHAEOLOGICAL MONITORING AND RECORDING**

BRP 10/02b

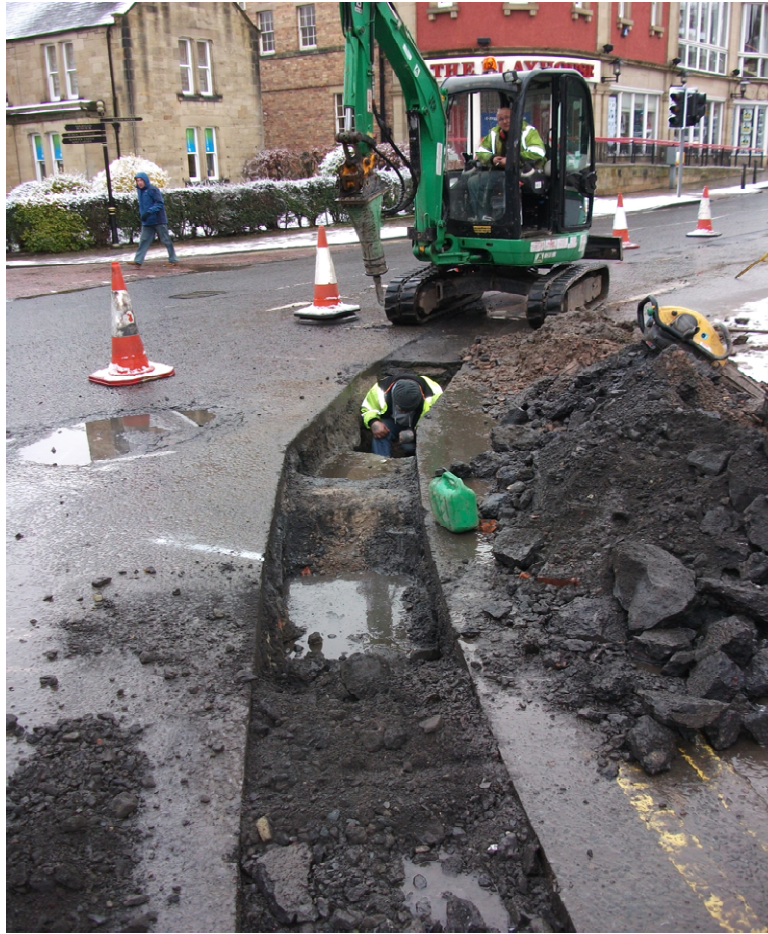
*Plate 1: Installation trench at the corner of Hotspur Street with Bondgate Without, facing north east*

- 4.1.1 The watching brief was undertaken intermittently between 17<sup>th</sup> and 23<sup>rd</sup> February 2010. The excavation trench varied in width between 0.4m and 0.7m and did not exceed 0.85m in depth. Only the initial work at the junction of Bondgate Without and Hotspur Street was monitored because of a misunderstanding arising from a series of delays caused by the presence of a culvert. No indications of any archaeological remains were uncovered during the course of this work, but it is worth bearing in mind that the trenches were of only modest depth and therefore were unlikely to have reached below the post-medieval accumulation of material. This inference is corroborated by the undifferentiated sequence of sediment commingled with débris consisting of drainage tile, glass, and brick in the sections that were subject to investigation. Numerous service lines cut across the trench, indicating that there is substantial disturbance in this part of the town from modern development.
