ARCHAEOLOGICAL INVESTIGATIONS

Enfield Wharf, Clayton-le-Moors, Hyndburn, Lancashire

ARS Report N°: 2023/26
OASIS ID: archaeol5-509794

Archaeological Investigations at Enfield Wharf, Clayton-le-Moors, Hyndburn, Lancashire

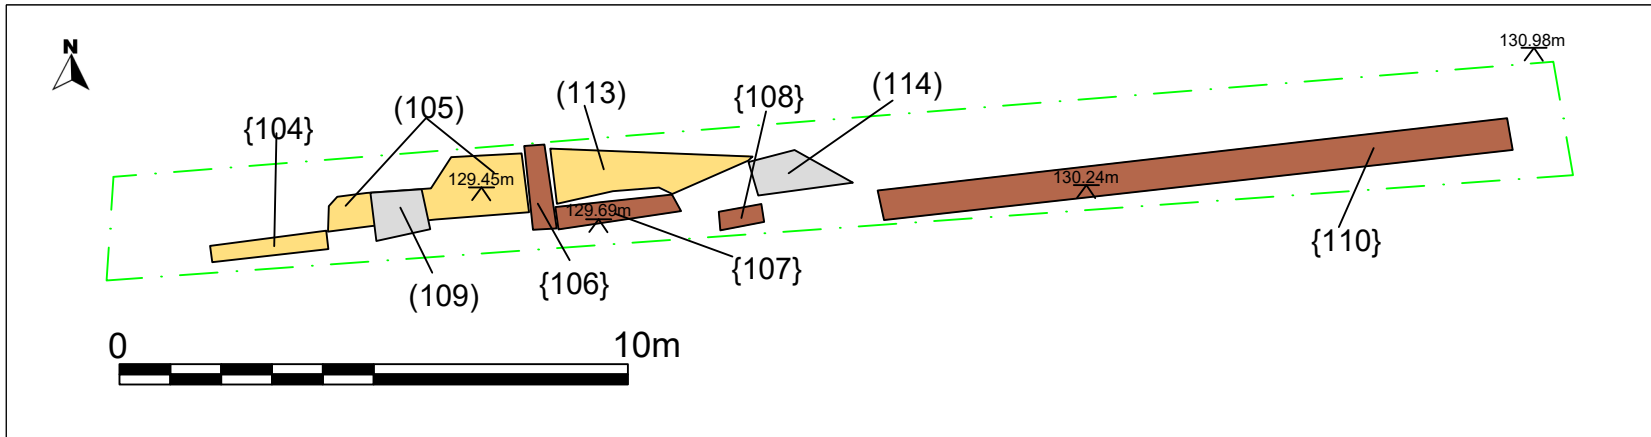
Figure 5: Plan of Trench 1 above photograph of Trench 1, looking east (scale: 1x1m, 1x2m)

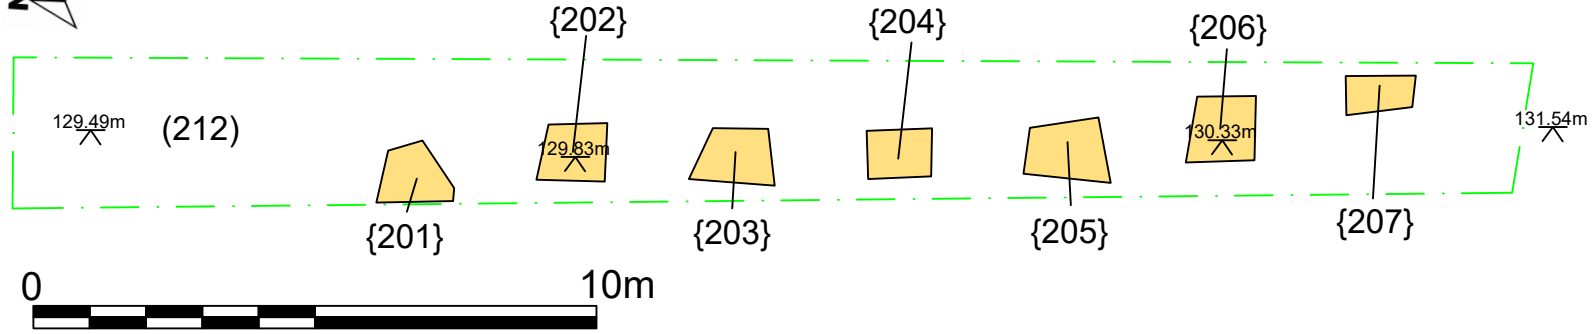
- 4.2.5 Trench 2 (Figure 6) was aligned north to south and targeted the southern building of the Soap Works and the adjacent building of Canal Mills. A series of sandstone pillar bases were encountered {201}, {202}, {203}, {204}, {205}, {206}, {207}, likely relating to the weaving sheds of the mill. These were laid directly onto natural clay (212). The trench was covered by an asphalt overburden (208), overlaying a layer of demolition rubble (209). Underneath this was another layer of asphalt (210) and another demolition layer (211).

Figure 6: Plan of Trench 2 above photograph of Trench 2, looking north (scale: 1x1m, 1x2m)

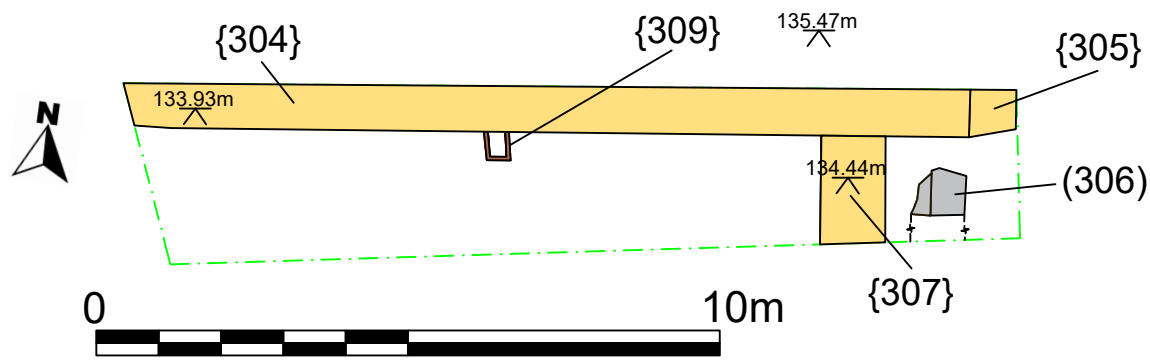
Figure 7: Plan of Trench 3 above photograph of Trench 3, looking north east (scale: 1x1m, 1x2m)

- 4.2.6 Trench 3 (Figure 7) was aligned east to west and targeted the southeast corner of the northern Canal Mills building. The trench was covered by an asphalt overburden (301), followed by a light grey demolition deposit (302) and a dark grey demolition deposit (303). These overlaid the stone walls {304} and {305} in the northern part of the trench. Wall remnant {305} was directly on top of wall {304} and probably represents the dressed stone superstructure, although only this single block remains, with wall {304} representing the more roughly constructed foundation course. The base of wall {304} which was founded on clay, stepped downwards towards the west, possibly following a natural slope. A single flagstone, (306), was located in the eastern end of the trench, which was at the same level as the top of wall {304}. This may have been a remnant of a surface at that level. A levelling deposit underneath the surface (308) separated it from a stone culvert {307}, which was constructed with handmade redbrick walls with large stone slabs on top, running south to north possibly into an east to west culvert beneath or to the north of wall {304}. Another south to north structure, {309}, made of brick and adjacent to, and leading beneath wall {304}, was present in the central/western part of the trench. This may have been part of a downpipe for surface drainage from Mill Entrance surface to the culvert system.

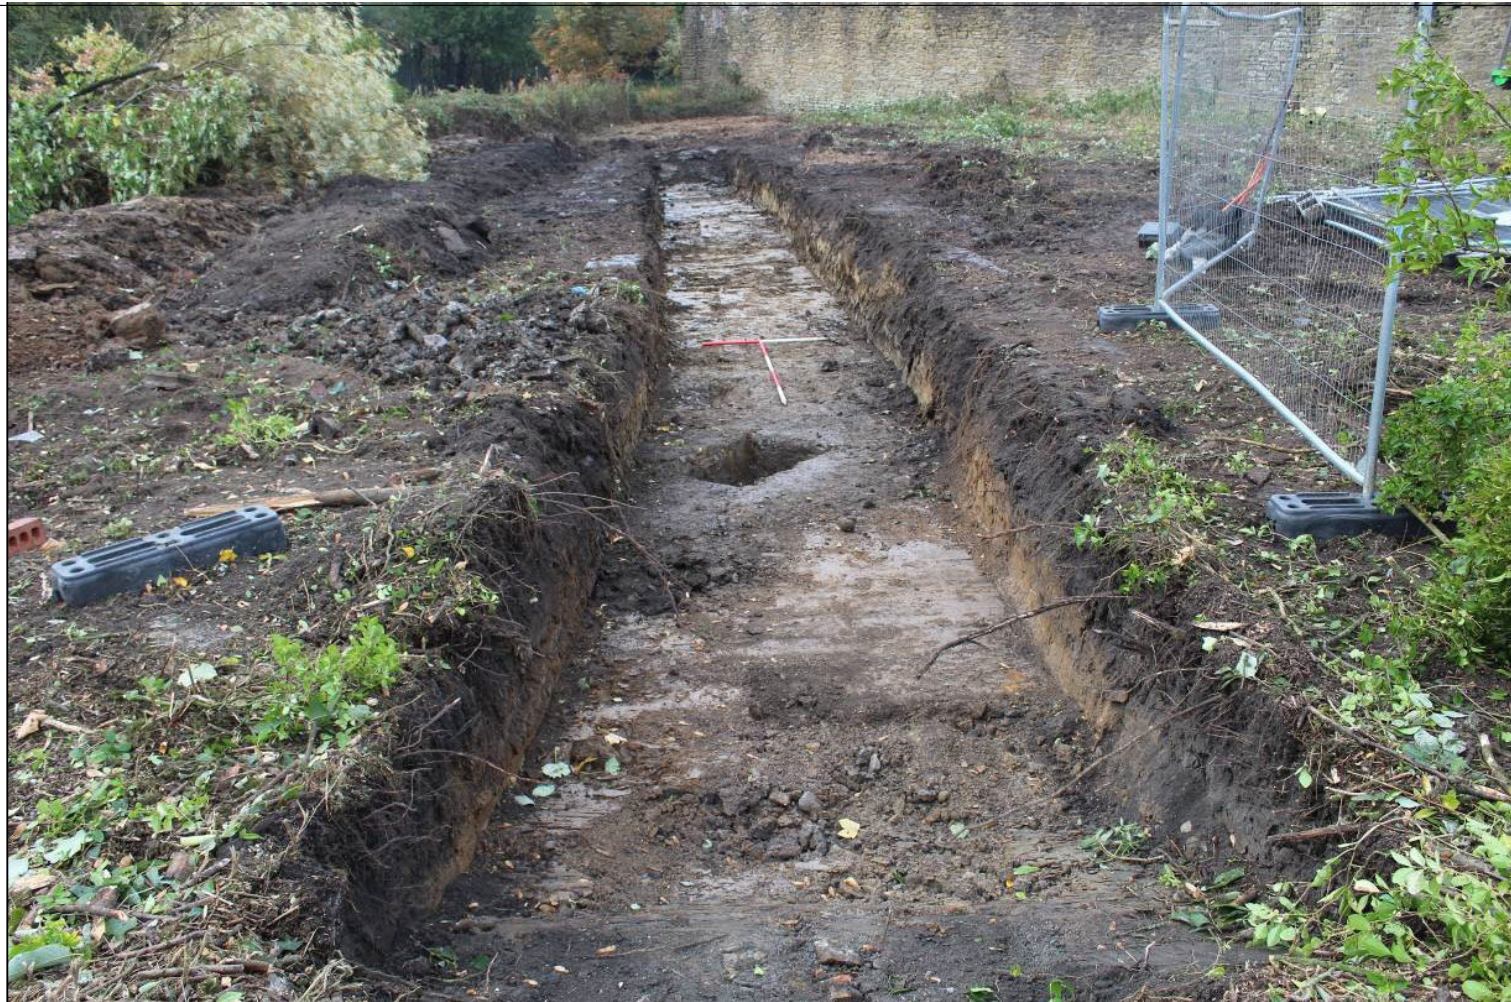
Figure 11: Plan of Trench 8 above photograph of Trench 8, looking north-west (scale: 1x1m, 1x2m)

4.2.11 Trench 8 (Figure 11) was aligned northwest to southeast and targeted the area south of Albion Mill. The first layer encountered was the topsoil (801), followed by the subsoil (802) and the natural substrate (803). Two features were discovered in the southeast part of the trench – a very shallow potential pit containing a broken sheet of plate glass [806] and a linear cut for a late 19th century salt-glazed drain [804]. The drain had been removed and only broken pieces of it remained. The possible pit, [806], was so shallow that it may more likely simply be the result of the fallen piece of glass having pressed into the natural clay and retaining water beneath.

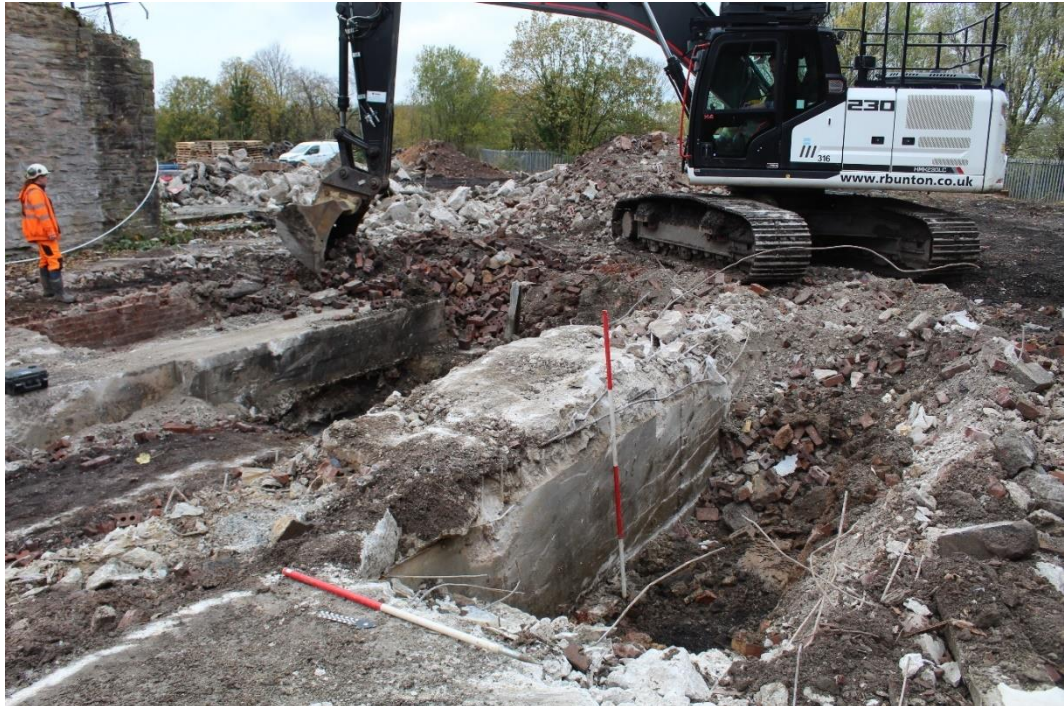
- 4.3.2 Area 1 (figure 12, figure 13) targeted the remains of the Soap Works positioned towards the northern extent of the site, as Trench 1 yielded the adjacent cobbled roadway and exterior wall of the structure and it was therefore considered likely that a chimney and associated features would also survive, informing about the power systems of the soap works. However, once excavated, the area proved to have been heavily altered and truncated by later developments with limited evidence of 19th century structures surviving.

Figure 13. Working Photograph of the Area 1 excavation showing modern concrete foundations {1001} and {1003}, looking south west (scale: 1x1m, 1x2m)

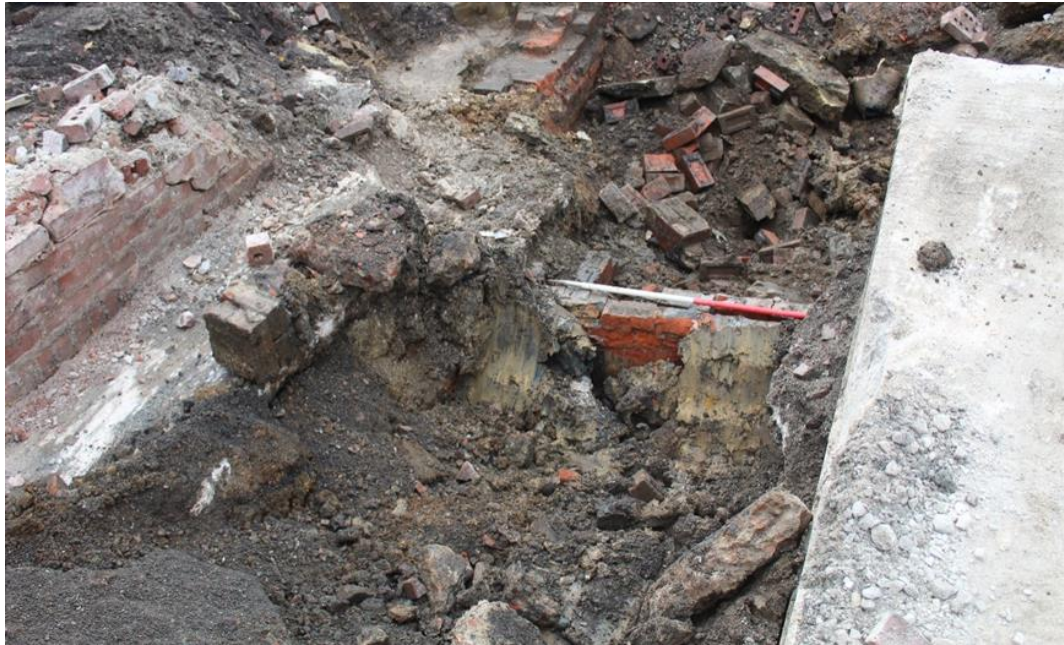
Figure 14. Overview of southern part of Area 1 showing culvert walls {1009} and {1015}, following removal of concrete slab (1005), with chimney wall {1007} in background and Wall {1004} in left foreground, looking west (scale: 1x1m)

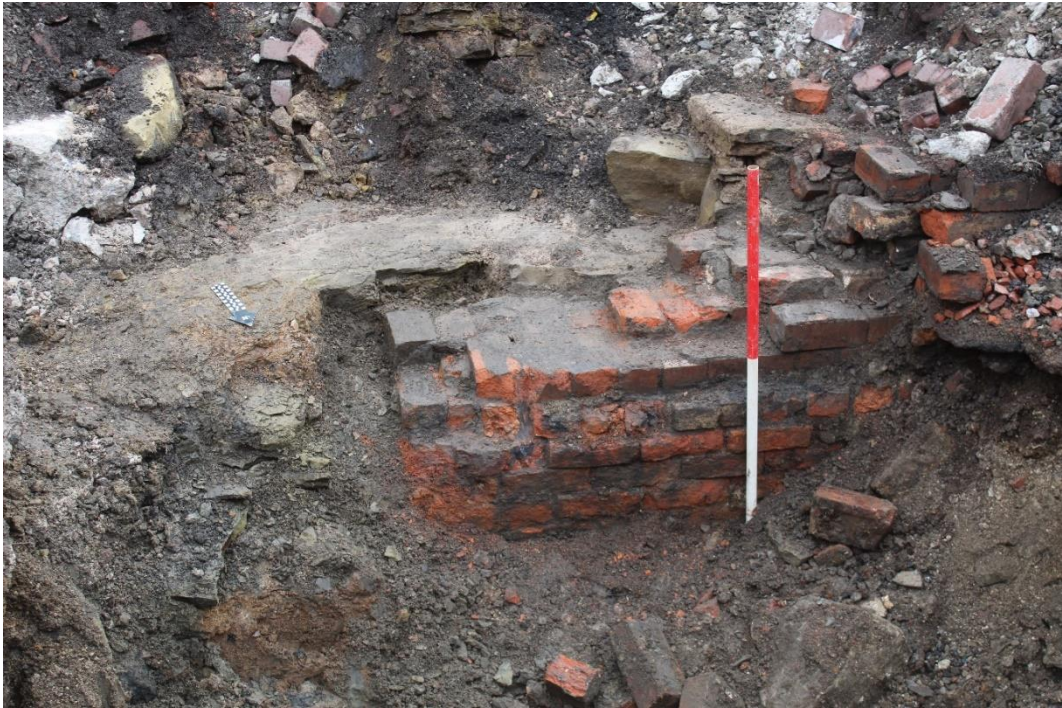
- 4.3.4 In the south-western part of the site a four-skin thick, handmade red brick wall with stepped foundation, {1007}, ran east to west, bonded with lime mortar (Figure 15). This wall had been truncated at either end and abutted a large piece of sandstone (1006) which may have been a bedrock outcropping which appeared to have been chiselled away to form a recess within which wall {1007} was laid. This wall is in the correct location to be associated with the soap works chimney depicted on late 19th century maps, however it showed no evidence of heat affectation on the bricks or mortar. This may have been the very base of the chimney foundation, using the bedrock outcrop as a convenient natural foundation for the remainder of the chimney which was therefore at a higher level and truncated during later activity on the site.

Figure 15. Photograph of 19th century wall {1007}, possible chimney foundation, looking south-west (scale: 1x1m)

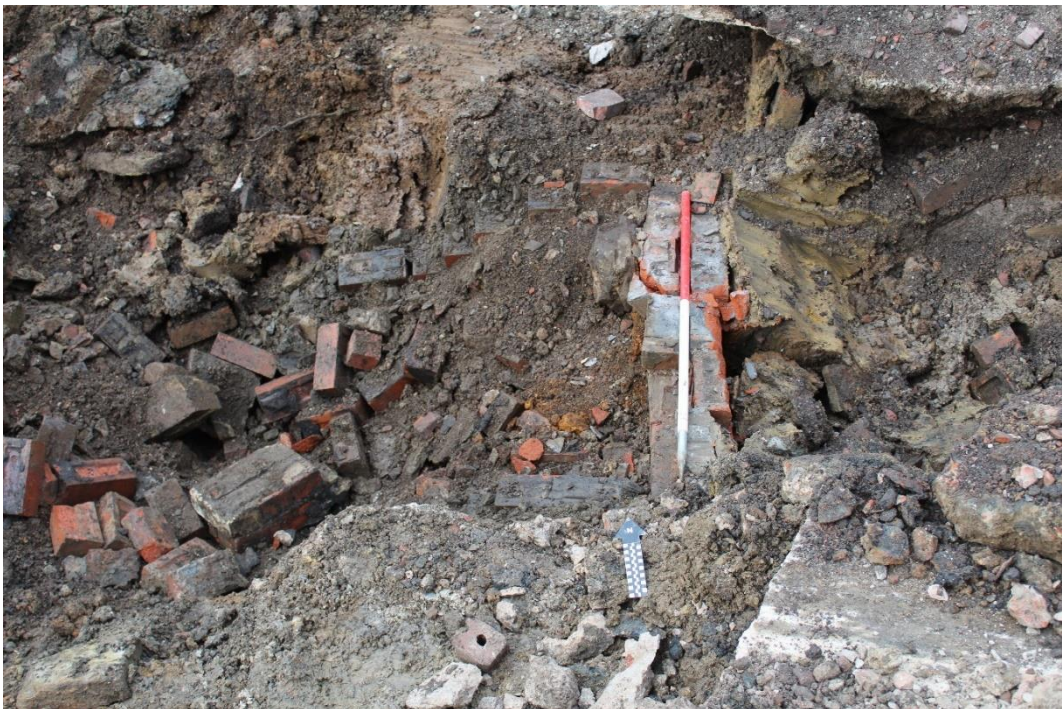
4.3.5 A truncated structure laid with machine made, frogged red bricks, probably of mid 20th century date (Figure 16) was located to the north of the potential chimney foundation {1007} and lay c.1.8m below current ground level. The structure comprised walls {1008}, {1009}, and {1015}, all frogged machine made red brick walls bonded with cement mortar, forming the end of a channel. This appeared to be a culvert and was probably associated with the building post-dating demolition of the soap works in the 1960s.

Figure 16. Photograph of 20th century culvert remains {1008}, {1009} and {1015}, looking north (scale: 1x1m)

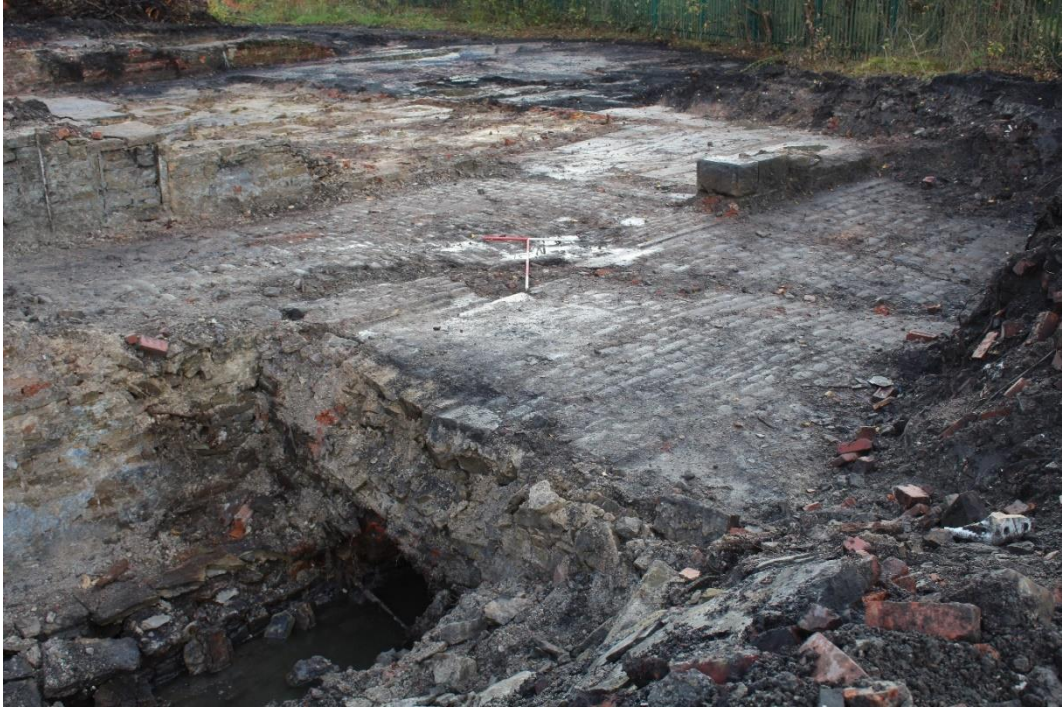
- 4.3.6 Area 2 (Figure 17 and Figure 18) targeted the section of the site surrounding the chimney depicted on the OS mapping of the Canal Mills. Unlike the first watching brief area, an abundance of 19th century structures were uncovered displaying multiple phases of renovation and repair to the mill's superstructure. Additionally, a relatively intact and large-scale culvert was uncovered in close proximity to the targeted chimney base.

Figure 18. Overview of Area 2, looking south-west with culvert {2064} beneath surface (2055) in foreground and walls {2035}/{2042}/{2043} in background (scale: 1x1m, 1x2m)

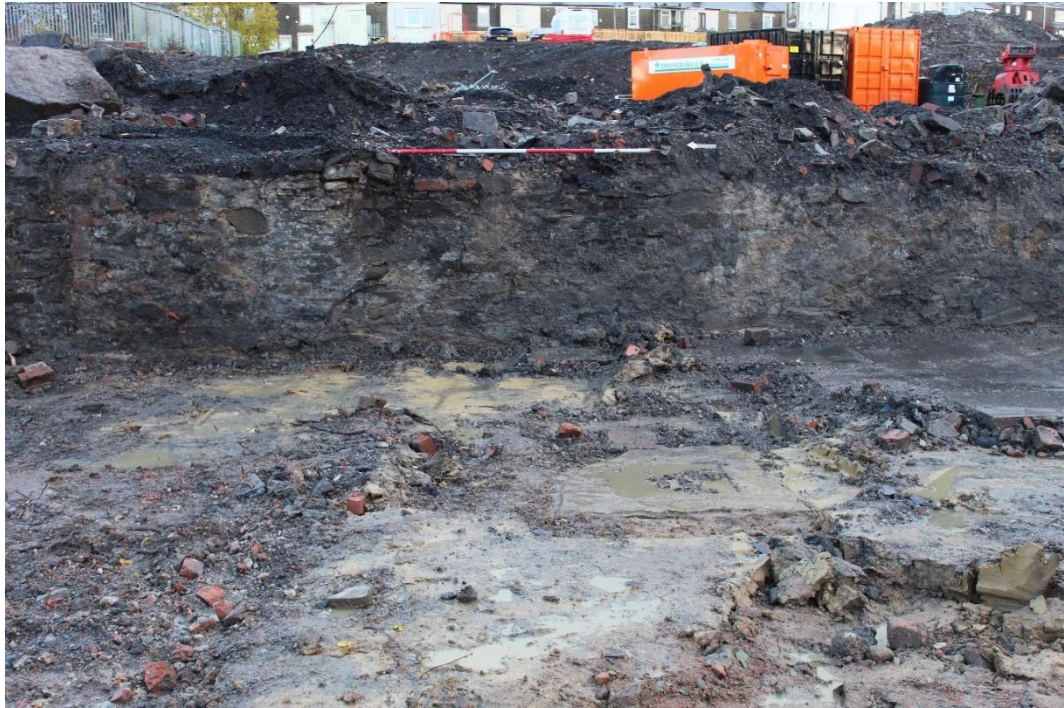
- 4.3.7 The largest room uncovered during the Area 2 investigation was rectangular and found at the southern limit of the excavation, bounded by walls {2035}, {2036}, {2042} and {2043} on the south, east, west and northern sides respectively. This room was a brick built addition to the southern, main, stone built mill building
- 4.3.8 Stone wall {2036} was the western wall of the southernmost of the two main Canal Mills buildings and also formed the eastern edge of the room (Figure 19). This wall was laid with rough hewn stone blocks and bonded with lime mortar. There was a blocked up doorway, {2066}, towards the northern end of the wall, suggesting later alterations to the structure.

Figure 19. 19th century stone wall {2036}, looking east (scale: 1x2m)

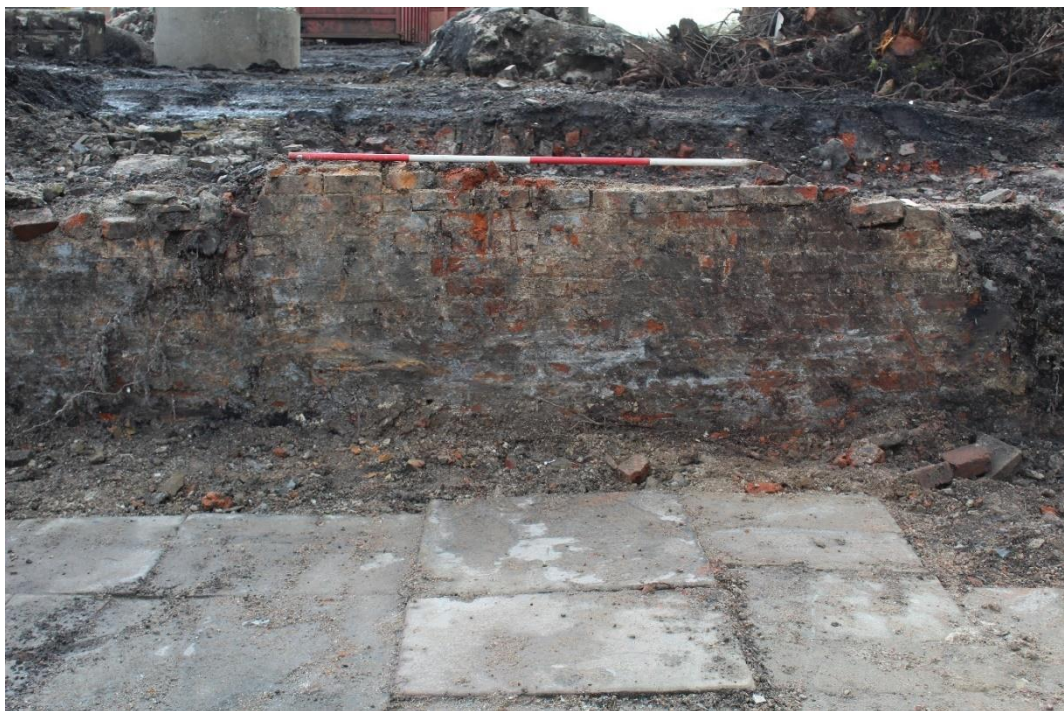
- 4.3.9 Wall {2035} (Figure 20) was a 19th century handmade red brick wall which bounded the room to the south and abutted stone wall {2036} at the eastern end. The wall was laid to an English bond with lime mortar.

Figure 20. Photograph of 19th century wall {2035}, looking south (scale: 1x2m)

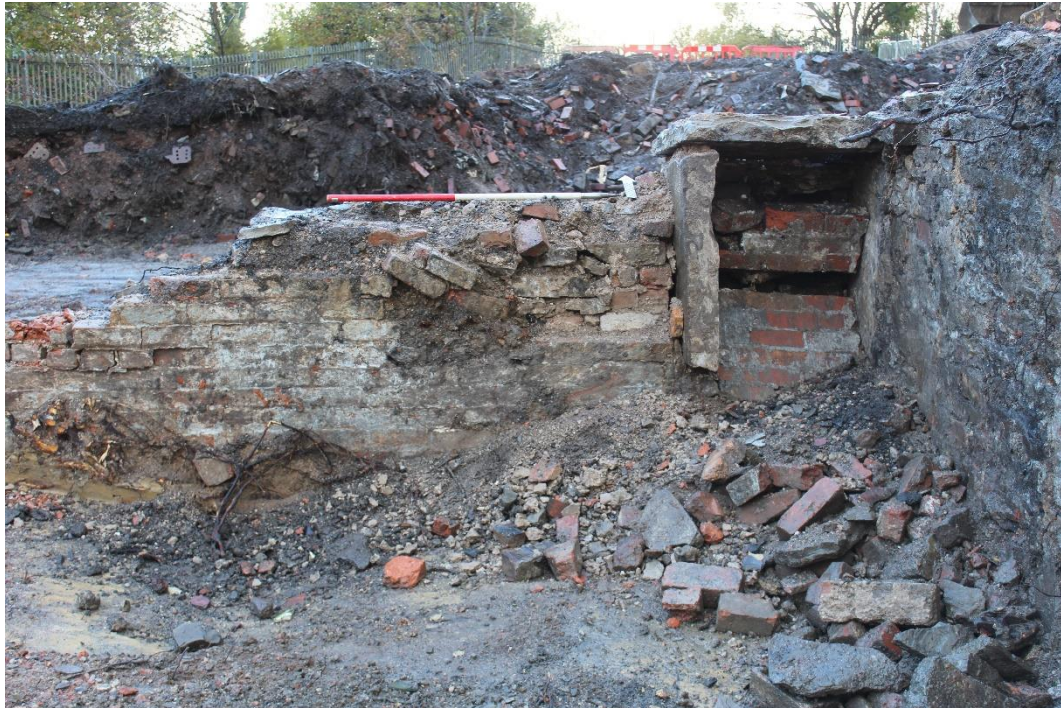
road surface between the two mill buildings. This doorway was blocked up at a later date, probably early 20th century, with machine made bricks and cementitious mortar, {2065}.

Figure 21. Photograph showing wall {2043} with former blocked access {2065}, looking north (scale: 1x1m)

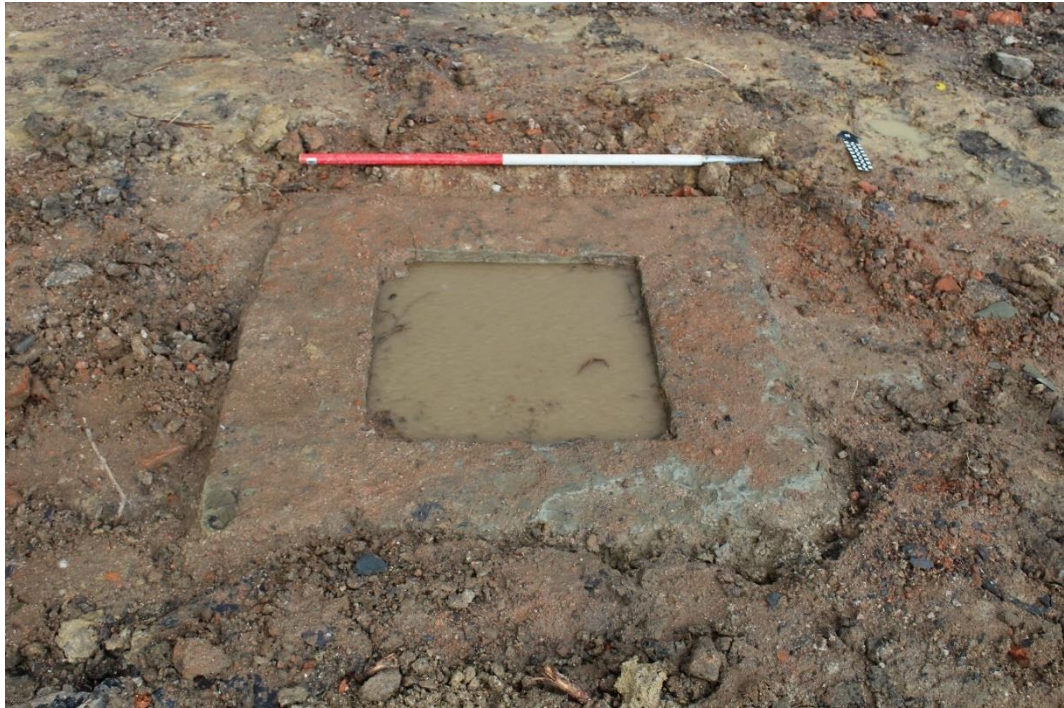
- 4.3.11 There was a truncated floor present in the southeastern corner of the room, floor (2038), which as laid with sandstone flagstones in various sizes. It seems likely that the floor would have continued across the entire room, but seems that a large number of the flagstones had been removed, probably during later developments or demolition of the mill. Two rows of stone pillar bases (e.g. {2048}, Figure 22) were set into the clay across the central part of the room in an east to west alignment. These stone structures were well preserved with the recess for the former uprights, probably cast iron pillars, visible on the surface of each.

Figure 22. Photograph of stone pillar base {2048}, looking north (scale: 1x1m)

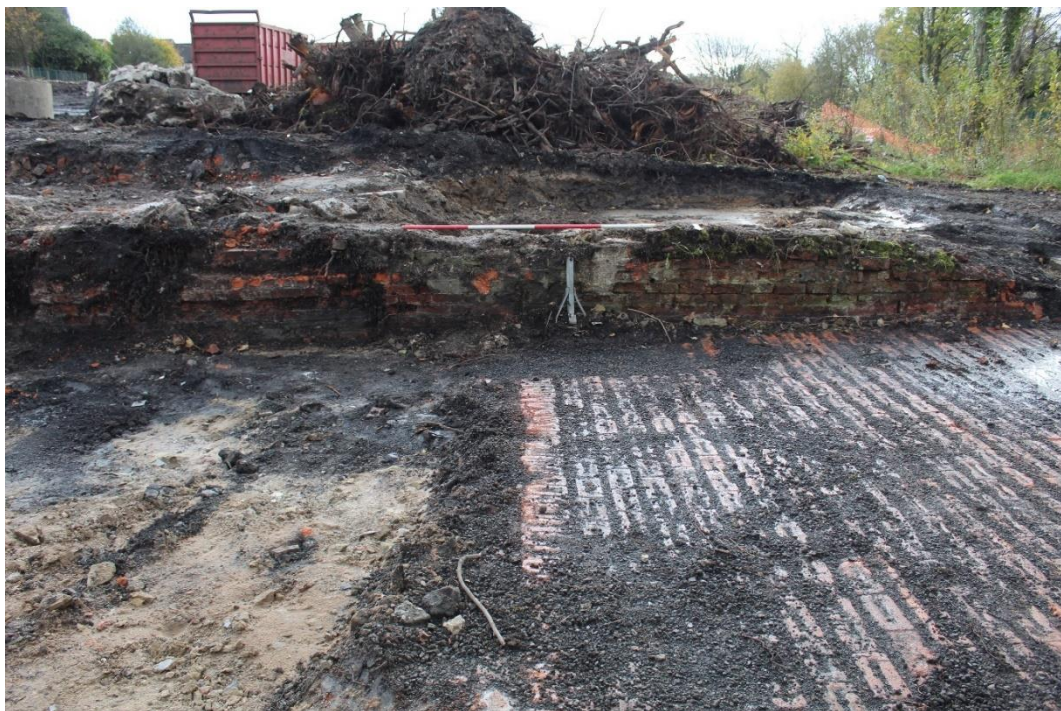
- 4.3.12 A 20th century brick surface (2037), laid with frogged machine made red bricks, formed the western limit of the room, and continued westwards to the edge of the bank down to the canal (Figure 23).

Figure 23. Photograph of 20th century surface (2037), looking south towards wall {2036} (scale: 1x2m)

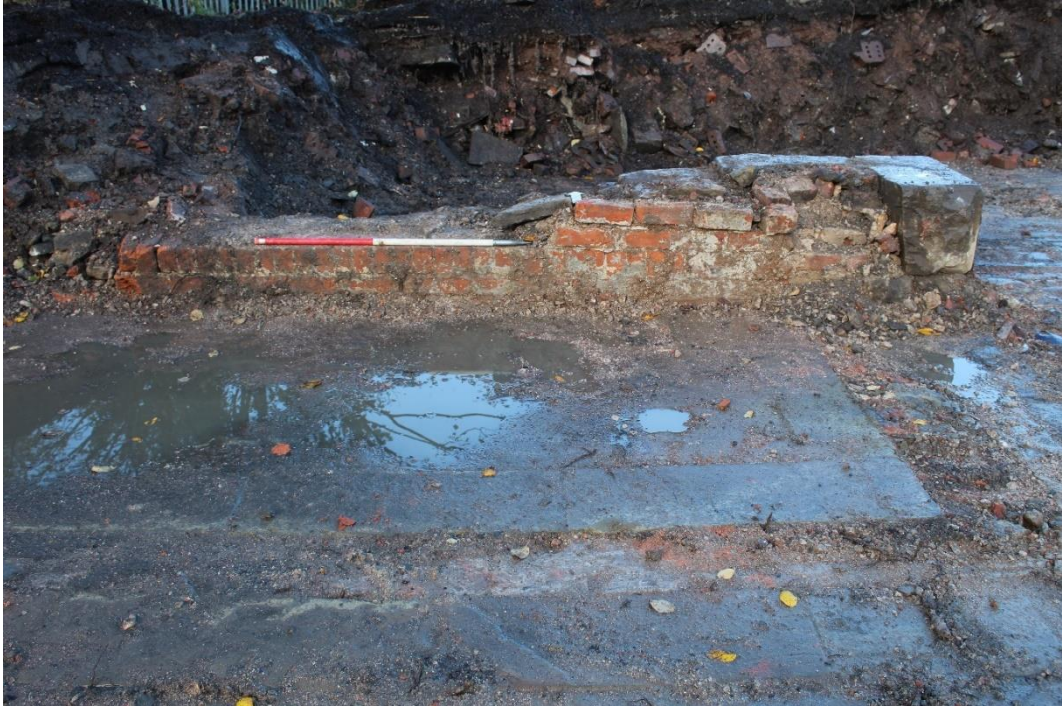
- 4.3.13 A small rectangular structure was unearthed in a poorly preserved state within the north-western part of the area (Figure 24). This structure comprised an east to west wall {2051}, a whitewashed handmade red brick structure consisting of two courses of stretchers atop a line of rowlock bricks bonded with lime mortar, as well as the foundation course of wall

{2050}, an L-shaped wall running southwards from wall {2051} and returning westwards. The two walls were likely built at the same time and were both set into stone surface (2041), which was laid with sandstone flagstones and abutted the road (2052).

Figure 24. Photograph of structure with wall {2051} in background and wall foundation {2050} in foreground, looking north (scale: 1x1m)

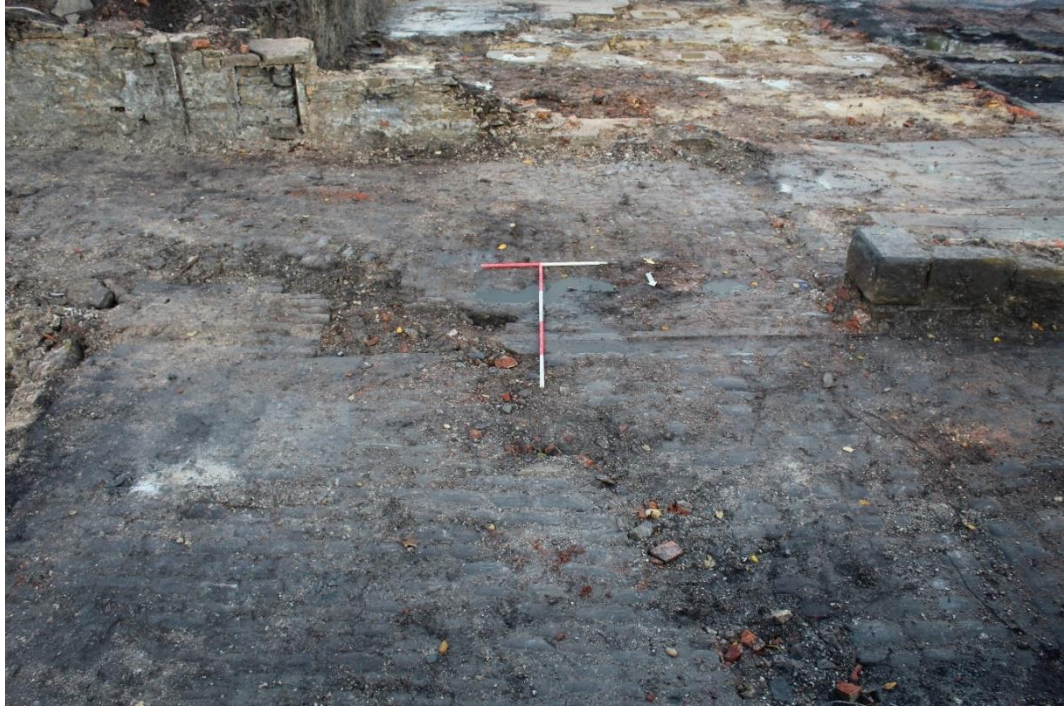
- 4.3.14 Cobbled stone road surface (2052) ran east to west across the centre of Area 2, laid with stone setts. Surface (2052) was truncated by a modern drainage cut, [2053], from north-west to south-east, an interaction also apparent in the neighbouring cobbled surface (2055). Surface {2052} represents the road between the two Canal Mills buildings, whilst surface (2055) represented the yard between the northern building and the canal, probably used as a loading/unloading area connecting the mill to the canal wharf.

Figure 25. Photograph of truncated cobbled surfaces {2055} in background and {2052} in foreground, with metal rail (2056) separating them, looking south (scale: 1x1m, 1x2m)

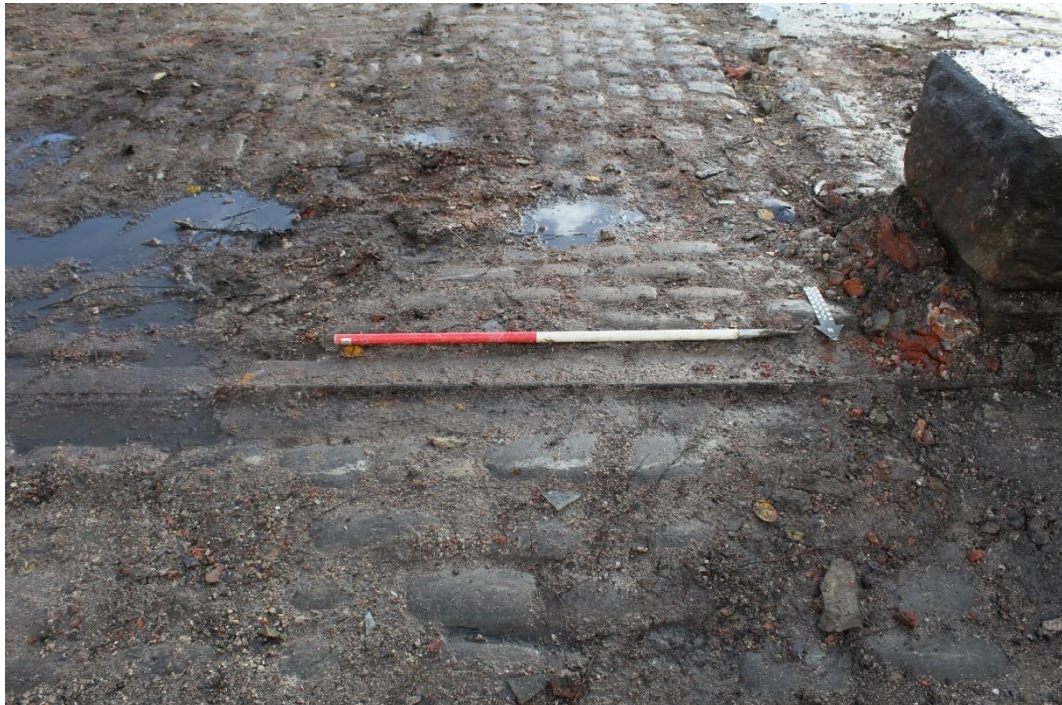
4.3.15 Surfaces (2052) and (2055) were separated by a thin metal rail (2056) running east to west (Figure 25). The positioning of this bar at a possible entrance to the section of the mill uncovered in Area 2 suggests that it would have acted as the fitting for a sliding door or gate perhaps securing the yard from the road.

Figure 26. Detail of metal rail (2056), looking south (scale: 1x1m)

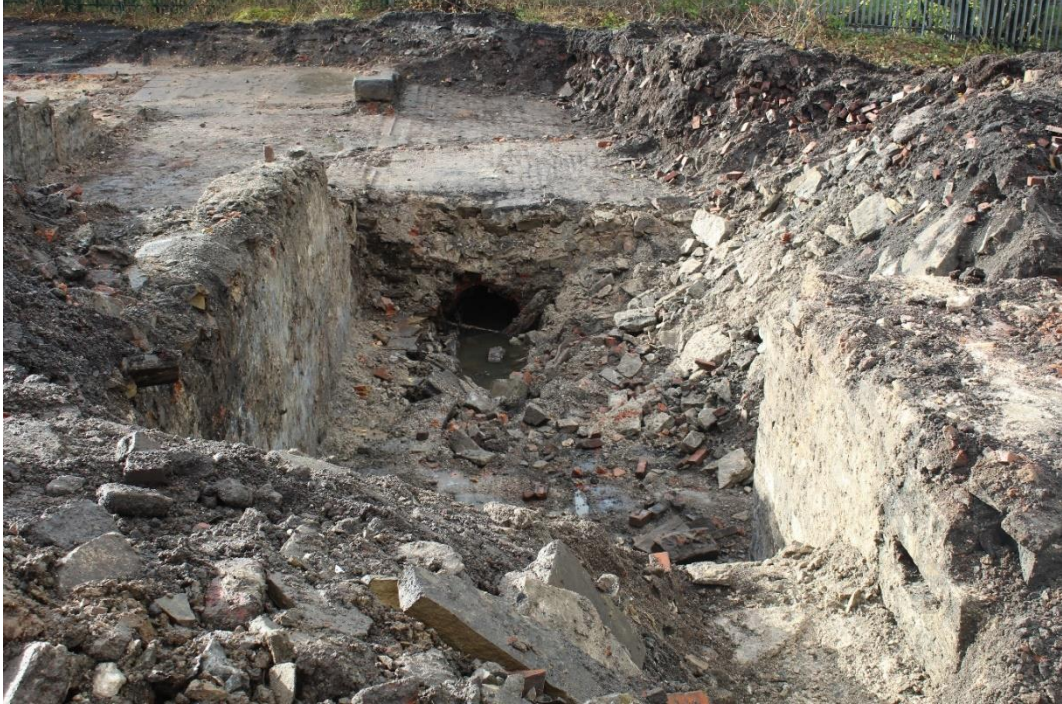
north of wall {2057} (Figure 27) which appeared to have been a main drain beneath the mill building, possibly connected to the culverts seen in Trench 3. It is probable that this culvert drained into the canal. The culvert was constructed with red bricks, to create a cylindrical tunnel, exposed during the excavation of a sondage into the area. The area around the culvert was filled with blocks of stone rubble. Unfortunately, due to the depth of this sondage the details of the culvert and its base were unable to be recorded further.

Figure 27. Photograph of culvert {2064} with stone wall {2057} on left and chimney {2061} on right, looking west (no scale)

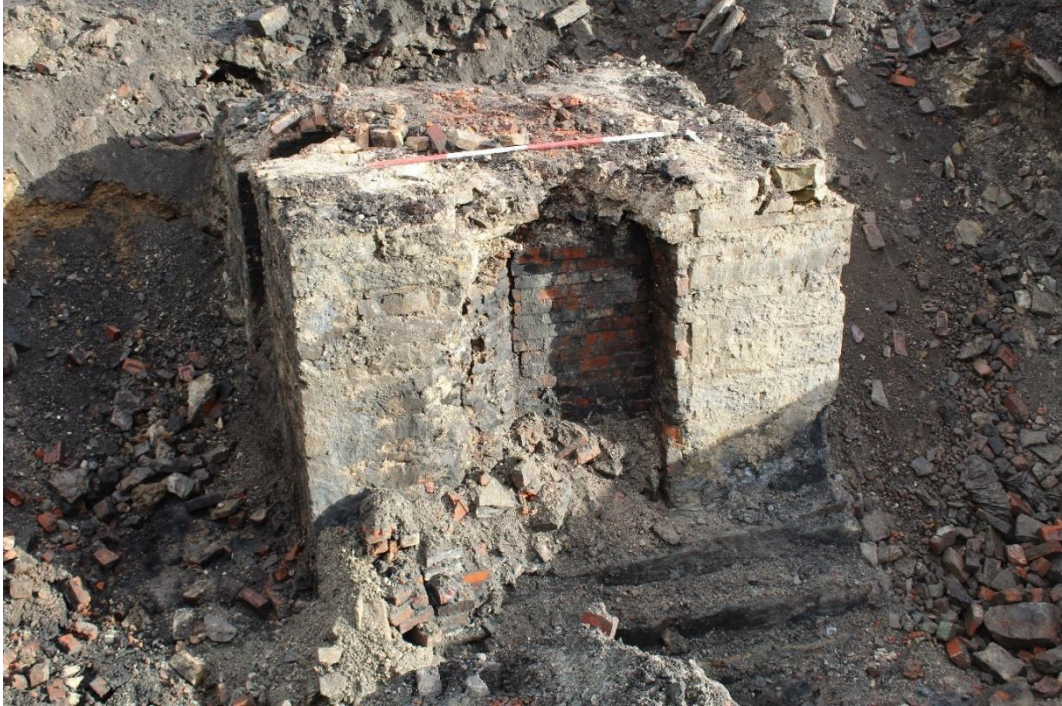
- 4.3.17 The stone base {2061} of a chimney (Figure 28) was uncovered to the northeast of the culvert at a considerable depth below ground level and thus it was not possible to investigate it in detail. Like the majority of contemporary structures, chimney {2061} was constructed in the 19th century primarily with a series of cut stone blocks. These were laid in four square columns atop a stepped base. The base of the vertical flue of the chimney was visible between the stone columns {2062}. On the northern side of the structure was an arched, brick built flue opening with an arched ceiling. This appeared to be built of firebricks which were heavily sooted.

Figure 28. Photograph of chimney base {2061} with brick flue {2062} visible between columns, looking east (scale: 1x2m)

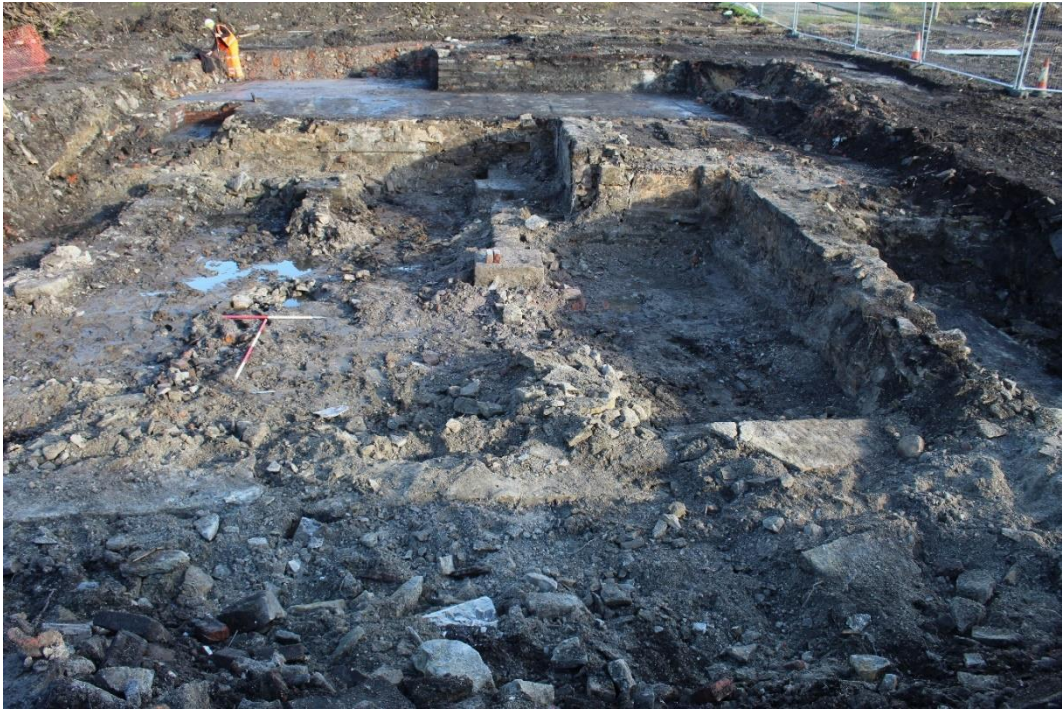
- 4.3.18 Area 3 targeted the south-easternmost section of the Canal Mills footprint, targeting an L-shaped room abutting the southern main mill building shown on OS mapping (figure 29 and figure 30). Whilst material evidence of the main building was in poor condition, the L-shaped room at the south-eastern limit was comparatively well preserved. The L-shaped room sat at a higher level than the western room, with a difference in floor levels of c. 0.5m.

Figure 30. Overview of Area 3, looking east (scale: 1x1m, 1x2m)

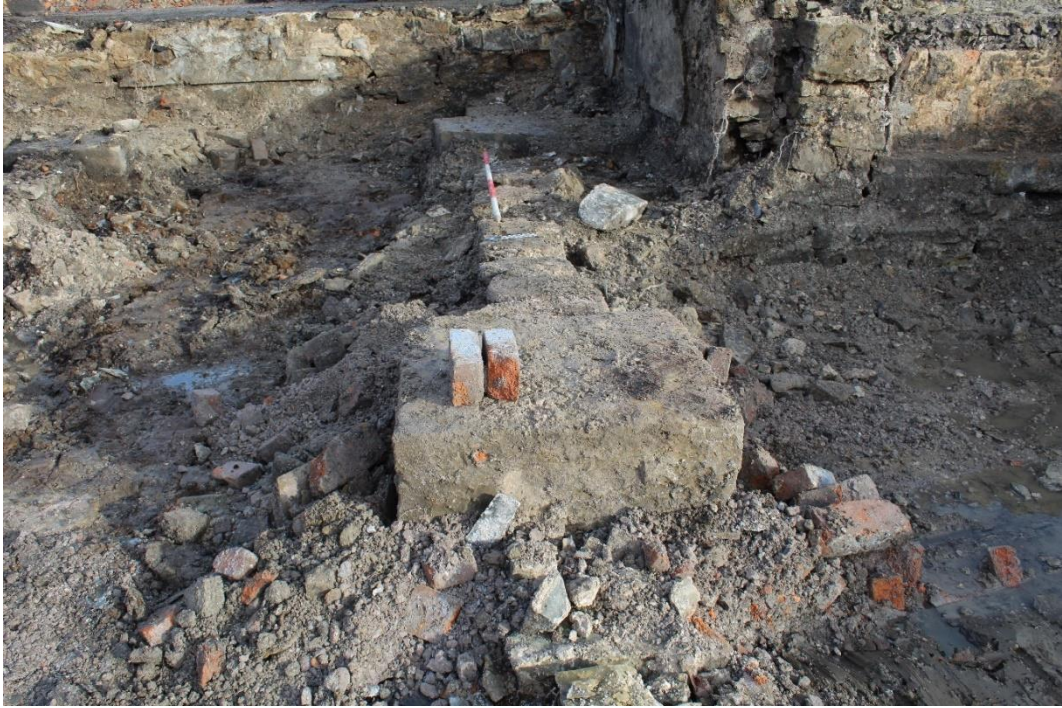
- 4.3.19 The majority of Area 3 comprised three sets of stone foundations set into natural clay running northwards into mill boundary wall {2012}. These foundations, though heavily truncated, comprised a series of stone beams (e.g. {2015}) with inset stone stanchion bases (e.g. {2017}) (Figure 31). These were probably under-floor supports for suspended wooden flooring in the Canal Mills building, with the larger stone blocks parts of pillar bases, probably for cast-iron uprights supporting a saw-tooth roof.

Figure 31. Photograph of stone foundation beam {2015} with stone stanchion base {2022} in foreground, looking east towards wall {2012} (scale: 1x2m)

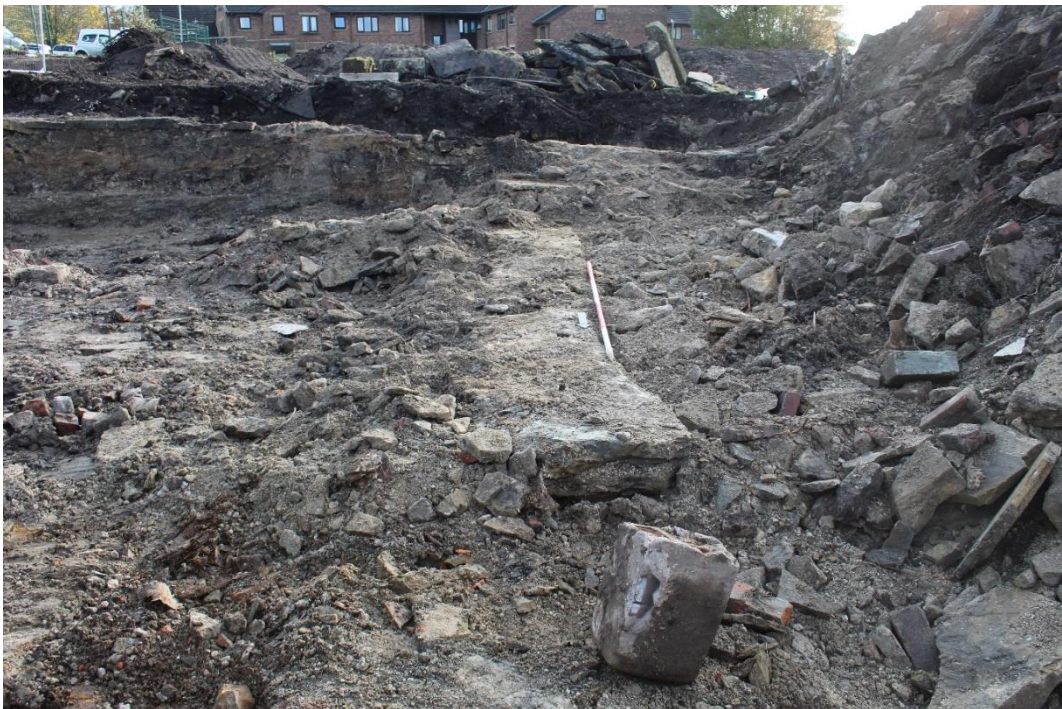
4.3.20 The interpretation of this area as below flooring level is further supported by the presence of two 19th century drains cut into the clay base of the excavations, below what would have been floor level. A ceramic pipe {2031} ran east to west along the south side of stone beam {2015} possibly continuing beneath wall {2012}. A stone wall {2025} formed the western edge of the area (Figure 32), with a stone built culvert running along the eastern side of it with an inserted ceramic pipe, possibly a later addition.

Figure 32. Stone wall {2025} looking south (scale: 1x2m)

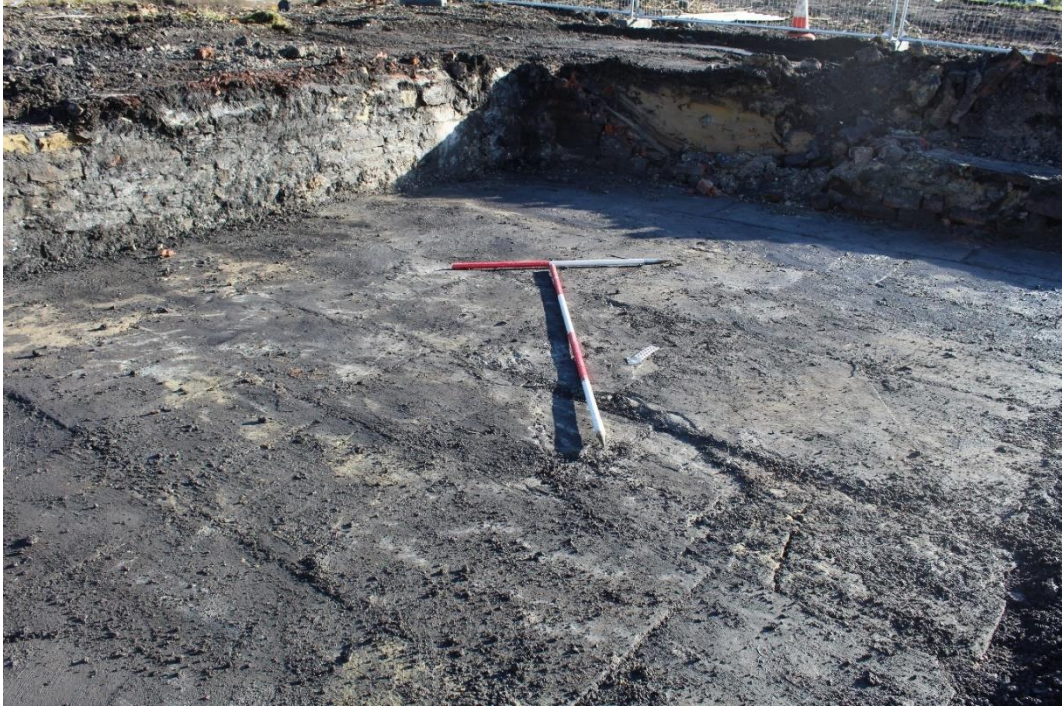
4.3.21 The upper section of Area 3 contained a series of surfaces and walls contributing to the L-shaped room depicted on the OS mapping. The southern section comprised 19th century sandstone flagstone surface (2004) bounded by stone mill boundary wall {2008} to the east, heavily truncated single skin, handmade redbrick wall {2009} to the south, and wall {2012} to the west (Figure 33). Wall {2009} was laid to a stretcher bond with lime mortar and containing a raised sandstone step (2010) providing an entrance to the room from Mill Street, this lends itself to the suggestion that the room provided an entrance into the mill complex from the road to the south.

Figure 33. Photograph of surface (2004), walls {2008} and {2009}, and step (2010), looking south-east (scale 1x1m, 1x2m)

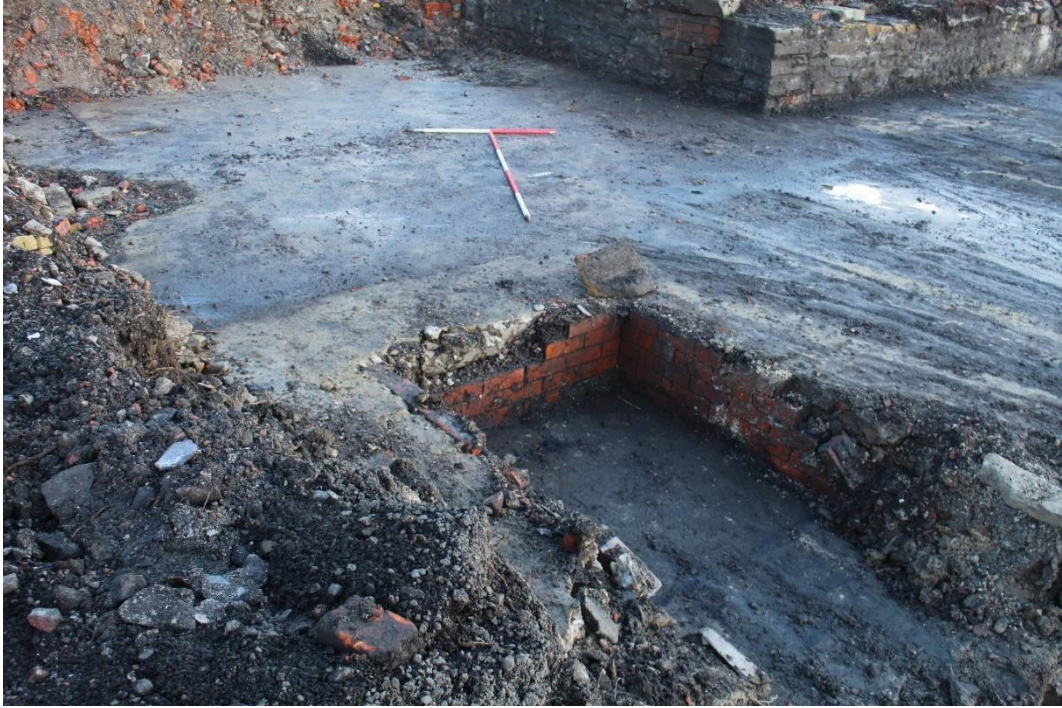
Figure 34. Photograph of concrete surface (2003) and brick lined feature {2028}/{2029}/{2011}, looking south-east (scale: 1x1m, 1x2m)

4.3.24 Floor (2003) was also bounded by stone wall {2006}, another segment of the 19th century footprint of the site. Wall {2006} was laid with roughly hewn stone blocks bonded with lime mortar also patched in two places with 20th century machine made red bricks and black ash mortar possibly during a phase of repairs to the original building.
