ARCHAEOLOGICAL INVESTIGATIONS

Enfield Wharf, Clayton-le-Moors, Hyndburn, Lancashire

ARS Report N°: 2023/26
OASIS ID: archaeol5-509794

Archaeological Investigations at Enfield Wharf, Clayton-le-Moors, Hyndburn, Lancashire

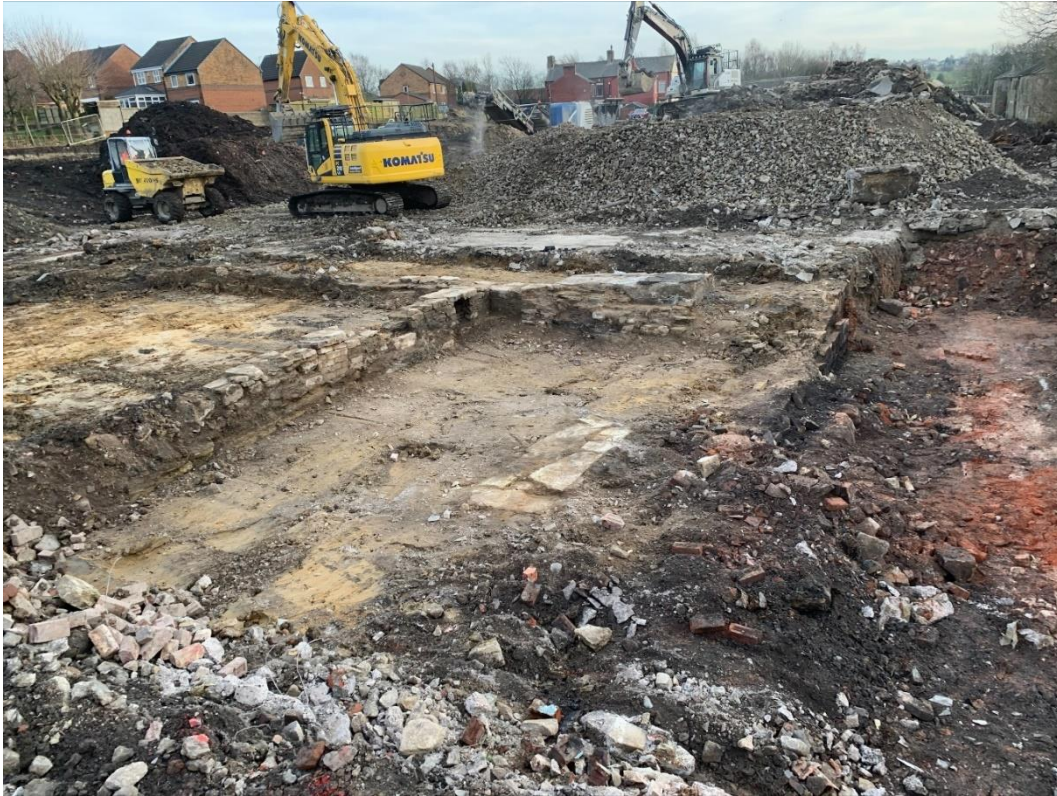
Figure 36. Overview of Area 4, looking southeast (no scale)

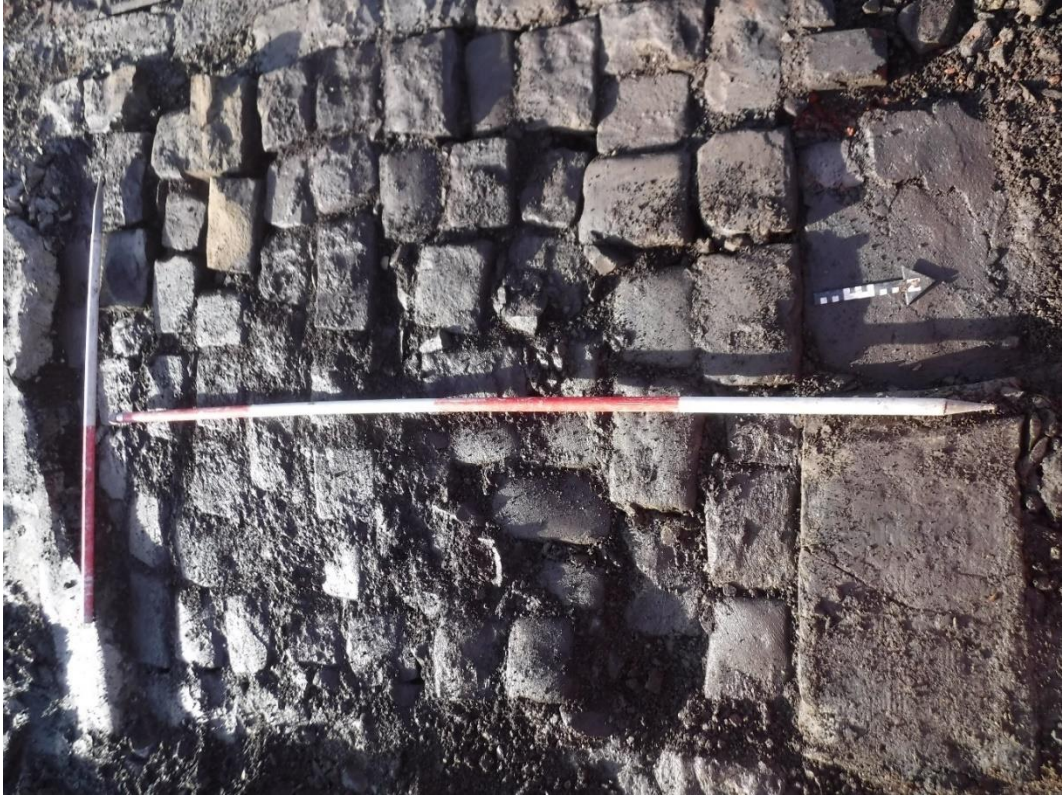
Figure 37. Photograph of cobbled surface (4019), looking west (scale: 1x1m, 1x2m)

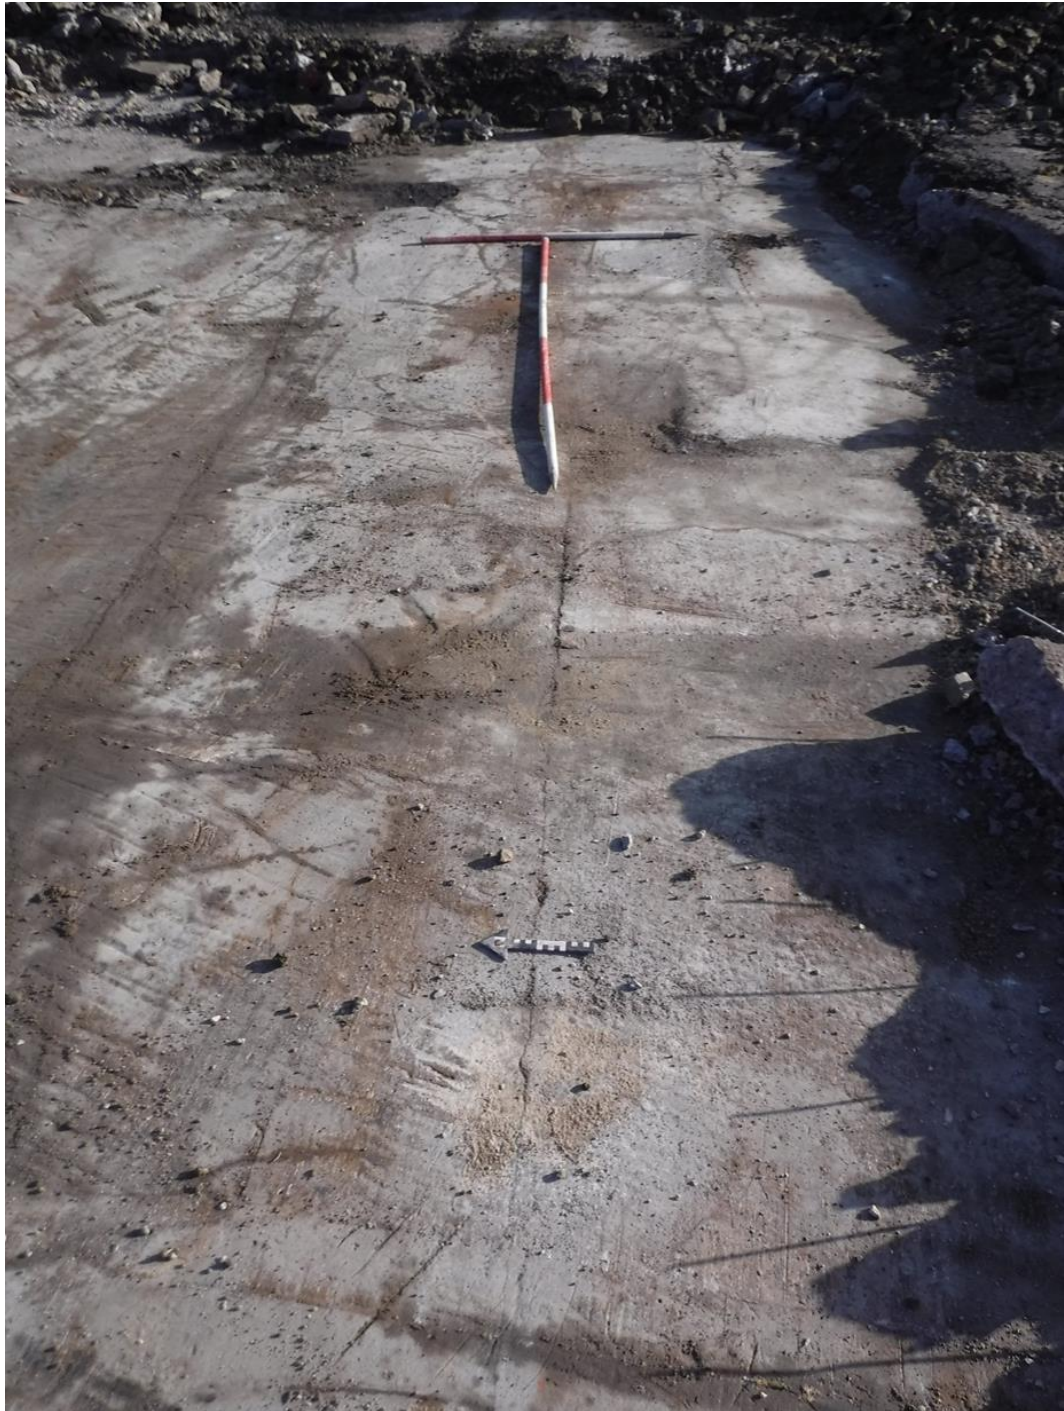
Figure 38. Photograph of mill floor surface (4011), looking east (scale: 1x1m, 1x2m)

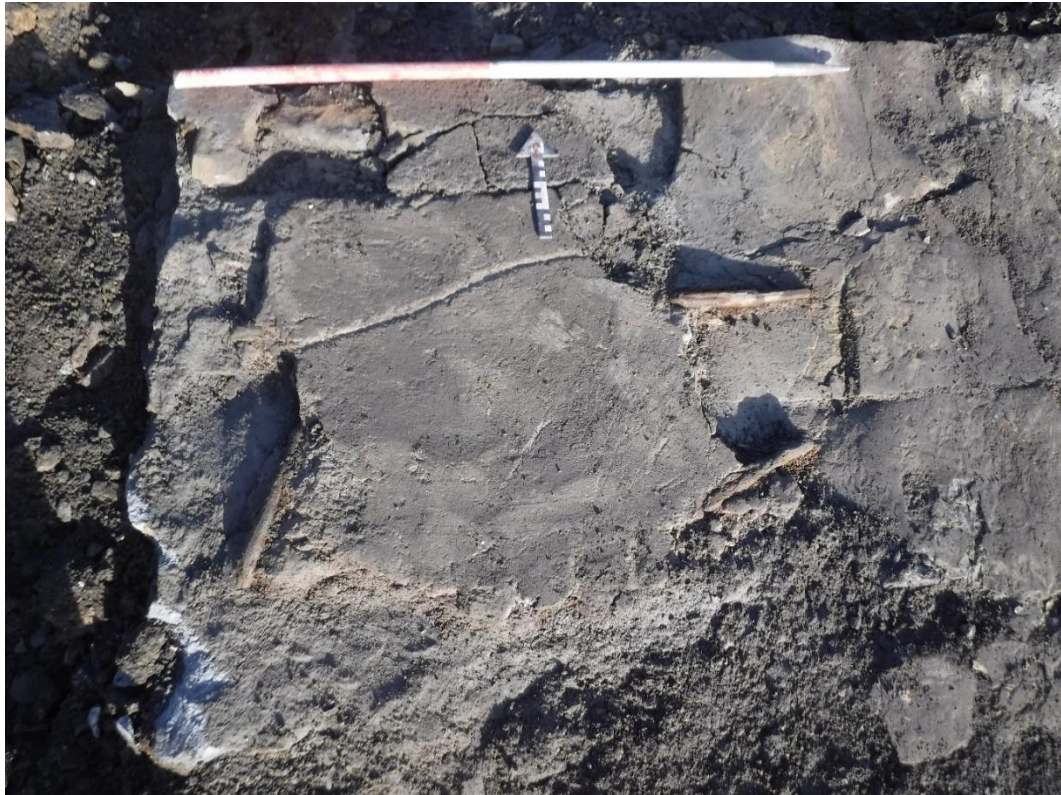
Figure 39. Photograph of machine fitting embedded into surface (4011), looking north (scale: 1x1m)

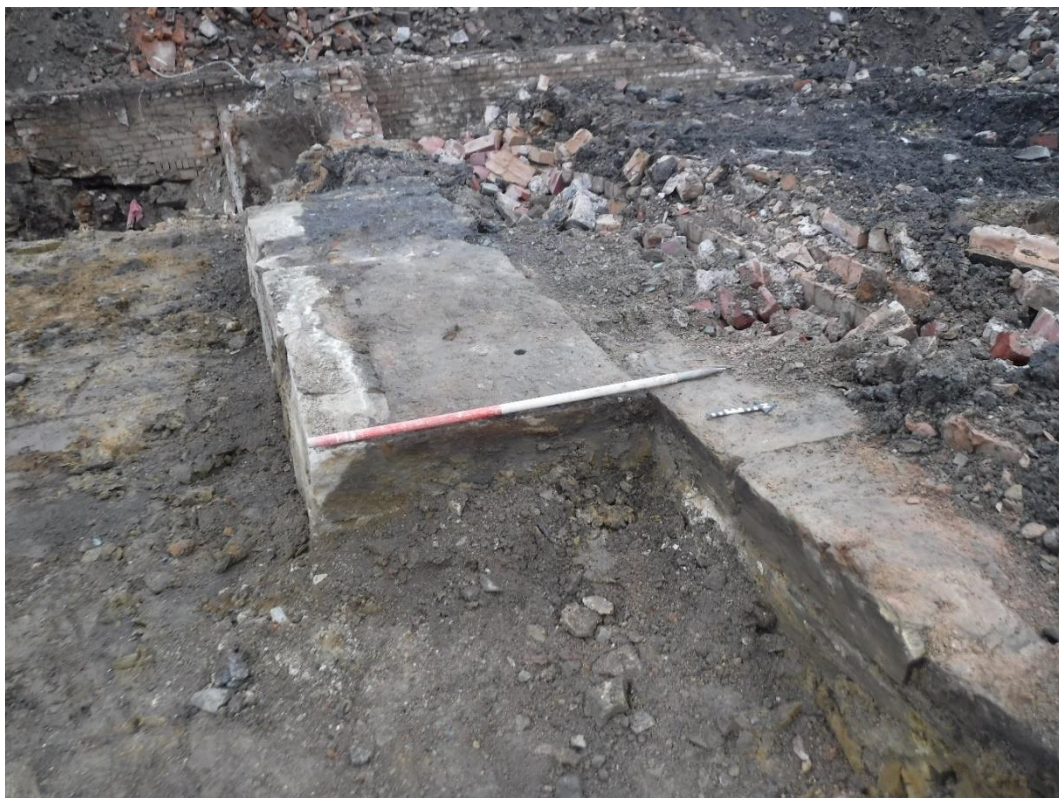
Figure 40. Photograph of machine bed {4013} and stone wall {4014}, looking northwest (scale: 1x1m)

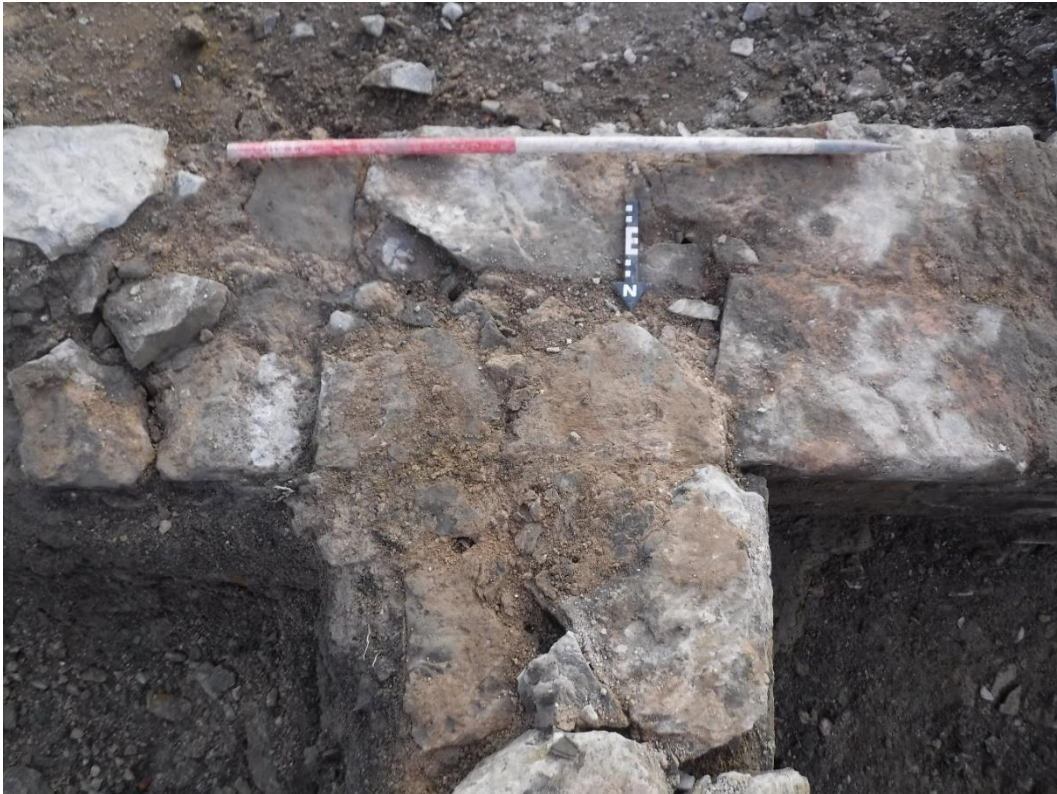
Figure 41. Photograph of interaction between stone walls {4016} and {4014}, looking south (scale: 1x1m)

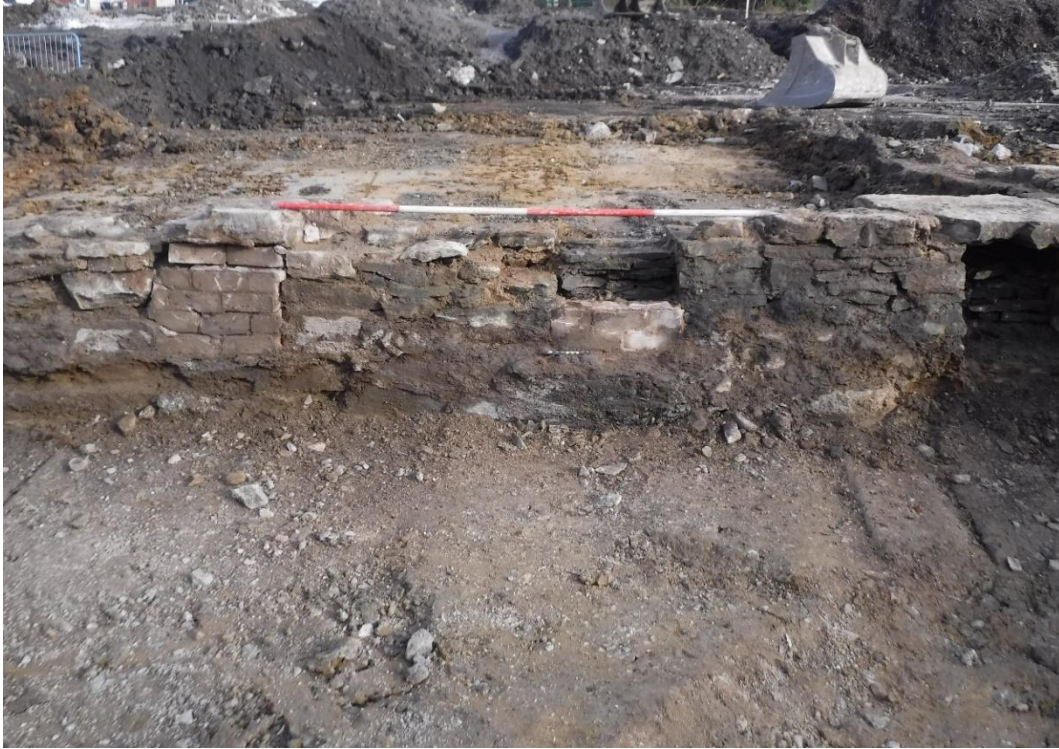
Figure 42. Photograph of insets within wall {4016}, looking east (scale: 1x2m)

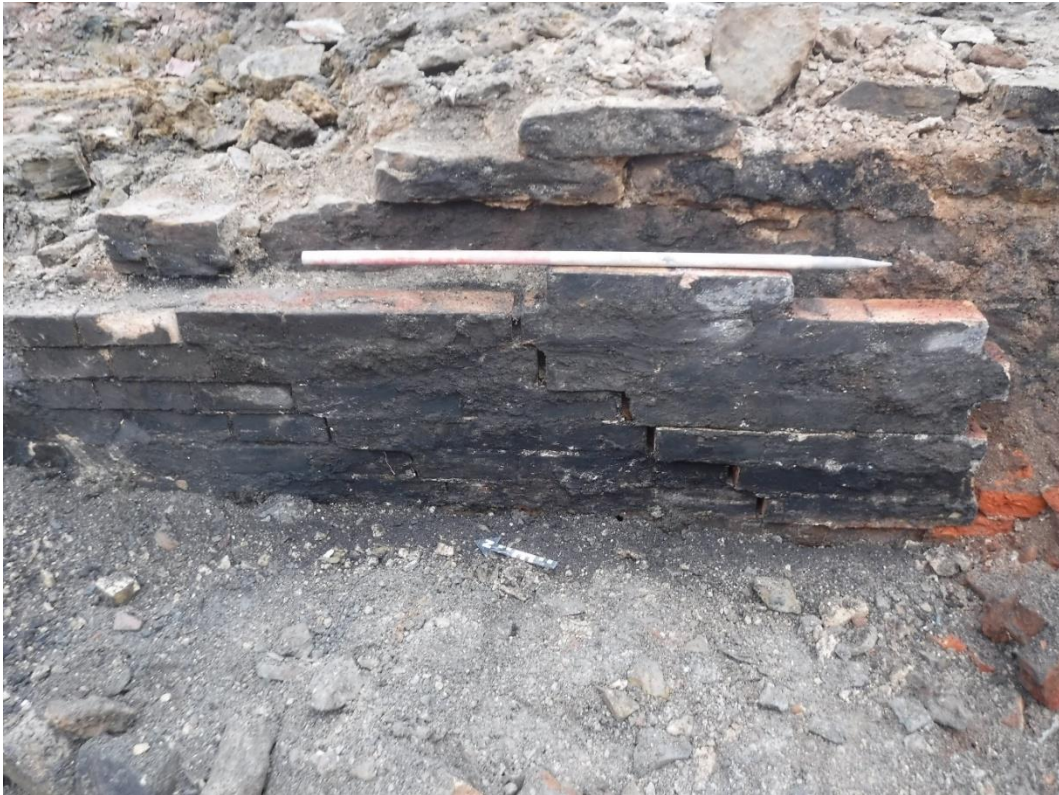
Figure 43. Photograph of poorly preserved boiler-bed wall {4008} against the background of stone wall {4010}, looking east (scale: 1x1m)

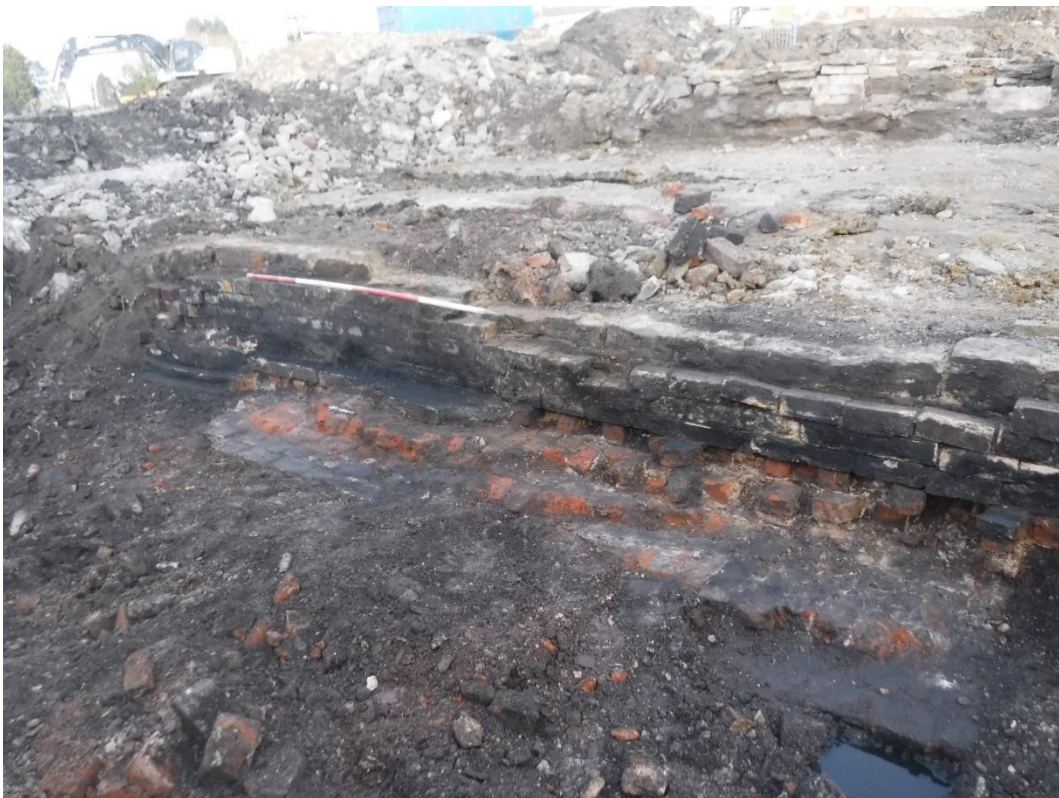
Figure 44. Photograph of boiler-bed wall {4008} and surviving base {4026}, looking north-east (scale: 1x2m)

4.3.33 The boiler-bed itself, though heavily truncated, was a soot-stained handmade redbrick and fire-brick structure bonded with lime mortar. The eastern limit of the boiler-bed was best preserved, with north-to-south stretcher bonded wall {4008} stepping down onto a mixed red and fire brick base {4026} (Figure 44) which formed the surviving eastern side of the boiler bed. The western side of the boiler-bed was truncated to the point that only surface {4025} remained, containing shallow stepping on its eastern edge and largely following the same brickwork as {4026}. This surface ran north to south and connected to east to west flue base {4009} at the southern end (Figure 45). All of the elements of the boiler bed would have been built in a single event.

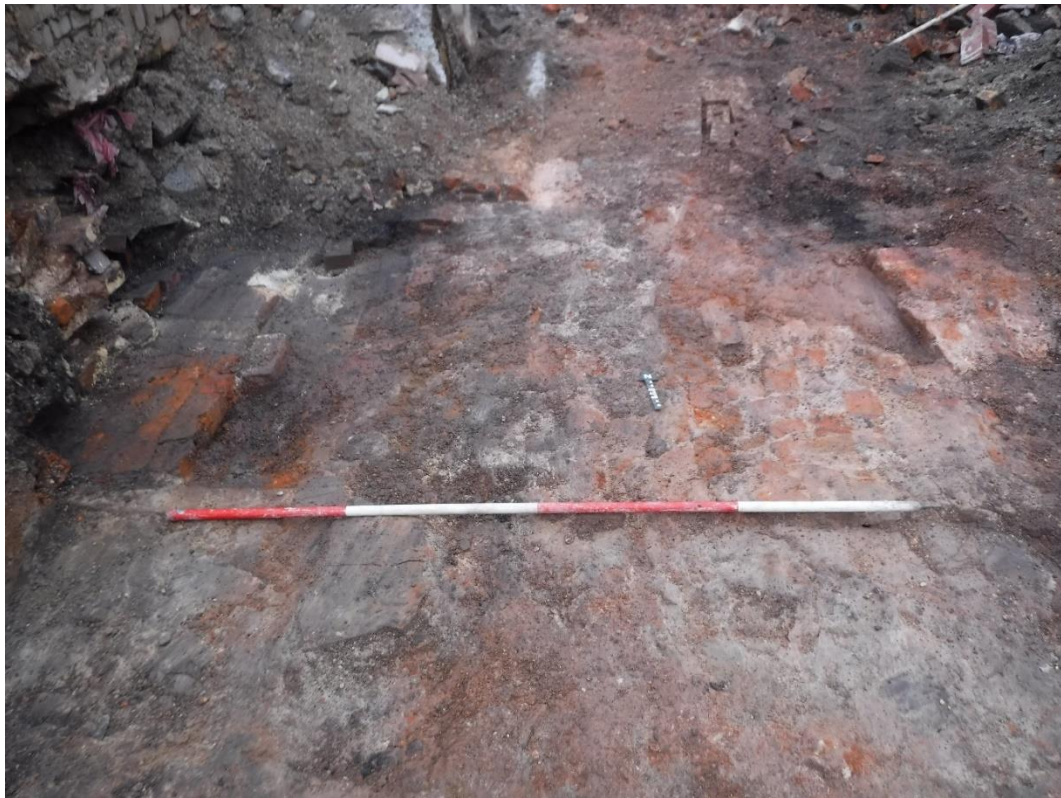
Figure 45. Photograph of base of flue {4009}, looking north with western side of boiler bed {4025} in background (scale: 1x2m)

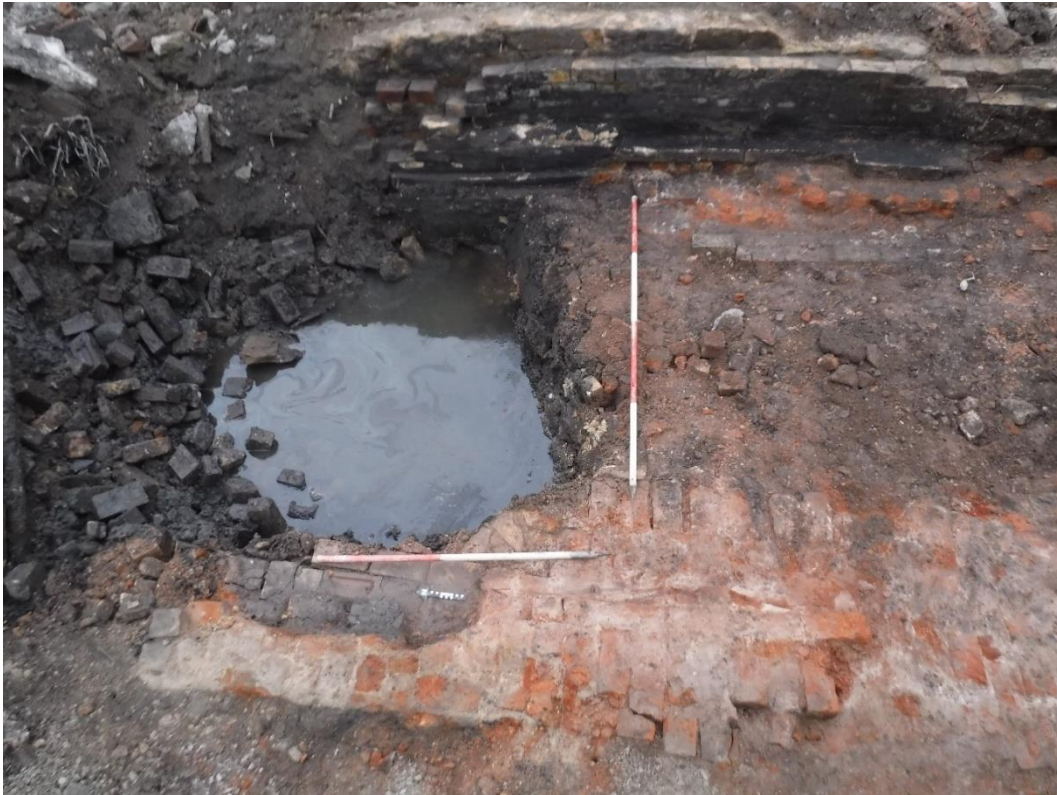
Figure 46. Photograph of sondage through material below boiler bed, looking east with {4008}/{4026} in background and {4025} in foreground (scale: 1x1m, 1x2m)

4.3.34 A sondage into the 0.61m+ deep demolition material (4023) was excavated in an attempt to test whether any further remains were present below; however, contaminated ground water present within the sondage meant it was not possible to investigate further (Figure 46). Nonetheless, a red brick structure {4027} was briefly observed at c. 0.5m lower than the base of the boiler bed as the sondage was being excavated. Given the culvert systems observed in Areas 1 and 2, as well as in Trench 3, it is likely that this was the top of another culvert leading under the mill building.

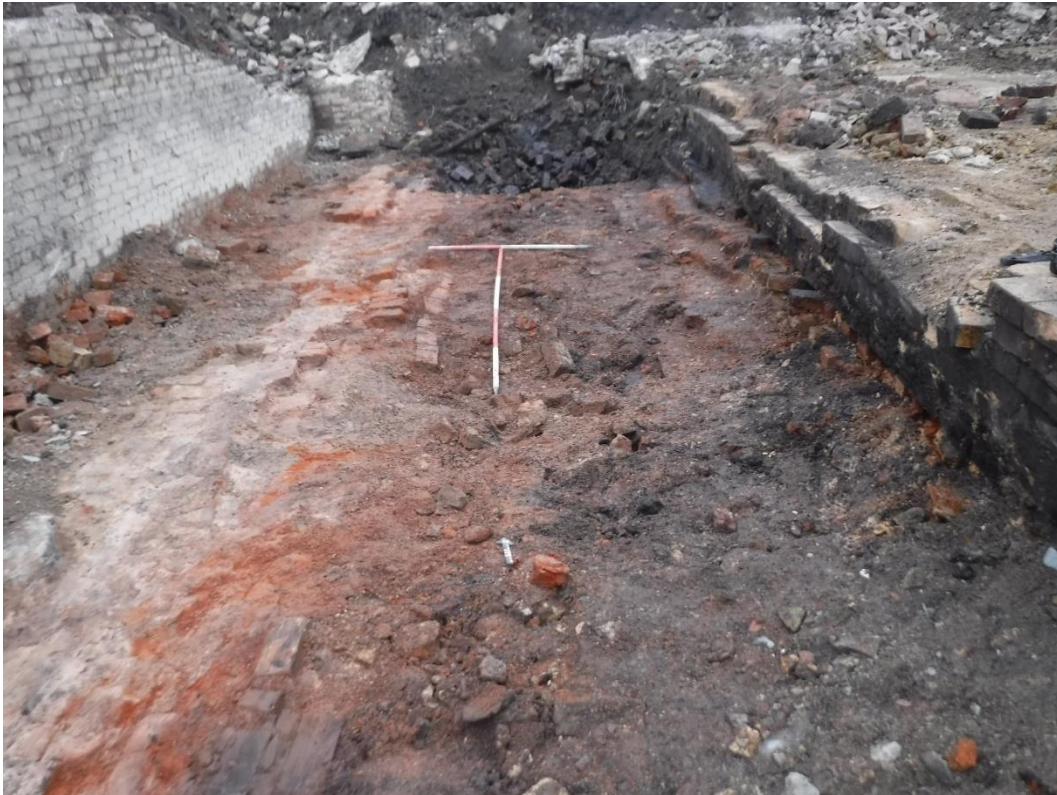
Figure 47. Photograph of exposed boiler-bed with {4025} on left and {4026}/{4008} on right, looking north (scale: 1x1m, 1x2m)

- 4.3.35 At the southern end of the boiler bed was the flue {4007}/{4009} encountered in Trench 6. This was constructed using standard handmade red bricks and firebricks, as well as including some “squint” bricks made using firebrick clay in wall {4008}, to create a change of orientation of the flue towards the south west. This south-western end of the flue was severely truncated by a mid-late 20th century wall laid with concrete bricks {4003}. This was the foundation of the modern building in this area that replaced the older mill building, although evidently reused parts of the foundations for it. It is likely, given the size of this northwestern room on the OS map, that a second boiler bad would have been located to the west of the surviving example, but if that was the case then it had been entirely truncated during the construction of the later 20th century building {4003} in this area.

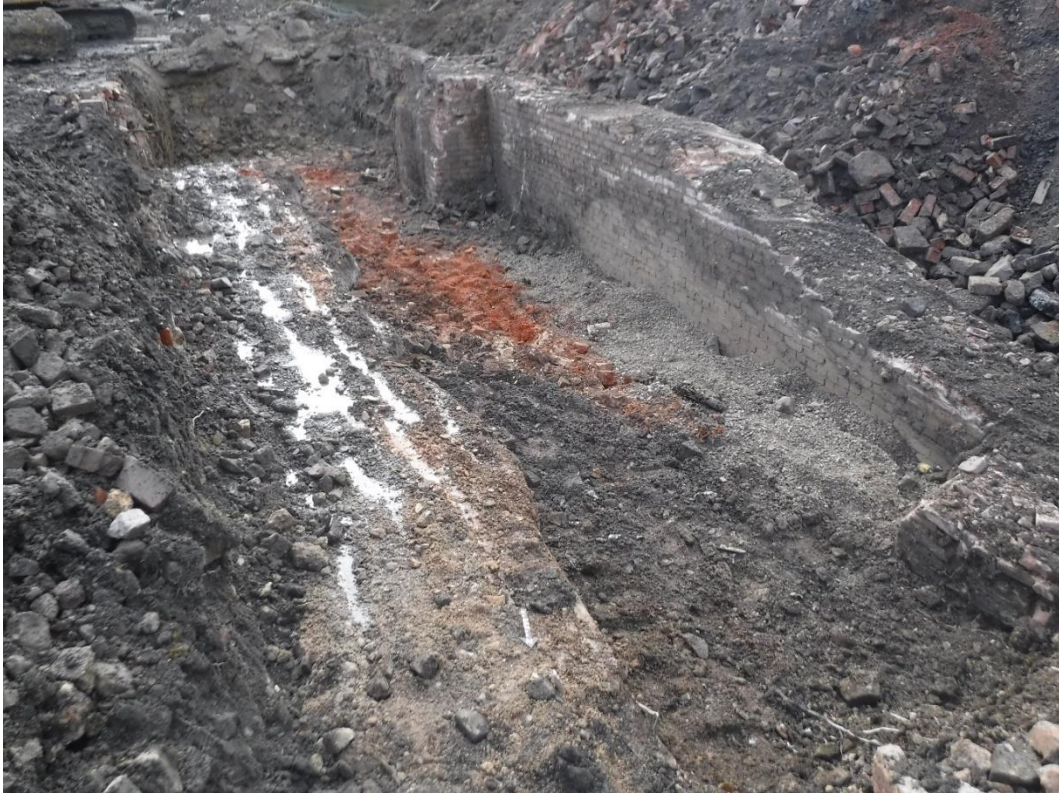
Figure 48. Photograph of 20th century wall {4003} truncating the boiler-bed present in Area 4, looking south (no scale)

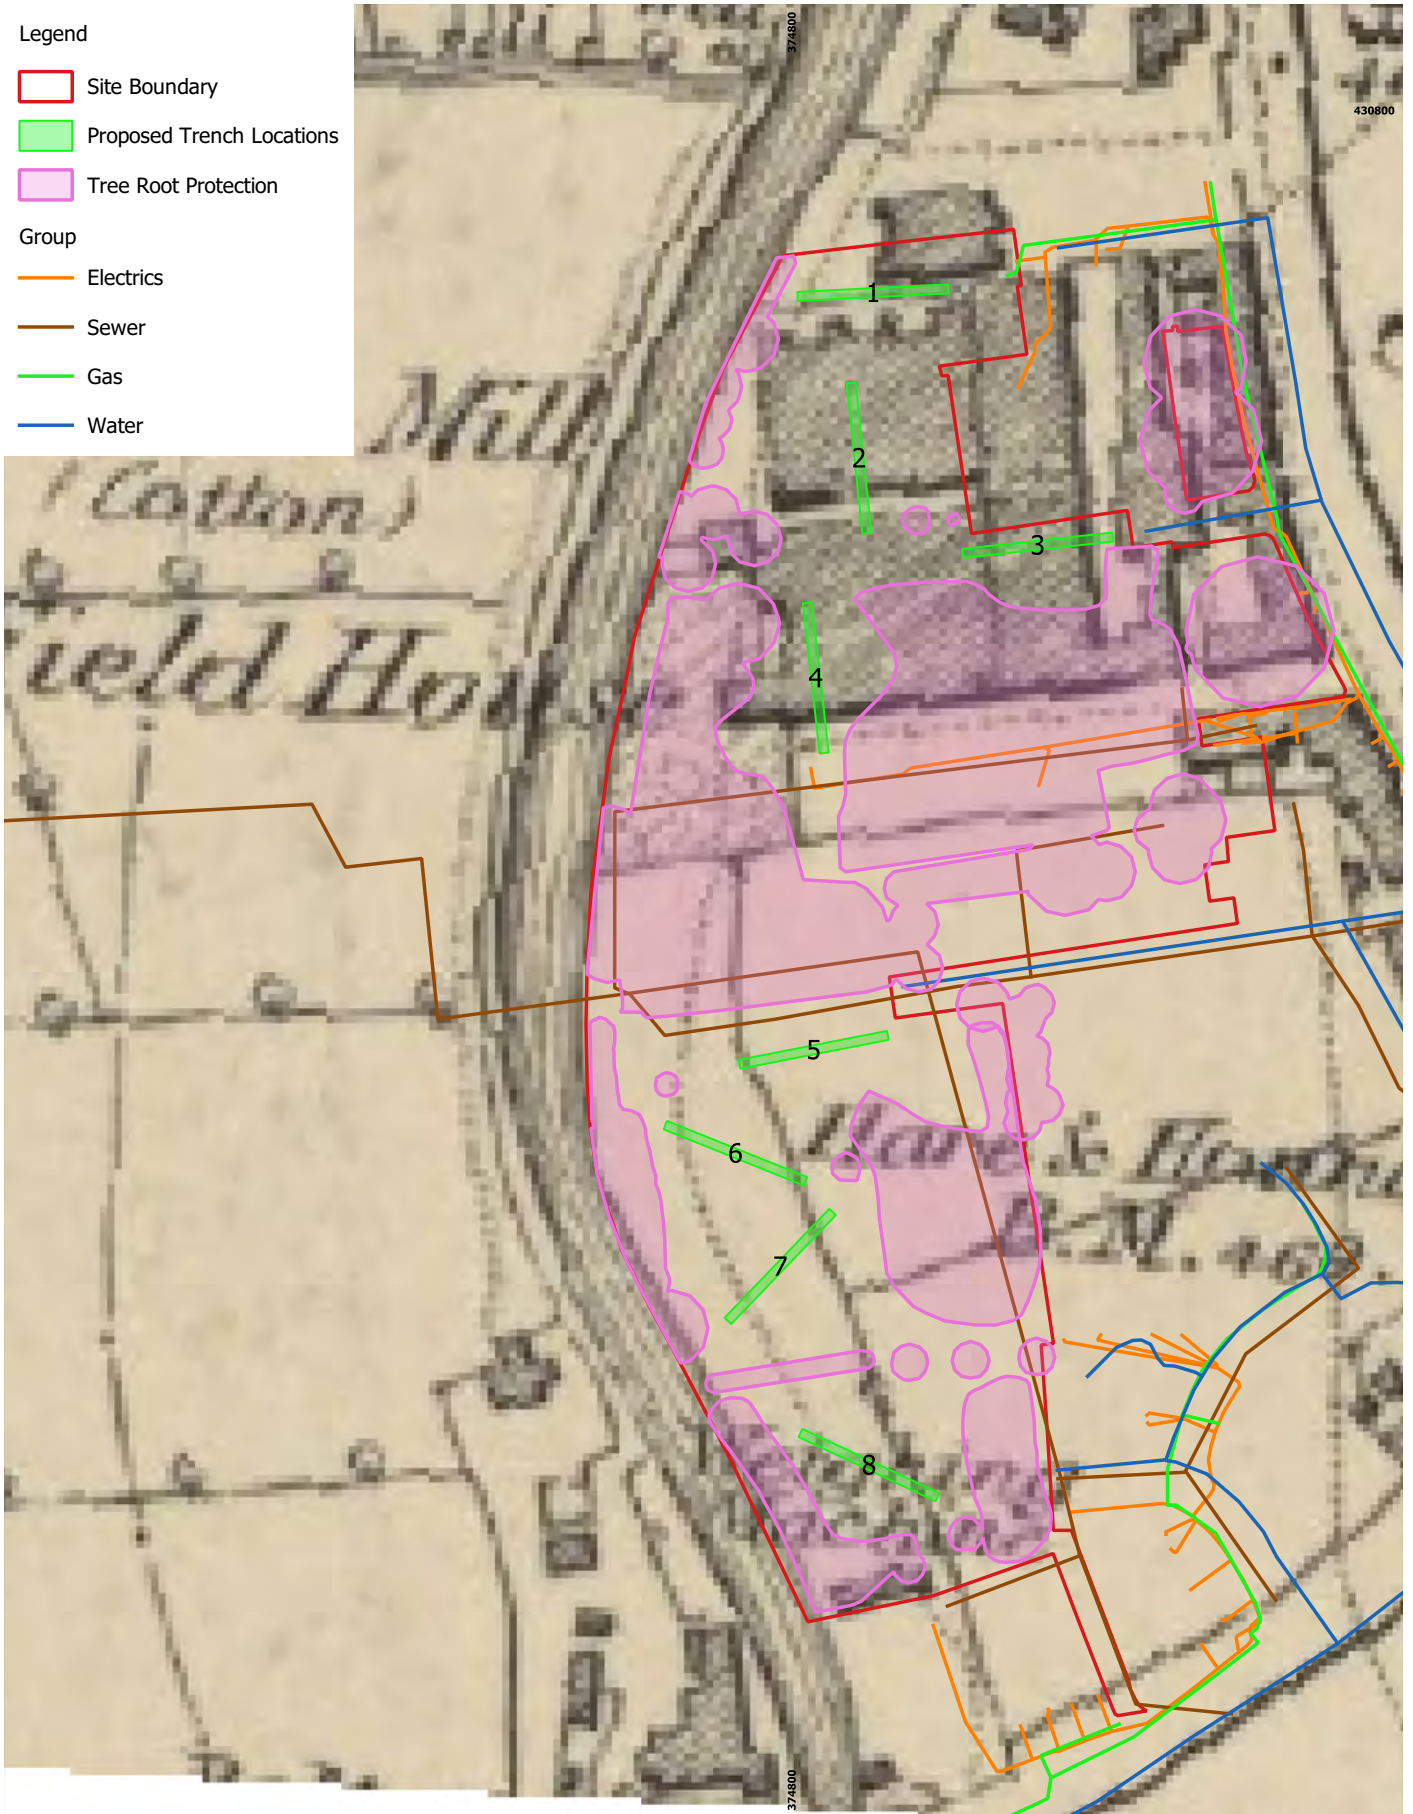
Figure 2: Proposed Trench Layout

3.1.1 The site will be subject to archaeological trial trenching. This comprises the excavation of 8 trial trenches measuring 30m in length by 1.8m in width, positioned in close approximation to those depicted on Figure 2.
