HISTORIC BUILDING RECORDING

Crank Gunsite Barracks, Crank Road, St Helens,

ARS Report N°: 2023/027

Historic Building Recording: Crank Gunsite Barracks, Crank Road, St Helens, Merseyside

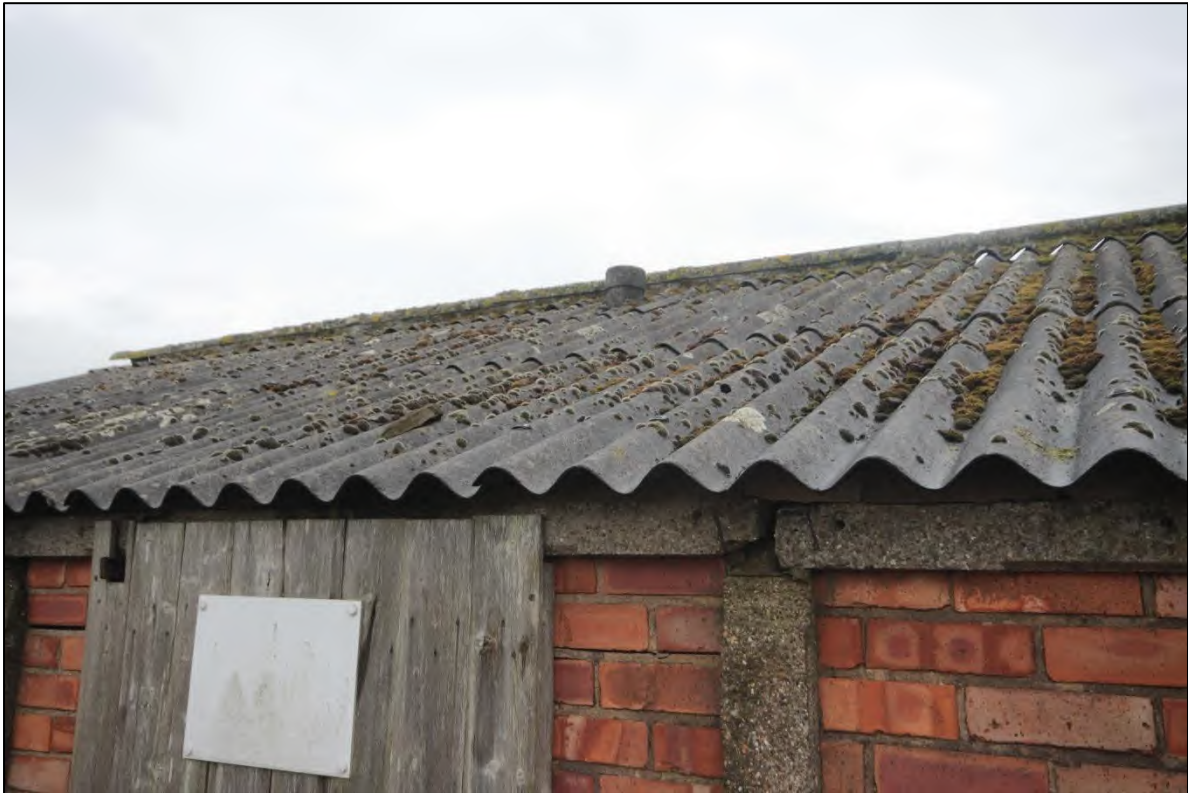
6.3.1 The five camp barracks buildings associated with the Second World War Crank Gunsite each represent single-storey rectangular structures. The buildings comprise prefabricated structures, each built with the same materials and of the same style. Each structure has a concrete frame, delineating the structures into distinct bays. These are formed of reinforced concrete with posts, and with kneebraces for the roof rafters. The buildings had each originated as three bays in width, though they vary in length, ranging between five and nine bays. Three of the structures are roughly orientated west to east, with two positioned north to south. The structures had been built with low pitched gabled roofing, covered with corrugated asbestos sheet cladding and with cast iron drainpipes (**Photograph 9**). Each roof structure is formed of the concrete frame, with a cast iron ridge beam, supporting timber purlins with corrugated sheeting above (**Photograph 10 & 11**). The buildings have been constructed with red engineering brick in a stretcher bond with cement mortar and feature concrete dressings (**Photograph 12**). The buildings feature cast iron outwards swinging window casements, which are tucked under the eaves and have projecting concrete sills (**Photograph 13**). A number of these feature outer timber plank shutters (**Photograph 14**). Each structure has fallen into disrepair, ranging in their severity. Most are missing parts of their roofing, with several missing entire exterior elevations.

Photograph 9: The corrugated roofing of the barracks buildings (File: HBR_167)

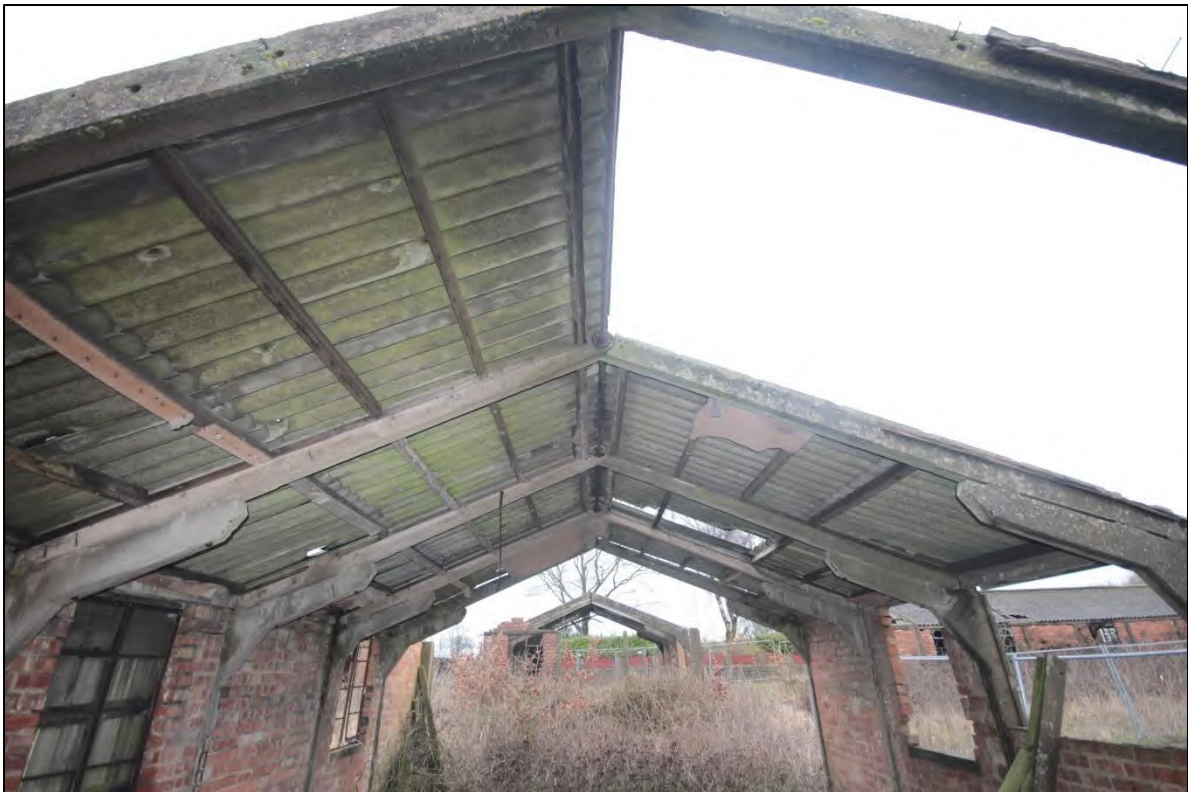
Photograph 10: View of the concrete framed roof structure within Building 3, taken facing north (File: HBR_103)

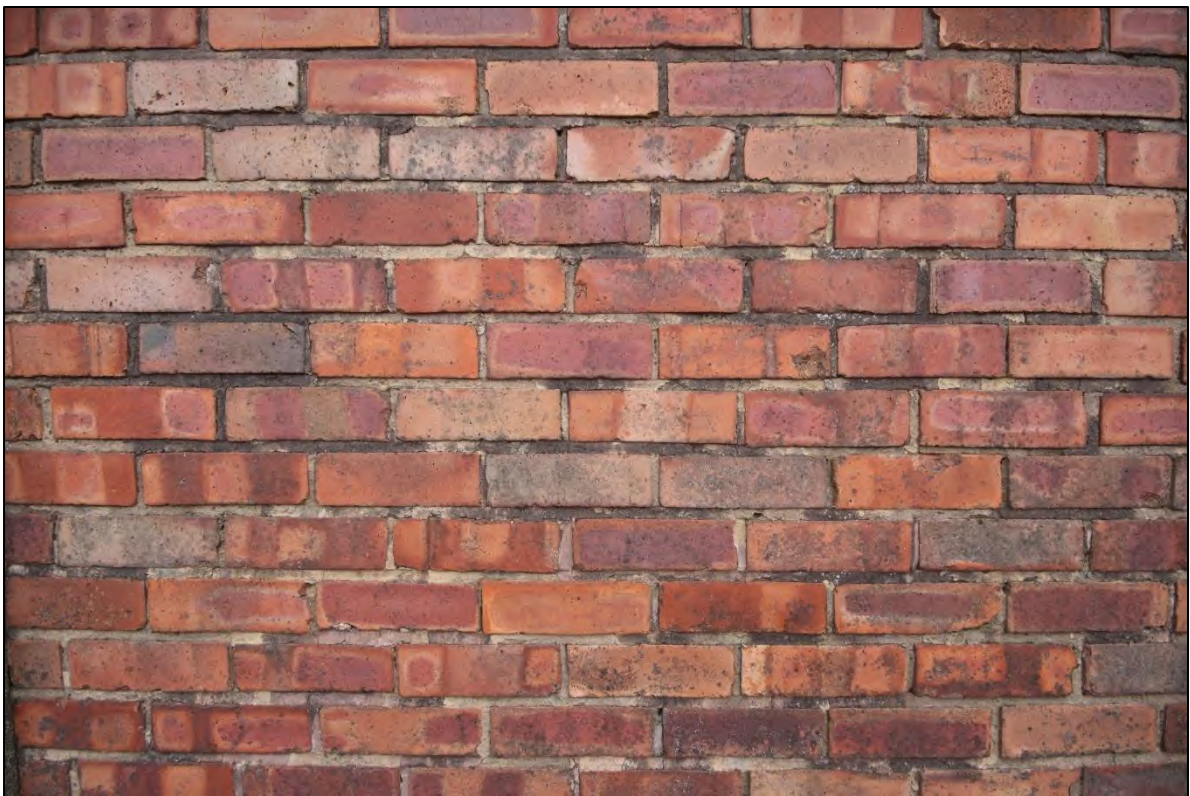
Photograph 12: View of the red engineering brick with cement mortar used in the construction of the barracks buildings (File: HBR_166)

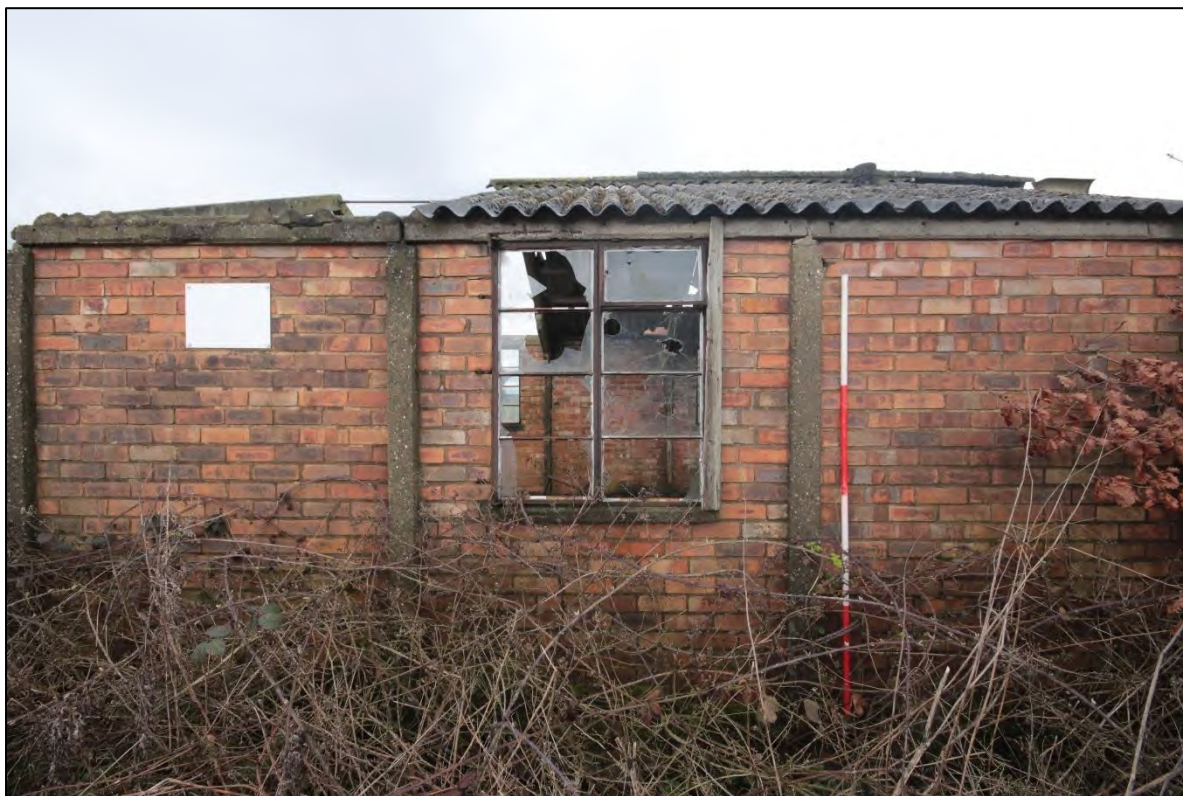
Photograph 13: View of a cast iron window casement associated with Building 2's eastern elevation, taken facing west with 2m scale (File: HBR_71)

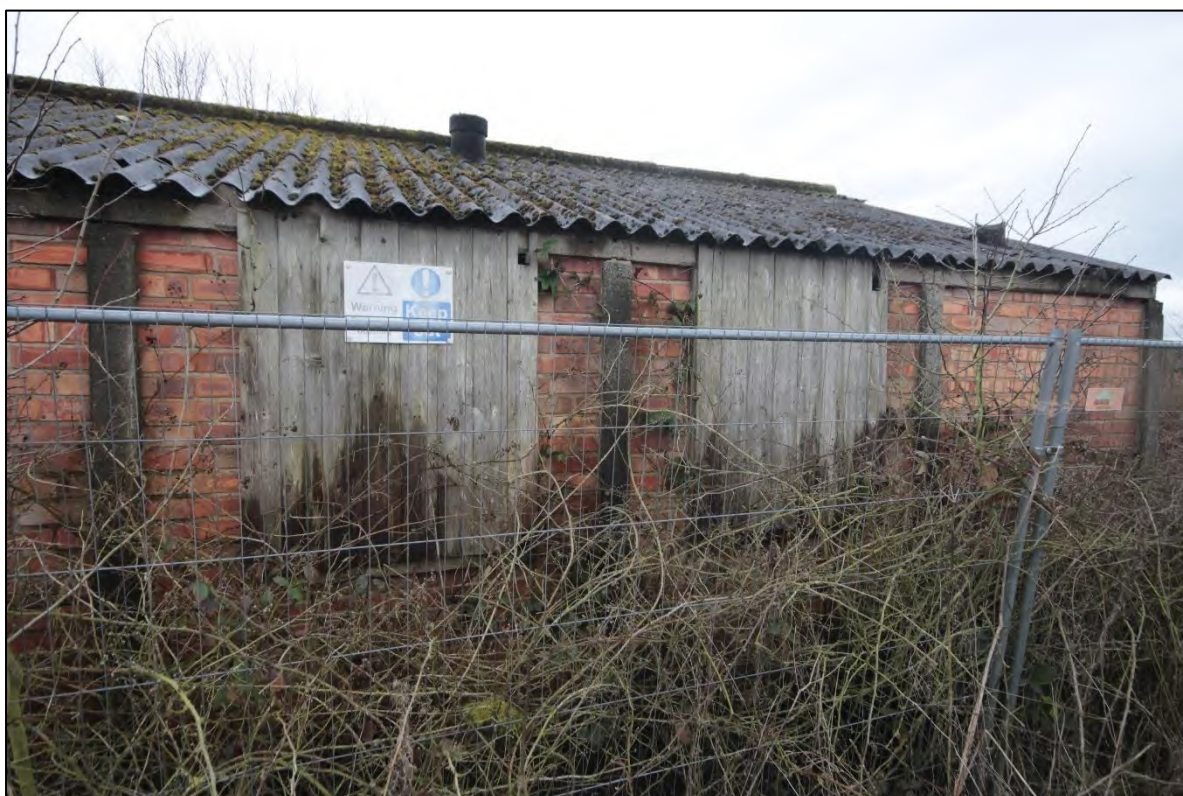
Photograph 14: View of the timber window shutters associated with Building 5's northern elevation, taken facing south-west (File: HBR_139)

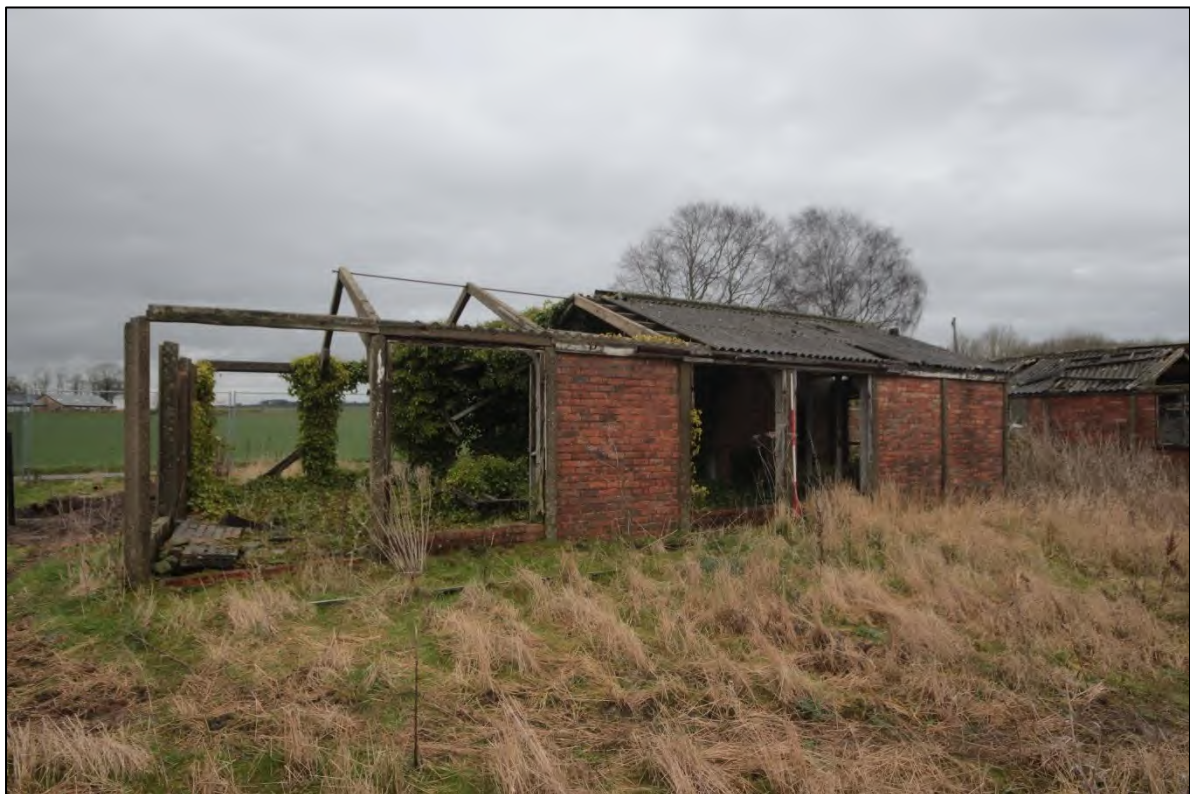
6.4.1 Building 1 comprises the westernmost structure of the barracks buildings, and is seven bays in length (**Photograph 15**). The roof coverings of the building have been lost within the western three bays, as well as various areas of the outer brick walling. The eastern extent of the roof retains a small concrete flue, as well as a roof light (**Photograph 16**). Three of the bays on the southern elevation retain large apertures with timber framing, with brick walling below (**Photograph 15 & 17**). The exact origins of these apertures is unclear, likely forming large windows. The western gable end appears to have originated with a central doorway now lost, as with the side elevations for the other buildings, which feature evidence of these (**Photograph 18**). The northern elevation had been mostly shielded from view by overgrown vegetation, with no features discernable (**Photograph 19**). On the eastern gable end, there is a central timber framed doorway with concrete lintel (**Photograph 20**). The upper portions of the elevation feature two extant ceramic vents, with a third now lost.

Photograph 15: Oblique view of Building 1's southern elevation, taken with 2m scale facing north-east (File: HBR_31)

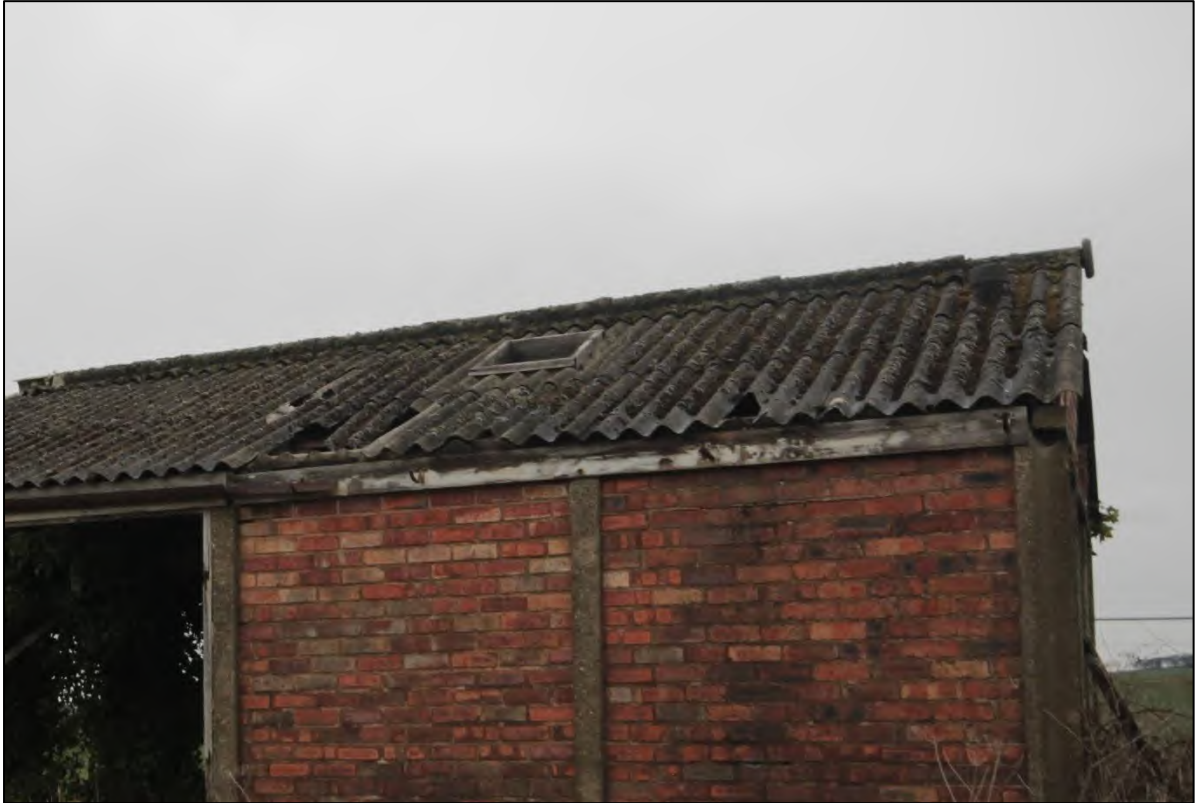
Photograph 16: View of the rooflight and concrete flue within the eastern extent of Building 1's roof structure (File: HBR_41)

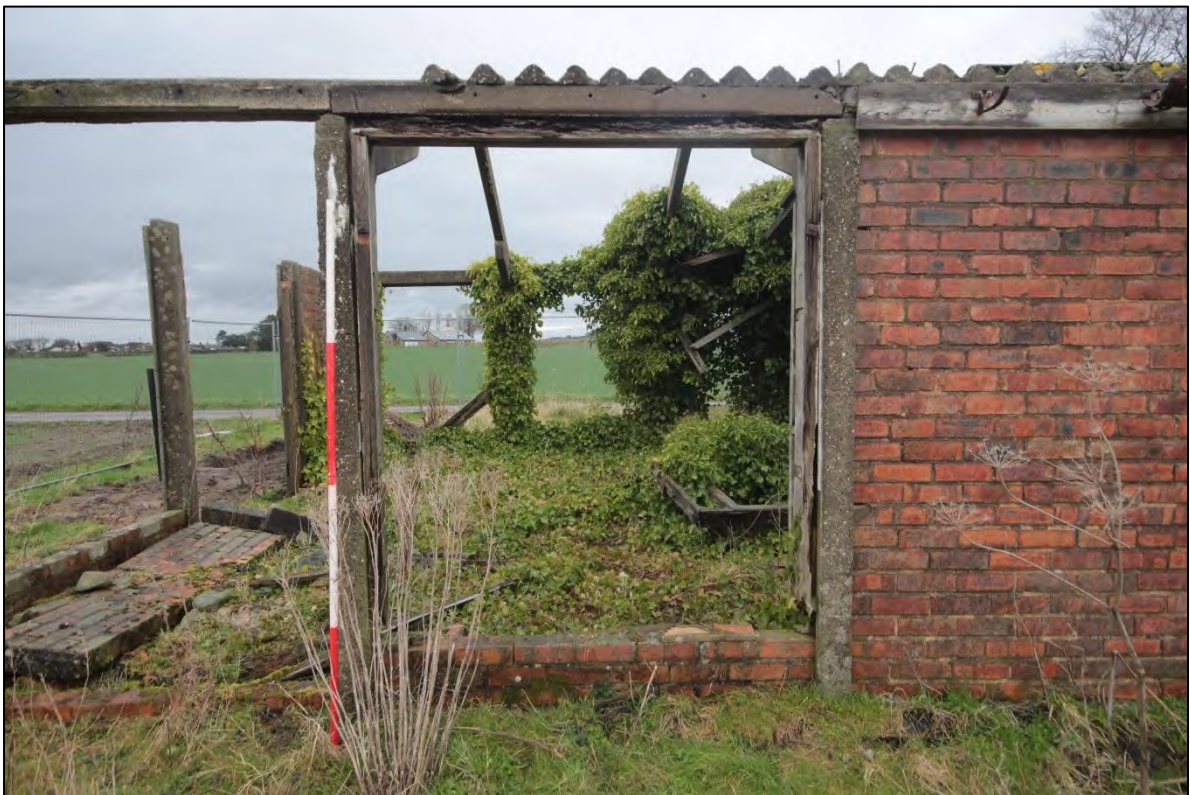
Photograph 17: View of an aperture with timber frame on the southern elevation of Building 1, taken facing north (File: HBR_33)

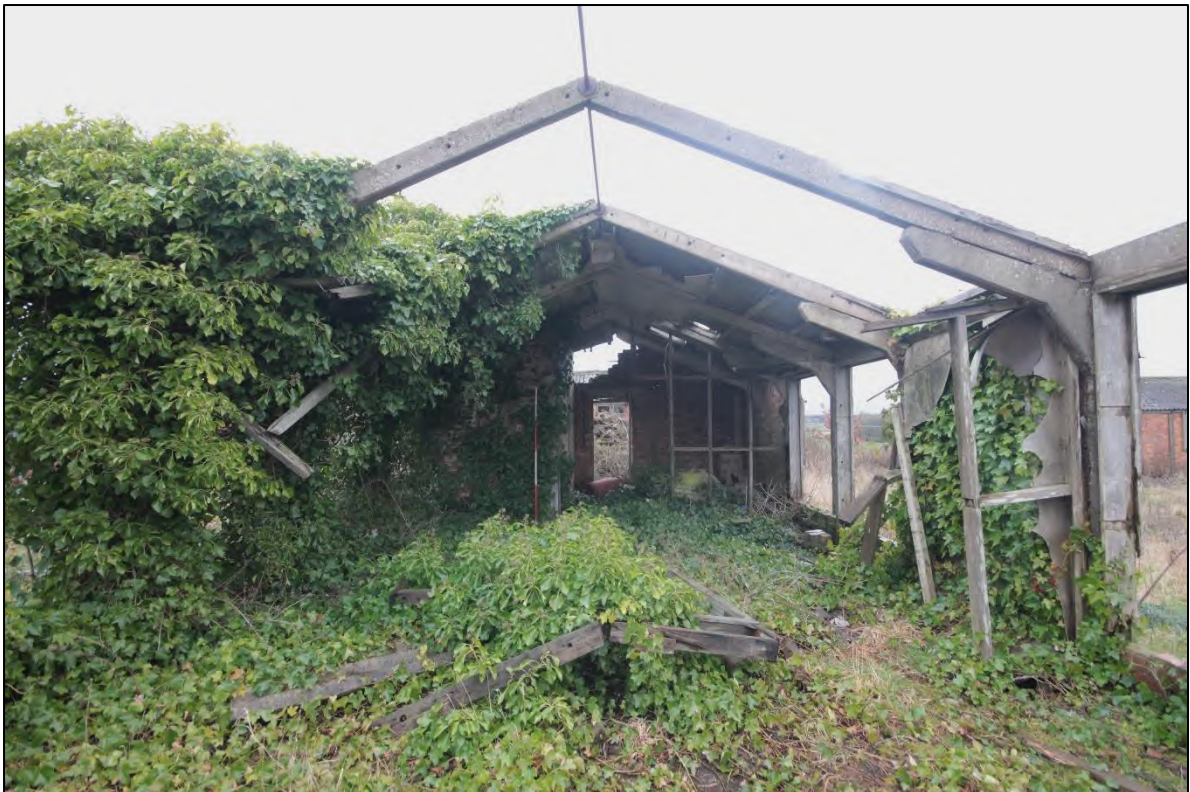
6.4.2 Internally, the building is comprised of a main space and a subdivided room within the north-eastern corner (**Photograph 21**). A circular aperture with the concrete flue and the roof light are visible within the eastern extent of the ceiling structure (**Photographs 22 & 23**). There is also extant cabling for previous electricity and communication. The interior has concrete flooring, predominantly covered over with vegetation. Partially surviving stud walling attached to the southern wall suggest that the space had formed an additional separate space to the east, as well as a small square space to the south-west (**Photographs 24 & 25**). Within the north-eastern corner of Building 1, there are three low brick walls up to c.0.7m in height, likely originally forming a sink (**Photograph 26**). The north-eastern room comprises a small rectangular space, with no features of note discernable (**Photograph 27**).

Photograph 21: View to the east within Building 1, taken with 2m scale (File: HBR_43)

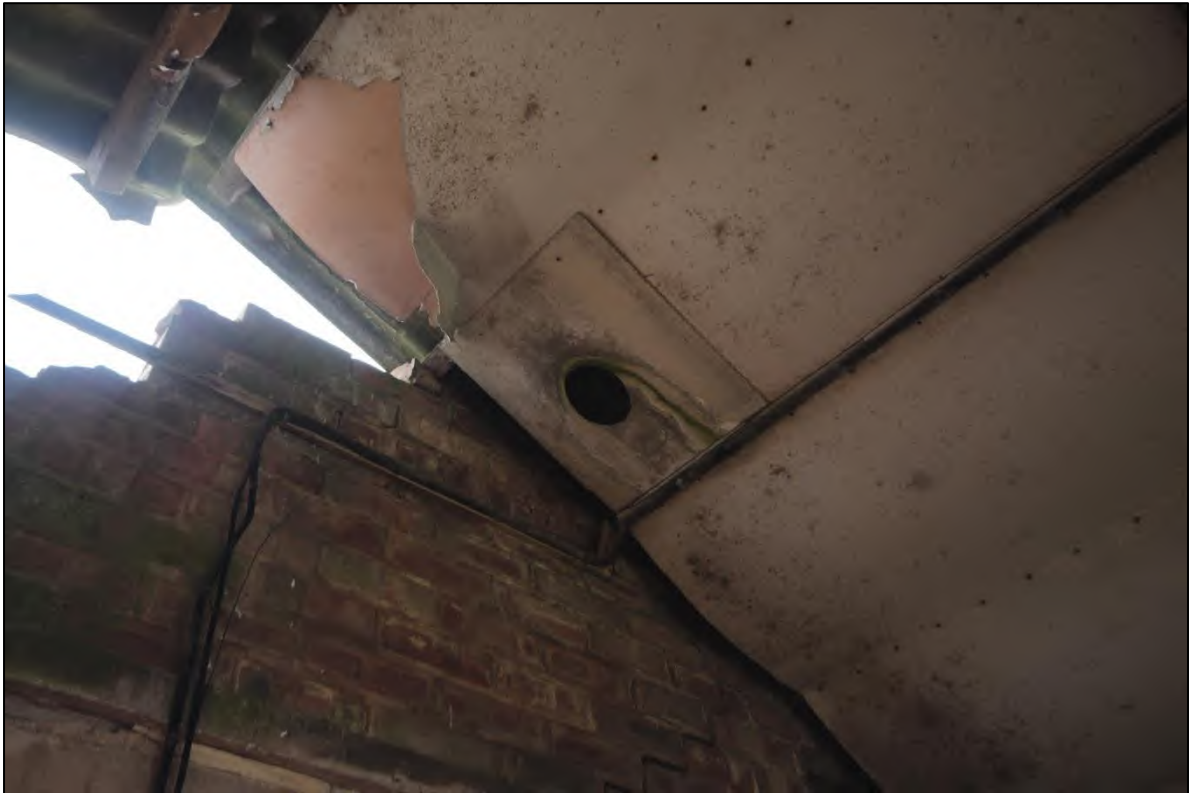
Photograph 22: The circular aperture associated with the flue within the eastern extent of Building 1's roof structure (File: HBR_164)

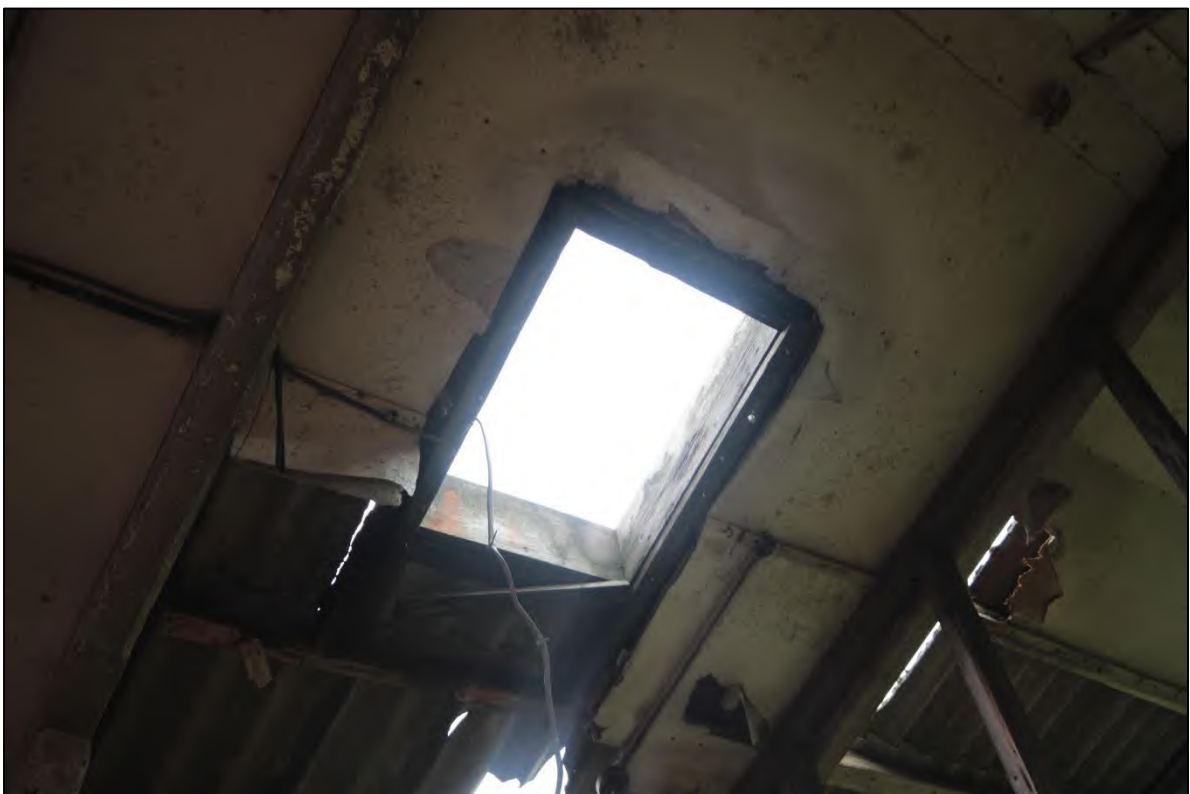
Photograph 23: The roof light within the eastern extent of Building 1's roof structure (File: HBR_165)

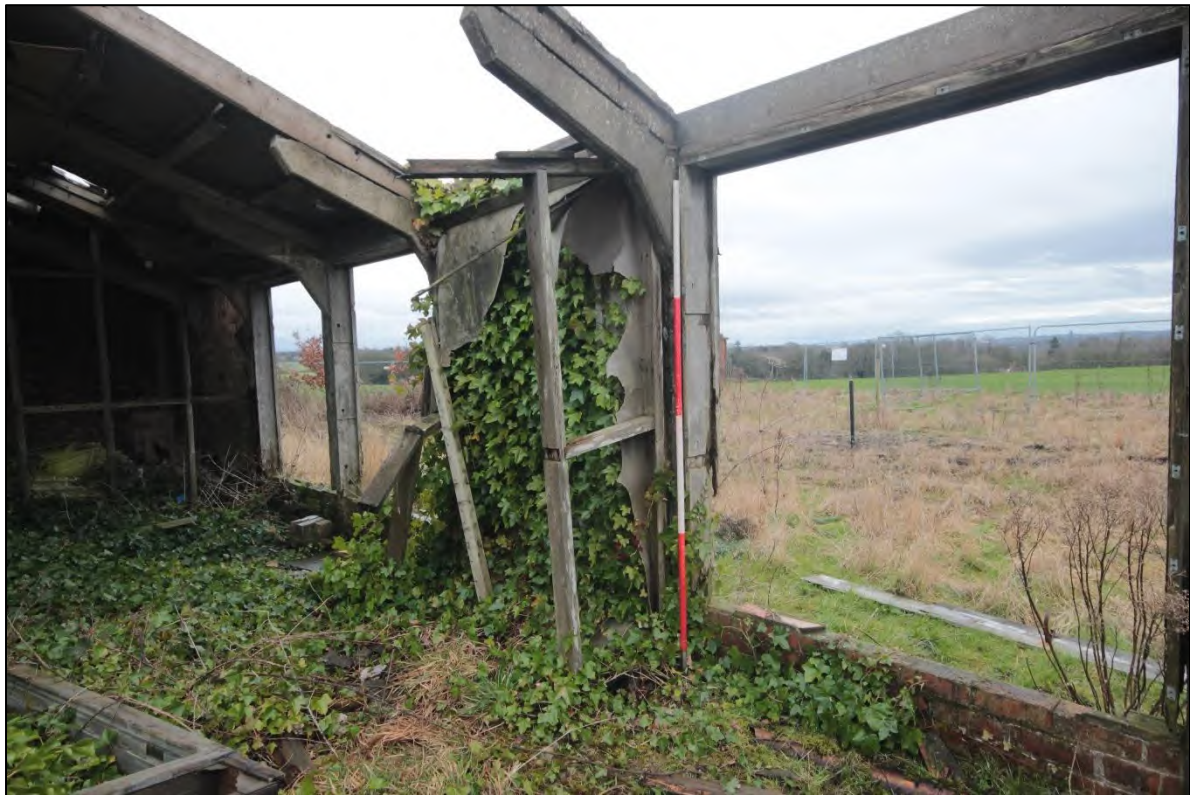
Photograph 24: View of the stud walling within the central extent of Building 1's southern wall, taken facing south-east with 2m scale (File: HBR_49)

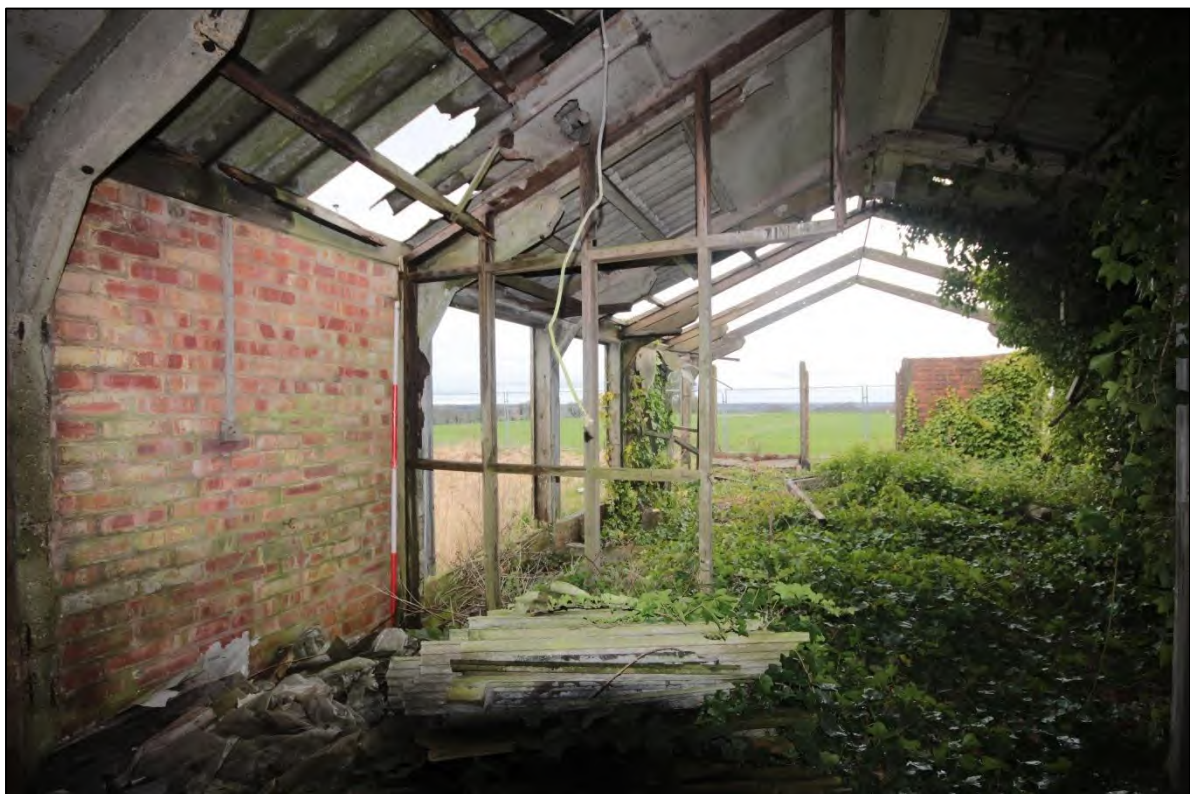
Photograph 25: View of the stud walling within the eastern extent of Building 1's southern wall, taken with 2m scale facing west (File: HBR_54)

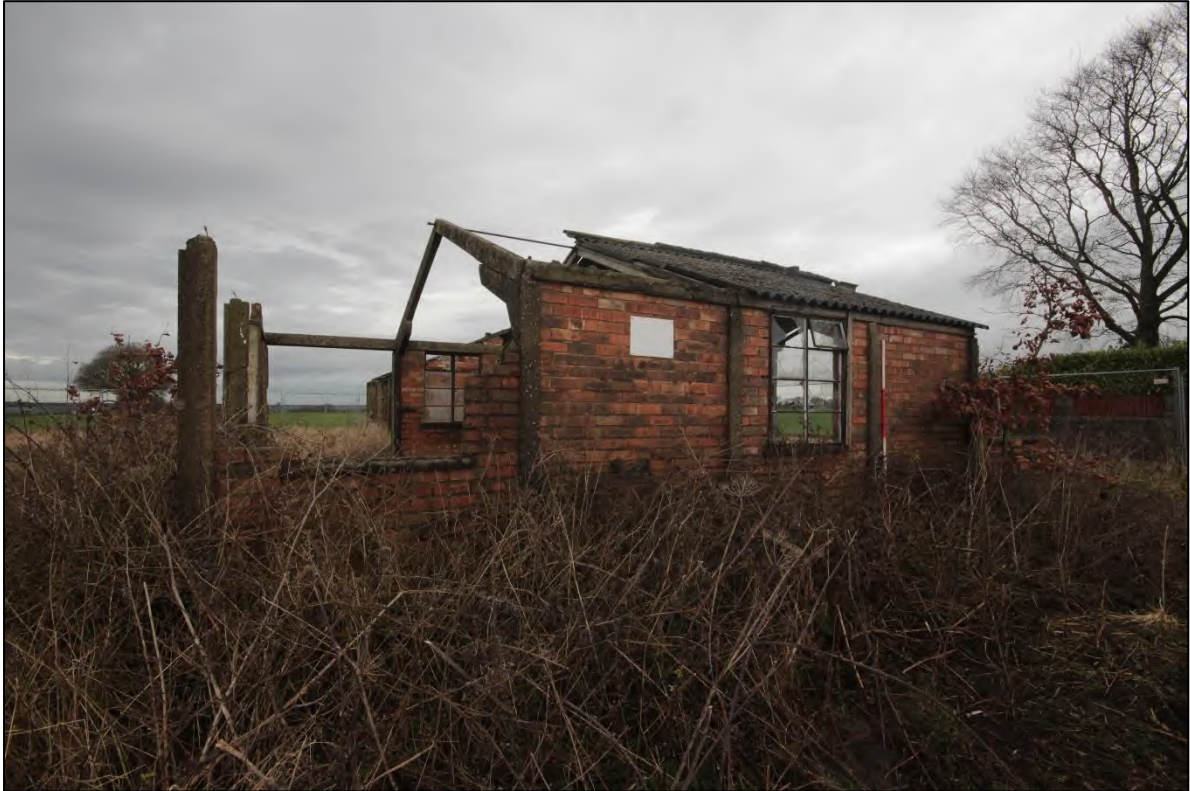
Photograph 31: Oblique view of Building 2's eastern elevation, taken with 2m scale facing north-west (File: HBR_70)

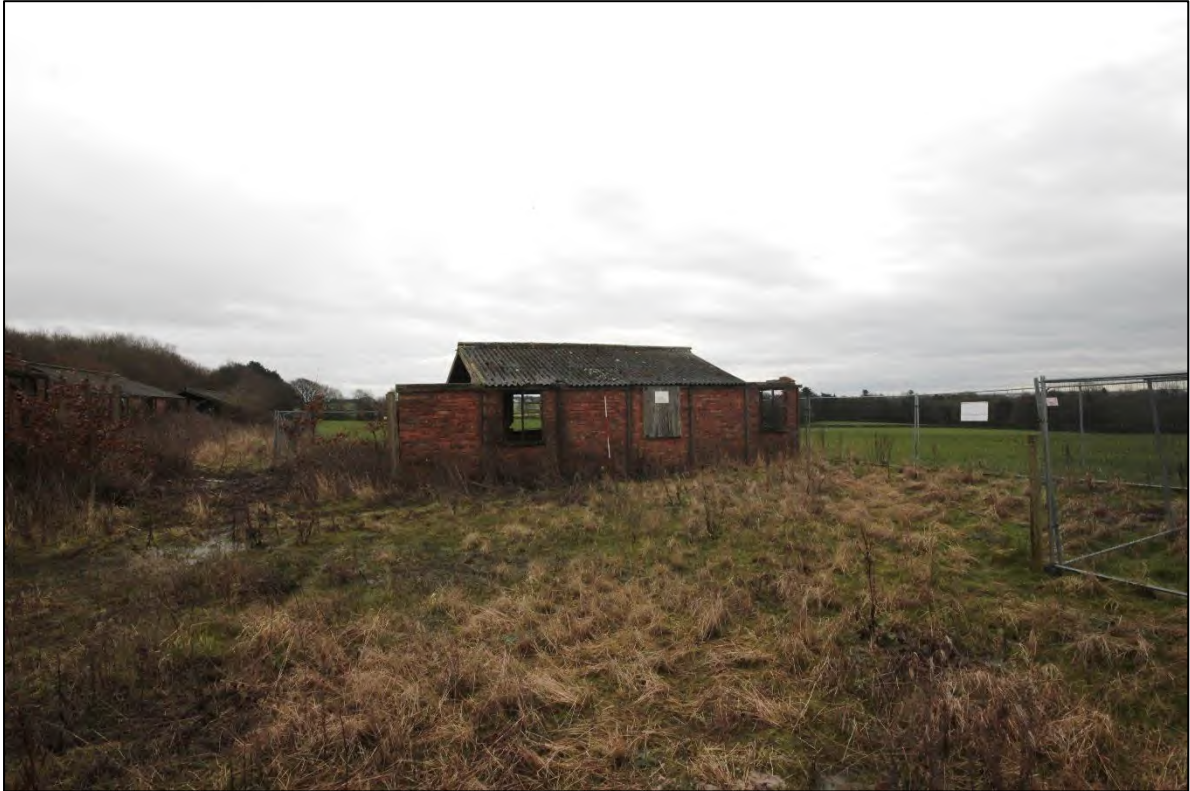
6.6.1 Building 3 comprises the southernmost structure within the PDA, representing one of the two buildings orientated on a roughly north-south axis (**Photograph 36**). The building is six bays in length, comprising one of the smaller structures on site, and the northern and southern bays of its roof are now lost. The western elevation features three cast iron windows, with the central window featuring timber shutters (**Photograph 37**). The northern elevation has been entirely lost, barring the concrete framing within the north-western corner of the structure (**Photograph 38**). The northernmost bay of the eastern longitudinal elevation has been lost, with two former window apertures present, retaining their concrete sills (**Photograph 39**). The southern gable elevation retains a cast iron window and part of its concrete frame, but is otherwise lost (**Photograph 40**).

Photograph 36: View of Building 3, taken facing south-east with 2m scale (File: HBR_89)

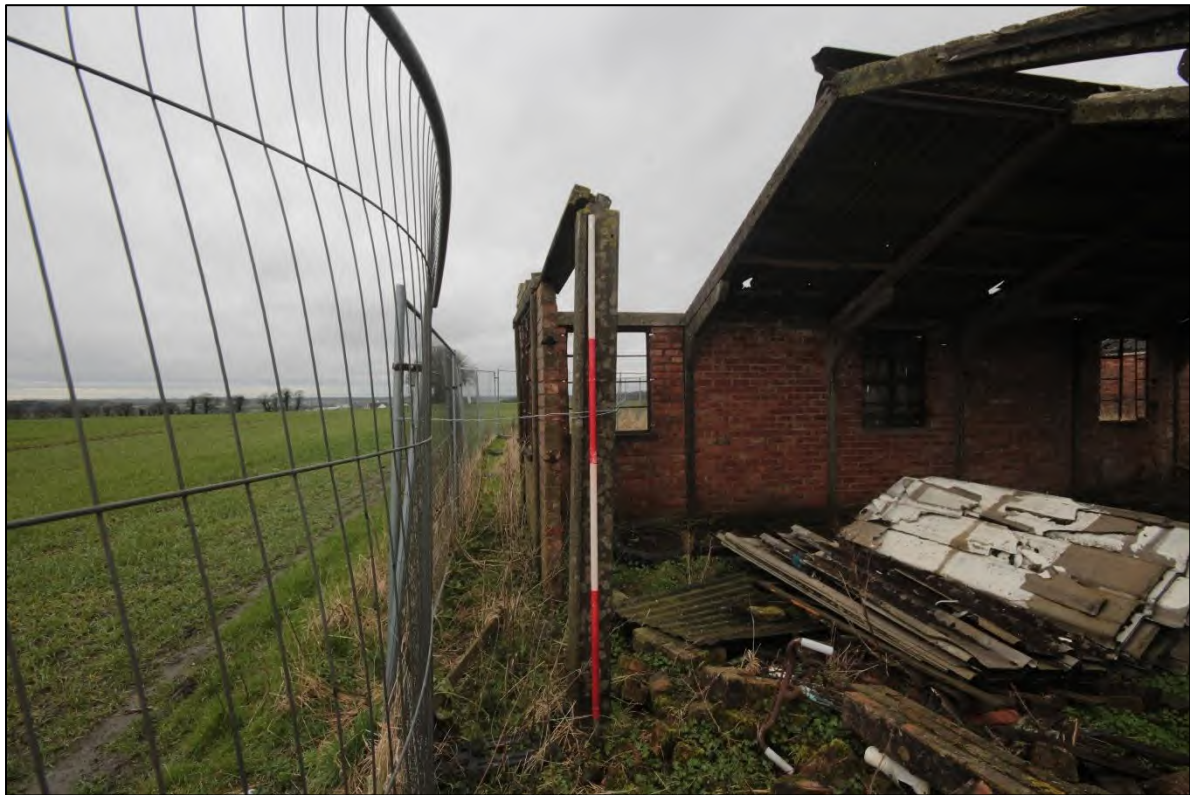
Photograph 40: View of Building 3's southern elevation, taken facing west with 2m scale (File: HBR_99)

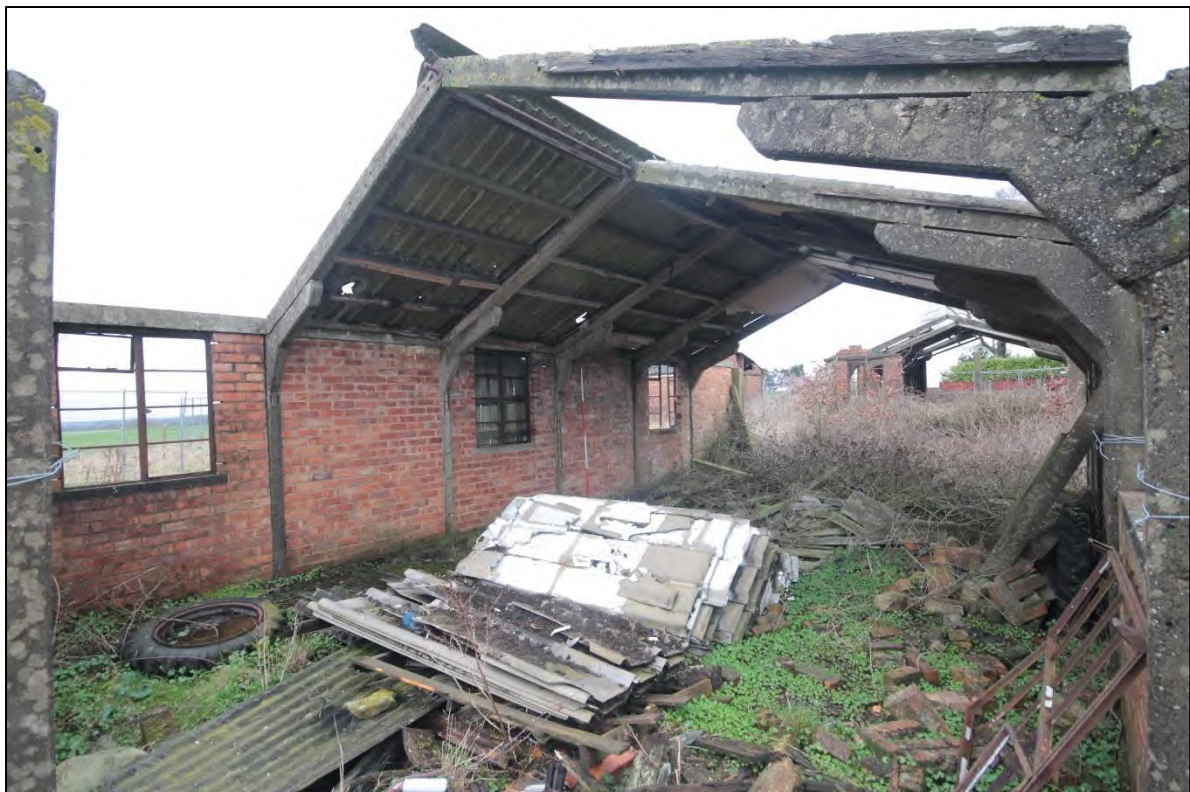
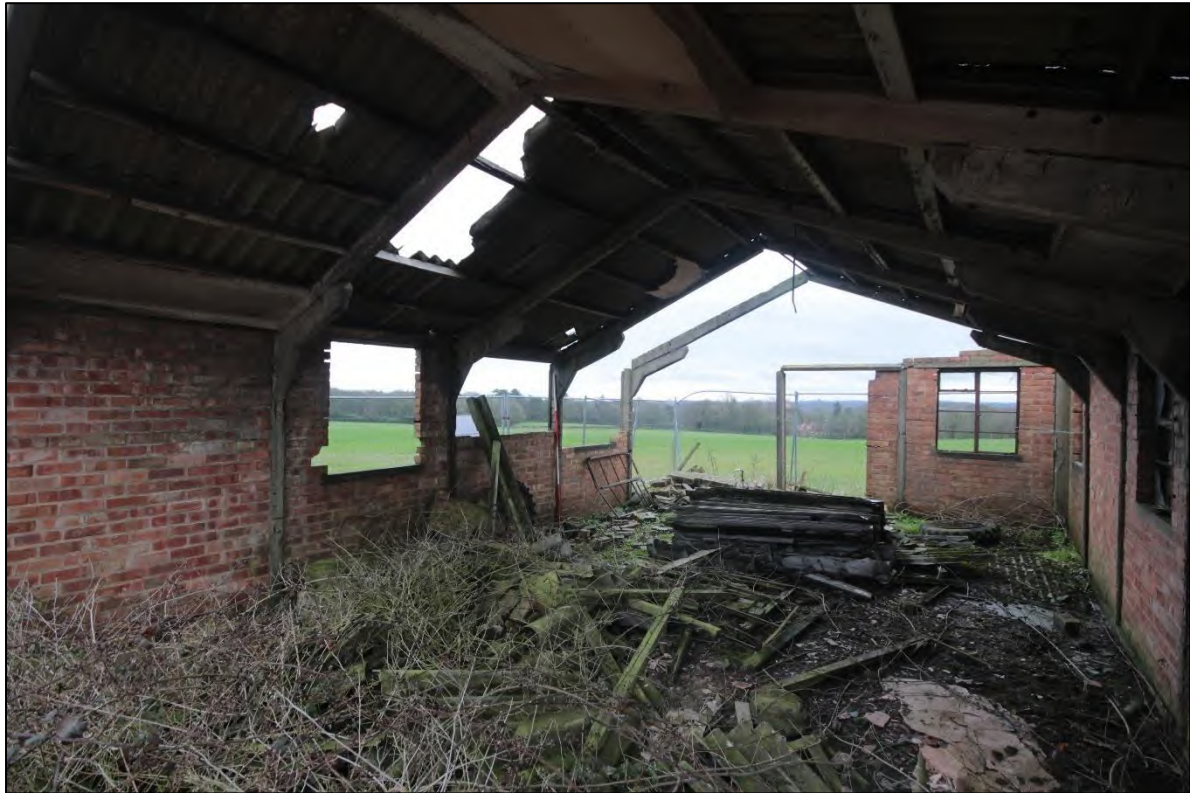
6.6.2 Internally, Building 3 appears to have originated as single open space (**Photograph 41 & 42**). The concrete flooring has been heavily covered over by vegetation and debris. No features of interest could be discerned.

Photograph 41: View to the north-west within Building 3, taken with 2m scale (File: HBR_101)

Photograph 42: View to the south-east within Building 3, taken with 2m scale (File: HBR_102)

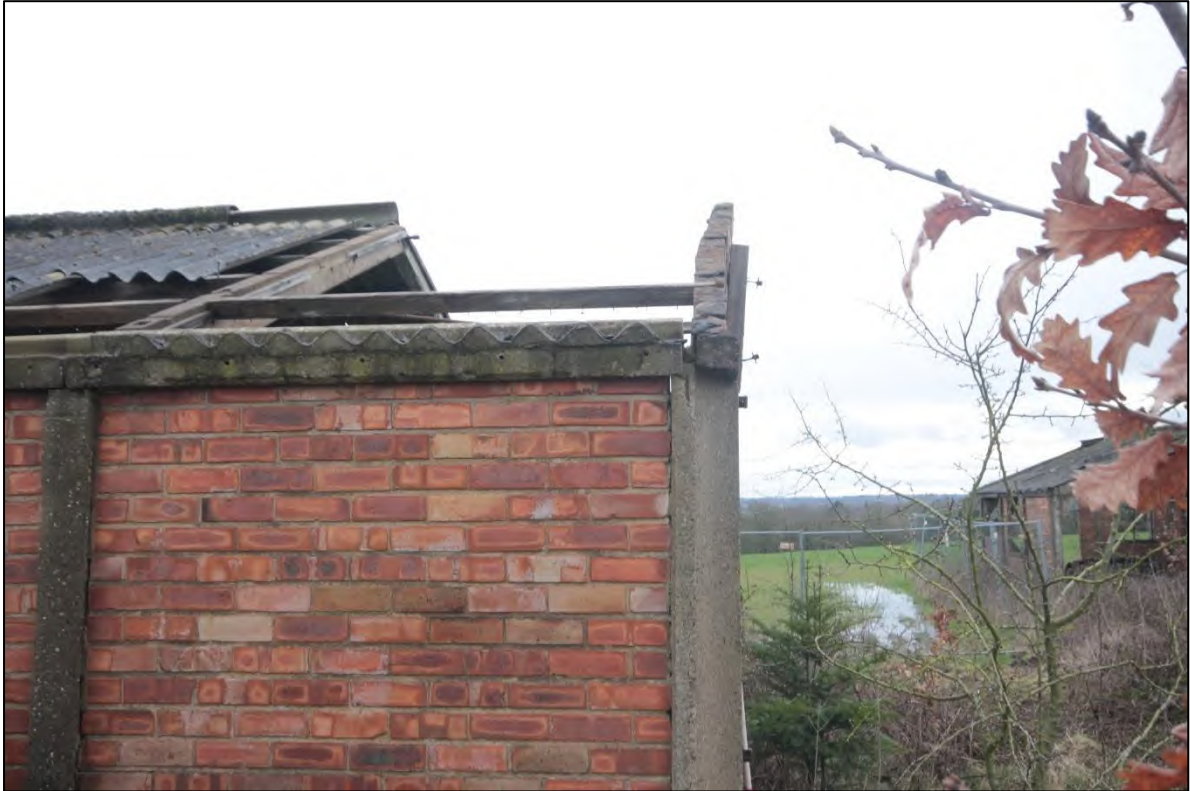
Photograph 45: View of the upper portions of Building 4's elevation leaning westwards, taken facing south (File: HBR_116)

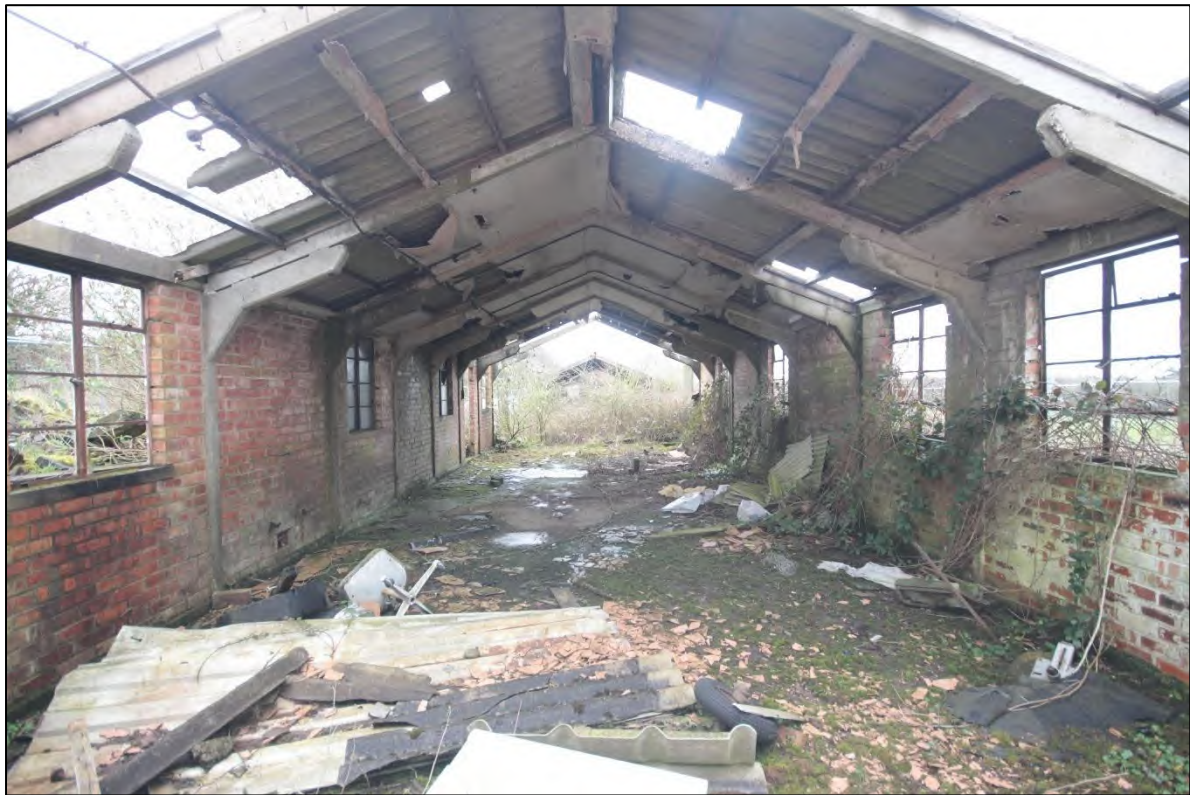
6.7.2 Internally, Building 4 comprises a long rectangular space with concrete flooring (**Photograph 51**). Access to the interior was limited due to structural concerns for the eastern elevation, as well as overgrown vegetation blocking access to the east. The interior appears to have been formed of a single large space, with no discernable features of interest noted.

Photograph 51: View to the east within Building 4 (File: HBR_123)

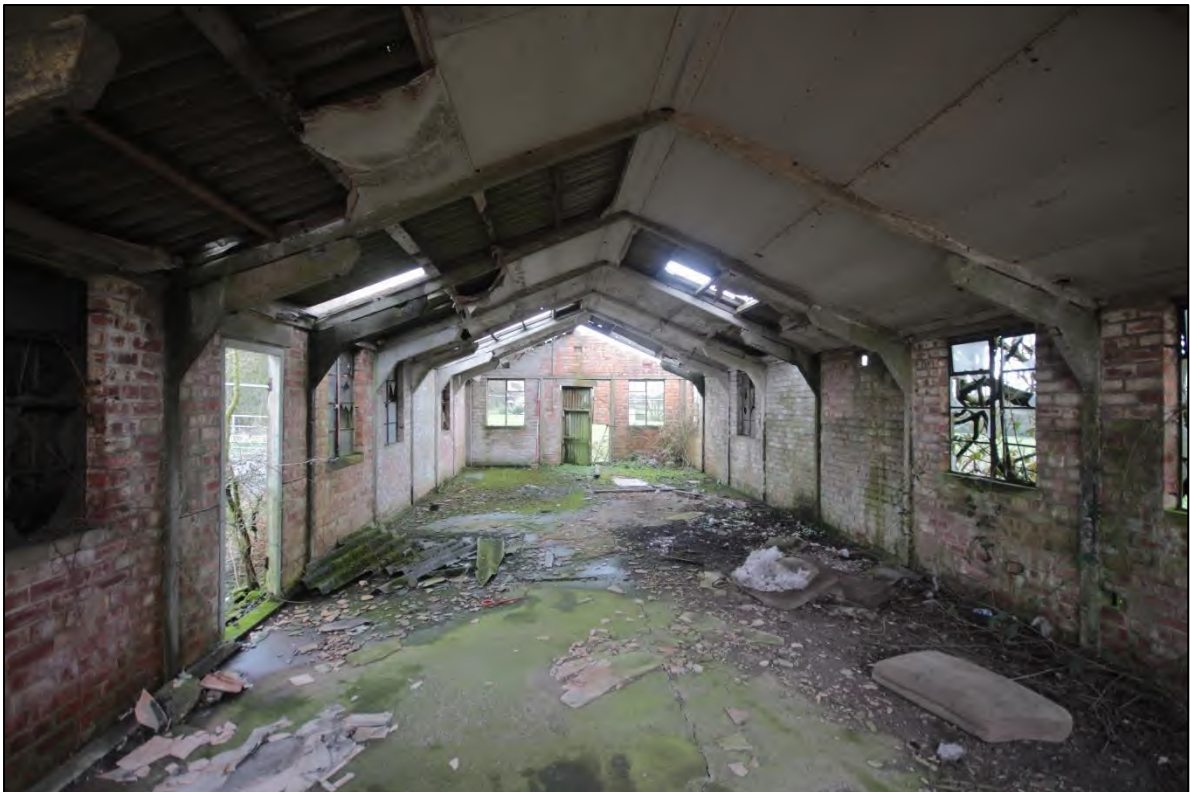
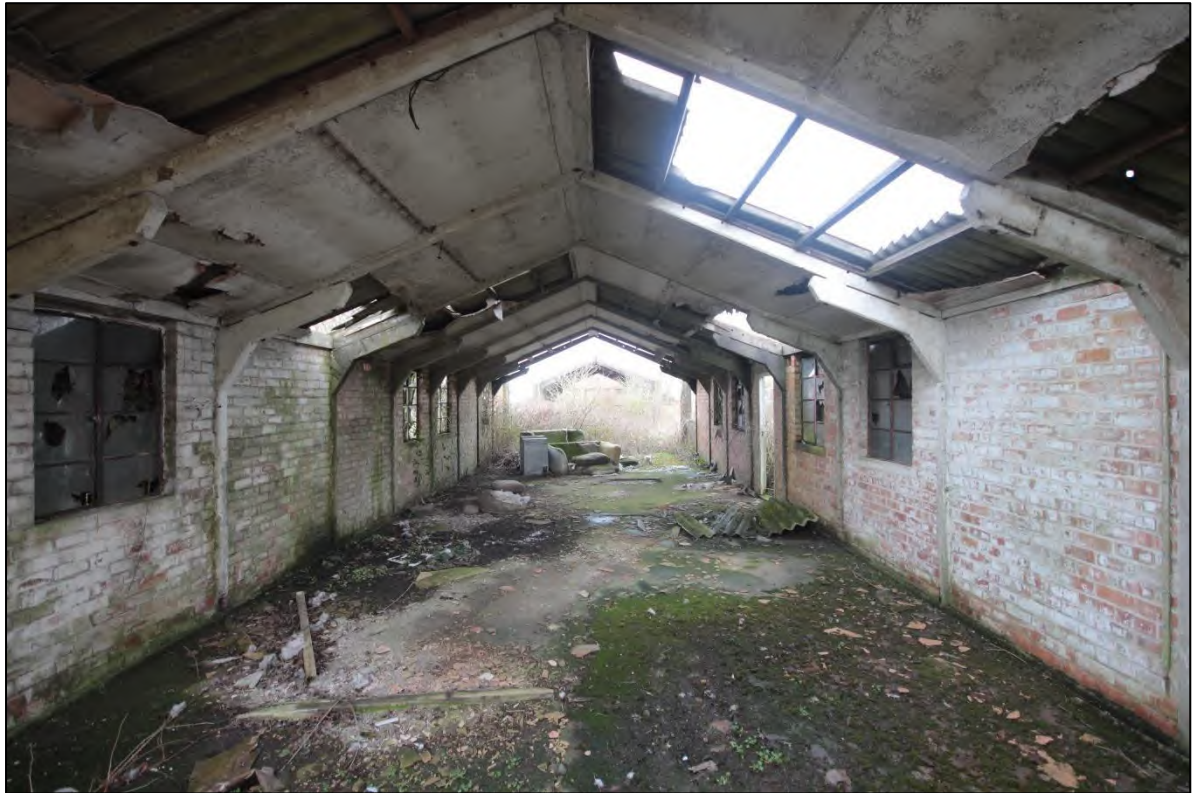
6.8.2 Internally, Building 5 comprises a single large rectangular space (**Photograph 59 & 60**). A straight joint within the eastern extent of the concrete flooring is present across the width of the space, suggesting that the interior had originated with a partition wall in this area (**Photograph 61**). This suggests that the space had originated with three distinct compartments, forming three bays to the west and six bays to the east. The larger eastern compartment would have been access from the doors on the northern and eastern elevations, with the western compartment likely accessed via a door on the western gable end, now lost. A rectangular outline is also present within the concrete flooring, adjacent to the eastern straight joint (**Photograph 61**). This resides beneath a circular aperture associated with a concrete flue on the roof, and had likely been associated with a heat source for the structure. No other features of interest could be discerned within the building.

Photograph 59: View to the east within Building 5, taken with 2m scale (File: HBR_144)

Photograph 60: View to the west within Building 5 (File: HBR_145)
