HISTORIC BUILDING RECORDING

Crank Gunsite Barracks, Crank Road, St Helens,

ARS Report N°: 2023/027

Historic Building Recording: Crank Gunsite Barracks, Crank Road, St Helens, Merseyside

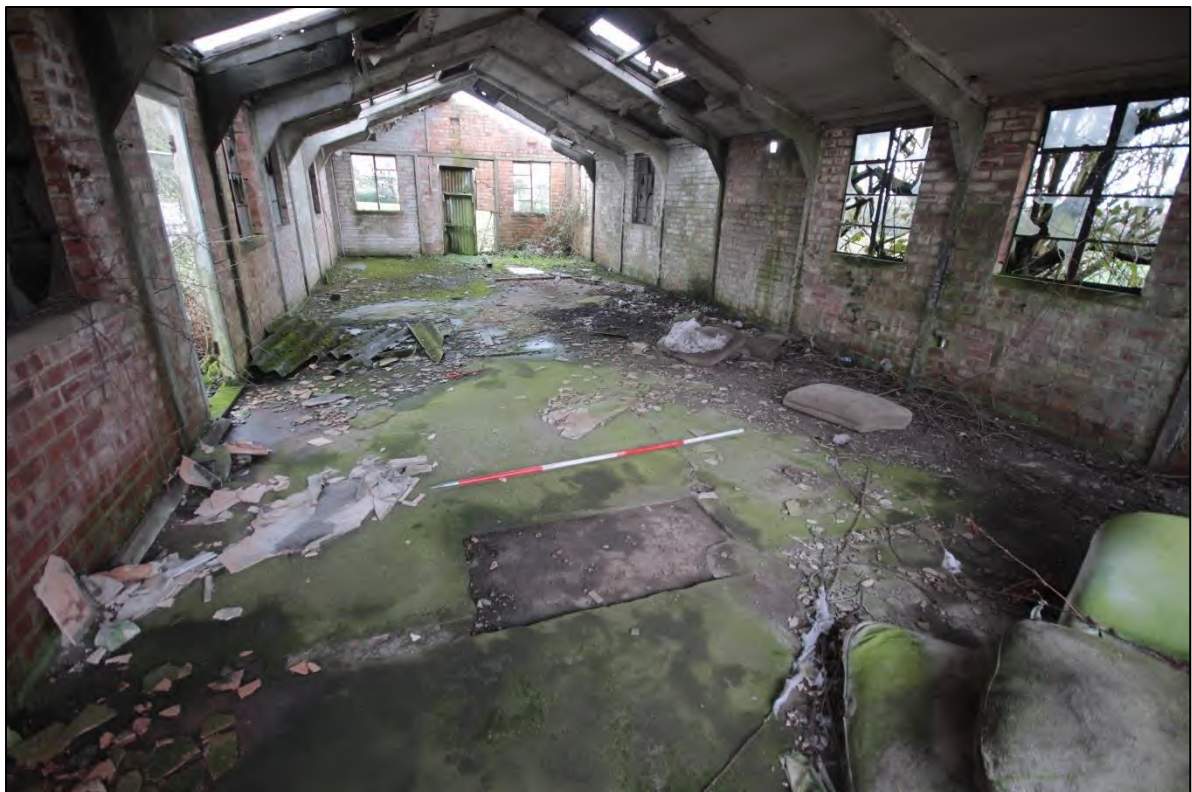
6.8.2 Internally, Building 5 comprises a single large rectangular space (**Photograph 59 & 60**). A straight joint within the eastern extent of the concrete flooring is present across the width of the space, suggesting that the interior had originated with a partition wall in this area (**Photograph 61**). This suggests that the space had originated with three distinct compartments, forming three bays to the west and six bays to the east. The larger eastern compartment would have been access from the doors on the northern and eastern elevations, with the western compartment likely accessed via a door on the western gable end, now lost. A rectangular outline is also present within the concrete flooring, adjacent to the eastern straight joint (**Photograph 61**). This resides beneath a circular aperture associated with a concrete flue on the roof, and had likely been associated with a heat source for the structure. No other features of interest could be discerned within the building.

Photograph 61: View of Building 5's concrete flooring, with a straight joint delineating a former partition wall, and rectangular outline likely associated with an earlier heating source. Taken facing south-east with 2m scale (File: HBR_143)

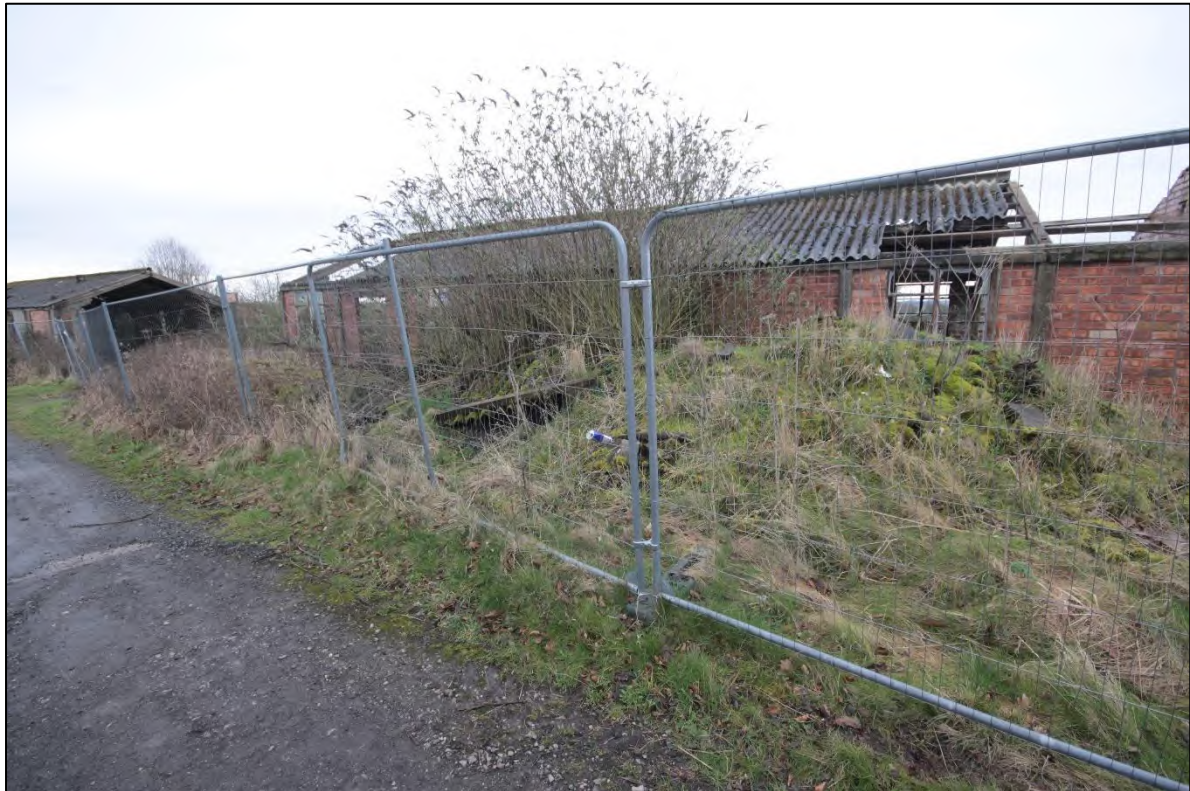
7.1.1 The site walkover of the 'red line boundary' was undertaken in March 2023. The site had comprised the five barracks buildings, bounded by agricultural fields to the west, south, and east, and by an access road to the north. The walkover identified several spoil heaps within the red line boundary, associated with lost building materials from the barracks structures, all of which are in a poor state of repair. A spoil heap is present between Building's 1 & 2 (**Photograph 62**), as well as to the north of Building 4 (**Photograph 63**). There are also extant building materials between Building's 4 & 5 (**Photograph 64**). No other archaeological features were noted within the red line boundary, with none identified within the surrounding agricultural field

Photograph 62: The spoil heap to the north of Building 4, taken facing south-east (File: HBR_170)

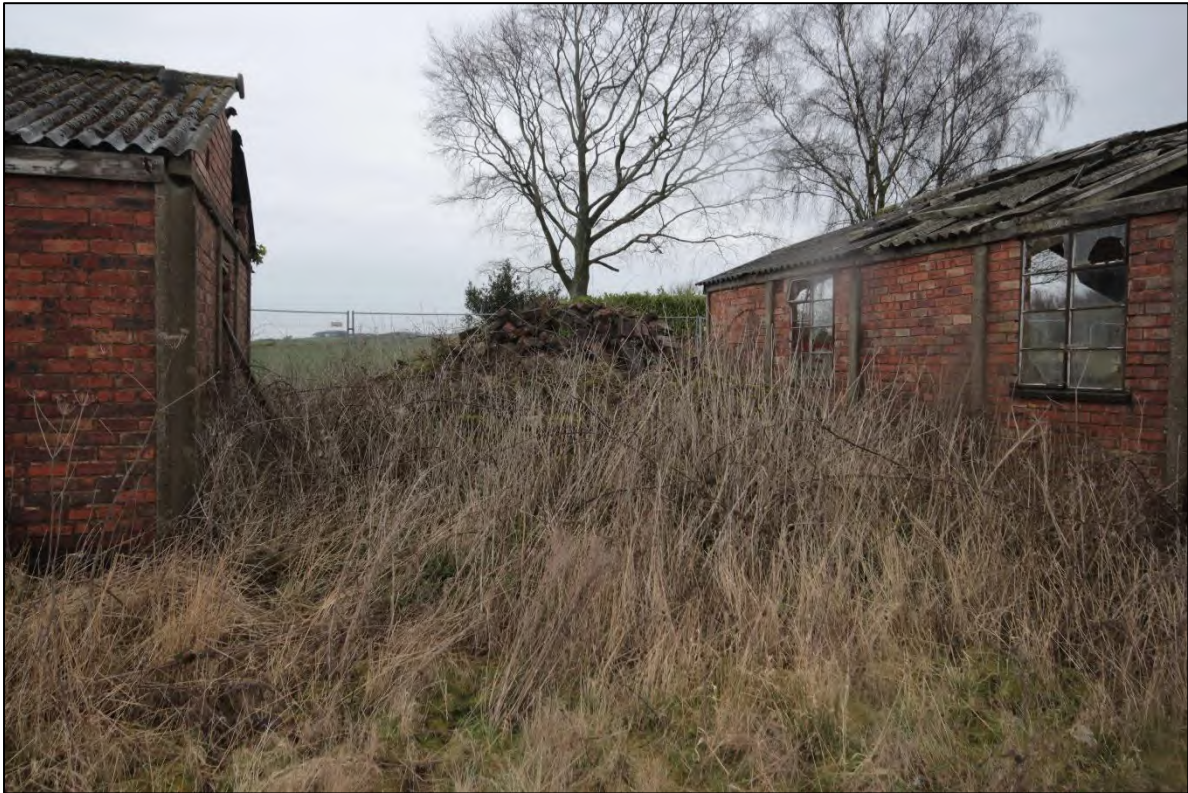
Photograph 63: The spoil heap between Building's 1 & 2, taken facing north (File: HBR_172)
