## Archaeological Watching Brief at Old Hall Hotel, Sandbach, Cheshire

**ARS Ltd Report 2011/62**

## **Archaeological Watching Brief at Old Hall Hotel, Sandbach, Cheshire**

### **Old Hall, High Street, Sandbach, Cheshire**

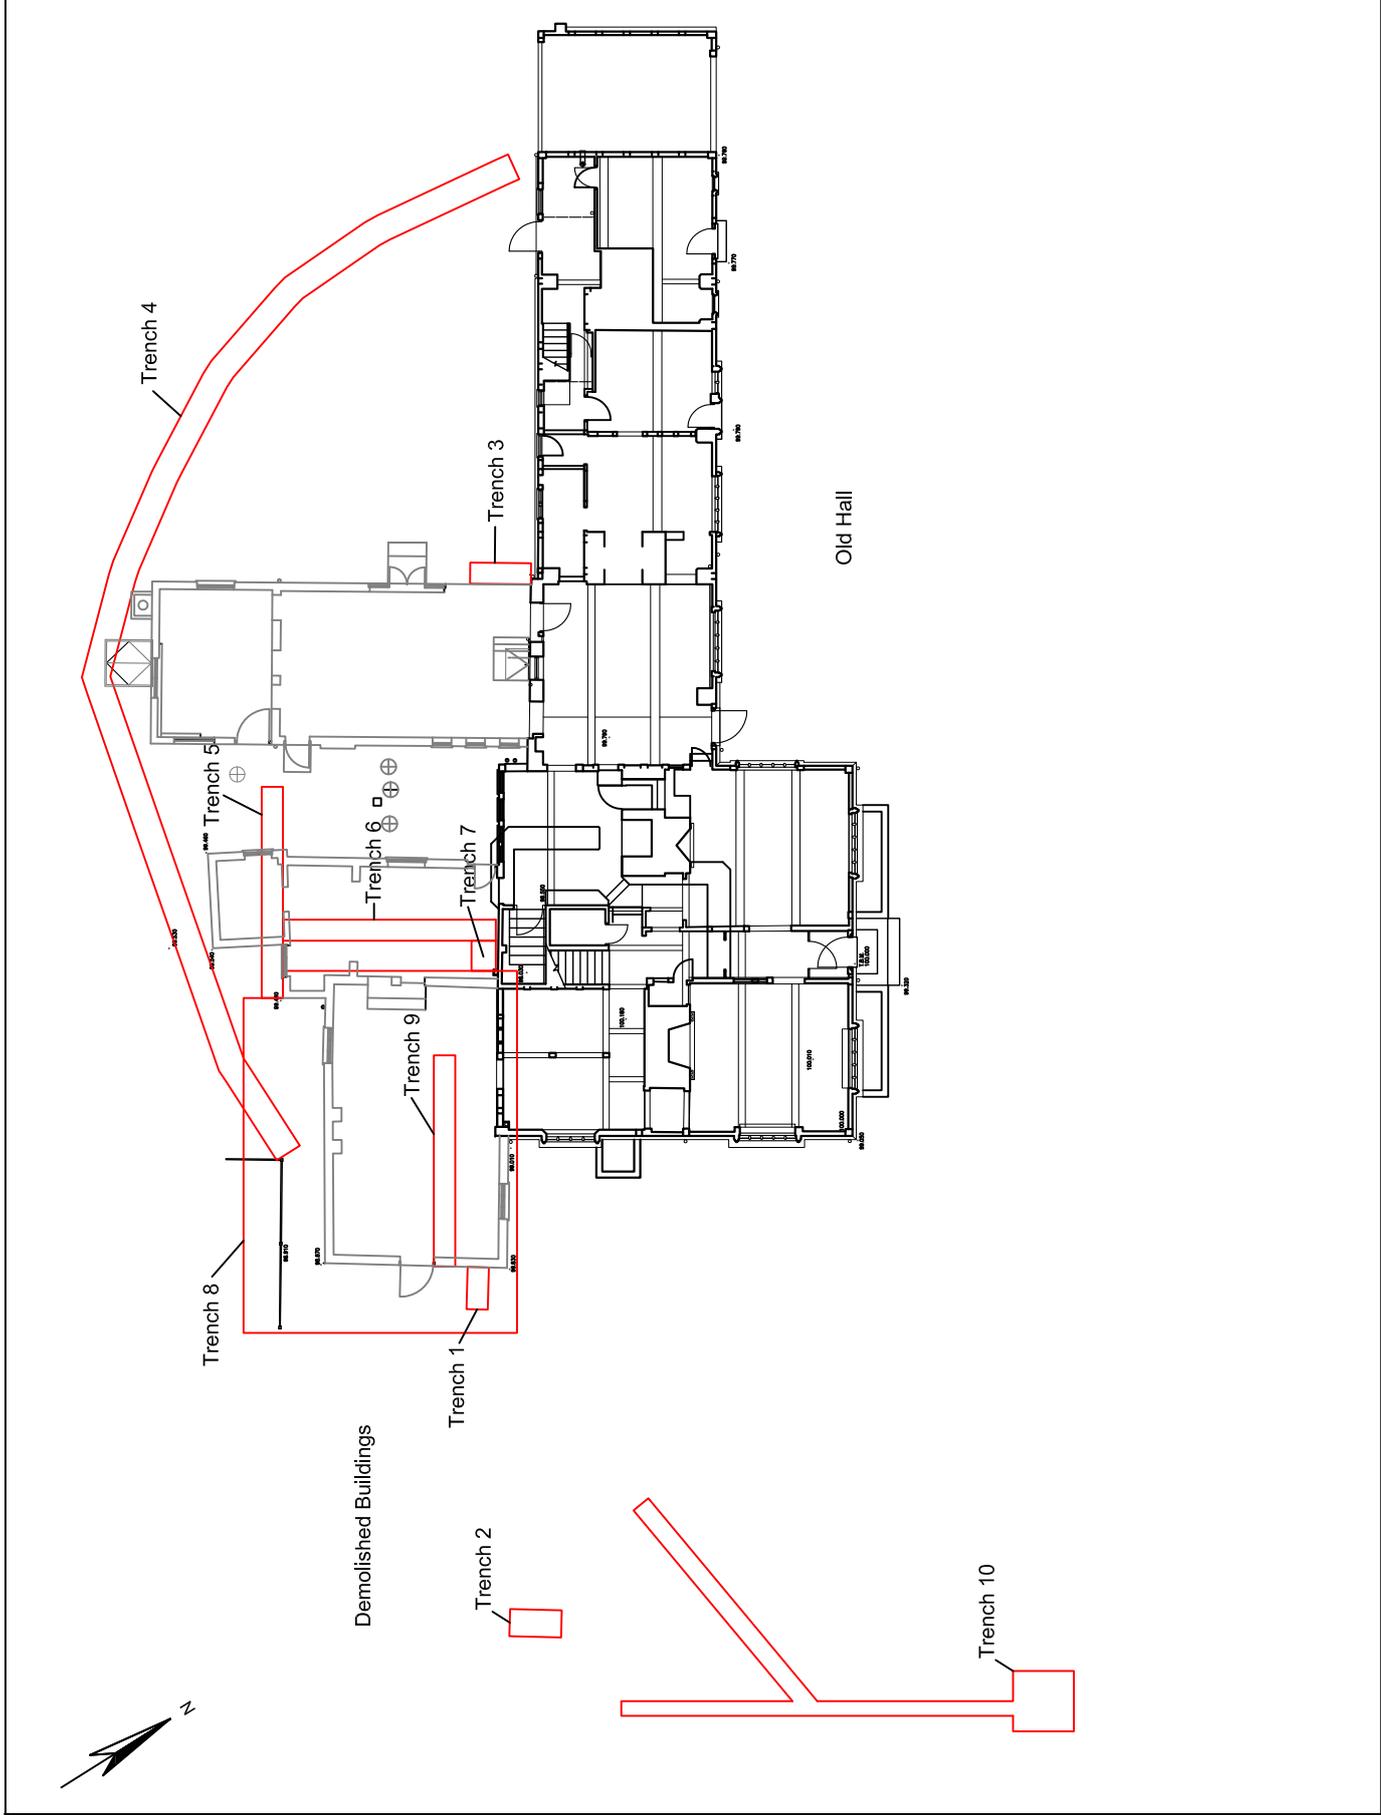
Figure 2: Trench Location Plan

- 2.1 The specification required that a watching brief should be carried out to observe any groundworks taking place for the proposed development in order to identify any potential archaeological remains. This involved monitoring the machine excavation of two small exploratory Evaluation holes, services trenches, foundation trenches and a soak-away (Fig. 2).

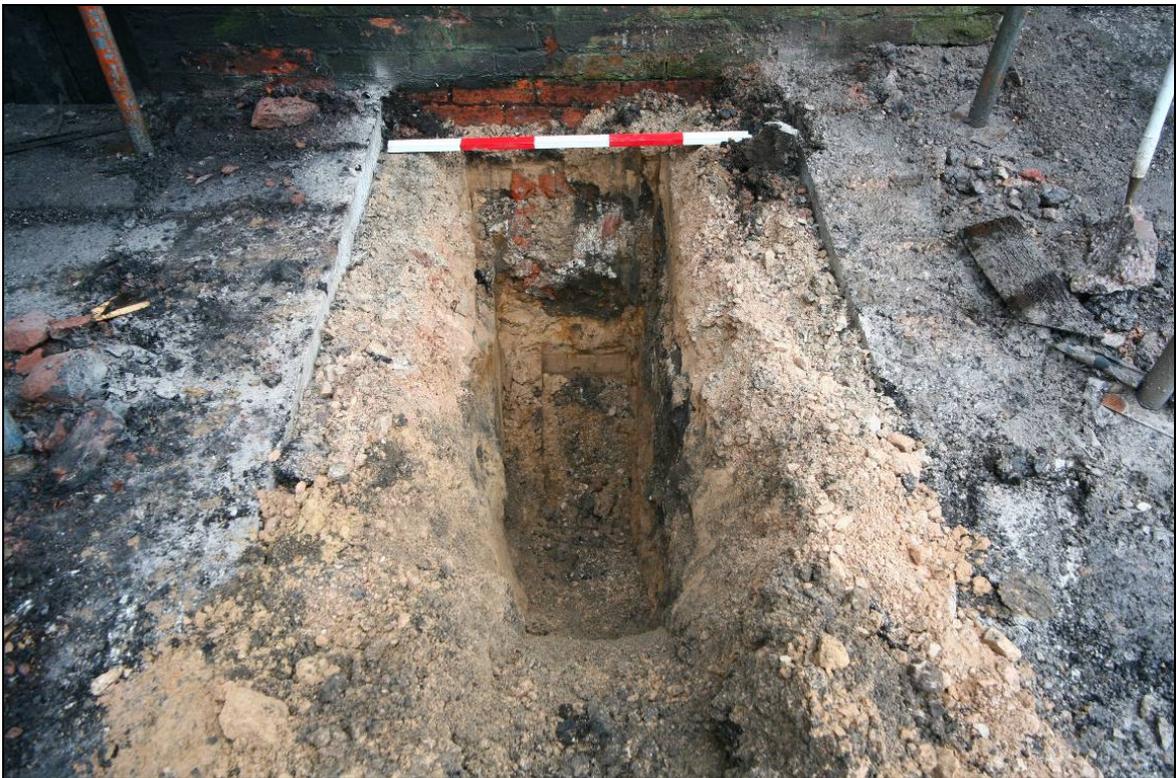
Figure 3: Evaluation trench 1

- 3.1 **Evaluation trench 1:** this trench was situated close to the east elevation of the brick extension at the rear of the Old Hall and was excavated to a maximum depth of approximately 1.3m (Fig 3). The excavation revealed that the top 500mm consisted of tarmac, sand and hardcore, below which a layer of fine yellow sand approximately 600mm thick was encountered. Below this, grey clay was present down to the maximum depth of the excavation. The wall of the adjacent brick building continued down to approximately 0.5m and was observed to rest directly on the sand. No features, finds or deposits of archaeological significance were revealed during the excavation.

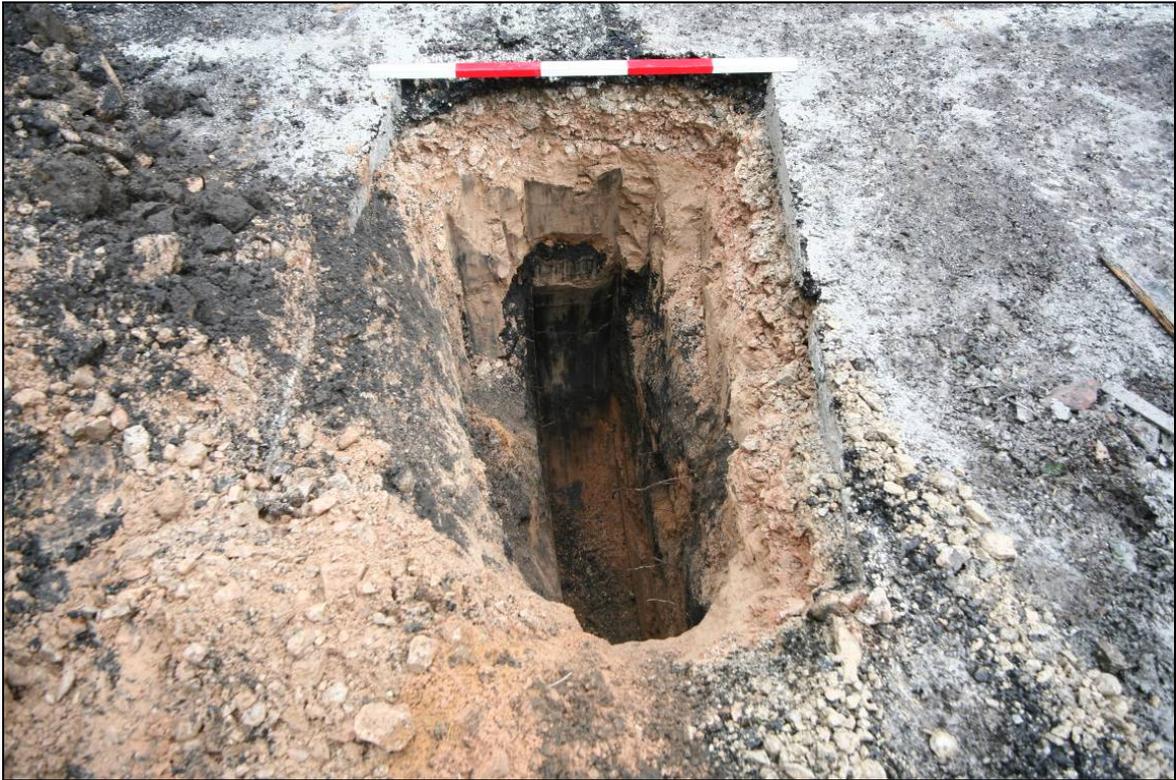
Figure 4: Evaluation trench 2

- 3.2 **Evaluation trench 2:** this trench had the same 500mm thick layer of tarmac, sand and hardcore as evaluation trench 1 but below it a 1m thick layer of top soil was encountered (Fig 4). Below this layer a fine yellow sand, similar to that recorded in Evaluation trench 1 was encountered. This continued down to the maximum depth of the excavation which was approximately 2m. No features, finds or deposits of archaeological significance were revealed during the excavation.

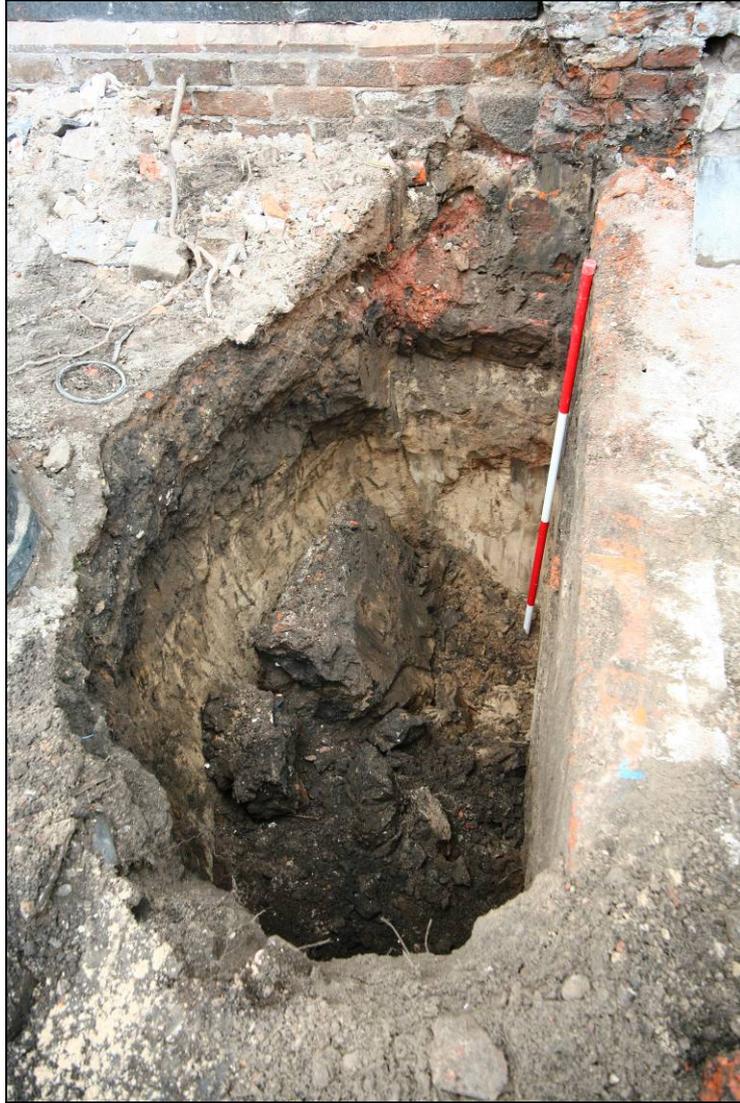
Figure 5: Trench 3 (scale 2m)

- 3.3 **Trench 3:** this trench was excavated at the rear of the long east/west range and measured 2m long x 0.7m wide x 2.30m deep (Fig. 5). The stratigraphy was equivalent to the preceding trenches, including the absence of any significant archaeology.

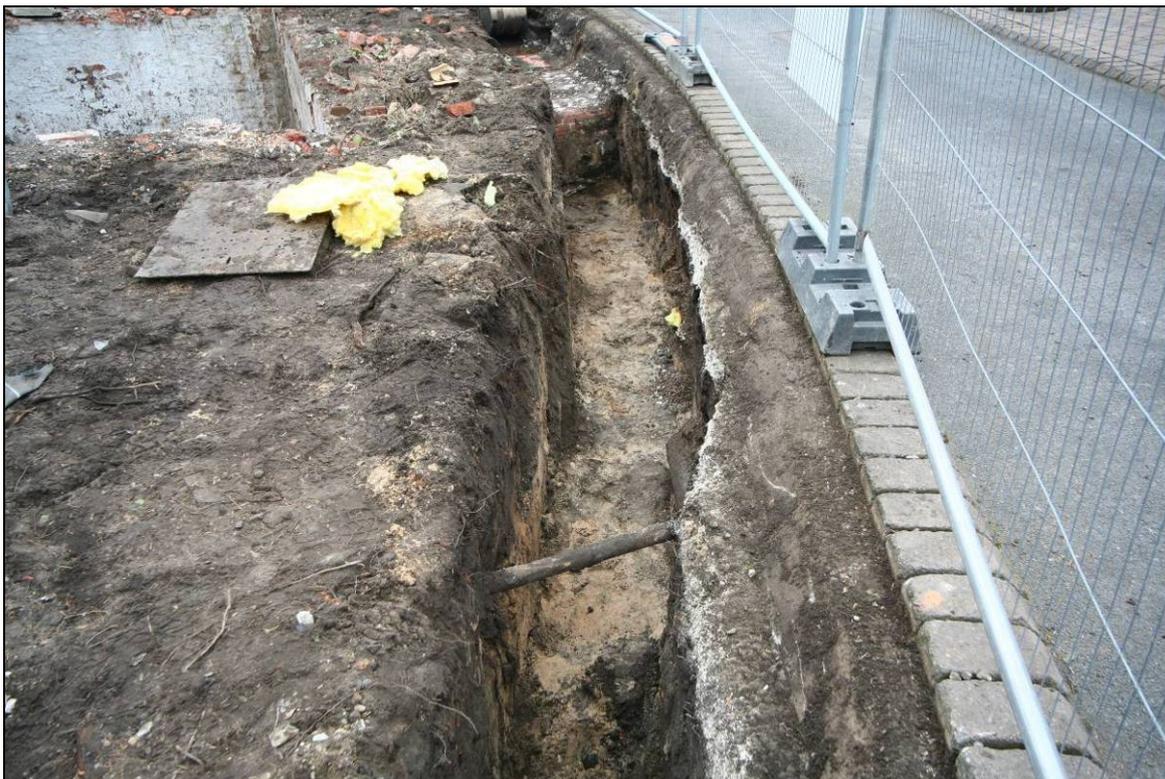
Figure 6: Trench 4

- 3.4 **Trench 4:** this trench was excavated along the rear limit of the site in order to accommodate the foundations for a new perimeter/boundary wall (Fig. 6). This trench did not reveal any significant archaeology.

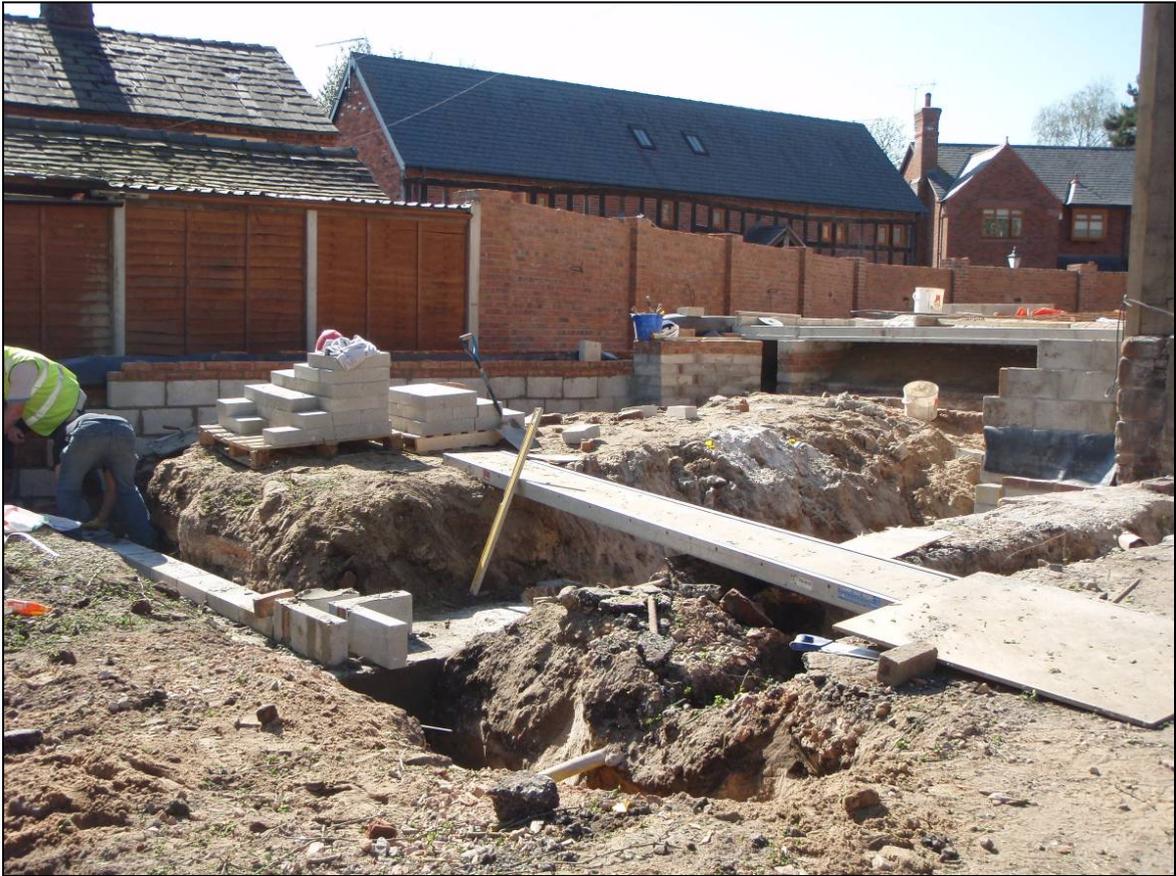
Figure 7: Trench 5

- 3.5 **Trench 5:** The excavated trench measured 17.1m x 0.9m and was excavated to a depth of 1.10m. The stratigraphy of the trench comprised black (10YR 2/1) topsoil (1001) measuring 0.4m in thickness, below the topsoil (1001) was a pale yellow (2.5Y 8/2) sand (1003) measuring 0.7m in thickness. The pale yellow sand (1003) continued below the depth of excavation. Archaeological finds recovered from within the topsoil (1001) comprised fragments of faunal remains, and ceramic fragments.

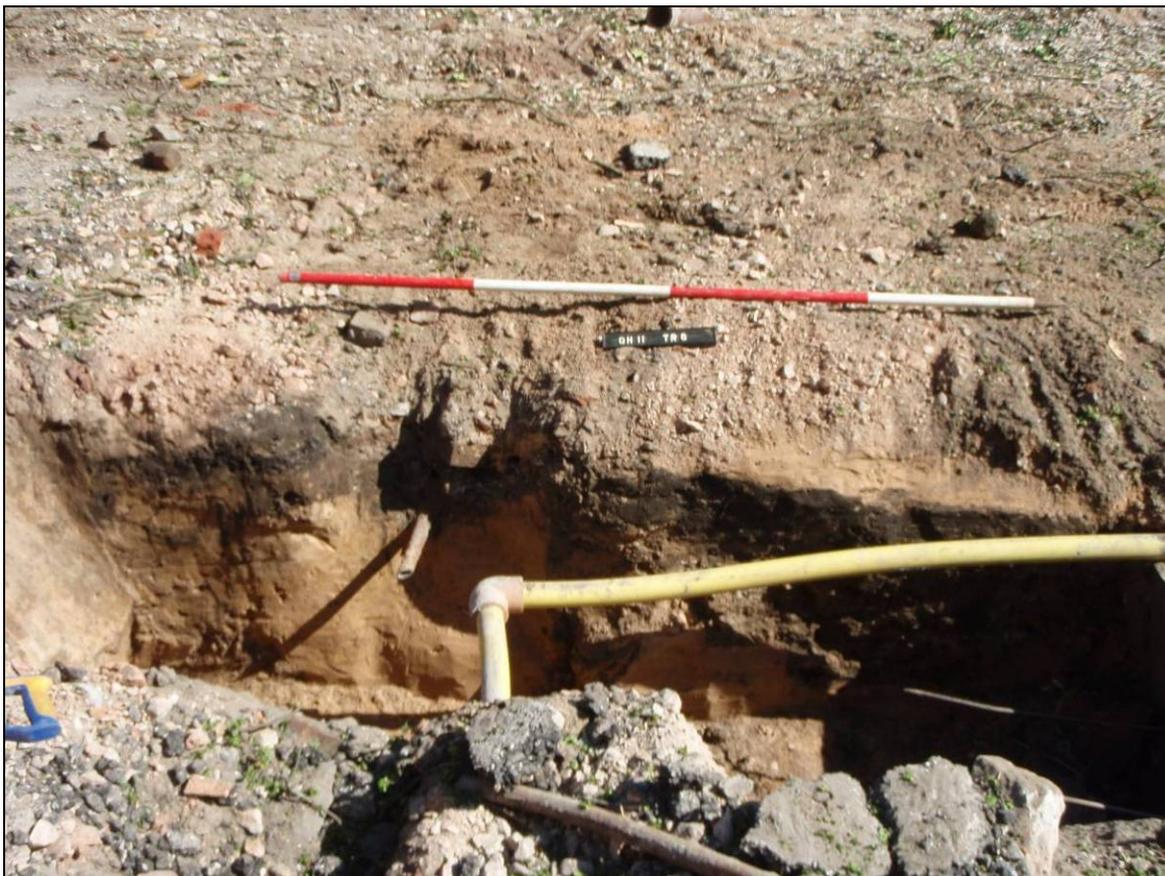
Figure 8: Trench 6

- 3.6 **Trench 6:** The excavated trench measured 7m x 0.9m and was excavated to a depth of 1.3m. The stratigraphy of the trench comprised a layer of tarmac (1005) measuring 0.07m in thickness below which was a hardcore layer (1006) measuring 0.1m in thickness. Below the hardcore layer (1006) was a black (10YR 2/1) topsoil layer (1001) which varied in thickness from 0.17m to 0.5m. Below the topsoil layer (1001) was a yellowish red (5YR 5/6) sand (1004) which varied in thickness from 0.63m to 0.96m in depth. The yellowish red sand (1004) continued below the depth of excavation. Archaeological finds recovered from within the yellowish red sand (1004) comprised a single ceramic fragment.

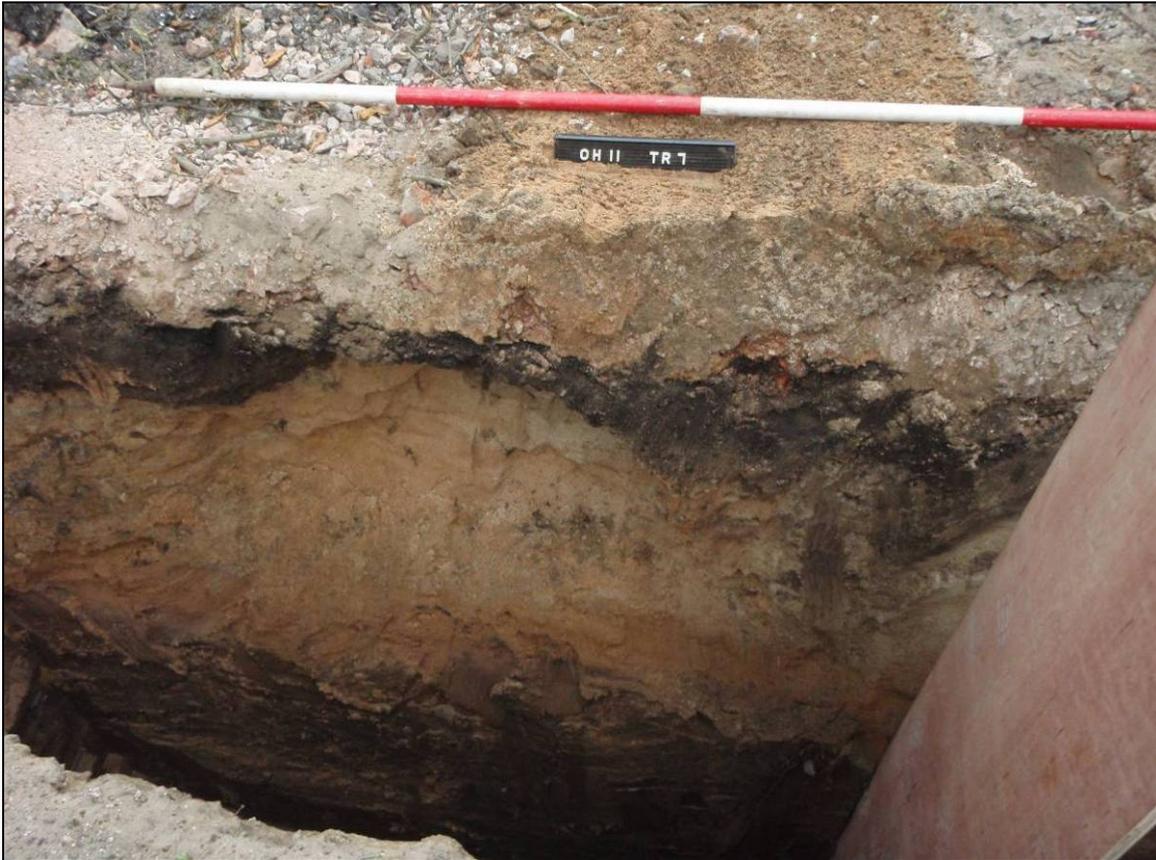
Figure 9: Trench 7

- 3.7 **Trench 7:** The excavated trench measured 2m x 0.9m and was excavated to a depth of 1.8m; the length of trench 7 was reduced to 1m when it was cut into by Trench 8. The stratigraphy of the trench comprised a layer of tarmac (1005) measuring 0.07m in thickness below which was a hardcore layer (1006) measuring 0.1m in thickness. Below the hardcore layer (1006) was a black (10YR 2/1) topsoil (1001) measuring 0.3m in thickness. Below the topsoil (1001) was a pale yellow (2.5Y 8/2) sand (1003) measuring 0.6m in depth, which overlay a yellowish red (5YR 5/6) sand (1004) measuring 0.13m in thickness. Below the yellowish red sand (1004) was a brown (10YR 4/3) clay (1007) measuring 0.6m in thickness. The brown clay (1007) continued below the depth of excavation. No archaeological finds were present in this trench.

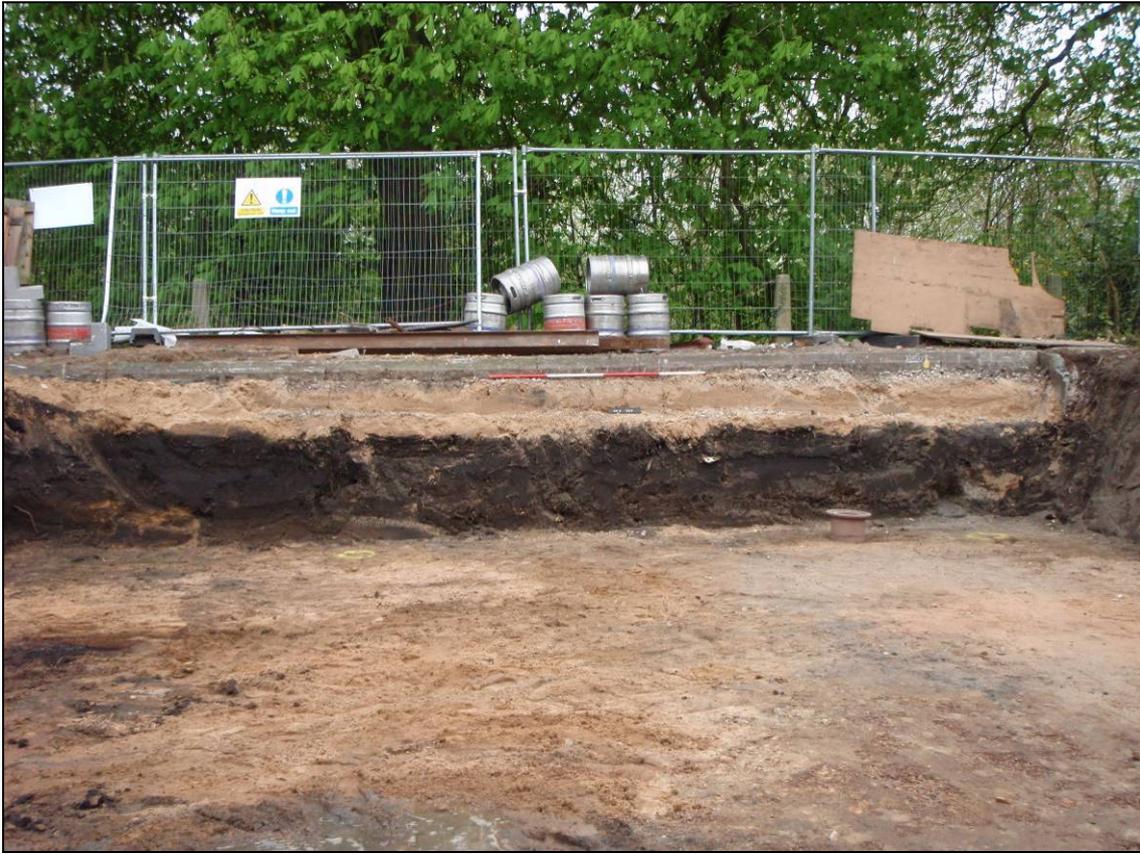
Figure 10: Trench 8, looking east (scale 2m)

- 3.8 **Trench 8:** The excavation of this trench was undertaken in order to provide the foundations of a proposed kitchen extension to the south-east of the main square range of the Old Hall Hotel complex. The trench was rectangular in shape and measured 10.5m along its southern edge, 12m along its northern edge and 9m along both the eastern and western edges; the trench was excavated to a depth ranging from 1.4 – 1.9m. The stratigraphy of the trench comprised a tarmac layer (1005) measuring 0.07m in thickness. Below the tarmac (1005) was a hardcore layer (1006) measuring 0.1m in thickness. In the south facing section below the hardcore layer (1006) was a black hardcore layer (1009) that contained brick fragments and CBM; this layer measured 0.02m in thickness. Below the black hardcore layer (1009) was a brown soil layer (1008) measuring 0.4m in thickness. These two layers (1008, 1009) were not ubiquitous across the trench and were only present at the left side of the south facing section. In the south facing section of Trench 8 the hardcore layer (1006) sat above a layer of pale yellow (2.5Y) sand (1003) which ranged in thickness from 0.3 – 1.3m. Below the pale yellow sand was a yellowish red (5YR 5/6) sand (1004) ranging in thickness from 0.3 – 1m. Below the yellowish red sand (1004) was a brown (10YR 4/3) clay (1007) ranging in thickness from 0.1 – 0.5m. The brown clay (1007) continued below the level of excavation. At the eastern extent of Trench 8 a buried garden soil layer (1010) was observed situated below the pale yellow sand (1003) and above the brown clay (1007). The buried soil was present in the north, west and south facing sections and ranges in thickness from 0.4 – 1m. This layer constituted the topsoil element of a garden that was present at the site. Archaeological finds comprising ceramic fragments of 19<sup>th</sup> – 20<sup>th</sup> century in date and faunal remains were recovered from contexts (1003) and (1010).

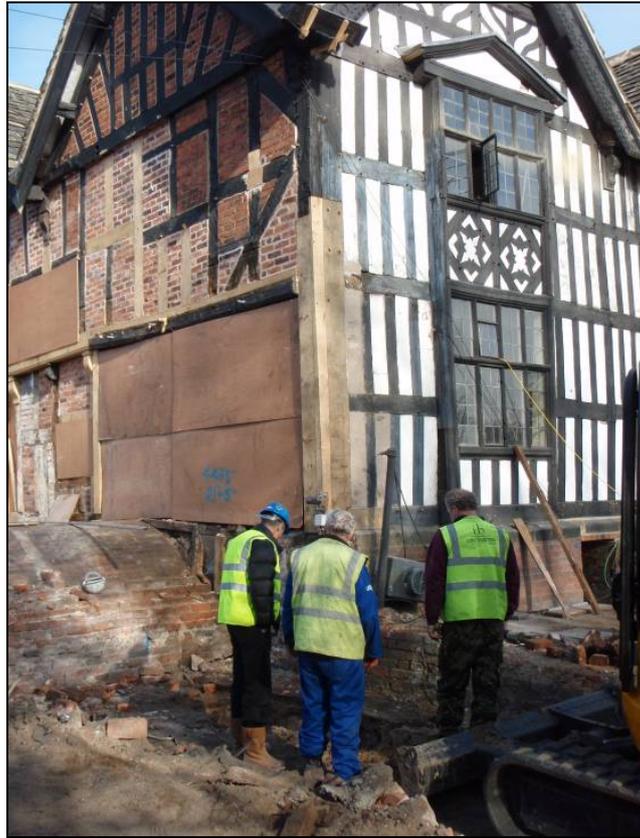
Figure 11: Location of trench 9, looking north

- 3.9 **Trench 9:** Trench 9 was located immediately to the south-east corner of the main square range of the Old Hall Hotel complex (Fig. 11) and was monitored on the 21<sup>st</sup> of March 2011. It consisted of a narrow east/west linear trench measuring *c.* 2.60 metres in length, 400mm in width and reached a maximum depth of 2.20 metres (Fig. 12). The excavation did not reveal any archaeological feature and the exposed stratigraphic sequence consisted of a brick paving floor over a made ground dark grey clay layer (100mm thick) which in turns was overlying the natural substratum layer composed of yellowish sand (800mm thick). A dark reddish brown clay natural layer was also observed beneath the sandy layer.

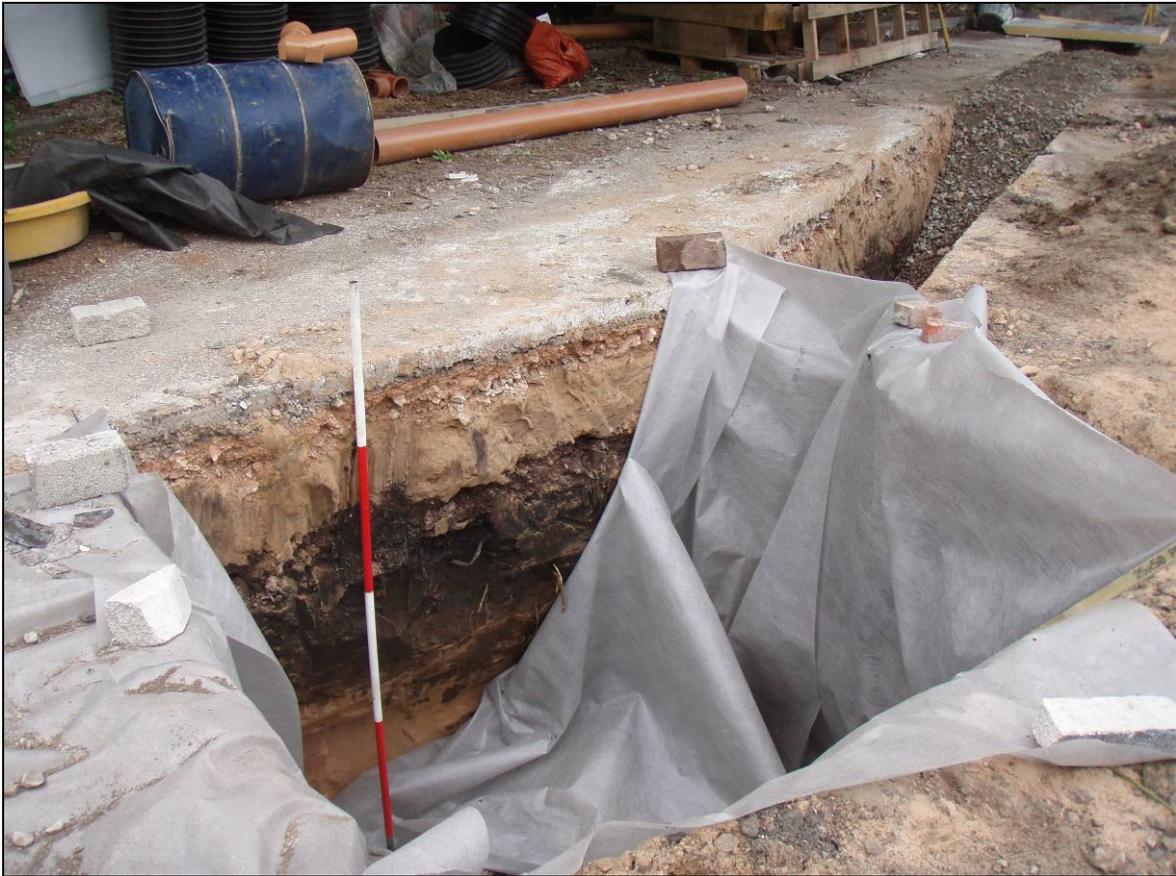
Figure 13: Trench 10, looking south (scale 2m)

- 3.10 **Trench 10:** this trench consisted of a large soak-away pit with associated trenches which was situated within the car park to the east of the site (Fig. 13). The pit was c. 2m in diameter and 2m in depth. The stratigraphy was equivalent to previous excavated trenches. No archaeological features, deposits or artefacts were encountered.
