Archaeological Evaluation at Riverside Business Park, Bakewell, Derbyshire

ARS Ltd Report 2011/75

July 2011

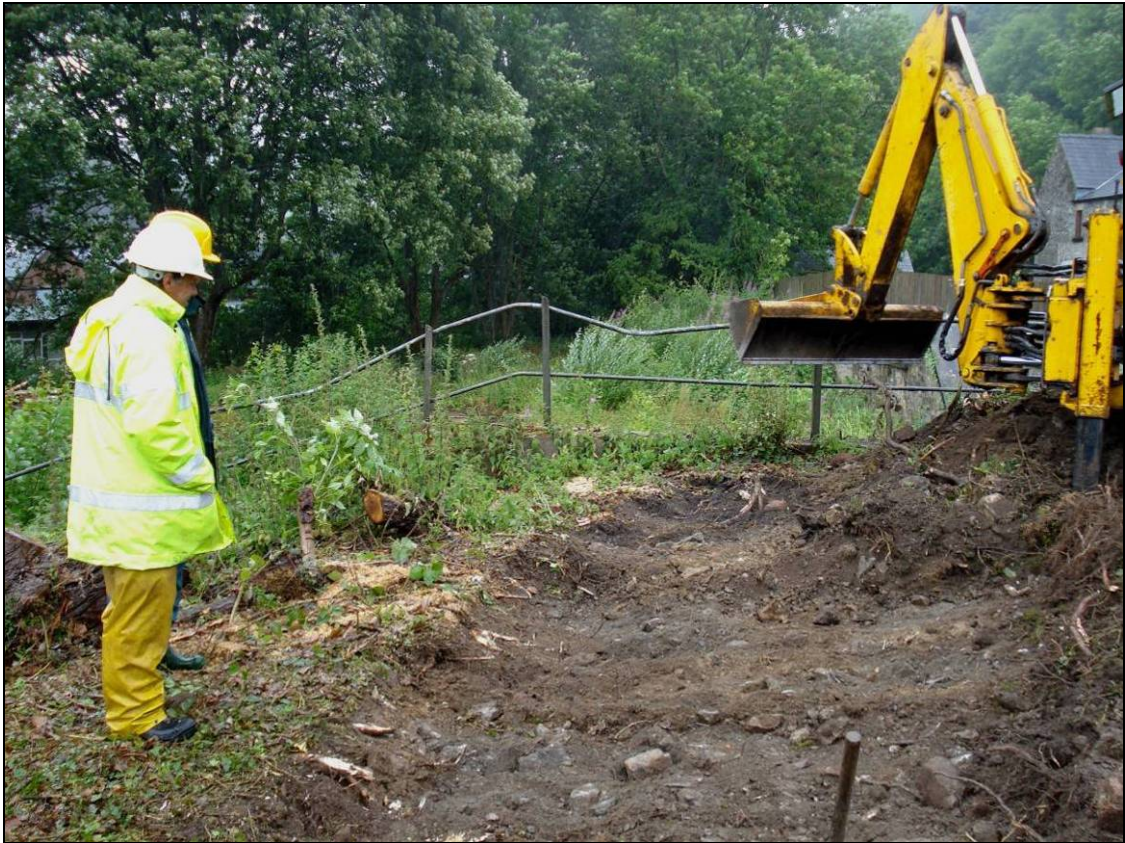
- 5.3 The stratigraphic sequence consisted of a thin layer of topsoil (101), which in turn overlay a series of made-ground layers (102) and (103) to a maximum depth of 1.20 metres below ground level (BGL). The made-ground layers were composed of mixed mid grey-brown firm clayey silt with sandy silt lenses containing frequent rubble. Roots disturbance from former trees were also largely present within the made-ground layers (Fig. 3).

Figure 3: Trench 1 during excavation, looking east

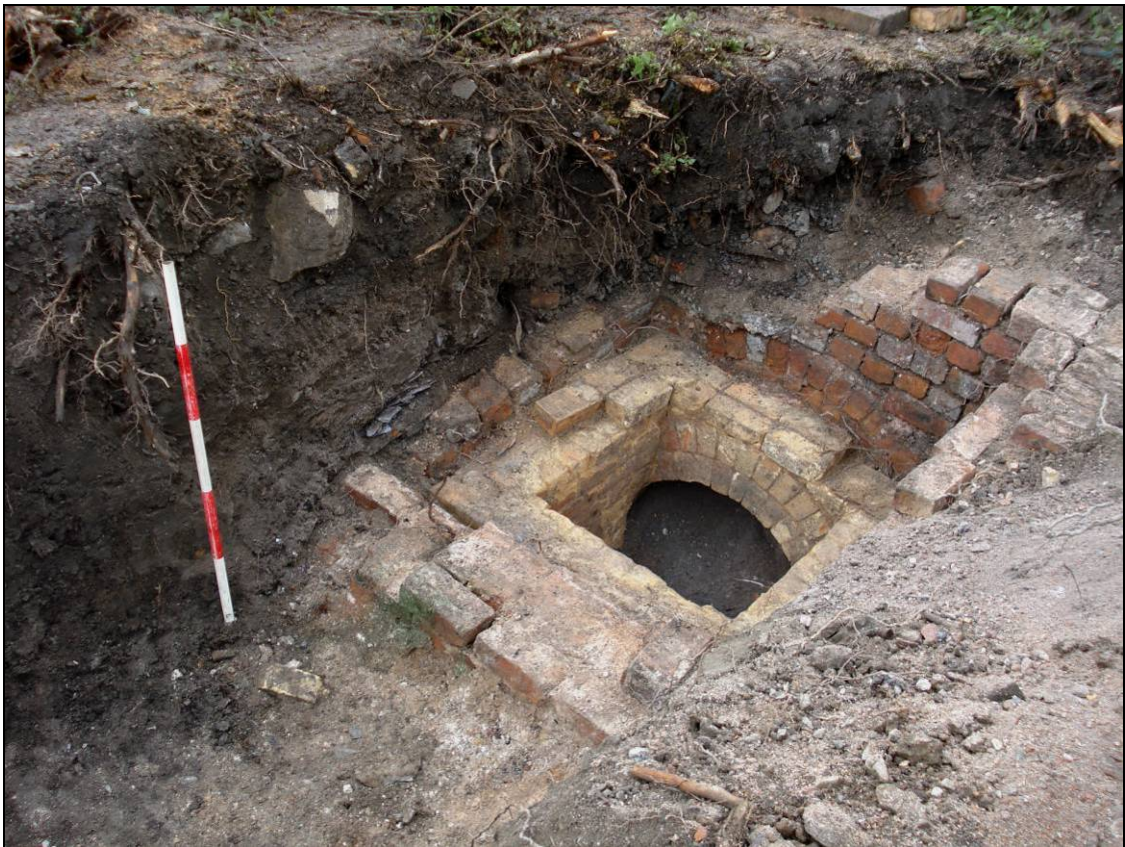
- 5.4 The excavation of the aforementioned layers revealed a basal section of a brick-built chimney stack to the east of the trench whose uppermost section was recorded at 700mm BGL (Figs 4 and 5). The structure is square in plan (*c.* 2 x 2 metres) and is composed of two double-skin brick walls (104) and (105). The outer wall (104) consists of eight courses of red bricks (9" x 4" x 3") bonded with lime mortar and laid mainly to English bond. The inner wall (105) consists of seven visible courses of fire or refractory yellow bricks (9" x 4" x 3") bonded with yellowish lime mortar. Brick samples of the aforementioned walls were retained. The structure appears to be built *in situ* and extends beneath the base of the trench. The eastern wall contains a barrel vaulted opening which would have connected the stack to a former boiler (Figs 6 and 7). The opening has a segmental arched head composed of two courses. Immediately over the opening, there is a similar arched head within the outer wall (104), acting as a relieving arch of the barrel vault of the former boiler. The vaulted opening extended to the east of the retaining wall where an equivalent arched opening was identified, although is now blocked with stones (Fig. 8). The interior of the stack measures *c.* 800 x 800mm and it was partially backfill with rubble, large sandstone architectural fragments and clayey silt with sandy silt lenses. A primary ashy deposit (106) was uncovered at *c.* 2 metres BGL inside the stack (Fig. 9); and an air/flue vent with a segmental arched head was also noticed within the western wall (Fig. 10).

Figure 4: Trench 1 with remains of chimney stack in the eastern side, looking east (scale 1m)

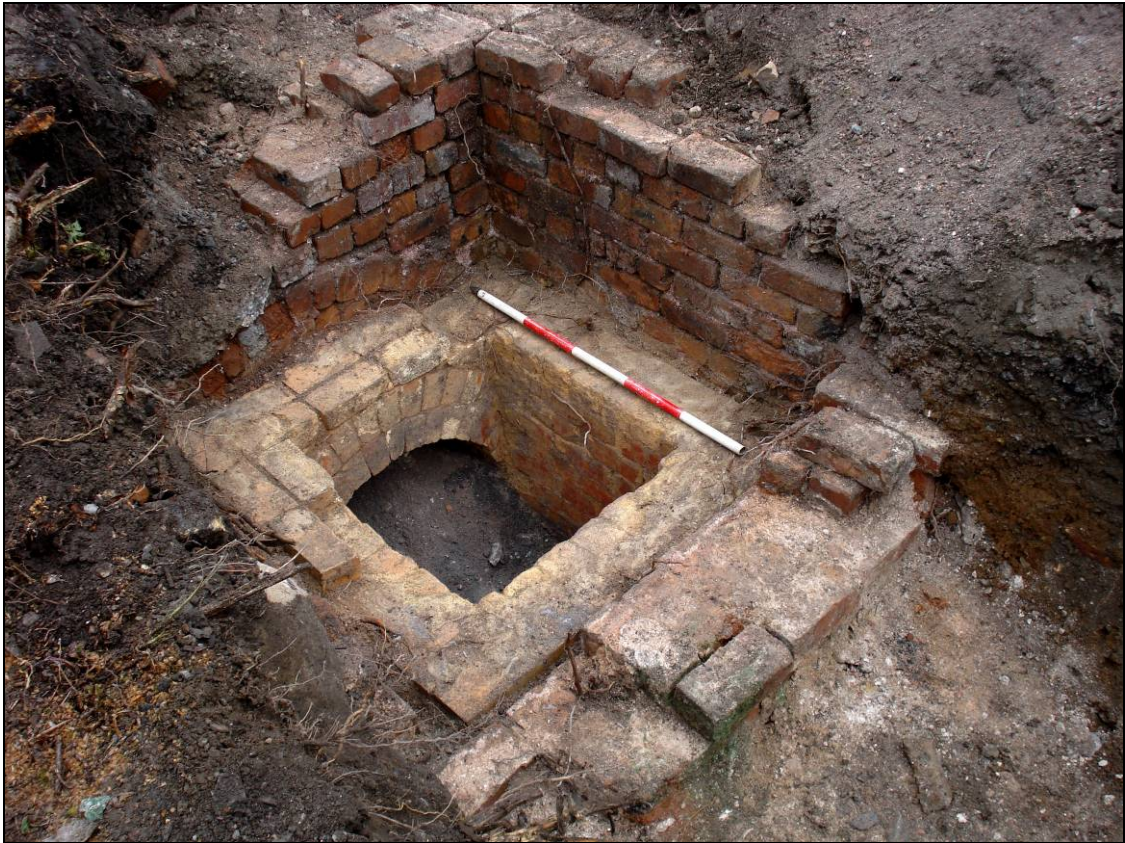
- 5.5 The remains of this chimney base and the blocked-up opening within the current retaining wall represent the remnants of an earlier works which might have been powered with a steam engine located to the east of the trench. The retaining wall is currently an L-shaped structure which contains several blocked-up doorways as well as the barrel vaulted opening which would have connected a boiler with the revealed chimney stack. Thus the wall represents the internal side of a former works with its adjoining chimney stack to the north-west corner. These remains may date to the mid 19th century as cartographic records of the late 19th century do not show clear evidence of the standing retaining wall with its associated chimney stack uncovered during the evaluation.

Figure 5: Basal section of a brick chimney stack, looking south-east (scale 1m)

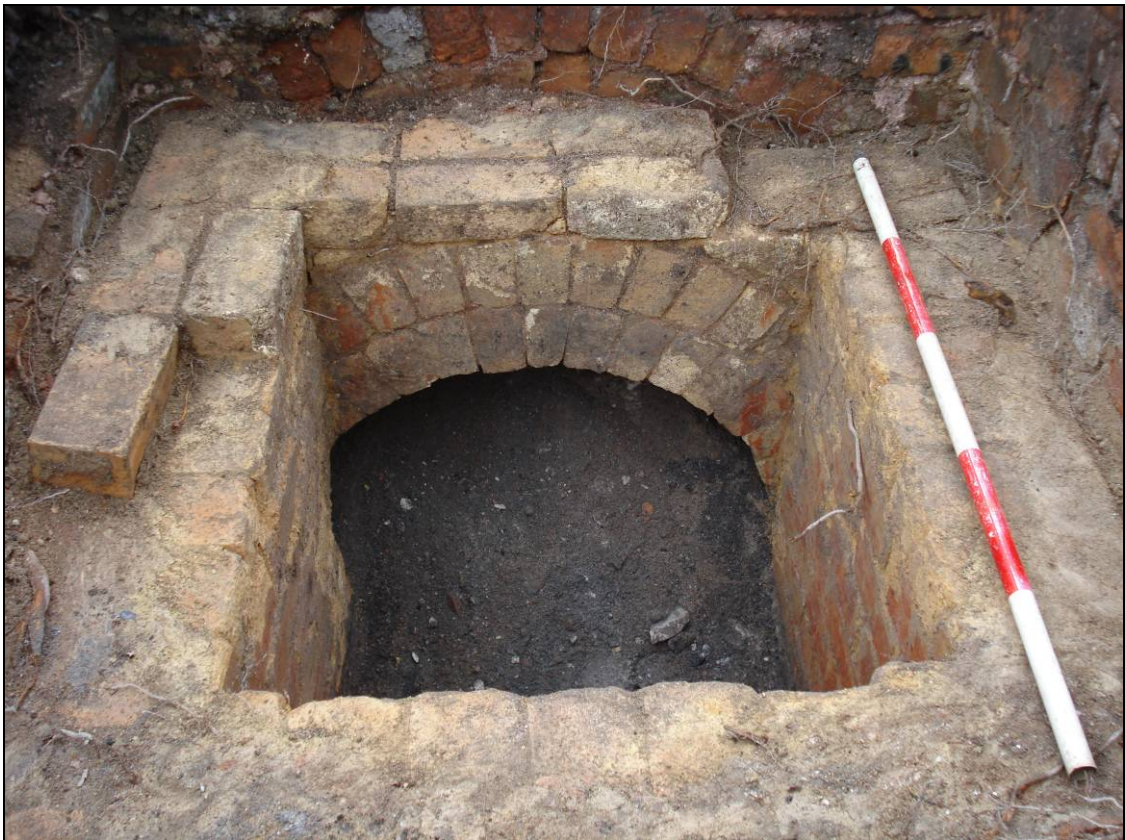
Figure 6: Segmental arched head of the barrel vaulted opening, looking east (scale 1m)

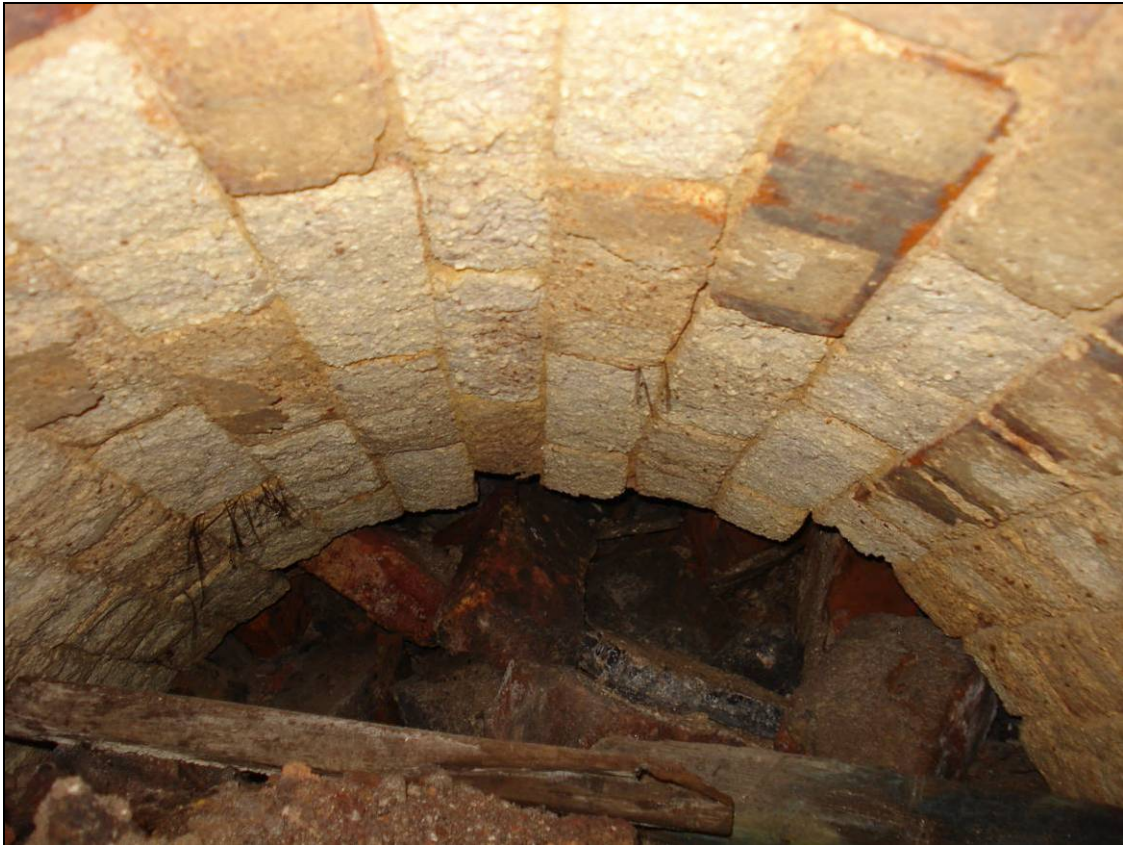
Figure 7: Vaulted flue opening, looking east

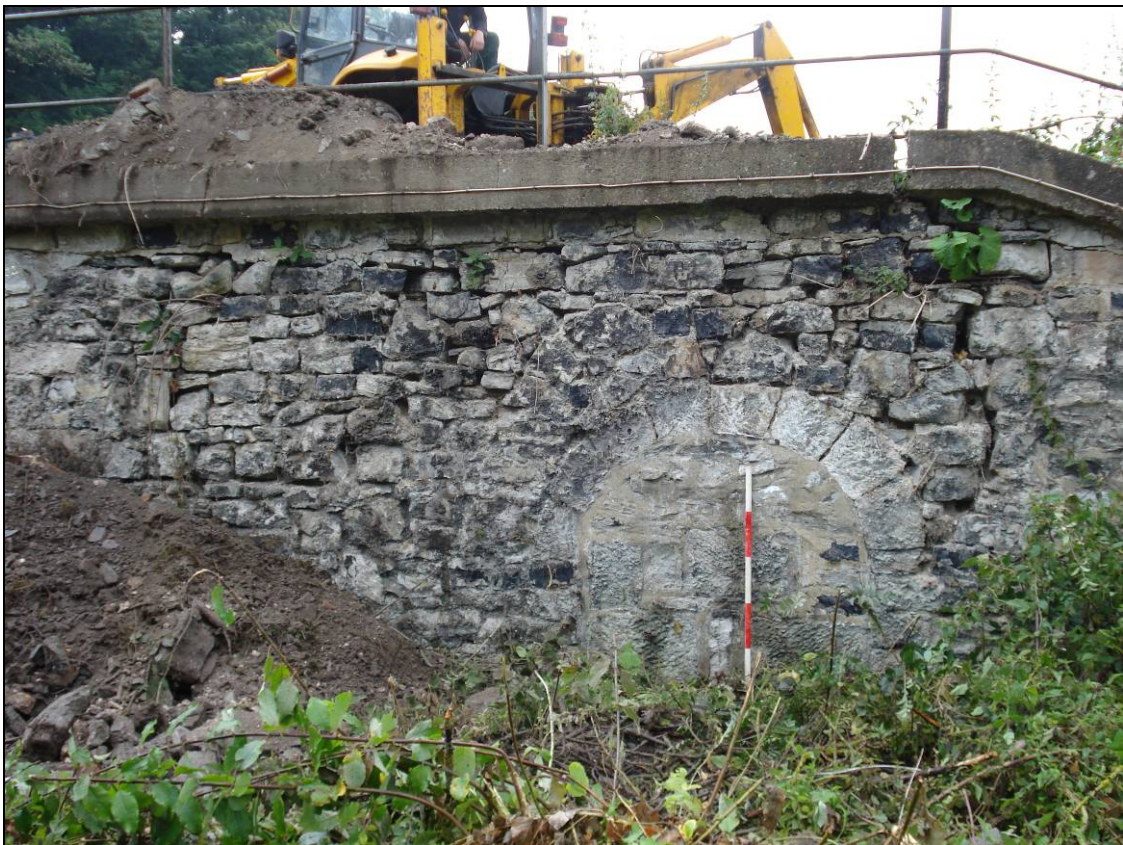
Figure 8: Arched opening of a former boiler adjacent to the stack behind the wall, looking west (scale 1m)

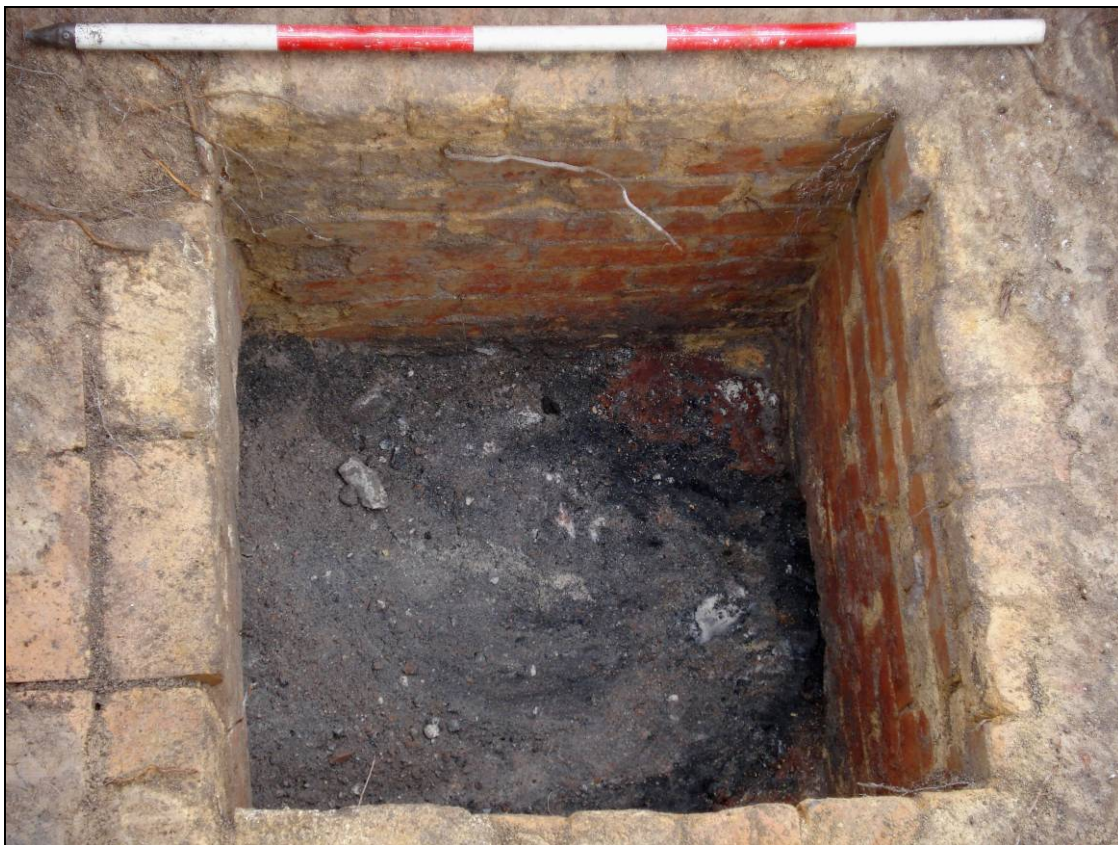
Figure 9: Ashy deposit (106) inside chimney stack, looking south (scale 1m)

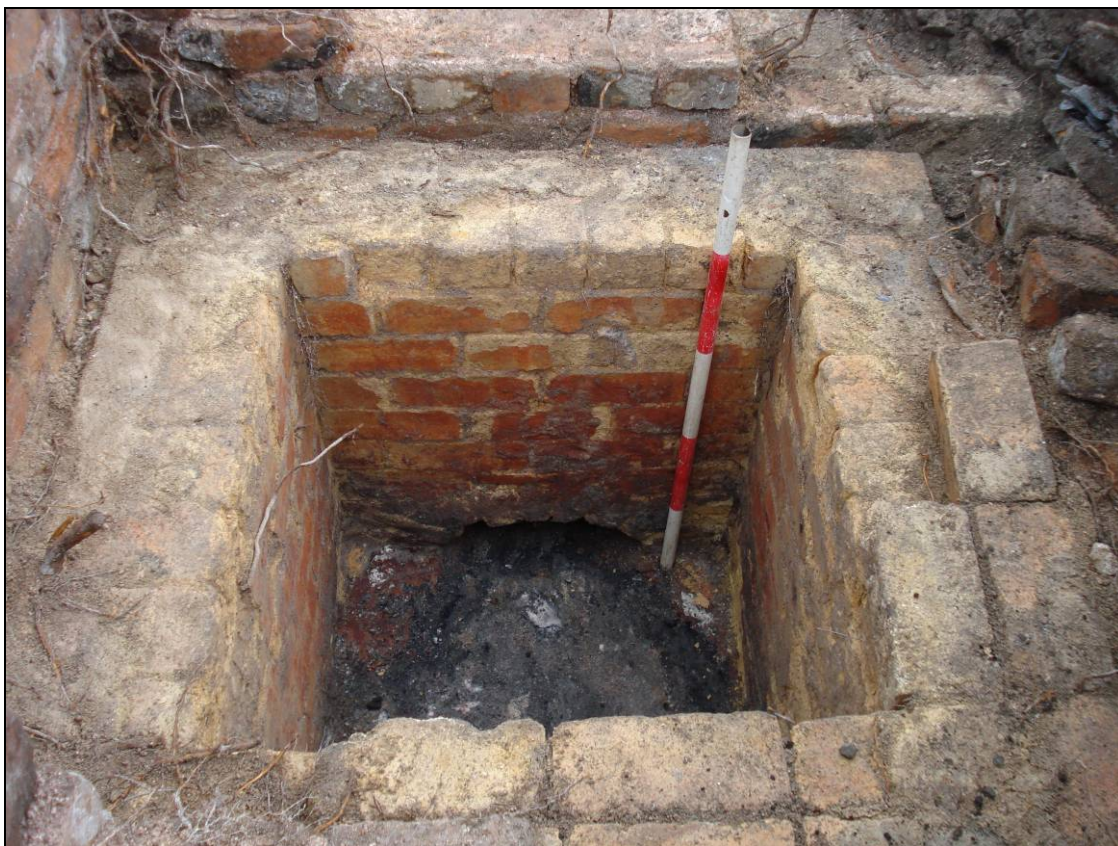
Figure 10: Detail of arched vent in the western wall (scale 1m)

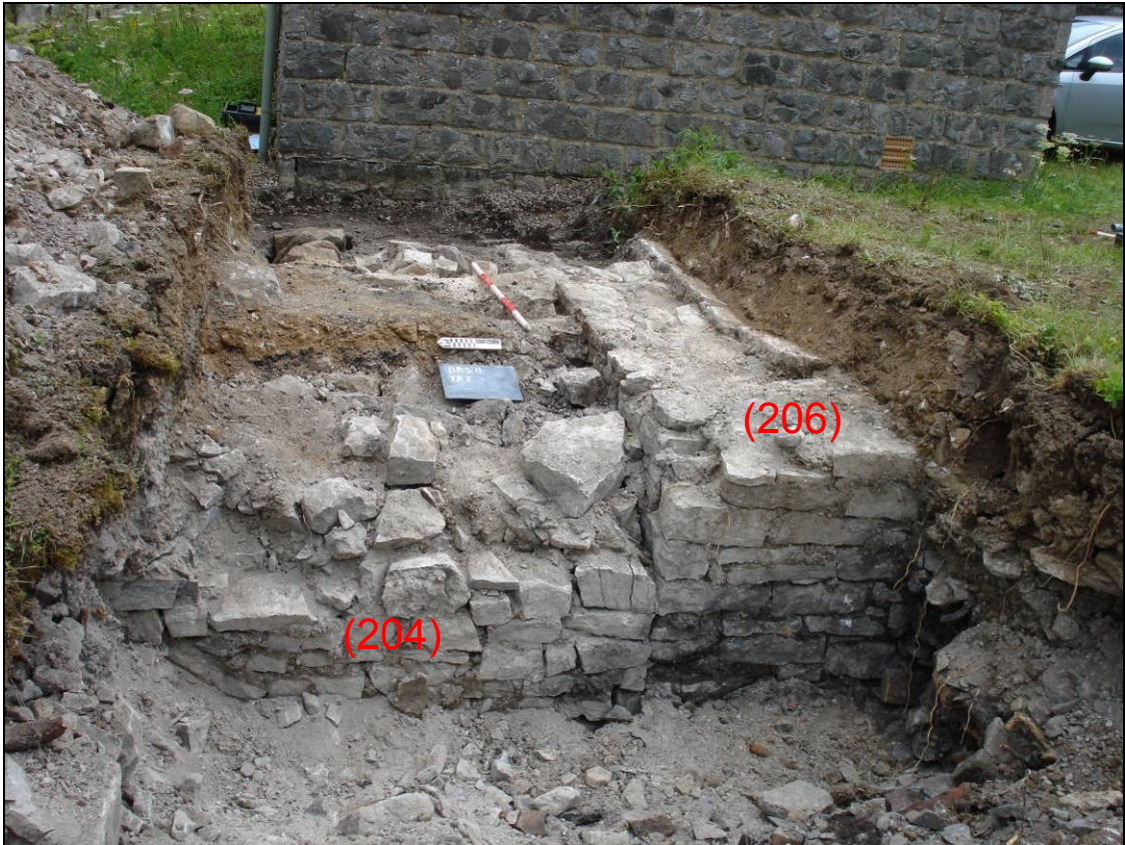
- 5.6 Trench 2 measured 6.50 metres in length (E/W), 2 metres in width (N/S) and reached an overall depth of *c.* 500mm and a maximum of 1.40 metres at the western end (Fig. 11). The trench was located across the proposed development area adjoining the western wall of an existing single-storey building.

- 5.8 An east/west wall (206) was revealed along the southern edge of the trench. The wall returns southwards, forming a north-west corner (Fig. 11). An associated internal floor (207) was also observed immediately next to the edge of the trench (Fig. 12). The outer side of the N/S return of wall (206) was excavated to a depth of 1.40 metres BGL, exposing a maximum of ten courses. The uppermost course was encountered at 400mm BGL. The wall is constructed with roughly hewn limestone elongated blocks (*c.* 350mm x 90mm x 20mm), built to courses and bonded with white lime mortar. Floor (207) appears to be made of lime ash compressed screed. It is possible that the floor might have been a secondary construction, as the initial floor may be located substantially lower as the exposed masonry (206) does not seem to be a foundation wall; instead it appears to indicate a standing wall of a building.

Figure 11: General view of trench 2, looking east (scale 1m)

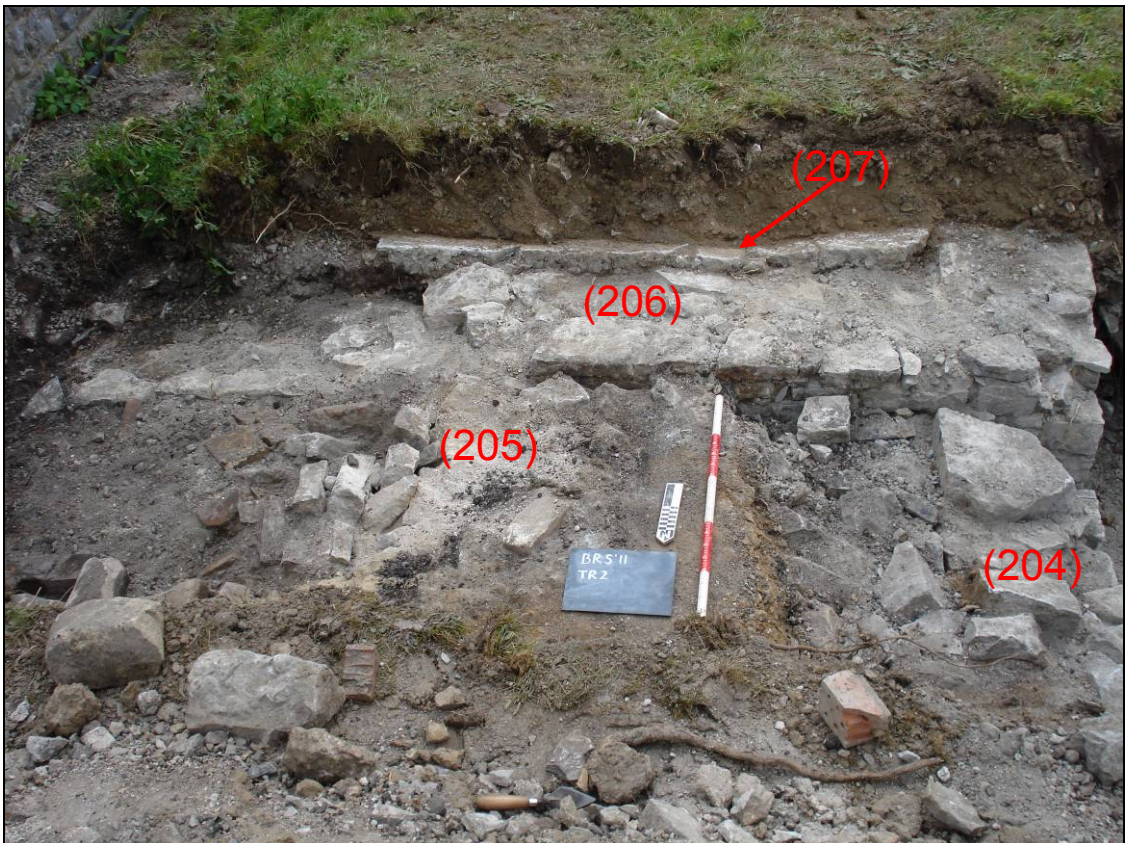
- 5.9 The outer northern side of structure (206) was abutted by an additional N/S wall (204) positioned against the corner of (206) and possibly by an equivalent wall (205) *c.* 1.75 metres to the east (Figs 11 and 12). The former wall consists of unhewn angular limestone rubble bonded with coarse lime mortar to irregular courses; and the latter was not excavated and only the upper course was partially noticed which is comparable to (204).

Figure 12: Trench 2, looking south (scale 1m)

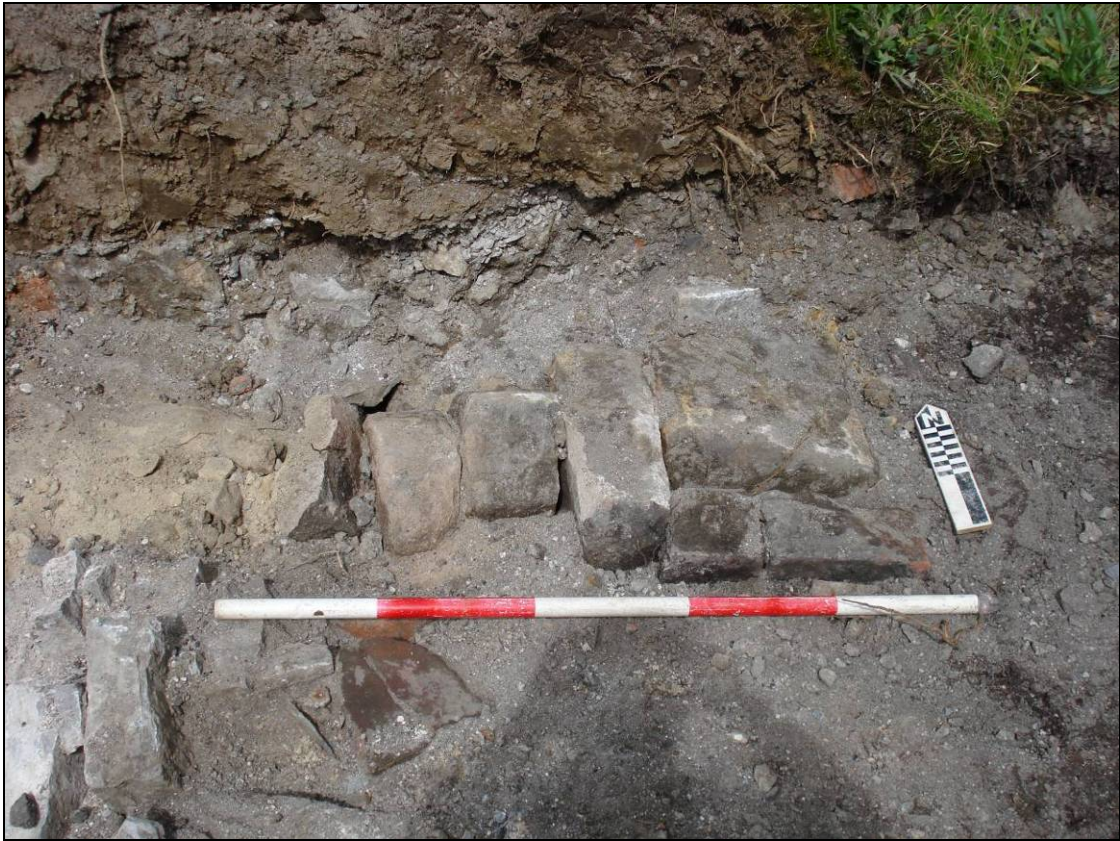
- 5.11 Amongst the rubble within the made-ground layers, a group of several sandstones (210) situated around the north-eastern side of the trench, may be the remains of a possible structure such as a culvert or similar chamber-like feature, as voids beneath the stones were observed (Fig. 13). This possible feature was not excavated.

Figure 13: Detail of possible structure 210, looking north (scale 1m)

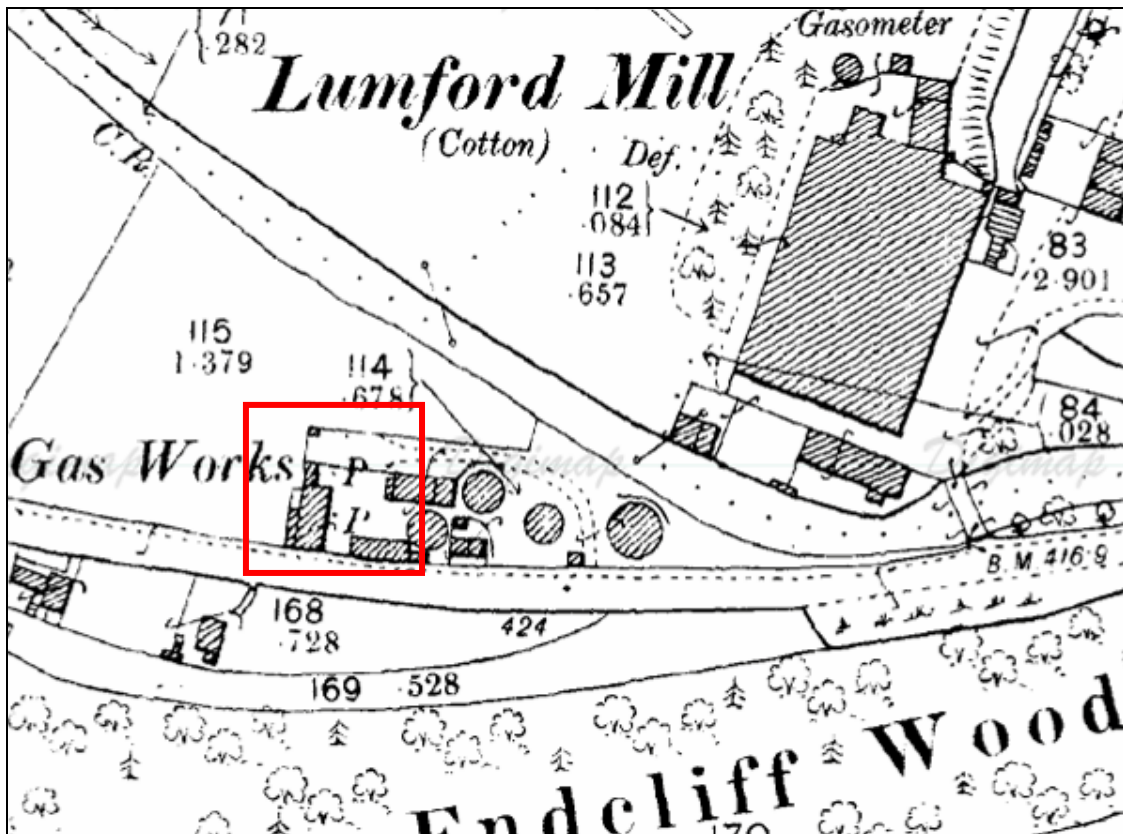
- 5.12 Structure (206) appears to be the corner of a large N/S building depicted in the 1898 Ordnance Survey map, and the abutments (204) and (205) may represent a northern extension indicated in the same map (Fig. 14).

Figure 14: Extract of the 1898 OS map of Bakewell, showing the proposed development area (red box)

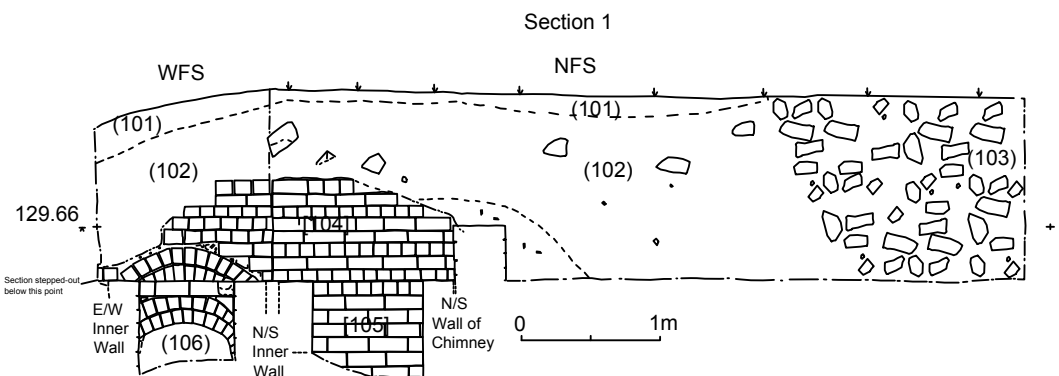
| <p>Archaeological Research Services Ltd Portland Square Bakewell Derbyshire DE45 1HB</p> | <p>Figure 15: Trench 1 Plan and sections</p> | | |

- 5.2 Trench 1 measured *c.* 6 metres in length (E/W), 2 metres in width (N/S) and reached an overall depth of 1.30 metres. The trench was located across the northernmost end of the proposed development area, between a boundary wall to the west and a retaining wall to the east.
