## An Archaeological Watching Brief at Bridge St., Morpeth

**ARS Ltd Report 2012/16**  
March 2012

*In January 2012 Archaeological Research Services Ltd were commissioned by Northumbrian Water Ltd to undertake an archaeological watching brief at Bridge St., Morpeth in Northumberland. The watching brief involved the monitoring of groundworks associated with the renewal of water main infrastructure along Bridge Street and in the area of the marketplace.*

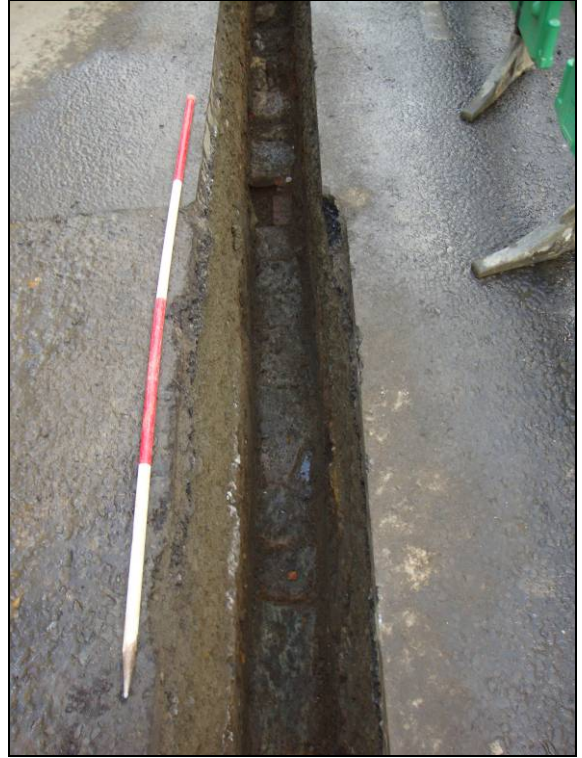
A section of stone and brick lined drain running along the  
base of the trench on Bridge Street

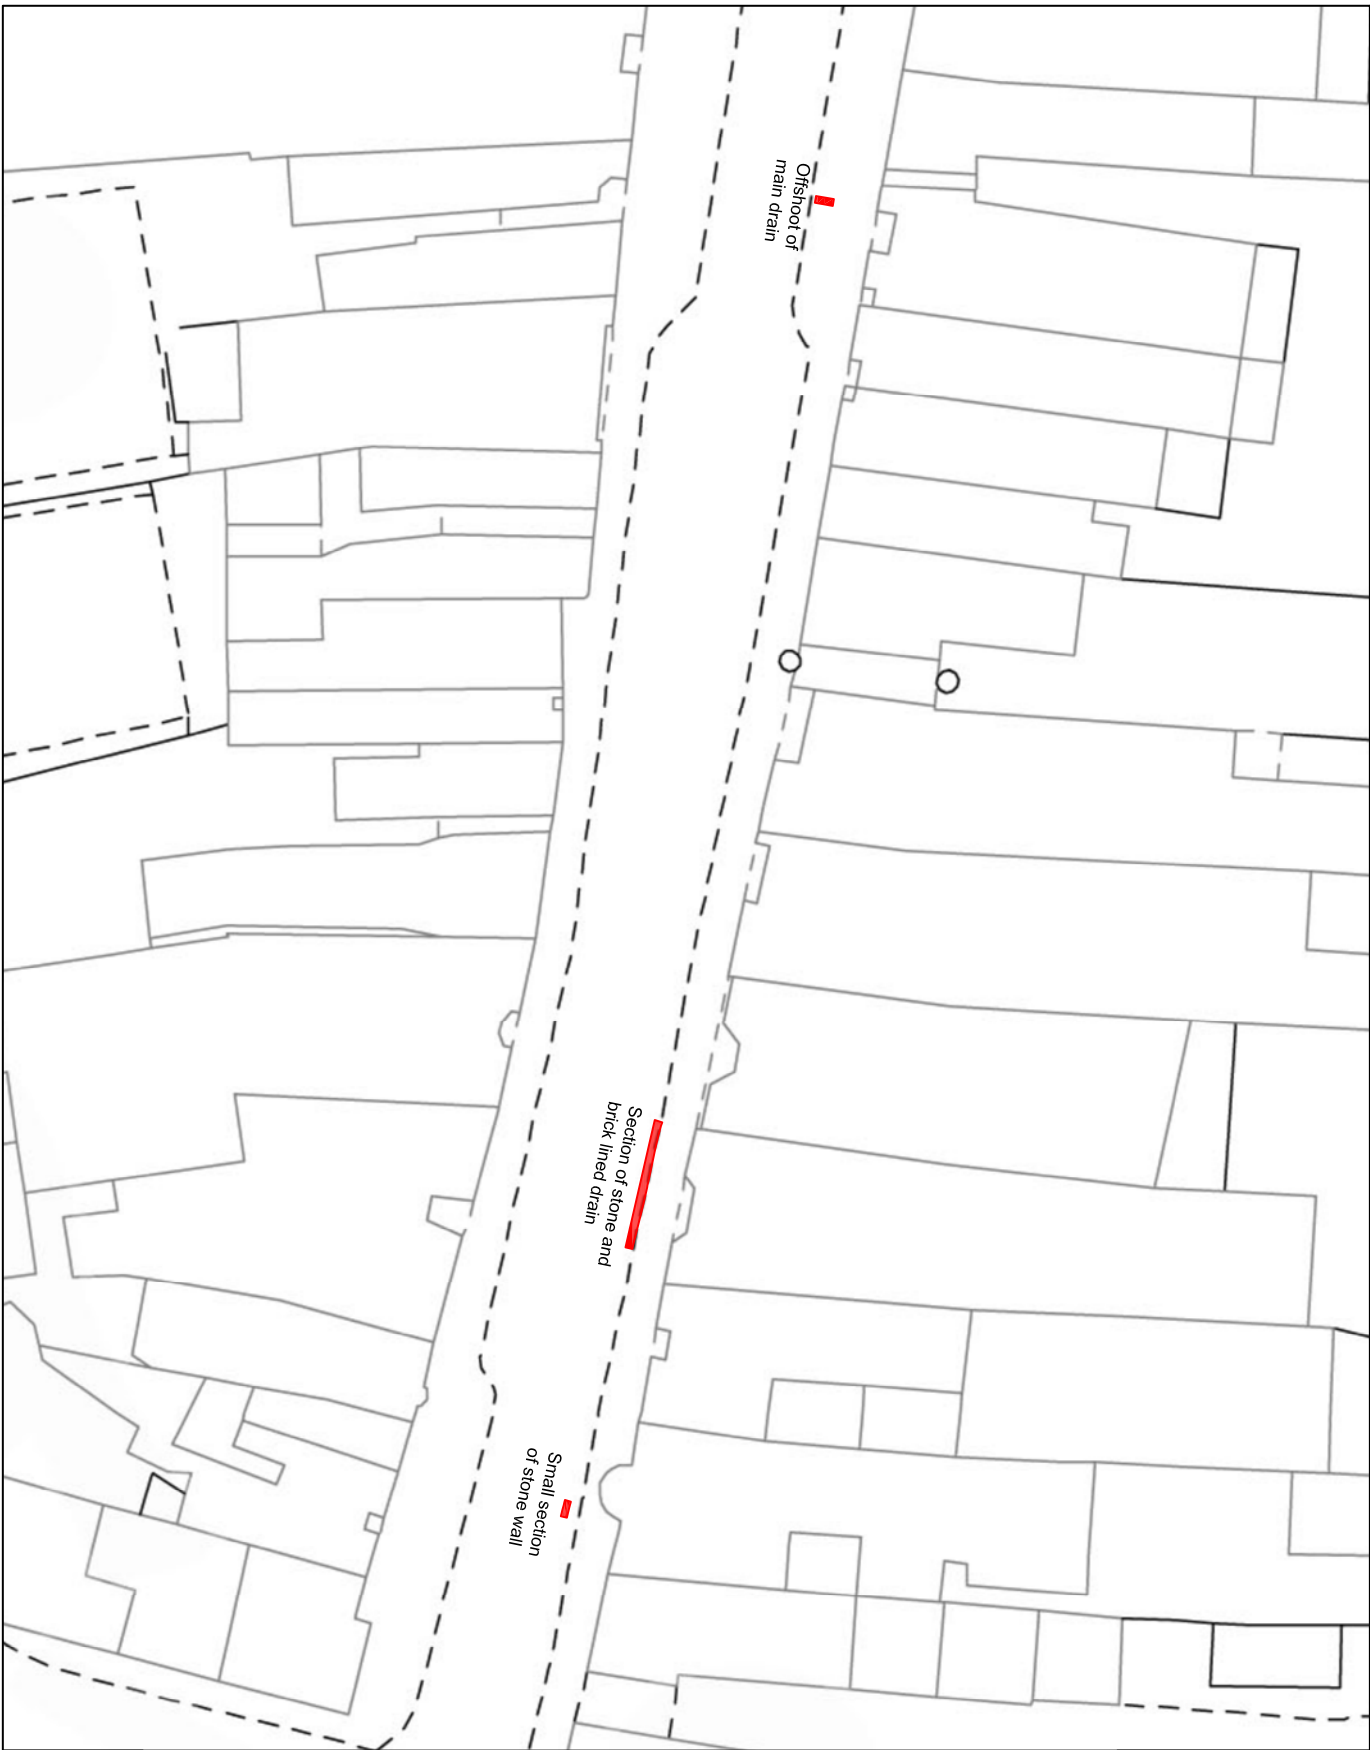
Figure 2:

A plan of Bridge Street in Morpeth showing the locations of recorded archaeological features

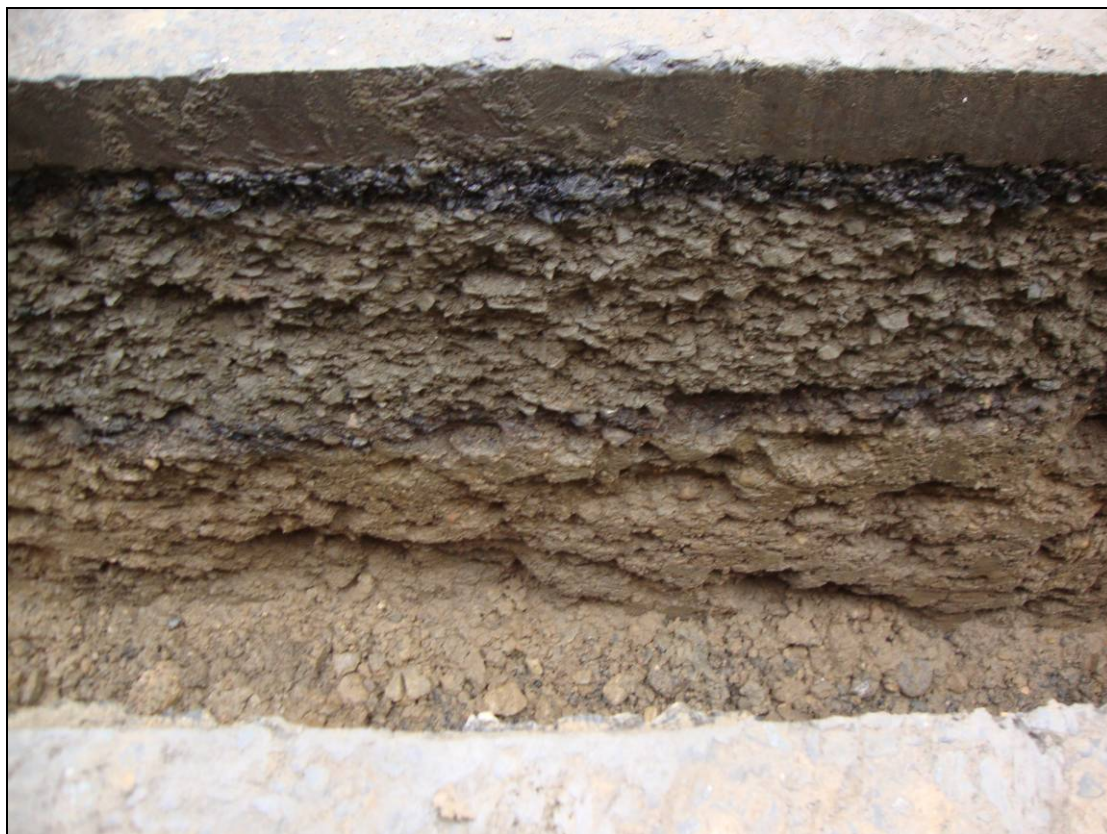
4.1. The stratigraphy of the trench along Bridge Street varied from the eastern end to the western end. Towards the eastern end of Bridge Street, the track was dug through road tarmac (001) with a depth of 0.1m. Below this was the makeup of the modern road consisting of grey angular stone chippings (002) with a depth of 0.35m. A previous road surface consisting of a thin layer of tarmac (010) was observed below the modern road makeup. Orange/yellow clay made ground (003) existed with a depth of approximately 0.5m below the previous road surface and above brown/black natural alluvial clay (004) that continued beyond the limit of the excavation (fig.4). This series of deposits appeared to indicate that the western extent of Bridge Street has been successively raised in level.

Figure 4. Stratigraphy of the trench towards the eastern end of Bridge Street

5.2. The difference in stratigraphy between the western end of Bridge Street and the eastern end is likely due to successive levelling of the roadway at various points in the past. This has led to the apparent removal of deposits in the area surrounding the marketplace and the building-up of deposits at the eastern extent of Bridge Street. The nature of the deposits would therefore suggest that a greater potential for the survival of archaeological remains exists towards the eastern extent of Bridge Street, although any remains are likely to be significantly affected by successive service and drainage works.

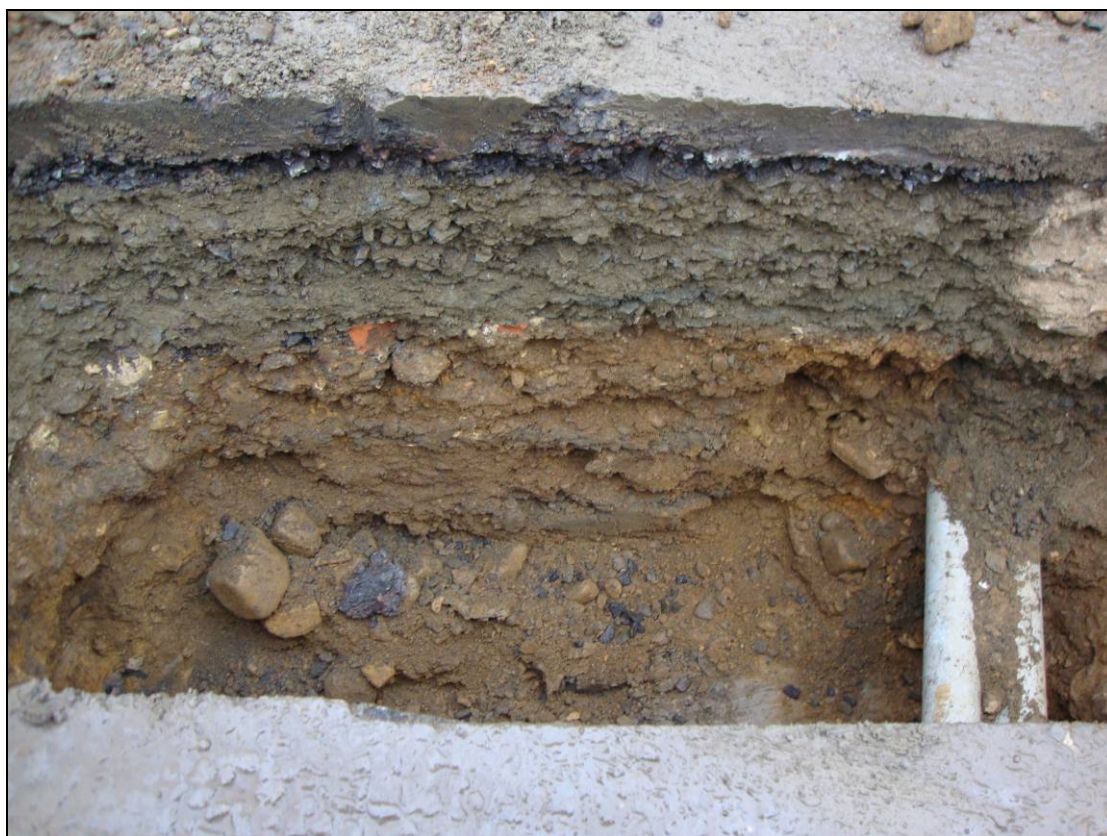
4.2. Towards the western end of Bridge Street the majority of the track for the new water supply was dug through a layer of road tarmac (001) with a depth of 0.1m. Below this was the modern road makeup consisting of grey chippings (002) with a depth of 0.35m and then natural sand and cobbles (011) with a depth of 0.5m. Natural orange/yellow alluvial clay (004) existed below this and continued beyond the limits of the excavation (fig.5). In the area immediately adjacent to the marketplace the ground appeared to have been levelled or lowered meaning that the modern layer of road tarmac (001) and the modern road makeup consisting of grey chippings (002) sat immediately above the natural alluvial sand and cobbles (011).

Figure 5. Stratigraphy of the trench towards the western end of Bridge Street

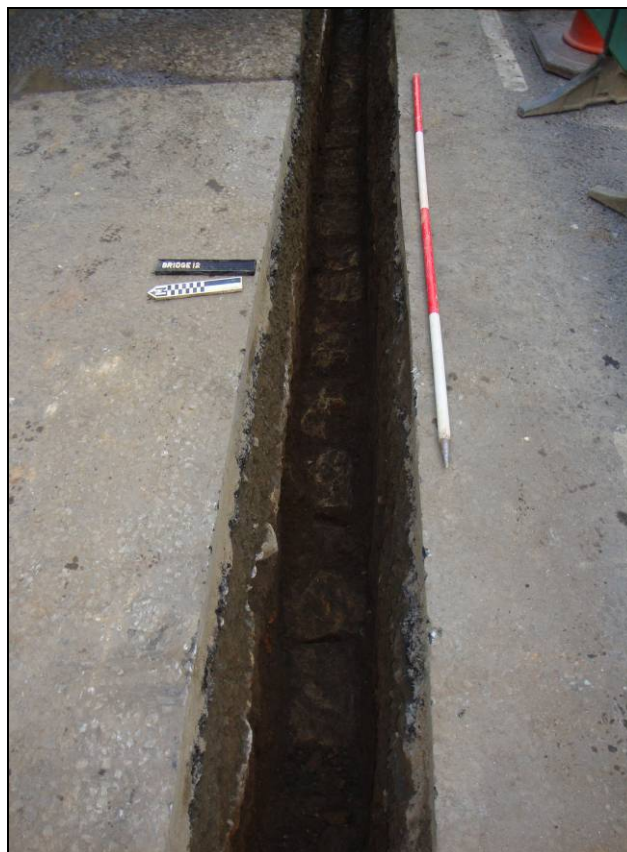
4.3. During the watching brief a series of flat stones were discovered running along the base of the excavated track approximately 1.2m deep. Upon inspection these stones were found to be capping a brick lined drain that was running along Bridge Street. A typical section of drain was cleaned and recorded during the watching brief and was centred roughly at NZ 19987 85929. Flat capstones measuring on average 0.3m x 0.3m x 0.04m (005) were sitting on top of two rows of two courses of red hand-made bricks (012) that were lining the sides of the drain (figs.6 and 7). The bricks measured 0.23m x 0.12m x 0.06m and were laid with a stretcher bond and no mortar between them, just sand. These bricks themselves were sitting upon more flat stones that formed the base of the drain (013). A repair to the drain was also observed, whereby a section of drain approximately 1m in length had been exposed, partially deconstructed, and then replaced roughly re-using the original materials (009) (fig.8).

Figure 6. Section of trench showing stone lined drain running along the base of the trench. Scale = 2m.

5.1. The stone lined drain and associated offshoot discovered on Bridge Street are thought to date to the Post-Medieval period. The bricks used to line the sides of the drain were not produced any earlier than the 19<sup>th</sup> century. The small section of stone wall also discovered in the trench is believed to date to the late 19<sup>th</sup> century. The clay pipe, pottery and glass all discovered in and around the wall confirm this date.

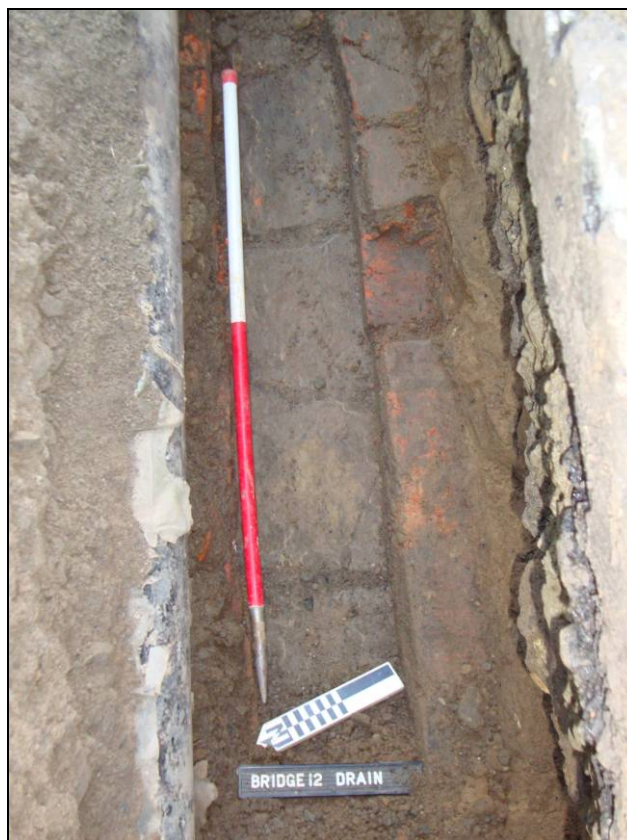
Figure 7. Bricks and stones lining sides and base of drain. Scale = 1m.

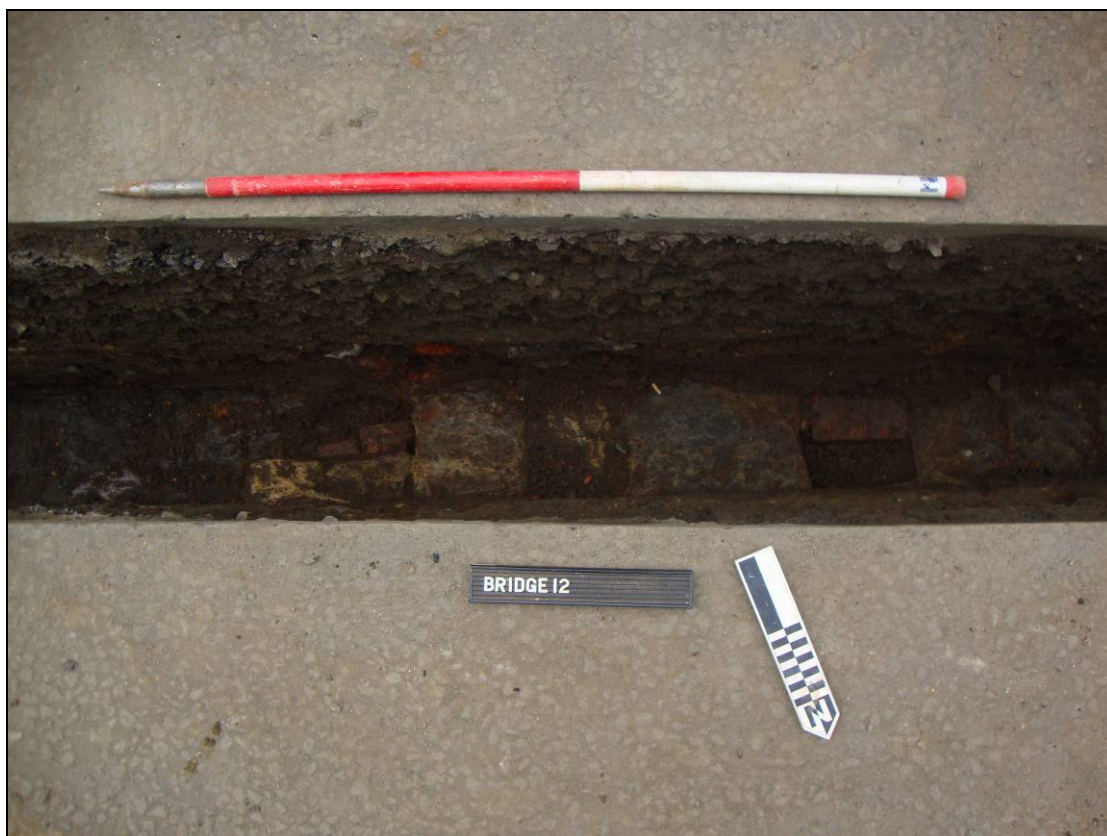
Figure 8. Photograph showing the repair to the drain using bricks. Scale = 1m.

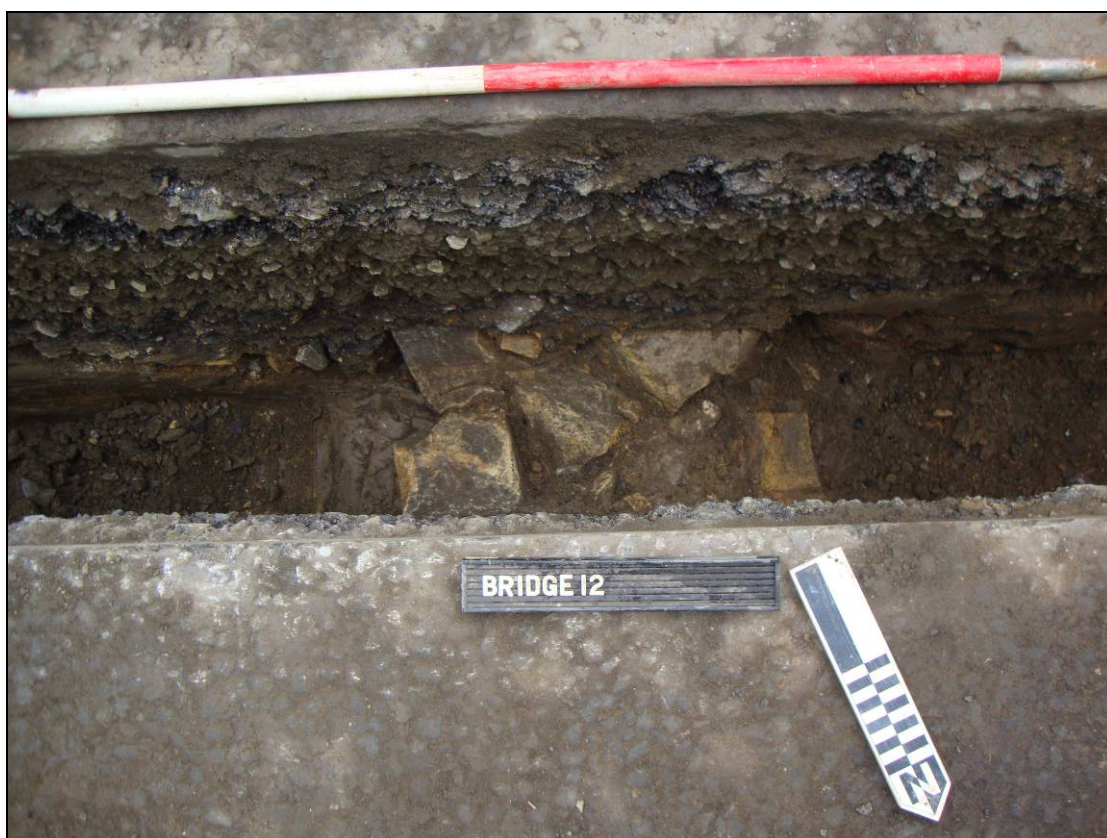
4.4. Also discovered during the watching brief was a small section of stone wall (fig.9). Previous groundworks had destroyed most of the wall, however, so that only 2 courses of the wall foundation remained. The wall was constructed using roughly squared sandstone blocks of various sizes that were resting upon a large flat sandstone slab (006). There was a possible sandy mortar between the stones that had degraded to a sandy material (007). A number of finds were recovered from the material both in and around the stones. These included lengths of clay pipe stem, sherds of pottery and pieces of glass.

Figure 9. The small section of sandstone wall foundation. Scale = 1m.

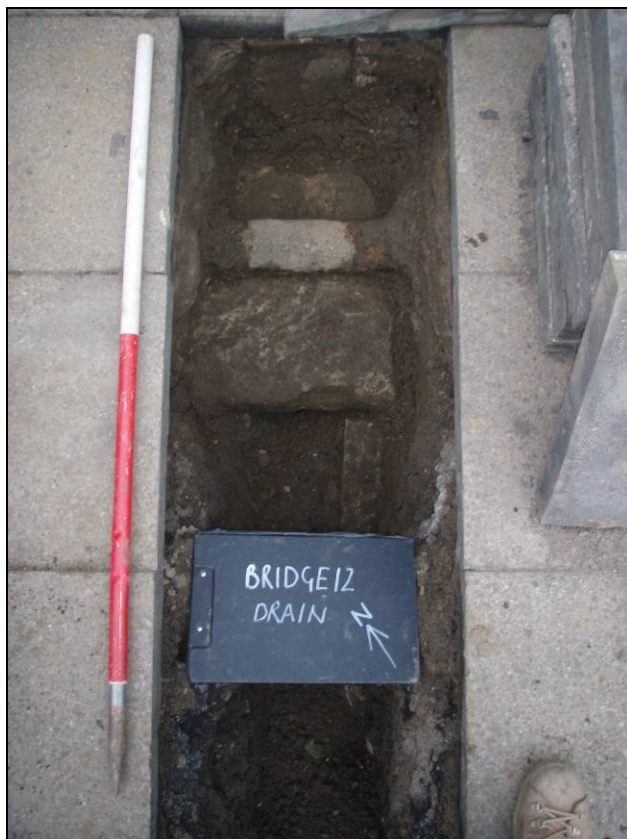
4.5. In one of the many service trenches that were dug at right angles from the main track towards the building frontages was a small section of stone built drain. This consisted of a large flat sandstone slab sitting on top of another slab (014) that had been placed on its side. It is believed that this was an offshoot of the main drain (fig.10).

Figure 10. Small offshoot of drain. Scale = 1m.
