An Archaeological Watching Brief at Dark Lane, Morpeth

ARS Ltd Report 2012/17 March 2012

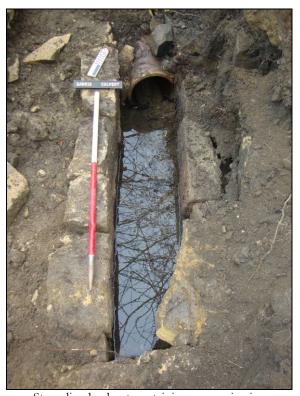
Stone lined culvert containing a ceramic pipe

presumably where it had been repaired or diverted at some point in the past. This was evidenced by the fact that the stones of the culvert seemed to have been disturbed and replaced where the ceramic pipe was inserted. The pipe then continued beyond the limit of the excavation on a different alignment to that of the original sandstone culvert structure.

5.1. The stone lined culvert containing the ceramic pipe that was discovered in the trench on Dark Lane was still in use and had fresh water running through it. The original culvert is thought to date to the 19th century, judging by the facing of the stones, while the ceramic pipe that is thought to be a repair or diversion probably dates to the early 20th century.

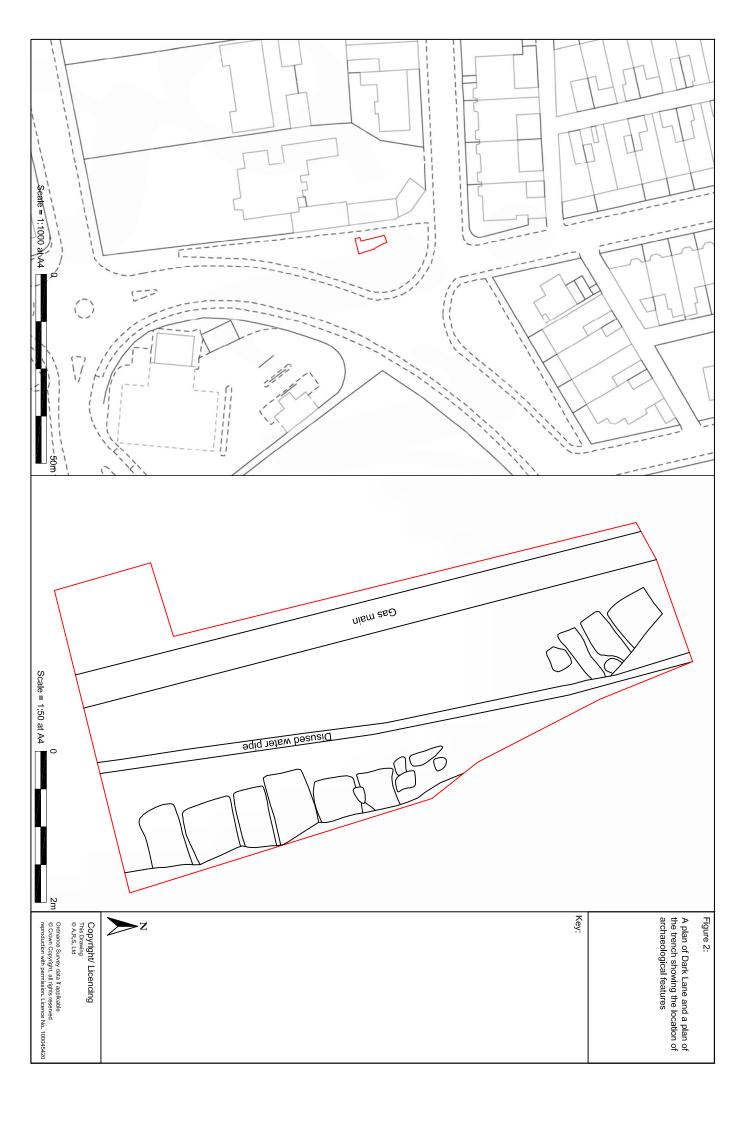
1.	Figure showing site location	5
	Plan of Dark Lane showing trench location and archaeological features	9
3.	Section of trench showing exposed sandstone blocks and ceramic pipe	10
4.	Close-up photograph showing sandstone blocks and ceramic pipe	10
5.	Sandstone capping stones covering culvert	11
6.	Stone lined culvert containing ceramic pipe.	11

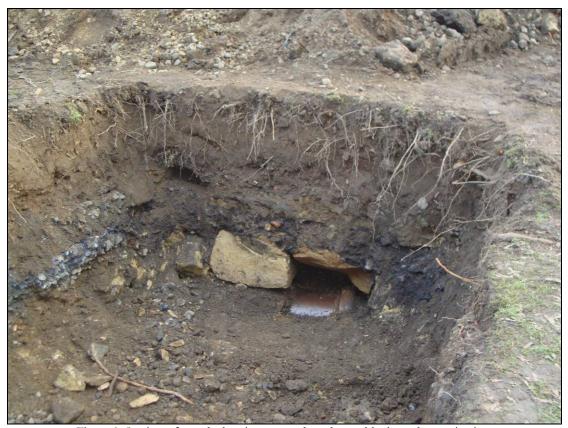
Figure 3. Section of trench showing exposed sandstone blocks and ceramic pipe.

4.1. The trench on Dark Lane was dug through turf and topsoil (001) that had a depth of 0.7m. The topsoil was a mid brown clayey silt with a fine texture and was sitting above a layer of tarmac from a previous road surface (002). Underneath the tarmac was a layer consisting of cobbles and bricks (003) with a depth of 0.25m. Discovered in the eastern side of the trench was a stone lined culvert which, for part of its length, contained a large brown ceramic pipe. The culvert was capped by large, roughly squared, yellow sandstone blocks with an average size of 0.65m x 0.5m x 0.2m. More yellow sandstone blocks, measuring on average 0.38m x 0.15m x 0.18m, lined the sides of the culvert (005) (fig.5). The stones had been roughly faced and were laid with a stretcher bond. A large ceramic pipe (006) (fig.6) ran along part of the length of the culvert,

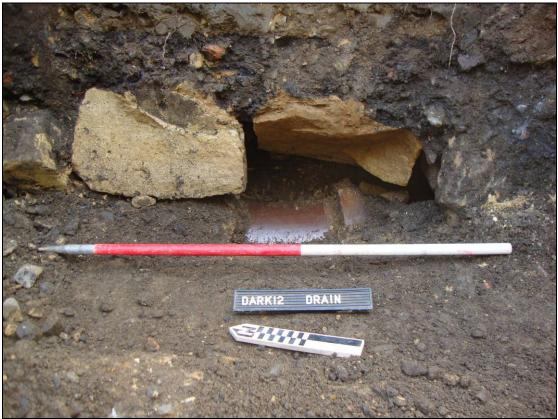
Figure 4. Close-up photograph showing sandstone blocks and ceramic pipe. Scale = 1m.

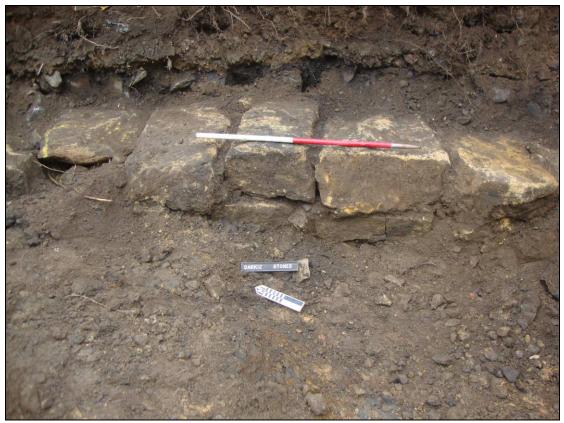
Figure 5. Sandstone capping stones covering culvert. Scale = 1m.

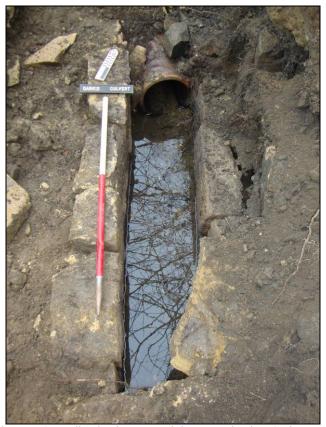
Figure 6. Stone lined culvert containing ceramic pipe. Scale = 1m.
