**An Archaeological Building Recording  
at Cleadon Infant's School, Cleadon, South  
Shields.**

**Archaeological Research Services Ltd**  
**Report No. 2012/39**  
June 2012

**Archaeological Research Services Ltd Report 2012/39**

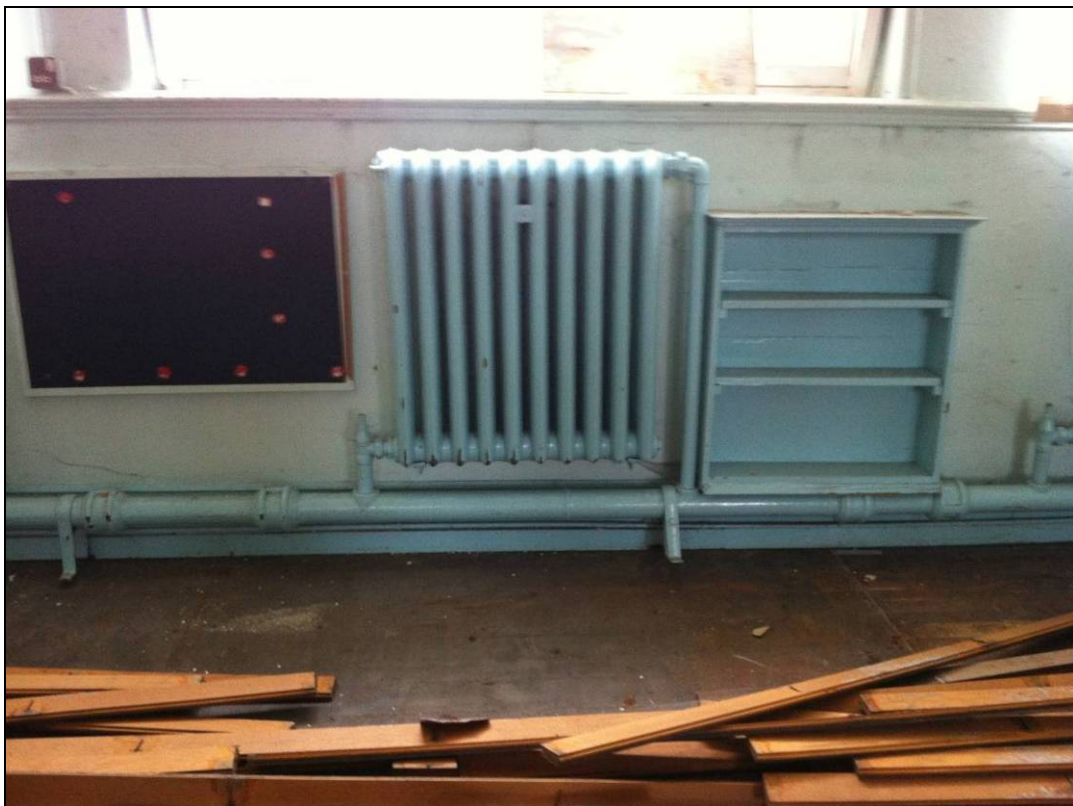
Figure 3: One of the original cast iron radiators in one of the classrooms.

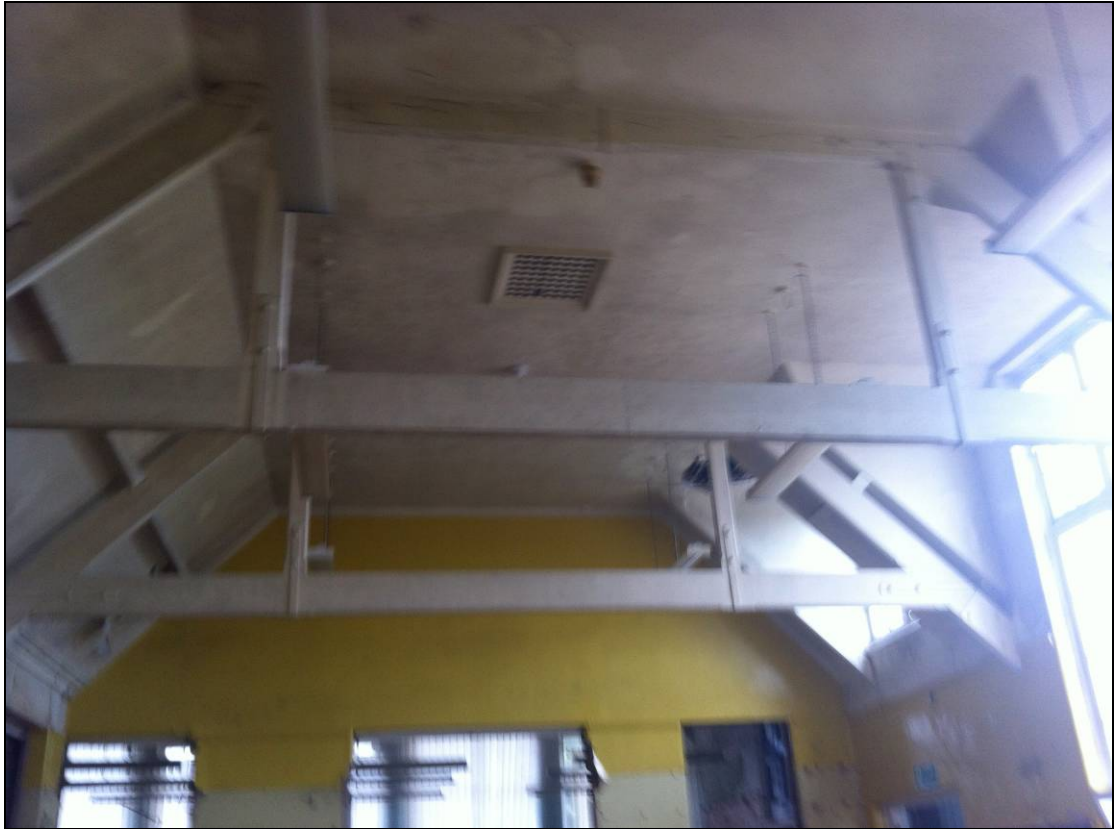
Figure 6: Detail of the ceiling in the main assembly hall, looking west

At the time of the building recording parts of the building had been demolished and all interior fixtures and fittings had been removed. However, some photographs, shown below, were taken by the client before and during the demolition works. These photographs show cast iron radiators, with external pipe work, in the main assembly hall and in classrooms (Figs. 3 and 8). The building's internal doors originally had windows with six panes above them and on one photograph the main assembly hall ceiling is shown (Fig. 6).

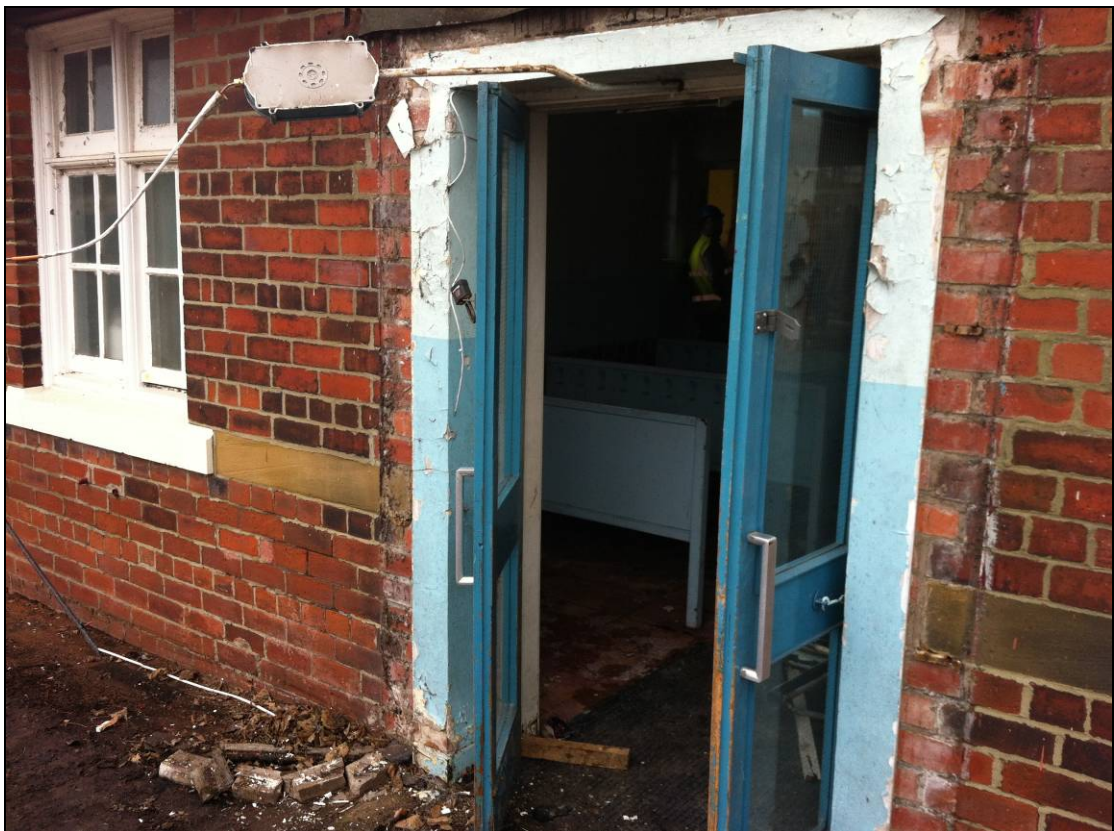
Figure 7: The western front porch, after demolition. Note coat hooks inside.

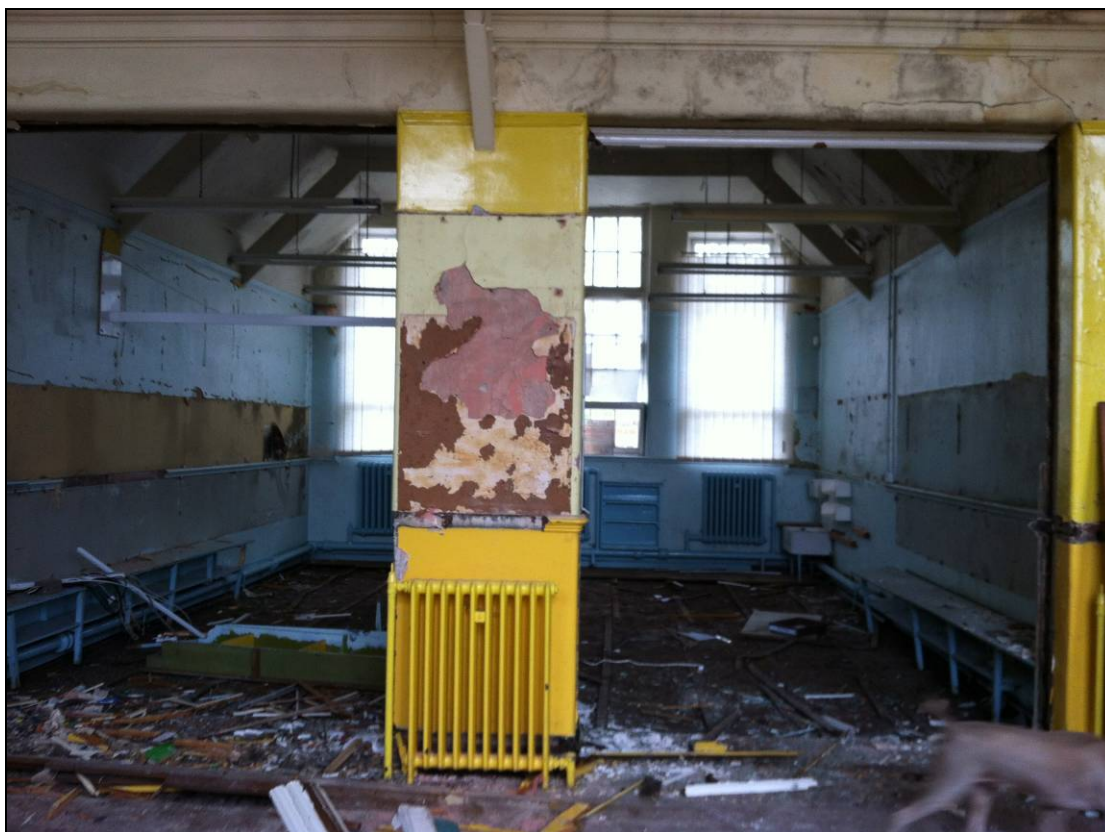
Figure 8: A view into one of the classrooms (Room 8) from the main hall. Note the cast iron radiators below the windows and the benches along the eastern and western walls.

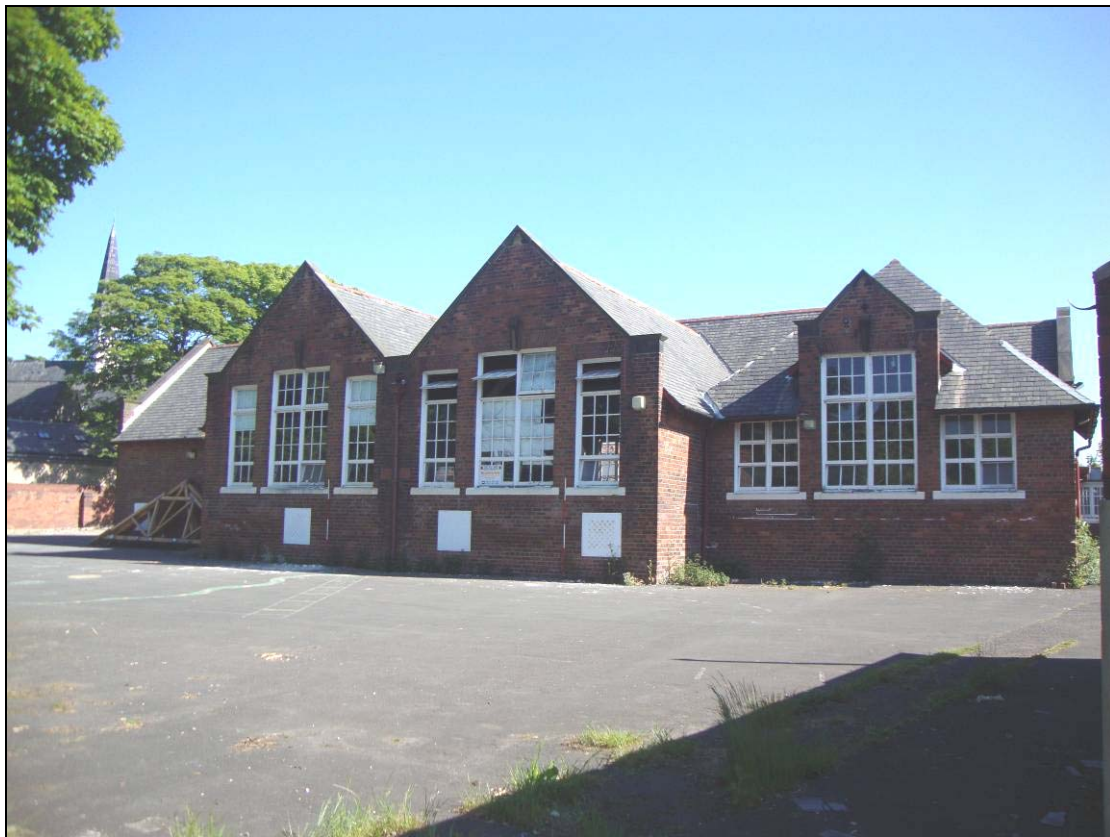
this manner. The window openings are formed with flat arches, in place of lintels, constructed in brick, with decorative sandstone keystones at the centre of the large double windows. The sills of the openings are in chamfered stone and have all been painted. It was therefore not possible to ascertain whether they were cast stone or natural. To the centre of this elevation two matching joined bays project southward from the building effectively forming a double gable topped by parapet walls with flat sandstone coping (see Fig. 15). To the eastern extent of the elevation a matching double window forms a dormer as it projects above the surrounding roofline, with a smaller flanking window to either side. There are also two metal grilles centred on this elevation for internal vents located in the walls of Rooms 7 and 8. This elevation does not exhibit any construction breaks and appears to have been constructed in one phase with no later alteration.

Figure 15: South facing elevation, looking north. Scale = 2m

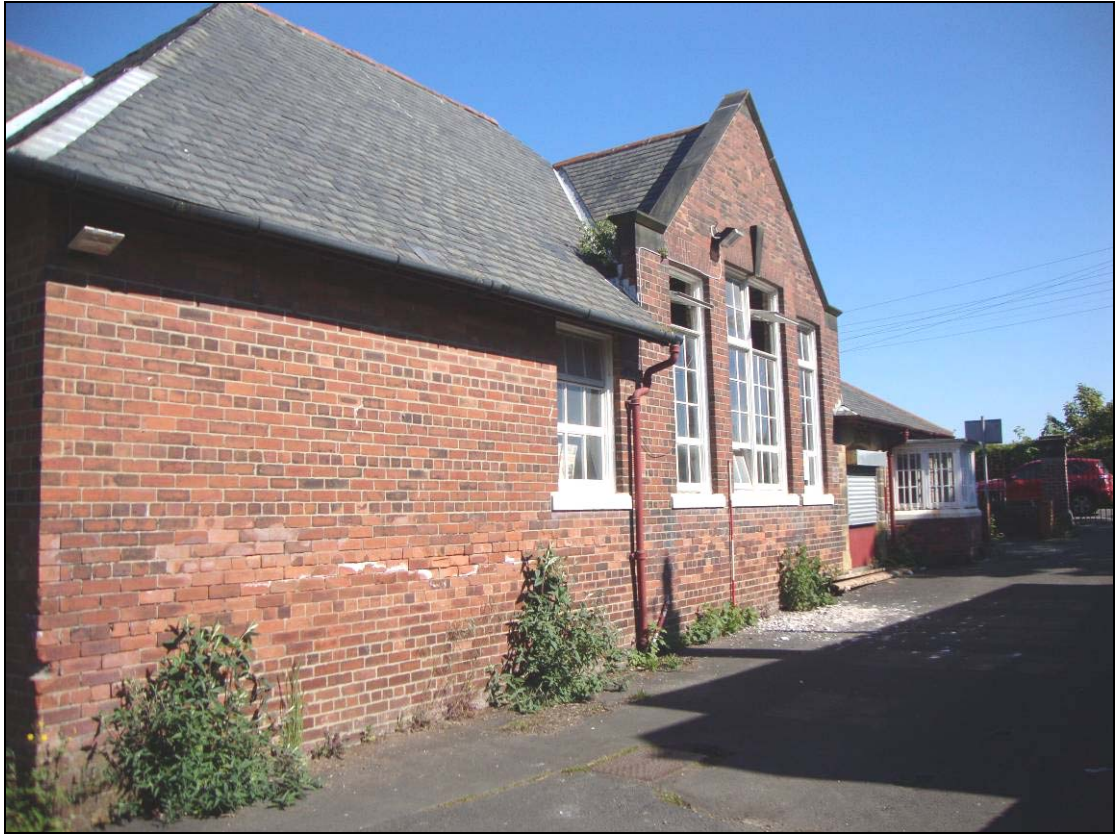
This elevation comprises the east facing elevation of the school building (see Fig. 80). The elevation is constructed of red imperial brick laid in three-course English Garden Wall bond, completed at the roofline of the central projecting gable by flat sandstone coping with sandstone kneelers and decorative keystone in the flat arch over the centre of the large paired window (see Fig. 17). The elevation also comprises five window openings, arranged with a large central window and two smaller flanking windows, a small single window to the south of these, and a canted bay window to the northern extent of the elevation. This arrangement reflects the layout of the rooms within, with Room 10, being a classroom, provided with a set of three windows arranged with a large central window and two smaller flanking windows. The canted bay window would originally have been mirrored at the northern extent of the western elevation, where a blocked opening shows it has been removed, and is placed here to provide wide views from a probable male Masters Room within. This would have been likely due to the position of the room next to the Boys entrance. The opening for the Boys entrance on this elevation is constructed of chamfered sandstone long and short quoins with a moulded step and decorative lintel inscribed with “Boys”, all framing a wide opening that could be seen internally to give access to a small porch area, finished in brown glazed brick. This elevation does not exhibit any construction breaks and appears to have been constructed in one phase with only minor later alterations.

Figure 17: East facing elevation, looking north west. Scale = 2m

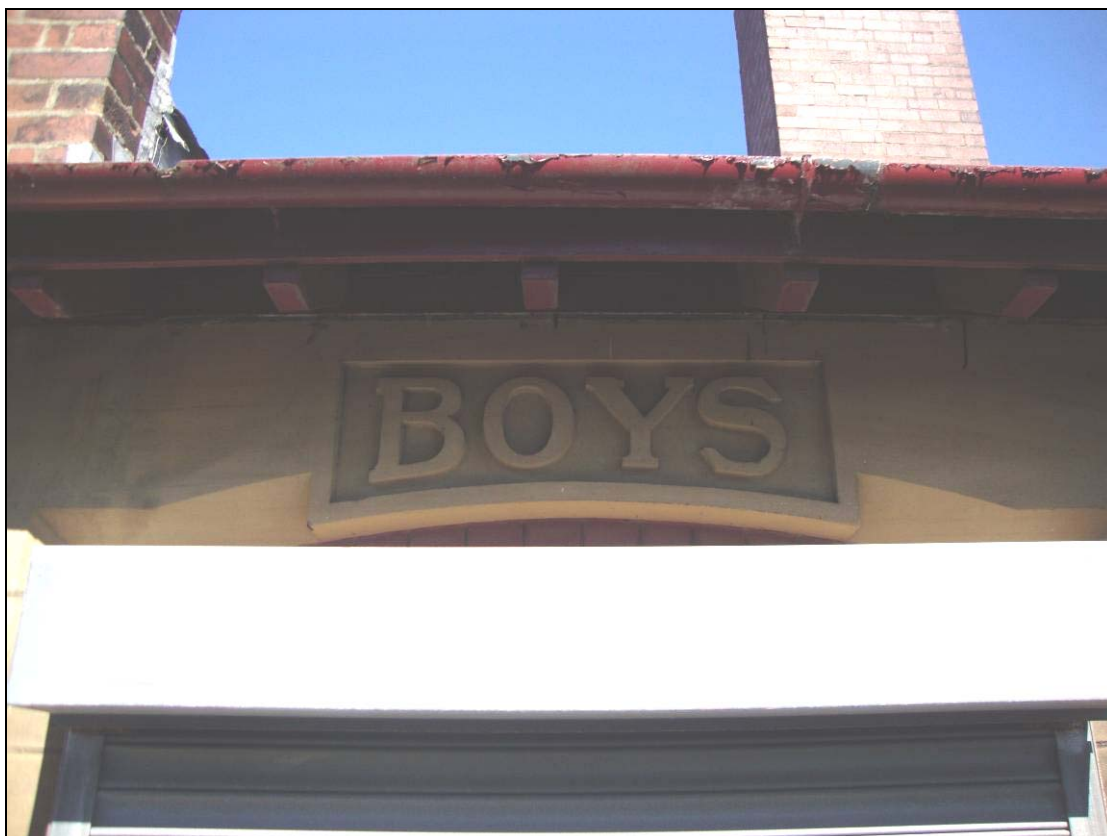
Figure 20: 'Boys' inscription above the blocked doorway into the boys' cloakroom.

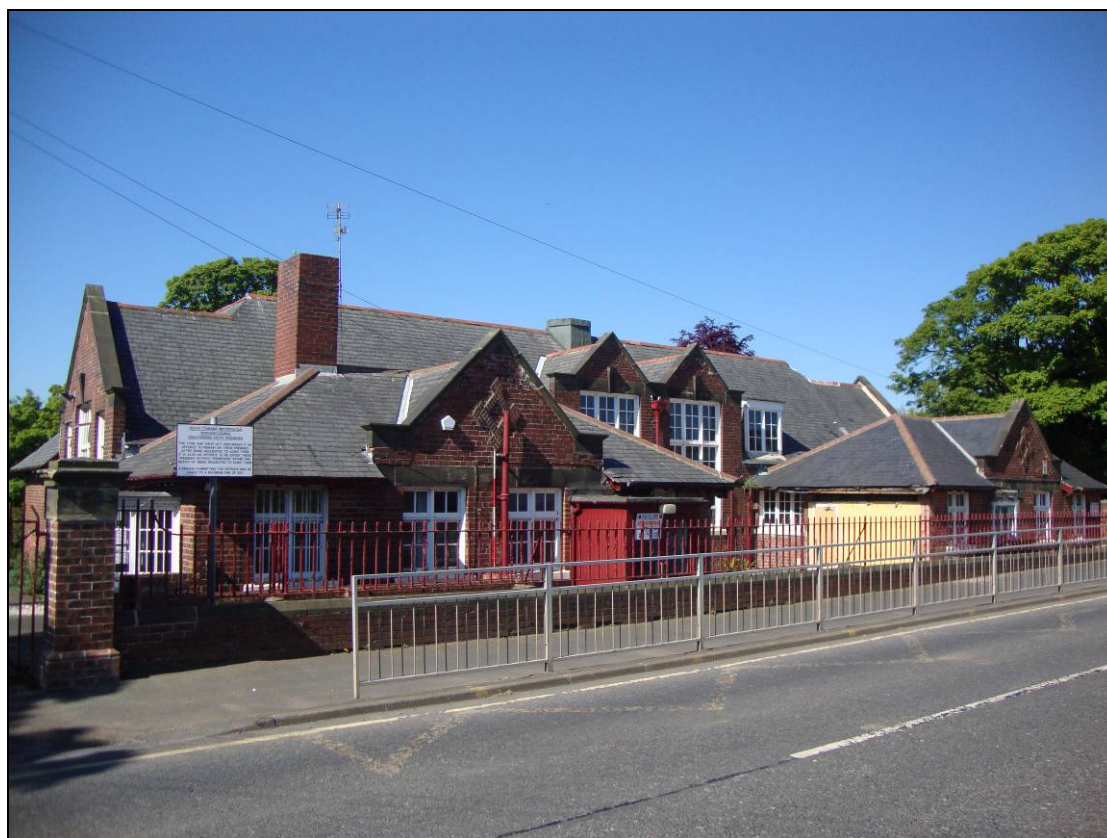
This highly symmetrical elevation comprises the north facing elevation of the school building (see Fig. 80). The elevation is constructed of red imperial brick laid in three-course English Garden Wall bond, completed in part at the roofline by flat sandstone coping with sandstone kneelers and decorative keystones over the centres of the large paired windows (see Figs. 22 and 24). Unlike the other elevations of the building, this principal elevation also comprises two sandstone string courses at sill level and at lintel level. The elevation also comprises 11 window openings, arranged almost completely symmetrically with a large pair of windows to the centre of the elevation, with flanking flat-roofed dormer windows to either side, and four windows to the eastern projecting wing, with three windows to the western projecting wing. The asymmetry in the window openings of the two projecting wings has been caused by the later insertion of a double door with projecting porch to both of these wings (see Fig. 80). The double door to the western projecting wing has made use of a previous window opening to create the opening for the door, whereas the double door to the eastern projecting wing has been inserted between two window openings. At the time of survey the porch to the western projecting wing had been demolished, as had a later extension to the western elevation at its northern extent, which had previously masked the former Girls entrance on that side. Also demolished was a later infill toilet extension to the centre of the north elevation, making use of the recess created by the two projecting wings on this side (see Figs. 25 and 26). This demolition revealed part of the original internally facing elevations of the projecting wings, and allowed the matching windows located here to be viewed (see Figs. 25 and 26). Also noted was the extensive damage caused by the later extension to these elevations, caused by the creation of access to the toilet extension (see Figs. 25 and 26).

Figure 21: North facing elevation, looking south west. Scale = 2m

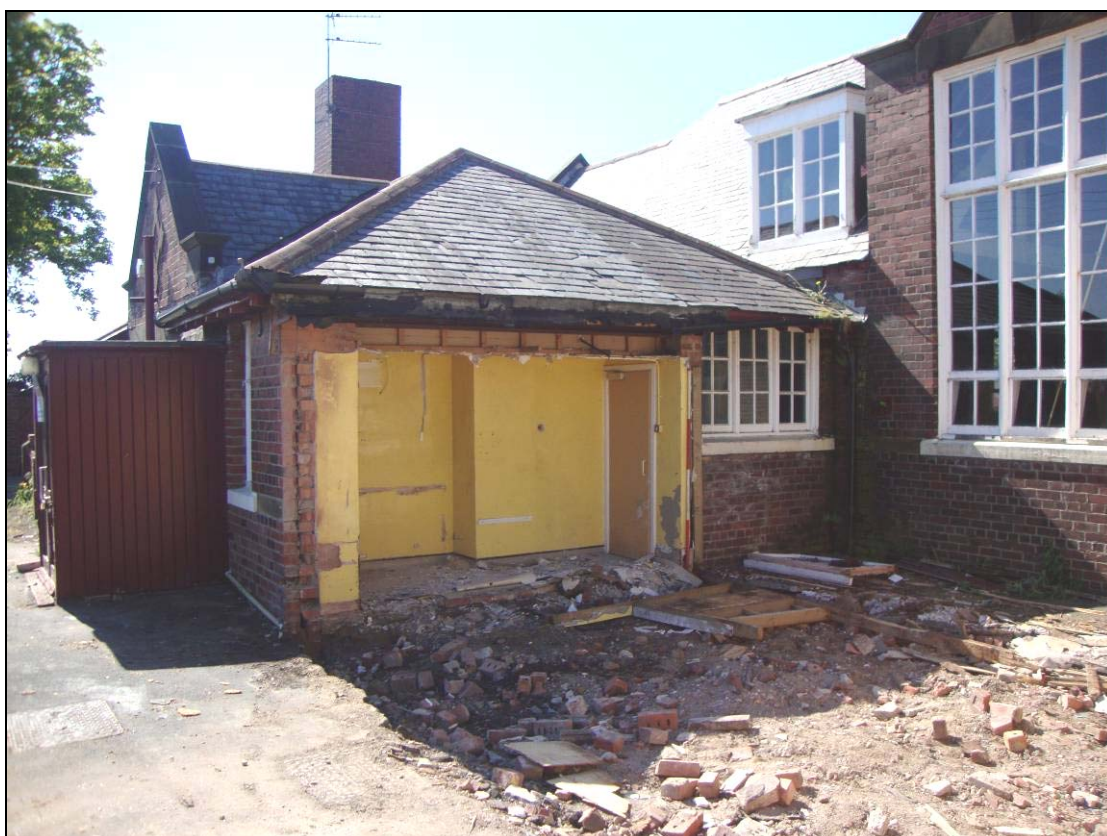
Figure 25: External west facing elevation of Room 11, looking south east and showing where the toilet block has been demolished. Scale = 2m

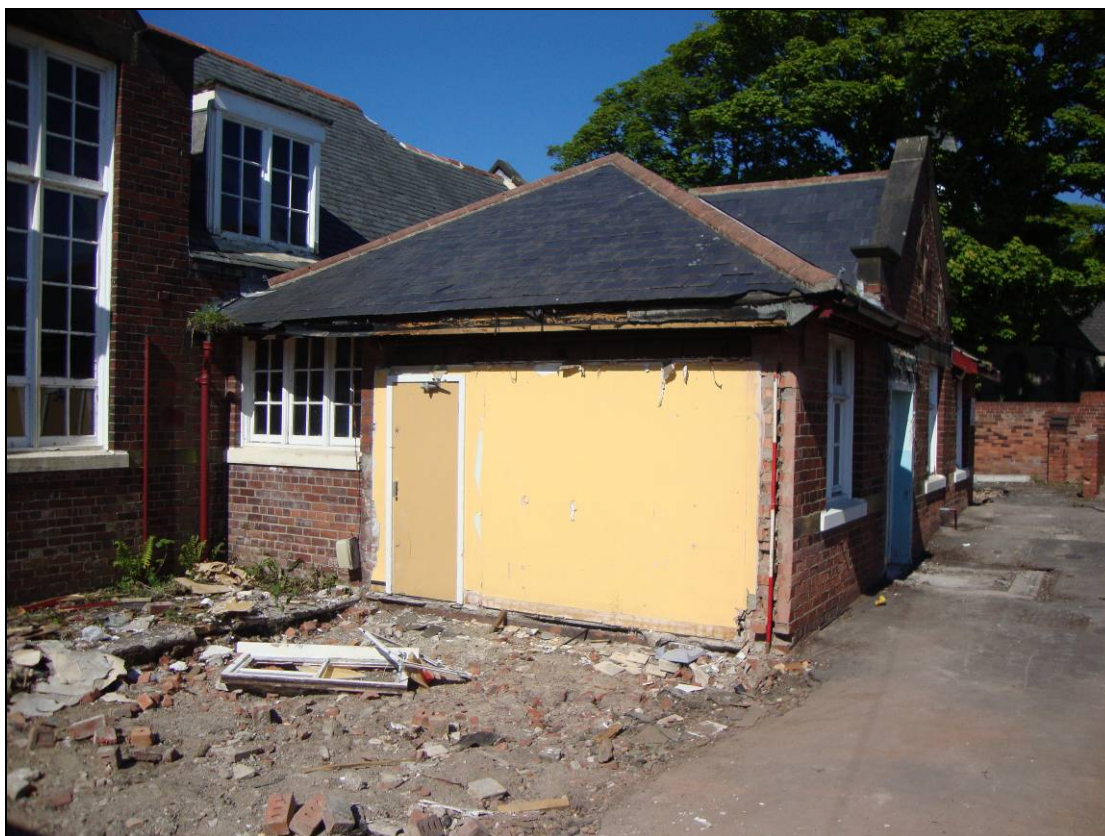
Figure 26: External east facing elevation of Room 1, looking south west and showing where the toilet block has been demolished.

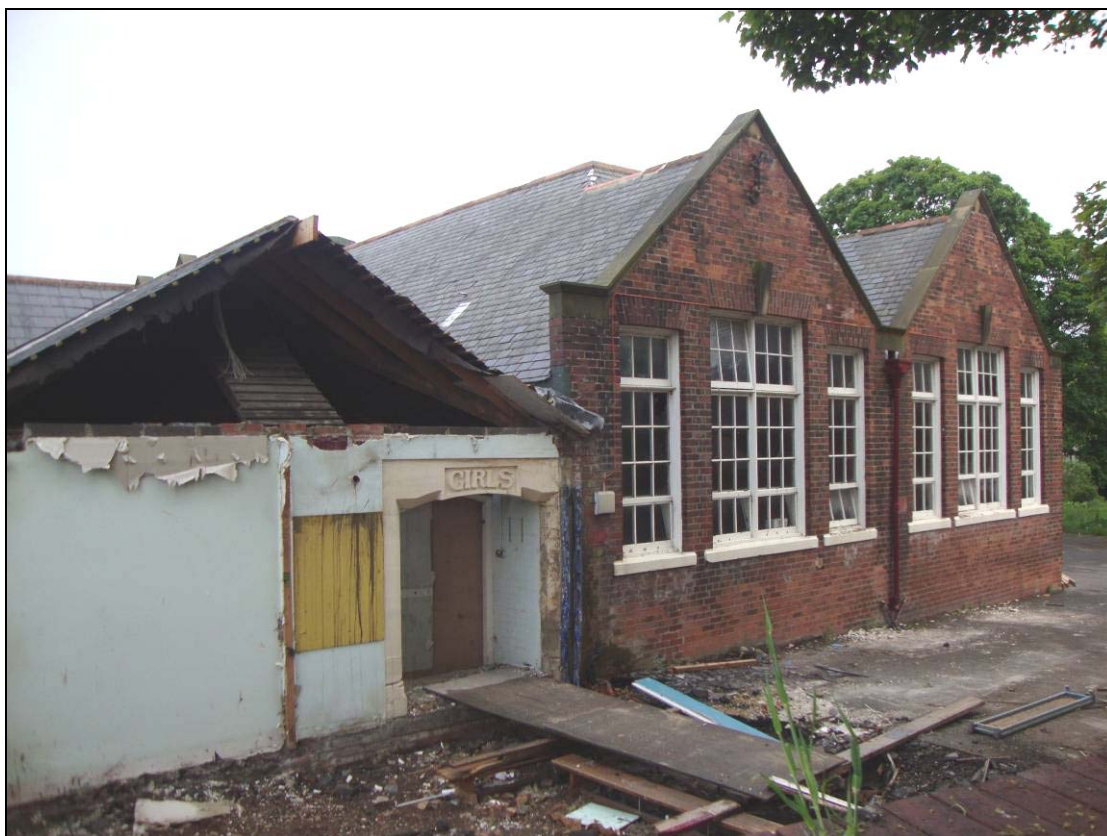
This elevation comprises the west facing elevation of the school building (see Fig. 79). The elevation is constructed of red imperial brick laid in three-course English Garden Wall bond, completed at the roofline of the two projecting gables by flat sandstone coping with sandstone kneelers and decorative keystones in the flat arches over the centre of the large windows (see Fig. 27). The elevation comprises six window openings in total; three windows are on the external west facing elevation of Room 5 and three are on the external west facing elevation of Room 6. Each set of three is arranged with a large central window and two smaller flanking windows on either side. This arrangement reflects the layout of the rooms within, with Rooms 5 and 6 each having three windows on their west elevations. Originally, at the northern extent of this elevation, there would have been a reflection of the canted bay window that can be seen on the east facing elevation. This window was demolished and blocked, however, and an extension was built. This extension had been completely demolished and was no longer extant at the time of survey. The original, later blocked, opening for the Girls entrance on this elevation is constructed of chamfered sandstone long and short quoins with a moulded step and decorative lintel inscribed with “Girls” (Fig. 29), all framing a wide opening that could be seen to give access to a small porch area, finished in brown glazed brick. What remains of this elevation does not exhibit any construction breaks and appears to have been constructed in one phase. This is discounting the later removal and blocking of the bay window and the subsequent construction and then demolition of the extension.

Figure 27: West facing elevation, looking south east.

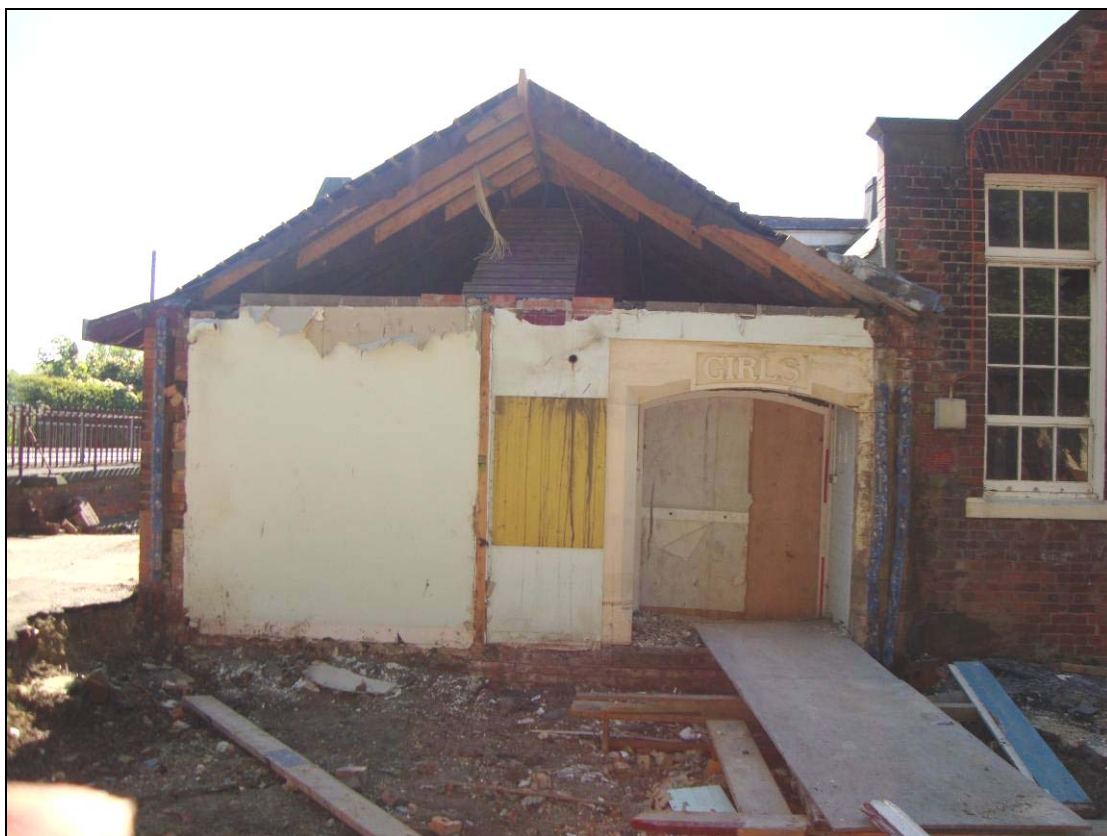
Figure 28: Northern extent of the west facing elevation showing where the extension has been demolished to reveal the original girls' entrance with inscription.

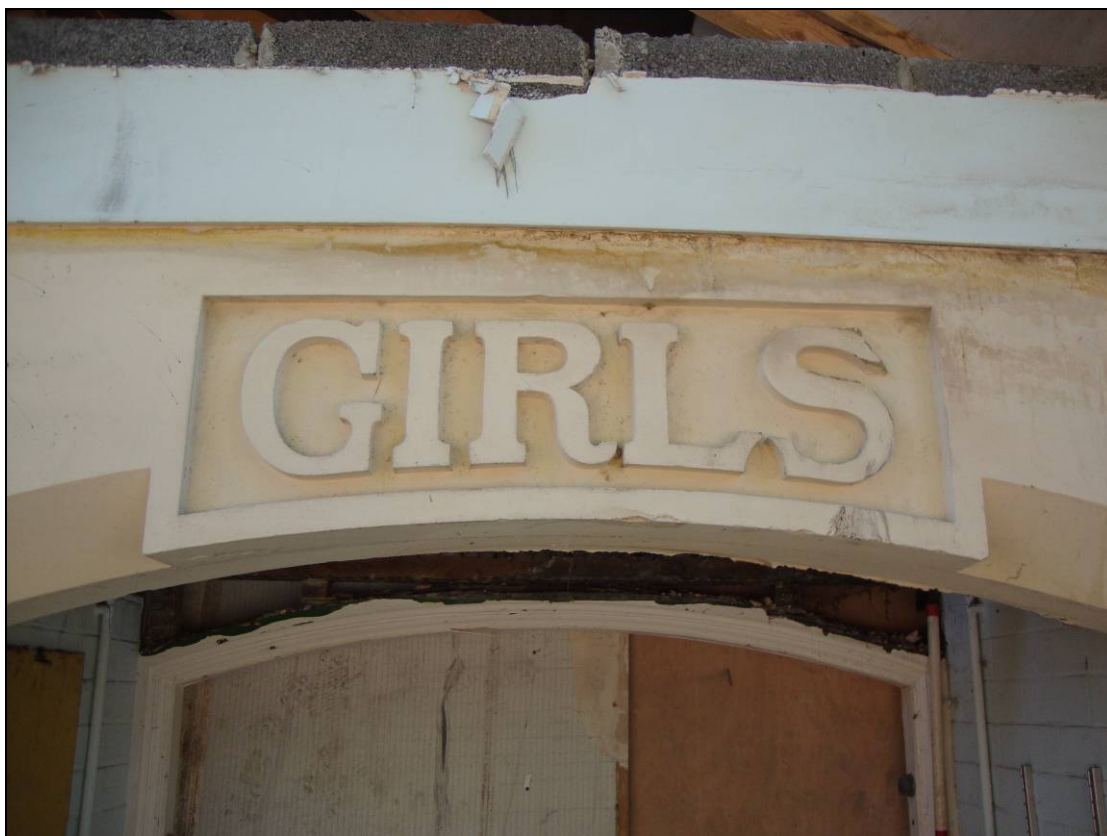
Figure 29: 'Girls' inscription above the original entrance in to the girls' cloakroom.

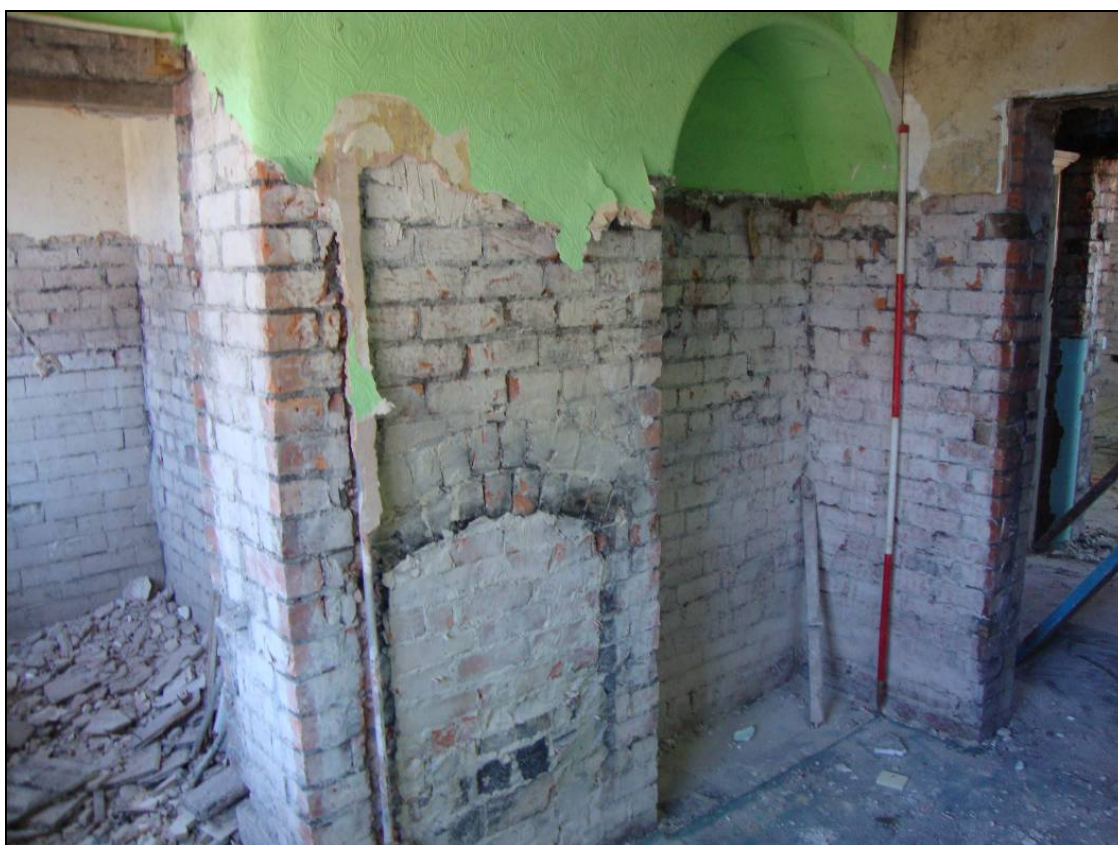
Room 2 is accessed from the south by a door that leads from Room 1. This room would have been the Mistresses' Room due to its location next to the girls' entrance. The room is 'L' shaped and runs from south to north and then west to east. At some point after the initial construction of the school, an extra room was created by inserting a partition wall and separating the 'L' shaped room in to two small rectangular rooms (both referred to as Room 2 for the purpose of this report). The extra room had a toilet and washbasin inserted with a small brick partition and a door to separate them (Figs. 35 and 36). The north elevation of the room has two windows; however one of these has been cut in half by the later inserted partition wall that separated off the wash basin and toilet. The west elevation of the room would have originally had a bay window; however this was later blocked in order to add an extension on to the west elevation of the building. Evidence of this blocking can be seen in the wall (Fig. 33). The east elevation of the room has an arched niche, possibly intended for shelving, and a blocked fireplace (Fig. 34).

Figure 34: East elevation of Room 2, looking south. Scale = 2m

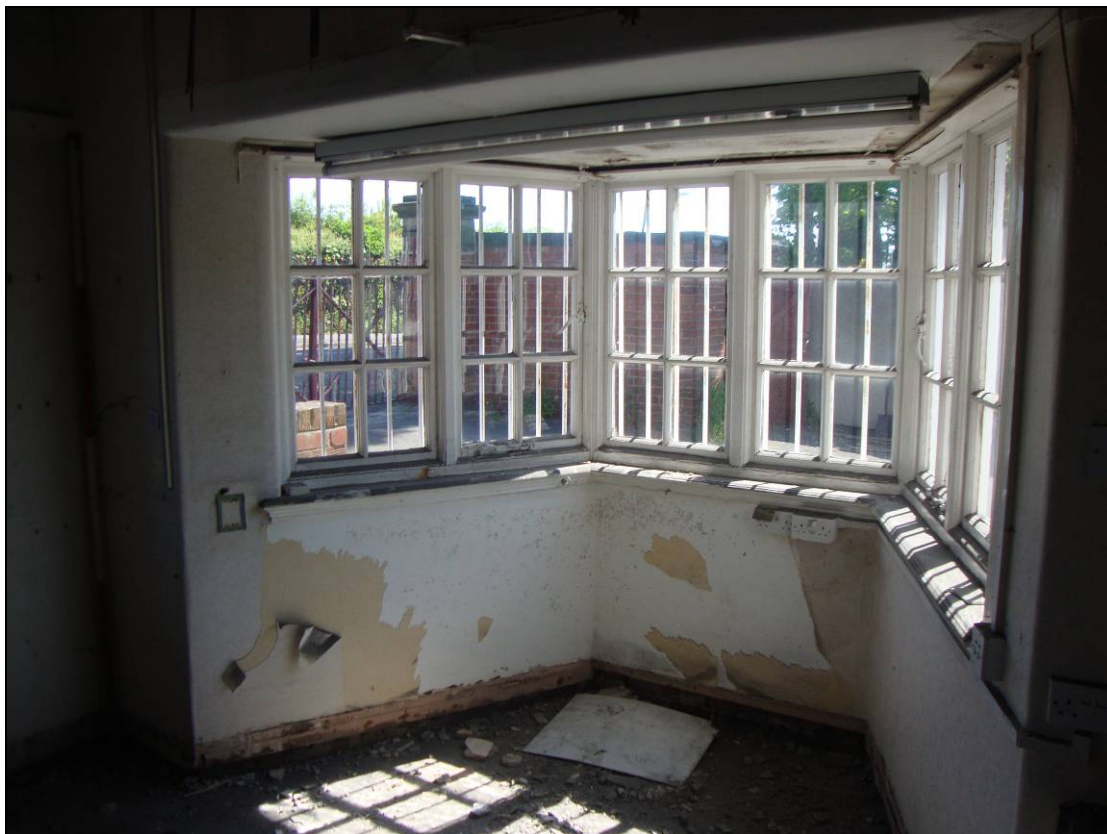
Room 13 comprises a small room in the north east corner of the building. This would have originally served as the Masters' Room due to its close proximity to the boys' entrance. The room has a doorway leading from Room 11 on the south elevation and a single window on the north elevation. There is a canted bay window to the east elevation, presumably so that the Masters were able to oversee the school boys while they were in the playground. There is a partially infilled niche in the wall of the west elevation as well as a blocked fireplace.

Figure 74: East elevation of Room 13, showing detail of bay window, looking east. Scale = 2m
