**Oak House, Main Street, Illston on the Hill,
Leicestershire**

**Archaeological Building Recording and
Watching Brief**

ARS Ltd Report 2012/24

June 2012

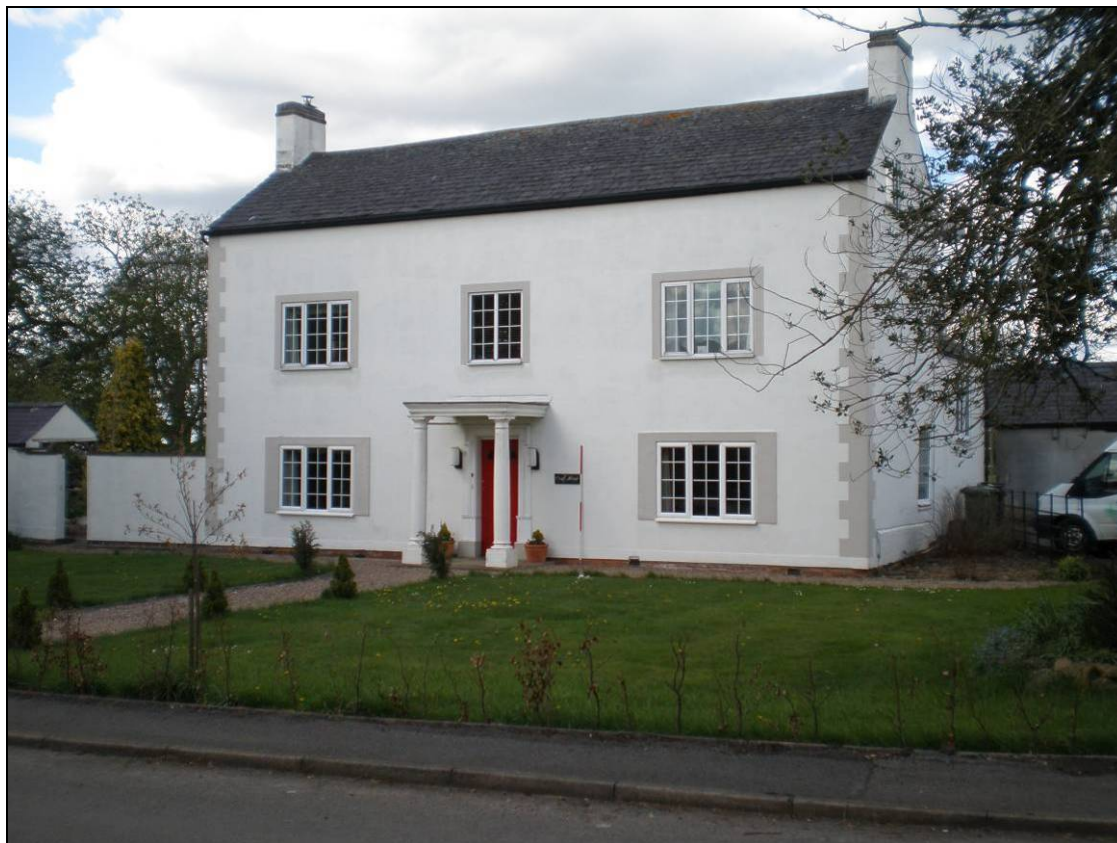
Plate 1: General view of the front south elevation (scale 2m)

4.1.1 The south elevation is the main side wall facing the street composed of three bays demarcated by window openings and a central porch on the ground floor (Plate 1). The roof is made of natural slate laid to diminishing courses and has plain close verges and eaves (Plate 2). Three dormer windows are proposed to be inserted along this side of the roof.

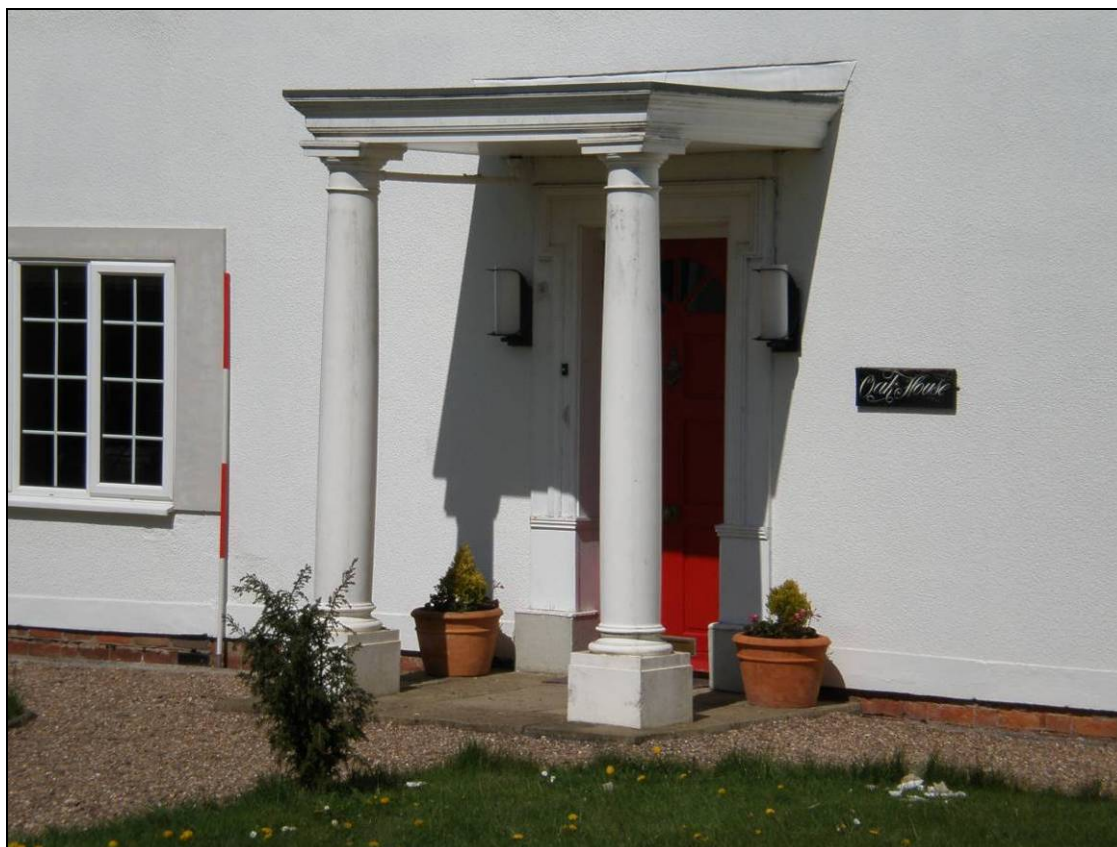
Plate 3: Detail of the porch (scale 2m)

4.1.2 The windows are modern replacements and the porch is also a later insertion made of soft wood and plastic resembling a Georgian style with Tuscan columns and moulded cornice (Plate 3). The doorcase and door are also fake Georgian items, the former containing moulded architrave and the latter composed of a six-panelled timber door with an upper fanlight (Plate 4). The corners of this elevation are decorated with fake quoins made of cement render (Plate 5).

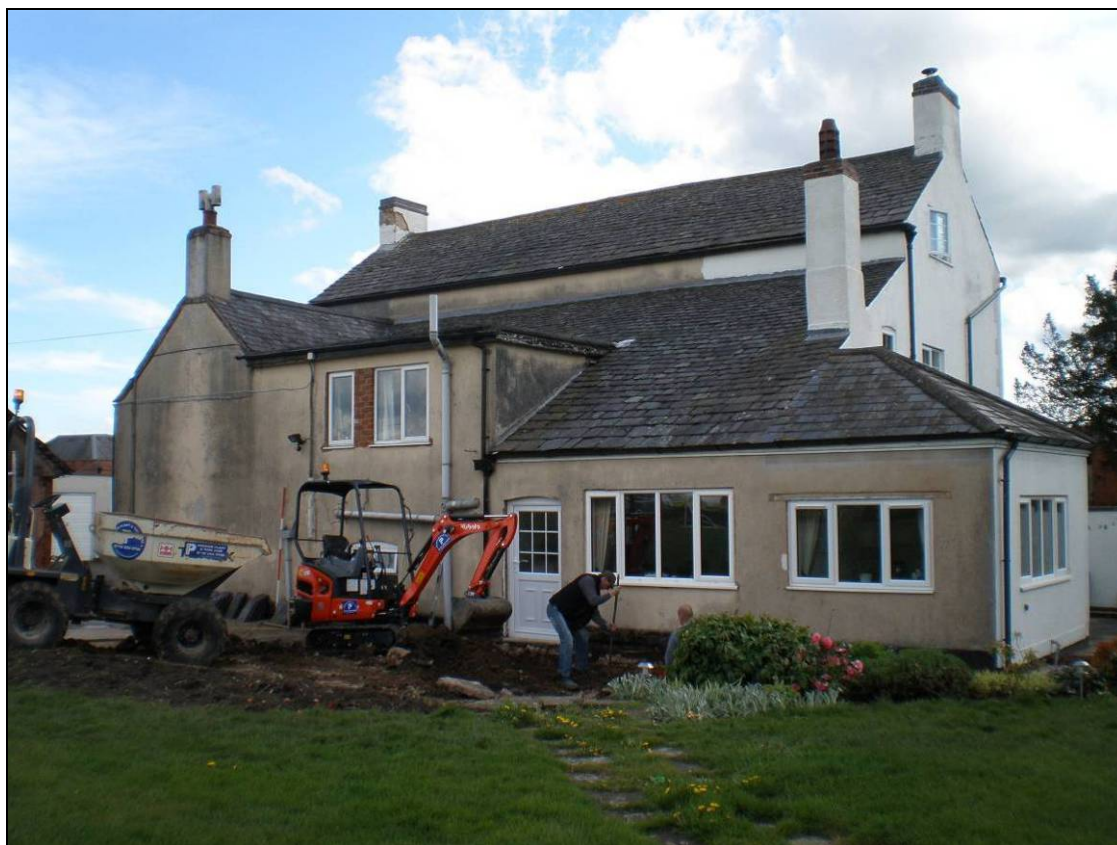
Plate 6: General view of the rear north elevation (scale 2m)

4.1.3 The rear north elevation is less regular than its counterpart as it consists of the large lean-to range with additional structures along the entire elevation (Plate 6). The eastern side has a two-storey range with a plain slated pitched roof and a single short window opening on the ground floor (Plate 7). The central area is also of two storeys with a flat roof covered with felt and window openings on each level arranged asymmetrically (Plate 7). The western side of the rear north elevation consists of a single-storey extension which projects slightly towards the west (Plate 8). The extension contains large modern casement windows and a doorway. It has a shallow hipped slated roof which incorporates part of the original lean-to roof built with natural slates laid to diminishing courses.

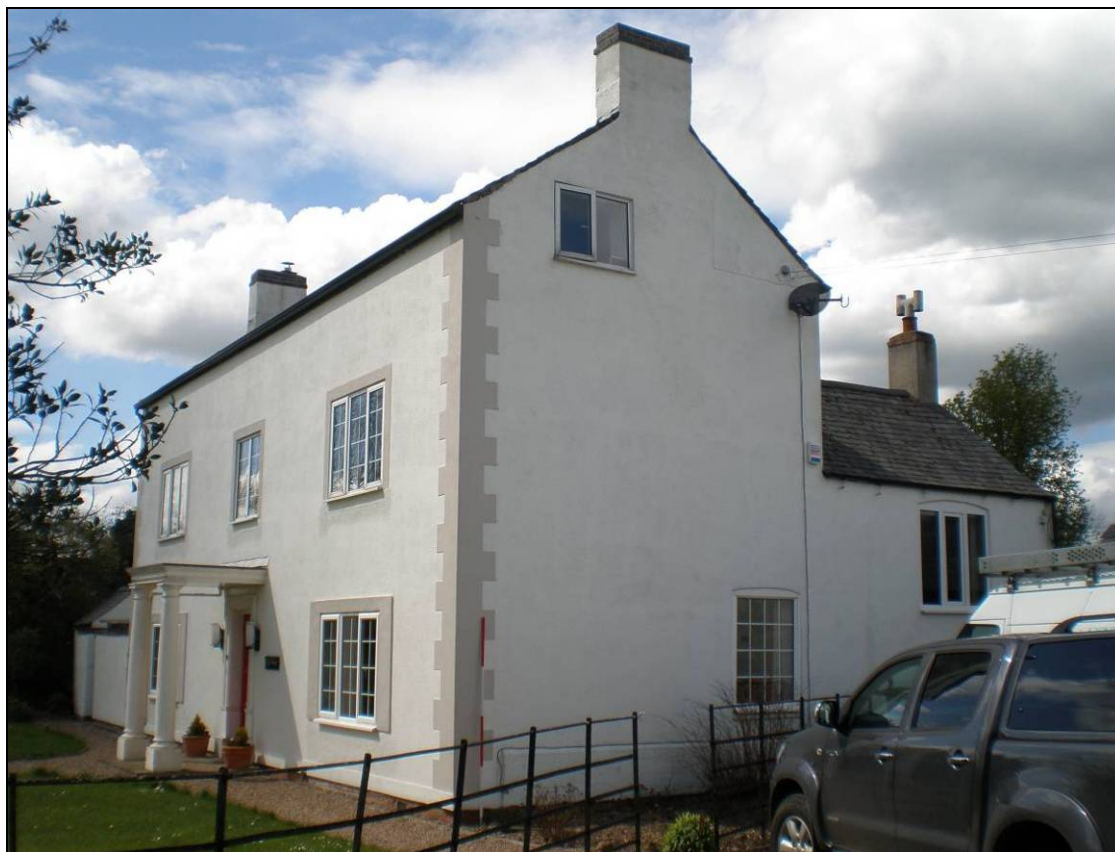
Plate 9: East elevation (scale 2m)

4.1.4 The east elevation consists of a plain gabled wall of the main range and the northern range creating a cross-wing effect (Plate 9). The gabled wall contains a large window opening on the ground floor and a smaller type on the attic (Plate 10). The lower section of the wall contains exposed stone masonry amongst the brickwork. The northern cross-wing has a central casement window on the upper level (Plate 11). All the windows are later insertions and/or modern replacements.

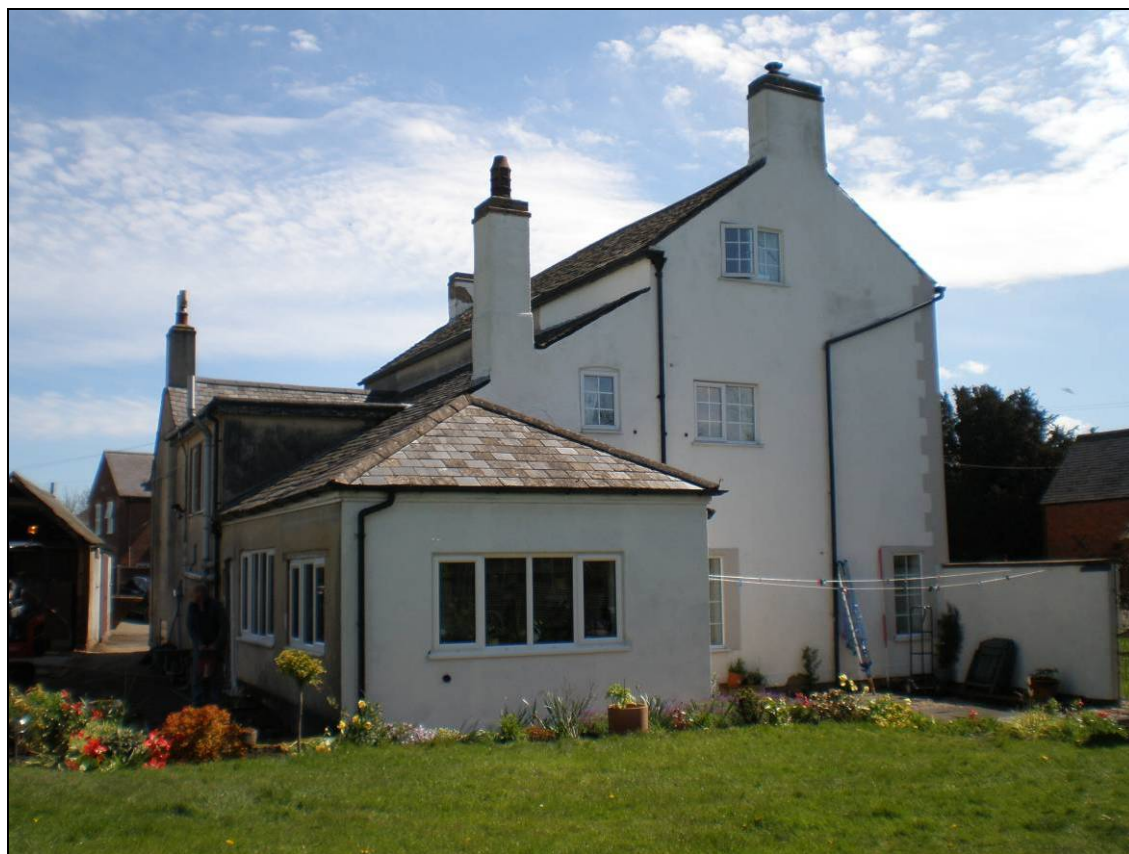
Plate 12: General view of the west elevation (scale 2m)

4.1.5 The west elevation is similar to its counterpart although with part of the original lean-to and the projecting hipped extension (Plate 12). There are window openings throughout the

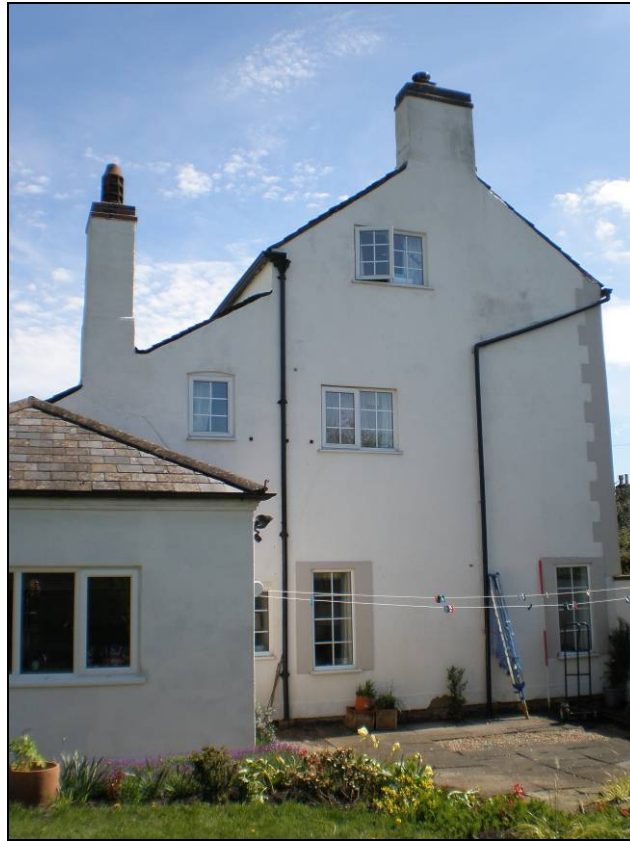
Plate 13: Detail of the gable side (scale 2m)

different structures although their arrangement and type are somewhat haphazard (Plate 13). The straight rain water pipe is a cast-iron type whereas the remainders throughout the house are later PVC pipes. Moreover the gutters of the main range appear to be original ones made of timber.

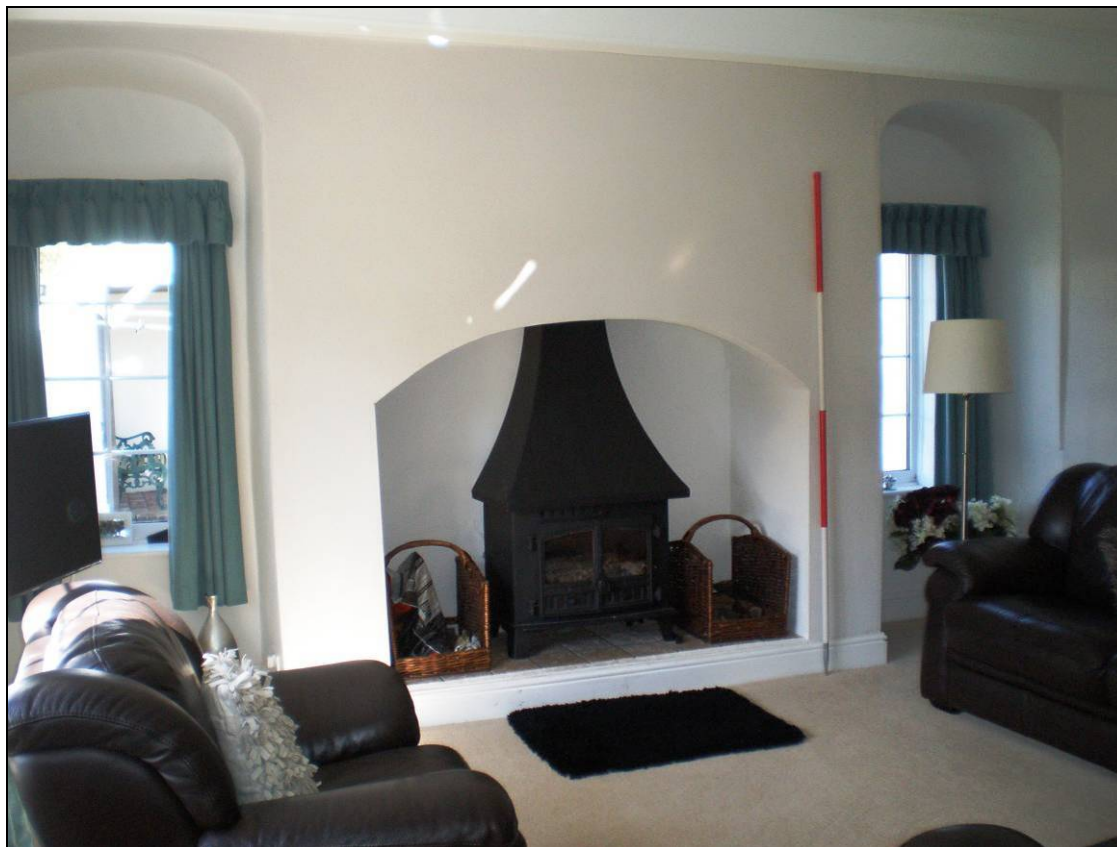
Plate 18: Room G-3, looking west (scale 2m)

4.2.3 G-3 is a living room comparable to room G-2 although the chimney breast is flanked by two recessed niche-like window openings with elliptical arched heads and the present fire place consists of a large cast-iron log burner (Plate 18). One of the ceiling beams contains four iron hooks (Plate 19).

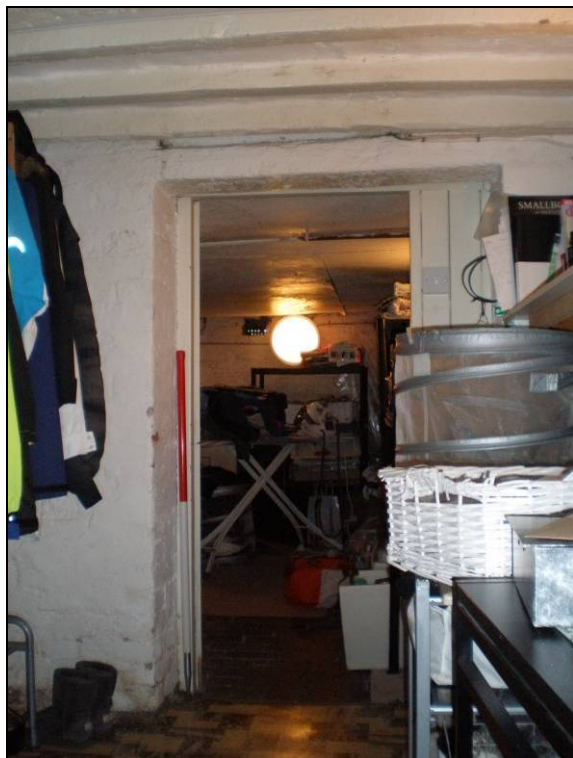
Plate 20: Room G-4 (scale 1m)

4.2.4 Room G-4 serves as a passageway into room G-5 within the north-east corner of the house. It has low exposed timber ceiling joists, brick walls and quarry tiled floor (Plate 20).

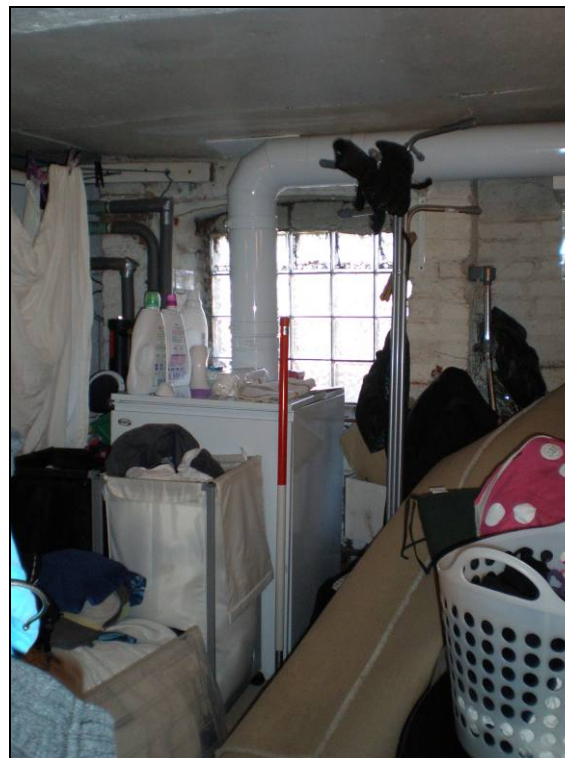
Plate 21: Former doorway in G-5 (scale 1m)

frosted window with slender glazing bars. The window opening has a segmental arched head and is flanked by two pilasters which bear high resemblance with doorways of farm buildings (Plate 21). It is suggested that the outer ground level might have been slightly raised and thus the doorway might have been modified into a window. The room contains a substantial timber ceiling bridging beam orientated east to west (Plate 22). The beam has wide flat chamfered edges (Plate 23) which may date to the 17th – 18th centuries (e.g. Cunnington 2002, 73).

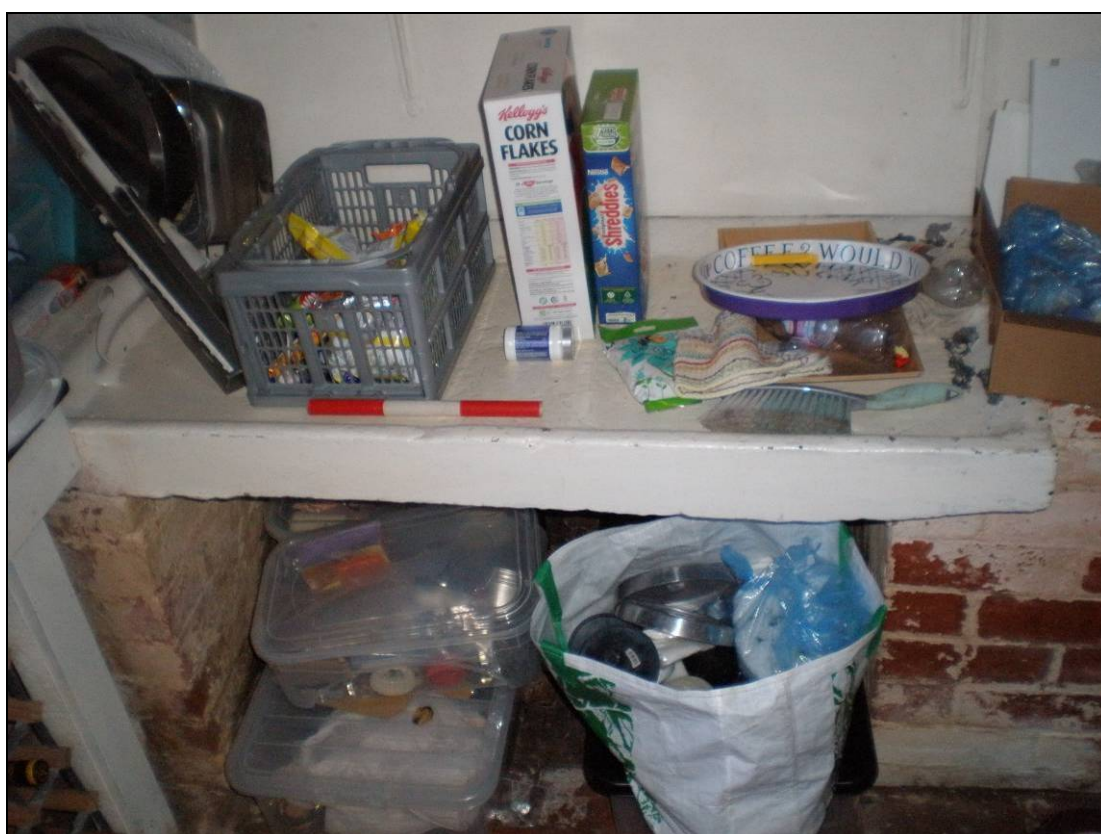
Plate 26: Detail of salting trough within the eastern end of room G-6 (scale 300mm)

4.2.6 Room G-6 is used as a pantry which is accessed from a small doorway through two short steps. There is a blocked-up window opening with a segmental arched head within the southern wall (Plate 24). It is unknown whether the former opening was a window or a doorway as it would not be logical to have an external window linking an adjoining room. There is a continuous work bench along the walls supported by short brick pillars and timber posts (Plate 25). The bench incorporates a stone salting trough within the eastern wall (Plate 26). The trough appears to be an *in situ* element of bench which are commonly dated from the 17th – 18th centuries (Hall 2005, 206).

6.2 The original Oak House may have developed around the 18th to early 19th century as indicated by a few vestiges including timber beams and a salting through. The main range of two and a half storeys may date to the late 18th or early 19th century based on architectural stylistic grounds. The lean-to range appears to be contemporary with the main range which would have incorporated part of earlier structures. Later minor modern additions include the current north-western extension. There are few original fixtures and fittings surviving except for the ones noted above. The house might have originally been used as a dwelling although the complex it represents would have contained farming buildings as indicated by the present outbuilding.

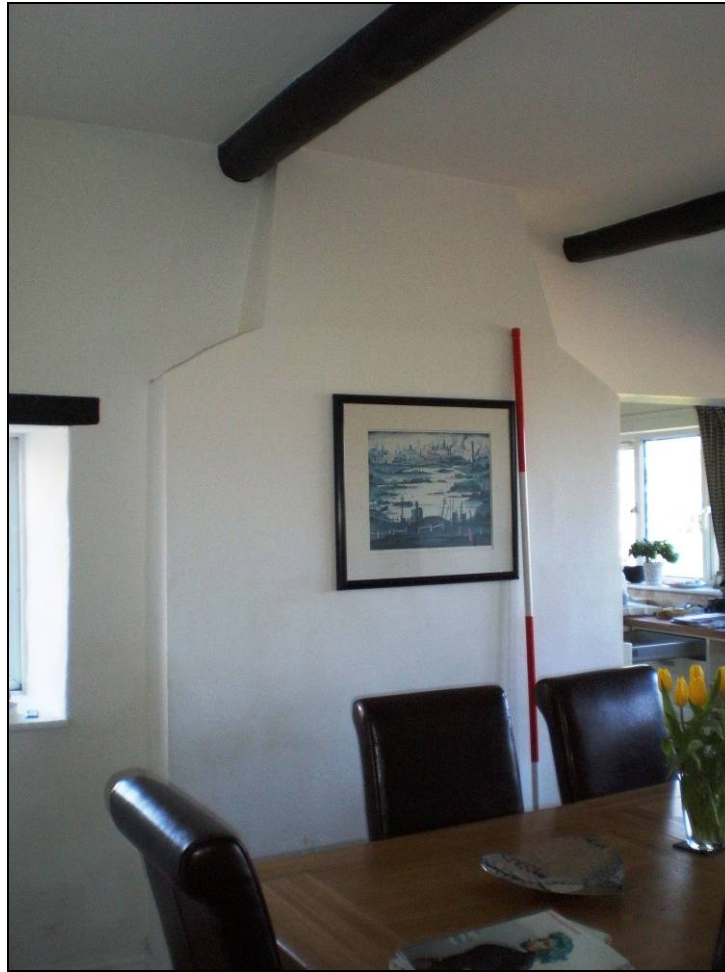
Plate 27: Room G-7, looking west (scale 2m)

4.2.7 Room G-7 is a large kitchen-dinner with a later extension to the west. The main structure corresponds to the original lean-to range containing a chimney breast and two exposed pole ceiling beams (Plate 27).

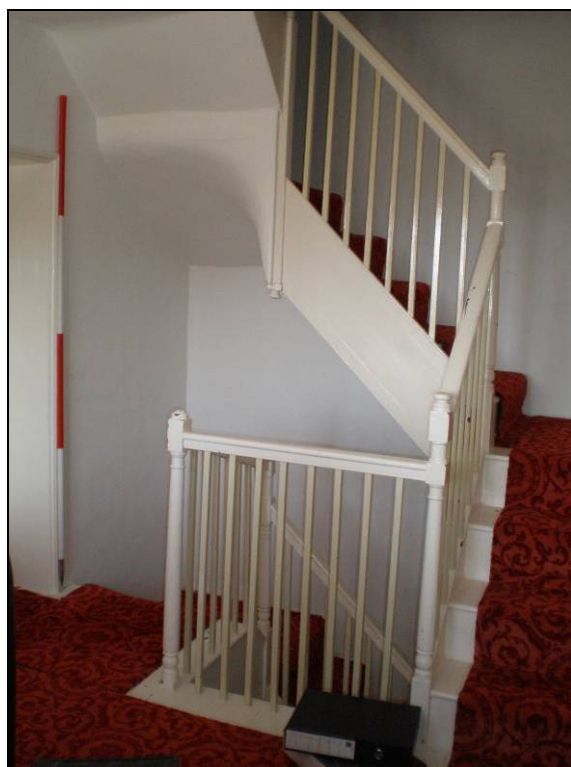
Plate 29: Staircase in F-1 (scale 2m)

4.2.8 Room F-1 is a lobby currently used as an office (Plate 28). It enables access to the adjoining rooms F-2 and F-3 and the staircase (Plate 29). The staircase leads to a mezzanine area (F-4) to the north through an arched doorway which contains a vestibule connecting bedroom F-5 to the east and two bathrooms to the north (Plate 30).

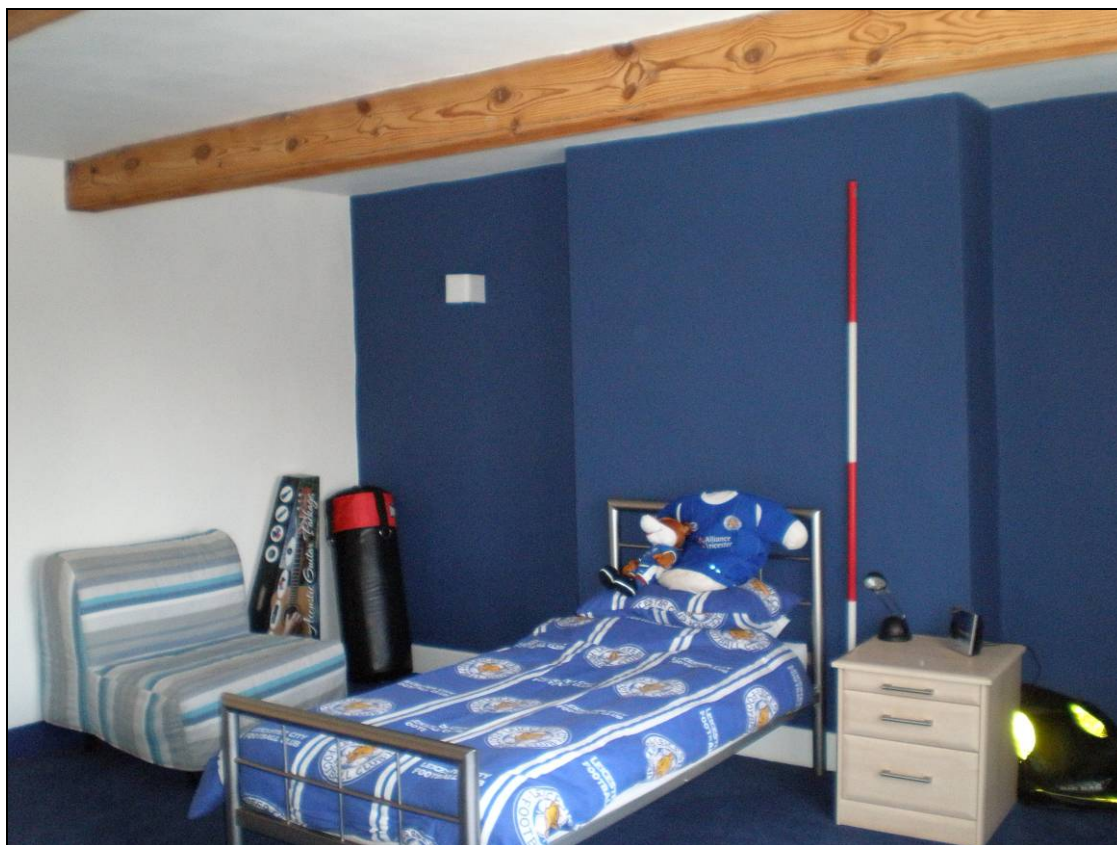
Plate 31: Room F-2, looking east (scale 2m)

4.2.9 F-2 is a bedroom whose structural arrangements and fabrics are equivalent to the room below with exposed ceiling beams and chimney breast on the east wall (Plate 31).

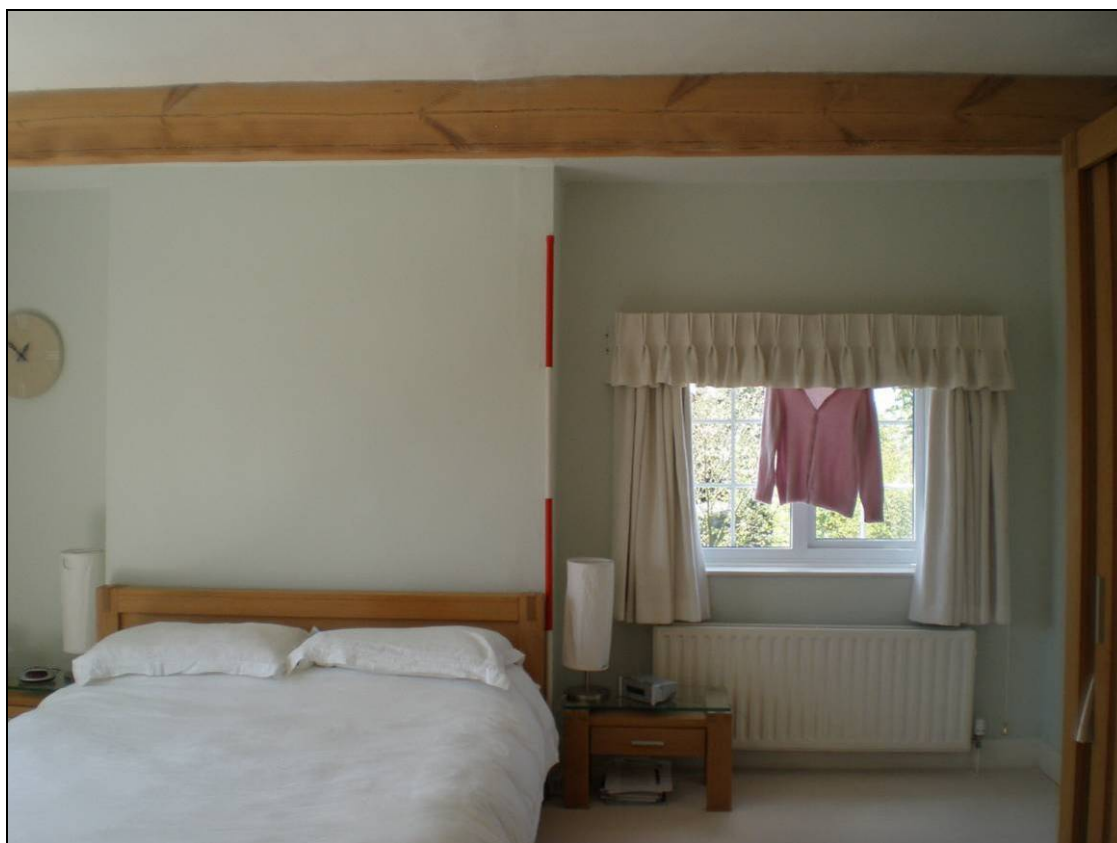
Plate 32: Room F-3, looking west (scale 2m)

4.2.10 F-3 is another bedroom comparable to F-2 (Plate 32) although it contains an en-suite bathroom to the north within the lean-to structure.

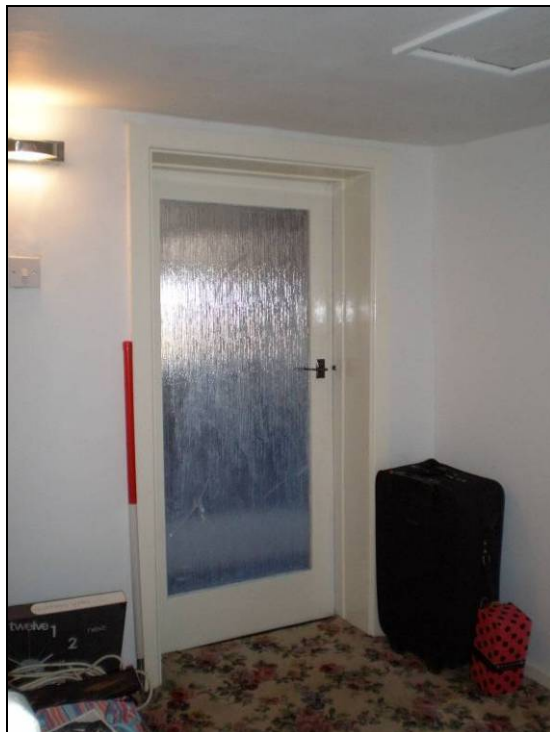
Plate 35: S-1, looking east (scale 1m)

4.2.12 This floor is positioned within the main range's loft area and contains two bedrooms linked by a large lobby (Plate 35). S-1 is the lobby which is accessed from the newel staircase whose uppermost dog-leg bend includes three winders rather than a landing (Plate 36). The southern area of S-1 contains a stud partition with a doorway creating a walk-in wardrobe.

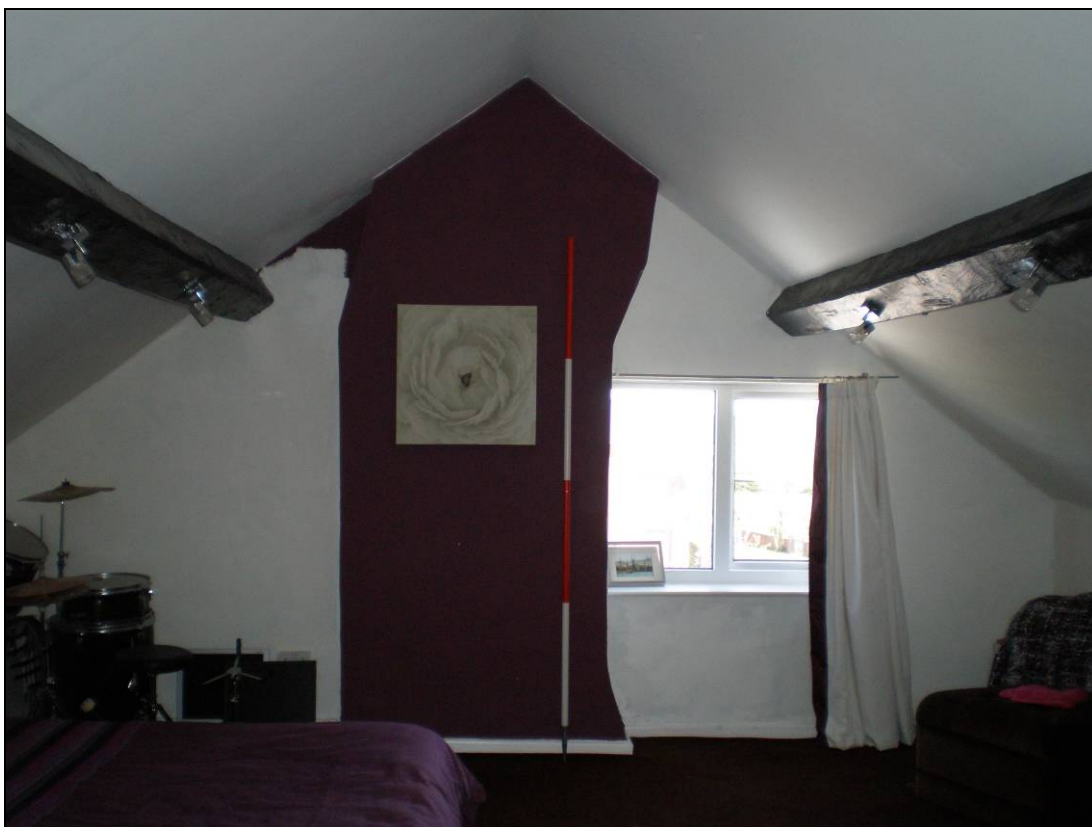
Plate 37: Room S-2, looking east (scale 2m)

4.2.13 Bedroom S-2 has an angled plastered ceiling with exposed timber purlins and a chimney breast on the end gabled wall with a small window opening adjacent to it (Plate 37). The side walls are rather short measuring approximately 1 metre in height. The proposed dormer will be located along the southern side wall which is internally devoid of significant fixtures and/or fittings and instead contains a modern radiator (Plate 38). The exposed purlins have been shaped employing hand tools as indicated by scars created by adze. The southern side purlin contains carpenter marks which bear no correlation with the present roof structure suggesting therefore that the timber might have been re-used from an earlier structure (Plate 39).

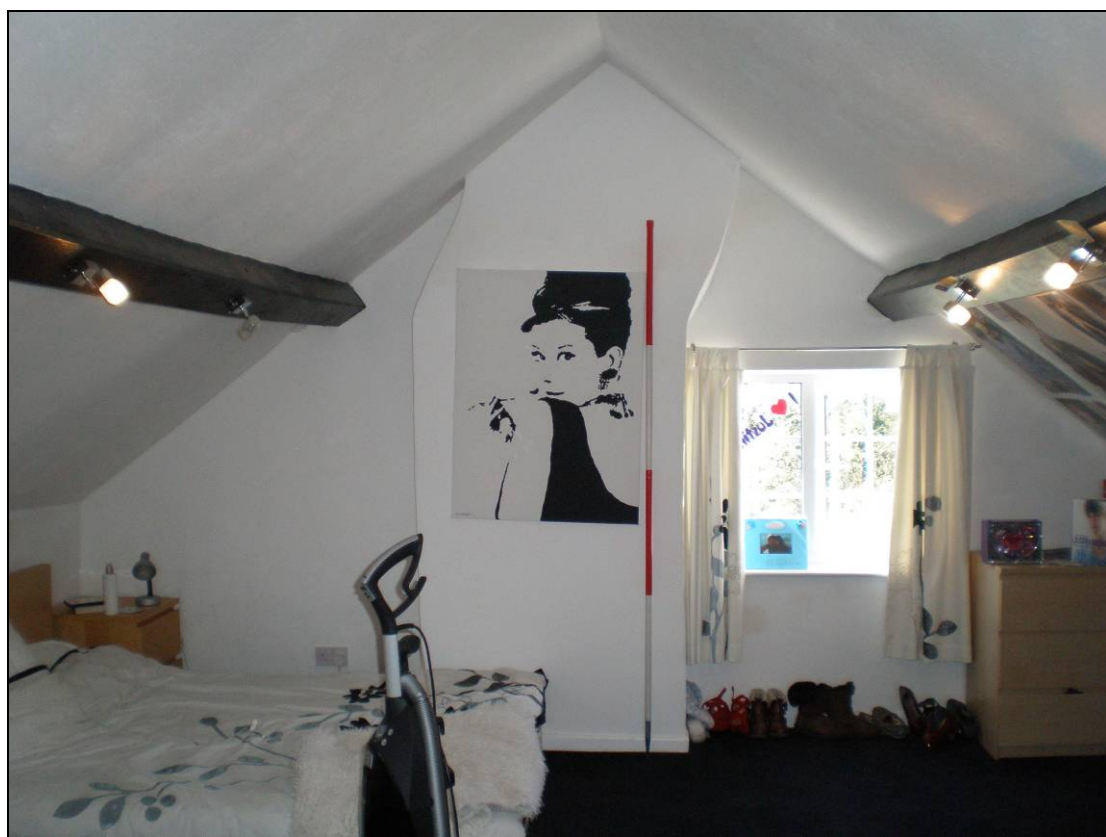
Plate 40: Room S-3, looking west (scale 2m)

4.2.14 Bedroom S-3 is comparable to its counterpart although with a window opening on the reverse side of the chimney breast (Plate 40). The proposed dormer will be located along the southern side wall which is also devoid of significant fixtures and/or fittings and instead contains a modern radiator (Plate 41). The exposed purlins are sawn timber linked to the rougher tiers towards the east with scarf joints (Plate 42).

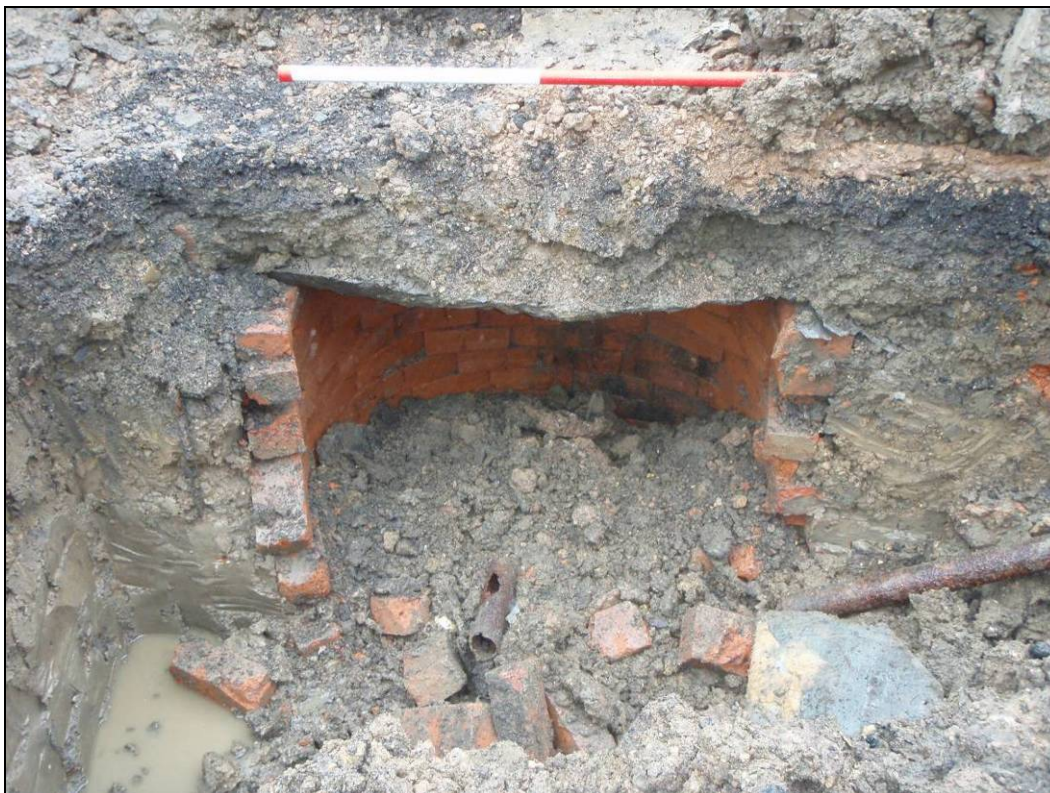
5.5 Situated below the made ground layer (002) and cut through the subsoil (003) was a brick well (105) within a shaft [107]. The well structure (105) was circular in shape and constructed from plain red bricks dried bonded (Fig. 5). The cut for the brick structure of the well [107] was barely visible in the surrounding ground, presumably as it was cut very close and then backfilled against the bricks. The location of the well is shown on plan (Fig. 3).

5.6 At some point in the modern period the well fell into disuse and was filled in with deposit (106), a coarse greyish brown sandy silt containing a high amount of stone and hardcore (mainly concrete). Early modern pottery fragments were found within the fill, giving a *terminus ante quem* for the infilling of the well. The deposit also contained charcoal, clinker and corroded metal.

Figure 5: The disused well (105) half-sectioned by mechanical excavator

6.4 The groundworks revealed little deposits or structure of archaeological significance except for the remains of a disused brick well which may date to the 19th century as indicated by the brick type (Cunnington 2002, 147; Iredale and Barrett 2002, 22).

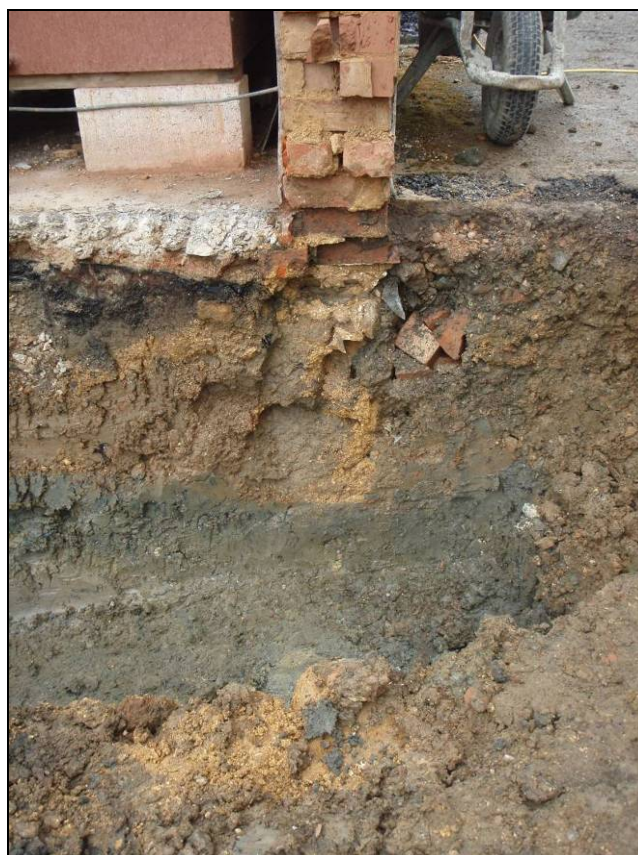
5.7 The natural substratum (004) was present below the subsoil (003) across the entire area. The depth was unknown as it was not fully excavated. It consisted of a dark greenish grey clay, with occasional inclusions of flinty gravel. At the southern end of the excavation area was a large patch of dark blackish blue silty clay containing occasional inclusions of gravel stones (008). This appears to be a natural deposit, possibly the result of standing water over a long period of time. The deposit possibly indicates a natural pond feature present before the outbuilding was constructed. The foundation trenches also revealed the depth of the present outbuilding to the east of the proposed development (Fig. 6).

Figure 6: Foundation trench showing the footings of the outbuilding
