## **Ryder Point, Brassington, Matlock: Watching brief and Photographic Recording**

**ARS Ltd Report 2006/10**  
March 2006

# **Ryder Point, Brassington, Matlock: Watching brief and Photographic Recording**

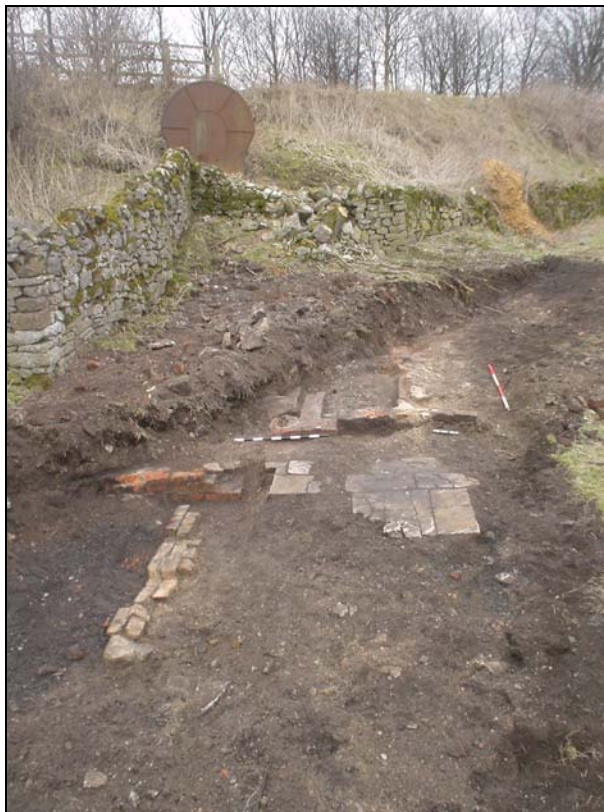
Fig. 3 Stone walls and flooring with boiler in background (scales=1m and 2m).

- 5.2 The remains consist of two patches of flagged flooring which are evidently part of a single original floor surface due to their uniform composition and level. These are associated with the footings of a red-brick wall three courses high and a wall of lighter coloured bricks which is noticeably lower than the rest of the structural remains (the nearest wall running towards the camera in Fig. 3 above).

- 5.3 The features furthest from the camera in Fig. 3 above describe one end of the rectangular structure. It is evident that this was reasonably substantial in construction as the tumbled remains of a number of courses of bricks can be seen on the eastern side (Fig. 4) and on the southern end a large block of cut gritstone is incorporated as some sort of footing or base (Fig. 5). The remains recorded are aligned with the boiler and also with the 'dog leg' described by the boundary wall of the field at this point and it seems reasonable to suggest that they are associated with the workings of the early railway system.

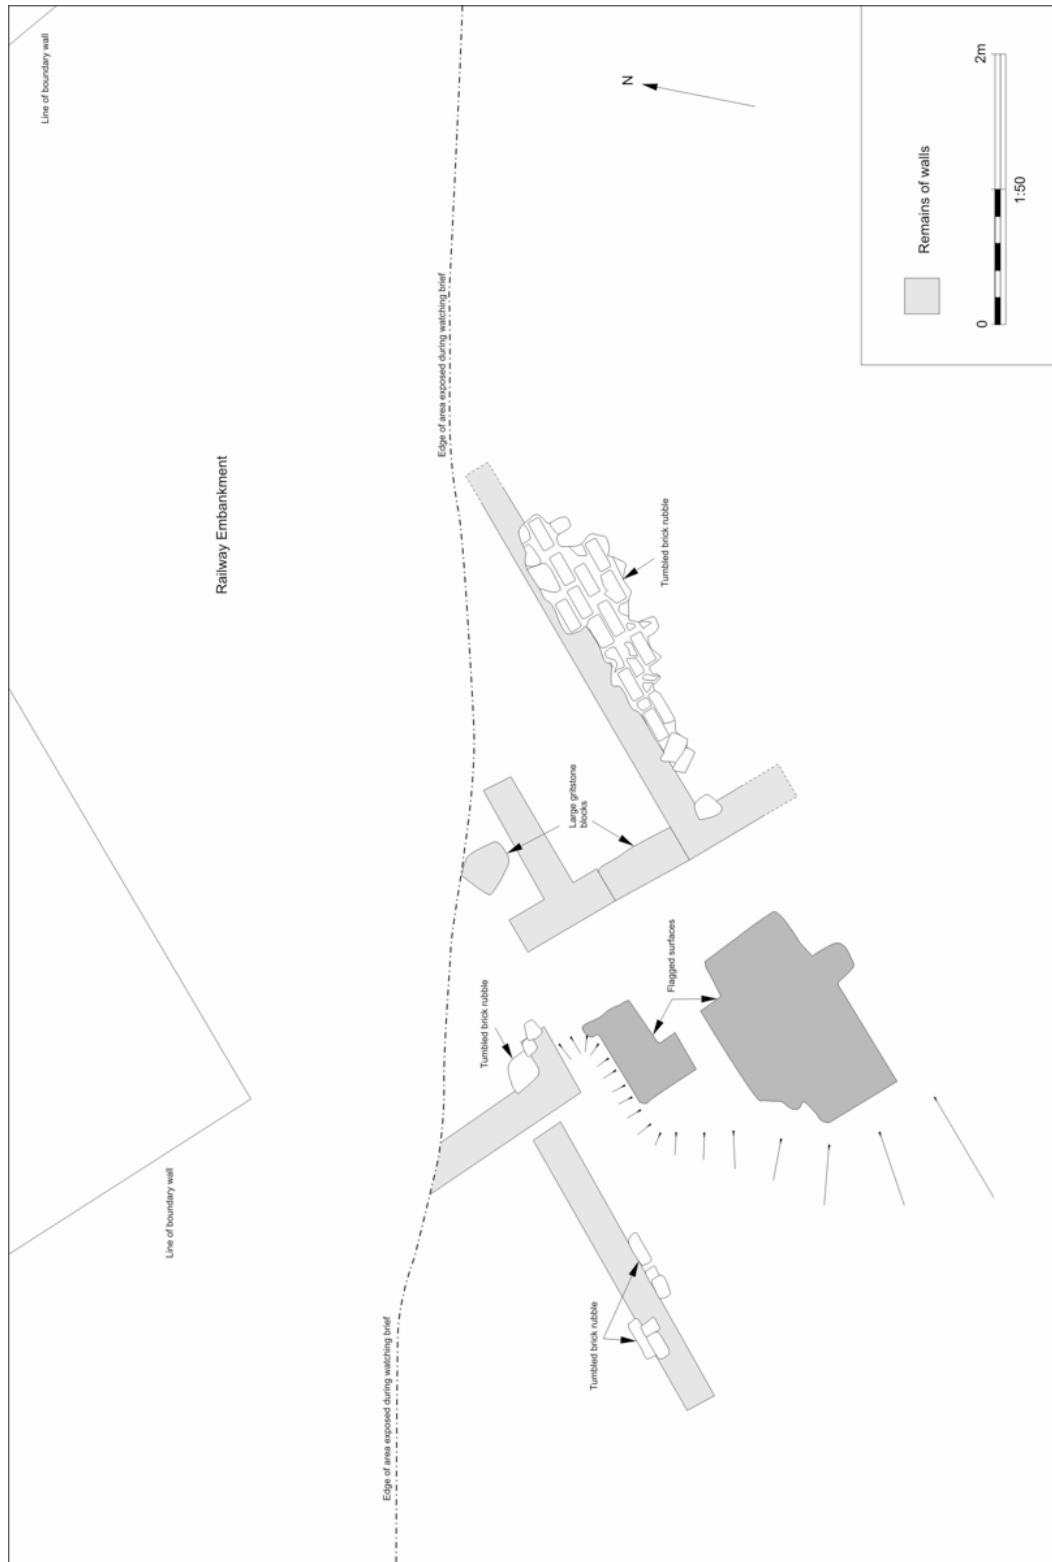
Fig. 4 Plan of features exposed during the watching brief.

- 5.1 The overburden was removed in the area close to the remains of the boiler and engine base across raised ground that had been presumed to represent ash and other waste materials associated with the boiler. Although there was evidence of ash piles, the deturfing revealed the remains of low walls and flagged flooring (Figs 3-4).

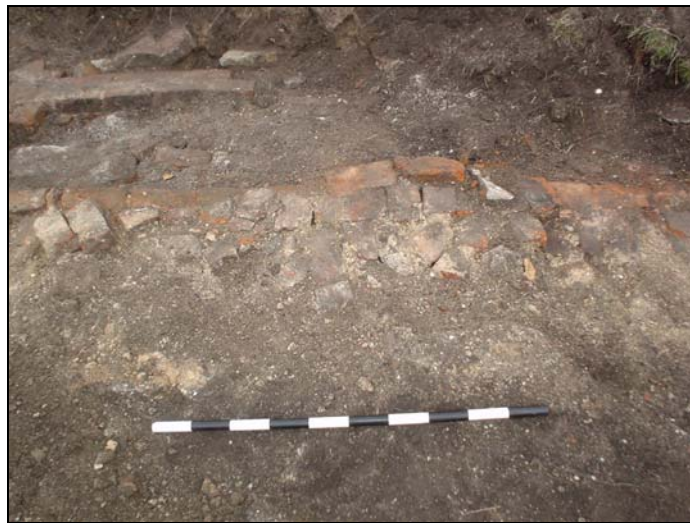
Fig. 5 Tumbled courses of brickwork on the eastern side of the rectangular structure. Facing west north-west (scale=1m).

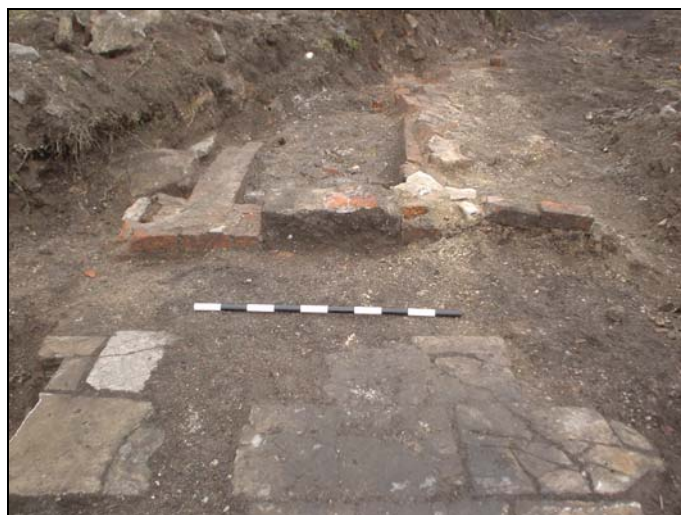
Fig. 6 Gritstone block incorporated within the fabric of the rectangular structure. Facing north-east (scale=1m).

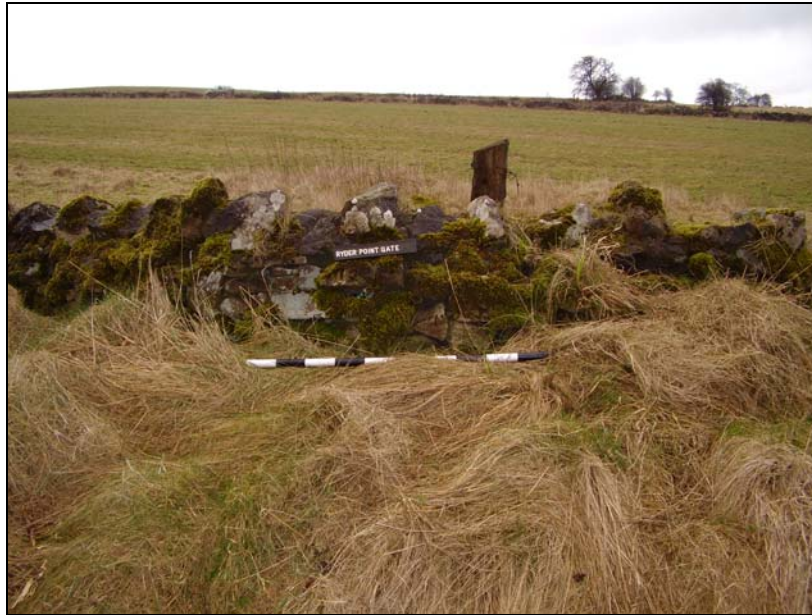
- 6.4 Image 1 (below) is of the area of wall to be demolished in order to create access from the new path to the High Peak Trail. The picture is taken from the High Peak Trail facing southeast, and shows little exposed wall due to the amount of spoil piled against the northern side (scale=1m)

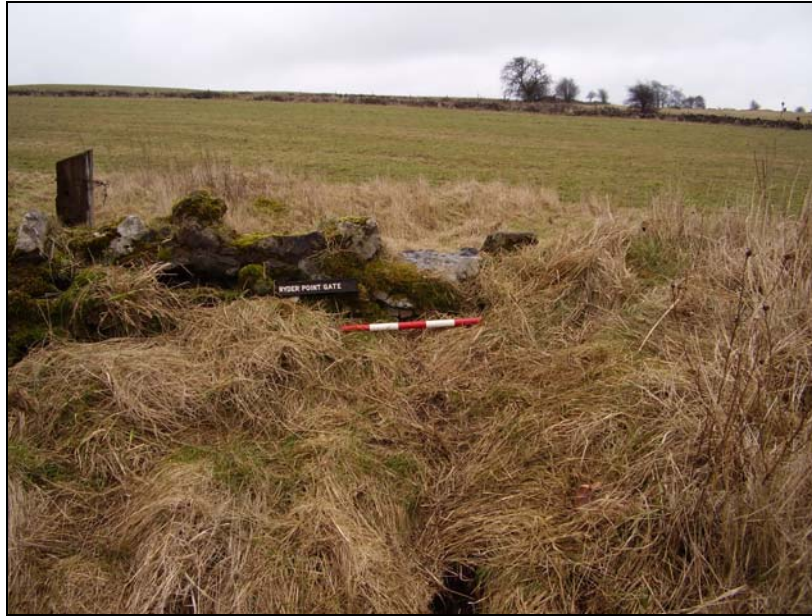
- 6.5 Image 2 (below) is taken a little to the west of 1. The picture is taken from the High Peak Trail facing southeast, and as with Image 1 shows little exposed wall due to the amount of spoil piled against the northern side (scale=0.5m).

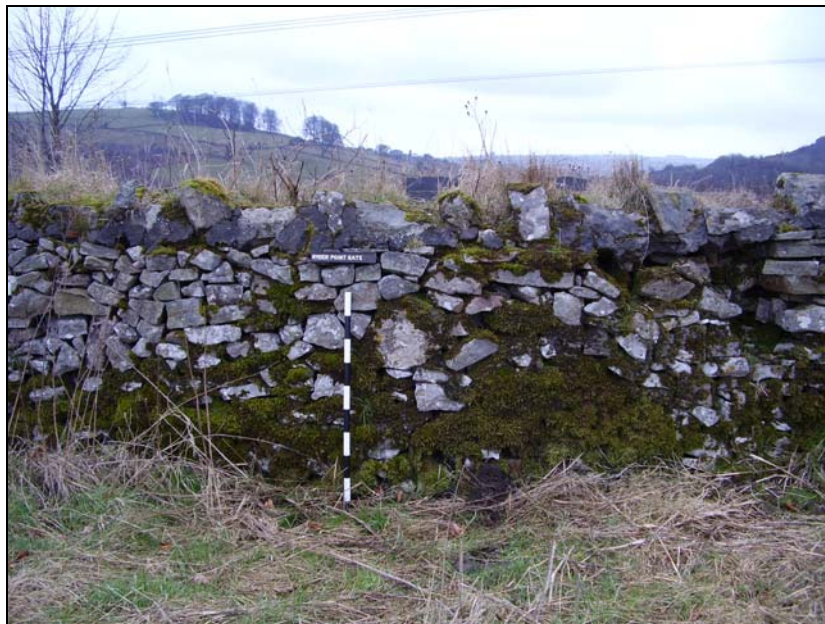
- 6.6 Image 3 (below) is taken facing the northwest towards the High Peak Trail from the interior of the field. The wall has an average height of 1.30m and width of 0.34m. This picture illustrates that the wall is of dry stone build with mortared capping stones and made from Limestone (scale=1m).

- 7.2 The section of boundary wall to be demolished appears to be original and presumably dates to the construction of the railway and shows no evidence of phasing or reconstruction in this section.

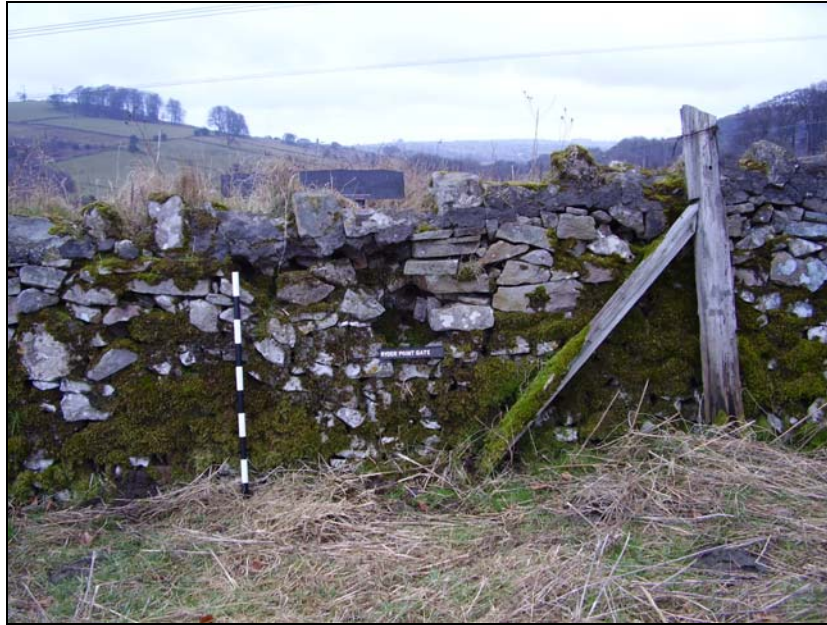
- 6.7 Image 4 (below), is taken facing northwest from the interior of the field facing the High Peak Trail to the east of Image 3 (scale=1m).

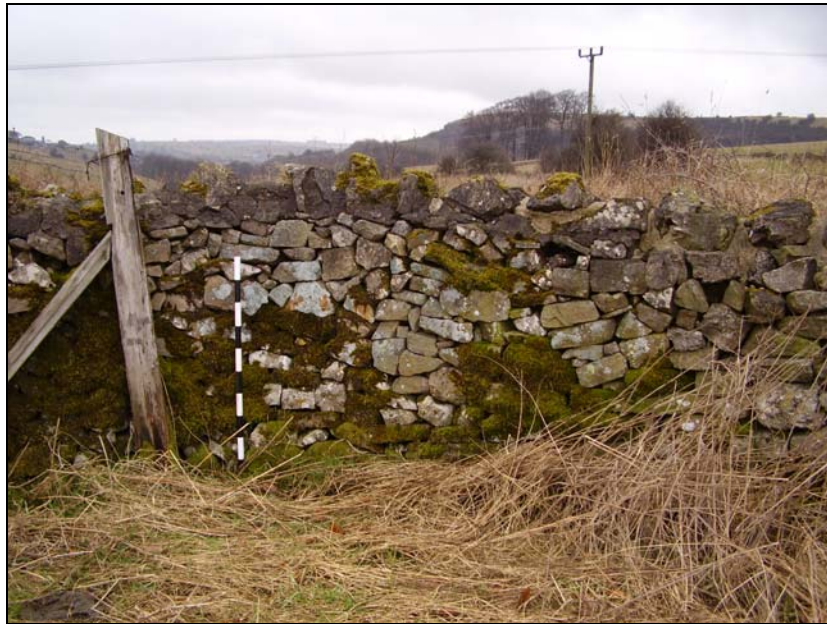
- 6.8 Image 5 (below), is taken facing northwest from the interior of the field facing the High Peak Trail to the east of Image 4 (scale=1m).
