An Archaeological Evaluation at Seaton Delaval Hall, Northumberland

ARS Ltd Report No. 2012/87

November 2012

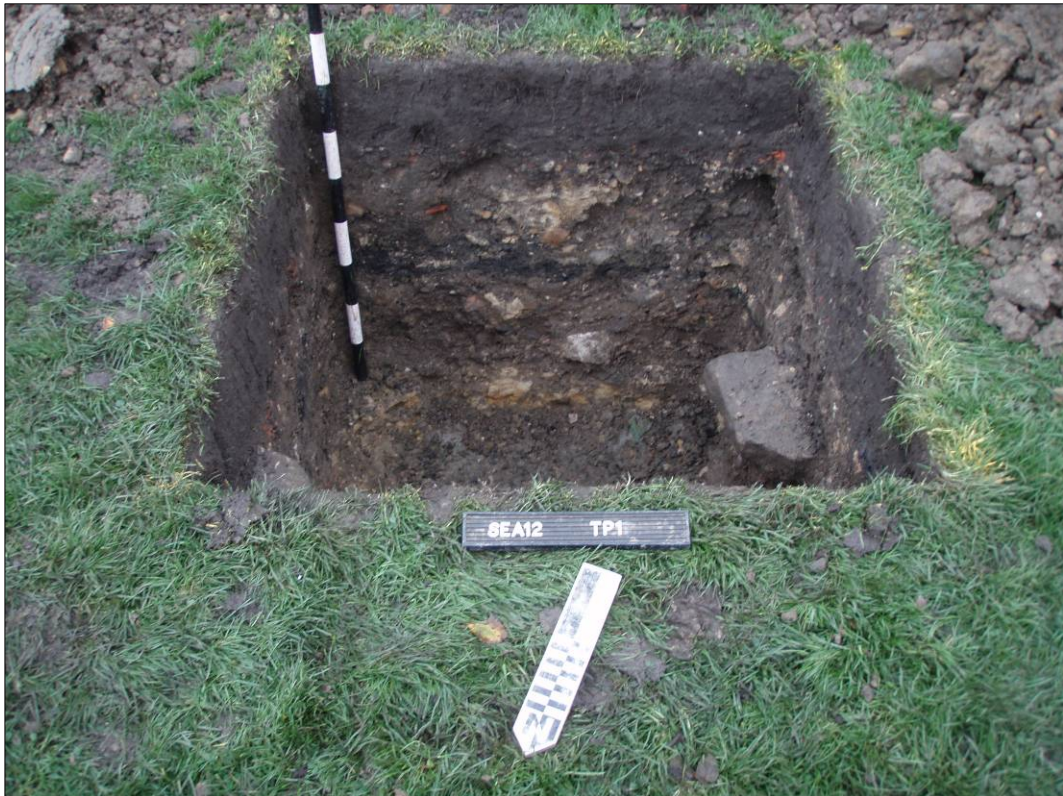
- 6.2.1. Test Pit 1 was located to the north of the north-western corner of the hall, adjacent to the tarmac trackway on a turf covered slope. The turf and topsoil, consisting of a dark brown silty loam (101), with a depth of approximately 0.2m, was removed to reveal a coarse grey silty clay containing a high proportion of demolition material (102). This had a maximum depth of 0.25m and contained roof tile, 2" bricks, glass, bone and pottery fragments (Figure 7). Context (102) overlay a thin deposit of coarse ash and coal (103) with a maximum depth of 0.08m which was removed to reveal a medium grey/brown sand deposit containing more demolition material (104). Context (104) contained roof tile, 2" bricks, glass, bone and pottery. This demolition material overlay a coarse deposit of sandstone chips in a sand matrix (105) with a maximum depth of 0.11m. The final deposit encountered consisted of a fine grey clay with sandstone inclusions (106) which possibly represented a re-deposited natural. No discrete features were discovered in this test pit, and nor was the natural substrate reached.

Figure 6 Test Pit 1.

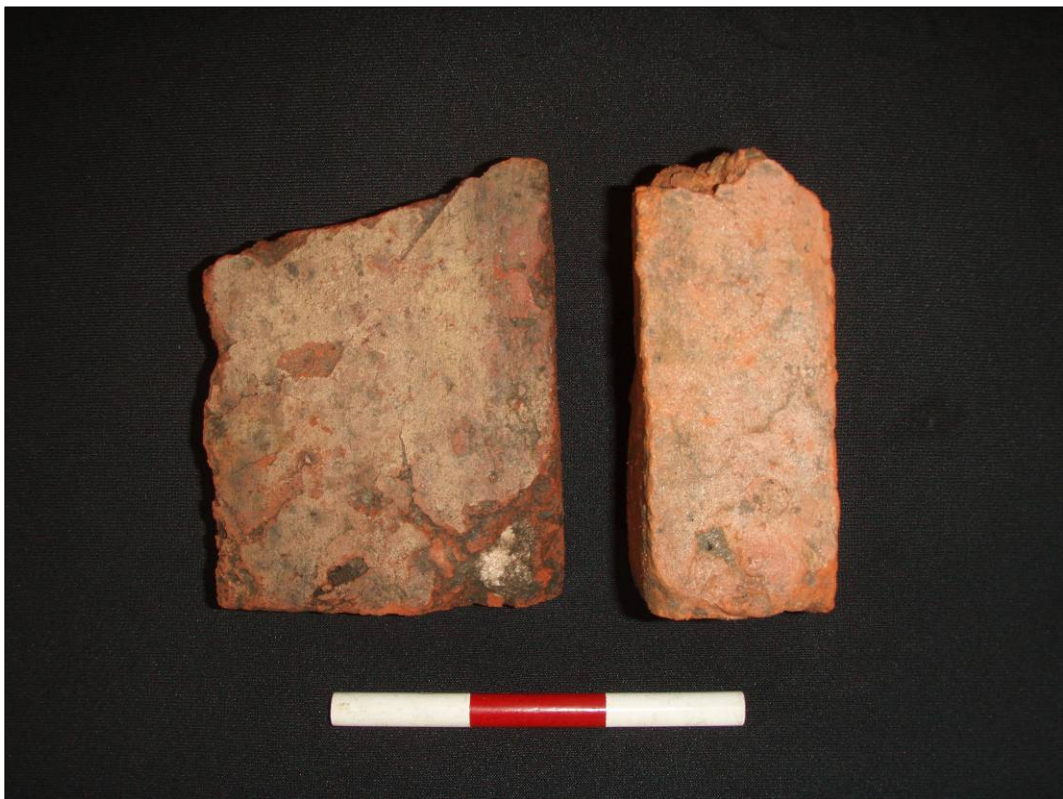
Figure 7 Test Pit 1; partial bricks located in (102).

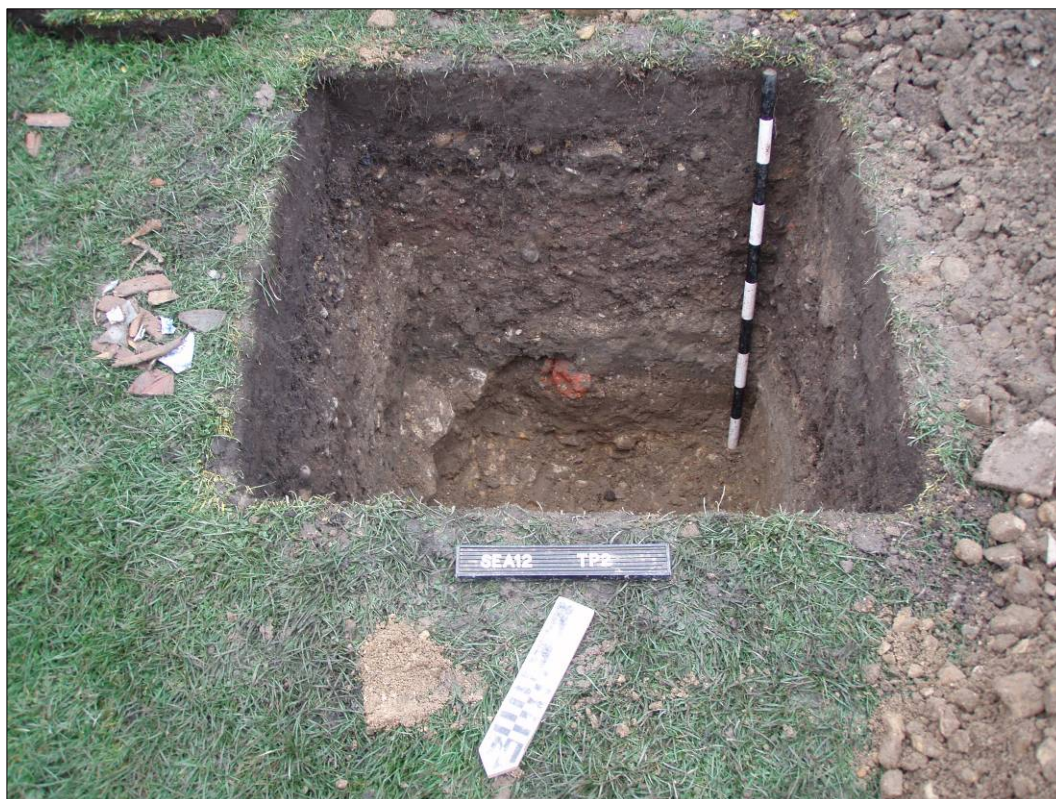
- 6.3.1. Test Pit 2 was located to the north of the north-western wing of the hall, to the east of Test Pit 1, on a turf covered slope. The turf and topsoil consisting of a dark brown silty loam (201), with a depth of approximately 0.19m, was removed to reveal a coarse brown/red silty clay (202) containing pottery fragments, ceramic building materials, glass and bone. This had a maximum depth of 0.2m and overlay a coarse grey/brown sandy clay with frequent stone inclusions and a maximum depth of 0.2m (203). Beneath this deposit a thin layer of crushed grey mortar with a maximum depth of 0.1m (204) was uncovered overlying a deposit of finely textured grey sand with a maximum depth of 0.16m (205). This overlay a coarse yellow grey deposit of construction debris (206) with a maximum depth of 0.07m. This was removed to reveal a coarse pale brown yellow sandy clay with frequent sandstone inclusions (207). This extended beyond the limit of excavation. No discrete features were discovered in this test pit, and the natural substrate was not exposed.

Figure 8 Test Pit 2.

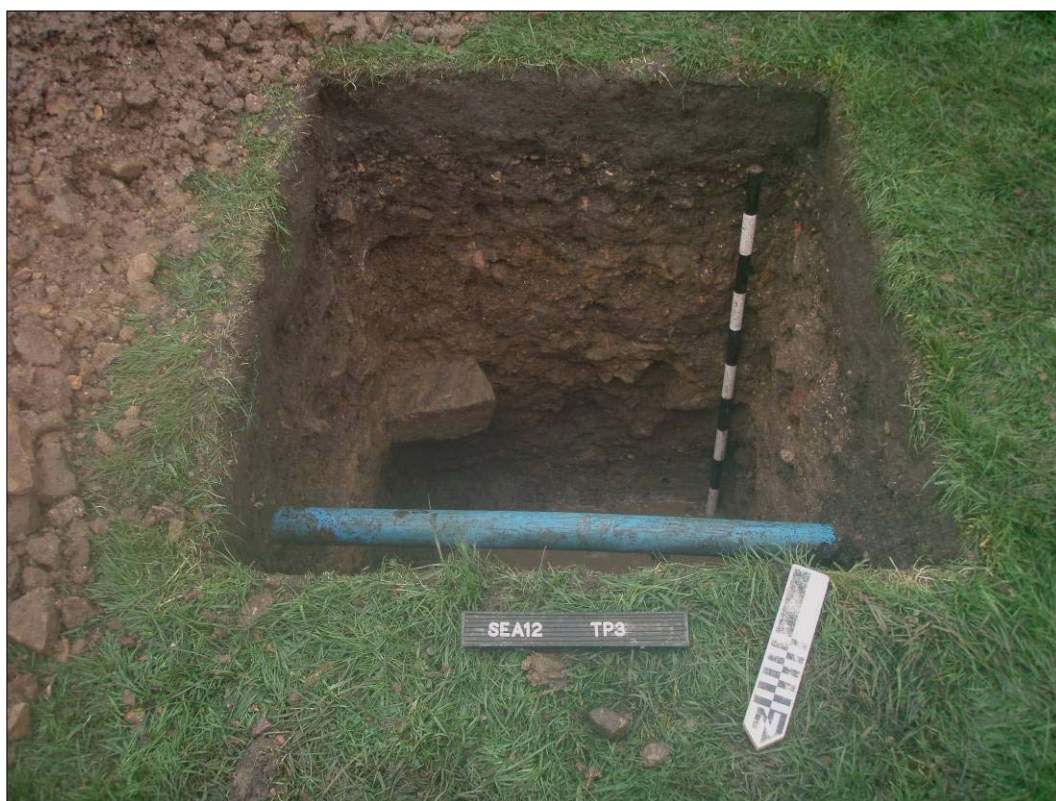
- 6.4.1. Test Pit 3 was located to the north of the west wing of the hall on a turf covered slope. The turf overlay a green plastic mesh and was removed to reveal topsoil

consisting of aerated dark brown sandy clay with a maximum depth of 0.15m (302). The topsoil overlay a coarse grey clayey sand deposit containing a high proportion of demolition debris (303). This had a maximum depth of 0.19m and contained corroded metal nails, pottery fragments, ceramic building materials and bone. A current blue plastic water pipe was also uncovered within this deposit (303). Beneath the demolition debris a coarse grey clayey sand (304) was uncovered. This contained further demolition debris and had a maximum depth of 0.19m. Context (304) overlay a coarse grey clayey sand containing frequent sandstone chips with a maximum depth of 0.26m (305) which was removed to reveal a deposit of large sandstone rubble blocks within a shallow grey silt matrix (306). This had a depth of approximately 0.2m and overlay a pale brown clayey sand with few inclusions (307). This layer extended below the limit of excavation. No features were discovered in this test pit.

Figure 9 Test Pit 3

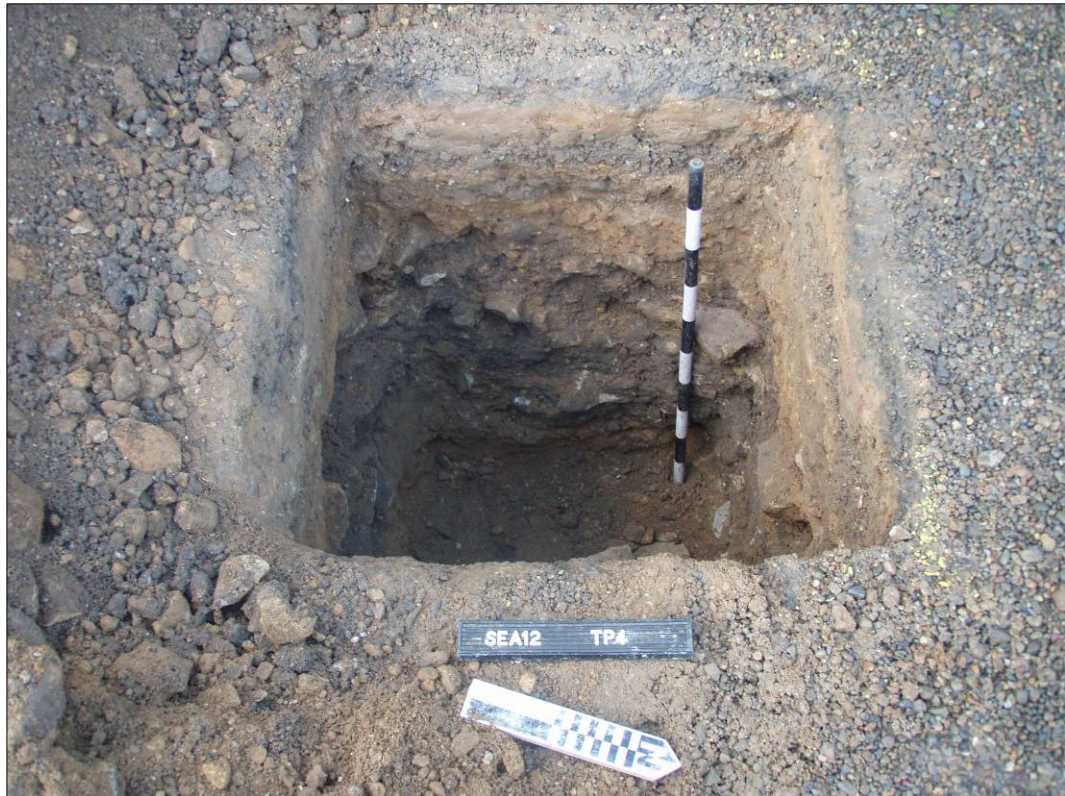
- 6.5.1. Test Pit 4 was located within the courtyard area to the east of the west wing of the hall, on a level gravel surface. The pea gravel lay within a dark grey silt deposit (401) and had a maximum depth of 0.07m. This was removed to reveal a coarse orange sand containing small angular sandstone chips (402) with a depth of 0.09m. Beneath this layer was a coarse orange-brown sandy clay containing gravel-sized stone inclusions with a depth of 0.09m (403), which was removed to reveal a coarse orange deposit of compacted crushed sandstone with a depth of 0.05m (404). Context (404) overlay a grey orange sand deposit with small rounded stone inclusions and a maximum depth of 0.07m (405) in turn overlying a thin orange sand deposit containing small stone fragments with a maximum depth of 0.07m (406). Beneath this deposit, large sandstone rubble blocks were uncovered within an orange brown silt matrix (407). This matrix had a depth of 0.2m and was removed to reveal a dark grey sandy silt with frequent stone inclusions and flecks of charcoal (408). Context (408) had a depth of 0.28m and contained bone and a corroded metal object. Beneath this deposit an orange brown sand containing gravel-sized stones and sand stone chips was uncovered (409). This extended below the limit of excavation. No features were discovered in this test pit.

Figure 10 Test Pit 4

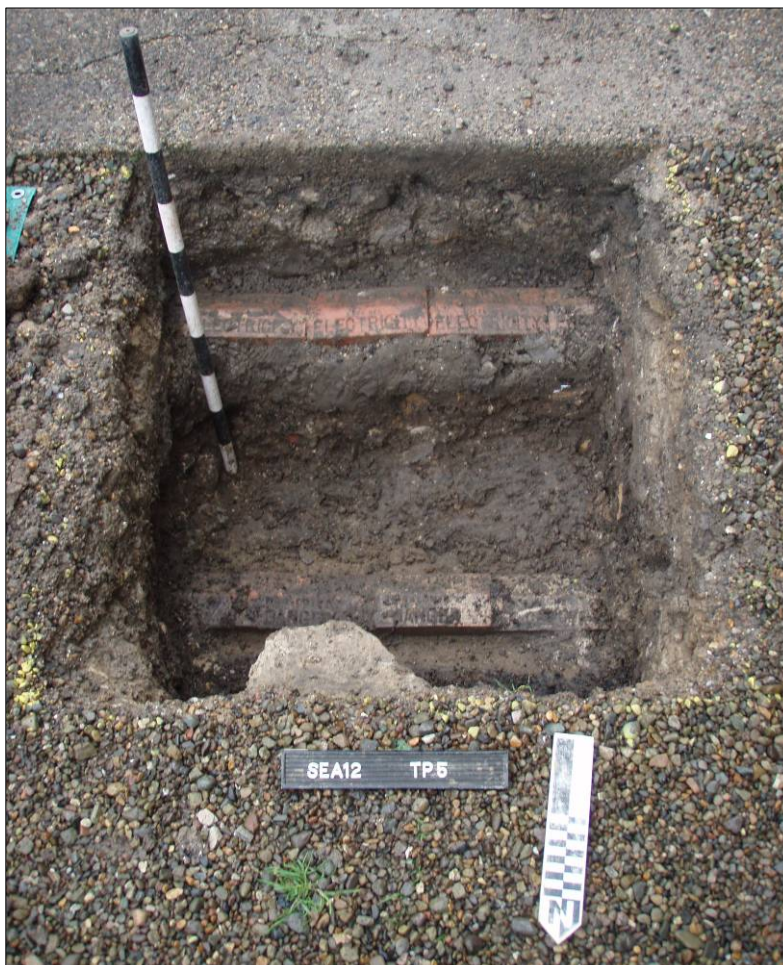
- 6.6.1. Test Pit 5 was located within the courtyard area to the north of the concrete path and east of the west wing of the hall, on a level gravel surface. The concrete path (501) had a depth of approximately 0.08m. The pea gravel lay within a dark grey silt deposit (502) and had a maximum depth of 0.07m. This was removed to reveal a brown grey clayey sand containing infrequent pea gravel, with a depth of 0.17m (503). This filled a vertical cut (510) for a live electricity cable (506). The remainder of the test pit contained a yellow sand deposit with frequent sandstone blocks (504). This had a maximum depth of 0.19m and overlay a dark brown sandy clay with frequent charcoal flecks. This deposit was cut by a 0.24m wide trench (509) for a second active electricity cable (507) filled with yellow grey sand (508). Excavation of this test pit was stopped at the level of the second electricity cable. Deposit (504) extended beyond the limit of excavation.

Figure 11 Test Pit 5

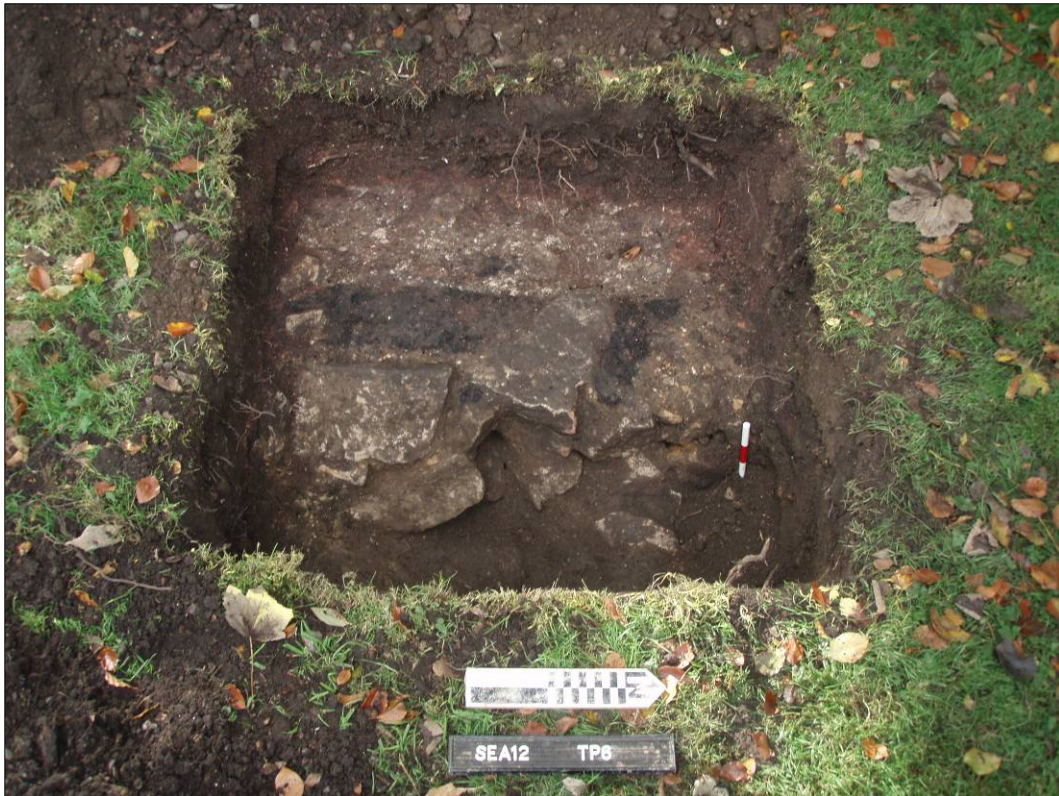
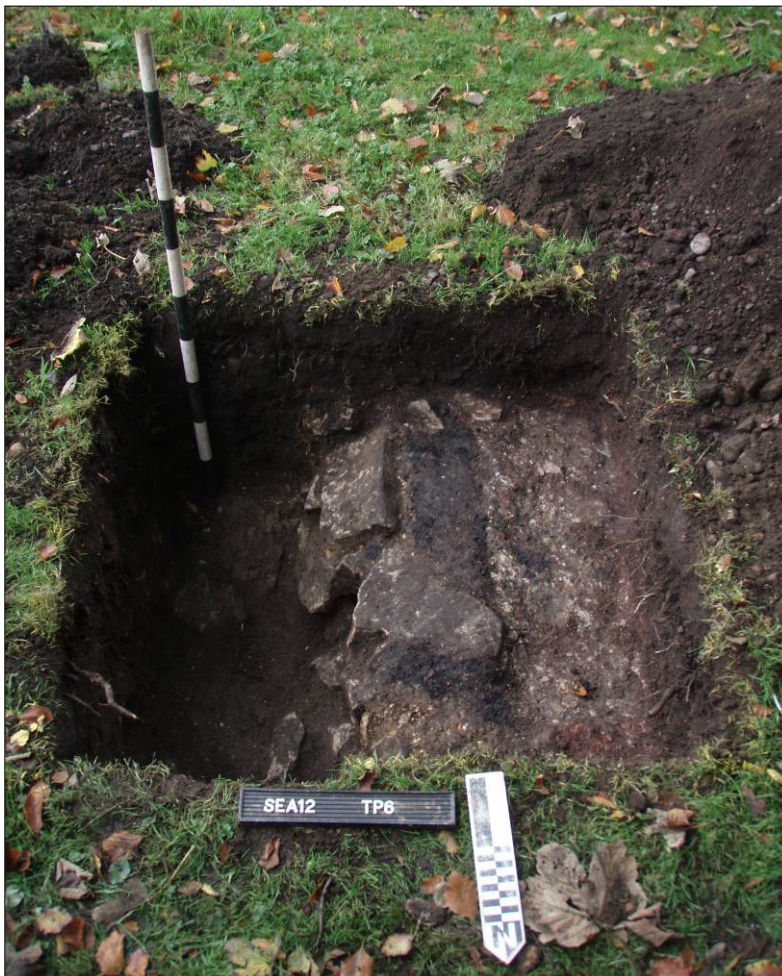
- 6.7.1 Test Pit 6 was located adjacent to the public footpath leading to the Church of Our Lady, immediately inside the area of the ha-ha associated with the hall. The turf and topsoil consisted of dark brown silty loam (601), with a depth of 0.01m. It was removed to reveal a shallow layer of gravel within a blackish silt matrix (607). This had a depth of 0.07m and overlay a deposit of fire reddened stone, possibly degraded sandstone (602). Context (602) had a depth of 0.02m and overlay a deposit of black ashy silt with flecks of brick or tile (603). This had a depth of 0.02-0.04m and was removed to reveal a mid-brown silty clay with frequent large stone inclusions (606). Context (606) had a depth of 0.21m and was cut by a vertical construction trench (604) for a large sandstone structure consisting of angular stones bonded in mortar with an area of possible mortar screed (605). This had dimensions of 0.36m in depth and 0.5m in width within the excavated area of the test pit. This feature was left in-situ and formed the limit of excavation.

Figure 12 Test Pit 6.

Figure 13 Test Pit 6.

- 7.3. Test Pit 6 contained sandstone rubble wall foundation which may represent the rear side of the ha-ha, being close to the projected line of the ha-ha in this infilled area. Although on balance it appears more likely that this wall foundation represents an earlier structure demolished to make way for the development of the pleasure grounds in this area. The sandstone foundation was overlain by two deposits showing evidence of burning, indicating that this structure may have been destroyed by fire. These burnt deposits were overlain by a gravel surface which is likely to represent a gravel footpath running along the inside, and along the top of, the ha-ha.

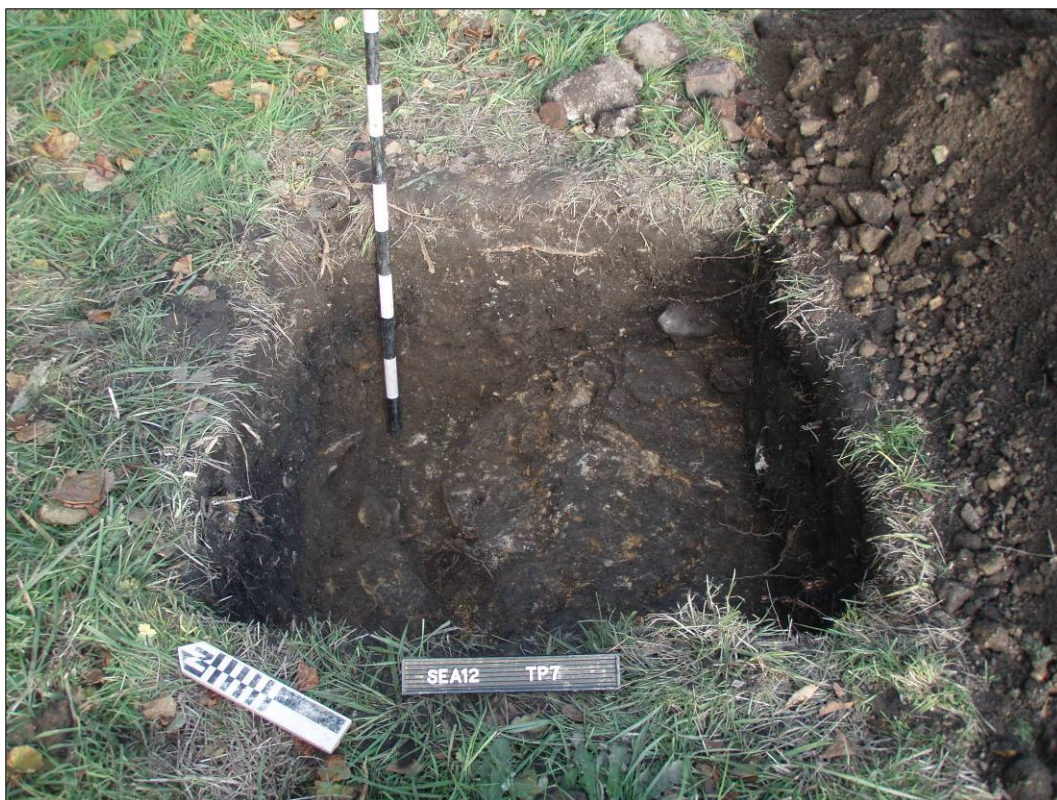
- 6.8.1 Test Pit 7 was located within Hall Farm to the west of the ha-ha associated with the hall, in a grazed paddock. The turf and topsoil consisting of dark brown clayey silt with a depth of 0.27m (701) was removed to reveal a pale brown silty clay with frequent sandstone chips and degraded stones (702). This had a depth of 0.29m and contained glass and corroded metal fragments. This deposit overlay a surface of degraded sandstone slabs or bedrock (703) across the entire test pit and formed the limit of excavation

Figure 14 Test Pit 7.

- 7.4. Test pits 7 and 8 were located within the general area of the cottages, seen on the First Edition OS map, however no evidence of the cottages or their demolition was encountered within the excavated areas. The test pits were excavated onto a sandstone surface (703) and (804). Owing to the small size of the excavation, it was not possible to ascertain whether this surface was laid or whether it represented the natural sandstone solid geology of this area. If it was a laid surface it may be associated with the cottages, however on balance it is more likely that the deposit is the natural bedrock. If this is the case, it indicates that the ground level in this area

has been significantly lowered. It seems most likely that this landscaping coincides with the construction of the ha-ha and the need to level out and reduce the ground to the west of it. This suggests that this stretch of the ha-ha was built into an excavated trench, rather than being built as an upstanding wall and infilled behind. The short section of walling noted in Test Pit 8 (803) is difficult to relate to features noted on the Ordnance Survey First Edition, however it may represent a section of probable garden wall located immediately south of Test Pit 8 on the First Edition map. Taken together with the cartographic evidence, the excavations seem to provide a useful insight into the mode of construction of the ha-ha and would seem to suggest the cottages were located somewhere in the gap between test pits 6 and 7, several metres to the north of their mapped location. This mapping discrepancy would explain the lack of structural evidence in test pits 7 and 8. The discovery of structural remains apparently earlier than the ha-ha in test pit 6 would therefore seem to indicate a structure on the site not only pre-dating the cottages, but the laying out of the gardens at the Hall as well.

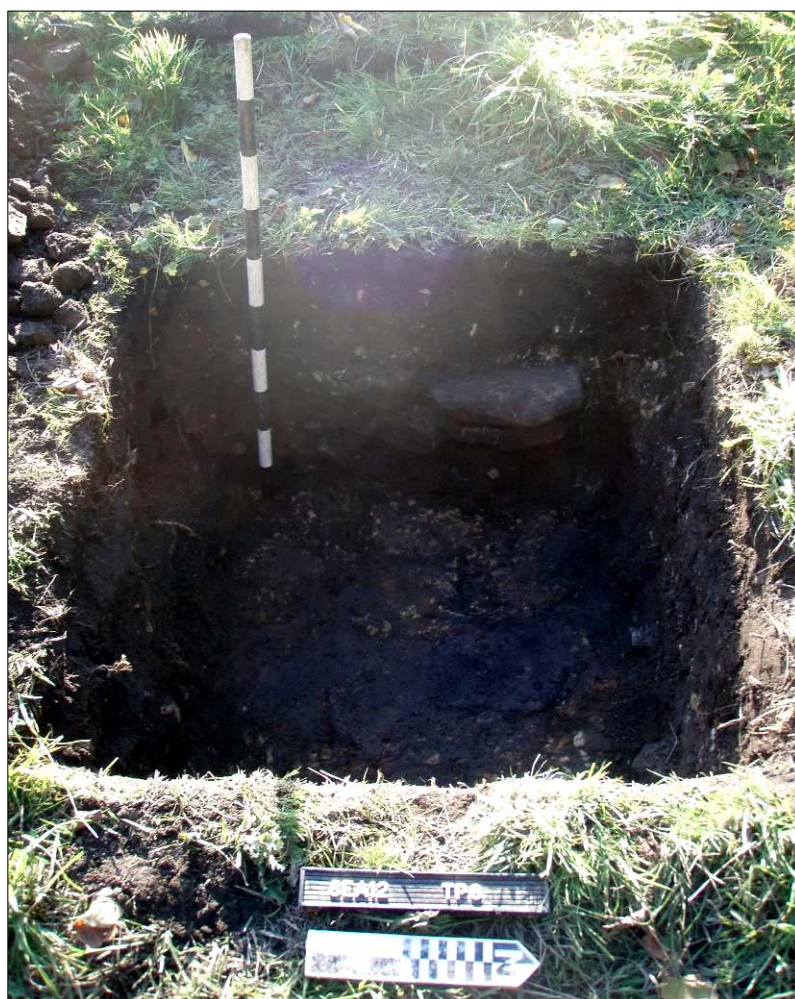
- 6.9.1 Test Pit 8 was located within Hall Farm to the west of the ha-ha associated with the hall and to the south of Test Pit 7. The turf and topsoil, consisting of dark brown silty clay loam with infrequent sandstone chips (801), with a depth of 0.22m was removed to reveal a light-brown grey silty sand containing frequent flecks of mortar, broken bricks and sandstone chips, as well as some larger stones (802). This had a depth of 0.35m and contained pottery fragments corroded metal, ceramic building material, glass and bone. Within this deposit a short section of walling was partially revealed along the eastern section of the test pit (803). This consisted of six rubble stones and was two courses deep, running for an excavated length of 0.6m. No discernable cut for this feature was noted. Beneath this walling (803) and deposit (802) a surface of degraded sandstone slabs or bedrock was revealed across the entire test pit (804) and formed the limit of excavation.

Figure 15 Test Pit 8.
