The Square, Hale Barns, Greater Manchester

Phase 2 Archaeological Evaluation

ARS Ltd Report 2013/103

November 2013

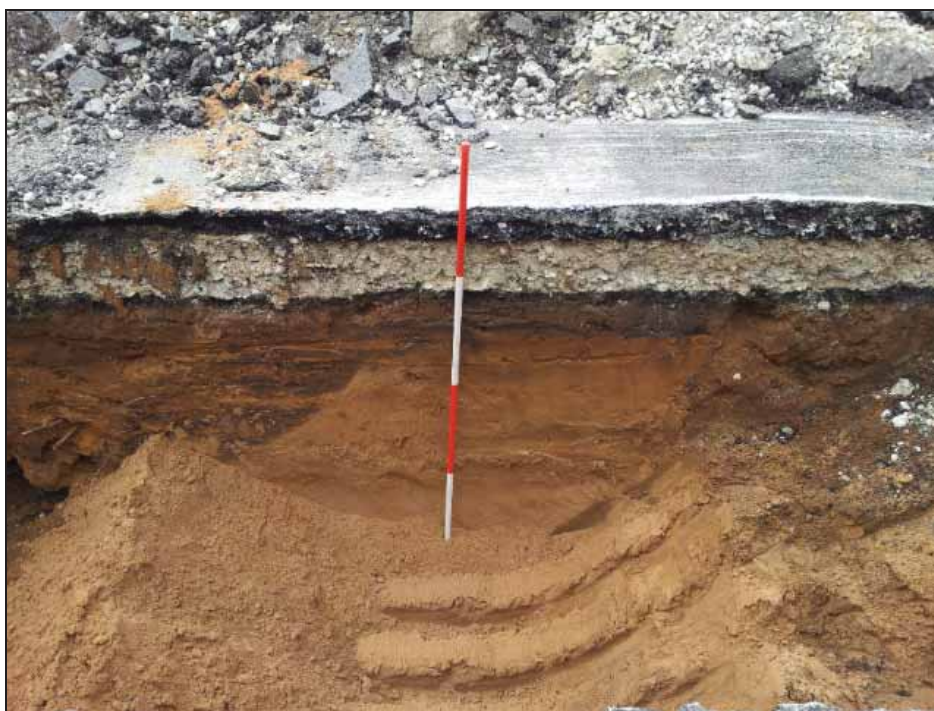
Figure 3. Original excavation depth of trench 1. Note the cut for a water pipe on the left, and the smaller cut for an unknown service trench on the right. Scale 2m.

5.1.2 The stratigraphic sequence consisted of an upper layer of tarmac and associated chalk and gravel bedding (101) c.0.45 metres thick, over a clean sandy deposit (102) comprising fine pale orange sand. Two modern service pipes were observed cut into the sand, one containing a water pipe which is still in use, the other containing unknown services capped with concrete. The trench was originally excavated to a depth of 1.75m (Figure 3) but, after consultation with the Heritage Management Director for the Greater Manchester Archaeological Advice Service, it was excavated further to a maximum depth of 2.25m in order to determine the extent of the sandy deposit. The excavation could not continue beyond 2.25m due to fears of undermining the existing service pipes, and at this depth the sand continued beyond the base of the trench.

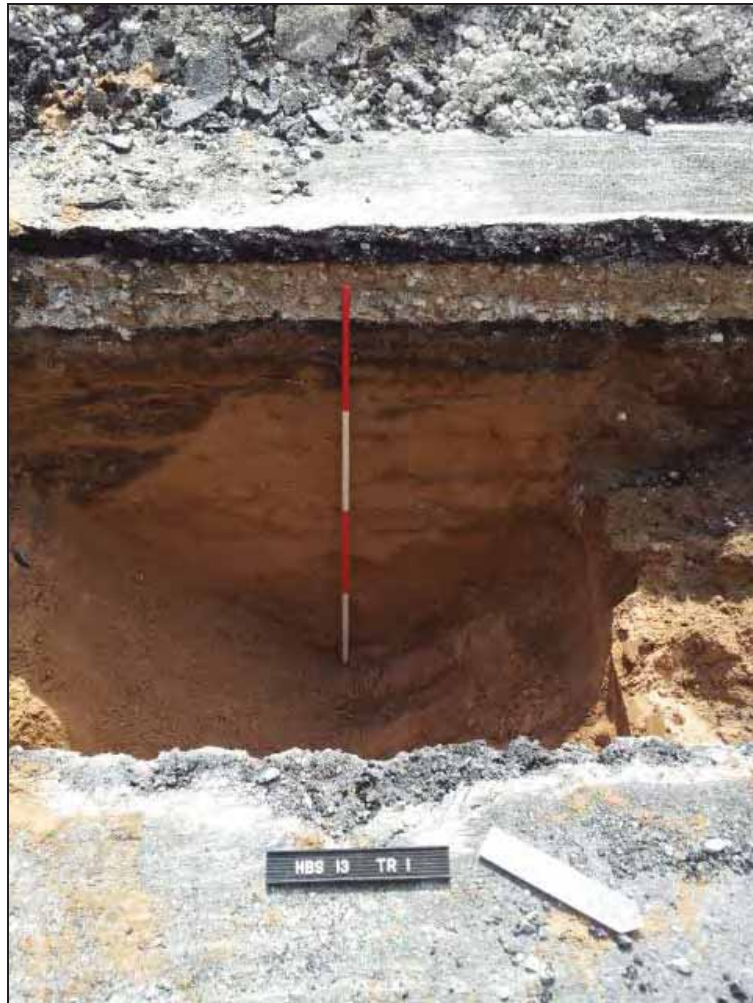
Figure 4 Final excavation depth of trench 1. Scale 2m.

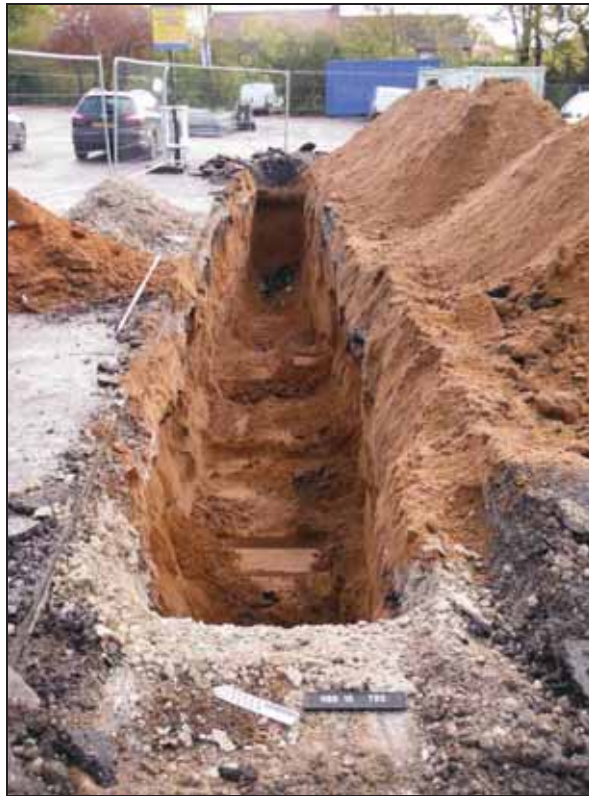
Figure 6. Trench 2. Scale 2m.

5.2.2 The stratigraphic sequence consisted of an upper layer of tarmac (201) and associated chalk (202) and gravel (203) bedding ≈ 0.45 metres thick in total, over a clean sandy deposit (204) comprising fine pale orange sand. Following pre-commencement consultation with the Heritage Management Director for the Greater Manchester Archaeological Advice Service, the trench was excavated deep into the sandy deposit in order to establish its character and extent. The sand reached a maximum thickness of 2.1m, and continued beyond the base of the trench. It was determined that at such a depth the deposit is likely to be natural rather than made ground, also supported by the clean and sterile nature of the deposit.

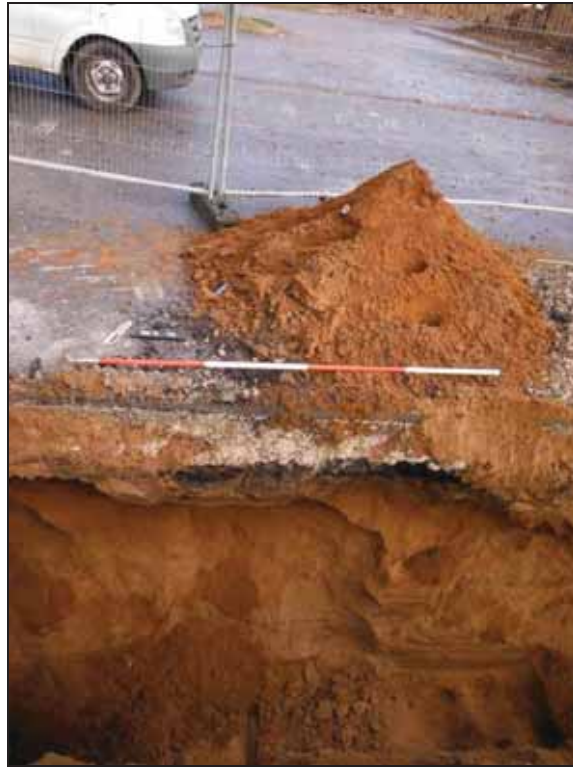
Figure 7. Example section of Trench 2. Scale 2m.

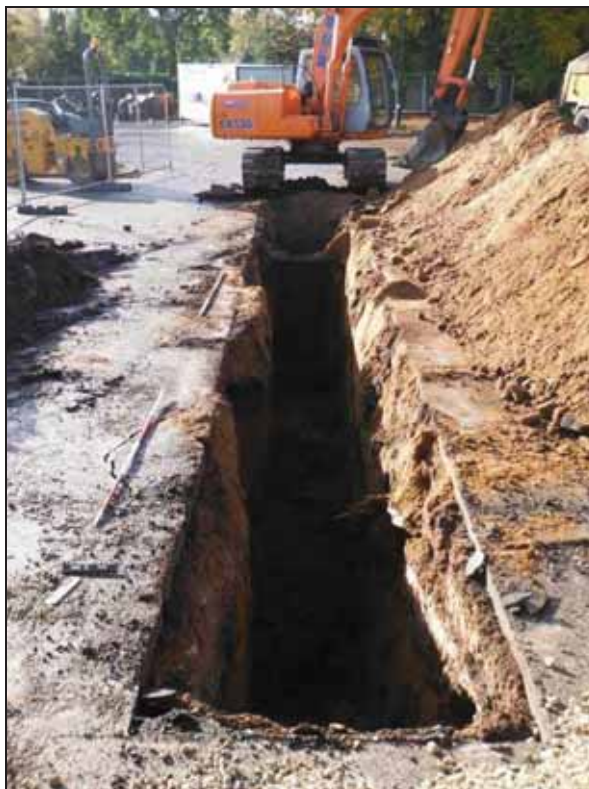
Figure 9. Trench 3. Scale 2x2m.

5.3.2 The stratigraphic sequence consisted of an upper layer of tarmac (301), upper made ground (302), concrete levelling layer (303) and lower made ground deposit (304) overlying the natural fine pale orange sand deposit (305). An electric cable associated with the electrical lighting for the car-park of the shopping complex was observed aligned south-east to north-west in the southern end of the trench.

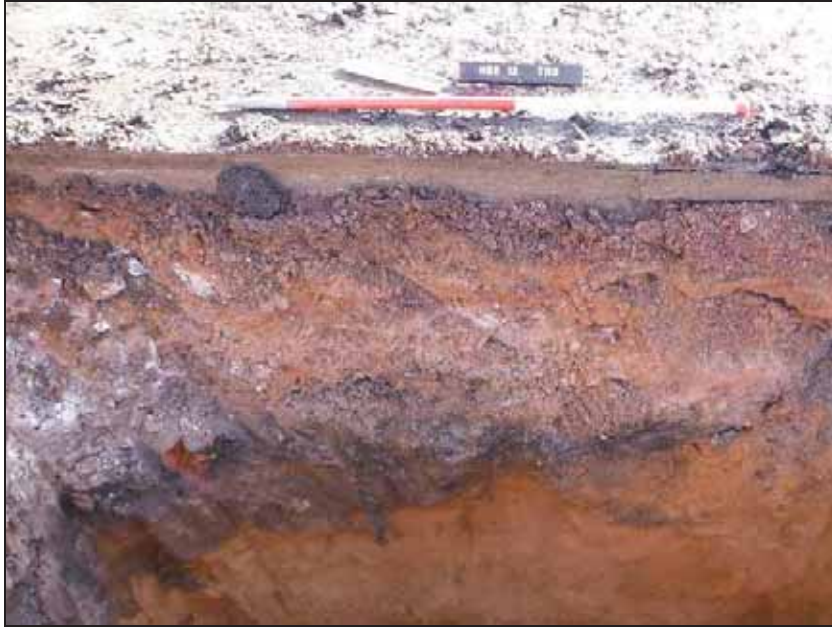
Figure 10. Section of the northern end of Trench 3, displaying enhanced levelling and compacting material associated with the construction of The Square shopping complex. The dark made-ground deposit (304) directly overlying the natural sand (305) was present across the entire length of the trench, although is obscured somewhat to the right of this photo by natural sand transferred by the machine bucket. Scale 1m.

5.3.3 The nature of the made-ground/bedding deposits were noticeably different to those in Trenches 1 and 2, containing a higher proportion of rubble and building debris and being slightly thicker, measuring in total c.0.95m from the ground surface to the top of the natural sand, in contrast to Trenches 1 and 2 where the distance from the top of the tarmac to the top of the natural sand was approximately 0.45m in each trench. As the north-eastern end of Trench 3 was located within 5 metres of the main Square shopping centre building, the thicker made-ground/bedding ((302) and (304)) and presence of concrete (303) in this trench is likely to represent the intent of compacting and stabilising the natural underlying sand (305) before the construction of the building.

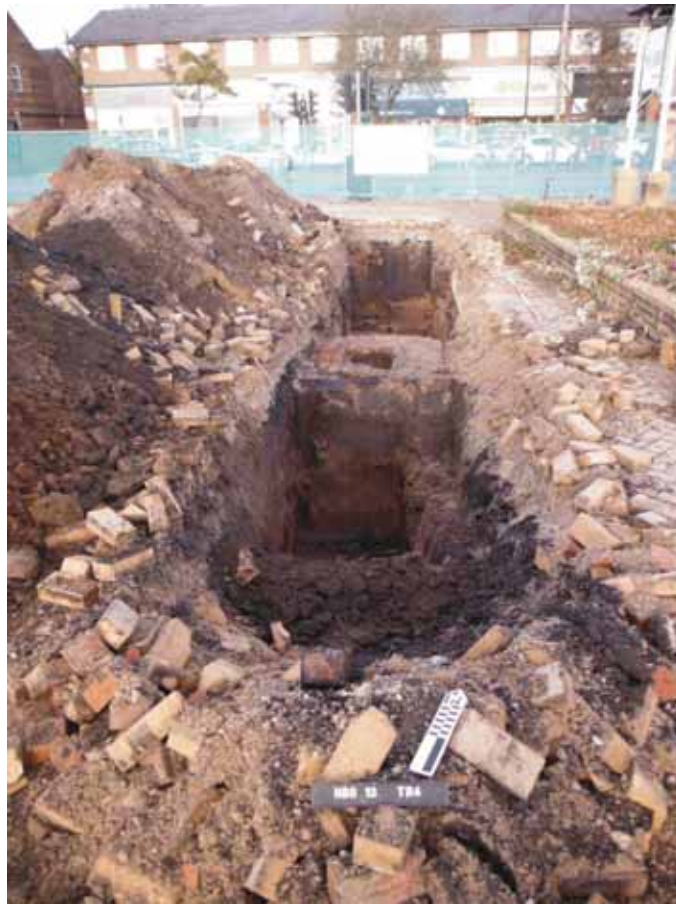
Figure 12. Trench 4. Scale 2m.

5.4.1 Trench 4 was located in the northern area of the site, in the current pedestrian entranceway to The Square shopping centre. Due to the presence of live gas pipes in close proximity to the trench, and the current demolition works restricting the possibility of re-locating the trench away from the gas pipes, the trench had to be shortened slightly to safeguard the pipes. Ultimately, the trench measured 12.8m in length and 1.6m in width.

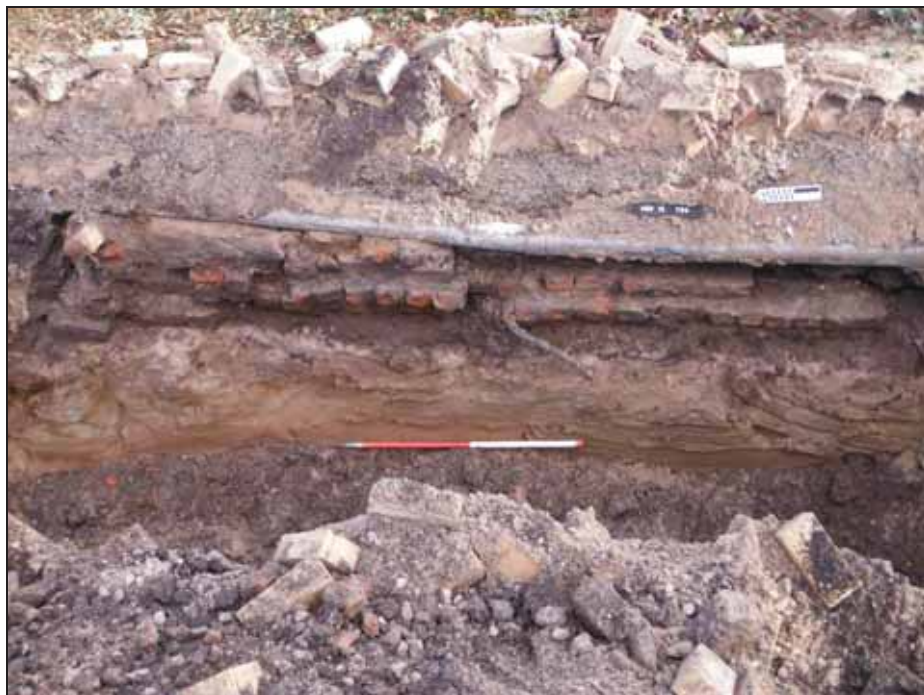
Figure 13 Wall (405), trench 4. Scale 1m.

5.4.4 Within deposit (404) two red-brick structures were present. Wall (405) was aligned roughly north-east to south-west and comprised plain, unfrosted wire-cut bricks, a maximum of four courses thick with cement mortar. The edge of the wall was situated in the section of the eastern side of the trench; due to the proximity of this side of the trench to known live gas pipes, it was not possible to extend the excavation in order to determine how thick the wall was. An electrical pipe was situated on the upper surface of the wall and is thought to be related to the car park lighting of the shopping centre. The wall ran for approximately 3.04m, although at both ends appeared to be truncated rather than terminating. Structure (406) was located to the south of wall (405), and although the two were not connected the brick type and cement mortar of (405) and (406) are identical; hence they are likely to be contemporary. Structure (406) was a square-built structure with a central hollow, 3 sides of which were 3 courses thick with the northern end being only a single course thick. The structure measured 1.52m in length (north-east to south-west) by 1.25m in width (south-east to north-west), although it should be noted that the full width is unknown as the feature continued into the trench section edge. The inner square hollow measured 0.80m by 0.42m. The width of each side of the structure varied, however it did appear somewhat disturbed, with substantial cement mortar over the upper surface of the structure suggesting further upper courses have been removed. Both (405) and (406) were situated within deposit (404), although no clear cut was apparent.

5.4.5 It seems likely that structures (405) and (406) are associated with the terraced houses that are known to have been situated fronting onto Hale Street. The 1876 edition Ordnance Survey map (Figure 20) shows no terraced housing on Hale Street within the site boundary; terraced houses first appear on the 1898 edition (Figure 21) of the Ordnance Survey map in a discontinuous row, with the 1909 edition (Figure 22) displaying a completed row of housing. The 1935 edition (Figure 23) shows the houses still present; however the 1968 edition (Figure 24) displays the houses demolished and The Square shopping centre constructed. Certainly the cement mortar present in both structures would indicate that they are no earlier than the late nineteenth century. Due to the alignment of wall (405), it is likely that this formed a front-to-back aligned wall of a house, or, due to its relative distance from the pavement, perhaps a yard wall. Square structure (406) is likely to have been located outside the back of the house, and may represent the remains of an outbuilding or storage facility. The location of a sewer/drainage pipe within close proximity to this structure may suggest it was a brick-built drain or man-hole.

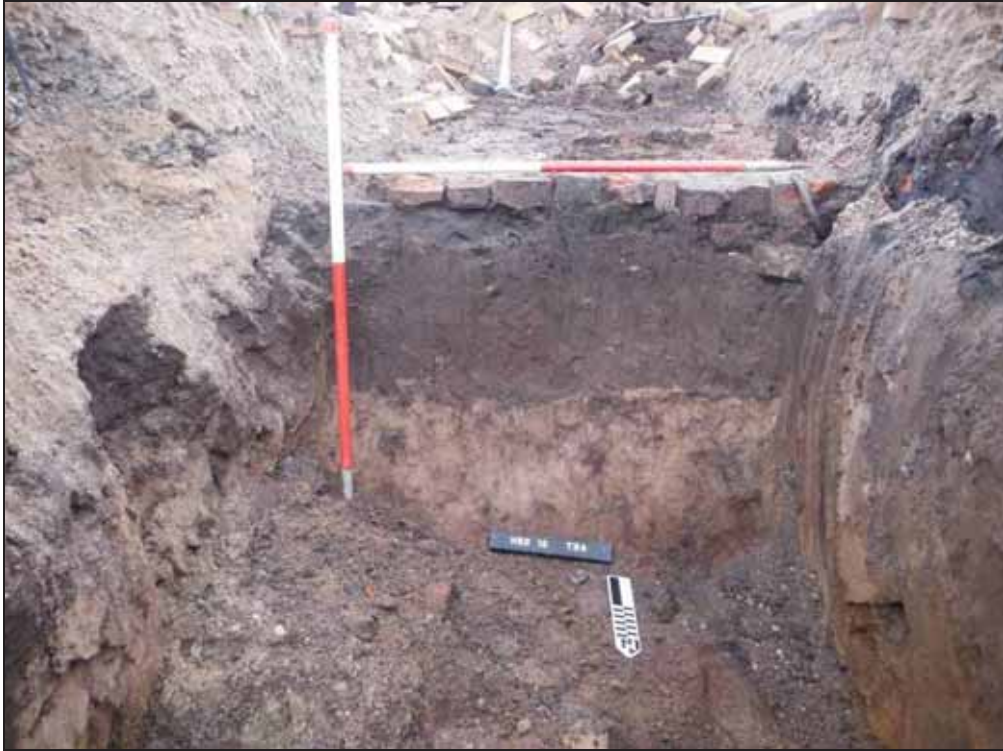
Figure 14. Structure (406), Trench 4, with levelling deposit (404) and natural sand (407). Scale 2x1m.

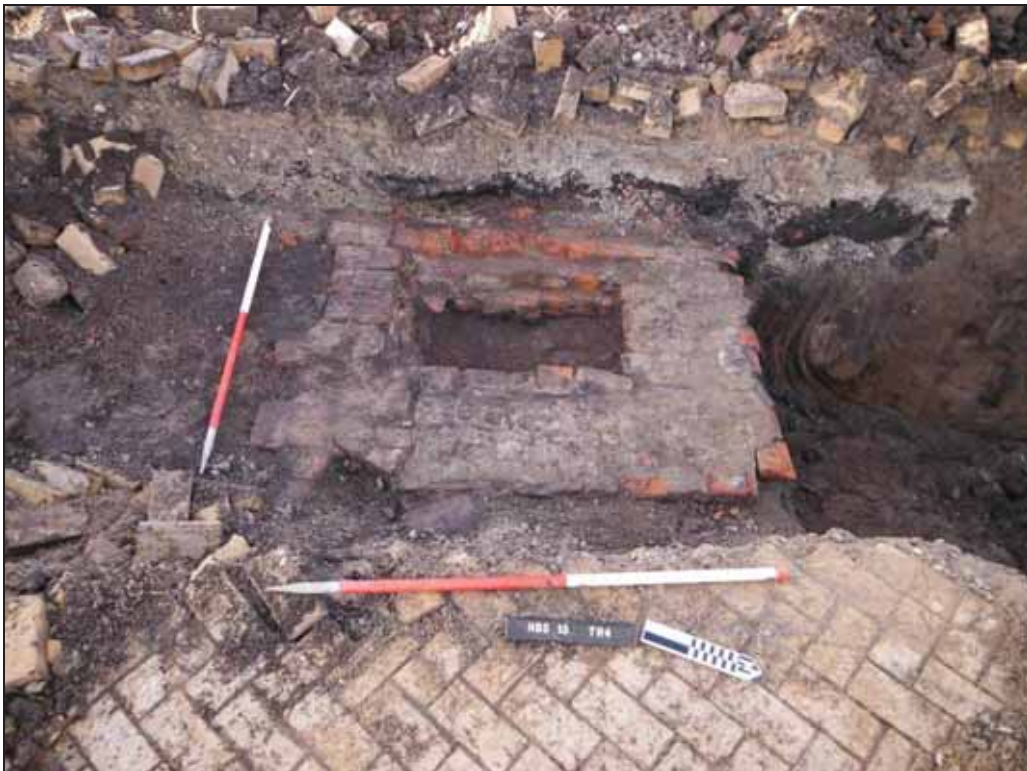
Figure 15. Structure (406), trench 4. Scale 2x1m.

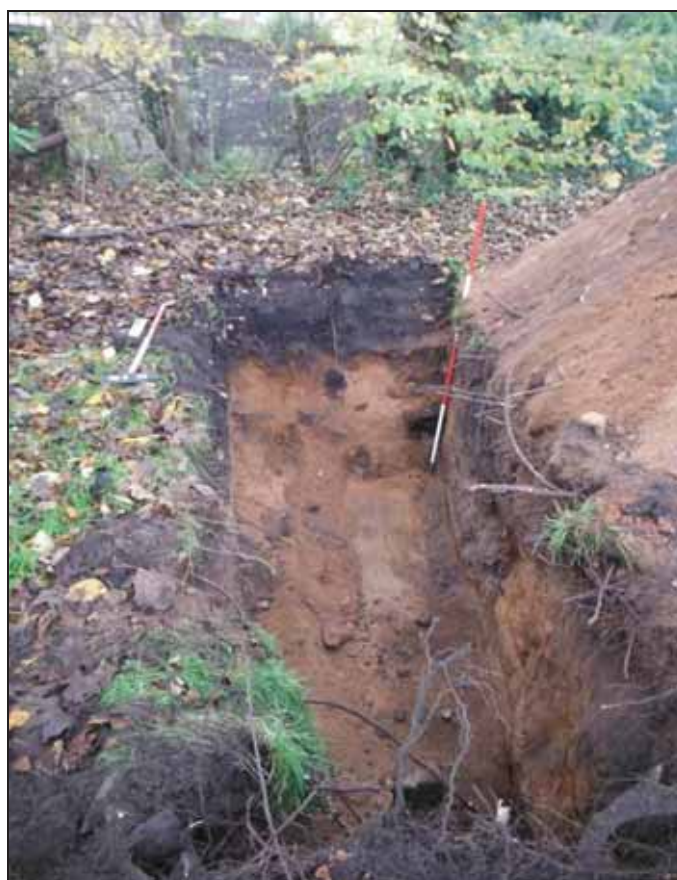
Figure 17. Trench 5. Vertical scale 2m, horizontal scale 1m

5.5.2 The stratigraphic sequence comprised dark brown silty-clay topsoil (501) with an upper surface of grass, measuring 0.65m thick. Directly beneath this was the natural sand (504).

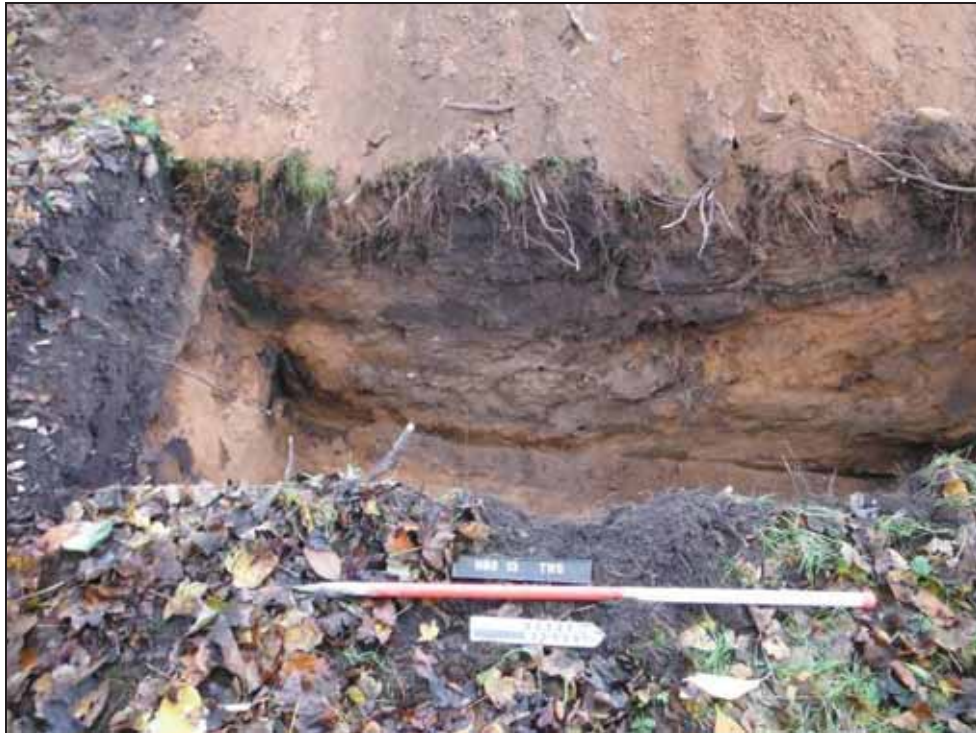
Figure 18 Cut [502] with demolition backfill (503), Trench 5. Scale 1m.

5.5.3 Cut [502] was observed within the natural sand (504), filled with mid brown-grey sandy clay with frequent building debris and cultural material (503). The cut was visible in both trench section edges, suggesting it may be a linear aligned roughly east-west. The cut measured 1.8m wide by 0.80m deep and displayed a shallow U-shaped profile. Nineteenth and twentieth century pottery, clay pipe stems, and glass fragments were recovered from this layer. The 1876 Ordnance Survey map (Figure 20) shows this area as blank, but a building is present in the area on the 1898 edition (Figure 21), which had then been demolished by the 1968 edition (Figure 24). The function of the building is unclear however it is aligned roughly north-south. As cut [502] was visible in both trench section edges the implication is therefore that it may represent the short axis of the known building. It seems likely that after the building was demolished the foundations were backfilled with the demolition material which now comprise demolition deposit (503) within the original foundation cut [502].
