**Rising Sun Public House, Thorne,  
South Yorkshire**

**Historic Building Survey**

**ARS Ltd Report 2013/81**

September 2013

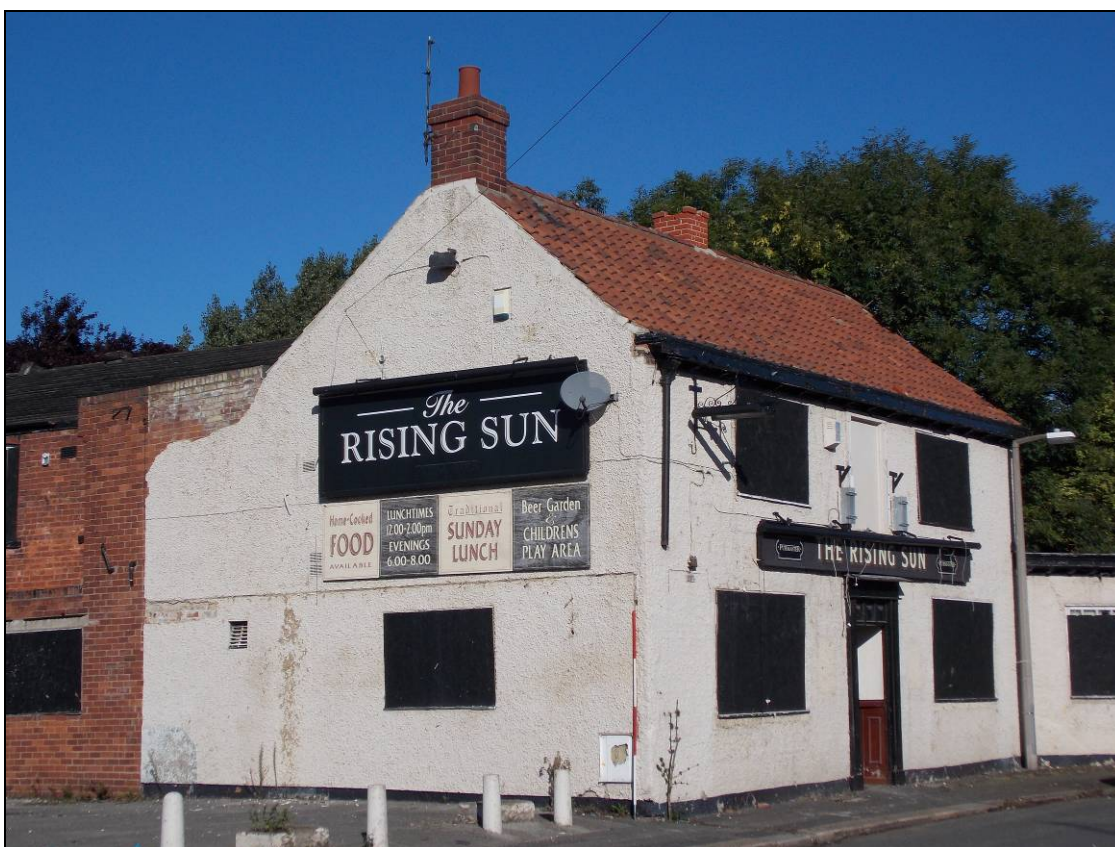
Plate 2: Detail of the main range, looking north-west (scale 2m)

4.1.1 The main original range is a two-storey structure built with reddish brown standard bricks (9" x 4½" x 3") although rendered externally with rough cast. It has a pitched roof with plain close verges and eaves, and two short chimney stacks projecting from the ridge. One of the stacks is positioned to the south end whereas the other is placed in the centre of the ridge and is built with later bricks. The roof is covered with clay pan-tiles although, based on their fairly clean and unweathered condition, they appear to be later replacements (Plate 2).

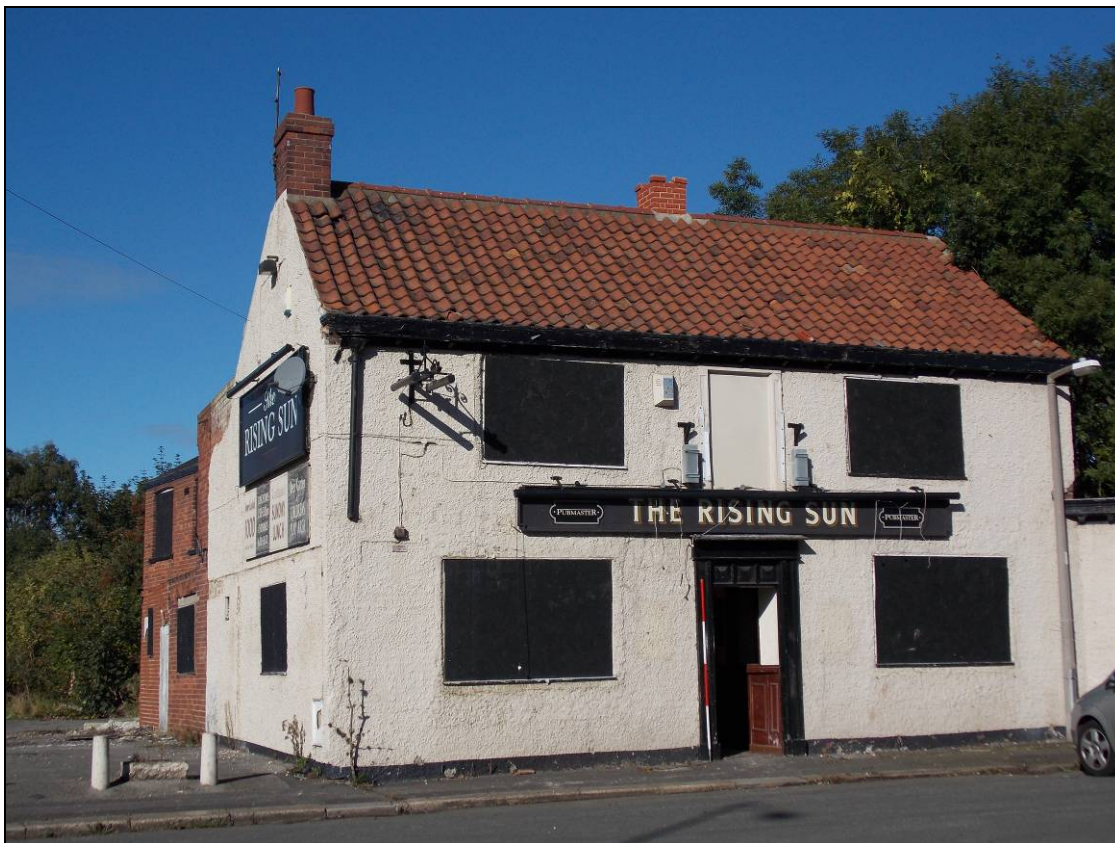
Plate 3: East elevation of the main range (scale 2m)

4.1.2 The east elevation is the main façade facing the main road, which is composed of three bays demarcated by window openings on each side, a central doorway on the ground floor and a possible loading bay or narrower window opening immediately above the doorway (Plate 3). The window openings are plain due to the rough cast and are currently boarded up. Their arrangement is symmetrical although the ones on the ground floor are slightly wider than their counterparts and with irregular vertical alignment between each storey. Remnants of an original cast-iron rain water pipe and wooden gutter are still extant. Recent deterioration of the gutter box has exposed the original brickwork devoid of rendering (Plate 4).

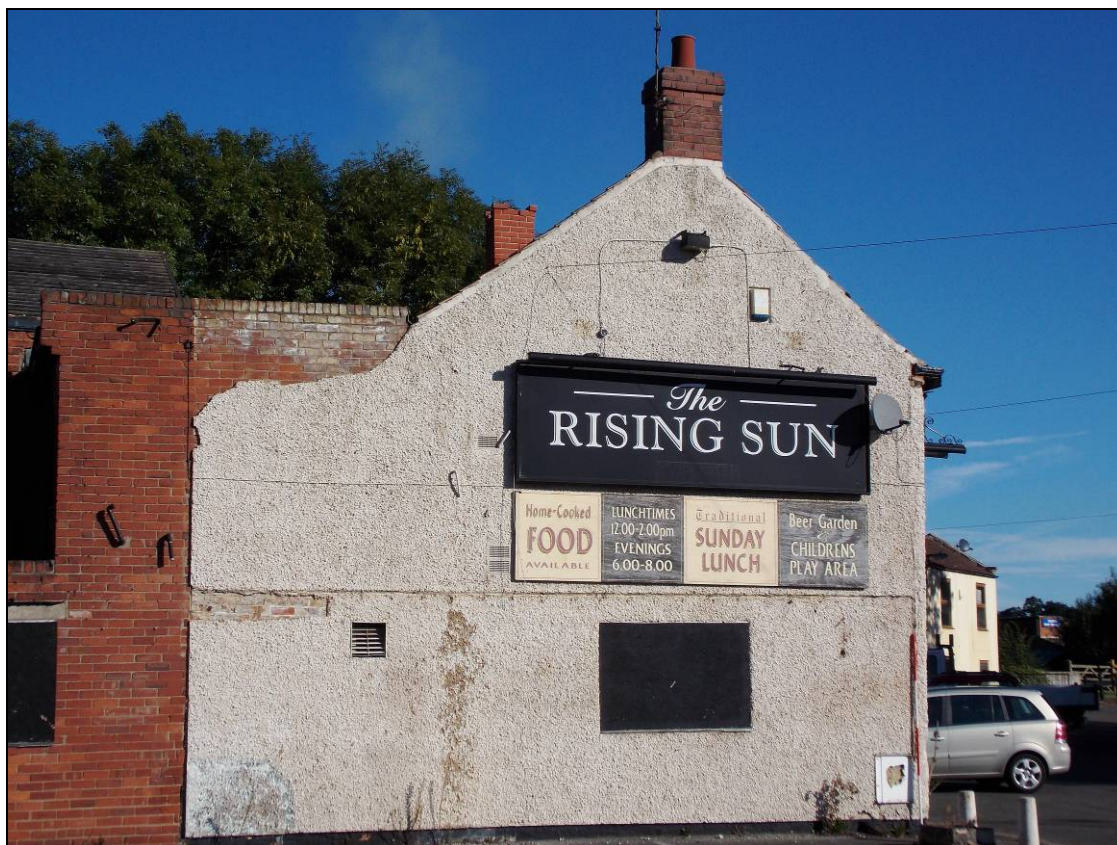
Plate 5: South elevation of the main range (scale 2m)

4.1.3 The south elevation is rather plain with a comparable window opening on the ground floor (Plate 5). The brick-built chimney stack, projecting from the ridge, is flush with the gable wall. Later brick-work, linking this range with a southern extension of the cross-wing, is also rendered with rough cast.

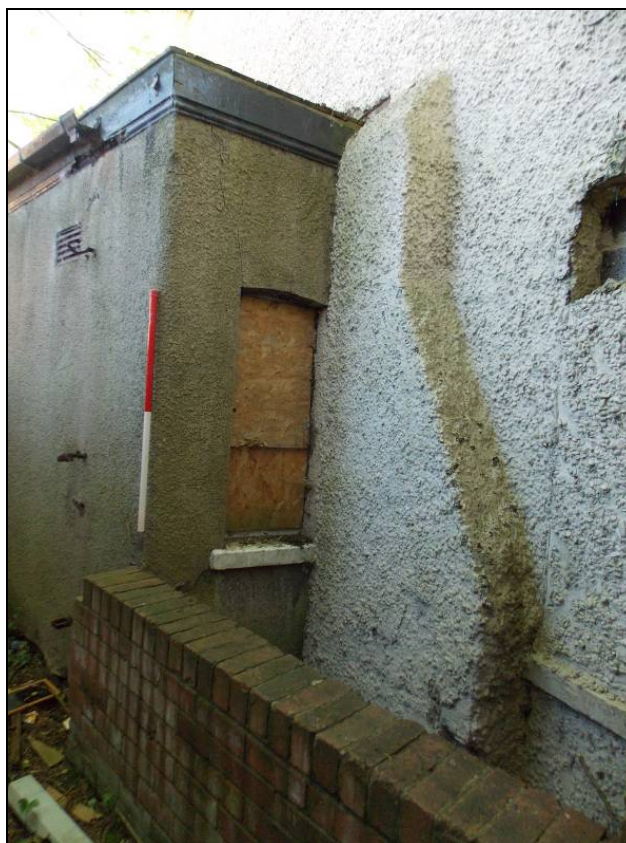
4.1.4 The north elevation is also rendered although partially obscured by a later single-storey extension with a flat roof (Plate 6). The rendered gable wall contains the remains of a truncated chimney stack abutting the brick wall.

Plate 6: North elevation with truncated chimney stack and additional extension, looking east (scale 1m)

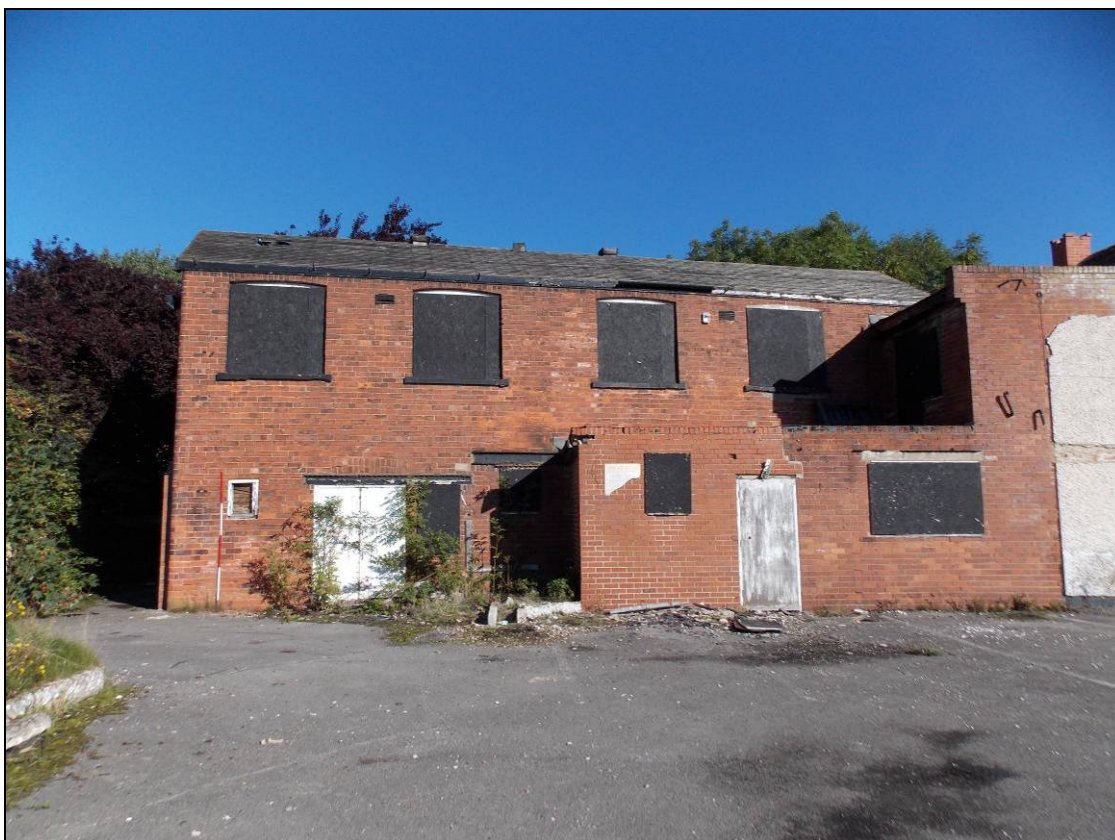
Plate 7: South elevation of the cross-wing (scale 2m)

4.1.6 The south elevation is the main façade facing onto the car park area. The first floor is very symmetrical whereas the ground floor is slightly plainer and has now several later insertions including a single-storey brick-built extension with a flat roof and additional openings. The original window openings of the first floor contain segmental arched heads built with single courses whereas the primary openings of the ground floor have double header courses (Plate 8). The westernmost edges of the brickwork are composed of single bull-nosed bricks.

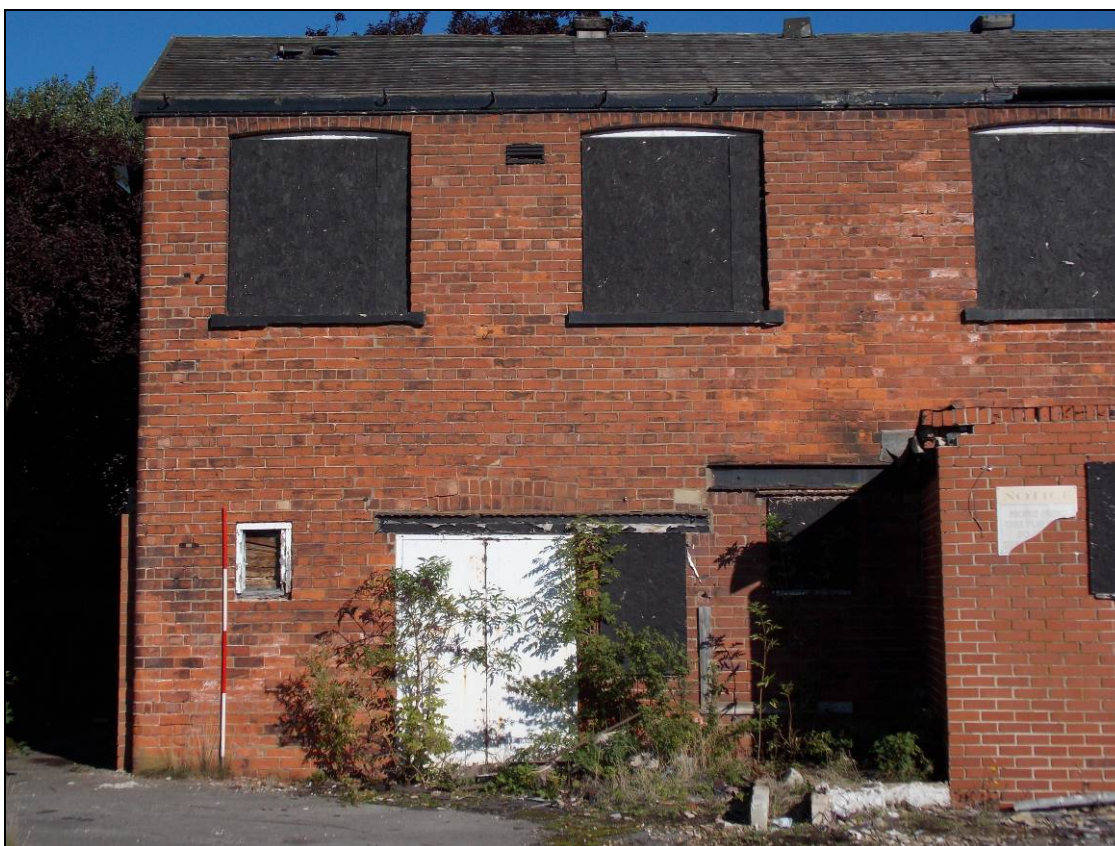
Plate 8: Western end of the cross-wing, looking north (scale 2m)

4.1.5 The cross-wing is a long east/west brick-built range of five bays and two-storey in height containing a pitched roof with plain close eaves and verges. The roof was originally covered with slated tiles although they have been now dismantled (Plate 7). The brickwork is composed of mid reddish standard machine-cut bricks (9" x 4½" x 3") laid in English Garden Wall bond (five stretchers to one of header) and bonded with lime mortar.

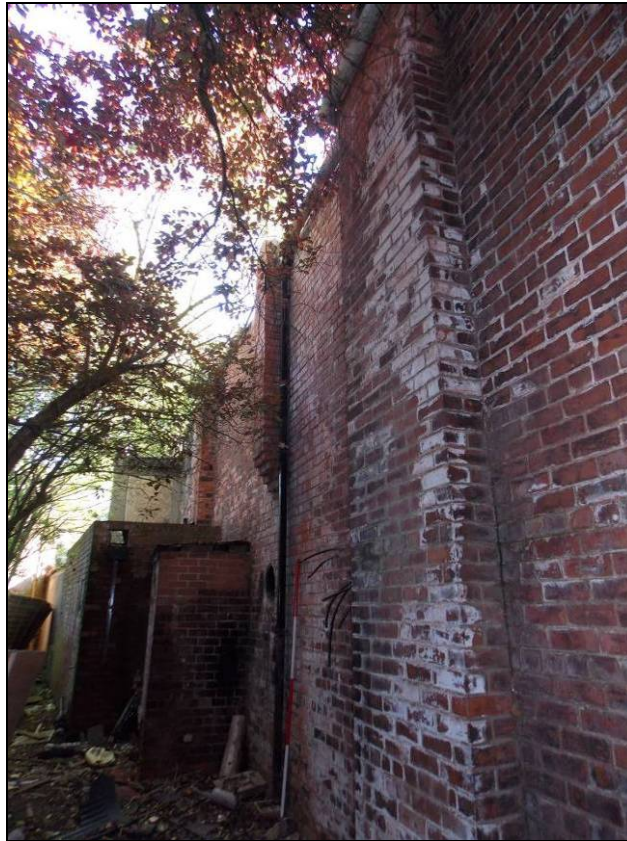
Plate 9: North elevation of the cross-wing, looking east (scale 2m)

4.1.7 The remaining elevations are plainer although the northern wall contains few pilasters and a possible truncated chimney stack (Plate 9).

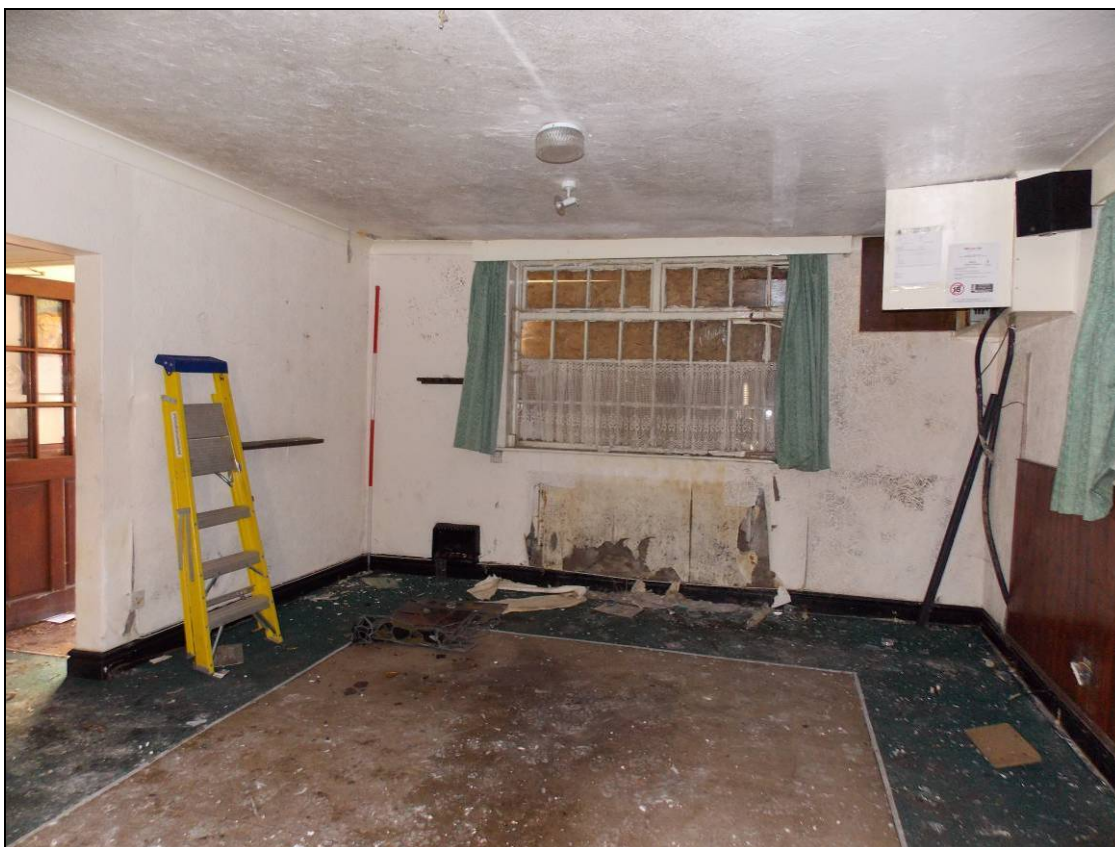
Plate 10: Southern room of the ground floor, looking east (scale 2m)

4.2.1 The interior of the entire public house appears to have been substantially altered through time and is currently in poor condition due to neglect and/or vandalism. The ground floor of the main range is composed of two rooms and a central lobby. The southern room is accessed from the lobby through a plain doorway and is lit by a large window composed of 32 lights and slender glazing bars (Plate 10). The internal fabrics consist of rendered walls covered with decorative paper, concrete floor with carpet and plaster board ceiling. The west wall has been removed and contains an RSJ supporting the upper section of this wall which was originally the external side of the range (Plate 11). The resulting opening leads to a later extension to the south which has a doorway which enables access to an inserted straight staircase for the upper floor (Plate 12).

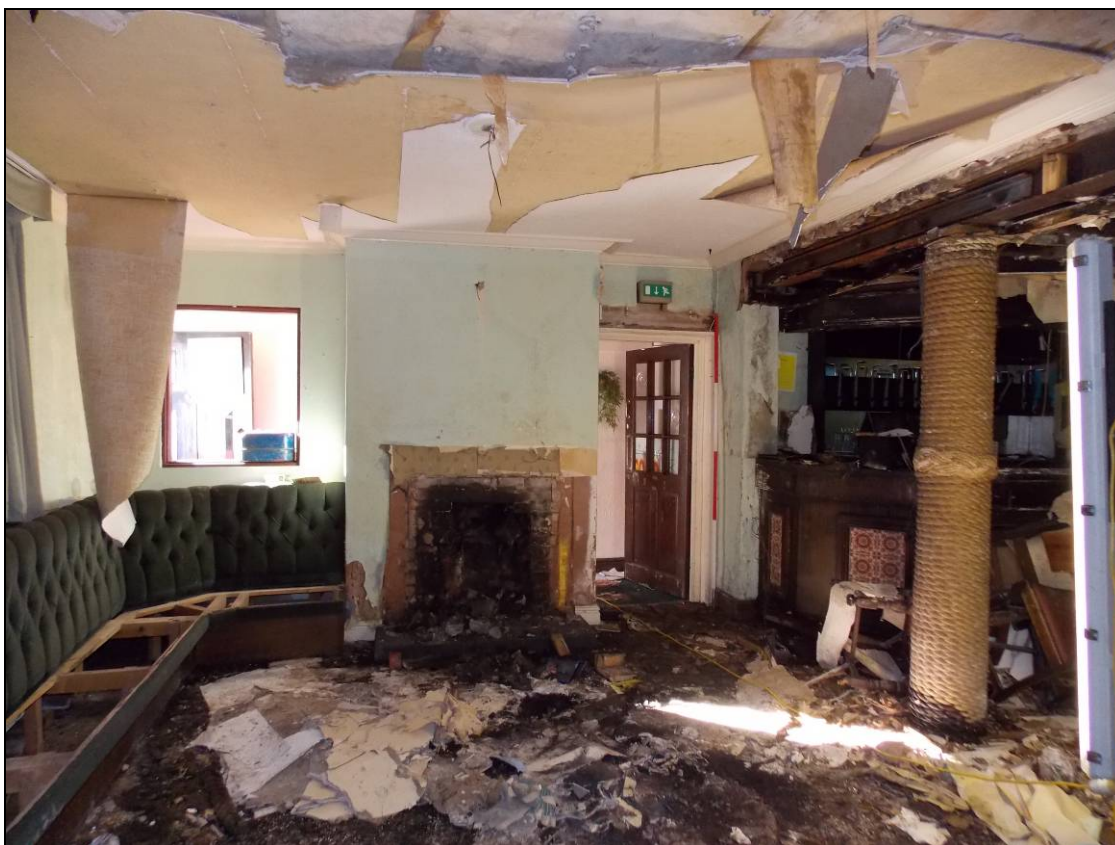
Plate 13: Northern room of the ground floor, looking south (scale 2m)

4.2.2 The northern room is similar to its counterpart although it contains a chimney breast with a fire place within the south wall (Plate 13). The main west wall has also been removed and the RSJ is supported by a stanchion which is encased with decorative ropes (Plate 14). The northern (external) wall of this room has also been removed and the resulting opening links this room with a later small modern extension (Plate 15).

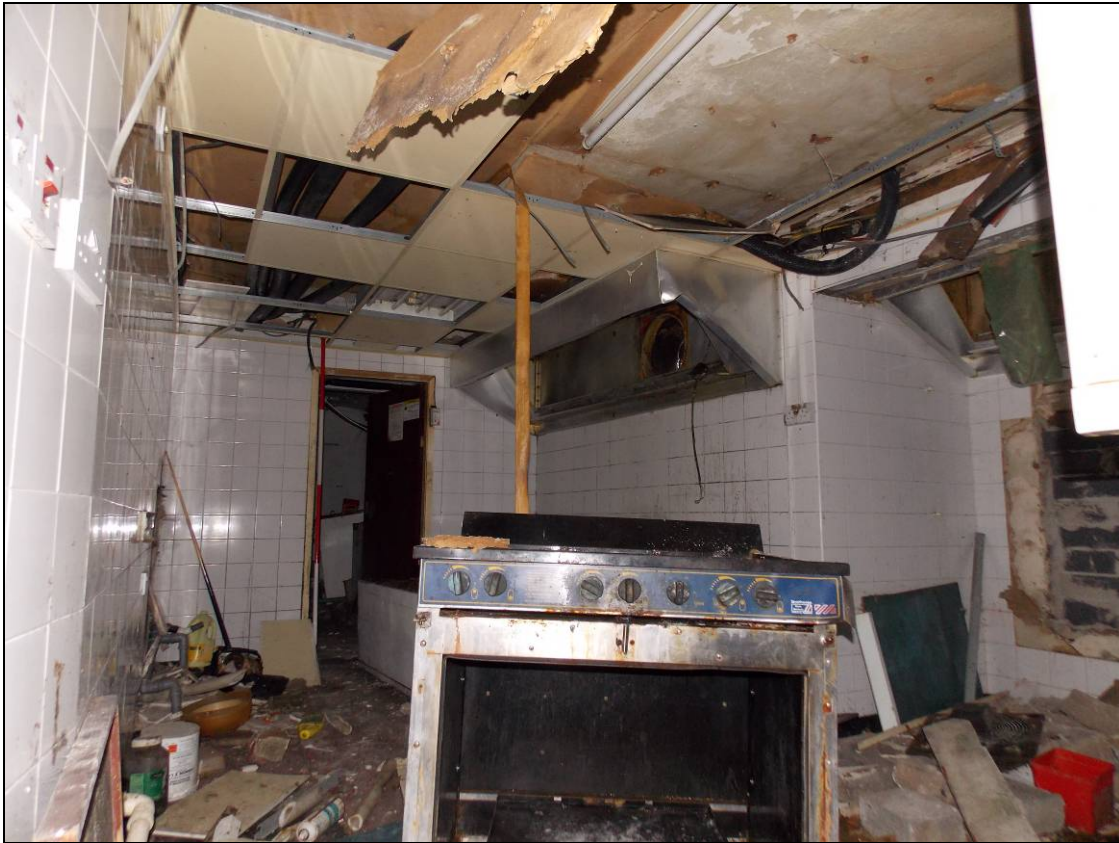
Plate 16: General view of the cross-wing, looking west (scale 2m)

4.2.3 The cross-wing contains a large kitchen (Plate 16) and additional modern rooms such as lavatories and storage areas.

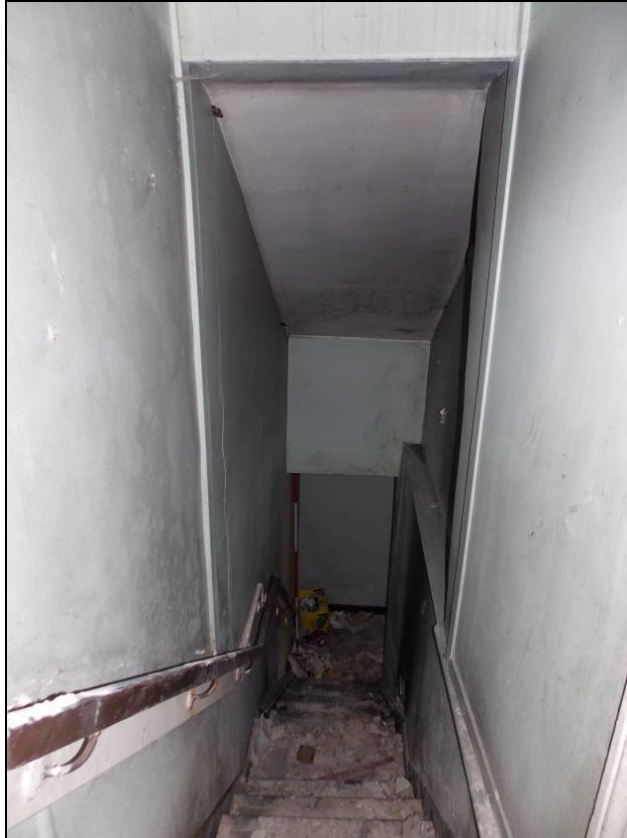
Plate 17: Staircase to the first floor, looking east (scale 2m)

4.2.4 The first floor is accessed from a straight staircase with wooden steps (Plate 17). The location of this staircase is outside the footprint of the original range and thus is a secondary element. The building survey, however, did not identify the original position of the staircase within the main range although based on the lay-out of the rooms; it might have been located within the central bay and between the side rooms. The current staircase enables access to two comparable rooms to the floor below and to the cross-wing to the west.

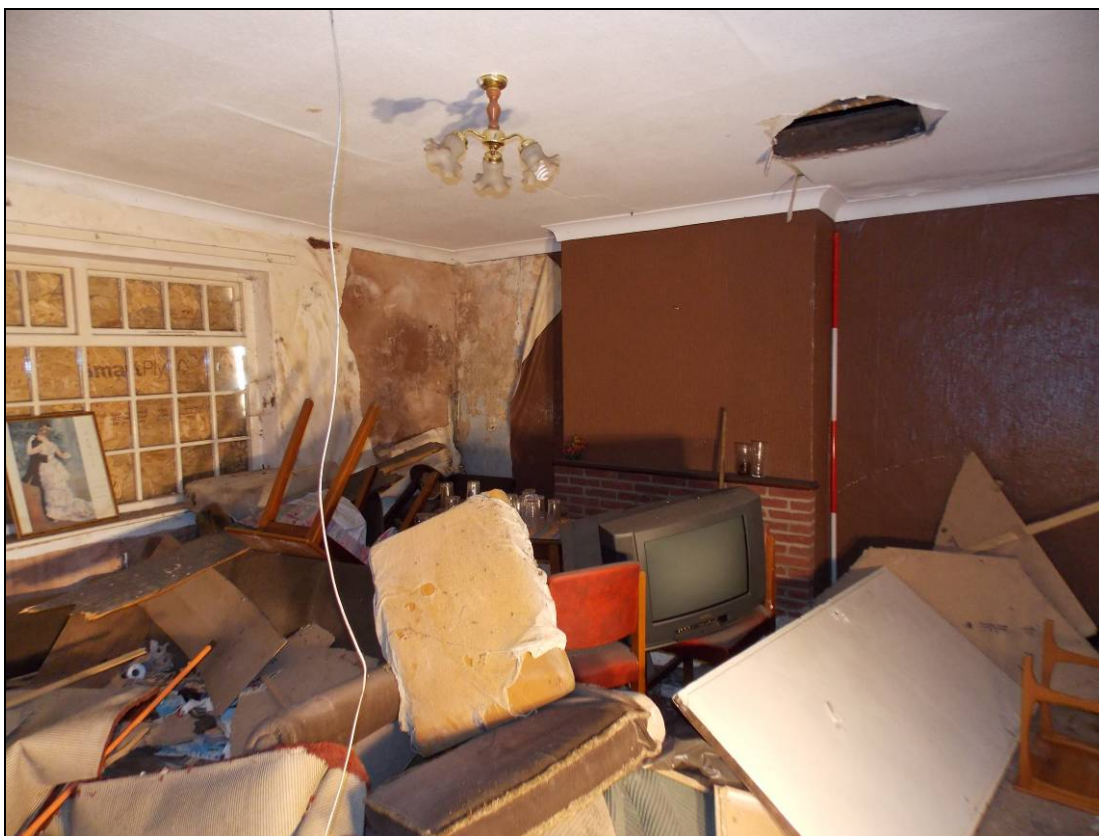
Plate 18: Southern room of the first floor, looking south (scale 2m)

4.2.5 The southern room has a chimney breast with a modern fire place (Plate 18). This room is accessed from a plain doorway within the south wall which also contains a built-in cupboard with a segmental arched head (Plate 19).

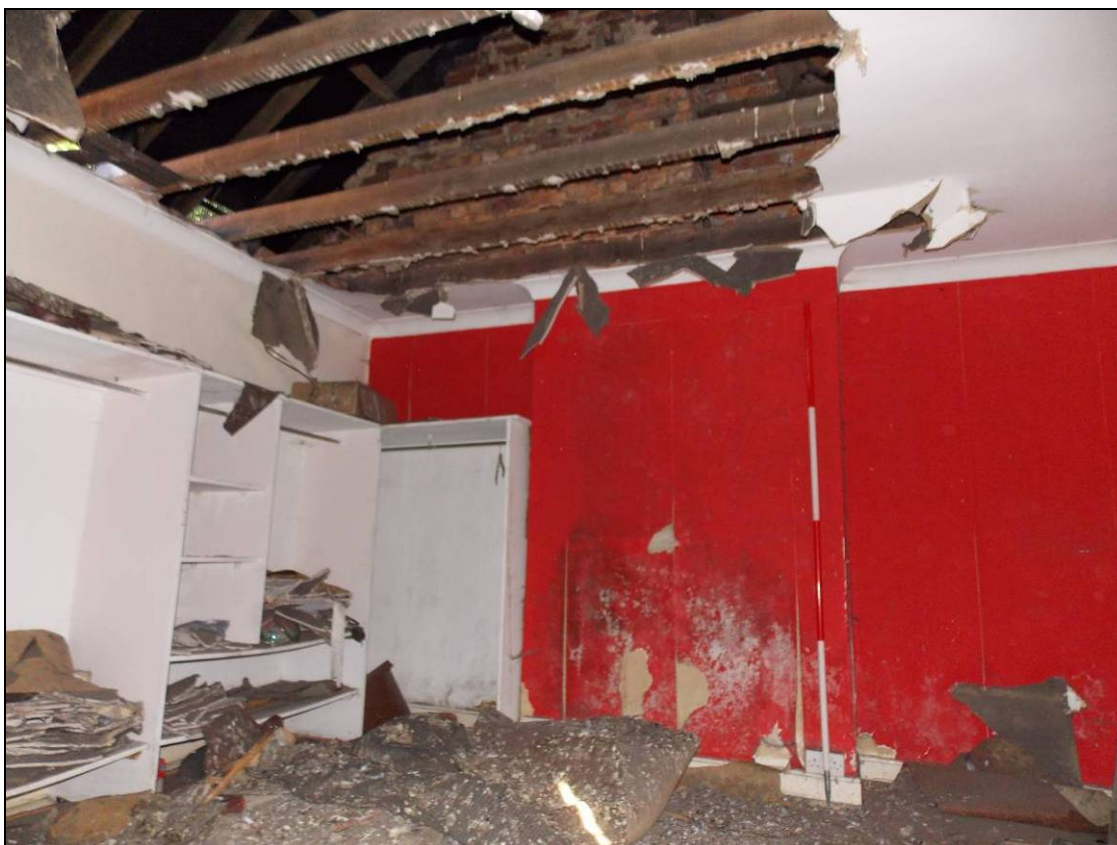
Plate 20: Northern room of the first floor, looking north (scale 2m)

4.2.6 The northern room is similar to its counterpart on the first floor containing a comparable chimney breast within the north end wall (Plate 20). The plaster boards of the ceiling is partially removed, exposing the ceiling joists which contain traces of former lath-and-plaster.

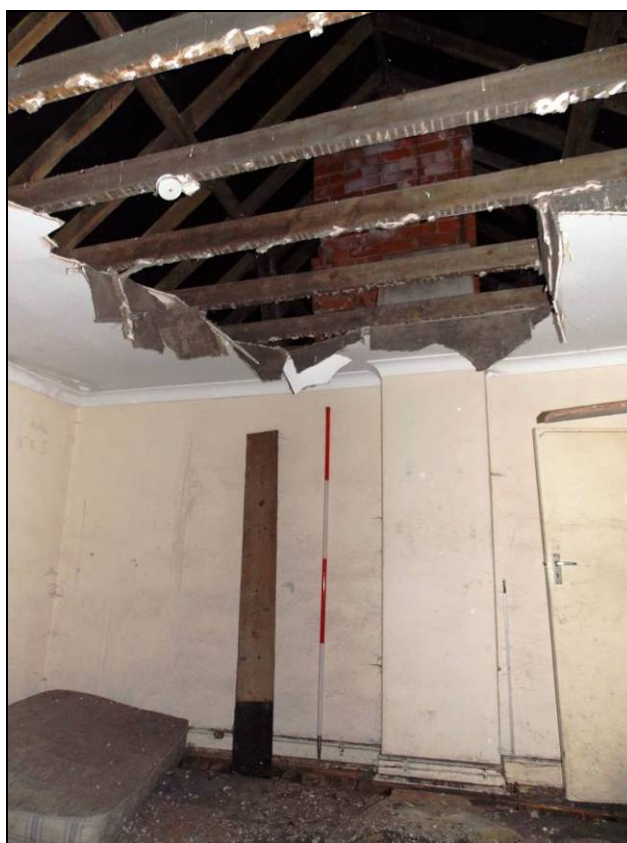
Plate 21: Northern room of the first floor, looking south (scale 2m)

4.2.7 It was also noticed that the roof structure consists of a pair of sawn timber side purlin carrying common rafters. The roof structure appears to be mostly original as indicated by the condition of the timbers except for the battens which would have been replaced when the recent tiles were inserted. The south wall contains the remains of a former chimney breast whose upper section is perceivable over the ceiling joists (Plate 21). The type of brickwork of

this chimney may indicate that this feature was a later insertion rather than being an original component. This feature would have been inserted when the original fire place within north room on the ground floor was removed along with adjoining walls to each side to create the opening between this room and the triangular-shaped single storey extension of the ground floor. Thus the additional fire place was built within the centre of the original building.

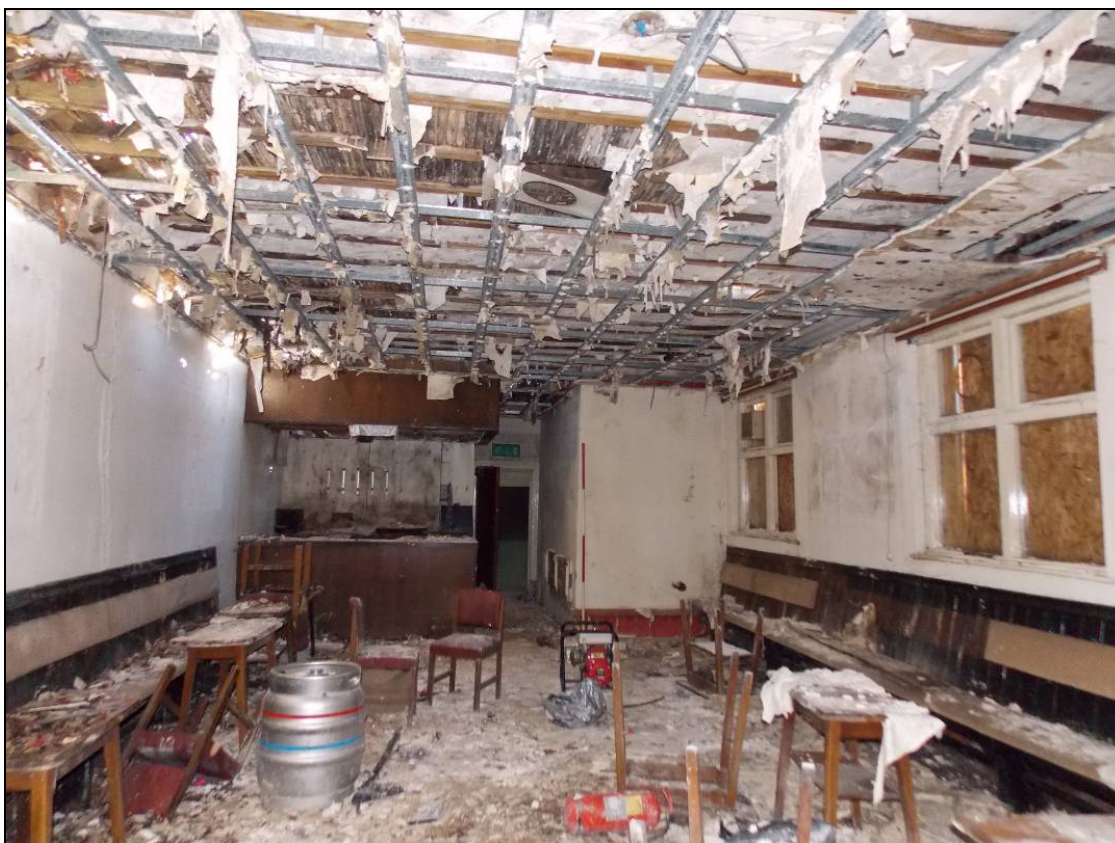
Plate 22: General view of the first floor of the cross-wing, looking east (scale 2m)

4.2.8 The cross-wing consists of a large modern lounge of little significance (Plate 22).

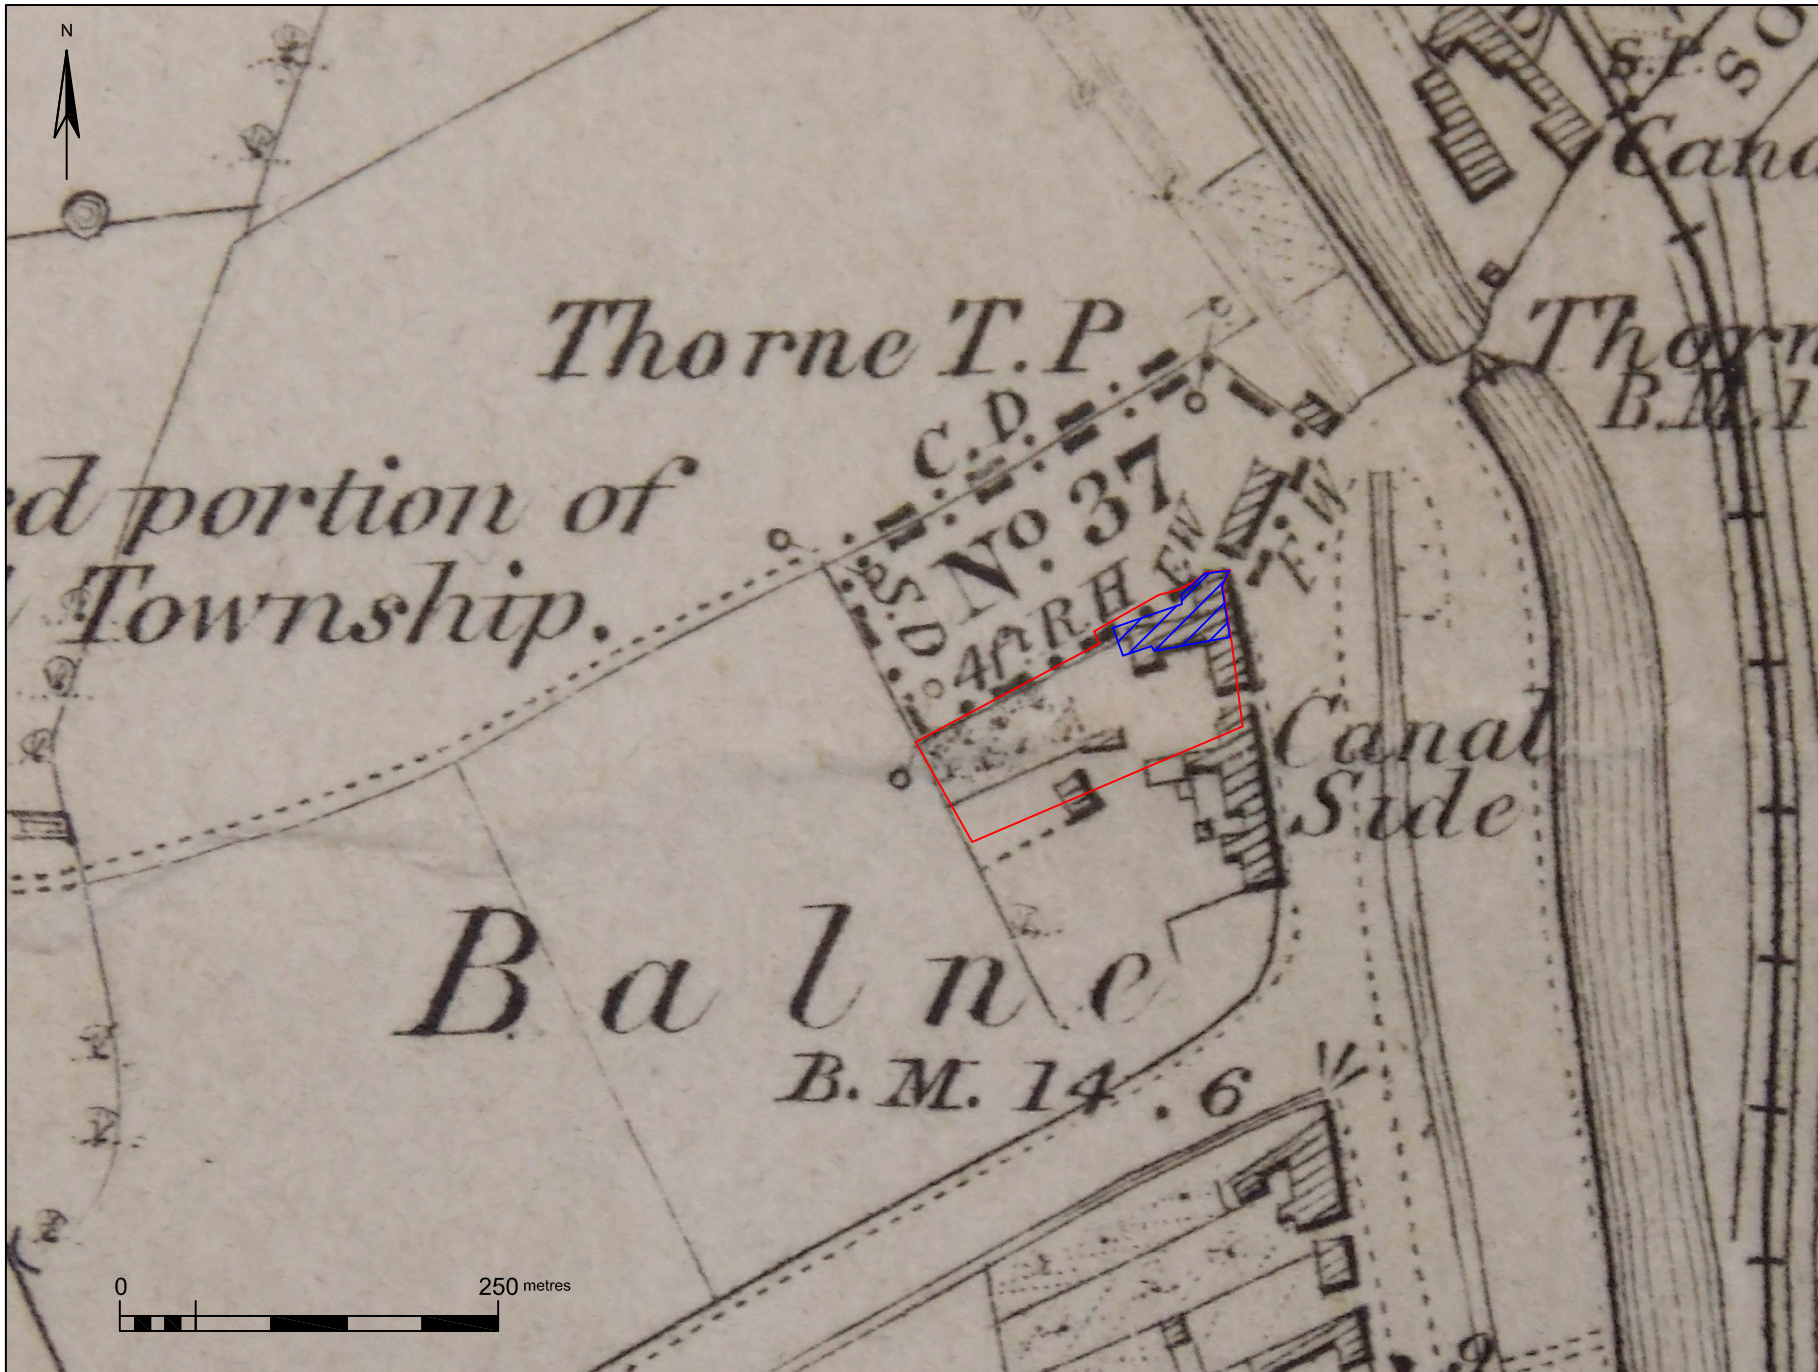
Figure 5:  
Extract of the 1853 OS Map

6.3 The Ordnance Survey map surveyed in 1853 shows the site in detail with a series of buildings which lie within the present structure including the cross-wing (Fig. 5). This canal side area is now labelled as ‘Balne’.

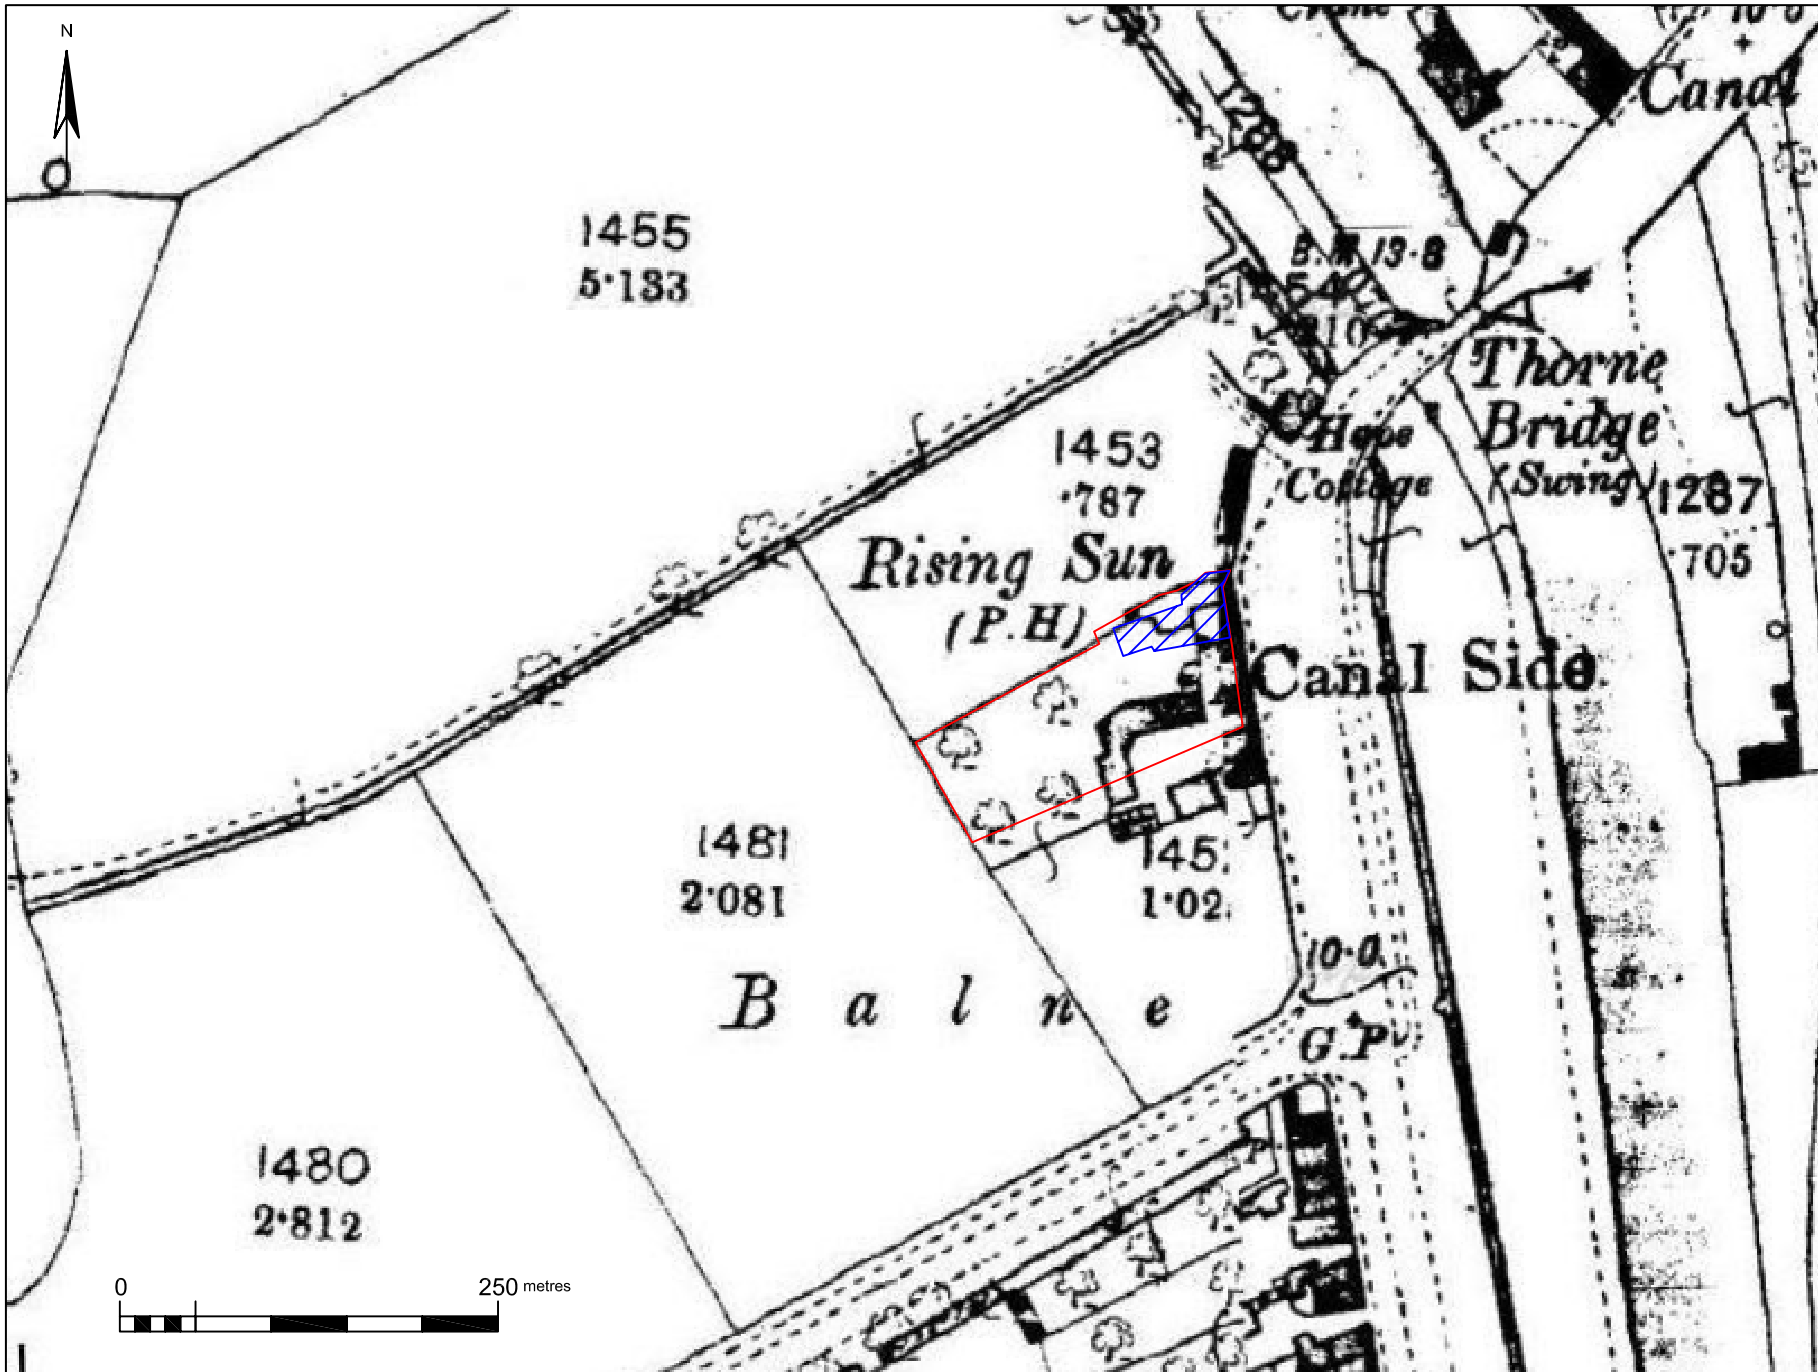
Figure 6:  
 Extract of the 1890s OS Map

6.4 The Ordnance Survey map issued in 1890s shows further development within the site. The footprint of the structure whose footprint matched up with the current public house appears to have suffered some alterations, although the precision of the depiction is slightly unclear. Nevertheless, this range contains the name ‘Rising Sun (P. H.)’ confirming its status (Fig. 6). No significant changes are discerned from the preceding editions of the Ordnance Survey maps except for a fairly recent removal of an ‘L-shape’ range to the south of the Rising Sun. The name of the public house was also retained throughout the years until the present day.
