Backford Hall, Backford, Cheshire: An Archaeological Evaluation

ARS Ltd Report No. 2013/80
September 2013

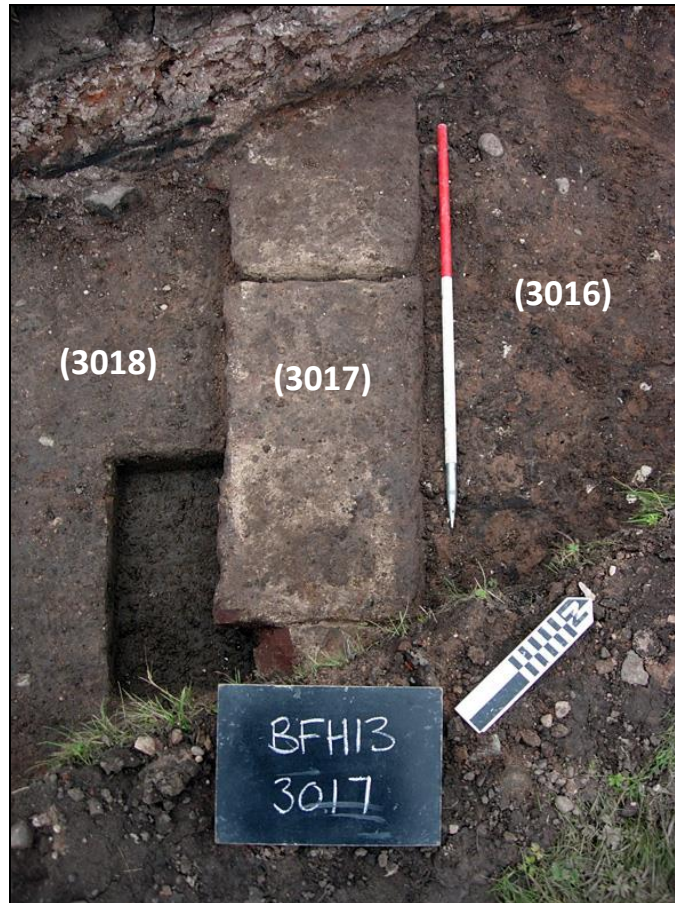
Figure 3. Wall foundation (3017). Scale = 1m

6.2.4 A possible surface deposit (3016/3014) relating to the wall (3017) was observed to the north-eastern side of the foundation blocks, which comprised a redeposited natural clay with coal dust inclusions. This deposit terminated at another rough alignment of stones (3013) similar in form to (3025) which may have related to the opposite side of the ditch cut [3027]. A mixed deposit (3012) comprising fragments of slate, mortar, brick, and pebbles was delimited to the south-west by the stone alignment (3013) and overlaid a pebbly layer (3023). The mixed deposit (3012) may have related to ground levelling, along with a deposit of levelled sand (3011) which overlaid it.

12.3 The ditch appears to have been filled and levelled, probably in order to construct the foundation for a structure. This structure may relate to an earlier phase of the hall as it does not respect the alignment of the current Backford Hall. The sandstone blocks were substantial, and would have provided a good solid foundation for an upstanding structure. That a skim of mortar remained on the upper surface appears to attest to at least one further course of masonry having been present in the past. A complete glass window quarry which was recovered from the context abutting the wall foundation would appear to suggest a relationship to a post-medieval structure.

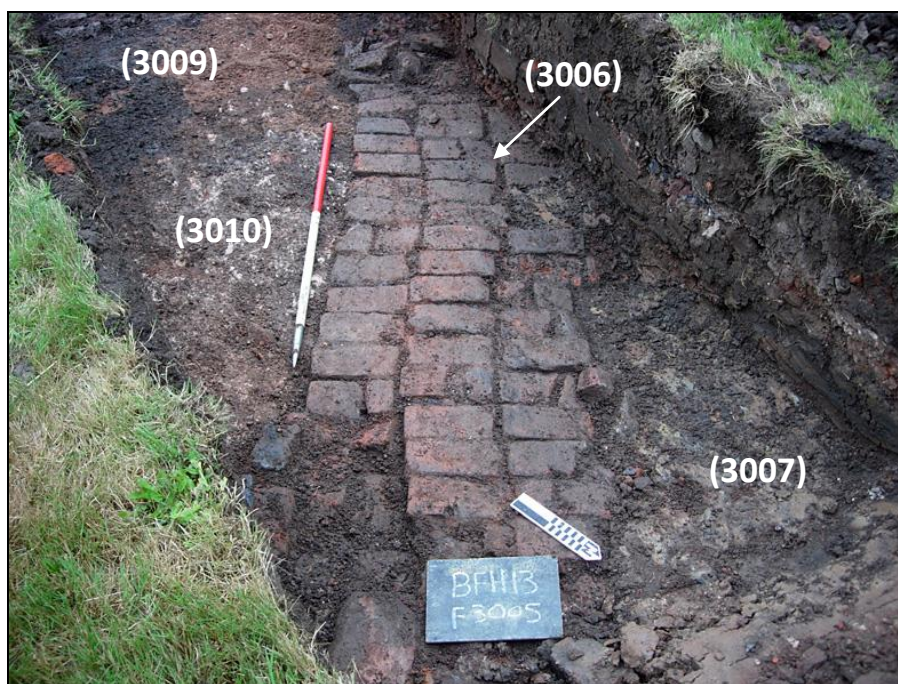
6.2.5 A regular alignment of bricks (3006) was observed at the north-eastern end of the trench (Figure 4). The feature appeared to be a pathway orientated in a roughly east to west direction. The path comprised a single course of square faced bricks, laid side to side lengthways along three rows. The bricks were hand made, and possibly slop moulded, dating to the late 16th to 17th century, and measured approximately 0.11 x 0.23 x 0.06m. The pathway was bedded into a clayey deposit (3010) which appeared to overlay the natural substratum at this location.

Figure 4. Probable pathway of brick construction. Scale = 1m

12.4 The brick built pathway also observed within this trench proved to be intriguing. Its relationship, if any, to the wall foundation, remains unknown. However, it was situated at roughly the same depth below the topsoil, although it was orientated along a different alignment. A brick which was examined from the path, dated to the late 16th – 17th century, which may provide a date for the feature. However, the bricks could easily have been re-used in a later feature.

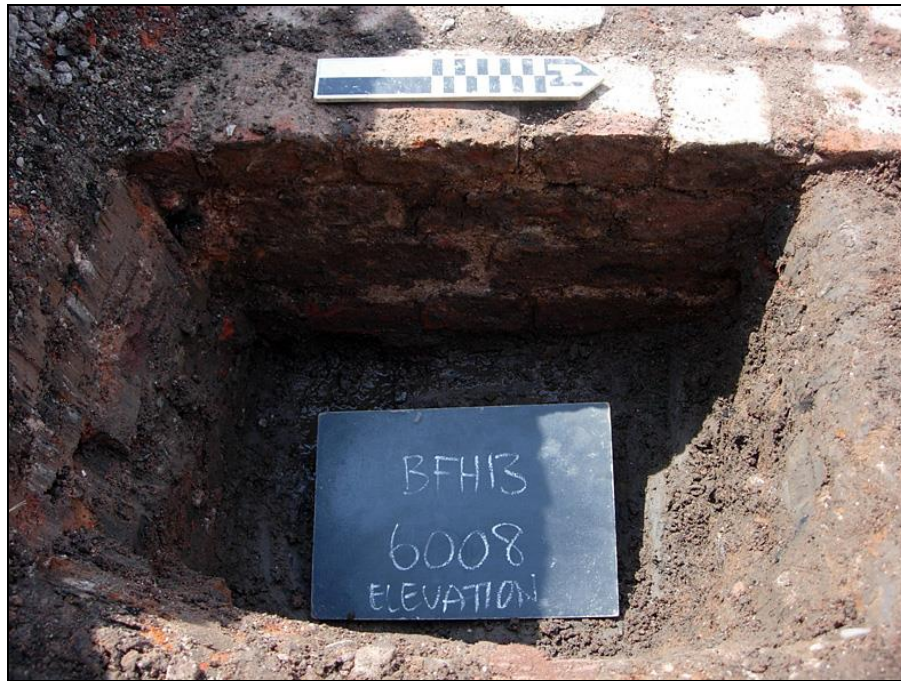
Figure 18. Wall (6008) elevation. Scale = 0.25m

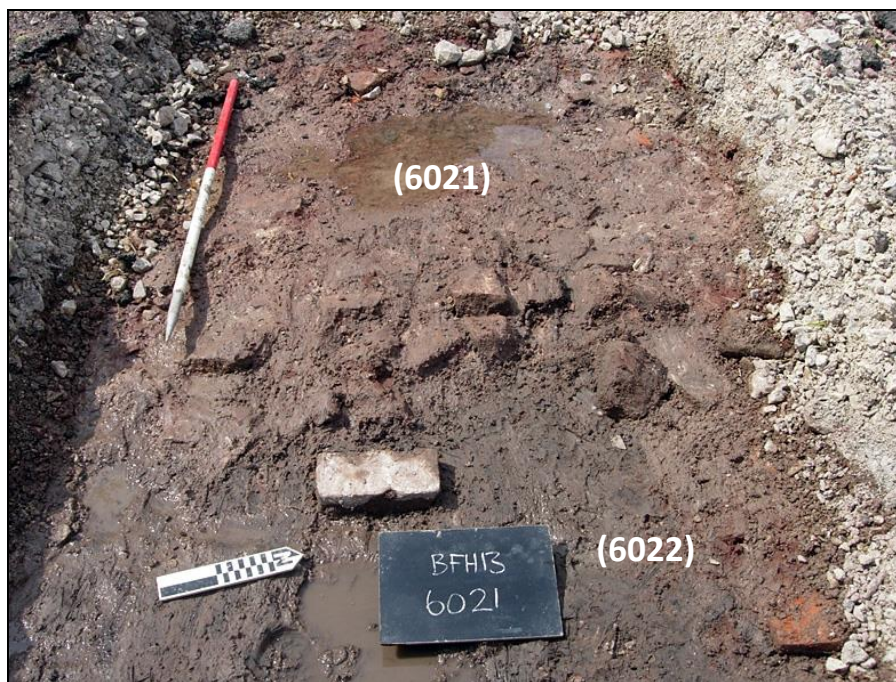
6.5.4 A discontinuous rubble spread (6021) was encountered towards the western end of the trench (Figure 23). The spread comprised very compacted brick and red sandstone rubble, which was less compact towards its eastern extent. The deposit, which had a maximum depth of 0.20m, continued beyond the limits of excavation at this end of the trench. This deposit was interpreted as a possible area of hard standing or a footing for a structure.

Figure 23. Discontinuous rubble spread (6021). Scale = 1m

12.11 An area of compact rubble which was observed towards the western end of the trench may have possibly related to the footing or foundation of a structure or a yard surface. The spread was discontinuous and its boundary ill-defined, but continued past the exclusion to the limit of excavation of the trench, covering an area of approximately 15sqm. This feature may relate to the known buildings presumed near this location, which were demolished in 1857 (HER No: 4549/0/4).

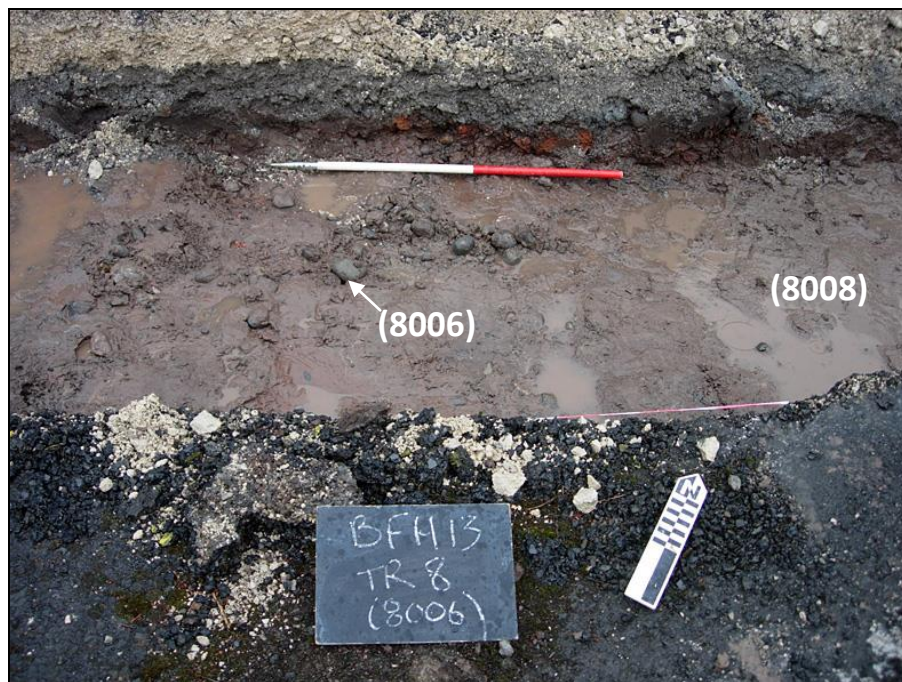
Figure 28. Cobble spread (8006). Scale = 1m

12.12 The cobbled spread recorded within *Trench 8* may have been a degraded or poorly constructed pathway or part of a yard surface that had a drain or culvert system running alongside it. The drain appears to have a continuation which was observed in *Trench 10*. These features may relate to a barn and stackyard (HER No: 4549/0/1) near this location (see Figure 47), which were demolished in 1857. The contaminated rubble spread observed towards the eastern end of the trench produced various sherds of pottery dating from between the 18th to 19th centuries, and visual inspection suggests that it represents a demolition or waste dump which may have related to the cottage (HER No: 4549/0/2) visible on the 1842 tithe map (see Figure 47).

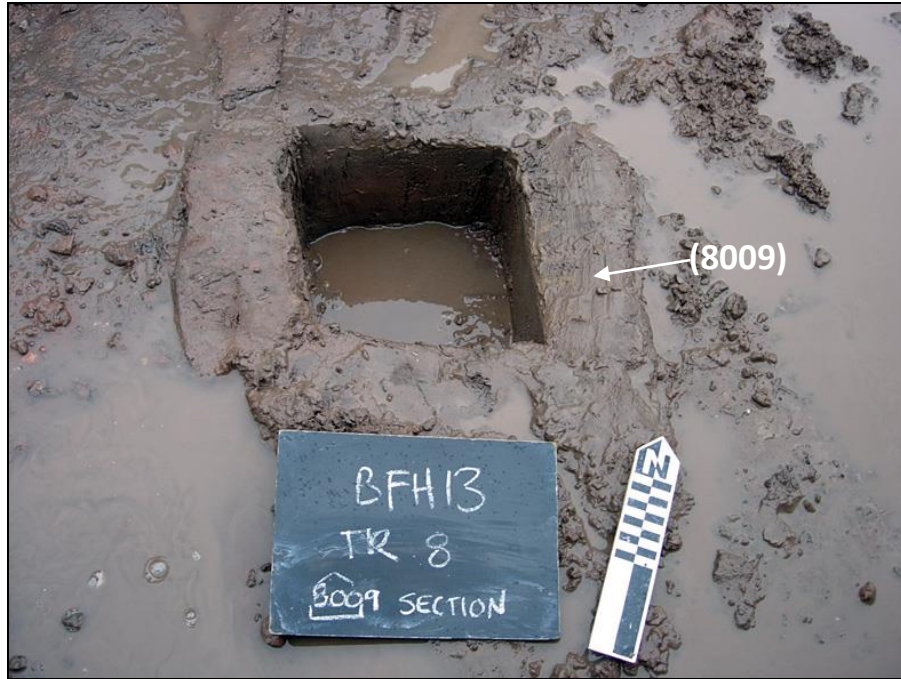
Figure 29. Probable drain/culvert (8009). Scale = 0.25m

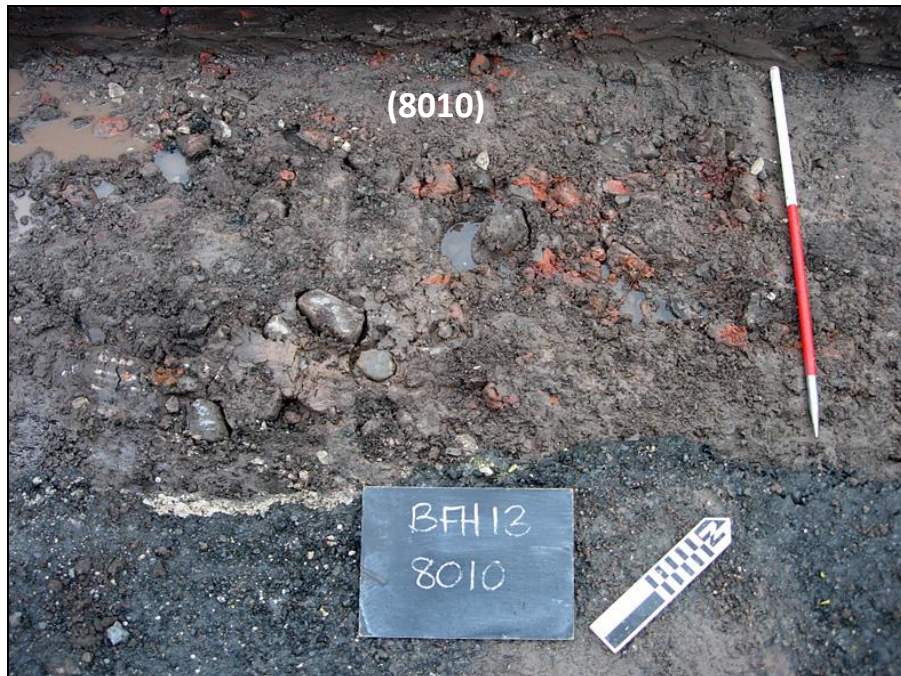
6.7.2 A deposit of cobbles and brick debris (8010) was observed at the eastern end of the trench (Figure 30) but was not investigated beyond visual examination due to some form of probable hydrocarbon contamination.

Figure 30. Deposit of cobbles and brick debris (8010). Scale = 1m

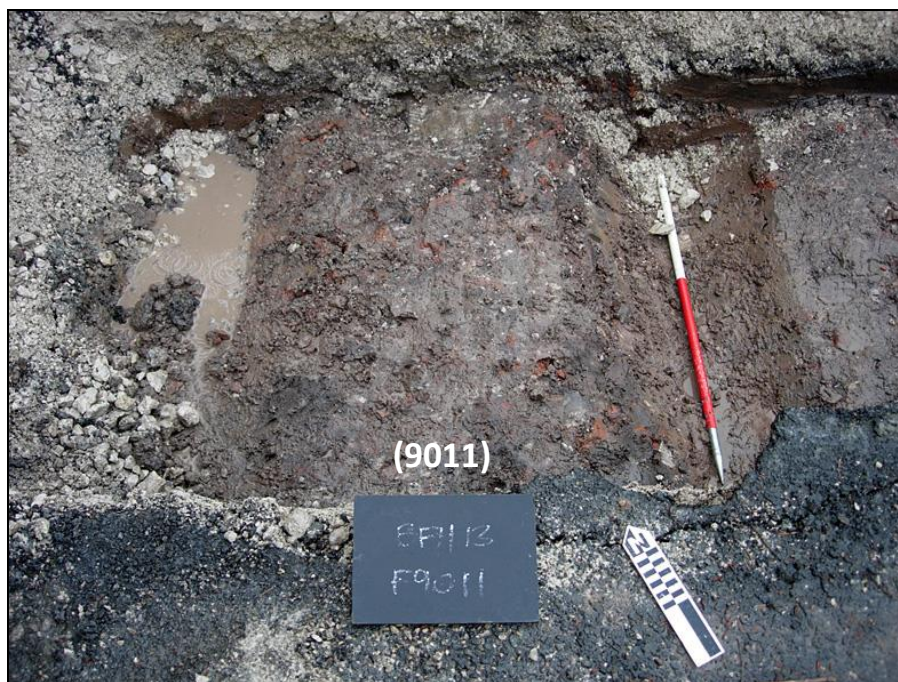
6.8.2 Towards the north-western end of the trench, and situated beneath deposit (9005) was a probable trackway, comprising two parallel linear metalled surfaces (Figures 33 and 34). These surfaces (9009 and 9011) comprised various materials, including brick waste, pebbles, and crushed lime mortar, which were packed down into the natural clay substrate. This trackway feature was overlain by a deposit of fine clay (9010) which was probably deposited as part of a ground levelling process.

Figure 33. Metalled surface (9009), part of a trackway. Scale = 1m

Figure 34. Metalled surface (9011), part of a trackway. Scale = 1m

12.13 A compact metalled trackway observed in *Trench 9* appears to be in-keeping with this area having been gardens or open space, and would have provided access across this ground, perhaps towards the possible barn or stackyard, or the cottage in the location of *Trench 8*. A drain running roughly parallel to the trackway alongside a depression in the natural substrate may have related to the same period of use.

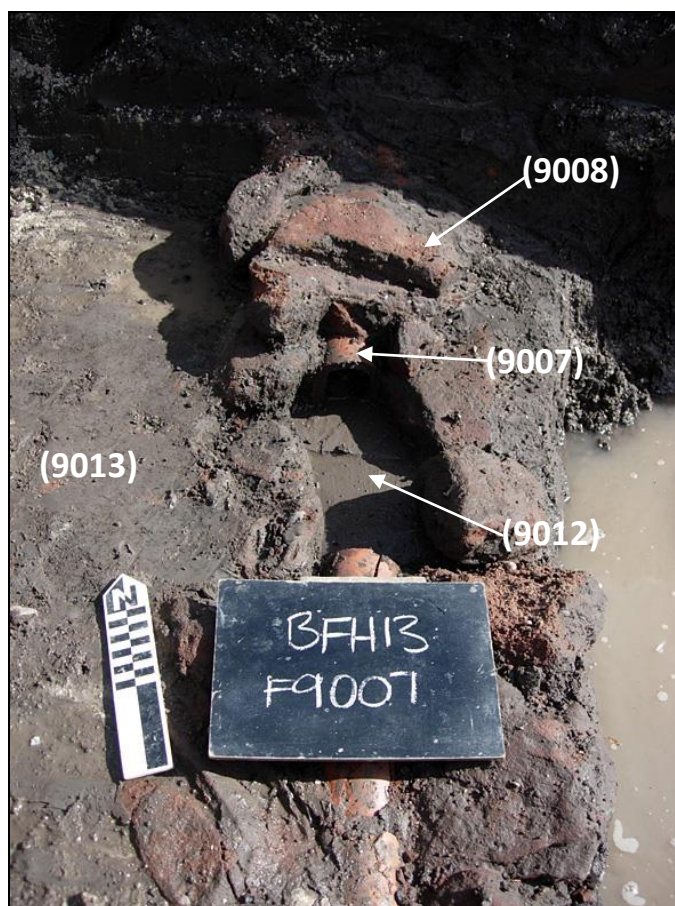
6.8.3 A well-constructed drain (9007) was recorded towards the north-western extent of the trench (Figure 35), comprising a slate base, on top of which was located a U-shaped drainage pipe, dated to the 17th – 18th century, which was revetted by two courses of roughly hewn red sandstone blocks. The orientation of this drainage feature was the same as that of the trackway

Figure 35. Feature (9007), post-excitation, detailing construction.
Scale = 0.25m

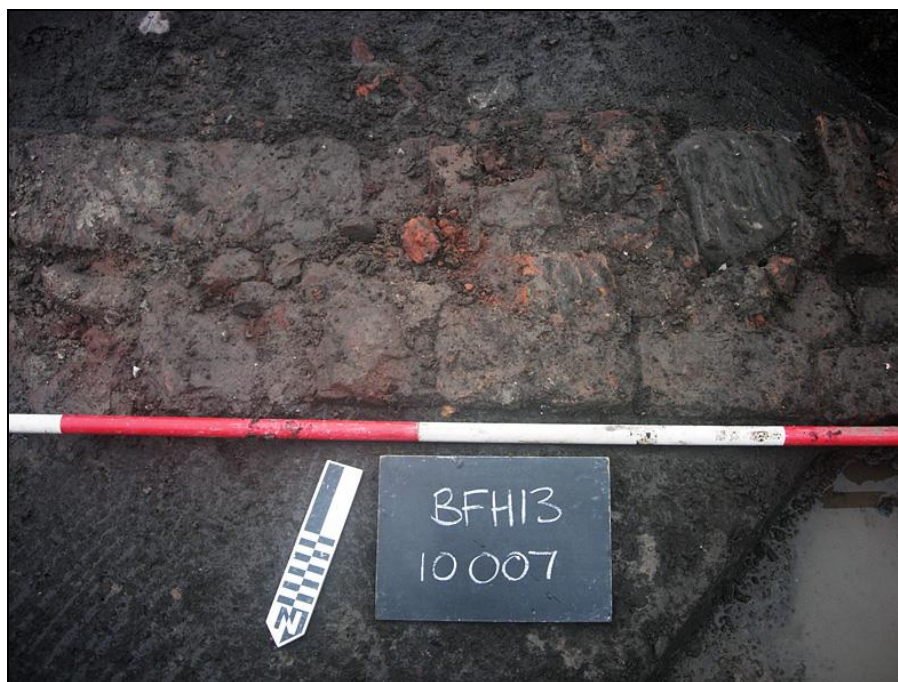
6.9.3 A substantial wall foundation (10007) was recorded, orientated along an east-north-east to west-south-west alignment (Figures 40 and 41). The trench was extended by approximately 3m at this location, along the line of the wall, in order to better understand the feature (Figure 45). The wall comprised two uneven courses (Figure 42). The lower course was composed of roughly hewn red sandstone blocks, measuring no greater than 0.36 x 0.46 x 0.12m, situated directly on top of the natural substrate (10006). The blocks were poorly bonded but of a solid construction. The secondary/upper course was of a poorer construction, comprising broken pieces of squared brick and roughly hewn sandstone. The wall displayed no discernible bond pattern. A pipe stem dating to the 17th to 18th centuries was recovered from between the two courses and the bricks of the upper course have been dated variously between the 16th and 18th centuries. A dark clayey silt deposit abutted the wall at either side, and was interpreted as a buried soil horizon, probably relating to a garden through which the wall likely ran. The termination of the wall observed

within the trench, in conjunction with a small deposit of rubble debris opposite, was interpreted as a possible gateway, or entrance through the wall feature.

Figure 40. Wall foundation (10007). Scale = 2m

Figure 41. Wall foundation (10007) detail. Scale = 2m

12.14 The large wall foundation recorded in *Trench 10* may have been a garden wall, either internal or exterior. The lower course comprising the larger roughly hewn sandstone blocks was more substantial and of different character to the poorly constructed second course. This perhaps suggests a re-use of an earlier already extant foundation. A clay pipe stem dating to c.1682 – 1757 was recovered from between the upper and lower courses, and could suggest a *terminus ante quem* (TAQ) for the construction of the lower course. The wall terminated within the boundaries of the trench, and although a continuation was not observed, a small deposit of brick rubble suggested that perhaps another portion of wall existed beyond the limit of excavation to the east. This space may have formed a gateway or entrance through the wall, which was abutted at either side by a buried soil horizon, helping to inform the interpretation that this was part of the gardens.

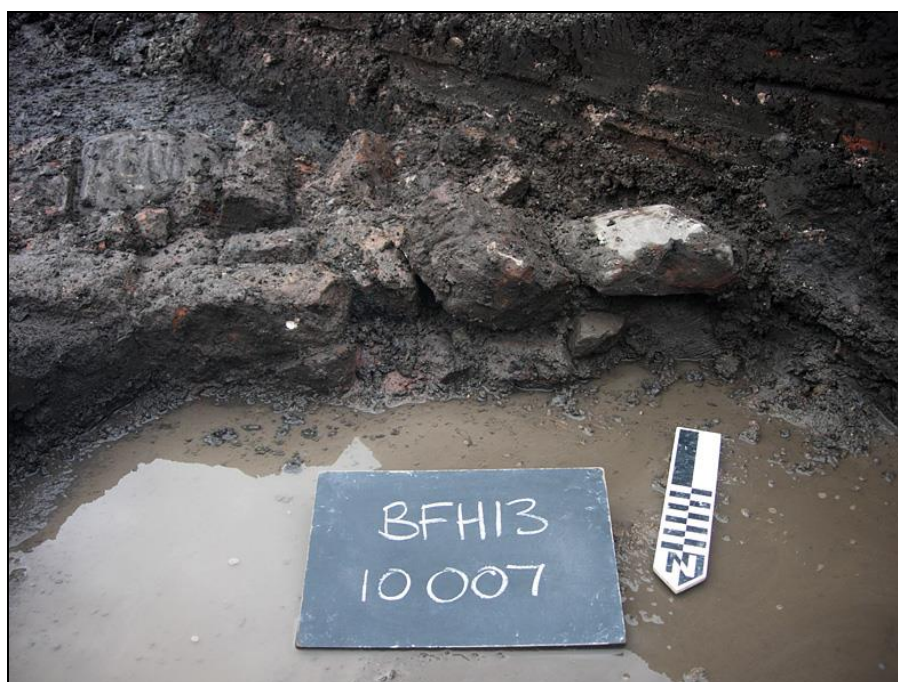
Figure 42. Wall foundation (10007) elevation. Scale = 0.25m

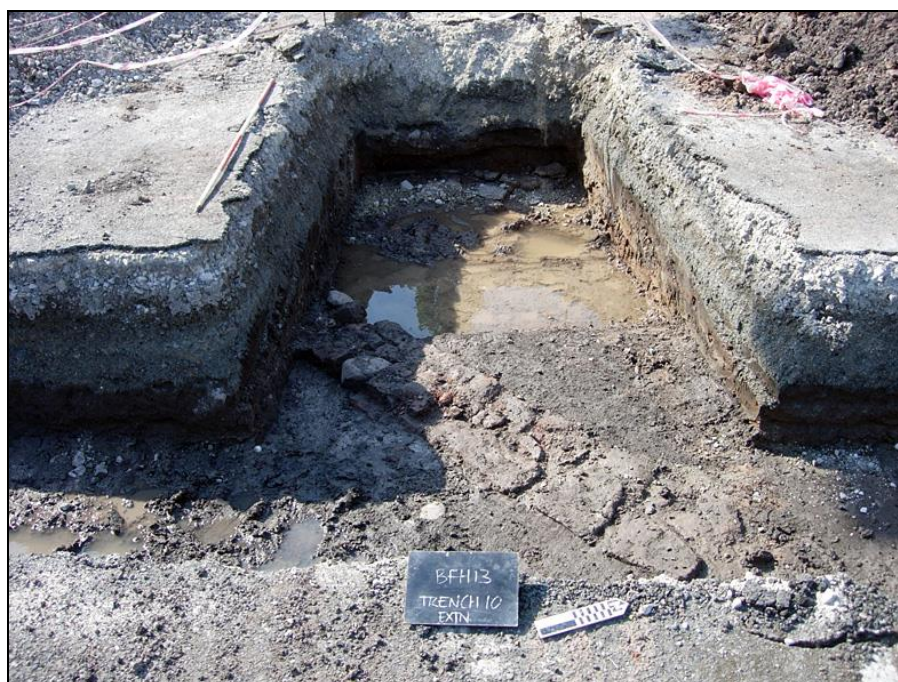
Figure 45. Trench 10, extension. Facing west. Scale = 2m
