**A Staged Programme of Archaeological
Work at Mill House, Ponteland,
Northumberland**

**Including Building Recording, Earthwork
Survey and Watching Brief**

ARS Ltd Report No. 2013/102
November 2013

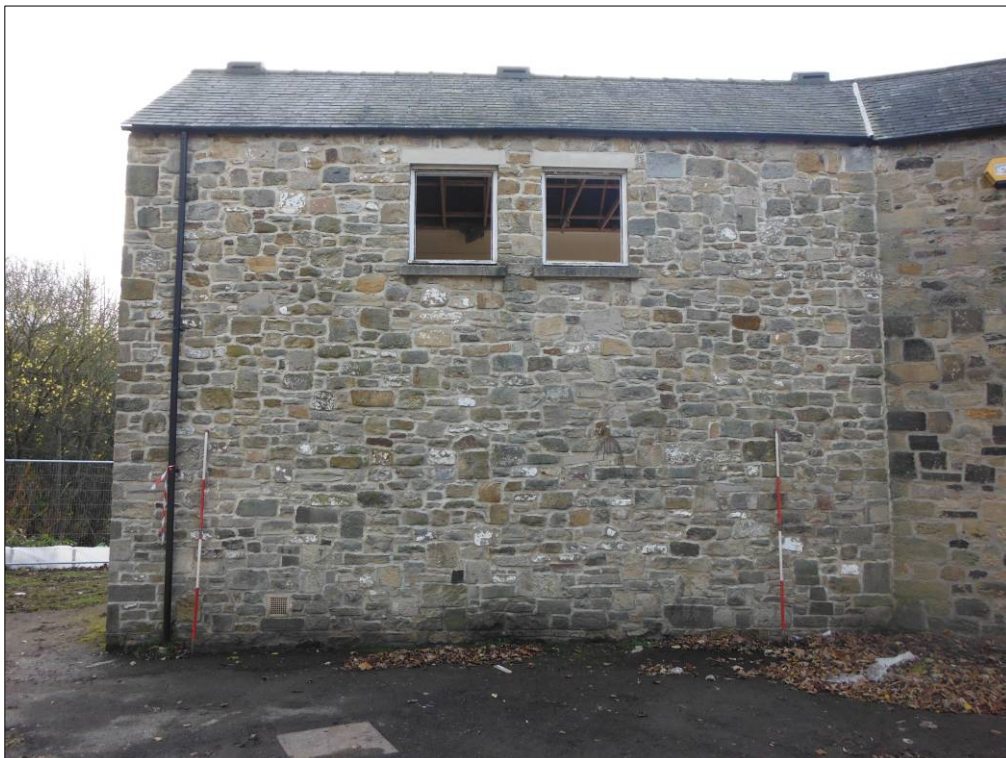
Figure 2: Northeast elevation of Building A showing vertical joint between Building A and B, on the right of the photograph (scale=2 x 2m).

A prominent vertical join is visible in the masonry between Building A and Building B which indicates that the two structures are of different phases.

The ground floor of the northeast elevation is featureless, whilst the first floor contains a pairing of two window openings with concrete lintels and sills (Figure 2).

Two prominent vertical joins are visible in the masonry between Building A and Building B; one of which indicates a change in phase between the two structures; and the other is necessitated by the change in orientation between Building A and the rest of Mill House. This change in orientation was most likely necessitated by its proximity to the river at this point. Had Building A been constructed along the same alignment as the rest of Mill House, its foundations would have been at risk of subsidence.

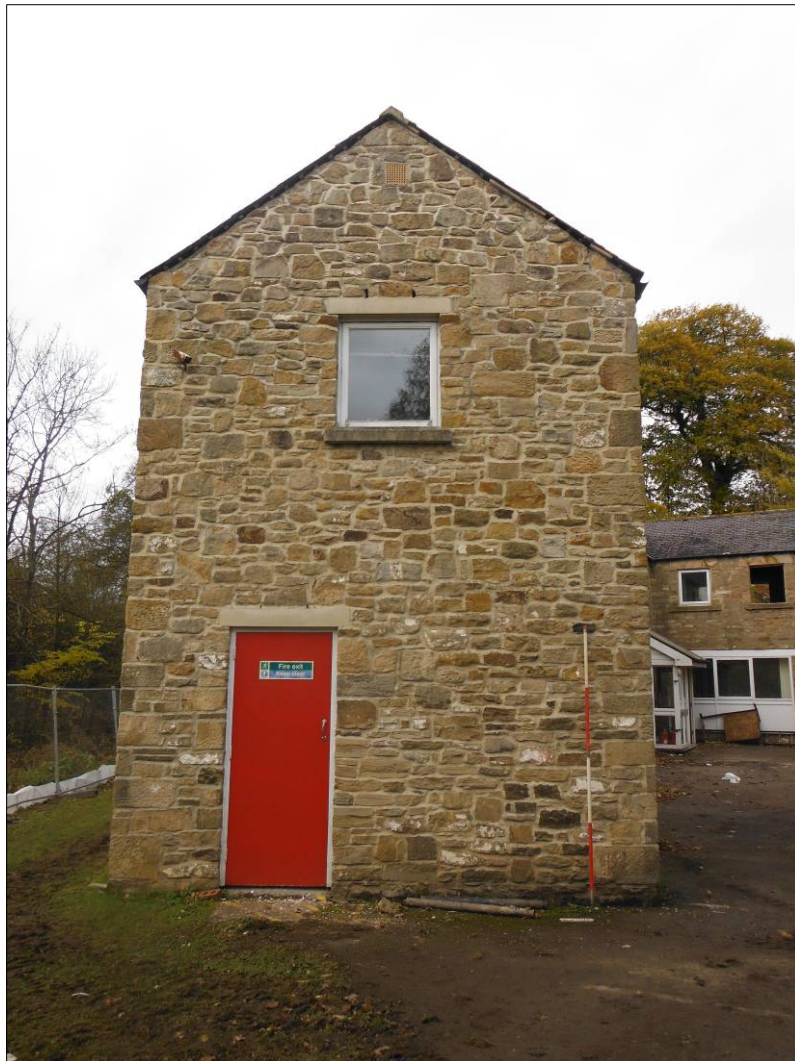
The southeast elevation of Building A contains a fire exit with a concrete lintel at the southern end of the ground floor and single window in the centre of the first floor with a concrete lintel and sill (Figure 3).

Figure 3: Southeast elevation of Building A (scale= 2m).

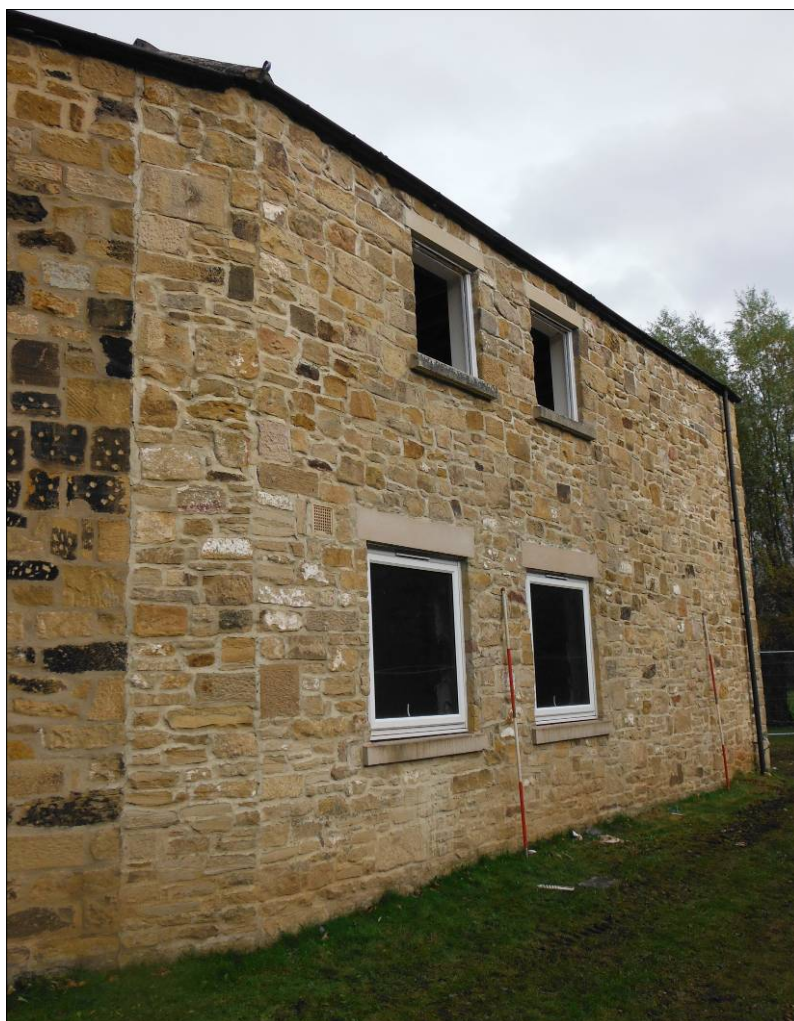
Figure 4: Southwest elevation of Building A (scale=2 x 2m).

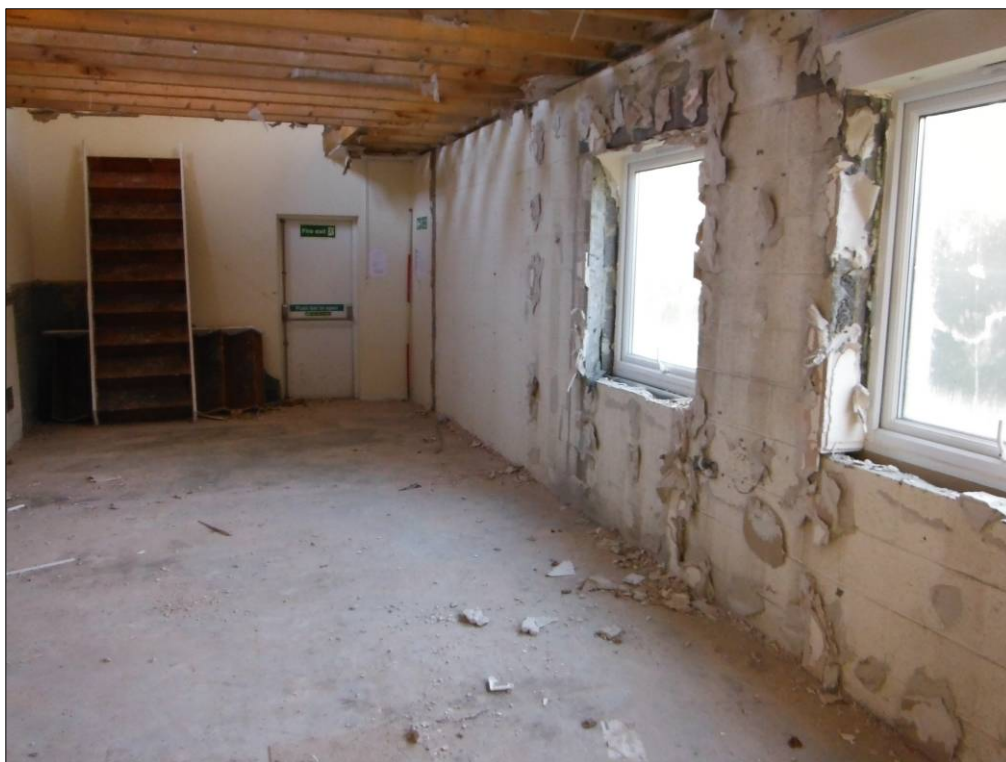
Figure 5: Interior of Building A, showing the southeast and southwest walls with remains of the staircase along the southeast end of the building (scale= 2m).

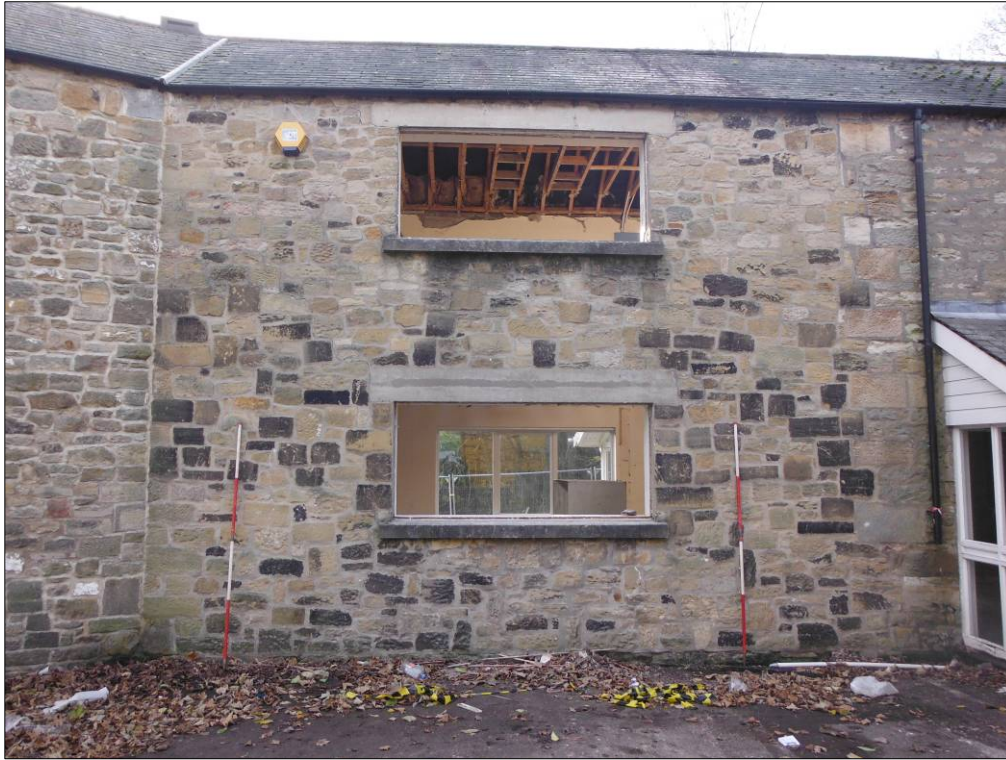
Figure 6: Northeast elevation of Building B (scale=2 x 2m).

The northeast elevation contains a large centrally placed window with concrete lintel and sill on both the ground and first floor levels. These windows are clearly of modern construction and appear to be original to the structure (Figure 6).

Prominent vertical joints are visible in the masonry between Building B and Building A, the southeast, and Building C, to the northwest. The junction with Building C has been keyed-in with large dressed sandstone blocks. These joints indicate that Buildings A, B and C are of different phases.

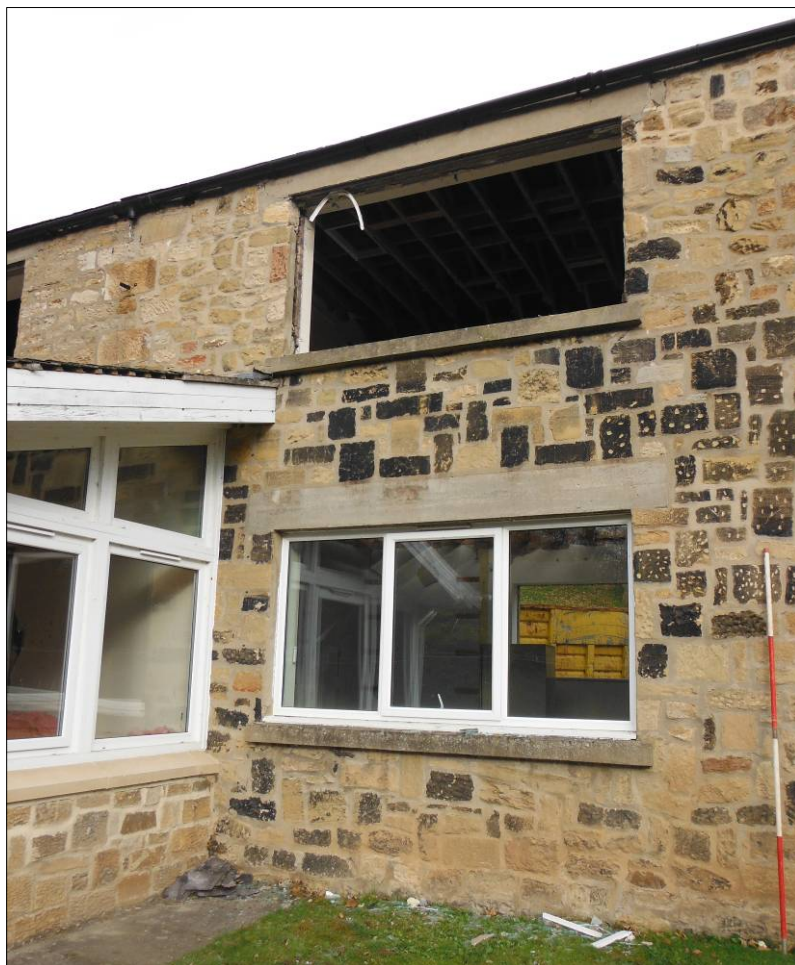
Figure 7: Southwest elevation of Building B (scale=2m).

The southwest elevation contains a large centrally placed window with concrete lintel and sill on both the ground and first floor levels. These windows with PVC frames are clearly of modern construction and appear to be original to the structure (Figure 7). Building D adjoins the northern end of this elevation

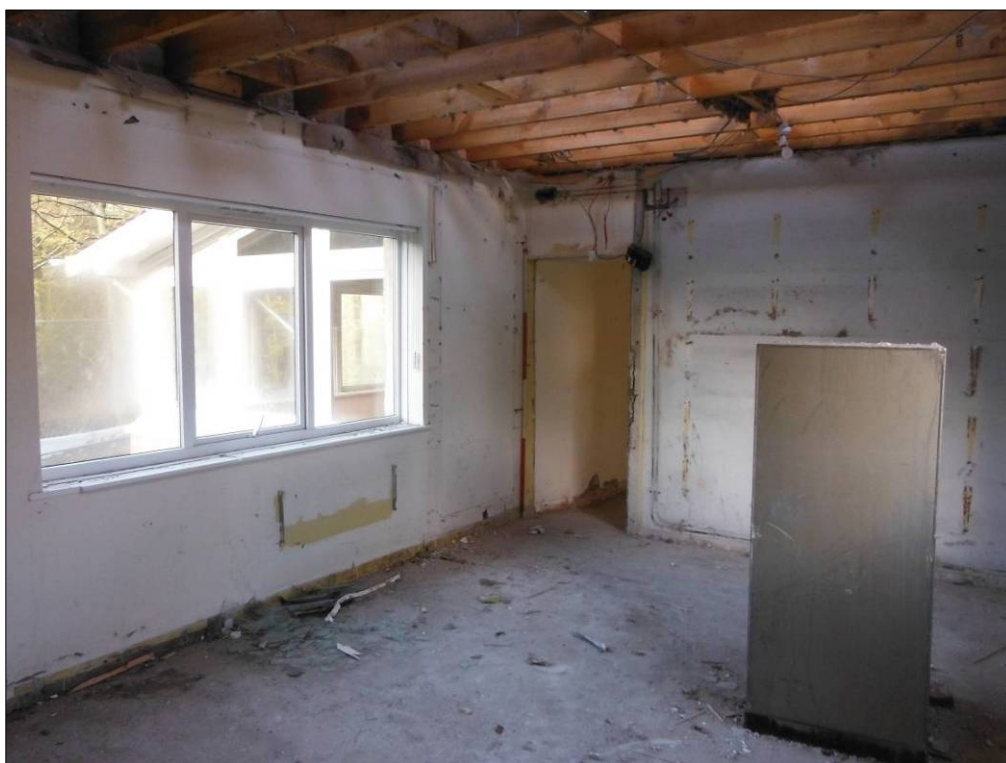
Figure 8: Interior of Building B, showing the southwest and northwest walls (scale= 2m).

Internally the ground floor consists of a single large open space, Room B1, previously used as offices. It is accessed via Building C through a single-width doorway in the west end of the northwest wall. The walls are covered with painted plasterboard, however the wall construction is visible around window and door openings where is clear that this building is brick-built with an external stone facing. The ceiling has been removed revealing the construction of the floor above, which is carried on southwest-northeast aligned timber floor joists with a central brace.

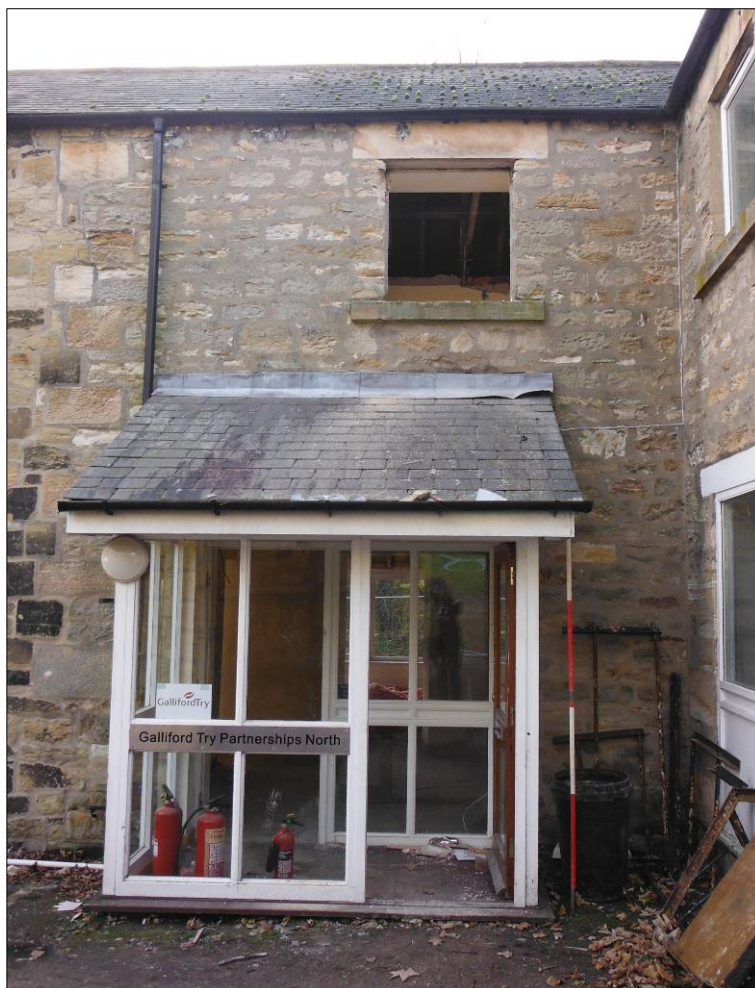
Figure 9: Northeast elevation of Building C Part 1 (scale=2m).

The northeast elevation of Building C comprises the northeast wall of the northwest-southeast aligned projection as well as the end wall of the main northeast-southwest aligned structure. Beginning with the projection, at ground floor level there is a glass-panelled porch in front of a wide opening forming the main entrance to the building (Figure 9). At first floor level there is an off-centre, small window with a sandstone lintel and sill with a narrow chamfer; this appears to be an original feature. Along the southern side of the elevation a vertical construction break is evident between this structure and Building B which post-dates it. This portion of walling has been roughly re-pointed.

The evidence from the windows indicates that there is a difference in phase between the northeast elevation of the projection and the northeast elevation of the main range. The projection is the earliest of the two, containing an original window with sandstone lintel and sill, whilst the end wall of the main range is clearly modern in date with an original modern window at first floor level.

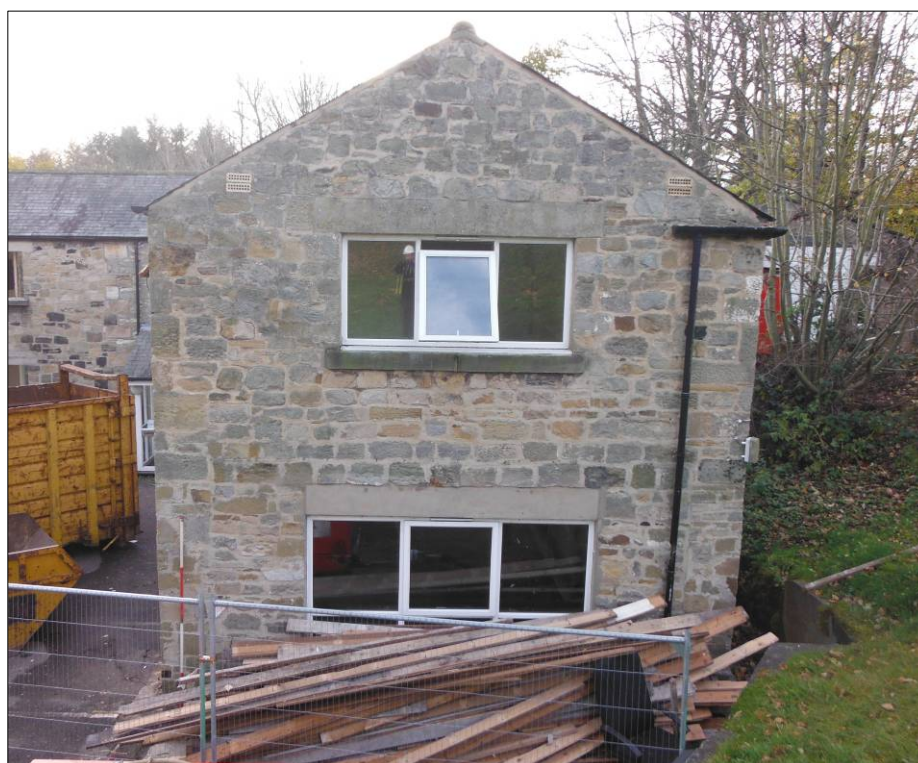
Figure 10: Northeast elevation of Building C Part 2 (scale=2m).

The northeast elevation of the main range is constructed of well-coursed sandstone masonry with dressed sandstone quoins on the southeast and northeast corners. It contains a large centrally placed window with concrete lintel and sill on both the ground and first floor levels (Figure 10). These windows are of modern date and that on the first floor appears to be original, whilst that on the ground floor is an insertion. This is evidenced by the different style of the lintel of this window together with patching in the stonework at either side of it. This wall has not been re-pointed.

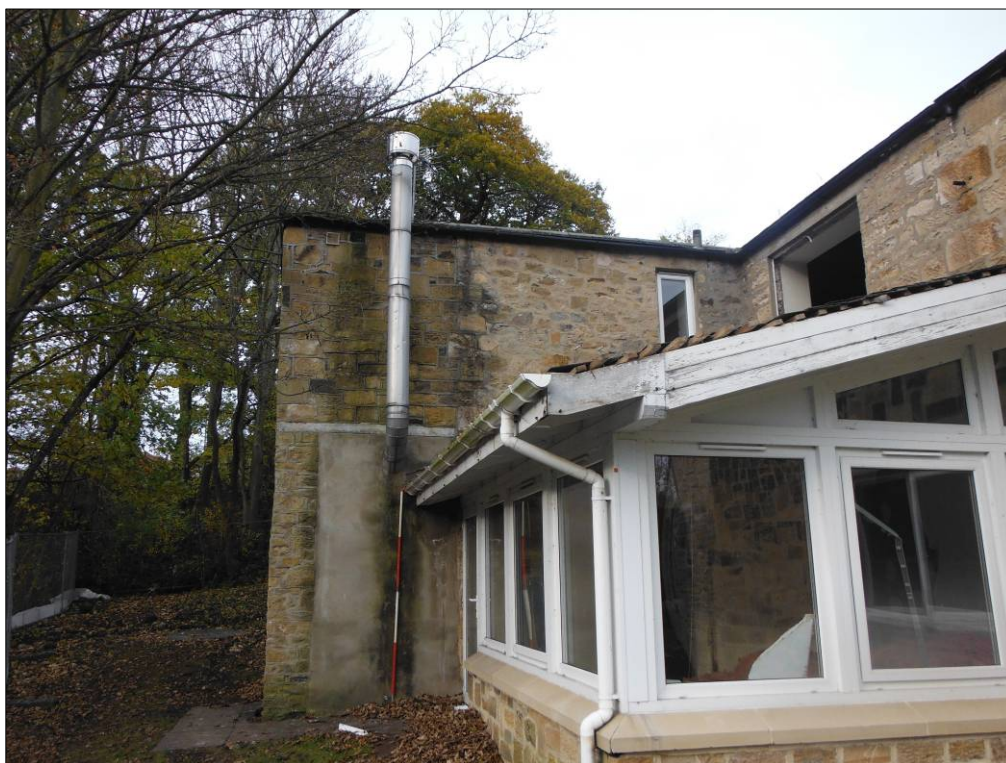
Figure 11: Southeast elevation of the western section of Building C (also showing Building E to the left of the photograph and Building D in the foreground) (scale=2m).

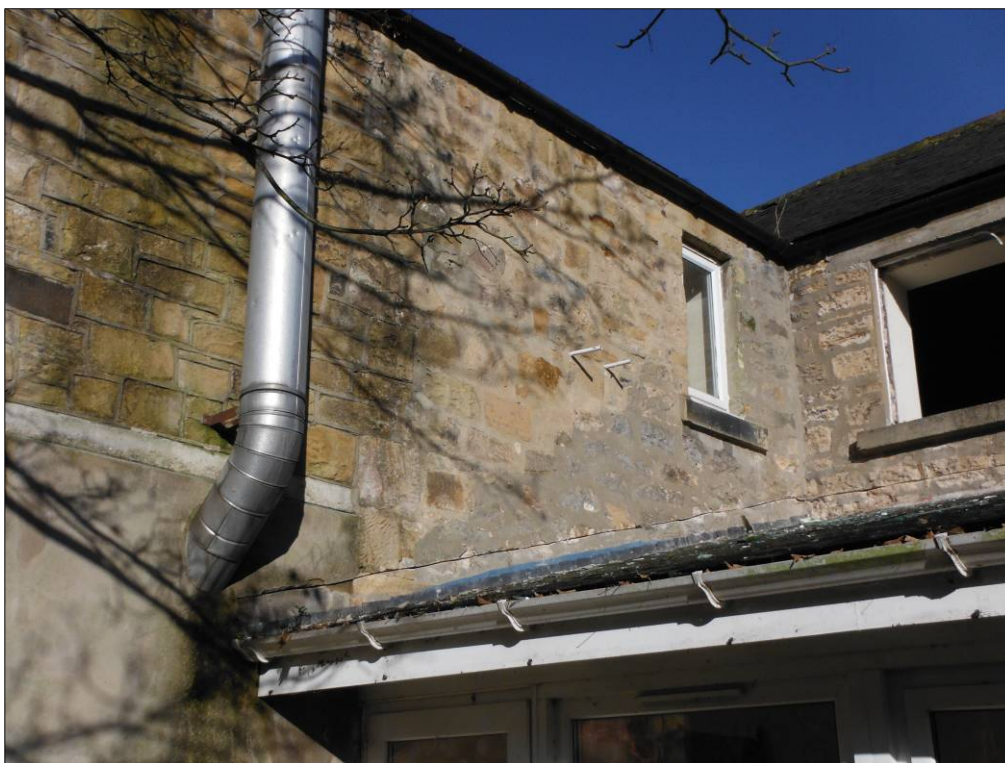
Figure 12: Detail of the ghost of a previous roof line on the southeast elevation of the western part of Building C.

A diagonal line visible in the masonry of Building C at this end of the structure is the ghost of a previous roof-line (Figure 12), showing that this portion of the building was originally built as a single-storey lean-to structure. This, and the non-coursed nature of this masonry, indicates that it post-dates the rest of Building C, making Building C an L-Shaped structure originally. The lean-to structure has then been raised to two storeys, and a narrow window inserted. This was done prior to the construction of Building E, and most likely prior to the addition of Building D also.

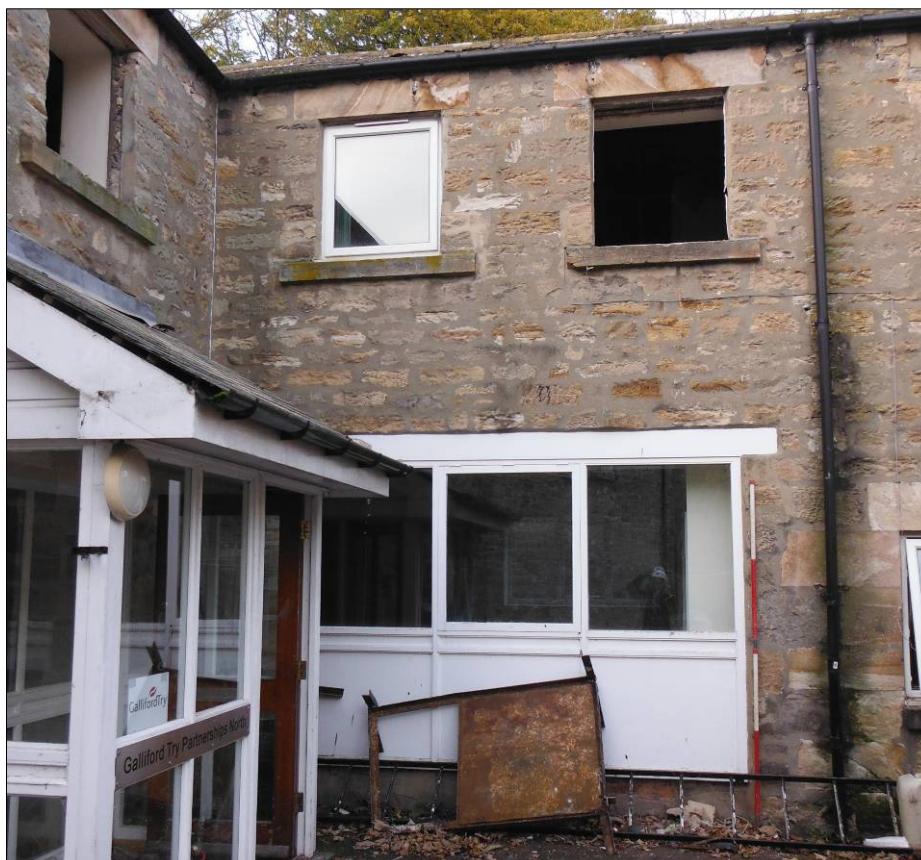
Figure 13: Westernmost section of the southeast elevation of Building C (scale=2m).

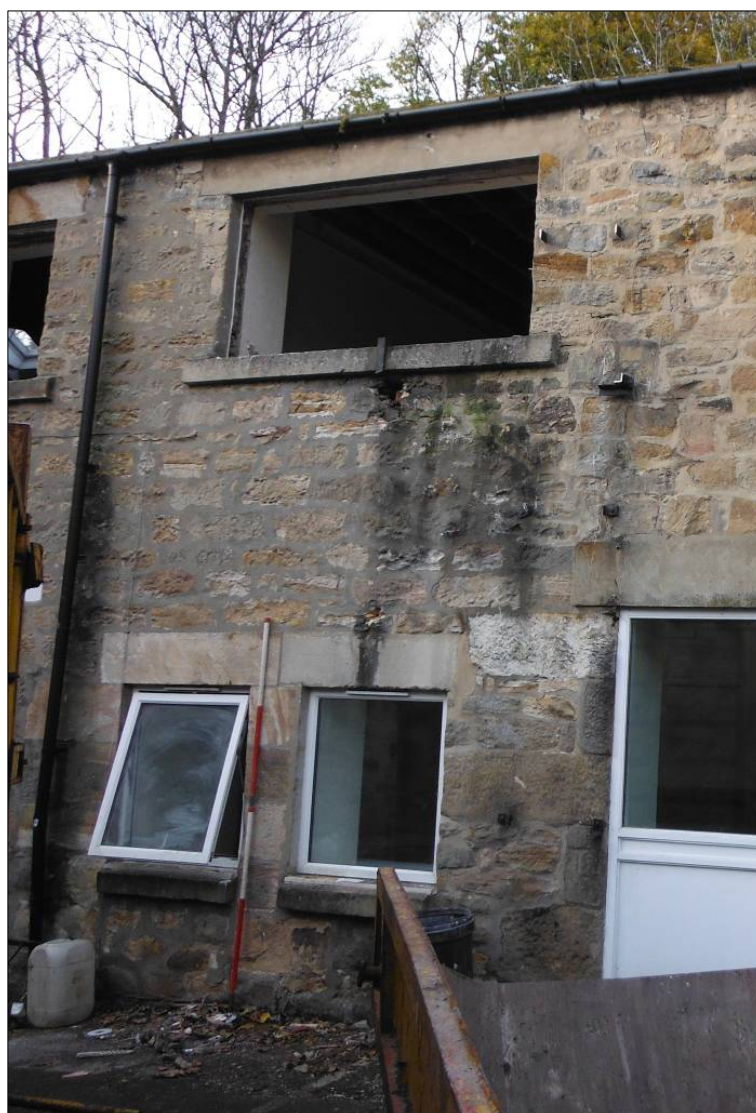
Figure 14: Middle section of the southeast elevation of Building C (scale=2m).

The middle section of the southeast elevation comprises the first eastern extension of this structure; it is constructed of well-coursed sandstone masonry and has been roughly re-pointed (Figure 14). At ground floor level the westernmost end of this section contains a doorway with dressed sandstone surround that has been remodelled into a window, the lower portion being blocked with non-coursed sandstone blocks. A modern window with concrete lintel has been inserted directly adjacent to this blocked door and the dressed sandstone door surround has been cut to accommodate it (Figure 15). At first floor level there is a large window opening with sandstone lintel and sill. This appears to be original to the structure, although it is difficult to note any patched masonry with the level of re-pointing that has taken place. The window has clearly been designed to be in keeping with those in the westernmost section, however the sandstone lintel is narrower and the sill is not chamfered suggesting that this window is of a different phase to those on westernmost section.

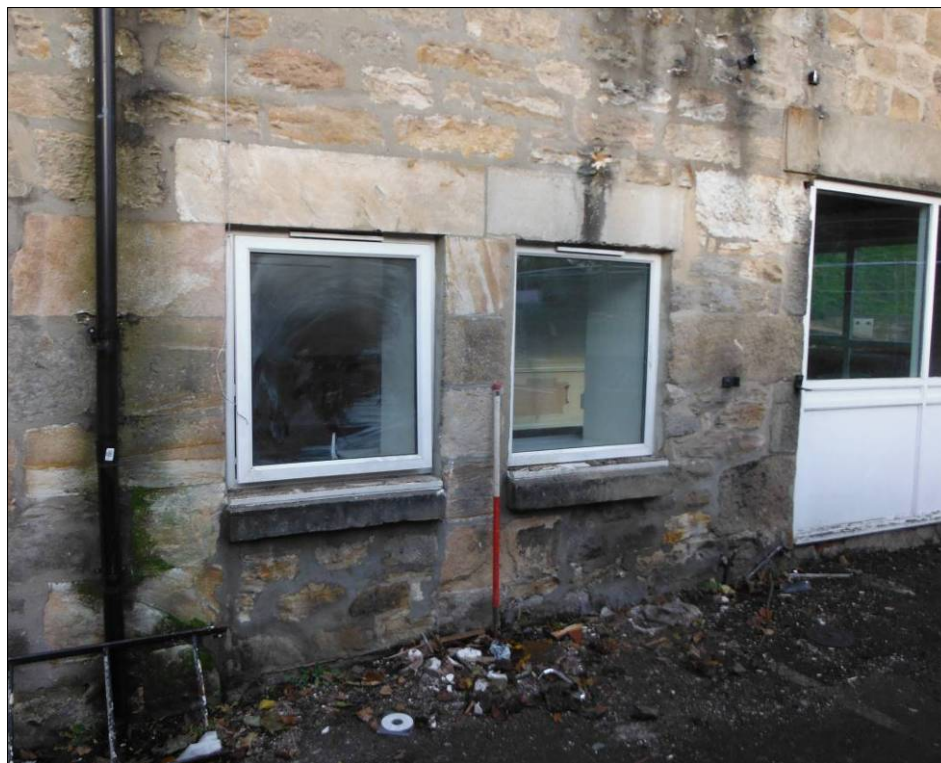
Figure 15: Detail of blocked original doorway on the middle section of the southeast elevation of Building C (scale=1m).

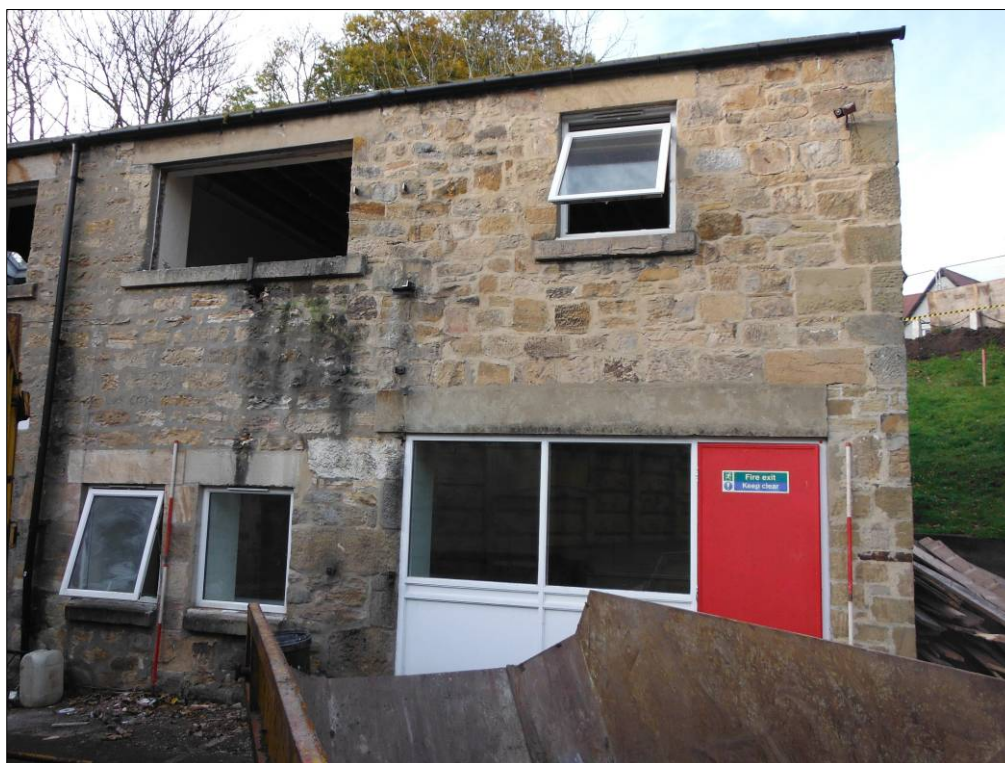
The easternmost section of the southeast elevation was added last; it is constructed of well-coursed sandstone masonry which has markedly larger blocks than the previous sections to the west. It has not been re-pointed (Figure 16). At ground floor level there is a large half-timber, half-glazed opening with dressed sandstone quoins to the west side a concrete lintel. This opening also contains a fire-exit. At first floor level there is a small window with sandstone lintel and sill. This has clearly been designed to be in keeping with the windows noted in the westernmost section of the elevation, however the lintel is narrower and the sill is not chamfered.

The difference in stonework noted between this section and those to the west, together with the difference in the style of the first floor window suggests that this section is a later extension of the building and may be fairly modern. The quoins noted on the west side of the large ground floor opening may mark the end wall of the previous phase, however they do not continue up to the first floor level. They may also mark the location of a previous doorway which has been extended into to the present opening.

Figure 16: Easternmost section of the southeast elevation of Building C (scale=2 x 2m).

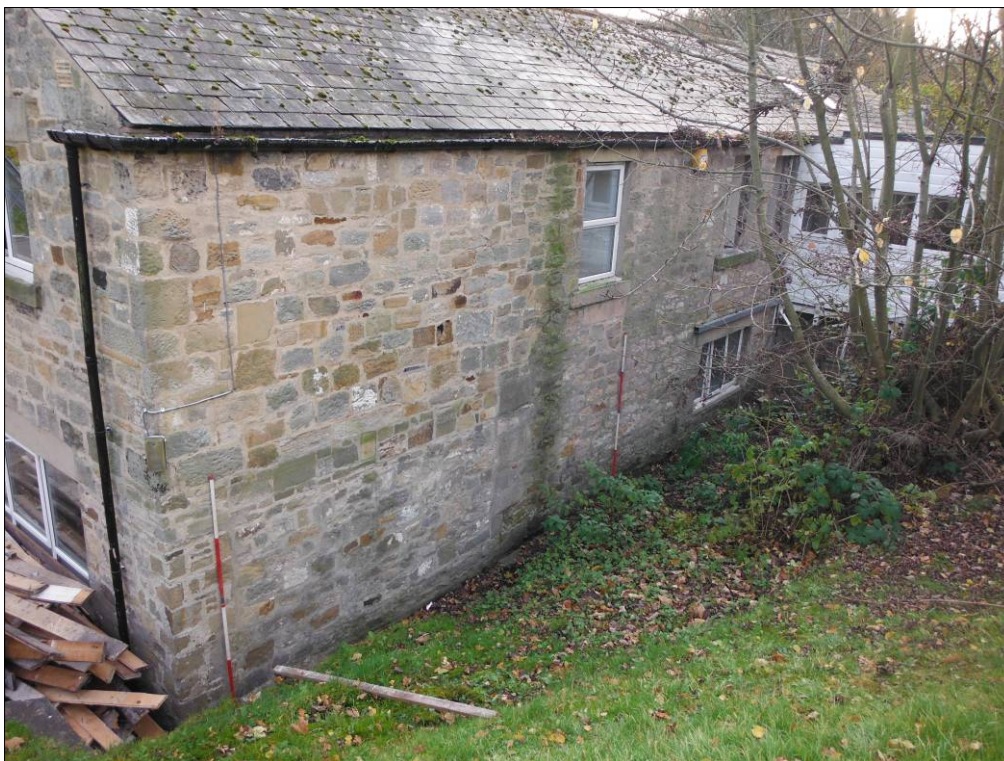
To the west of this large opening a vertical line of stained stonework marks the location of a previous down pipe (Figure 17) and may mark the location of the end of the building prior to the addition of the easternmost section and the remodelling of the roof and guttering system.

Figure 17: Northwest elevation of Building C (scale=2 x 2m).

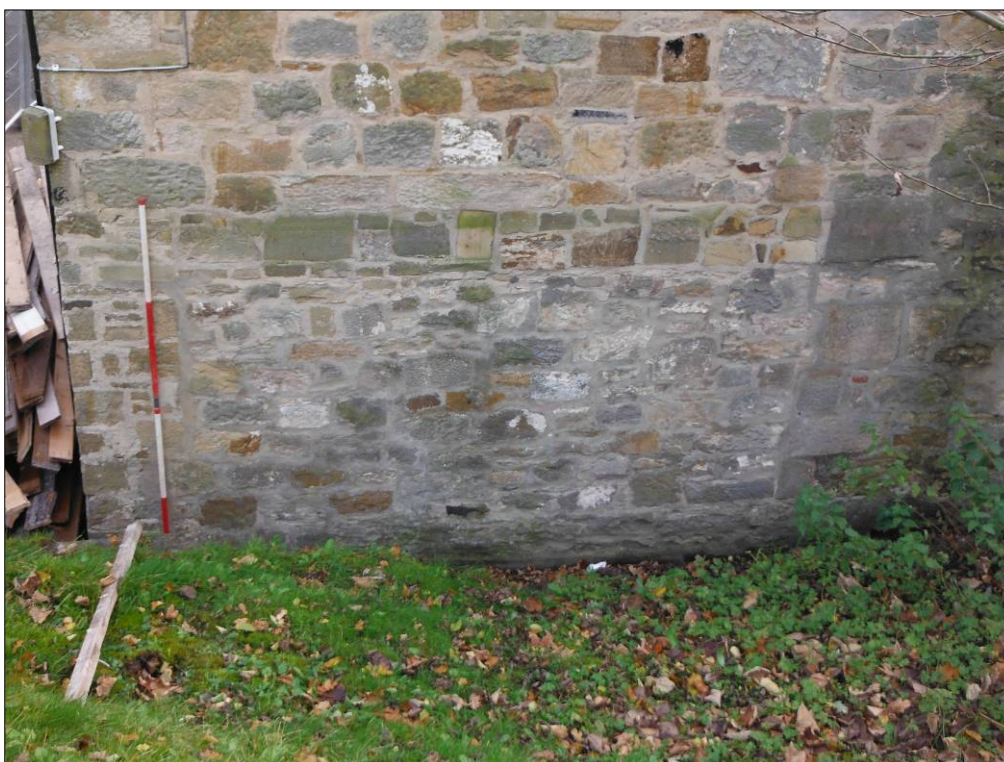
Figure 18: Detail of blocked opening at the eastern end of the northwest elevation of Building C (scale=2m).

The northwest elevation of Building C is partially obscured by the addition of Buildings F and G on this side of the structure, however element of the northwest elevation can still be seen within Building F. As with the southeast elevation, this elevation bears evidence of differing phases of construction within Building C (Figure 17). Beginning with the eastern most section; this is the latest addition to the structure and is constructed of roughly-coursed sandstone masonry which uses larger blocks than elsewhere in the structure. At ground floor level there is large blocked opening, whilst the first floor level is featureless. The blockage on the ground floor has also necessitated the rebuilding of the northeast corner of the building at this level, where there are now no quoin stones present (Figure 18). The original purpose of this opening is unknown.

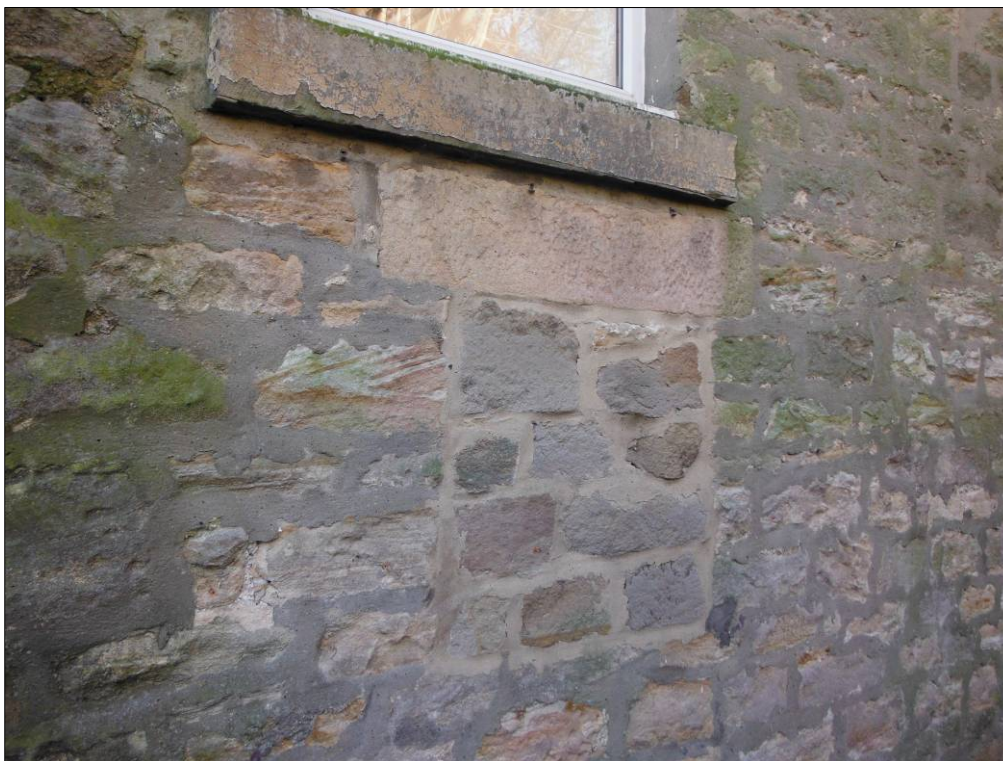
Figure 19: Detail of blocked opening in the ground floor of the middle portion of the northwest elevation of Building C.

The middle section of the northwest elevation is constructed of well-coursed sandstone masonry without quoins. This section of walling has been roughly re-pointed and contains a single long window at first floor level with a sandstone lintel and sill. Directly below this window a smaller blocked window is traceable in the masonry. This had a punch dressed sandstone lintel with no evidence of the sill remaining (Figure 19). Aside from the change in masonry between this portion and the easternmost section of walling, further evidence of differences in phase are notable in the building interior, these are discussed in Section 3.3.10 and 3.3.12.

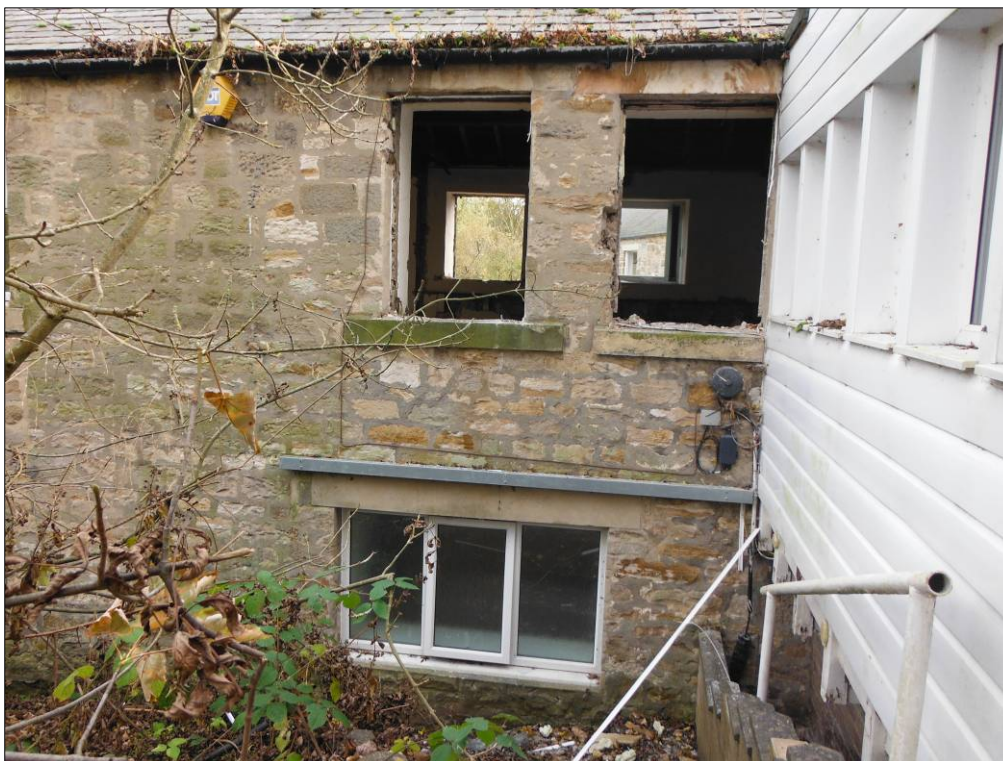
Figure 20: Western section of the northwest elevation of Building C before it is obscured by Building F.

The westernmost section of walling before Building F is the earliest; it is constructed of well-coursed sandstone masonry although this has been roughly re-pointed and has been patched up following the insertion or remodelling of window openings (Figure 20). At ground floor level there is a single wide window opening with a concrete lintel and timber sill, this is an inserted opening as evidenced by the patched stonework above the lintel. At first floor level there are two long window openings with sandstone lintels and sills. These do not appear to have been inserted but are longer than the original opening noted on the southeast elevation and may therefore have been lengthened at the base. Some patched stonework is evident to the east of the easternmost window which may relate to this phase of work.

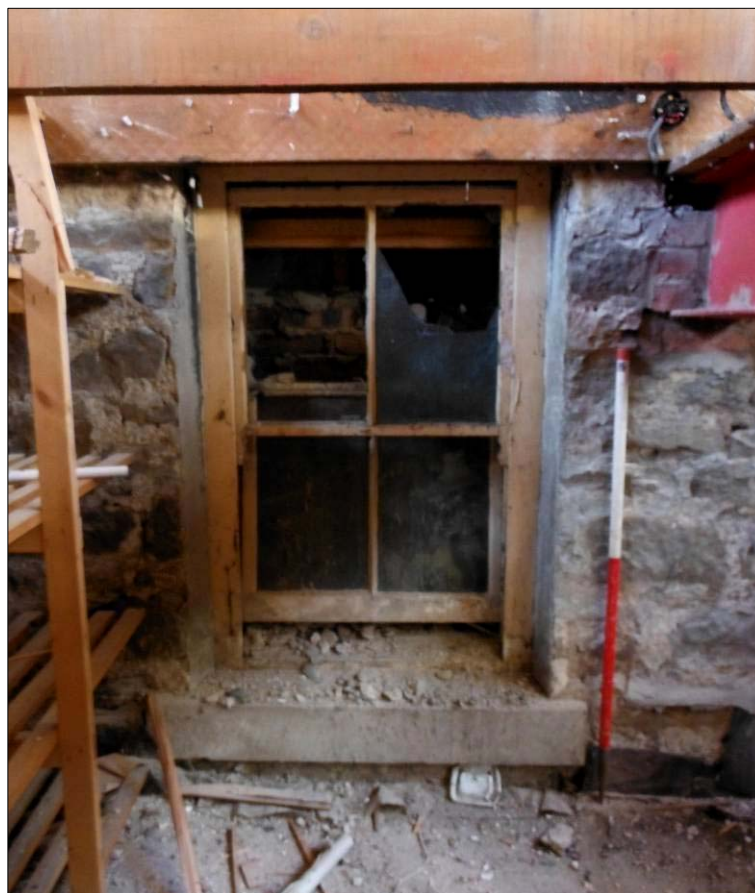
Figure 21: Inserted blocked sash window on the northwest elevation of Building C, preserved within the basement of Building F (scale=1m).

Building F has been built onto the northwest elevation of Building C. In the basement of Building F there is a blocked inserted window that would have been at the ground floor level of Building C. Although this window is an insertion, it is the earliest style of window frame identified at the site and is a timber-framed, four-paned, sash window with moulded horns (Figure 21). Its style most likely dates to the second half of the 19th century. This window is not visible on the interior of Building C as it is blocked by a modern staircase.

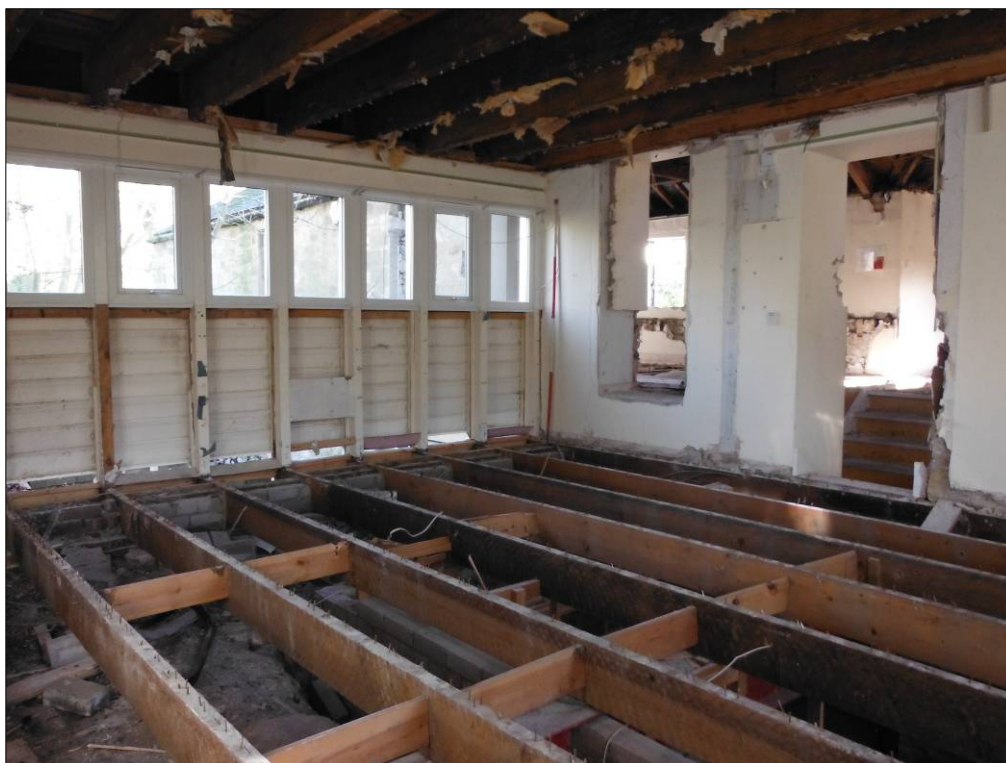
Figure 22: Inserted doorways on the northwest elevation of Building C contained within Building F (scale=2m).

At first floor level the northwest elevation of Building C can also be viewed from Building F. This contains two inserted doors; the westernmost door has clearly been inserted in order to give access to the new Building F, however the easternmost door does not communicate with the floor level of Building F and must therefore relate to an earlier phase in the building's history (Figure 22). The door appears to have been constructed by lengthening an existing window opening which itself appears similar to the window openings noted on the exterior immediately to the east.

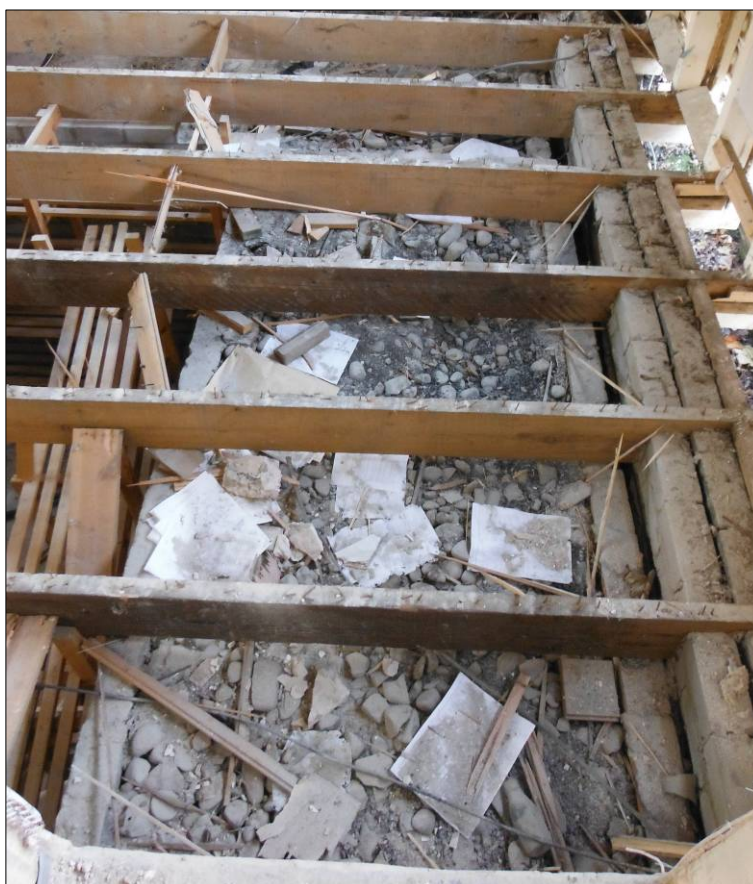
Figure 23: In-filled brick structure below the floor of Building F, viewed from the easternmost inserted doorway in the northwest elevation of Building C.

Some evidence of the original function of this door may be found beneath the floor of Building F where an in-filled brick structure was noted during the building survey (Figure 23). This was constructed of domestic 9” bricks laid stretcher and may have been a coal house or out-house added to the mill building. It is depicted on the Ordnance Survey Map of 1916 (Wooler 2011, Figure 12), although it is actually located slightly to the east of where it is depicted on the mapping. Wooler suggests that the structure is an external stair due to the manner in which it is depicted on the mapping (Wooler 2011, 18). It may have been the case that a short set of external steps were located on the roof of this structure leading from the higher ground located to the north of the building up to the inserted door on the northwest elevation of Building C. These steps may then have been removed, and the building in-filled when Building F was constructed.

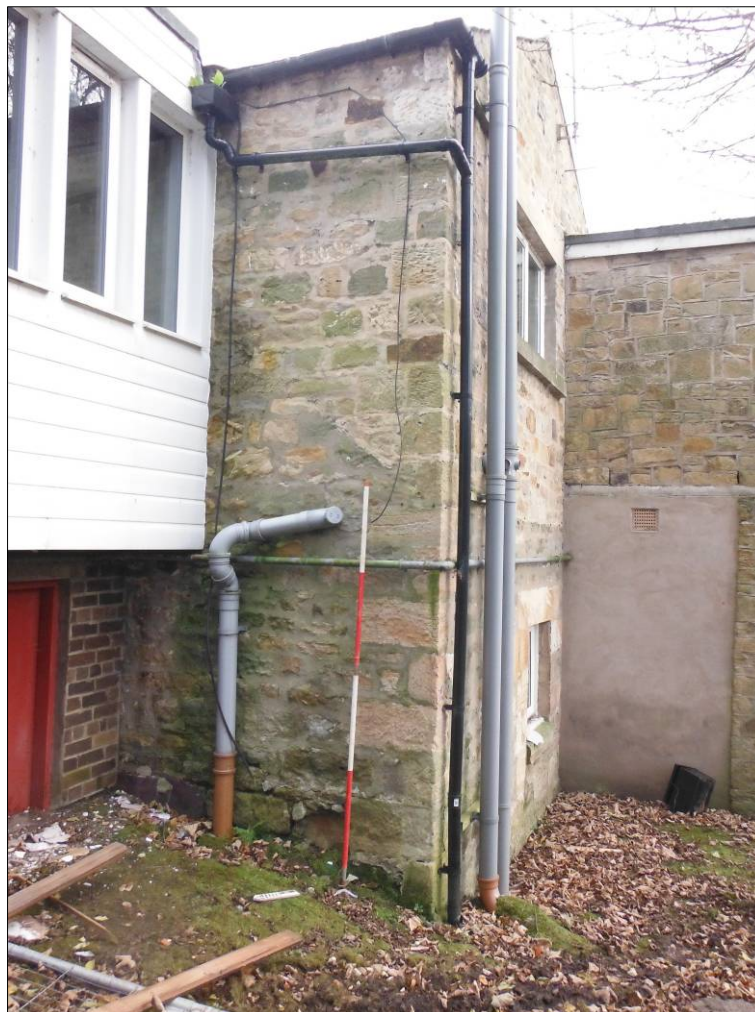
Figure 24: Western end of the northwest elevation of Building C (scale=1m).

The final section of the northwest elevation of Building C is visible to the west of Building F. This is constructed in well-coursed sandstone masonry. A diagonal line visible in the masonry at this end of the structure is the ghost of a previous roof-line (Figure 24), similar to that noted in the same location on the southeast elevation. This shows that this portion of Building C was originally built as a single-storey lean-to structure. The lean-to structure has then been raised to two storeys and this was clearly done prior to the addition of Building F.

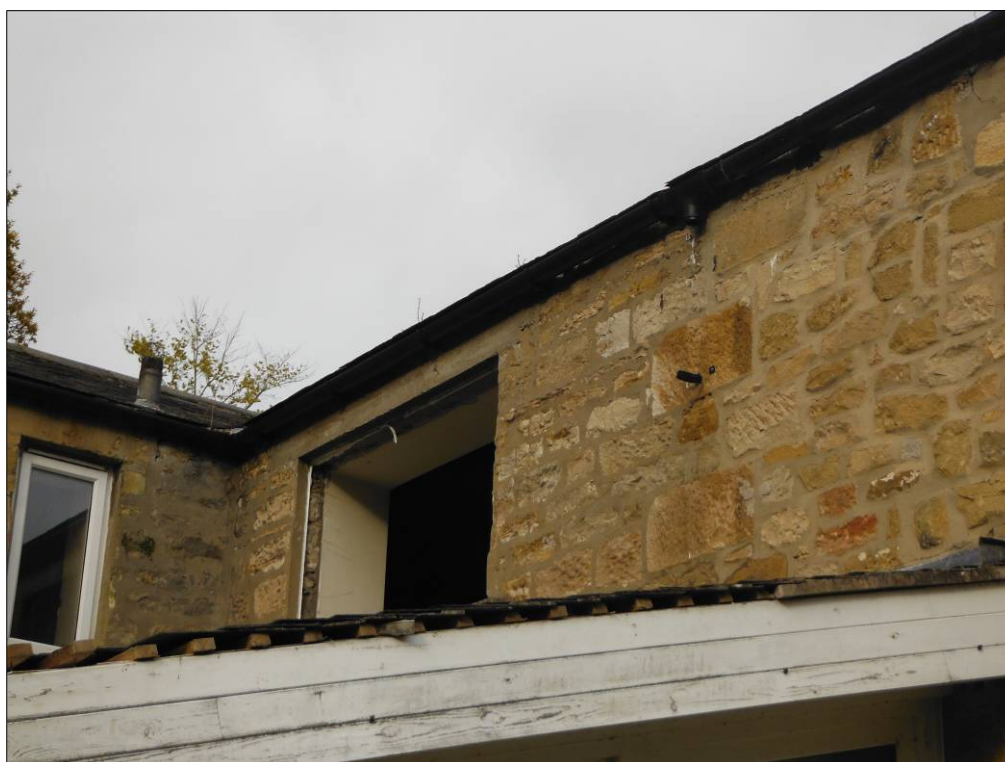
Figure 25: Southwest elevation of the northwest-south-east aligned projection of Building C.

The southwest elevation is split between the southwest end of the northeast-southwest aligned main range and the southwest elevation of the northwest-southeast aligned projection. Beginning with the projection; very little of this elevation is now visible due to the addition of Building D. The small section of walling that is visible is constructed of well-coursed sandstone masonry without quoins (Figure 25). A vertical construction break is visible between this structure and Building B to the south which has been keyed-in using large sandstone blocks. This indicates that Building B post-dates Building C. There is a single window opening at first floor level of this elevation that appears to be an insertion, bearing no resemblance in style to those located on the northwest and southeast elevations of this building.
