**A Staged Programme of Archaeological
Work at Mill House, Ponteland,
Northumberland**

**Including Building Recording, Earthwork
Survey and Watching Brief**

ARS Ltd Report No. 2013/102
November 2013

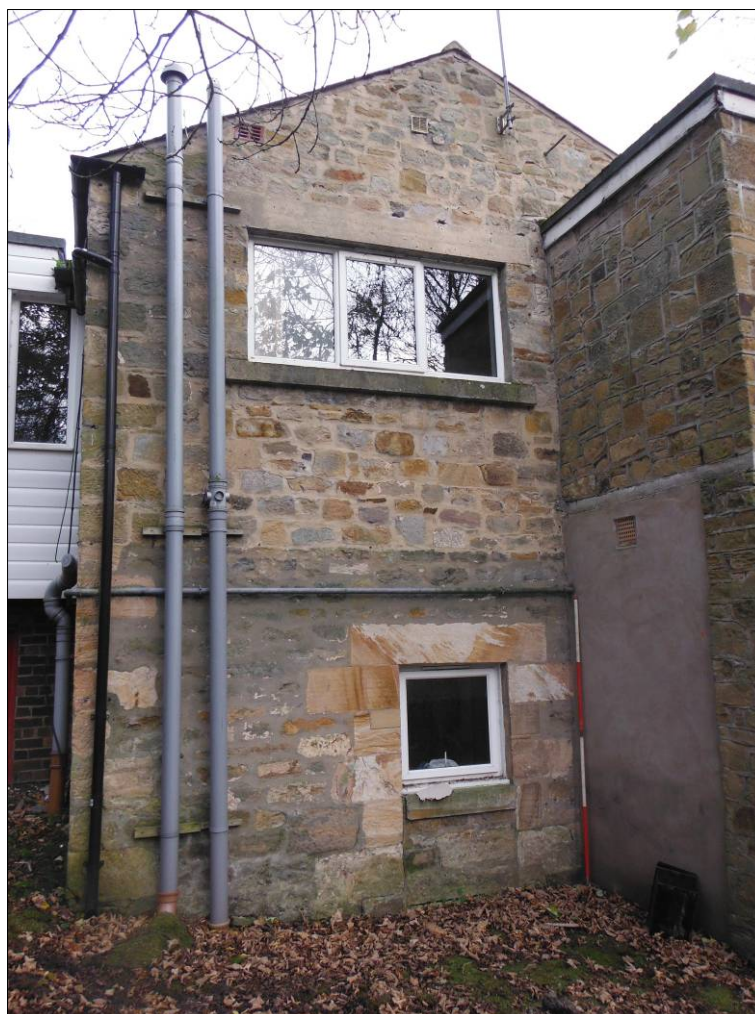
The southwest elevation of the main range is partially obscured by the addition of Building E (Figure 26). It was constructed in two phases, as the evidence of the original lean-to structure noted in the northwest and southeast elevations shows. The earlier ground floor level has been heavily re-pointed but appears to be constructed of roughly coursed sandstone masonry, using smaller stones than the later first floor level. The ground floor contains an original doorway with sandstone surround that has been remodelled into a window. The first floor contains a single large window with concrete lintel and sill that is modern in date and appears to be original to the structure.

Figure 26: Southwest elevation of the main range of Building C (scale=2m).

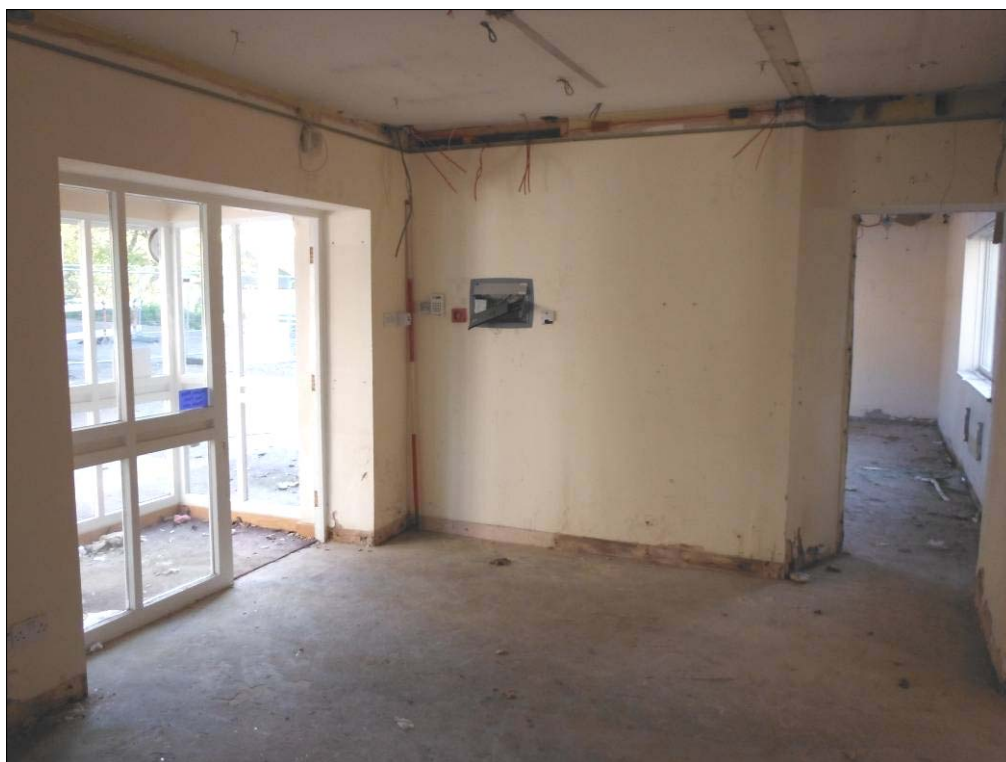
Figure 27: Northeast and southeast walls of Room C1 (scale=2m).

Room C1 was used as the reception area for the Galliford Try offices, but was part of the original mill structure. It is accessed via a large modern opening with a glass fronted porch in the northeast wall (Figure 27). As this space was used as reception area, it is a central communication area. Room C1 gives access to Building B, via a single width doorway in the southeast wall, Building D, via a double-width opening in the southwest wall, and the remainder of Building C, via a single width doorway in the northwest wall (Figure 28). The doorways are the only features located in this room and all walls are covered with painted plasterboard, removed in places to reveal the wall construction.

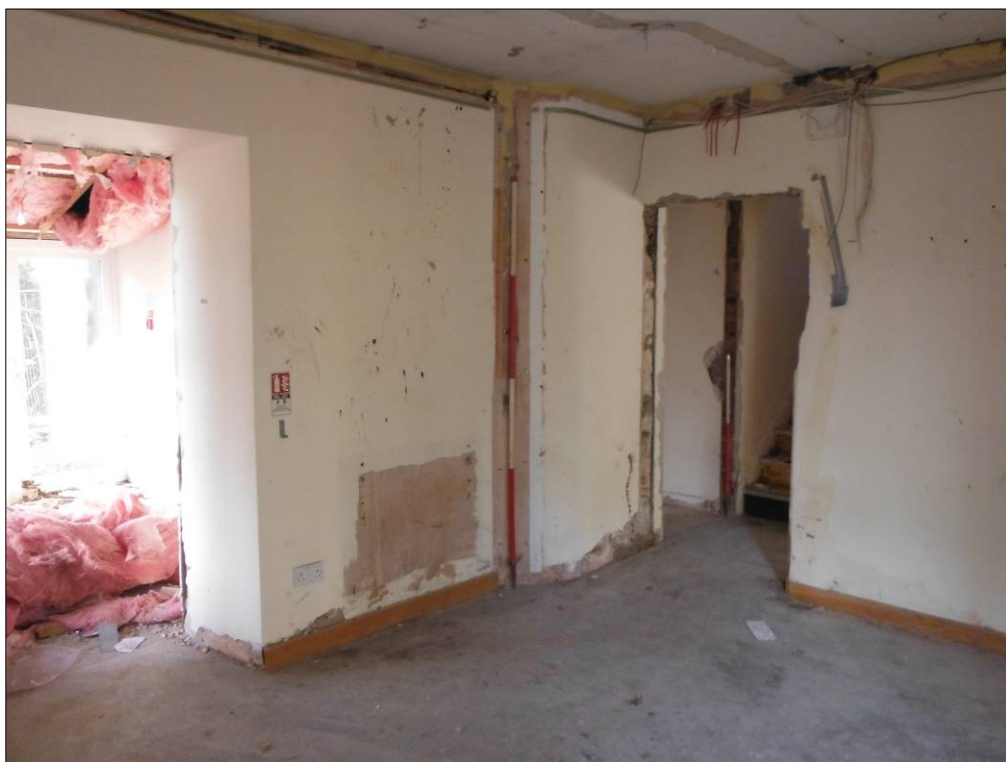
Figure 28: Northwest and southwest walls of Room C1 (scale=2m + 1m).

The northwest wall of Room C1 is a brick-built partition wall, indicating that this area of the ground floor of Building C would have been an open space originally. No features or fixings relating to the original mill workings were uncovered in Room C1.

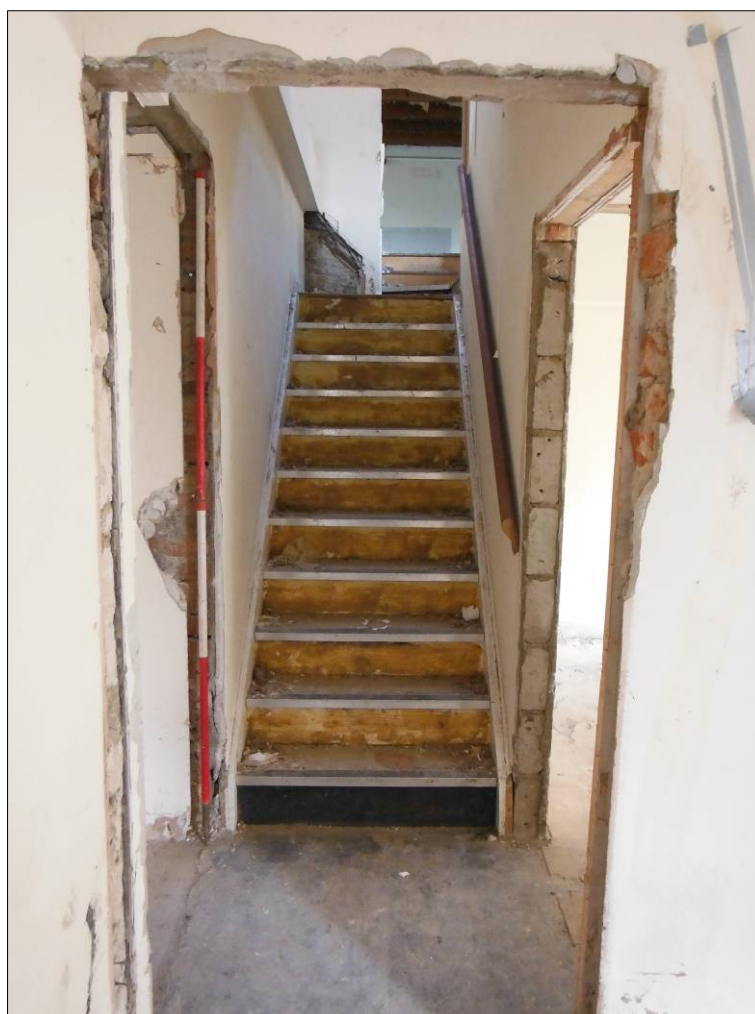
Figure 29: Modern staircase along the southwest wall of Room C2, also showing the brick-built partition of Rooms C1 and C2 in the foreground with the breeze-block partition of the staircase behind (scale=2m).

Room C2 contains a modern staircase giving access to the first floor along its southwest wall (Figure 29). This is separated from the remainder of the room by a breeze-block partition wall. This staircase blocks a ground floor window on the northwest wall of Building C that was visible in the based of Building F (see Section 4.3.5).

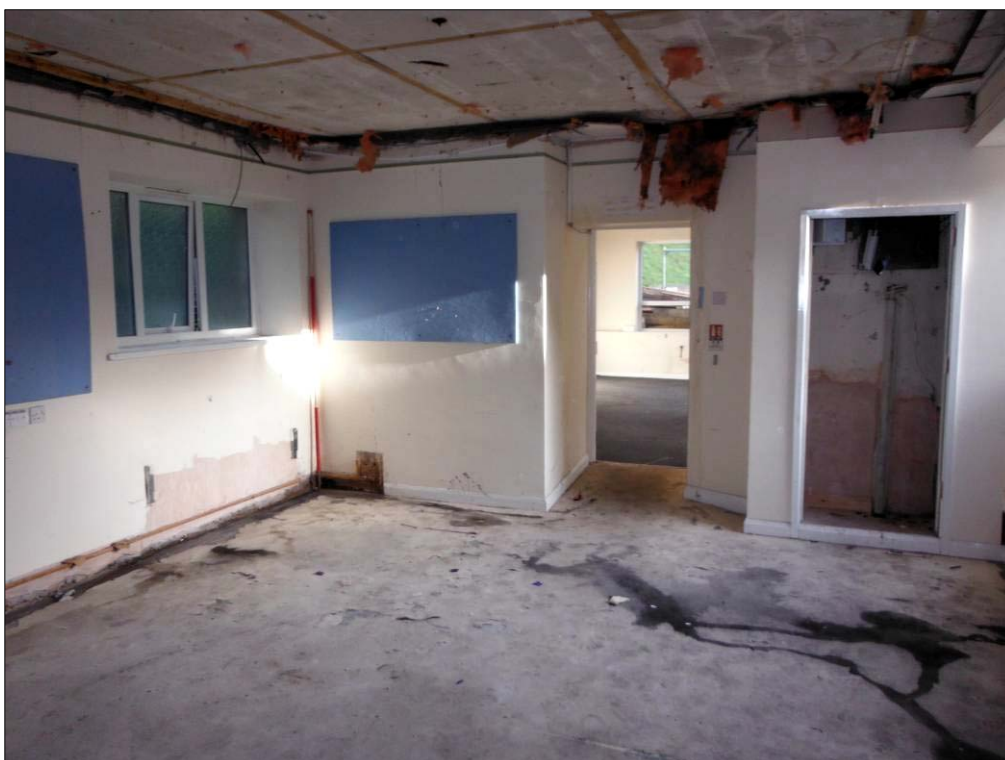
Figure 30: Northwest and northeast walls of Room C2 (scale=2m).

The area contained within the remainder of Room C2 marks the original extent of the mill building prior to the addition of two extensions to its eastern end. Access is via a single-width doorway in the southwest wall. The southwest wall contains an under stair cupboard, whilst the northwest wall is featureless save for a large window opening. The northeast wall is thicker at the northern end than it is elsewhere (Figure 30) and further investigation of this area revealed that the thickening consisted of a brick skin on the inside of the sandstone wall (Figure 31). This was built to provide the flue for a fireplace at first floor level which most likely dates to the conversion of the mill to domestic purposes (Figure 32).

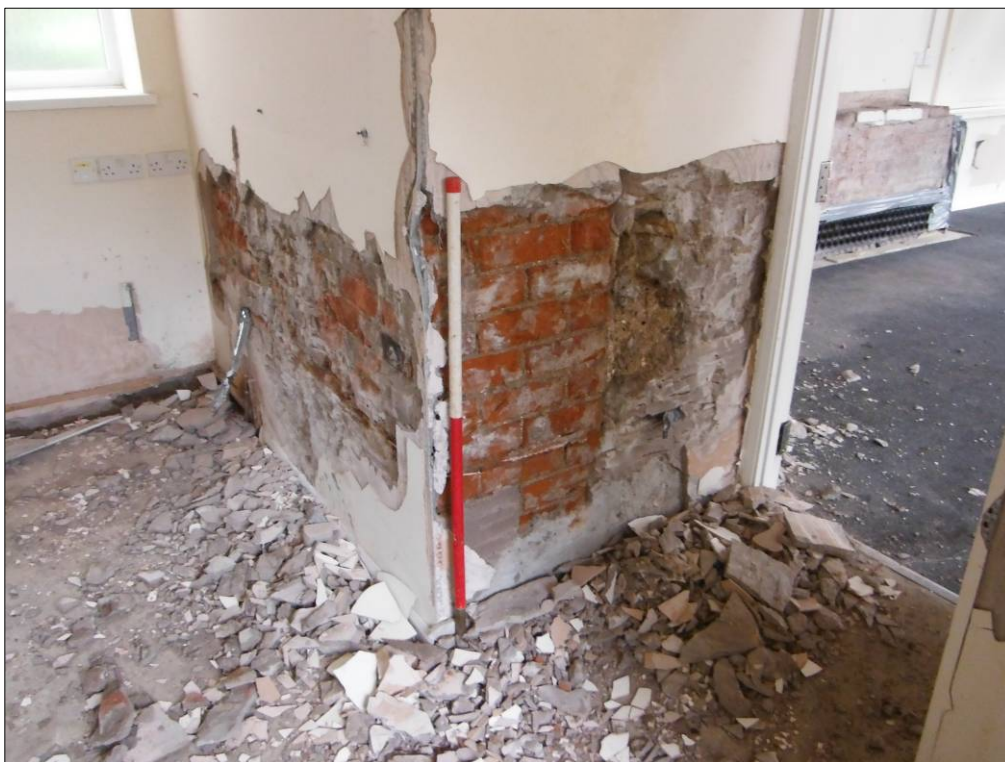
Figure 31: Northern end of the northwest wall of Room C2, showing the brick skin applied to the interior of the sandstone wall (scale=1m).

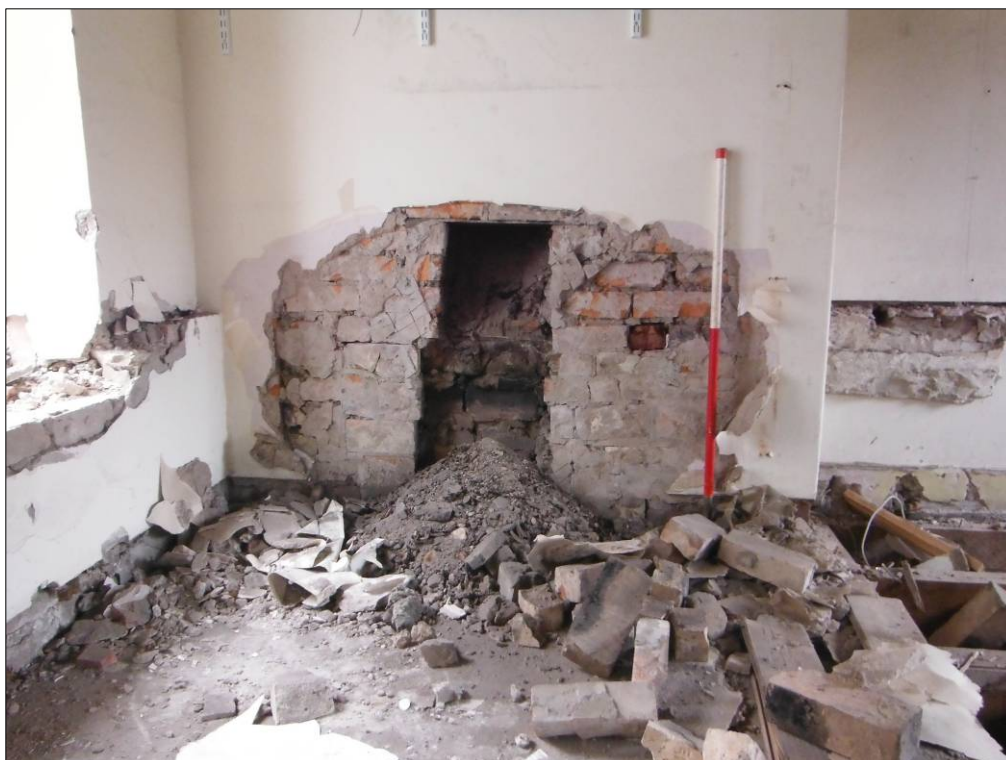
Figure 32: Northern end of the northwest wall at first floor level above Room C2, showing the flue provided in the brick skin applied to the interior of the sandstone wall (scale=1m).

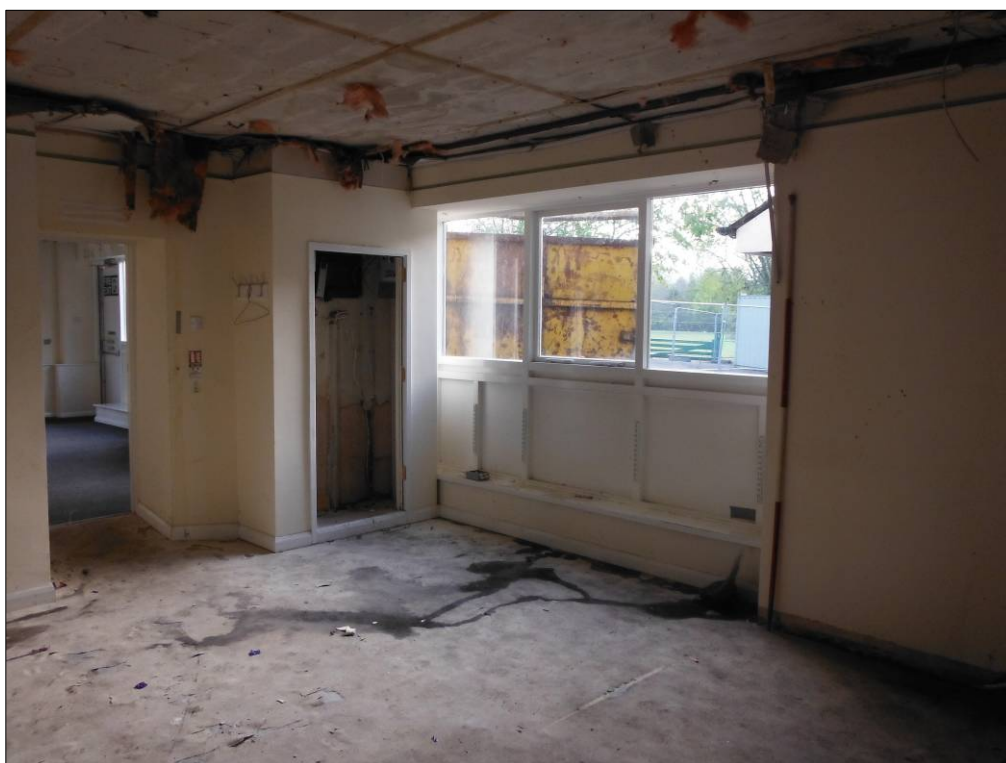
Figure 33: Northeast and southeast walls of Room C2 (scale=2m).

The northwest wall also contains an inserted cupboard constructed of timber boarding which partially blocks the wide window opening located in the southeast wall (Figure 33). No features or fixings relating to the original mill workings were uncovered in Room C2.

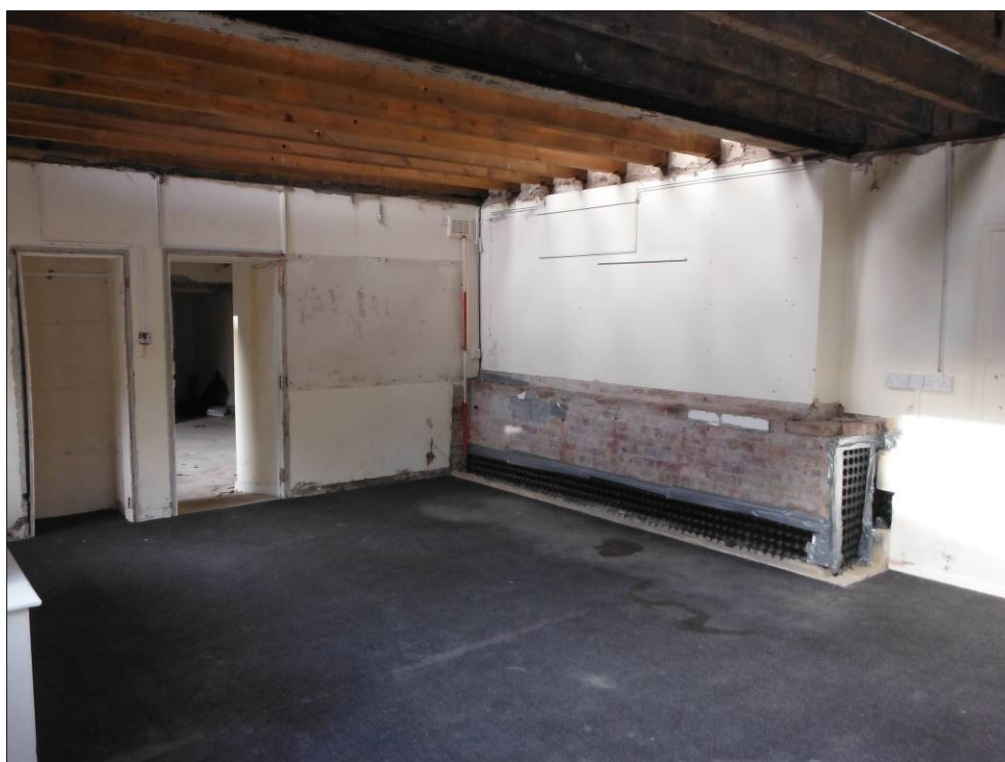
Figure 34: Southwest and northwest walls of Room C3 (scale=2m).

The room is accessed through the southwest wall via a single-width doorway from G2 (Figure 34). The southwest wall also contains a large wall cupboard. There is a brick-built platform along the northwest wall of Room C3 which also contains some concrete blocks. The purpose of this feature is not known, but it marks the extent of the first extension to the mill. This extent is also notable in the southeast wall where there is a marked change in thickness between the walls of the westernmost half of the room and those of the easternmost end (Figure 35). A Reinforced Steel Girder (RSG) has also been inserted in the ceiling at this point, most likely marking the location where the end wall of the previous extension has been removed, requiring the addition of extra reinforcement to carry the floor above at this point. From this point onwards the eastern end of the building uses aged, reused floor joists to carry the first floor, whereas those in at the western end of the room are not reused and therefore appear newer (Figure 36).

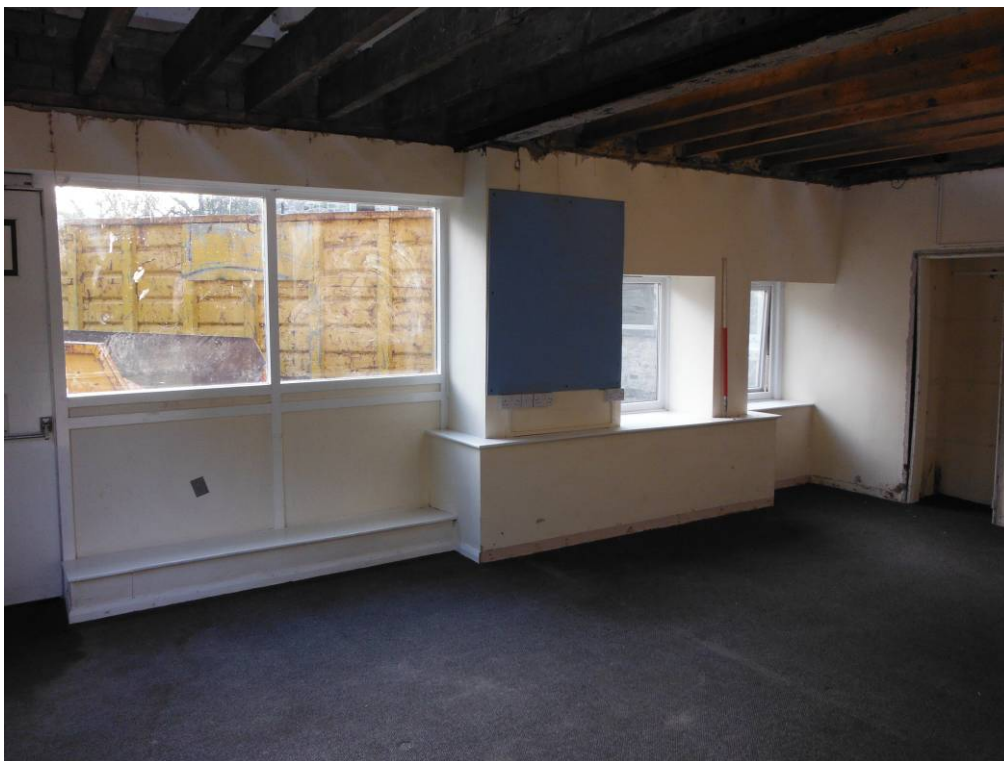
Figure 35: Southeast wall of Room C3 (scale=2m).

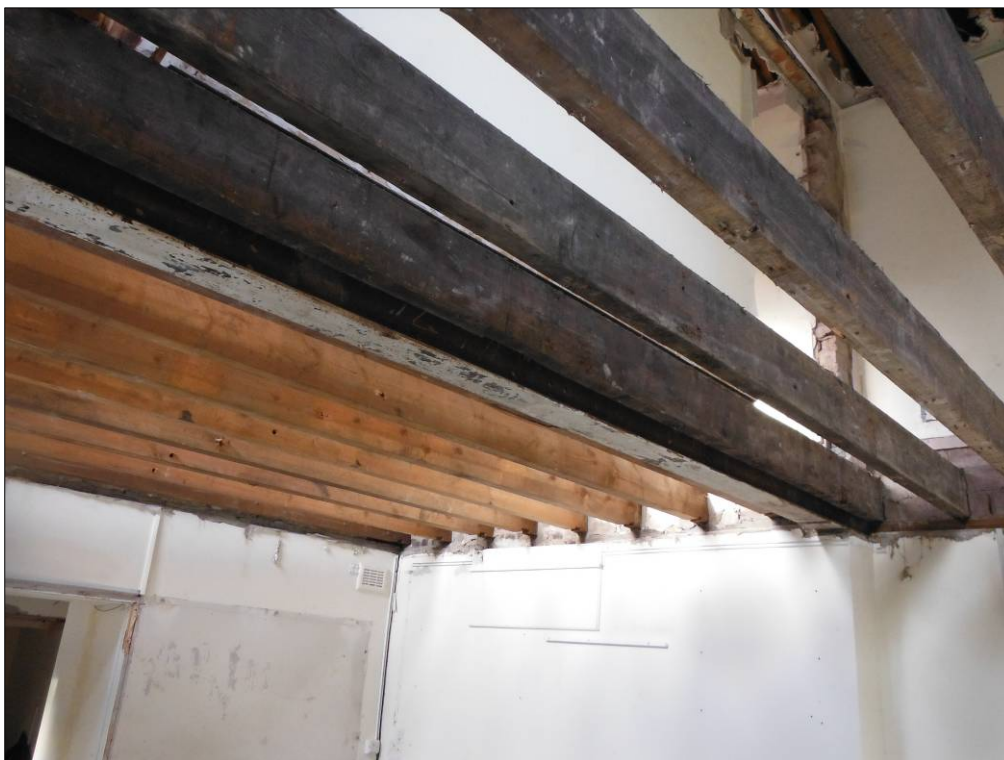
Figure 36: Change in floor structure marking a difference in phase within Room C3; note the inserted RSJ in the centre with the aged reused floor timbers of the eastern portion of the room to the right.

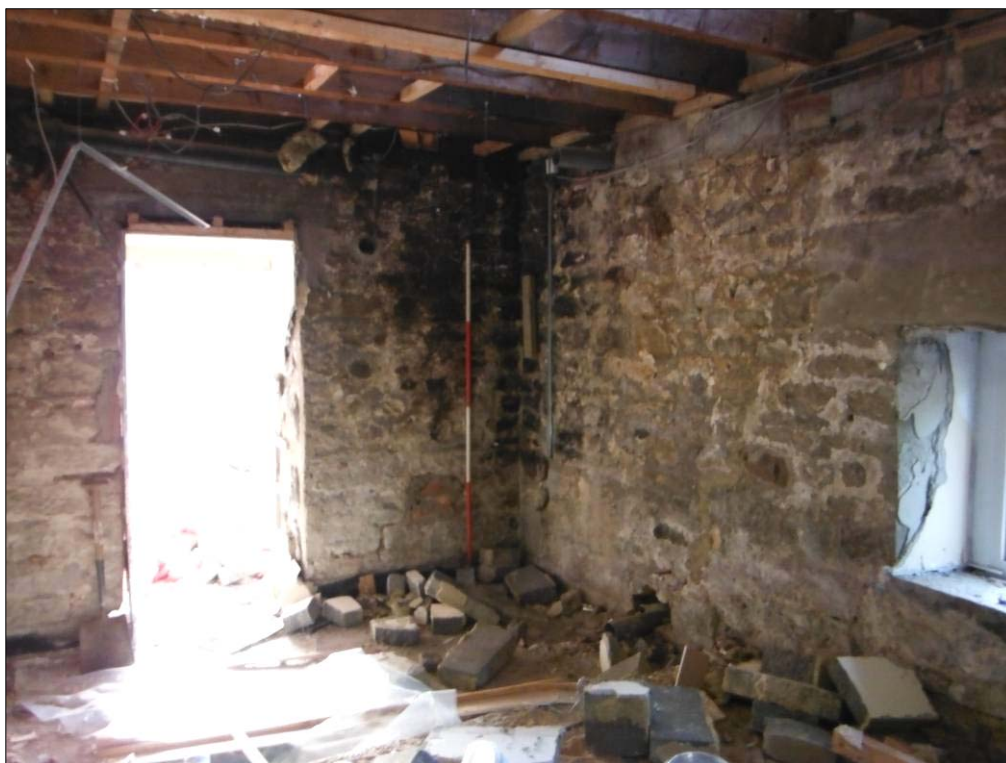
Figure 37: Southeast wall of Room C4 (scale=2m).

Room C4 is accessed via a single-width inserted doorway in the northeast wall. The southeast wall contains a single-width doorway giving access to Building D (Figure 37). The southwest wall contains the blocked doorway remodelled into a window noted on the external elevation. Above this window it is clear that the original stone wall of the lean-to has been raised in order to carry the floor joists of the room above. The walls of the room above are notably thinner than the ground floor level, giving further evidence that this part of the building was originally single-storey (Figure 38). The northwest wall contains a blocked doorway that would originally have provided external access, but would now be contained within Building F (Figure 39).

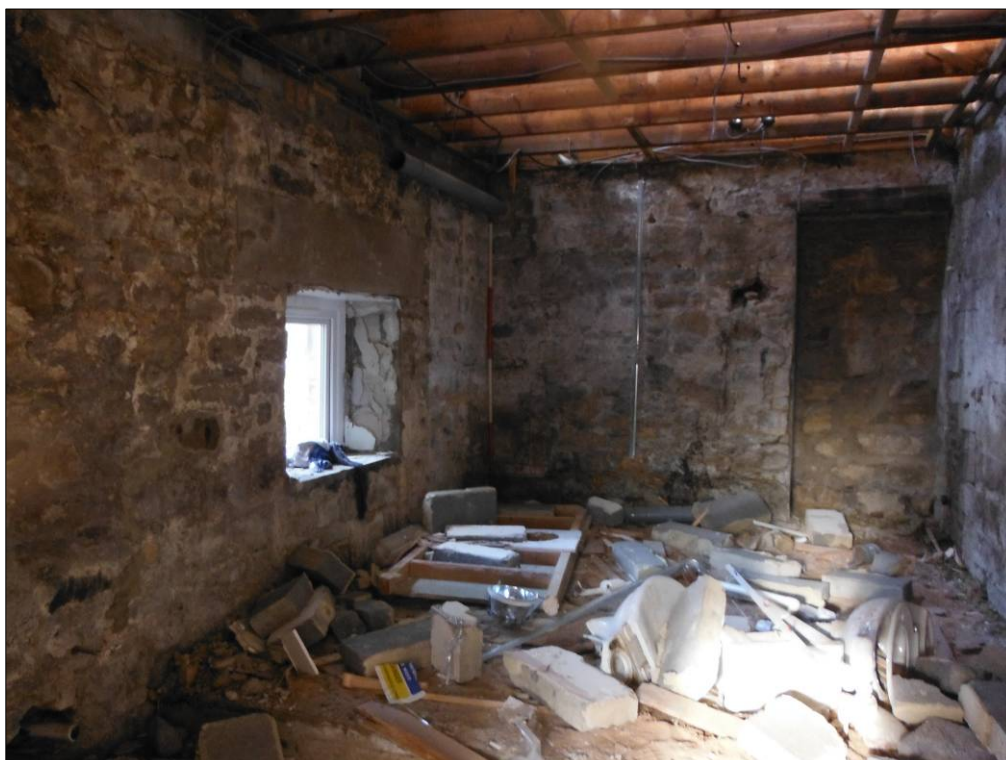
Figure 38: Southwest and northwest walls of Room C4 (scale=2m).

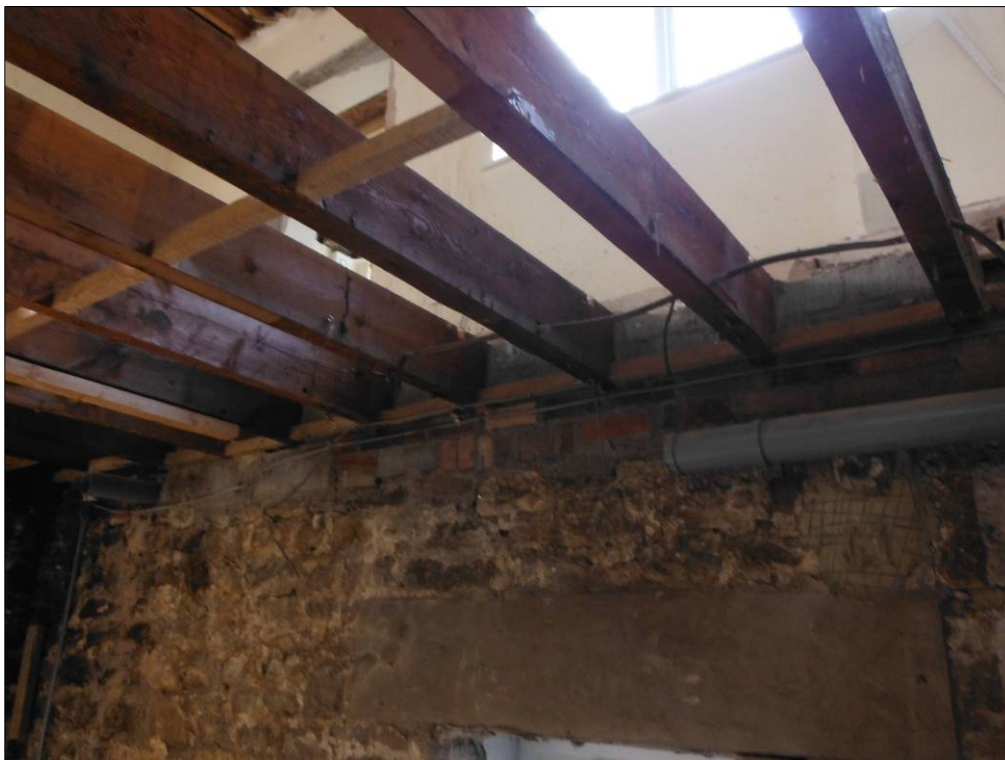
Figure 39: Insertion of the floor and addition of the first floor along the southwest wall of Room C4.

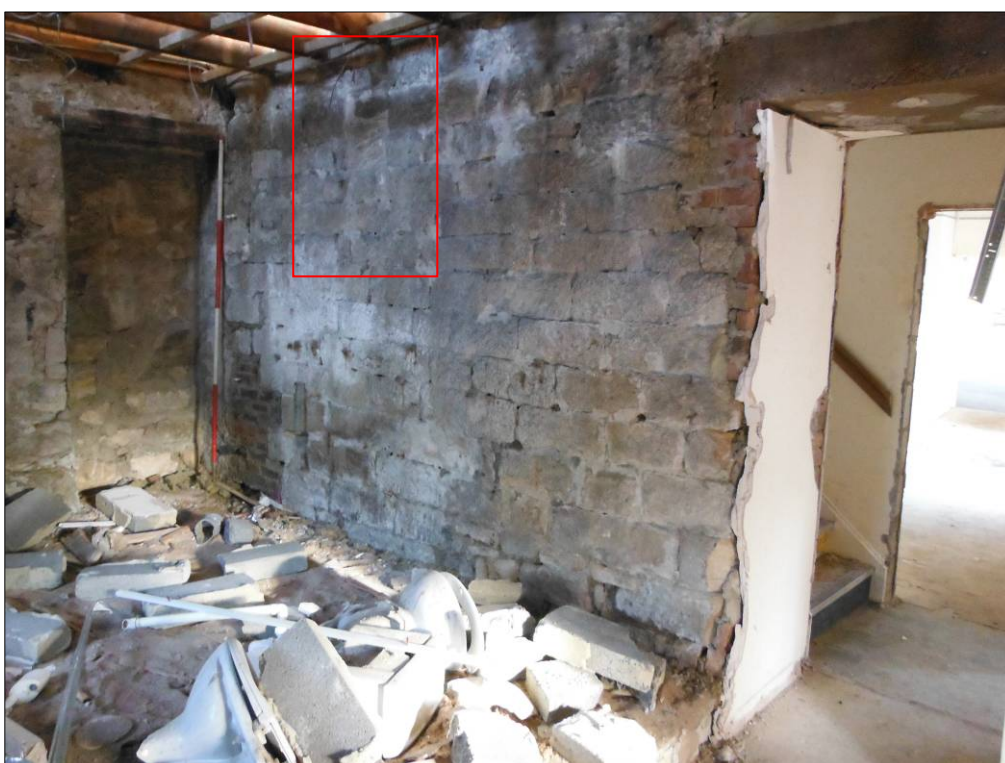
Figure 40: Northeast wall of Room C4 with location of the rectangular slot outlined in red (scale=2m).

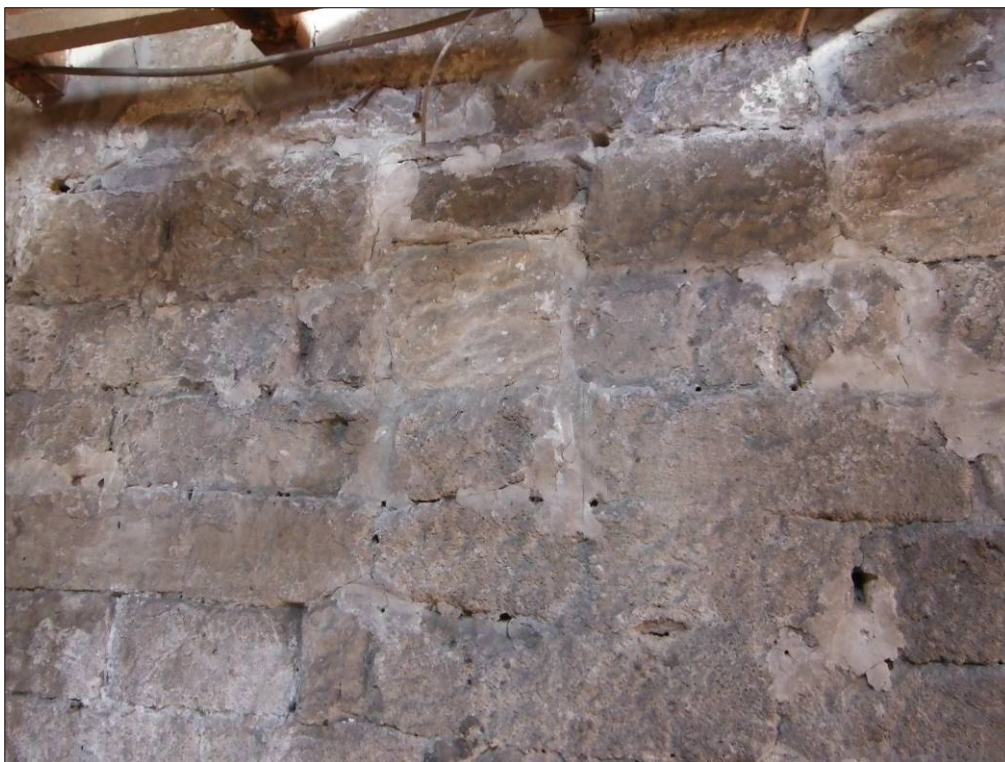
Figure 41: Rectangular slot in the northeast wall of Room C4 marking the location of a possible drive shaft.

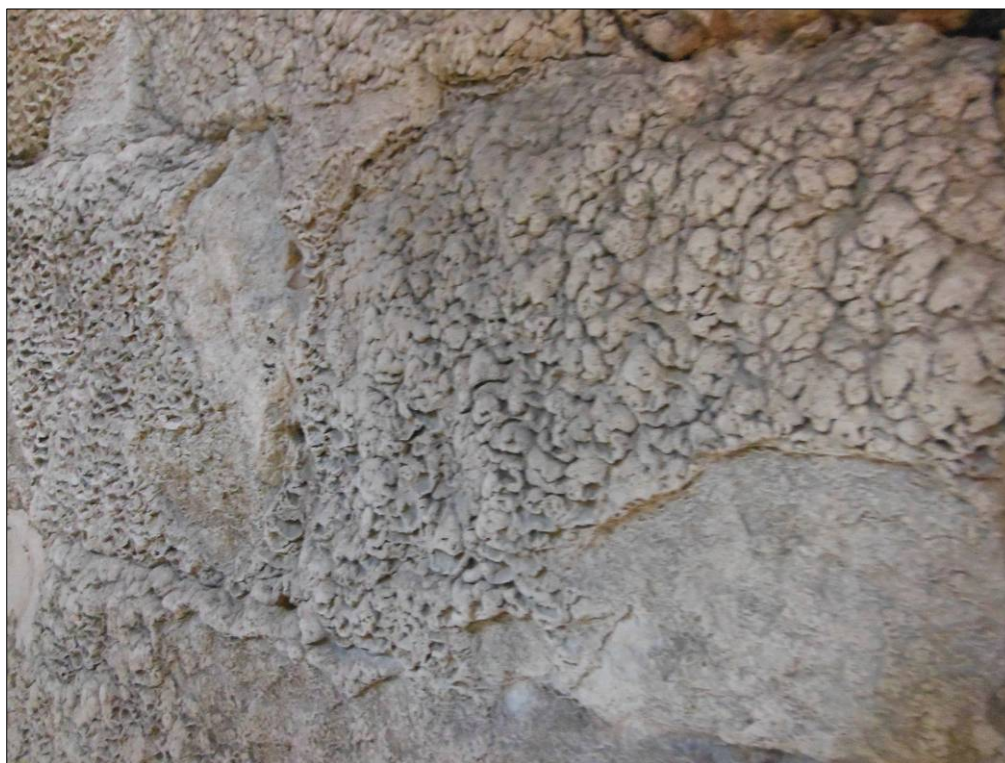
Figure 42: Calcification of the stone on the northeast wall possibly providing evidence of increased water action in this location.

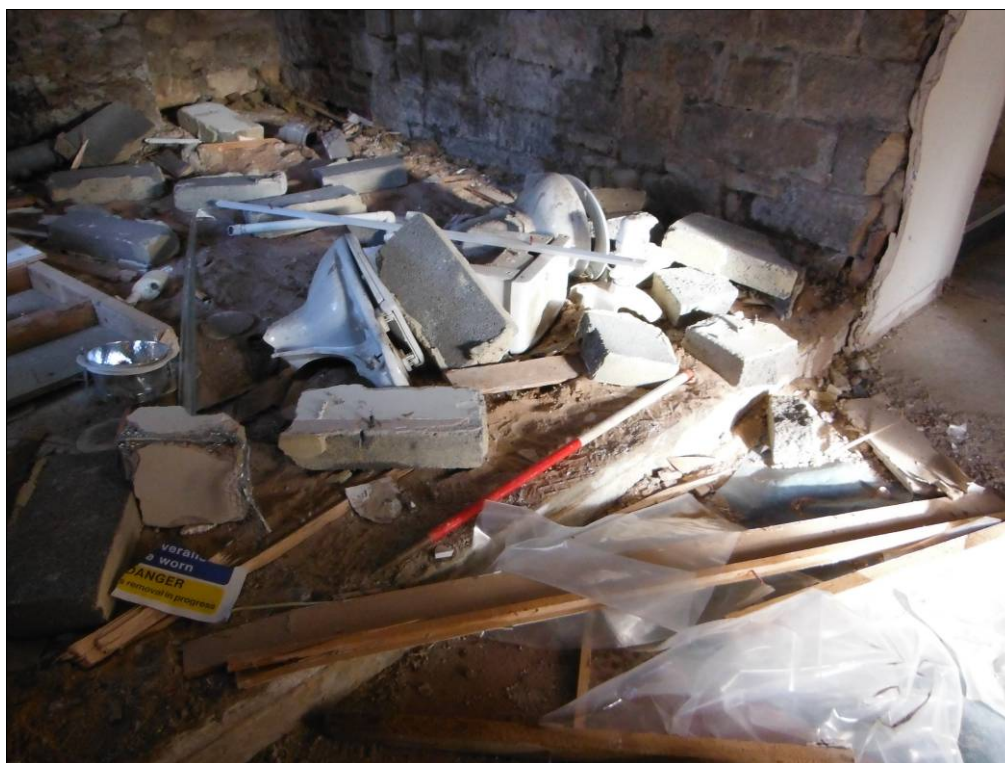
Figure 43: Concrete platform covering the probable location of the wheel pit in Room C4 (scale 1m).

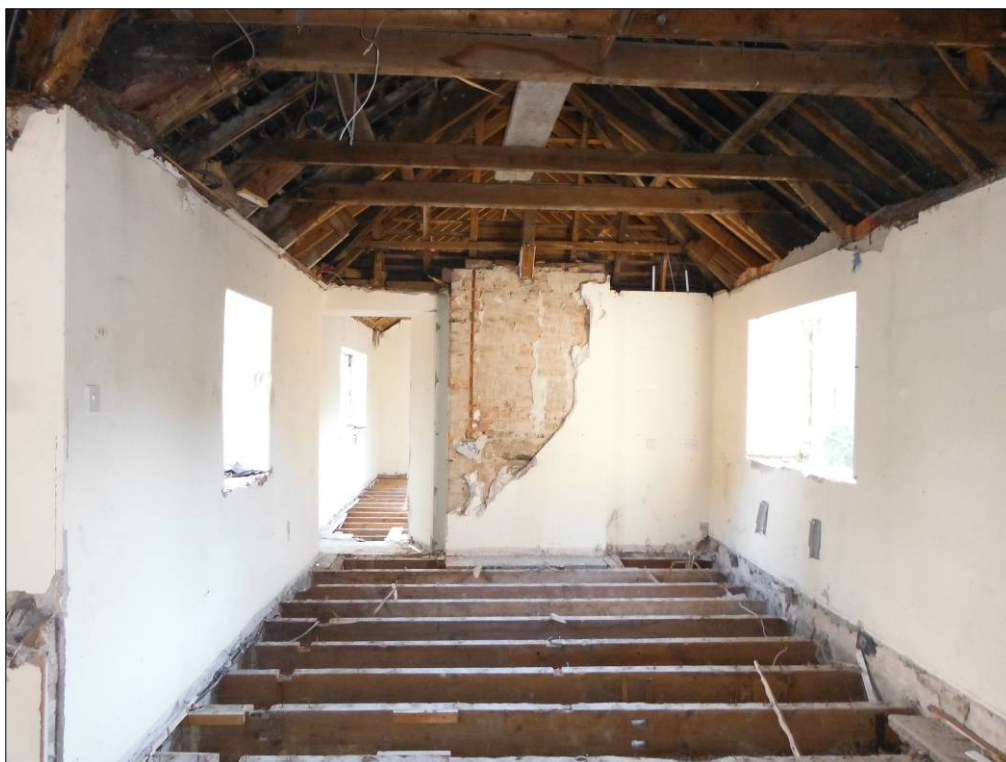
The first floor over Room C1 contains the windows noted on the northeast and southwest elevations as well as an inserted fireplace contained within an inserted thickening of the southeast wall (Figure 44). This wall also gave access to the first floor over Building B via a single-width doorway to the left of the fireplace, however there was no safe access to Building B at this point. The insertion of the fireplace most likely marks the time when the mill building ceased to function as a mill and had been renovated into housing. This change can be noted in the Ordnance Survey mapping when the 1916 map describes the building as 'Mill Houses' as opposed to 'Ponteland Mill (corn)' (Wooler 2011, 18).

Figure 44: First floor over Room C1, showing inserted fireplace in a brick-built chimney breast in the southeast wall.

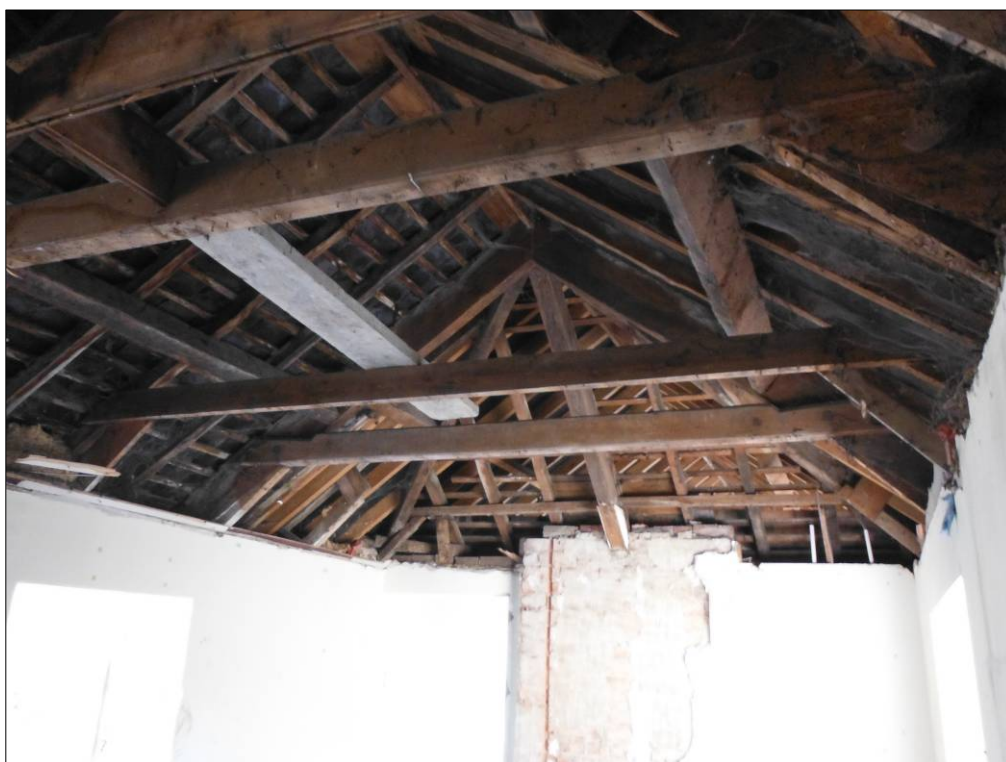
The roof structure over this room is original and shows that the southeast end of the building was originally hipped, prior to the addition of Building B to the south (Figure 45). This gives information relating to the original appearance of the structure as well as the phasing of its development.

Figure 45: Detail of the roof structure at the first floor over Room C1, showing the original hipped end of the building prior to the addition of Building B to the south.

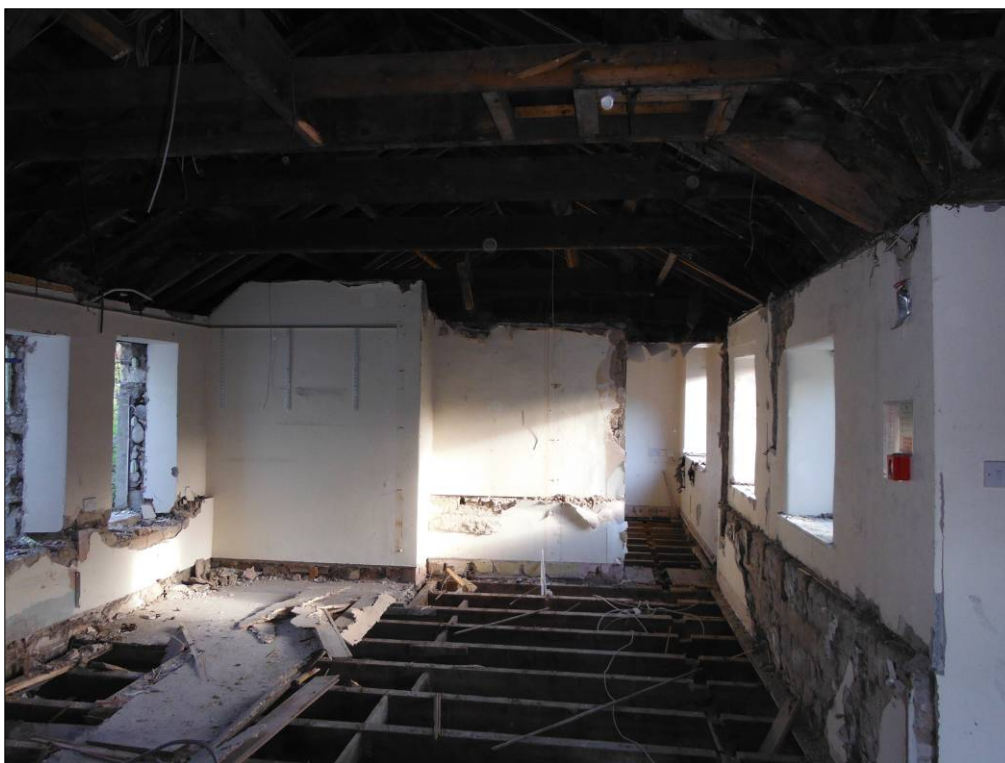
Figure 46: First floor over Room C2.

The first floor over Room C2 shows the windows noted in the southeast and northwest elevations as well as the original end wall of the mill building at its northeast end (Figure 46). This wall also gives access via a single-width doorway to rooms over the eastern extensions to the mill, however there was no safe access to these rooms at this point.

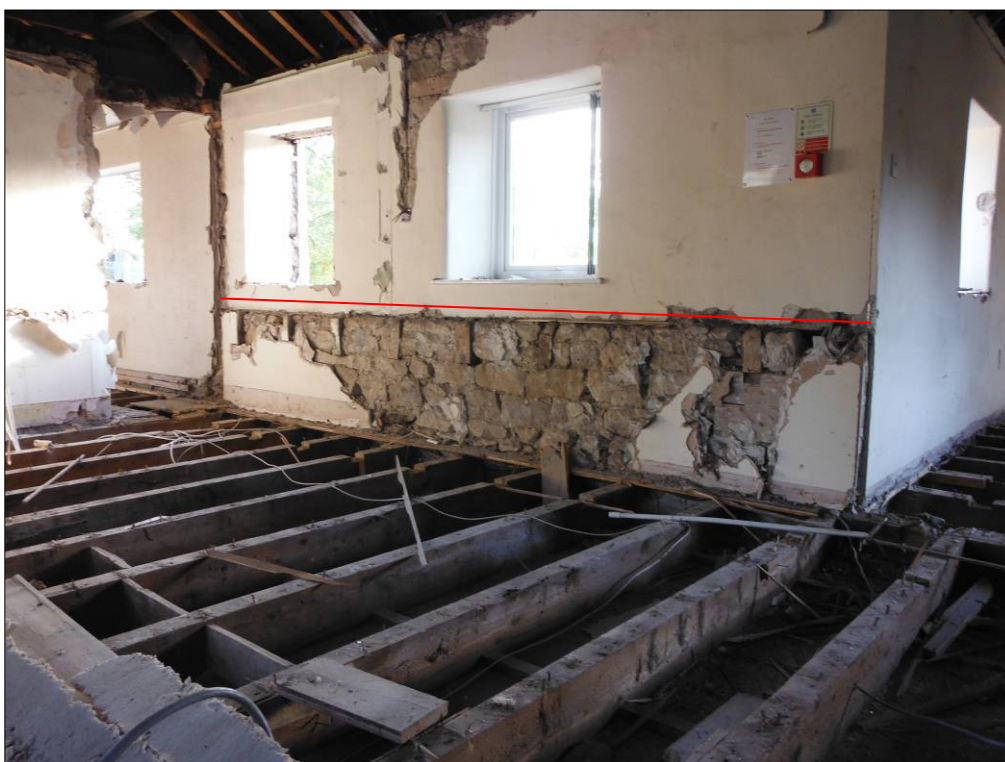
Figure 47: Southeast wall of the first floor over Room C2 showing the original floor level of this part of the building.

The southeast and northwest walls of this room show that the present floor level is lower than the original floor level in this part of the building (Figure 47). The original floor level is located c.0.7m above the present level and the increased ceiling height that this would have provided for the ground floor room would have allowed more space to house the large mill machinery that would have been found within this structure. The first floor room would therefore have had the appearance of a loft space, lit by small windows low down in the side walls.

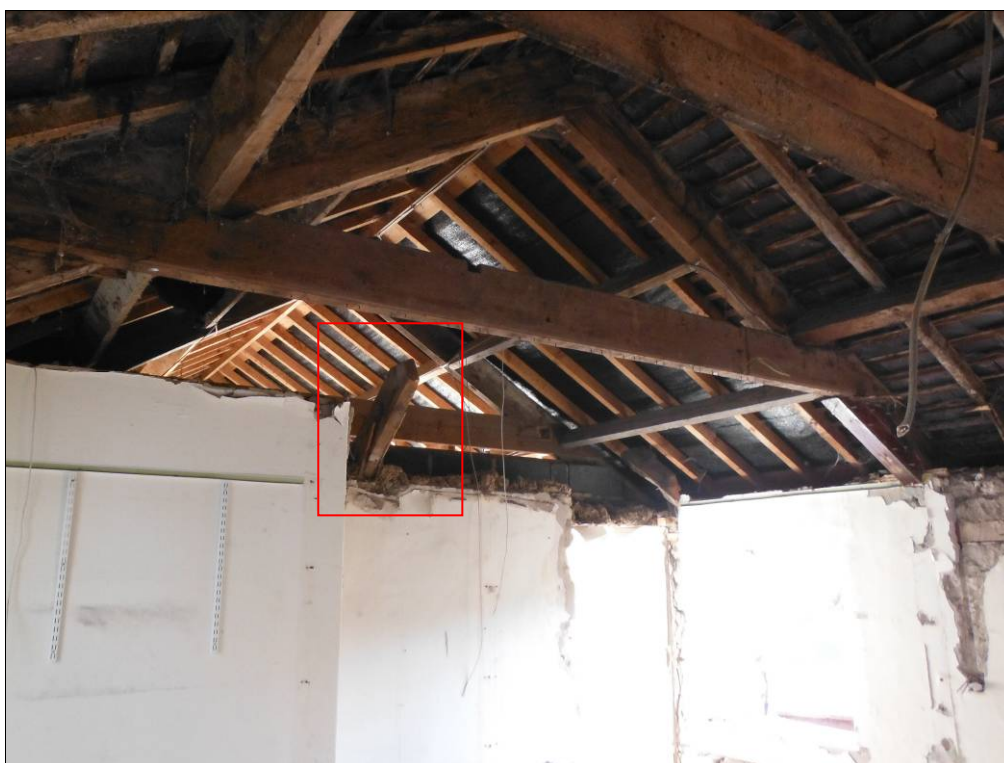
Figure 48: Detail of the roof structure at the first floor over Room C2, showing evidence of the original hipped end of the building (outlined in red) prior to the addition of extensions to the east.

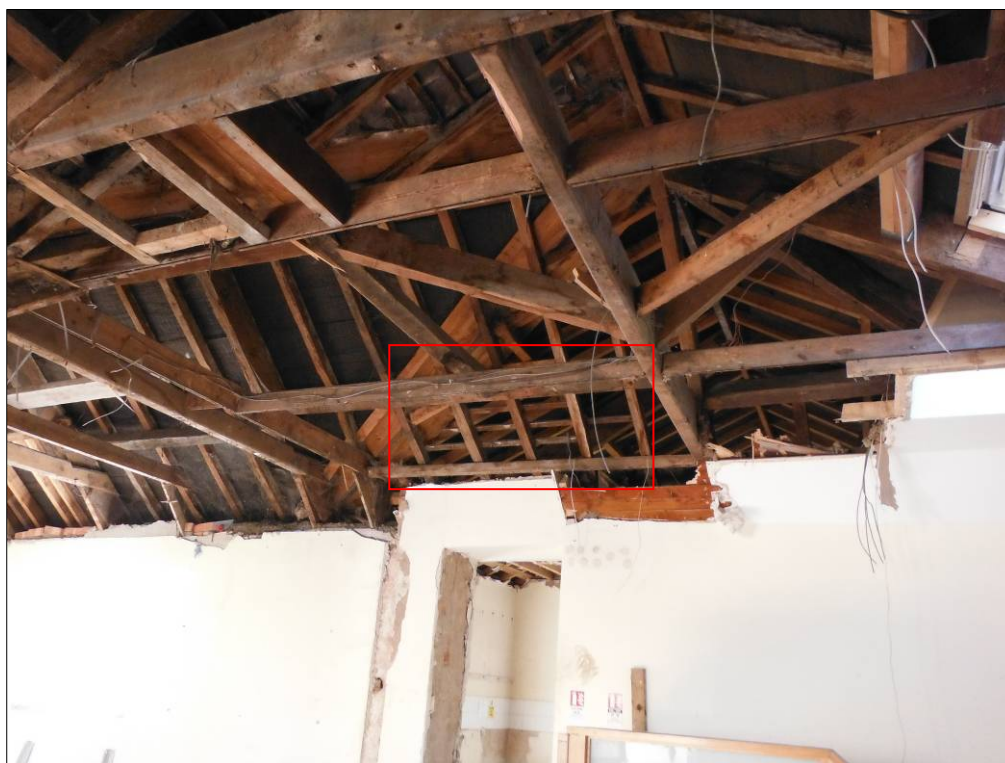
Figure 49: Detail of the roof structure at the first floor over the southwest end of Room C2, showing evidence of the original battens (highlighted in red) to fix the original roof covering, prior to the addition of Room C4 to the west.

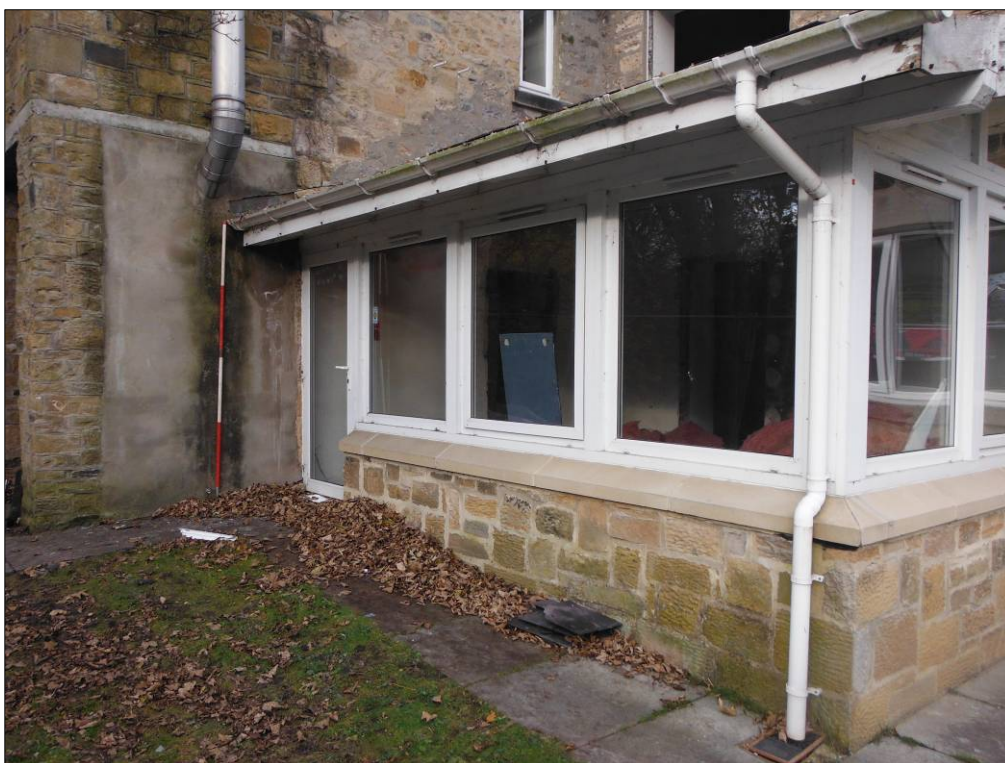
3.4.1 Building D is aligned northwest-southeast and adjoins Buildings B, C and E along its northeast and northwest ends. It is a single-storey, stone-built PVC and glazed conservatory-type structure previously in use as a meeting room. This structure is clearly of modern construction and contains no features of architectural or historical merit (Figure 50 and 51). Its location indicates that it may overly sections of the original tail race coming from Room C4 to the north.

Figure 50: Southwest elevation of Building D, showing Buildings C and E in the background (scale=2m).

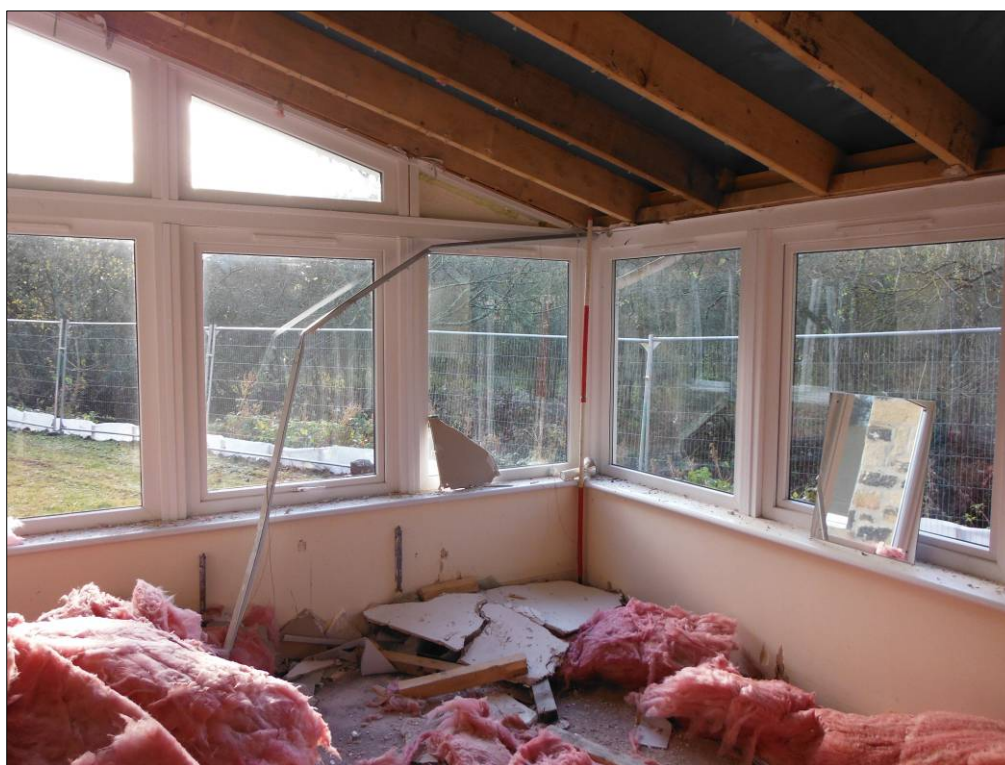
Figure 51: Southeast and southwest walls of Building D (scale=2m).
