**A Staged Programme of Archaeological
Work at Mill House, Ponteland,
Northumberland**

**Including Building Recording, Earthwork
Survey and Watching Brief**

ARS Ltd Report No. 2013/102
November 2013

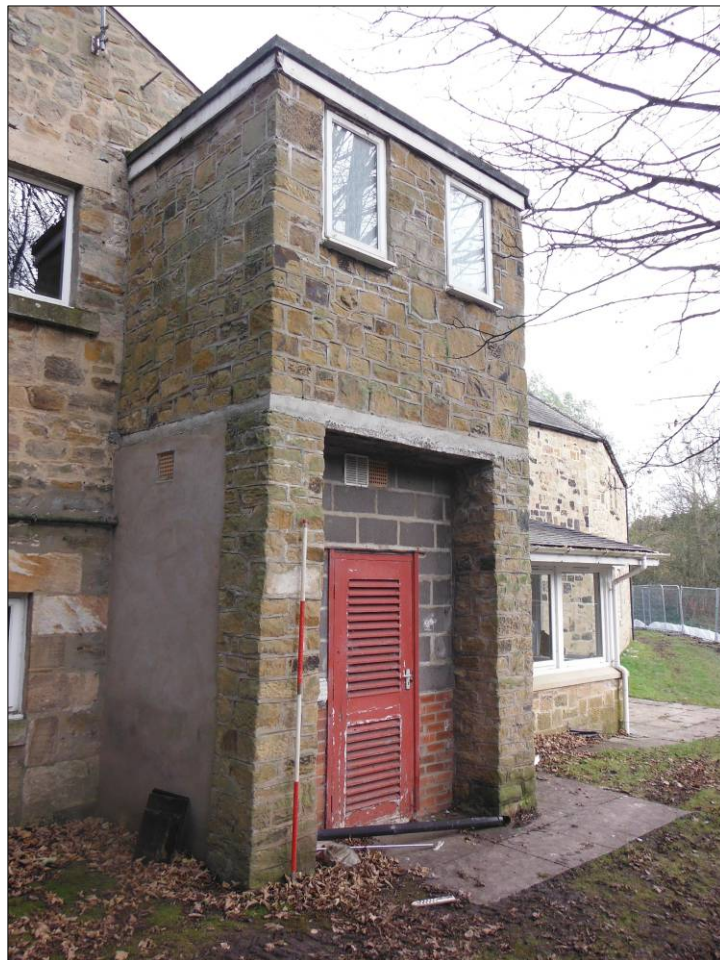
3.5.2 This building is a two-storey structure, constructed of squared-random sandstone masonry with tuck pointing. It has a flat roof covered with asphalt and a timber weatherboard. This structure is clearly of modern construction and contains no features of architectural or historical merit (Figure 52). There was no access to the interior of the ground floor as this contains the heating system for the office building. There was also no safe access to the first floor room with is accessed via a single-width doorway in the southeast wall of Building C and contained two small windows in the southwest wall.

Figure 52: Northwest and southwest elevation of Building E (scale=2m).

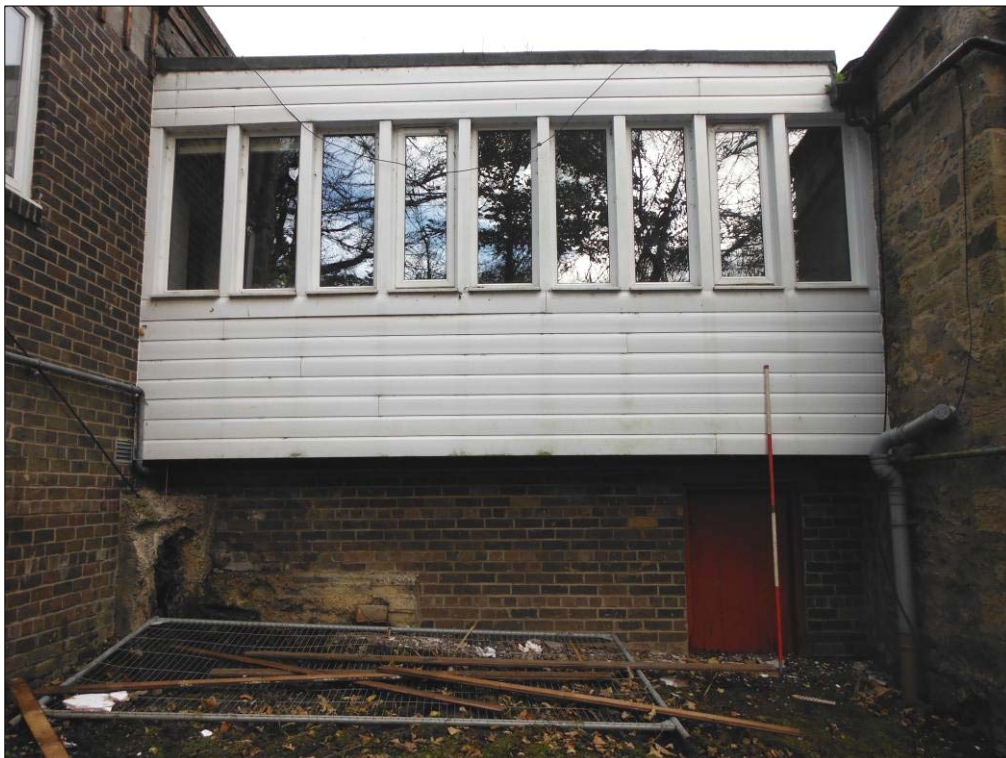
3.6.2 This building is single storey with a basement, built over the raised ground to the north of Building C. It is of half-timber, half-brick construction with the bricks laid to English Garden Bond. It has a flat roof covered with asphalt (Figure 53 and 54). This building is clearly of modern construction and bears no intrinsic architectural merit. However evidence of past landscaping works, possibly associated with the original mill building are contained beneath the floor of this structure.

Figure 53: Southwest elevation of Building F (scale=2m).

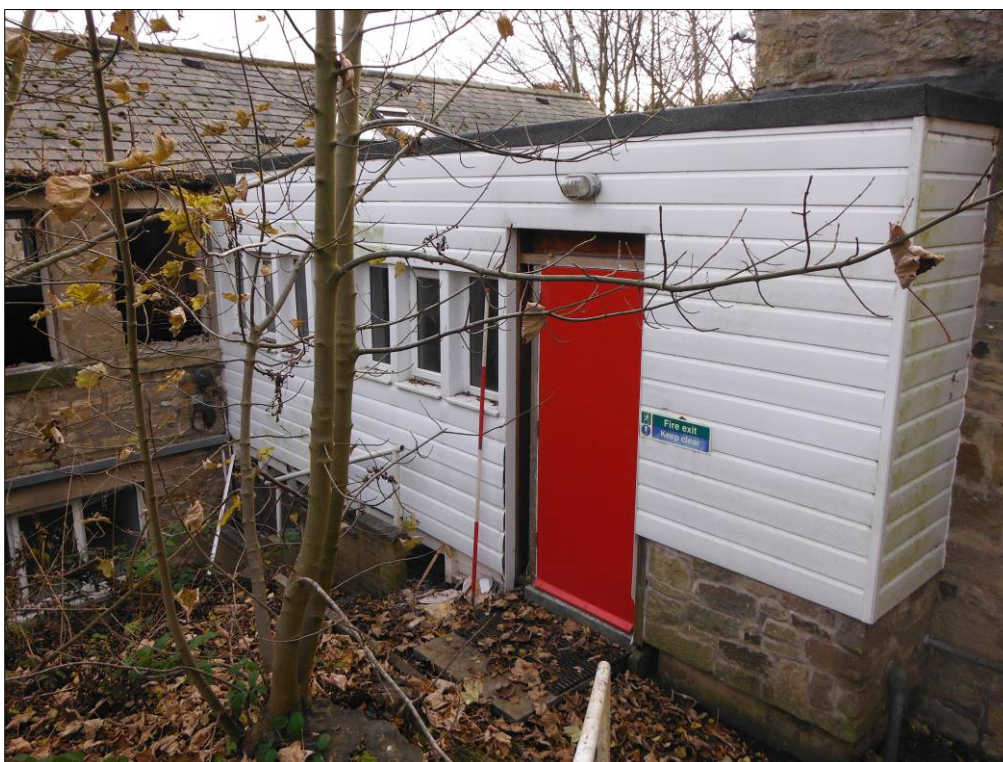
Figure 54: Northeast elevation of Building F (scale=2m).

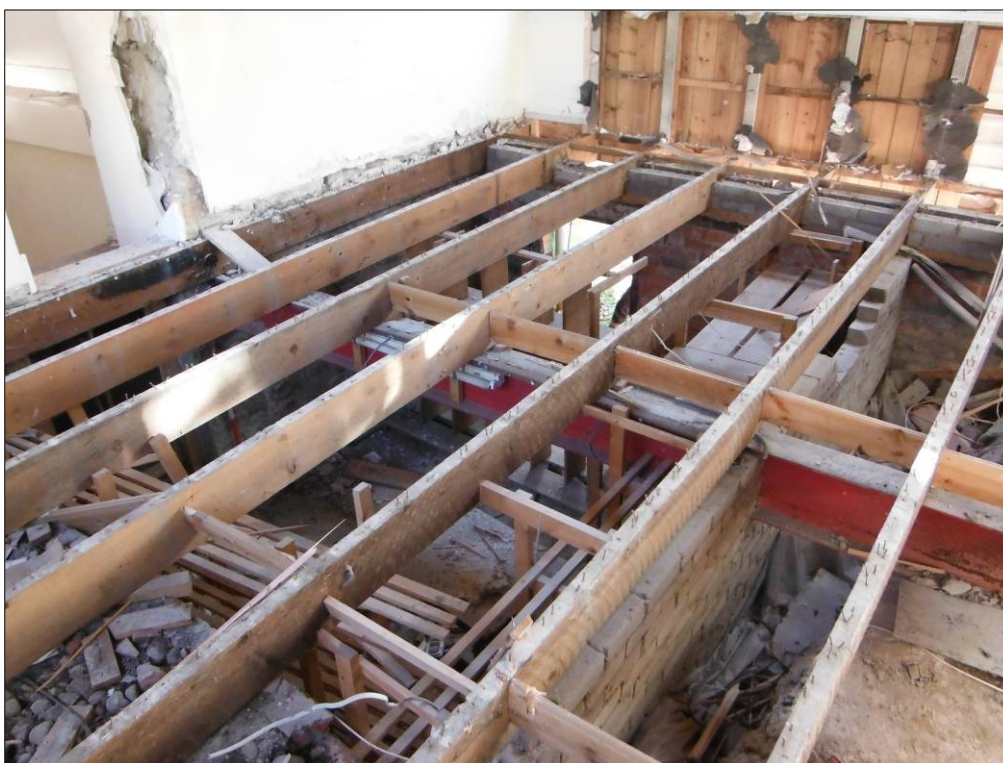
3.6.3 A low single-width doorway in the southwest elevation gives access to a basement room with a very low ceiling height beneath the floor of Room G1 above (Figure 55). The basement room covers only around one third of the space under this structure, the rest being taken up by an in-filled brick structure (discussed in Section 3.3.5) and an area of previously landscaped ground preserved beneath the floor (Figure 56). This is the preserved previous ground surface prior to the erection of Building F and shows the extent of the original hollowed out area associated with the mill building and mill pond to the north. When Building F was constructed, this bare earth was blocked-up behind a wall of engineering brick, laid stretcher, creating the space now used as a basement room.

Figure 55: Basement room beneath the floor of Building F.

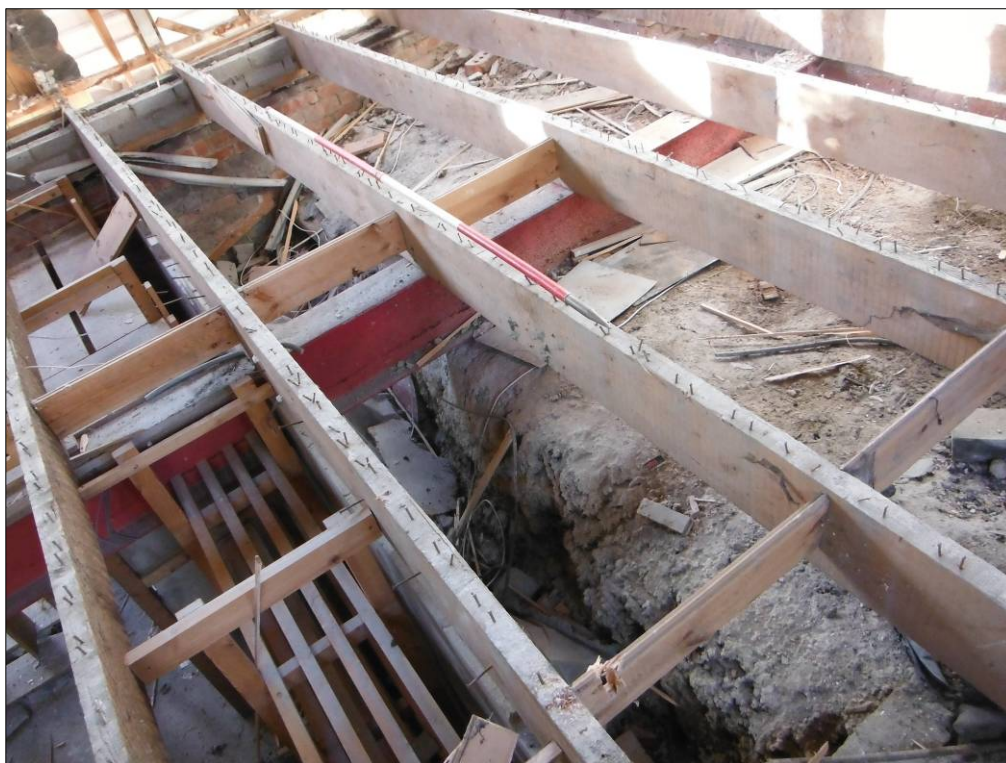
Figure 56: Preserved previous ground surface beneath the floor of Building F (scale=2m).

4.3.4 The remains of a previous ground surface were encountered during the course of the building recording under the floor of Building F (see Section 3.6.3). The southern side of this previous ground surface had been cut away in a steeply sloping scarp and this may represent the original extent of the mill pond, prior to the conversion and extension of the mill buildings. This would have given the mill pond a diameter of *c.*15m.

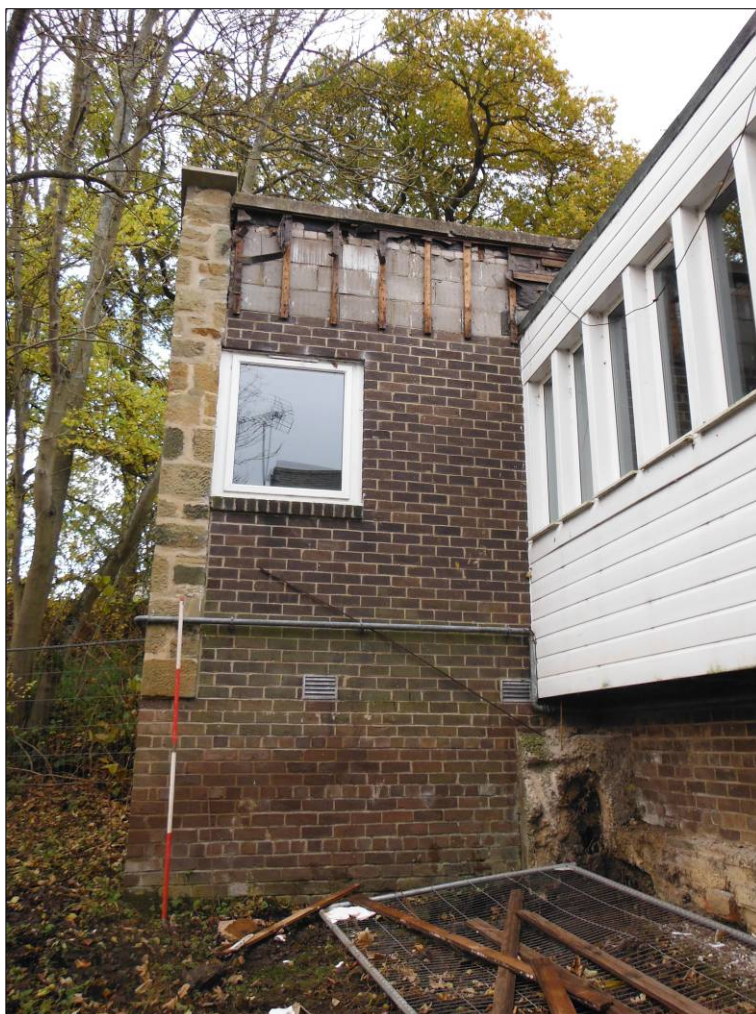
Map evidence shows that Building G was constructed between 1964 and 1978. It appears to be contemporary with Building F to the south and was built as office accommodation. It has remained in use as office accommodation to the present with little or no alterations.

Figure 57: Southeast elevation of Building G (scale=2m).

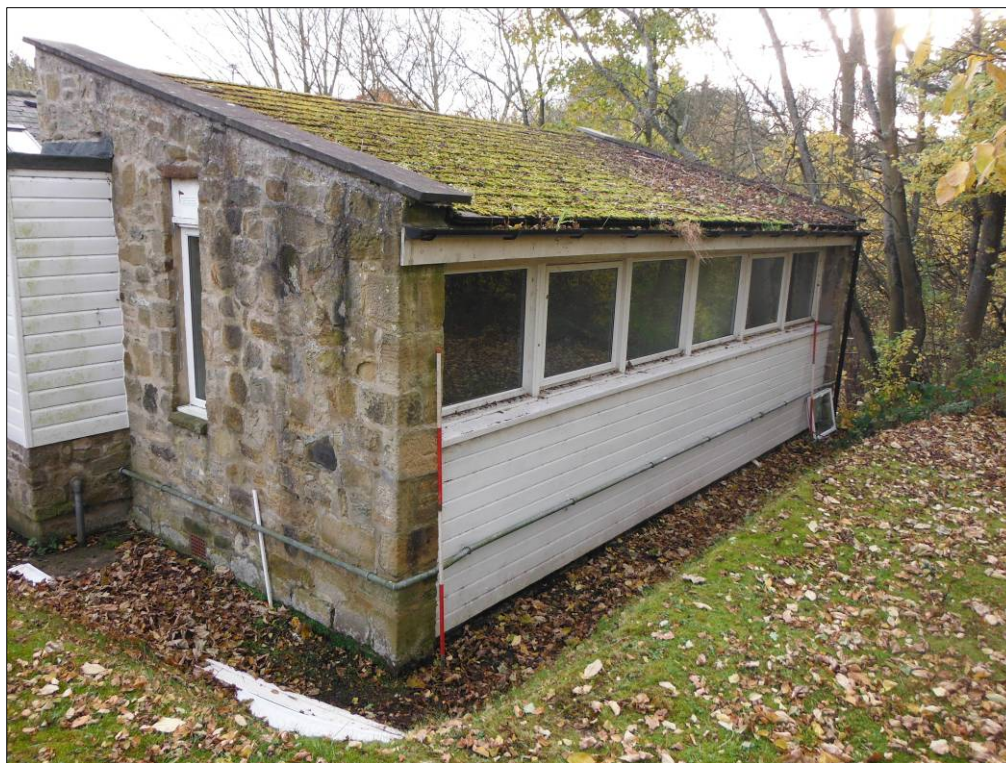
Figure 58: Northeast and northwest elevation of Building G (scale=2 x 2m).

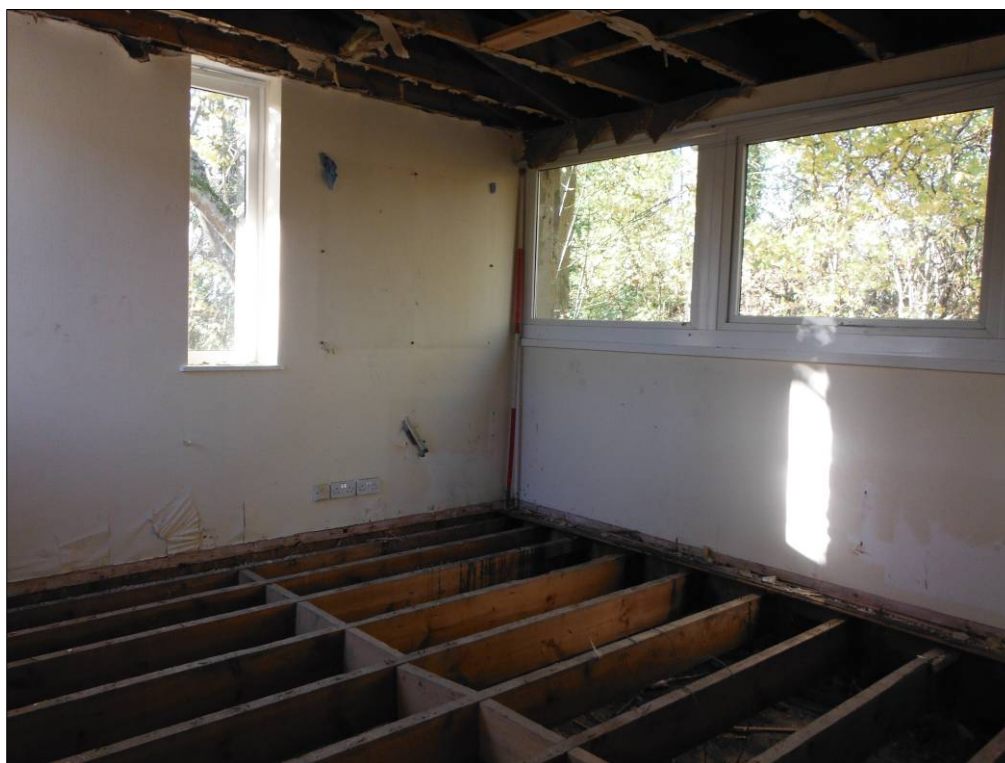
Figure 59: Southwest and Northwest walls of Room G1 (scale=2m).

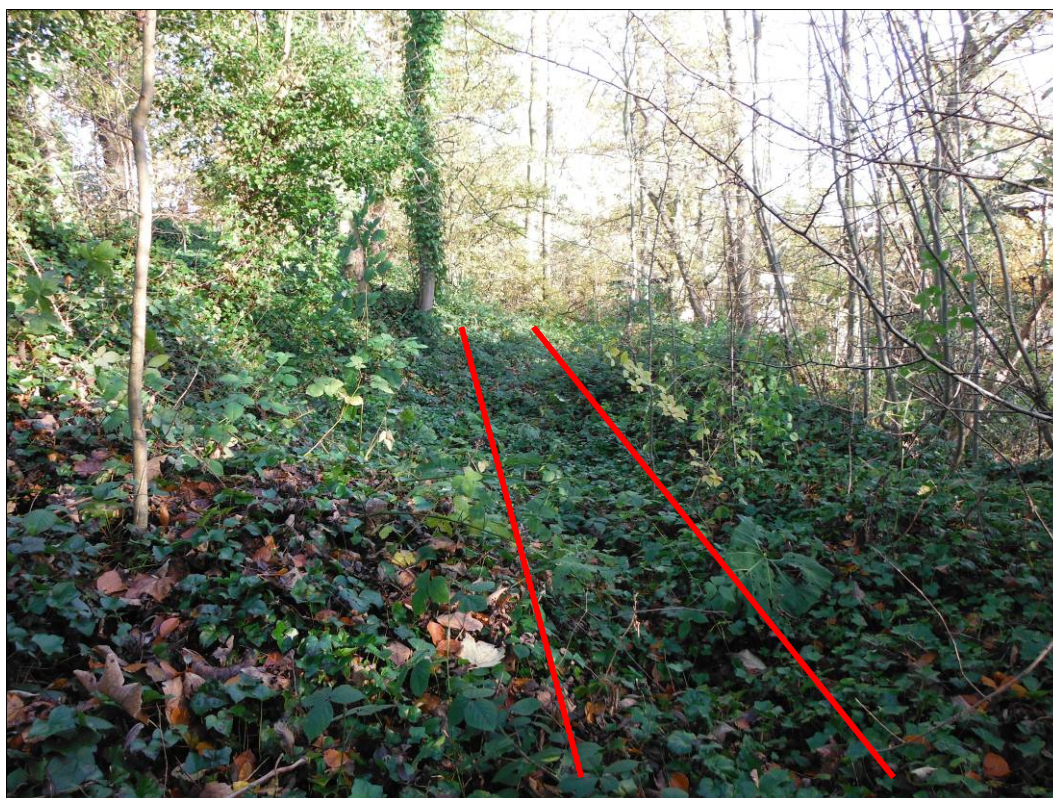
Figure 60: Length of surviving head race to the northwest of the building (highlighted in red), surviving as a slight depression at the centre of the picture on a landscaped terrace cut into the side of the hill. The earthwork is greatly obscured by foliage.

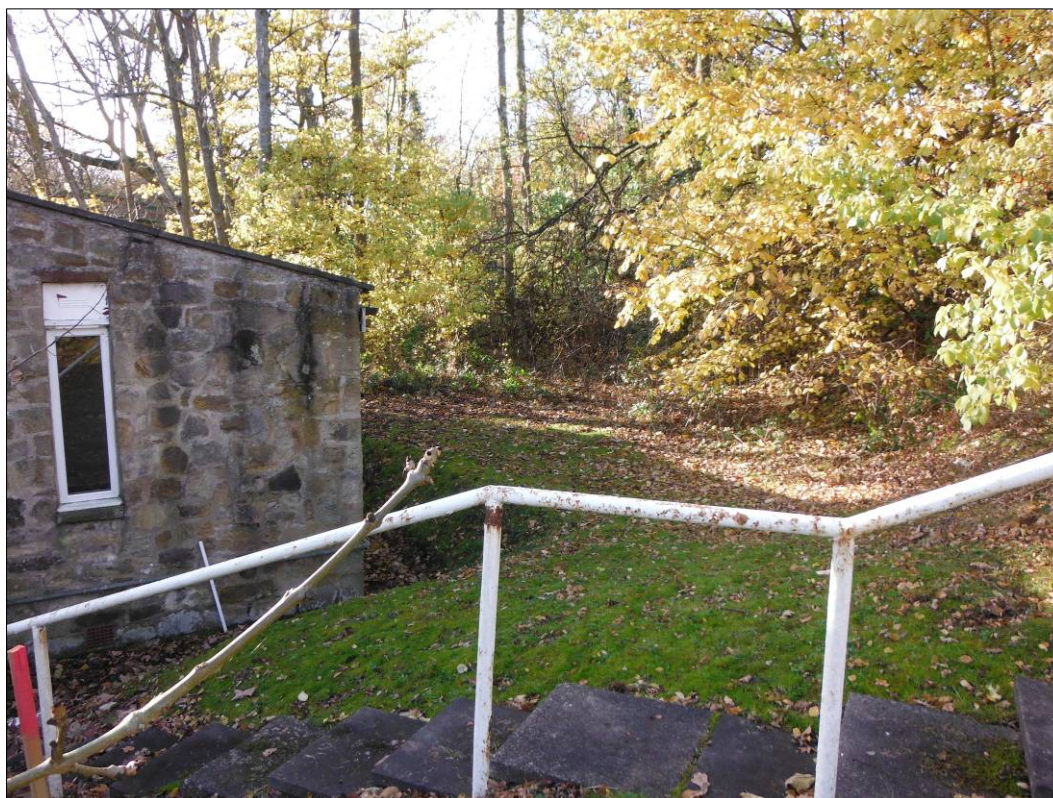
Figure 61: Area of the original mill pond, filled in and cut away to allow the modern extension of the building at this side.

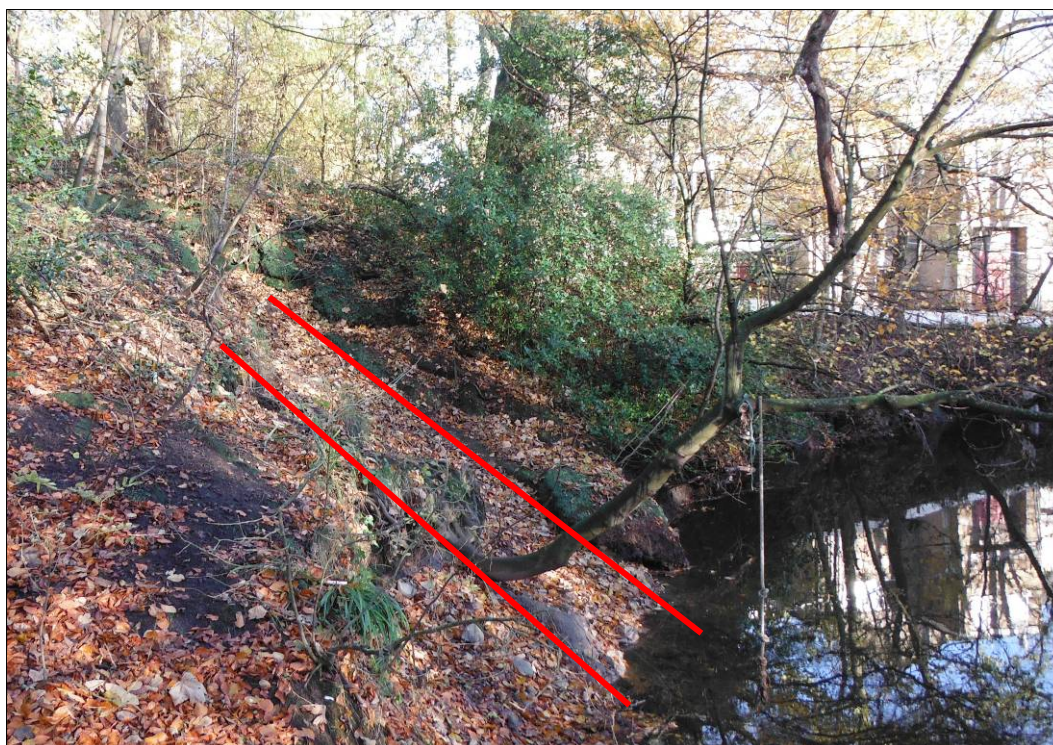
Figure 62: Length of surviving overflow channel to the northwest of the building (highlighted in red), surviving as a slight depression at the centre of the picture cut into the side of the river bank. The earthwork is greatly obscured by foliage.

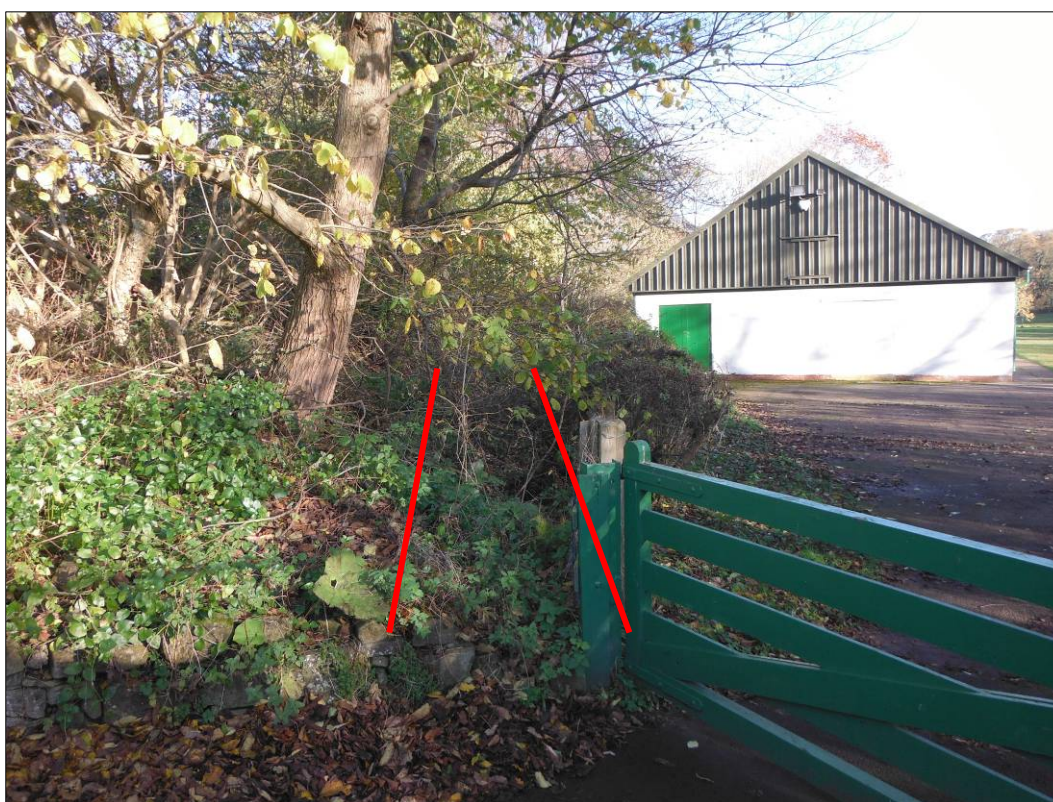
Figure 63: Length of surviving tail race to the east of the building (highlighted in red), surviving in use as a property boundary ditch at the centre of the picture. The earthwork is greatly obscured by foliage.

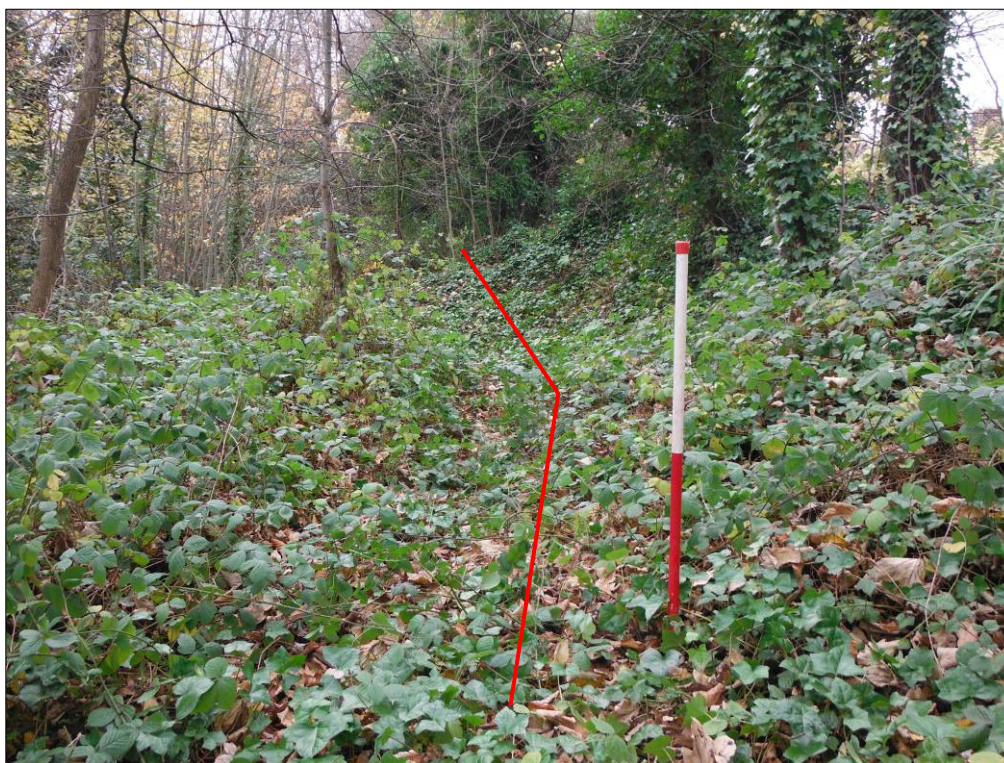
4.2.2 The survey recorded a c.25m section of mill race (MR1) to the northwest of Mill House. This was observed to be a very distinct earthwork, particularly to the northwestern end of the survey area, furthest away from Mill House. The northern bank of the mill race was formed by a large steeply sloping artificial scarp, cut into the north side of the naturally sloping hillside. This scarp created an artificially flat area into which the mill race was cut. The southern bank of the mill race consisted of a low degraded linear bank, c.0.5m in width, running along the top edge of the naturally sloping river bank (Figure 66).

Figure 66: Earthwork remains of the mill race (MR1 highlighted in red), looking west (scale = 1m).

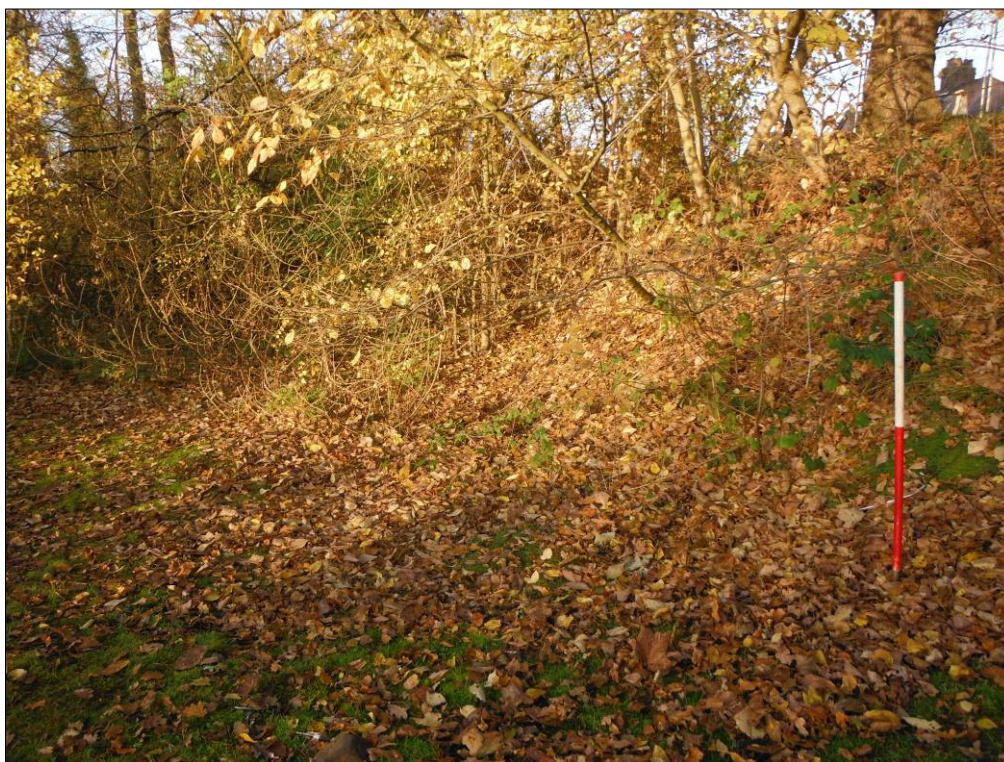
4.3.2 The survey recorded the truncated remains of the mill pond, immediately to the northwest of Mill House. This was observed to be a very distinct earthwork which was further defined by the presence of established trees around its edge. Only the northern and part of the eastern banks survive and are formed by a large steeply sloping artificial scarp, cut into the naturally sloping hillside in a similar manner to the construction of the mill race. This scarp created an artificially flat area which was likely to have been scooped out to form the mill pond. The mill pond is now a flat, dry area containing young tree growth (Figure 67). The southern and western sides of the mill pond are no longer extant, as these areas have been subject to later landscaping (L1 and L2).

Figure 67: Earthwork remains of the mill pond (MP1), looking northwest (scale = 1m).

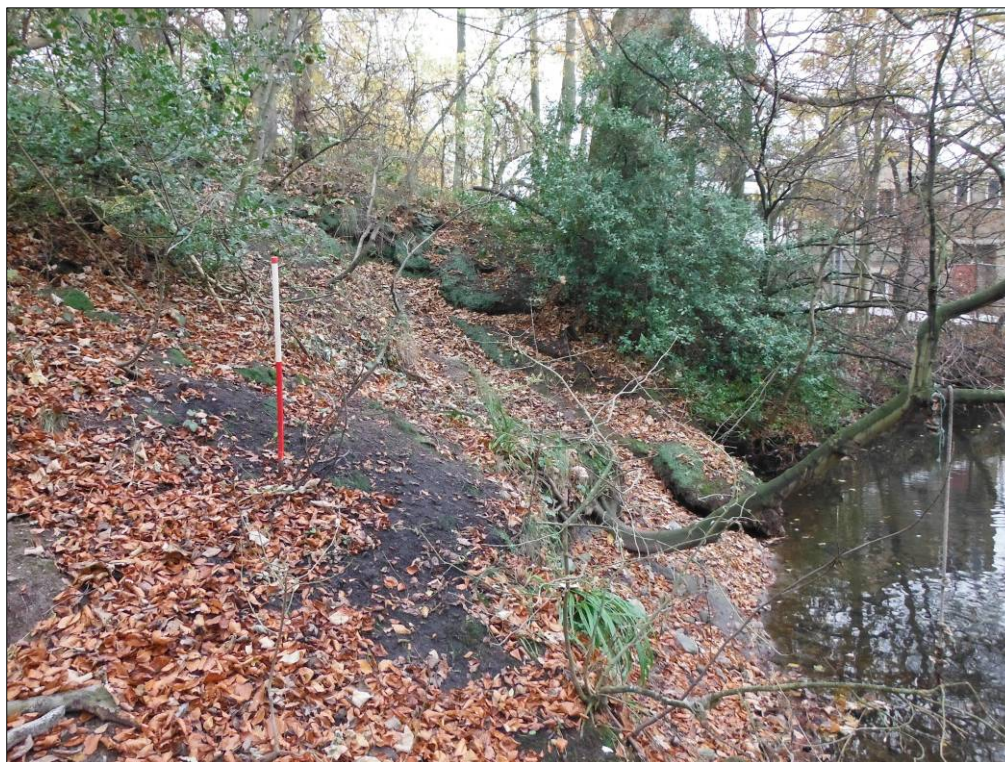
4.4.2 The survey recorded the remains of a bypass sluice (SL1) on the southern side of the mill race (MR1), to the west of Mill House. This was observed to be a distinct earthwork channel formed by a sharp northwest to southeast aligned cut into the naturally sloping river bank (Figure 68). Only the top of the channel was safely accessible to record as part of the earthwork survey.

Figure 68: Earthwork remains of the bypass channel (SL1), looking east (scale = 1m).

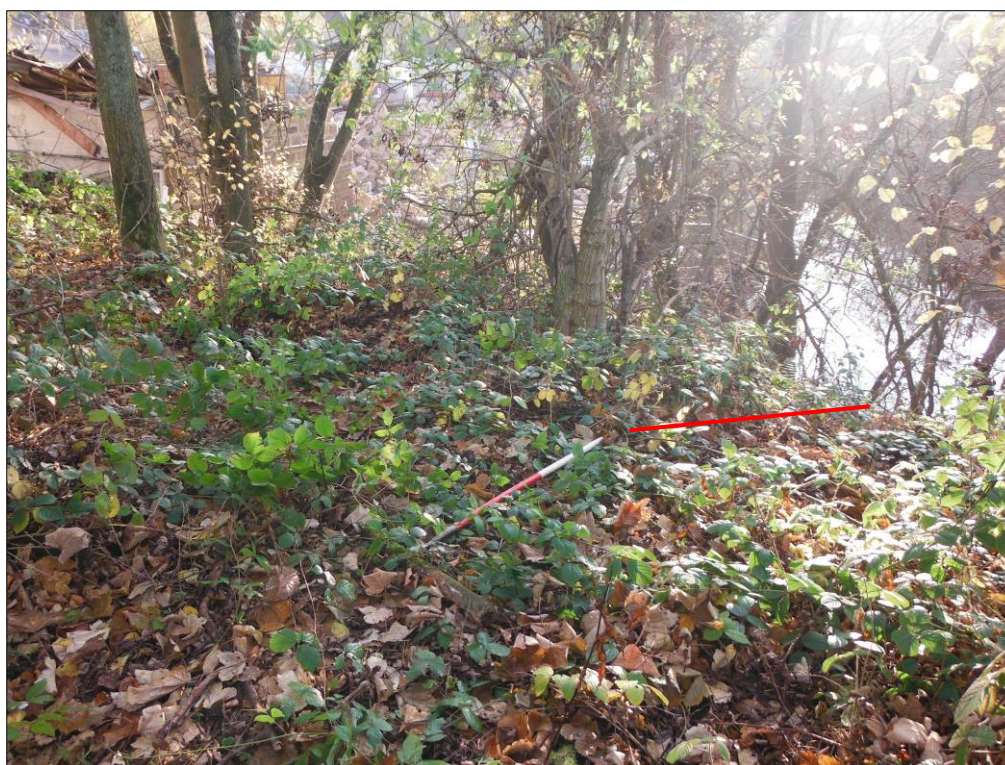
4.5.2 Landscaping L1 is located to the west of the bypass sluice (SL1) and consists of a degraded channel cut into the naturally sloping sides of the river bank (Figure 69). This runs parallel to the bypass sluice, from the mill pond (MP1) down to the river. The creation of this channel also involved the destruction of the southern bank of the mill race (MR1) and the western side of the mill pond (MP1). This destruction indicates that the channel was constructed either the same time as, or after, the mill went out of use and was converted to domestic purposes. The purpose of the channel, therefore, was to drain the mill race and pond of water, so that it would not flood Mill House to the south. The Ordnance Survey Second and Third Edition maps show that this conversion occurred between 1896 and 1916, when the remains of the mill race are labelled as 'old mill race' (Wooler 2011, Figures 11 and 12). This most likely also dates Landscaping L1.

Figure 69: Earthwork remains of Landscaping (L1), looking southwest (scale = 1m).

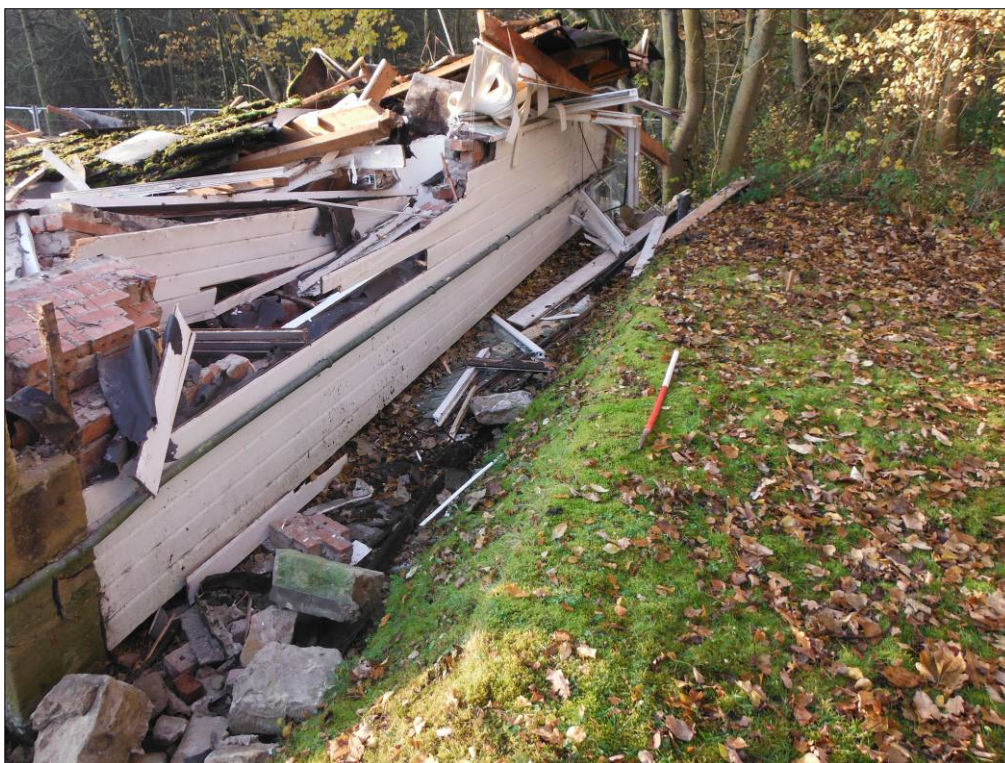
4.5.3 Landscaping L2 is located immediately to the north of Mill House and cuts the southern side of the mill pond (MP1). It was observed to be a distinct earthwork consisting of a steeply sloping linear scarp running alongside the north and east walls of Building G (Figure 70). This earthwork is very well defined and has suffered very little subsidence, suggesting that it is of modern date. It is most likely associated with the construction of Building G and the associated destruction of the southern side of the mill pond. The Ordnance Survey National Grid 1:2500 maps show that Building G was constructed between 1964 and 1978 and this most likely dates landscaping L2.

Figure 70: Earthwork remains of Landscaping (L2), looking west (scale = 1m).

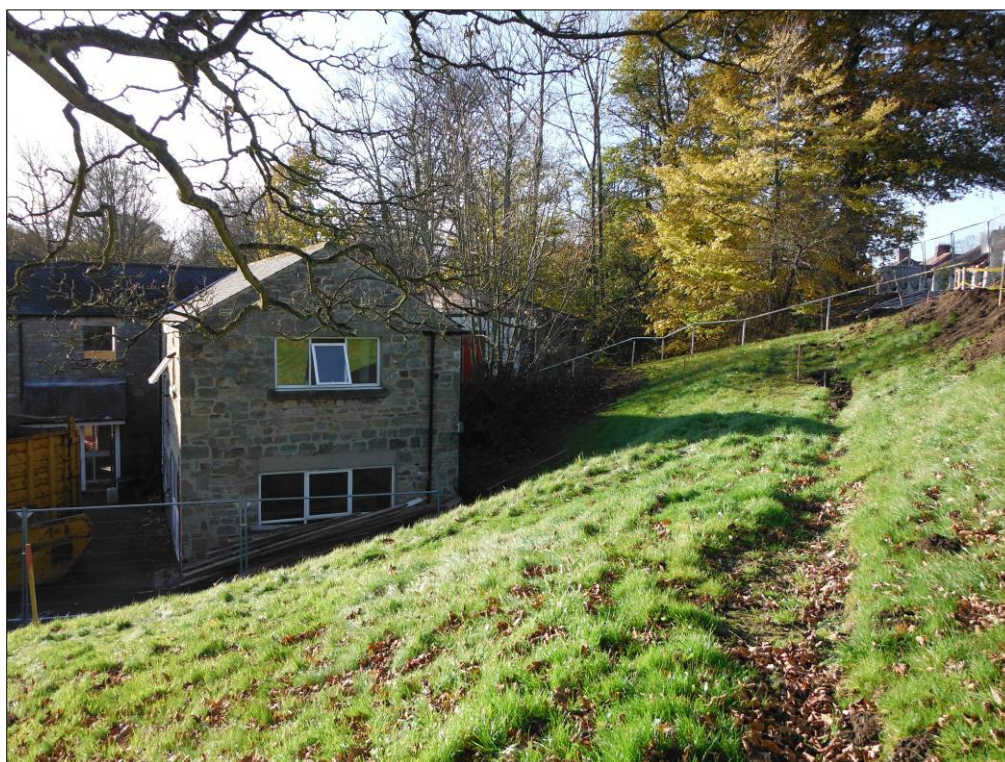
Figure 71: Earthwork remains of Landscaping (L3), looking west.

4.5.4 Landscaping L3 is located immediately to the north of Mill House and east of the mill pond (MP1). It was observed to be a distinct earthwork consisting of a steeply sloping curvilinear scarp running alongside the north and east walls of Building C and cut

into the naturally sloping hillside (Figure 71). It has a concrete retaining wall at the base allowing space for a footpath around Mill House. This earthwork is very well defined and has suffered little subsidence, suggesting that it is of modern date. It is most likely associated with the final eastward extension of Building C, which is difficult to discern on available Ordnance Survey mapping. The building recording noted that this extension was constructed of brick walling with an exterior sandstone skin and was therefore a modern addition. The associated landscaping L3 is therefore most likely a modern feature also.

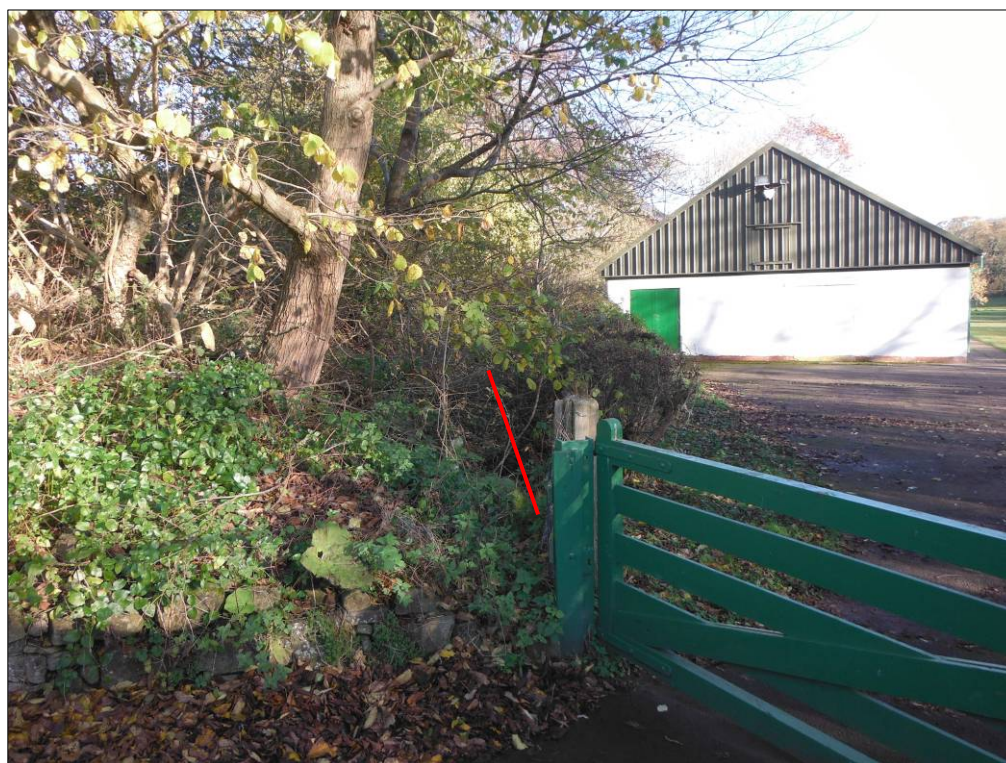
Figure 72: Earthwork remains of Tail Race (TR1), looking east.

4.6.3 Tail race TR1 marked the westernmost visible section of the tail race and ran for a length of c.15m. This was observed to be a much degraded earthwork, particularly the southern bank. The northern bank of the tail race was formed by a large steeply sloping

artificial scarp, cut into the north side of the naturally sloping hillside in a similar fashion to the construction of the mill race to the northwest. This scarp created an artificially flat area into which the tail race was cut. The southern bank of this section of the tail race has been removed and a boundary fence now marks its previous location (Figure 72).

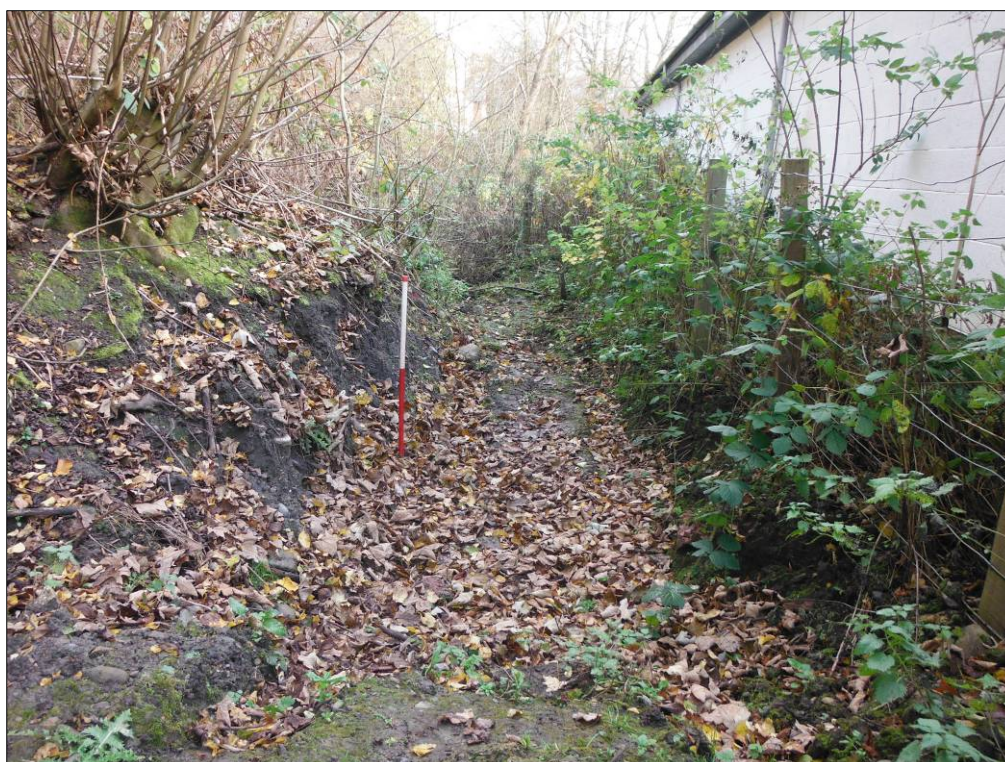
4.6.4 Tail race TR2 consisted of a $\approx 17\text{m}$ section of tail race running alongside the north wall of the Scout Hut. In a similar fashion to tail race TR1, the northern bank was formed by a large artificial scarp cutting into the naturally sloping hillside, and the southern bank had been removed and a boundary fence put in its place. It appears that this section of the tail race has recently been re-cut, most likely as a drainage ditch. A raised area has been created at the western gable of the Scout Hut and from there, as a sharp, almost-vertical sided cut marks the previous location of the tail race. This has a width of $\approx 1.5\text{m}$ and appears to have been machine cut to its present state (Figure 73).

Figure 73: Earthwork remains of Tail Race (TR2), looking east (scale=1m).

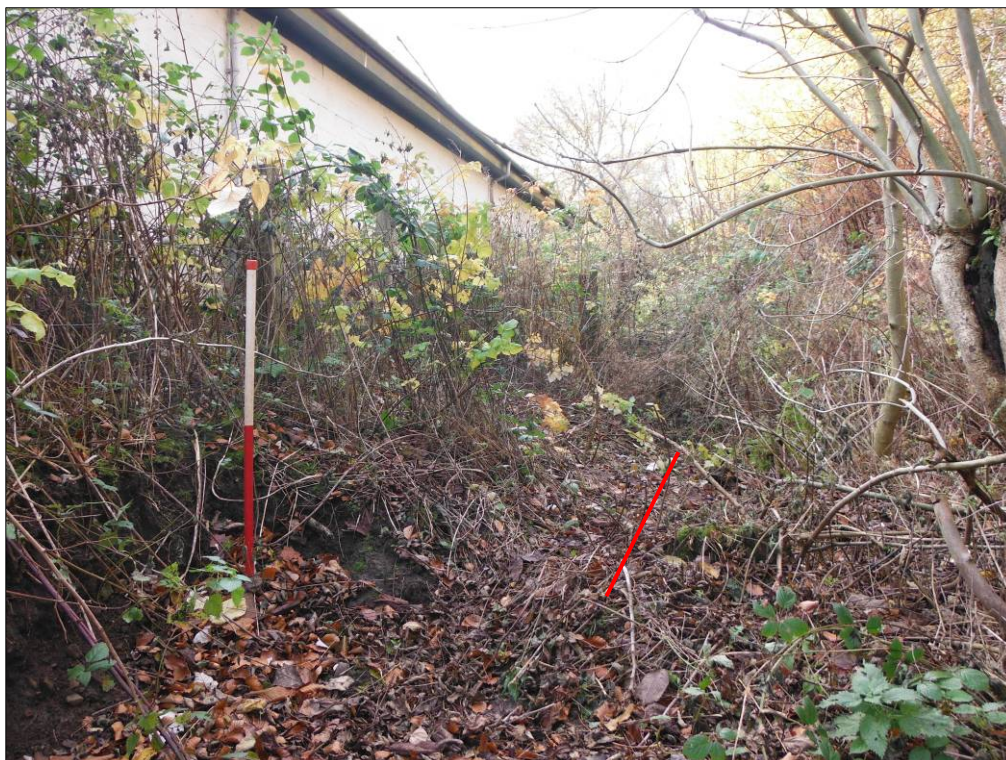
4.6.5 Tail race TR3 consisted of a $\approx 11\text{m}$ section of tail race running alongside the north wall of the Scout Hut up to its eastern gable. Only a $\approx 2.5\text{m}$ section of the original tail race survives in this area and the base lies $\approx 1\text{m}$ to the north of its present location immediately to the east and west (Figure 74). In this surviving section the northern bank is formed by a large artificial scarp in the naturally sloping hillside. This created an artificially flat area into which the tail race was cut. The south bank consisted of a gradually sloping bank, the rear side of which has been removed to make way for the Scout Hut. The tail race in this section had a width of $\approx 1.5\text{m}$. Immediately to the west of this surviving section, a further machine-cut section was observed running to the east gable of the Scout Hut. At the east gable a further machine cut was observed in the northern bank of the tail race, presumably marking the machine's turning circle (Figure 75). A gently sloping earthen pathway leads from this area southwards into the park.

Figure 74: Earthwork remains of Tail Race (TR3), showing the short surviving section, looking west (scale=1m).

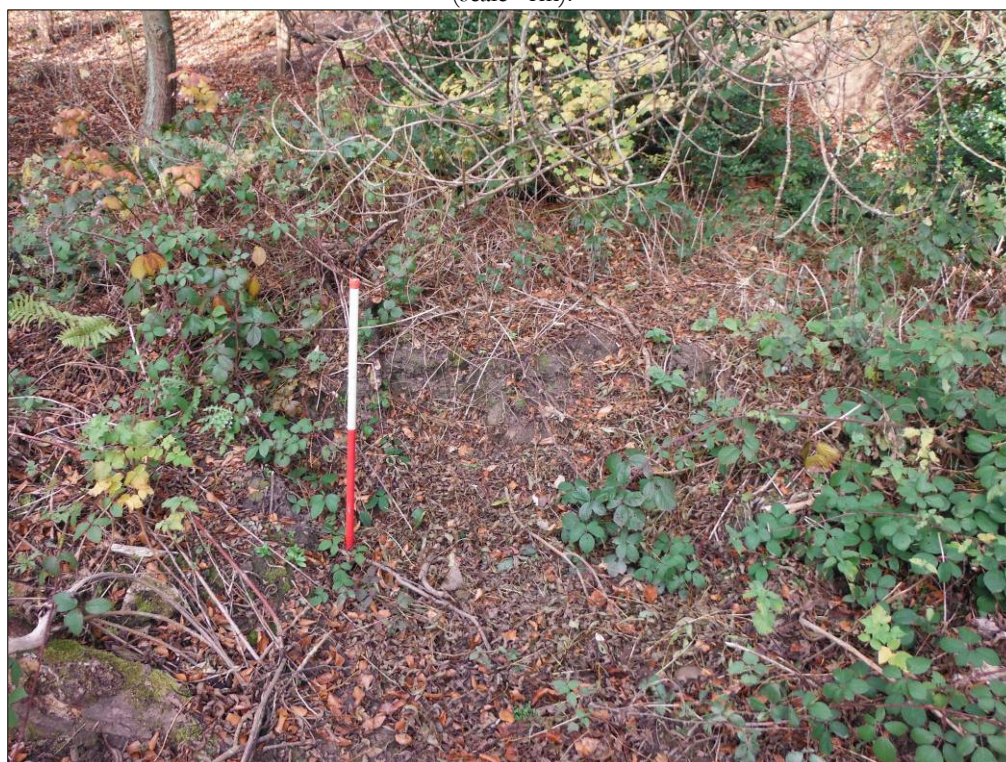
Figure 75: Earthwork remains of Tail Race (TR3), showing the machine cut into the northern bank, looking north (scale=1m).

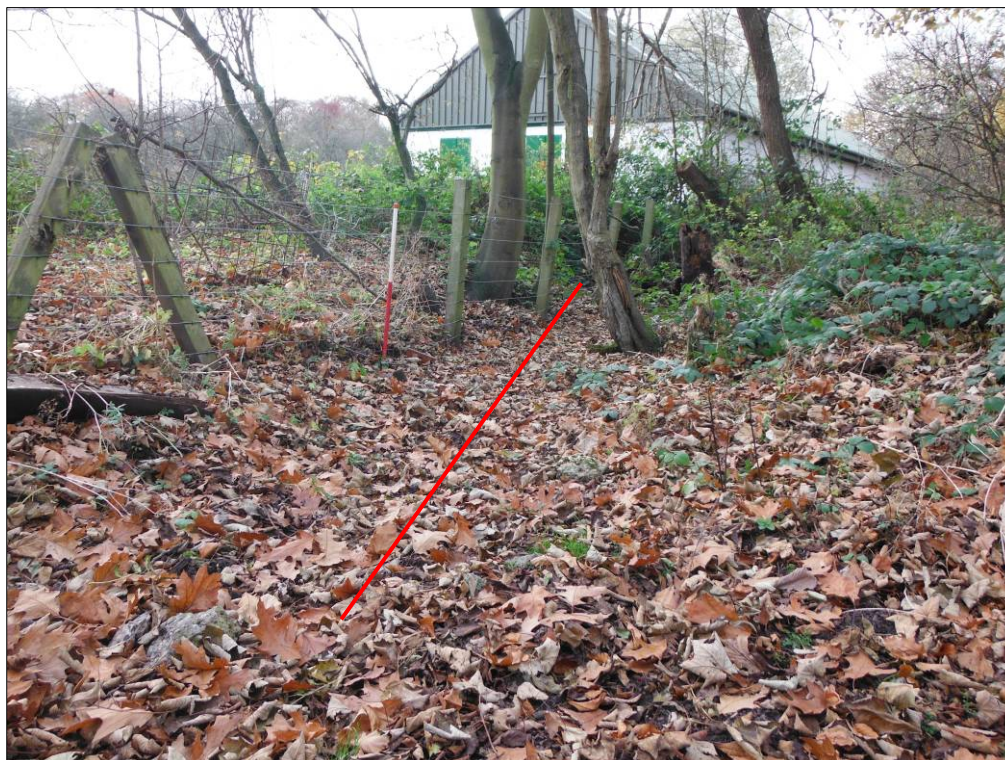
4.6.7 Tail race TR4 consisted of a c.12m section of tail race running eastwards from the eastern gable of the Scout Hut. This section of the tail race has not been re-cut and survives as a partially degraded earthwork with a northern and southern bank. The

northern bank is formed by a large artificial scarp in the naturally sloping hillside. This created an artificially flat area onto which a ditch and northern bank were constructed. The northern bank has a width of c.4m and survives a low flat-topped mound. The south bank is of similar construction and survives has a width of c.1.5m. The tail race in this section has a width of c.1m (Figure 76). Local evidence states that this area floods in wet weather.

Figure 76: Earthwork remains of Tail Race (TR4), looking west (scale= 1m).

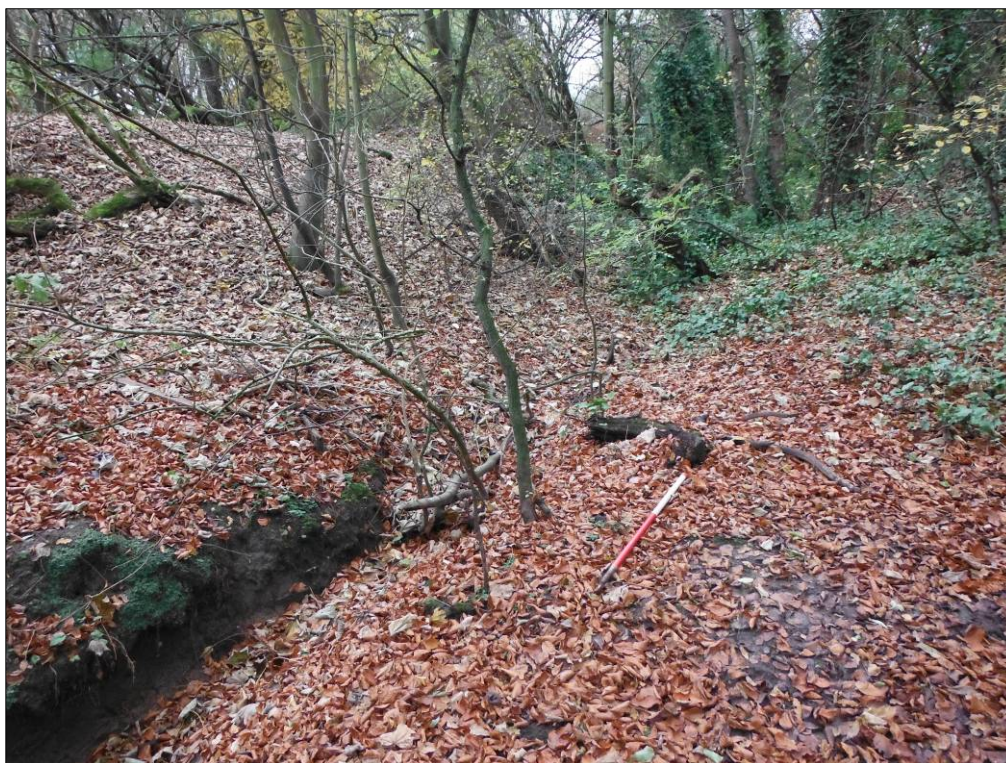
4.7.2 The first feature is located across the river to the west of Mill House. This consisted of a linear ditch that is marked on the First Edition Ordnance Survey map of 1865 (Wooler 2011, Figure 10) and continues to be depicted as a drainage ditch to the present day. This feature would have originally functioned as a further bypass for the mill race (MR1), cutting off its supply some distance before the identified bypass sluice (SL1). The earthwork consists of a narrow linear ditch feature and presently functions as a surface water drain into the river (Figure 77).

Figure 77: Earthwork remains of bypass channel for the mill race, looking west (scale= 1m).
