**A Staged Programme of Archaeological
Work at Mill House, Ponteland,
Northumberland**

**Including Building Recording, Earthwork
Survey and Watching Brief**

ARS Ltd Report No. 2013/102
November 2013

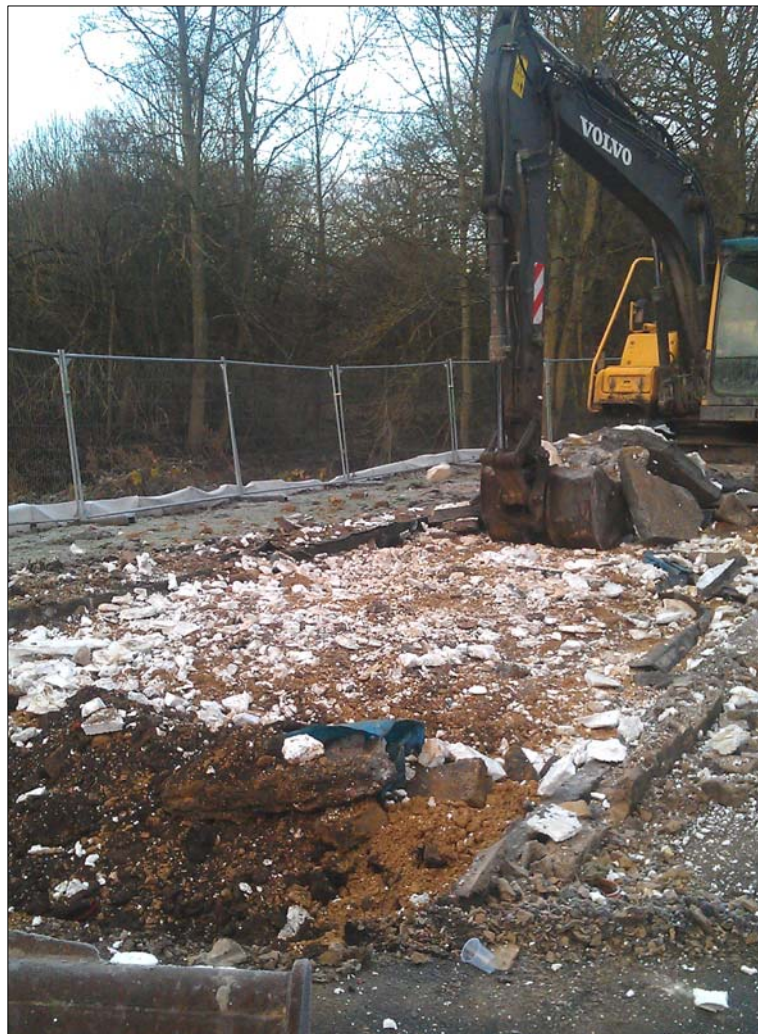
5.1.2 The concrete floors and foundations of Mill House were removed by a machine using a toothed ditching bucket (Figure 84). The resulting masonry was removed from site and the excavated areas filled in with spoil and debris.

Figure 84: Removal of the floors and foundations of Mill House.

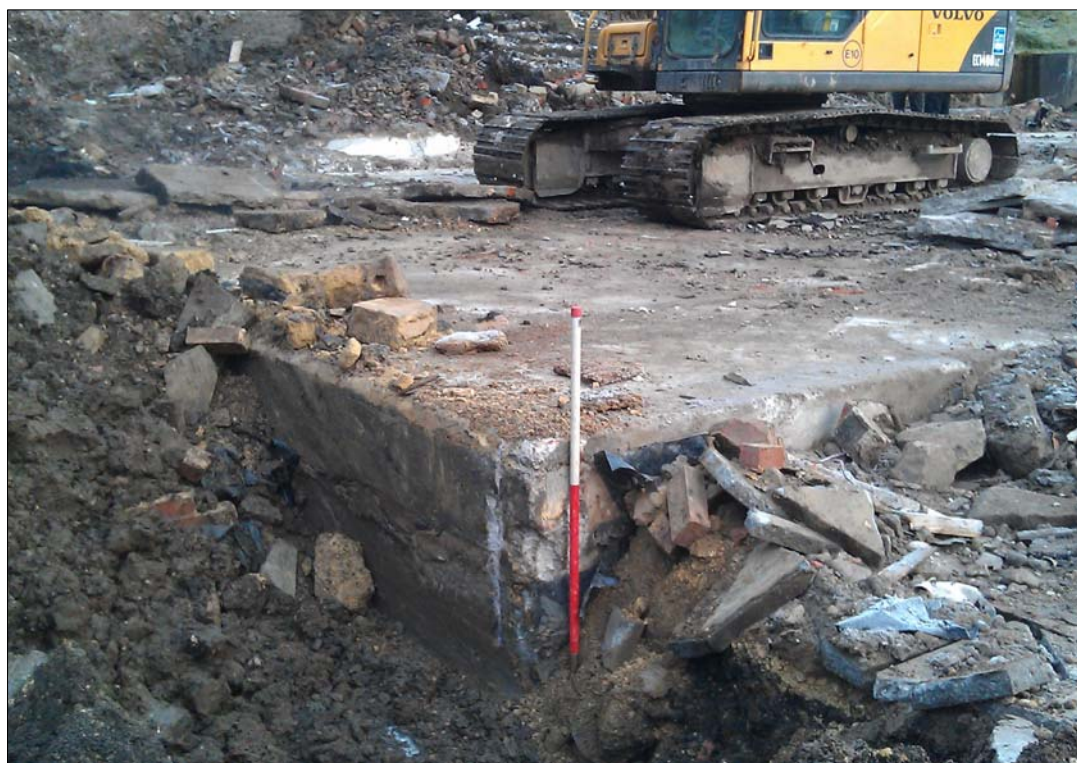
5.1.4 The Building Recording element of this programme of work indicated that any remains of the wheel pit were likely to be located beneath a concrete pad in Building C, Room C4 (see Section 3.3.11). This concrete pad (003) was found to extend to a depth of $\approx 0.9\text{m}$ on its western side and $\approx 0.35\text{m}$ elsewhere (Figure 85). The pad was removed using a breaker to reveal a make-up layer of concrete and brick chippings (004) which had a depth of $\approx 0.4\text{m}$ (Figure 86). This was removed to reveal a layer of dark brown silty clay loam (005) which was excavated to a total depth of $\approx 1.4\text{m}$ beneath the concrete cap (Figure 87). No evidence of the wheel-pit was discovered at this depth, suggesting that the wheel-pit was either removed prior to the installation of the concrete cap, or it was originally located elsewhere. The depth of concrete required to cover this area, however, acts as circumstantial evidence of there having been a perceived risk of subsidence at this location and this was most likely due to the previous presence of a wheel-pit here. Some remains of the base of the wheel pit may be preserved in this location at a depth of over 1.4m , but were not observed during this phase of work and it is considered likely that the wheel pit was purposefully removed.

Figure 85: The concrete pad (003) forming the floor of Building C, Room C4 prior to removal

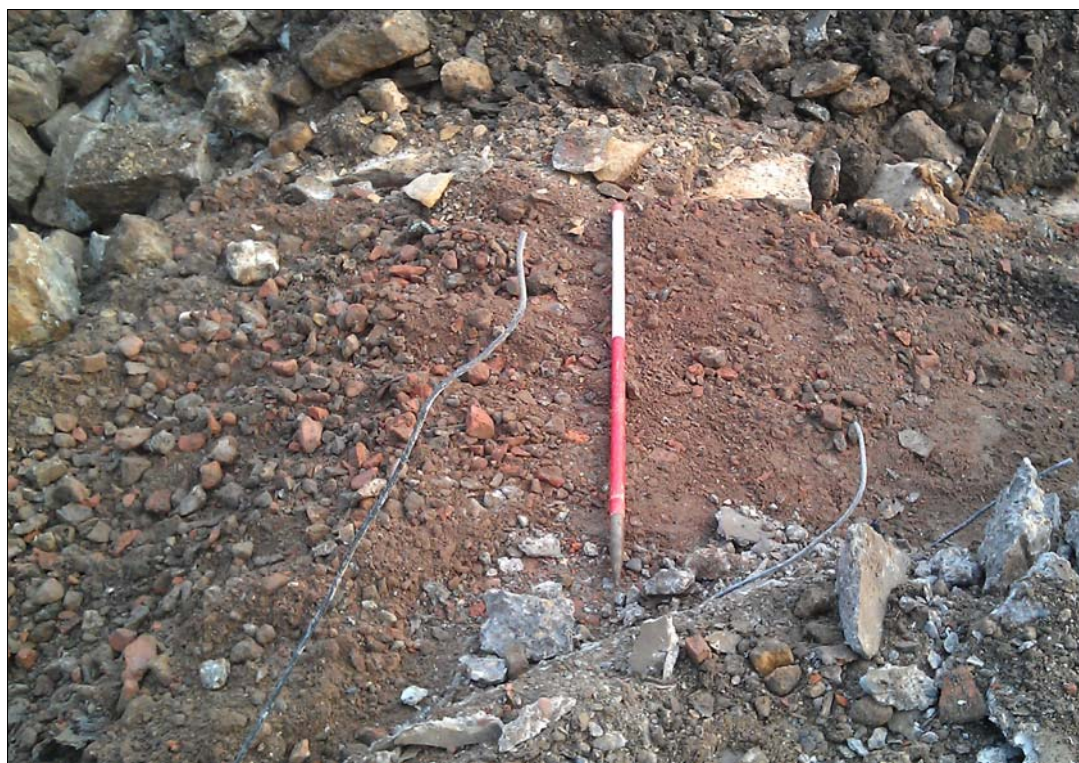
Figure 86: Brick and concrete chippings (004) beneath the concrete pad (003) in Building C, Room C4.

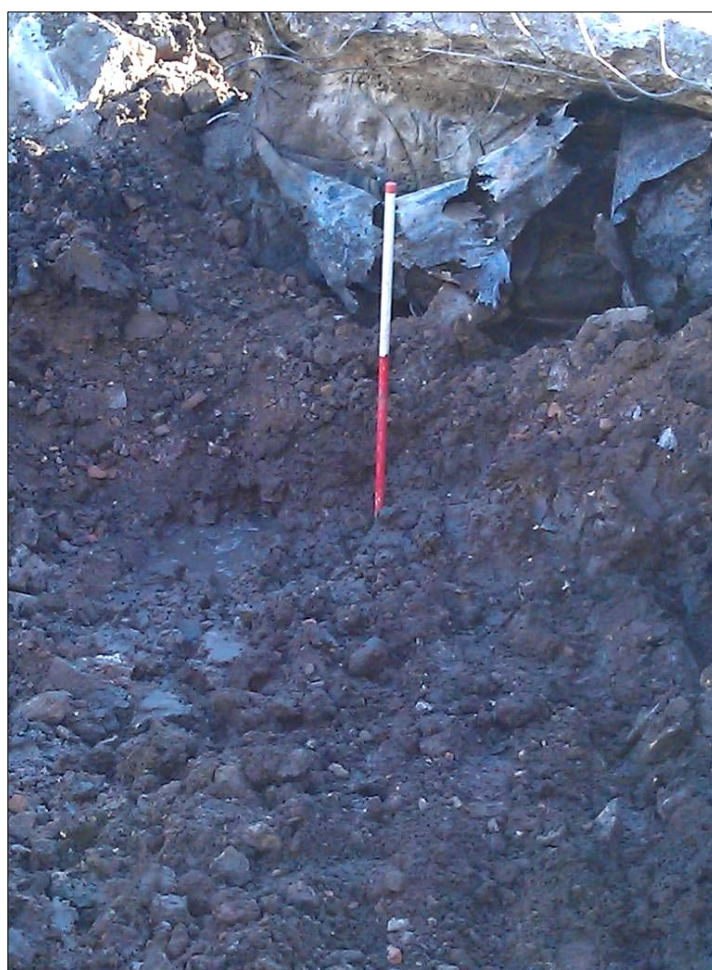
Figure 87: Brick and concrete chippings (005) beneath the brick and concrete chippings (004).
