**Buxton and Leek College Campus, Leek,
Staffordshire**

**Archaeological building recording and
watching brief (Volume 2)**

ARS Ltd Report 2014/44
June 2014
OASIS ID: archaeol5 – 174831

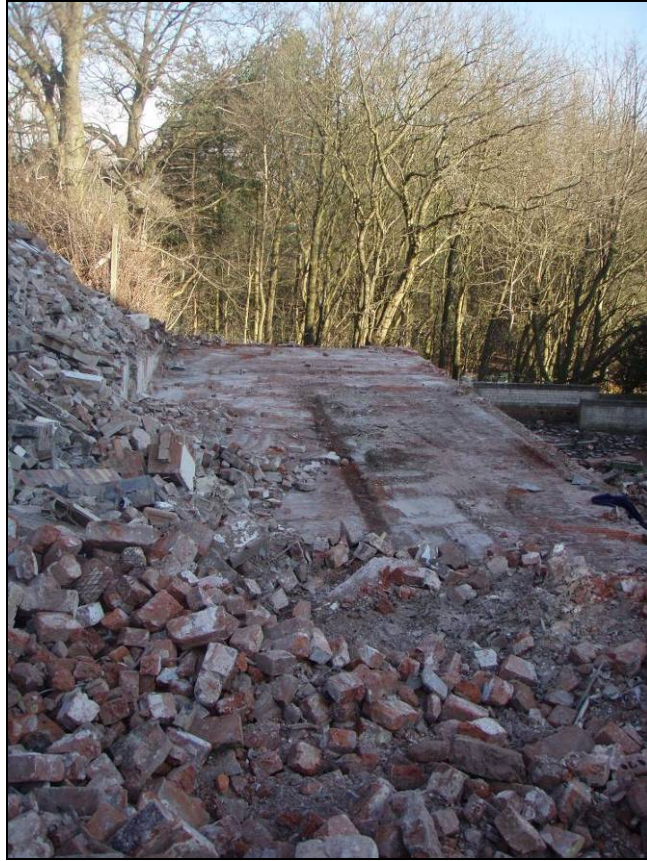
5.1.1 This area was located within and around the footprint of the Mill which was monitored during demolition, as part of an intra-demolition strategy, and subsequent ground-works. Following the demolition of the standing Mill structure, the stratigraphic sequence encountered during the watching brief consisted of a concrete floor surface (101), with an overall thickness of 150mm, with a basal thin plastic sheeting. Directly beneath this concrete floor there was a layer of clean medium sand (102), approximately 100mm thick, which overlay Type 1 hardcore (103) comprising large angular gravel, approximately 100mm thick, used as bedding for the concrete floor. All of these layers were present across the entirety of the site (Area 1).

Figure 3: Concrete floor of the demolished Mill block, looking north.

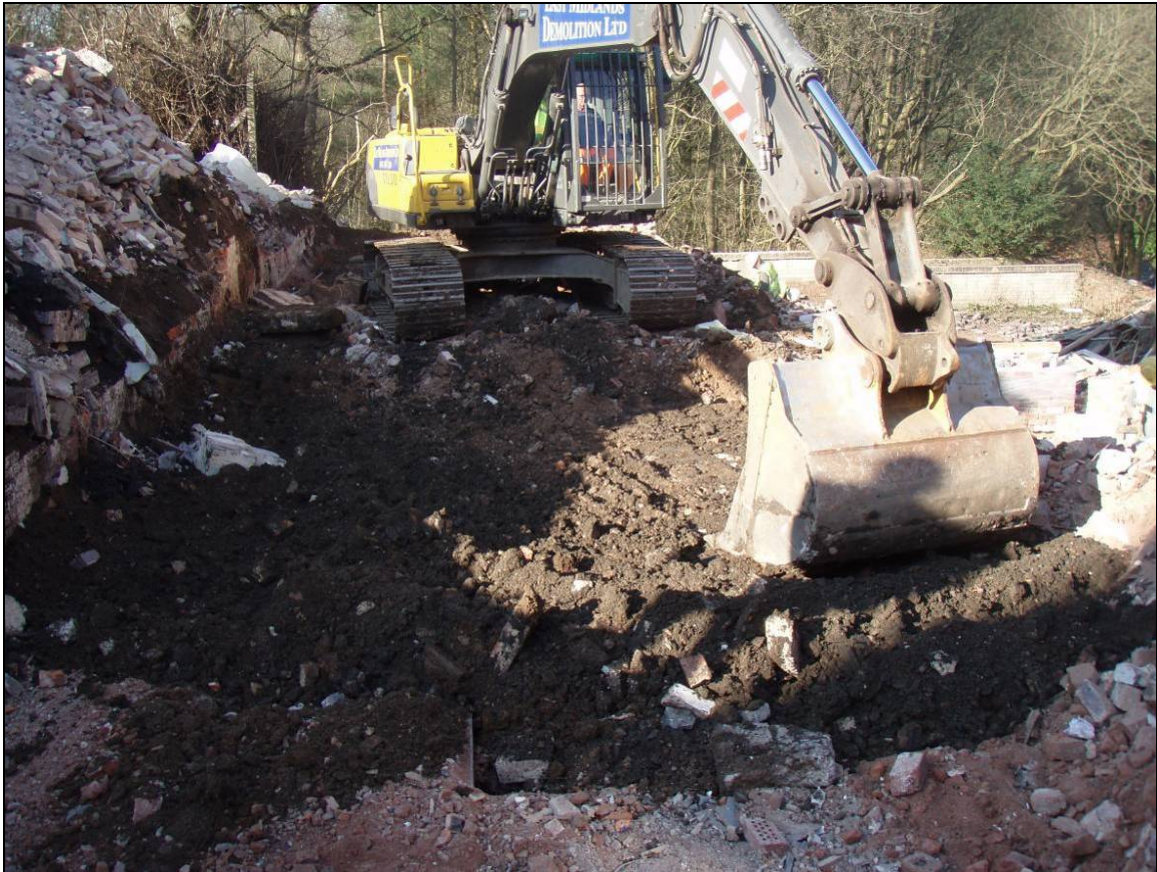
5.1.2 Directly underneath the floor surfaces was a thick layer composed of brown and occasional orange mottles silty clay with lenses of fine sand (104), yielding a maximum thickness of 2 metres towards the northern end of Area 1 and 900mm at the southern end. This was fairly compacted, and it seems likely that this deposit was placed prior to the construction of the Mill in order to level the site and prepare the ground for its construction.

Figure 5: Made ground layer beneath the concrete floor of the Mill, looking north.

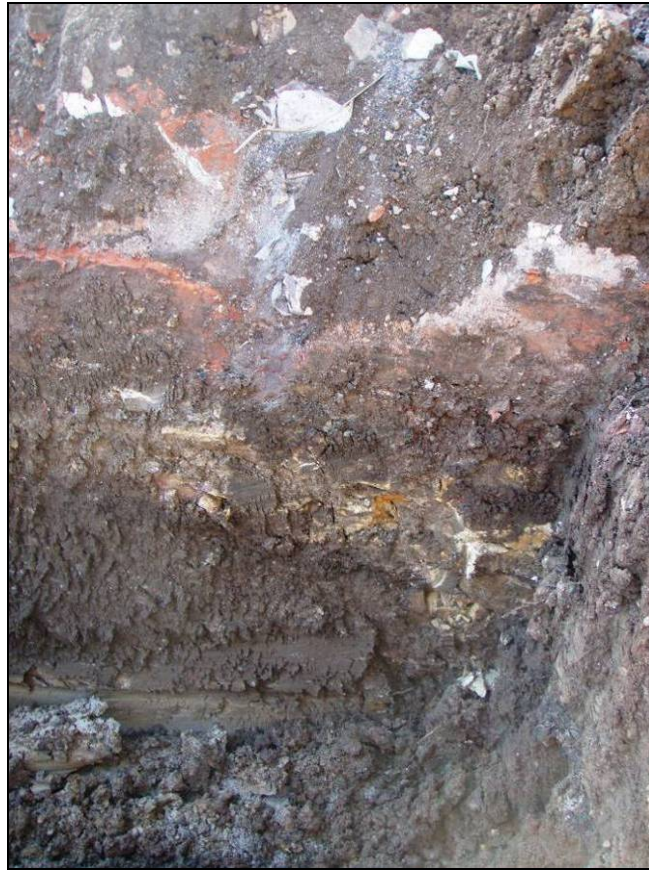
5.1.3 The natural sub-stratum (105) was encountered immediately below the levelling layer and consisted of a pale yellow and blue silty clay layer with large stone inclusions and patches of dark grey mudstone particularly towards the southern end of the site. The excavation did not expose any traces of the former transmission power mechanism of the former Mill. Furthermore, no archaeological features, deposits or artefacts were identified (Figs 3 – 7).

Figure 7: Stratigraphic sequence down to the natural sub-stratum.

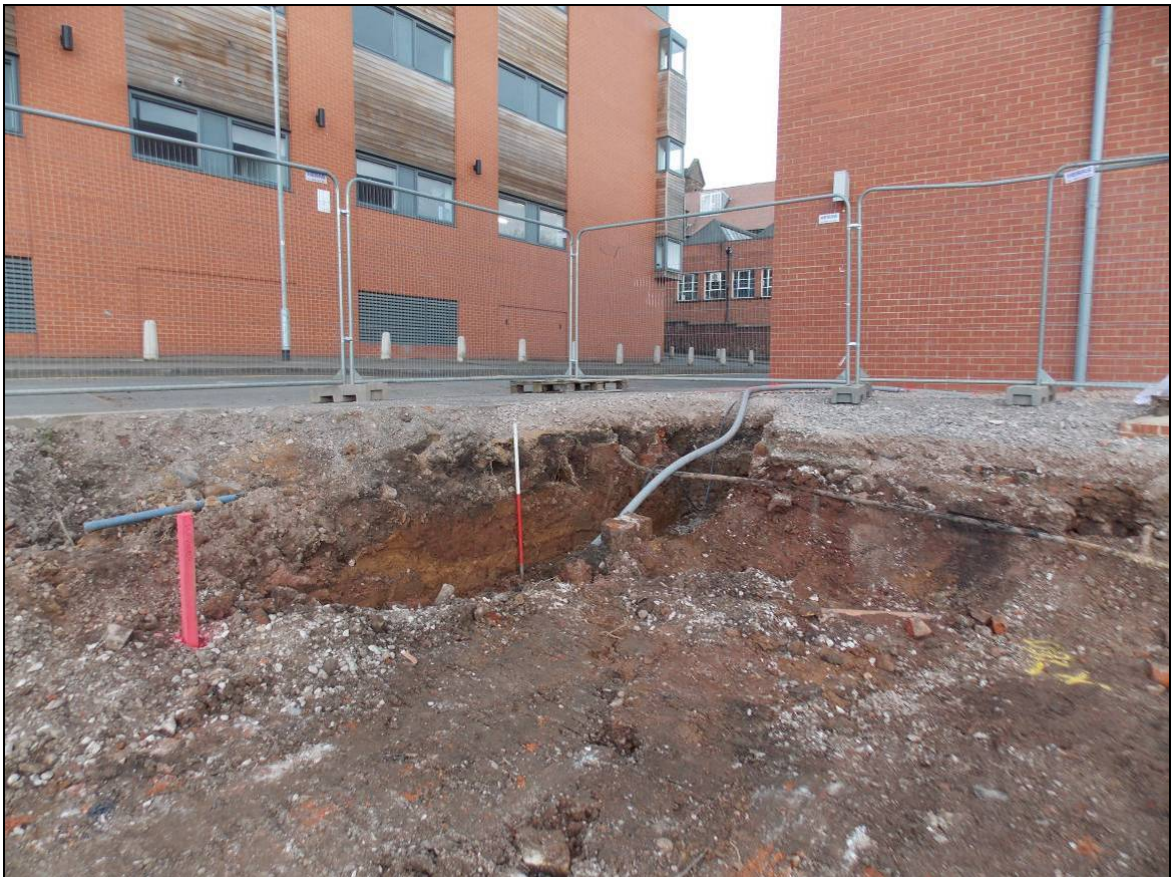
5.2.2 The southern (upper) sub-division was formerly occupied by a building whose construction appears to have reduced partially the horizon of the natural sub-stratum. Indeed, the stratigraphic sequence prior to the construction of the former building was observed within the edge of the excavation area. It was established that the entire site was covered by a made ground layer (201) composed of dark brown silty clay with frequent fragments of modern demolition material forming therefore the so-called overburden. This overlay a sub-soil layer (202) with an overall thickness of 400mm which in turn overlay the natural sub-stratum (203) composed of yellowish clay (Figs 8 – 10). The proposed construction within this area will involve piling foundations whose steel capping and linking joists will be constructed within a made layer that is going to be laid over the already truncated natural horizon. Thus this area produced negative results. Moreover, no artefacts (even residual and/or unstratified) were identified.

Figure 9: North-facing section showing the stratigraphy of Area 2, looking south-west (scale 1m).

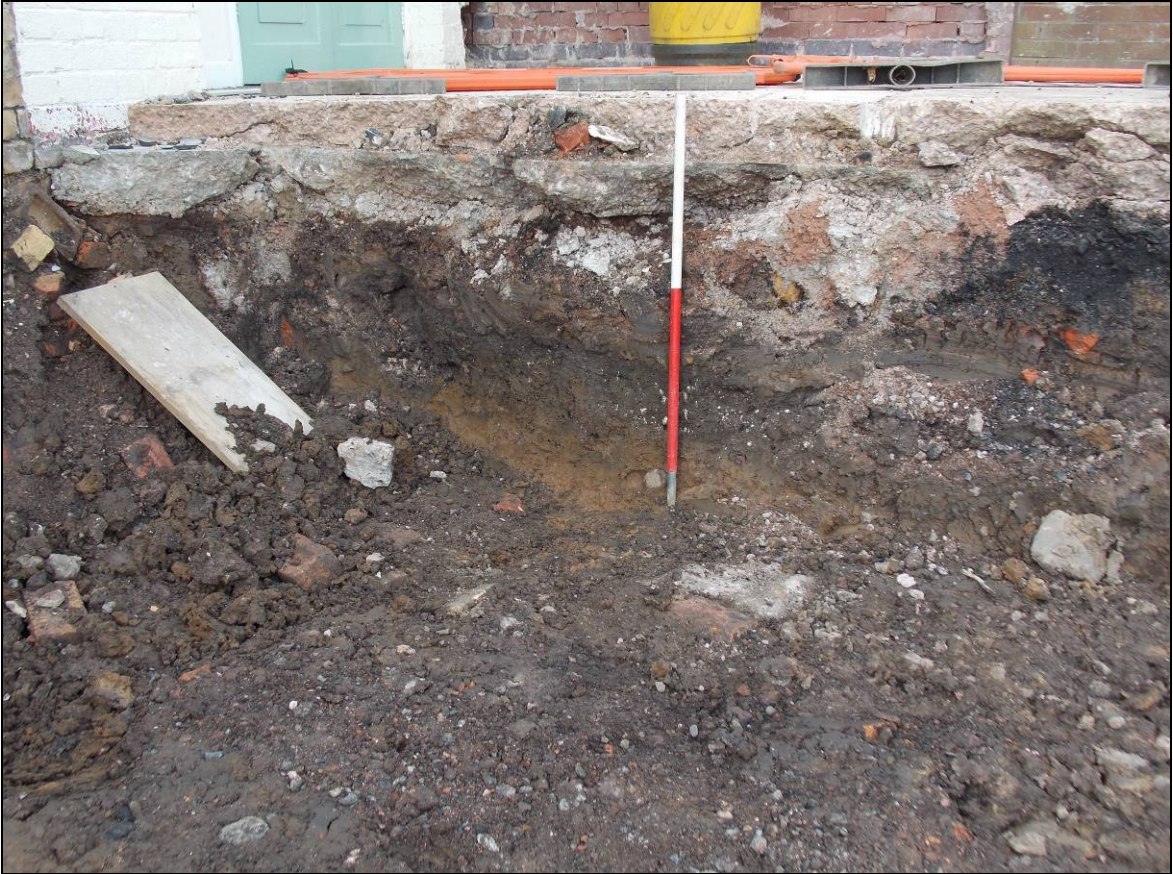
5.3.2 Small pockets of sub-soil (303) were observed within the southern section of the excavated area. Its thickness was established following a small sondage excavated in close proximity to the Main Building to the south and was also observed along the western edge of Area 3. This consisted of mid greyish brown firm silty clay with an overall thickness of 20mm thick. The sub-soil overlay the natural sub-stratum (304) which was composed of light yellowish brown clay, and its undisturbed horizon was established at a height of 189.39 metres AOD (Figs 11 – 15).

Figure 13: Detail of the stratigraphic sequence of Area 3, looking west (scale 1m).

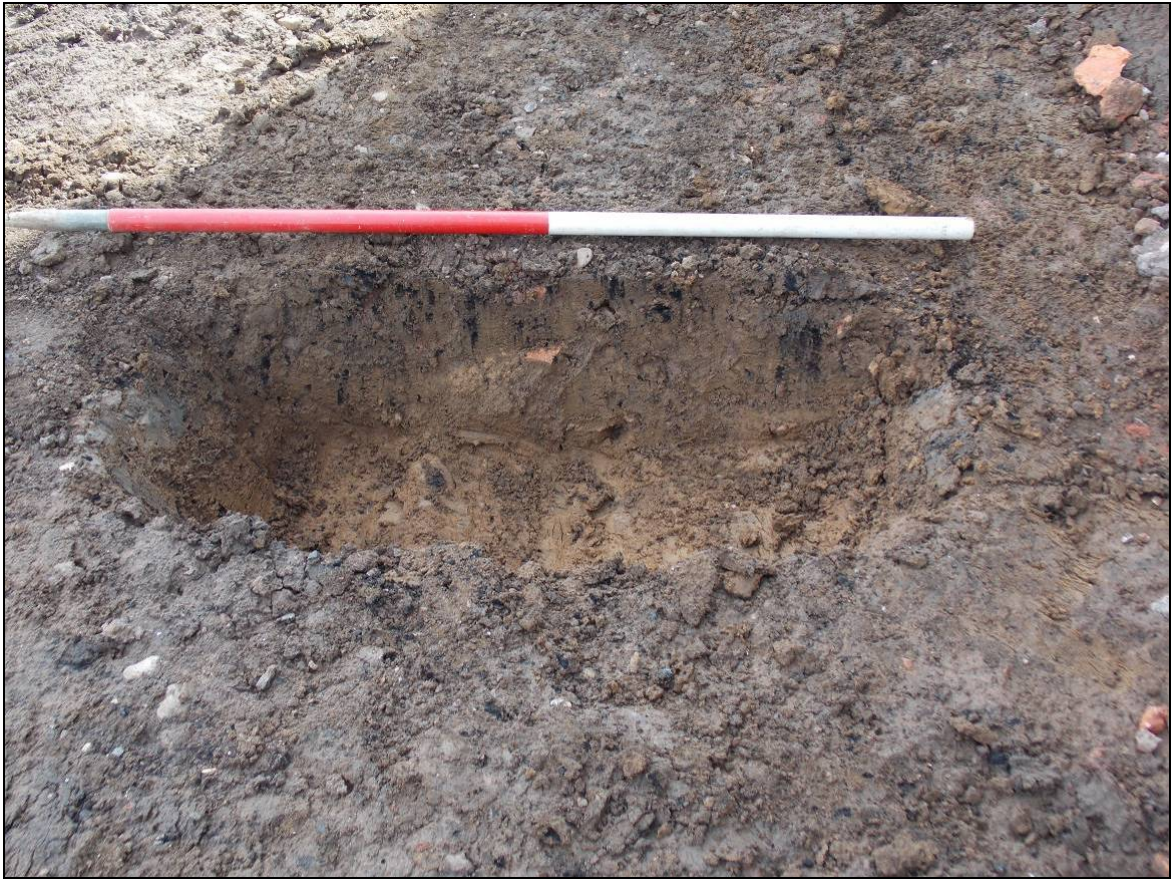
Figure 15: Detail of excavated sondage through the sub-soil exposing the natural clay sub-stratum (scale 1m).

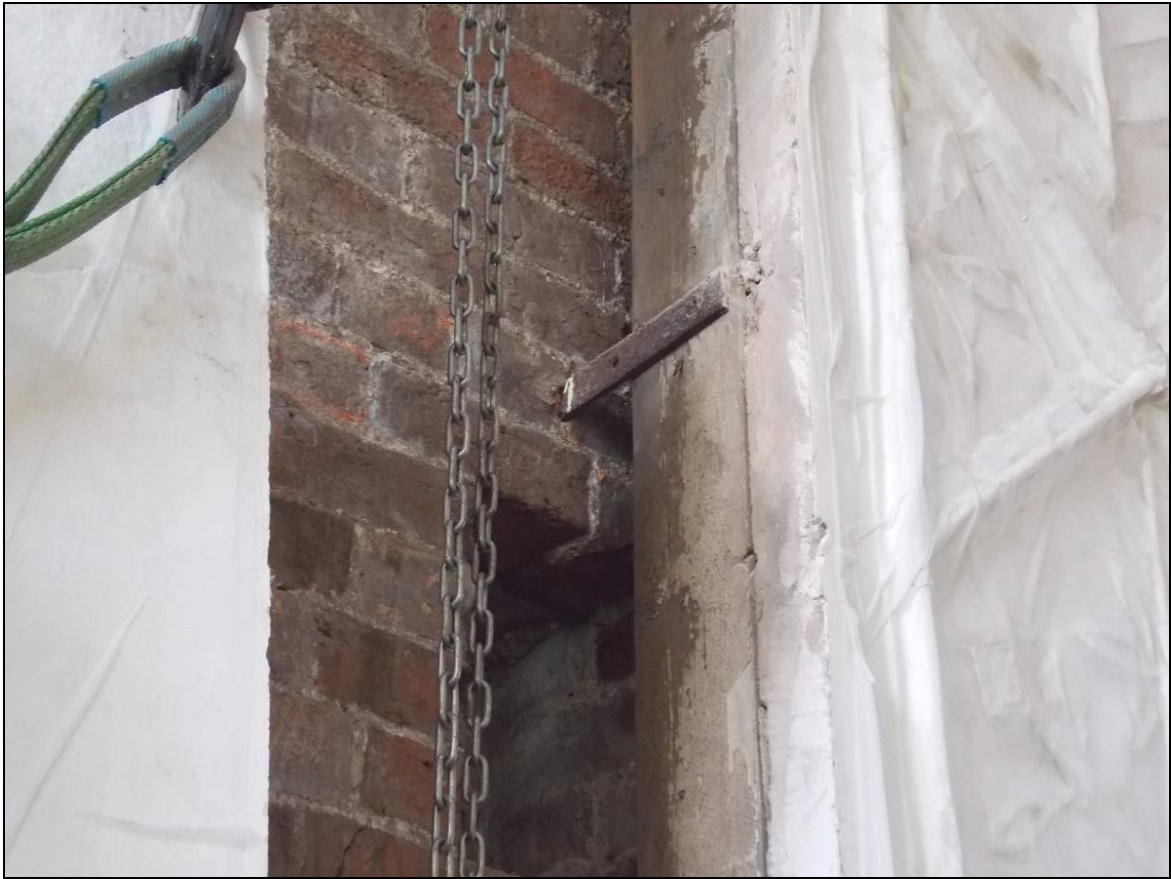
several wrought-iron straps nailed to additional timber joists which had also been nailed to the original ceiling joists when it was removed from its primary location (Figs 16 – 18). Although the ceiling appears to be a single panel, close inspection enabled establishing that it is composed of two separated panels (Panel 1 to the left and Panel 2 to the right) carefully joined together. This was clearly perceived following their dismantlement showing that each panel contains a separate frame and iron straps fixed into the wall (Figs 19 and 20).

Figure 20: Detail of iron strap supporting the frame of Panel 2.

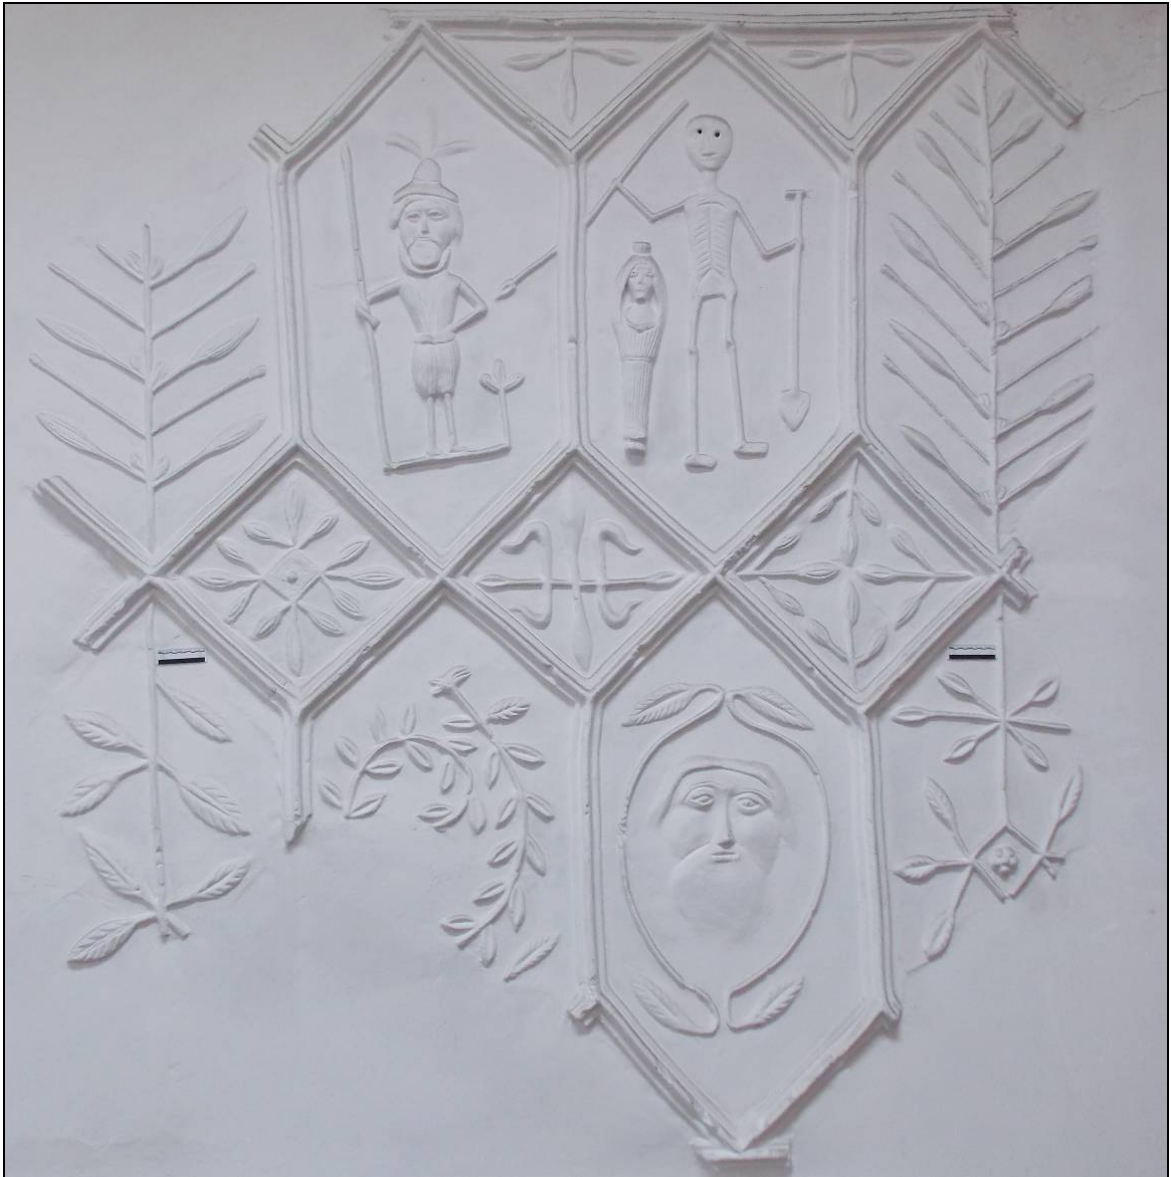
5.5.3 Panel 1 measures 2.70 metres in height, 2.74 metres in width and ≈ 150 mm in thickness. The low relief design is framed with a thin moulded rib with internal sub-divisions in triangular, square kite and elongated hexagonal shapes creating plates or boards with internal designs including the representation of the triumph of death amongst foliated plates, although no detailed assessment of the art and meaning of the plasterwork appears to have been conducted. The low relief has suffered some deterioration and later repair are discernable (Figs 21 – 23). The edges of the plaster are either concealed with later scantling battens or repaired with later plaster. The representation of the death depicts an anthropomorphized skeleton with a long spade (on the left hand) and a lance (on the right hand). Adjacent to the death is a person which appears to be wrapped in a shroud tied with ropes although the bust is mostly exposed (Fig. 24). The lance is targeting a gentleman (denoted by his moustache and beard) within the adjacent plate (Fig. 25). Within the lower section there is another bearded figure which may represent god (Fig 26).

Figure 21: General view of Panel 1 (scale 2 x 100mm).

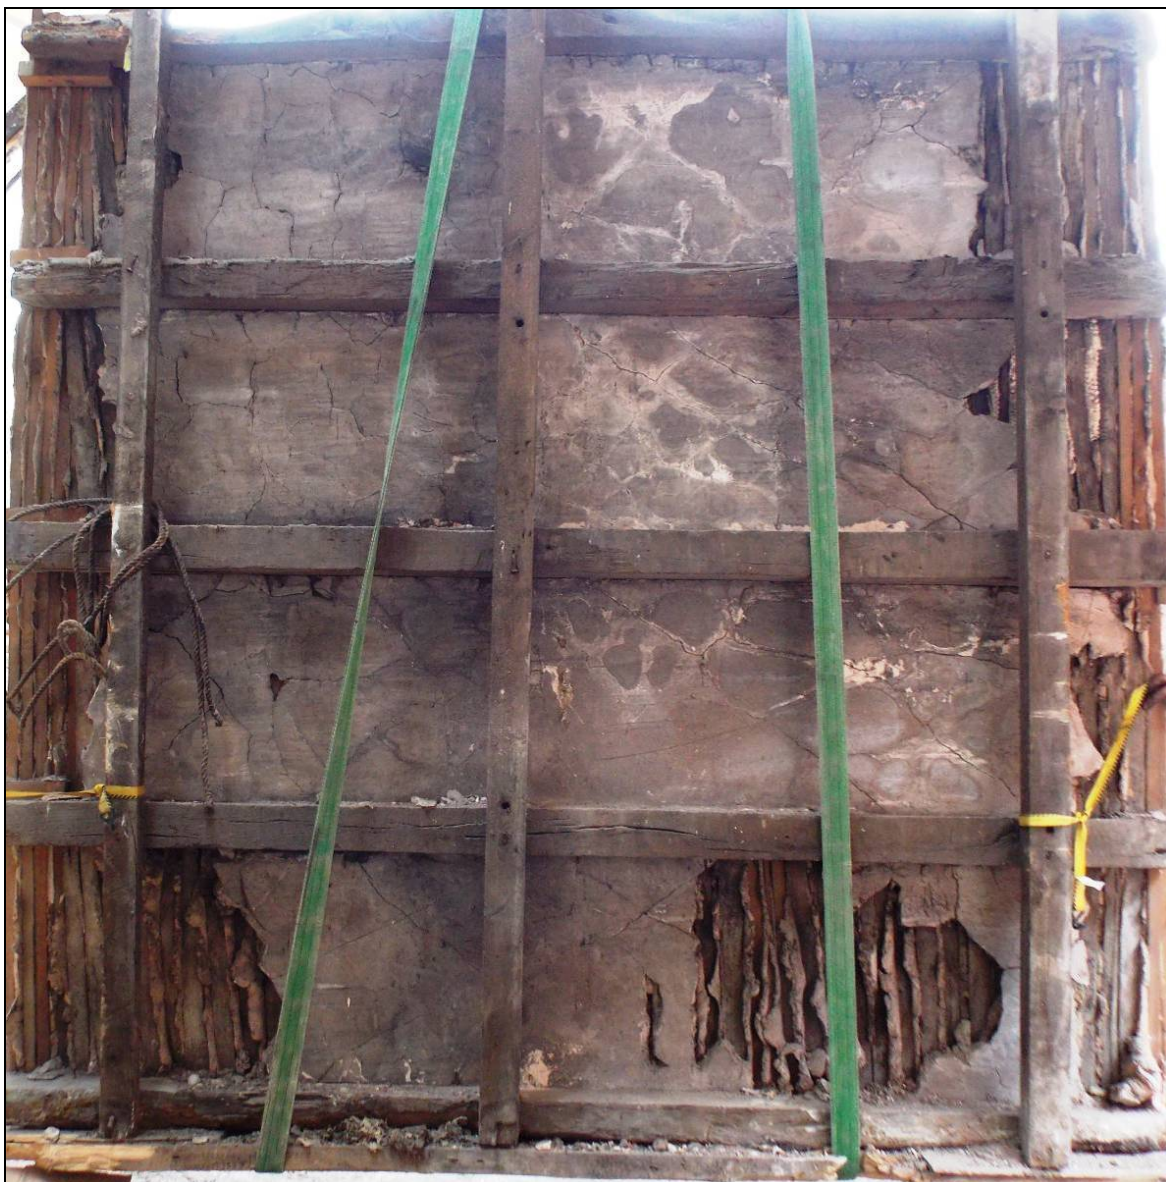
5.5.4 The reverse side of the ceiling panel was examined during the dismantlement prior to its transportation outside the building for curation and conservation. It was established that the ceiling structure is composed of five timber square joists (≈ 110 mm x 110mm) with flat chamfered edges on the soffit, each measuring exactly 1” (2.54cm) in width (Figs 27 and 28). The joists extend across most of the panel’s width and are positioned approximately 500mm apart, creating a robust frame composed of two members along the upper and lower extremities of the panel, a central member and two intermediate ones between the centre and the top/bottom edges.

Figure 27: Reverse side of Panel 1.

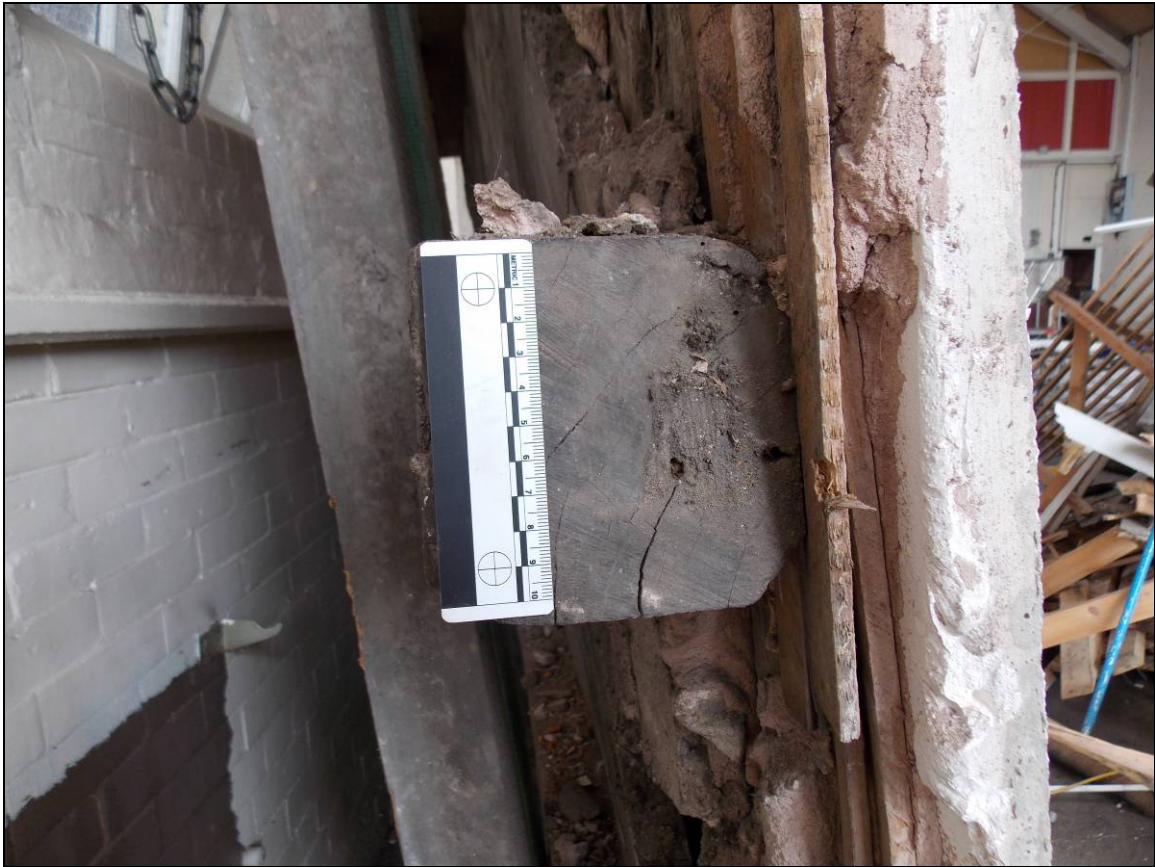
Figure 28: Original timber joist with flat chamfered edges (scale 100mm).

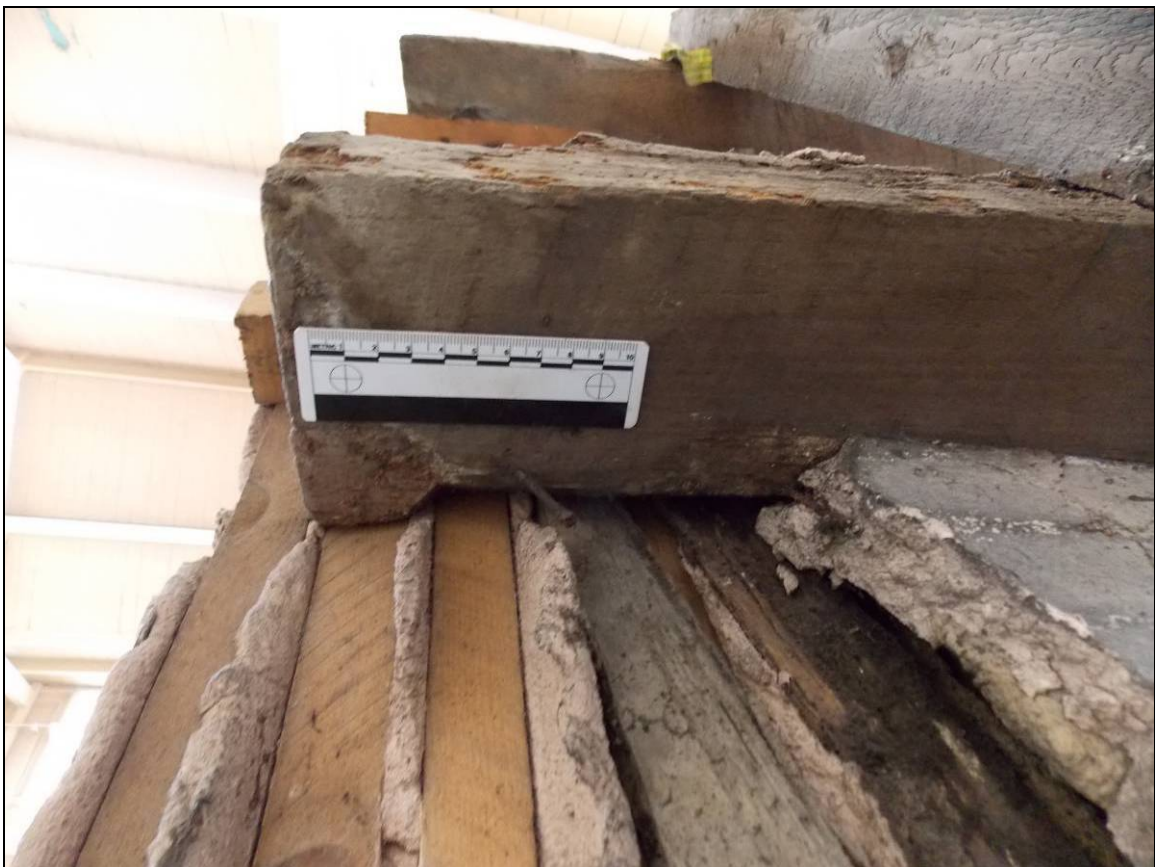
Figure 29: Ceiling joist with stop chamfer (scale 100mm).

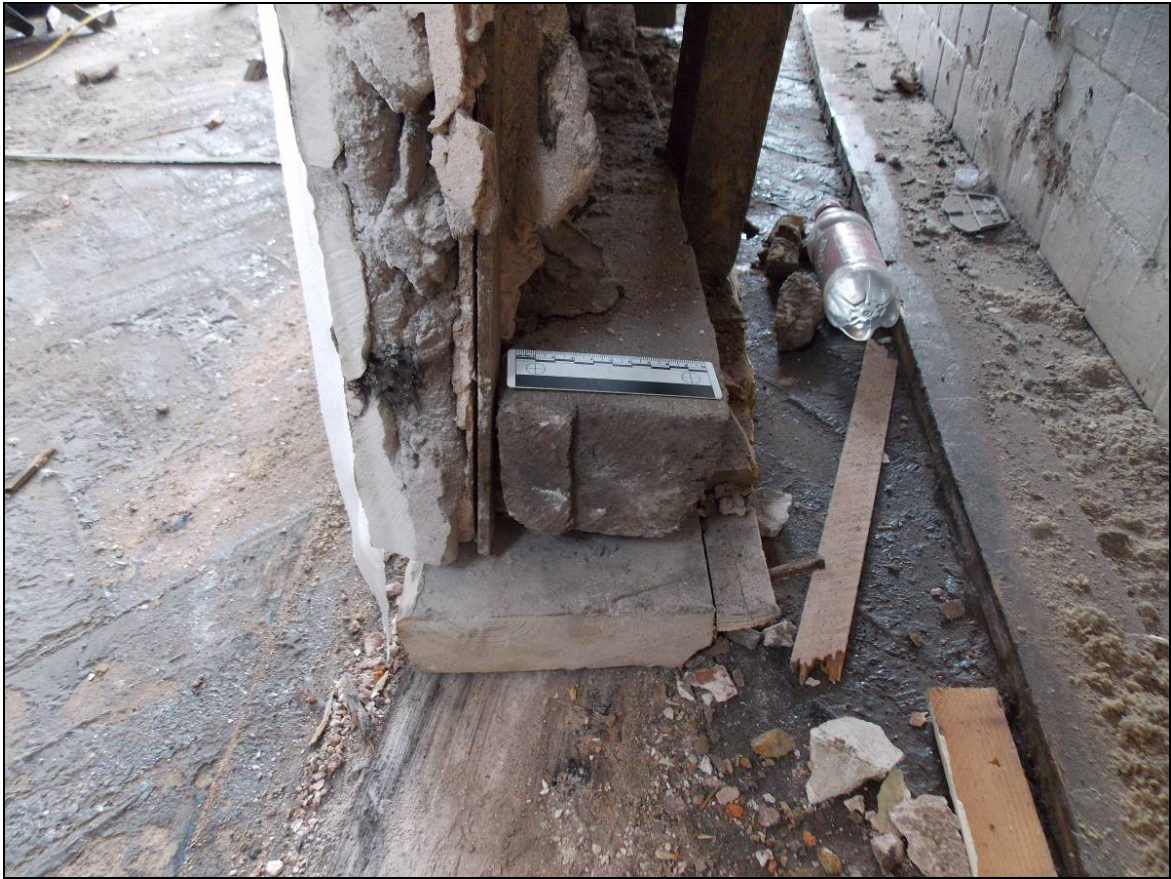
5.5.5 There are also three later plank-like joists nailed to the primary joists creating a frame from where ropes and slings could be threaded through in order to facilitate its lifting and transportation to the Gymnasium. The edges of the primary joists were sawn off when the ceiling panels were removed from the original building and thus their true ends have been lost. However, the left edge of the uppermost joist (as determined by its attached position on the wall) is slightly longer and retains a run-out chamfer stop (Fig. 29). Moreover, the left lateral edges retain their true ends as indicated by their sawn-off tenons (Fig. 30). These ends also have run-out stop chamfers although mostly obscured by later plaster repair. The chamfered edges indicate that the ceiling would have originally consisted of exposed beams and joists, and the plaster ceiling added at a later time.

Figure 30: Ceiling joist with sawn-off tenon (scale 100mm).

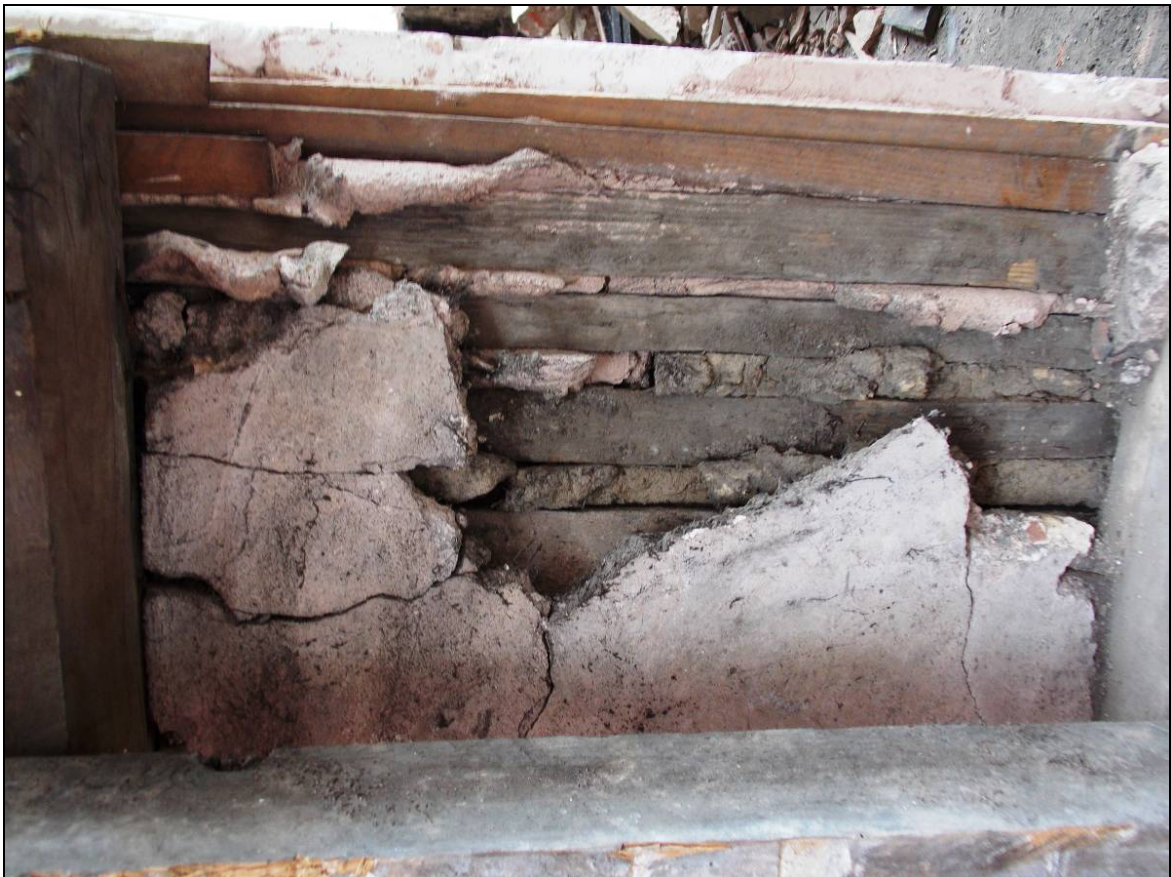
5.5.7 Although it was established that the plaster is applied onto rivens laths split by hand which are nailed to the structural timber joists of the original plasterwork, it became apparent that a later coating of plaster, including areas reinforced with metal mesh, has been applied to the original structure (Figs 31 and 32). Furthermore, some of the laths are also later replacements including wooden laths possibly split from fruit boxes as exhibited by traces of rather illegible red printed writing (Fig. 33). In addition to this, a fairly thick (c.30mm) veneer of lime ash plaster screed has been applied to the underside of the ceiling and secured to the sides of the original joists with nails. At first glance, this veneer was thought to have been applied as a mean of floor/ceiling insulation; however, close inspection revealed a series of incised inscriptions which appear to have been made before the plaster set as part of a former restoration work. The main inscription is located immediately behind the bearded gentleman adjacent to the representation of the death and reads 'A. D. 1897 Repaired By F. P. of Leek' (Fig. 34). An adjacent engraving (positioned within the area behind the legs of the death) reads 'Repa' and it is thought to have been intended for 'Repaired' but the size of the writing is much larger and so, its creator might have realized that the space between the joist would have not accommodated the proposed note (Fig. 35).

Figure 31: Detail of riven laths and different plaster veneers.

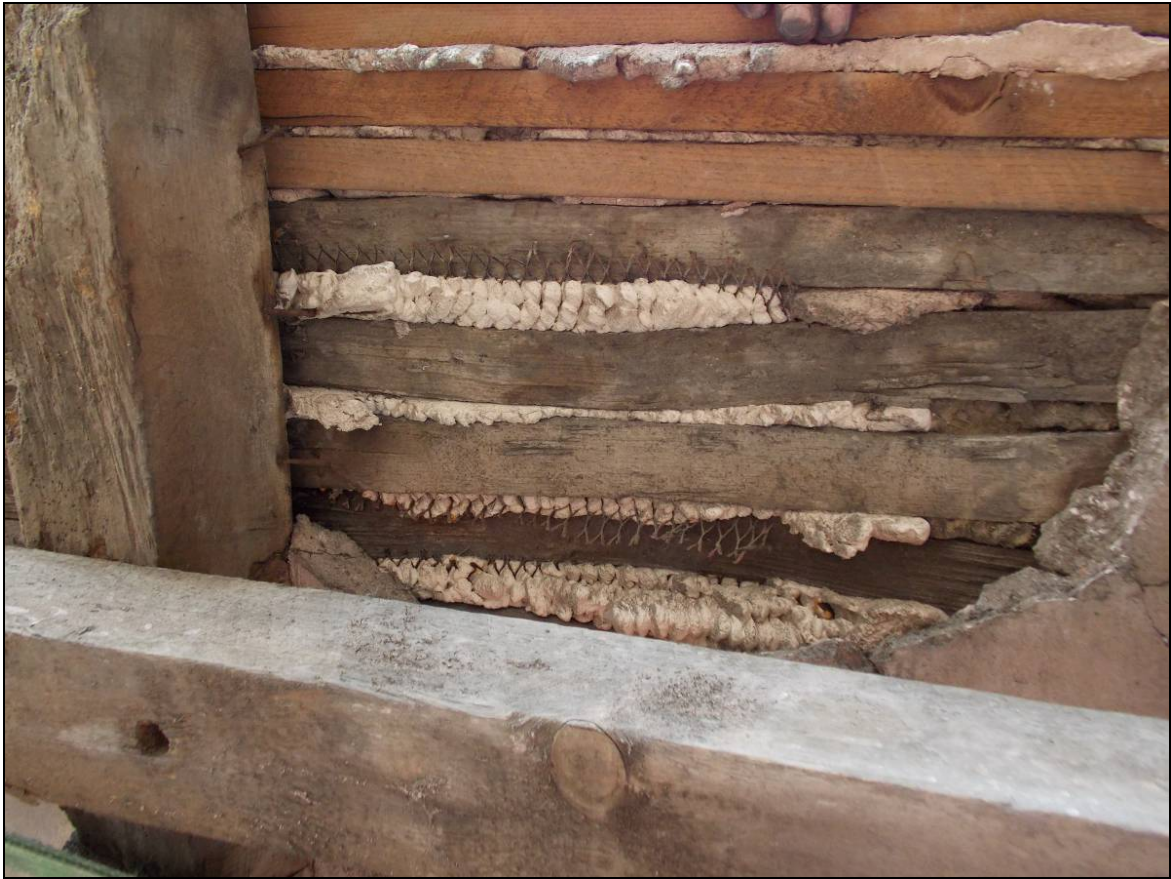
Figure 32: Repaired area with metal mesh.

The ceiling was repaired in the late 19th century, presumably when the ceiling was removed from its original building and re-erected in the Carr Gymnasium when it was built in 1900.

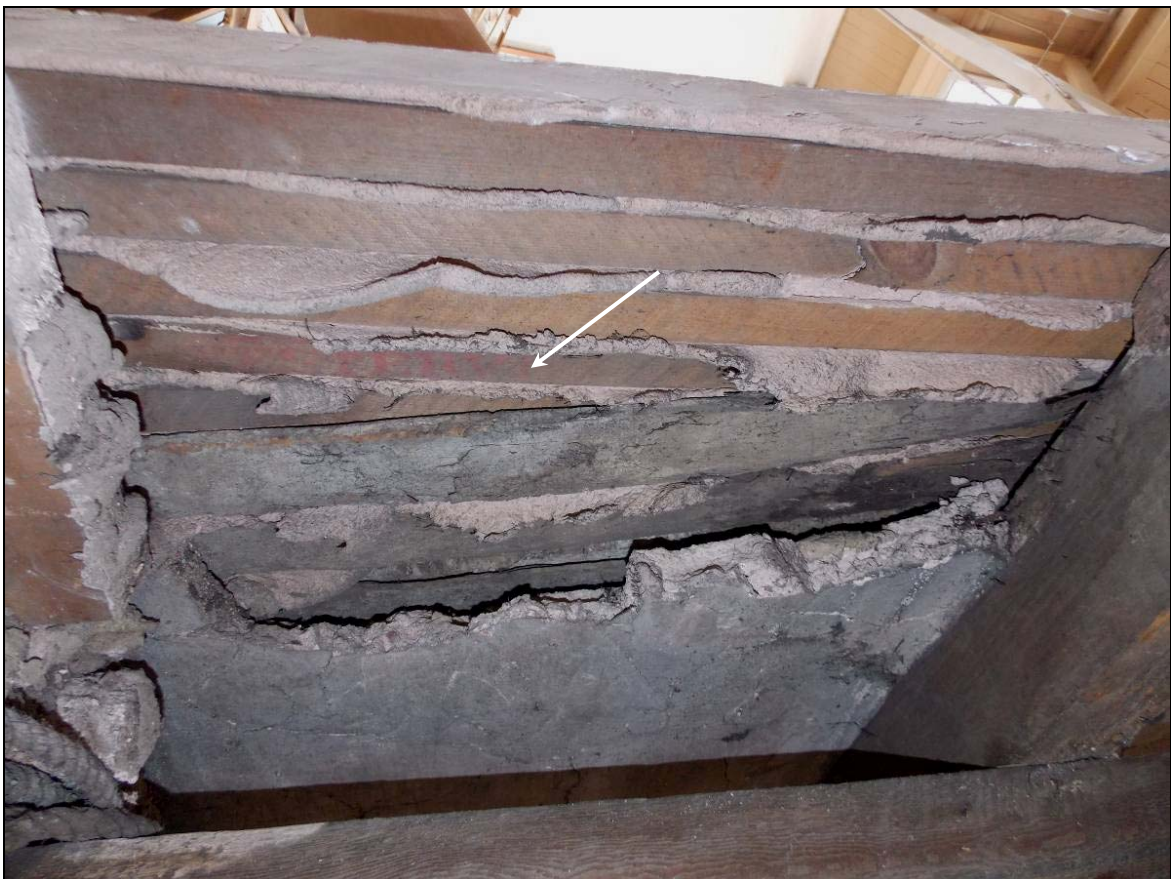
Figure 33: Detail of replaced lath with printed writing (arrow).

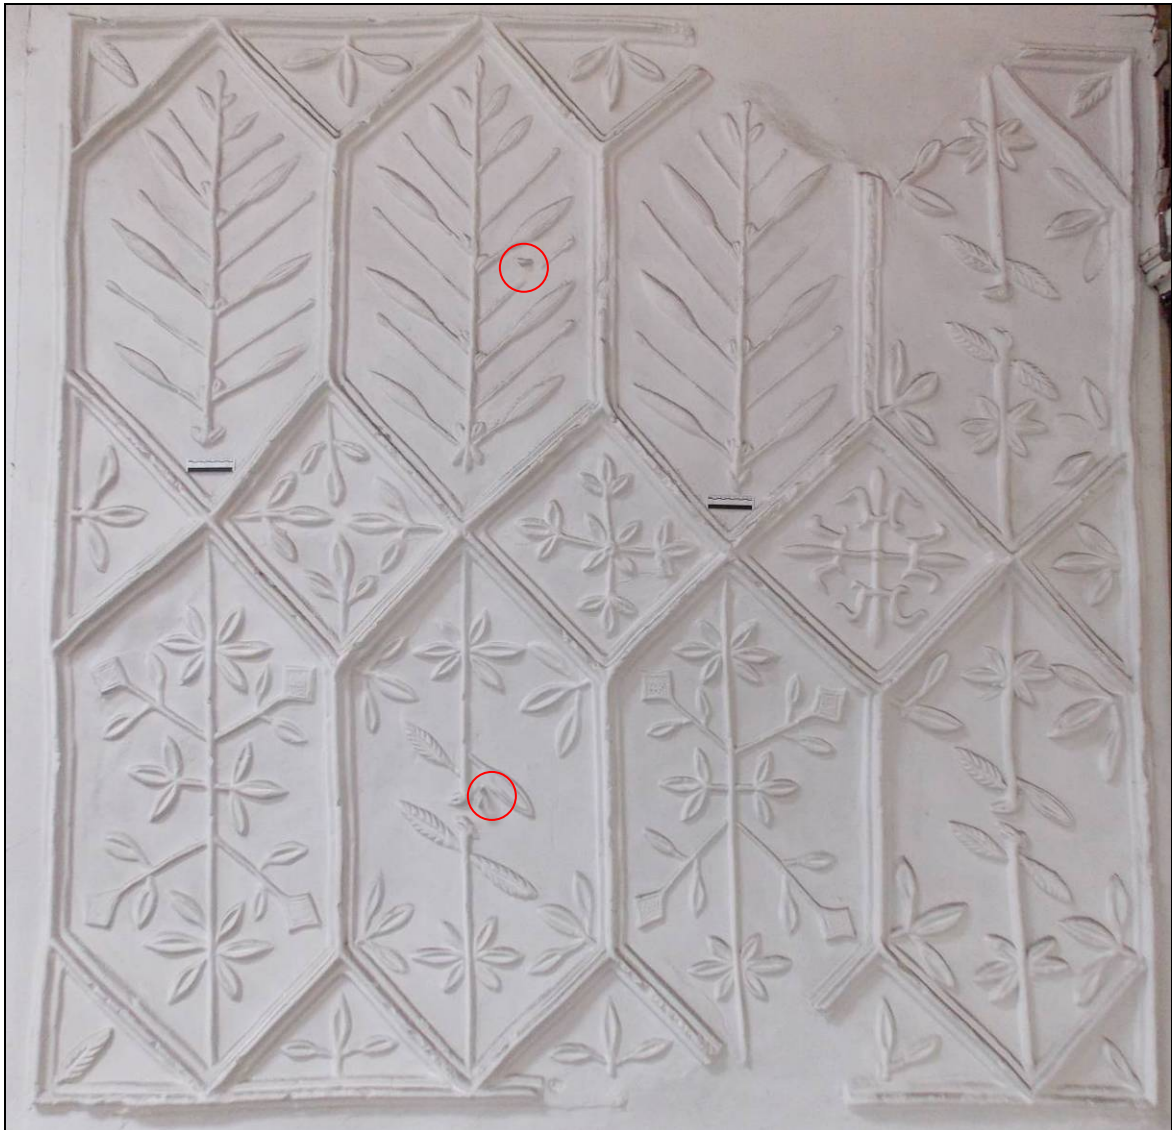
5.5.9 Panel 2 measures 2.70 metres in height, 2.60 metres in width and ≈ 150 mm in thickness. The slight discrepancy of width with its counterpart is dictated by the secondary joint created when the panels were mounted on the wall; however, their surrounding moulded ribs are of equivalent dimensions. The low relief design consists of symmetrical foliated plates or boards comparable to Panel 1 suggesting therefore that they both were originally part of the same ceiling. This panel is more complete although slight damage is also discernable (Figs 37 – 41). Of note are two fixed U-shaped wrought-iron hooks which might have been designed to hang items such as lighting oil lamps (Figs 37 and 42).

Figure 37: General view of Panel 2 with two hooks denoted by red circles (scale 2 x 100mm).

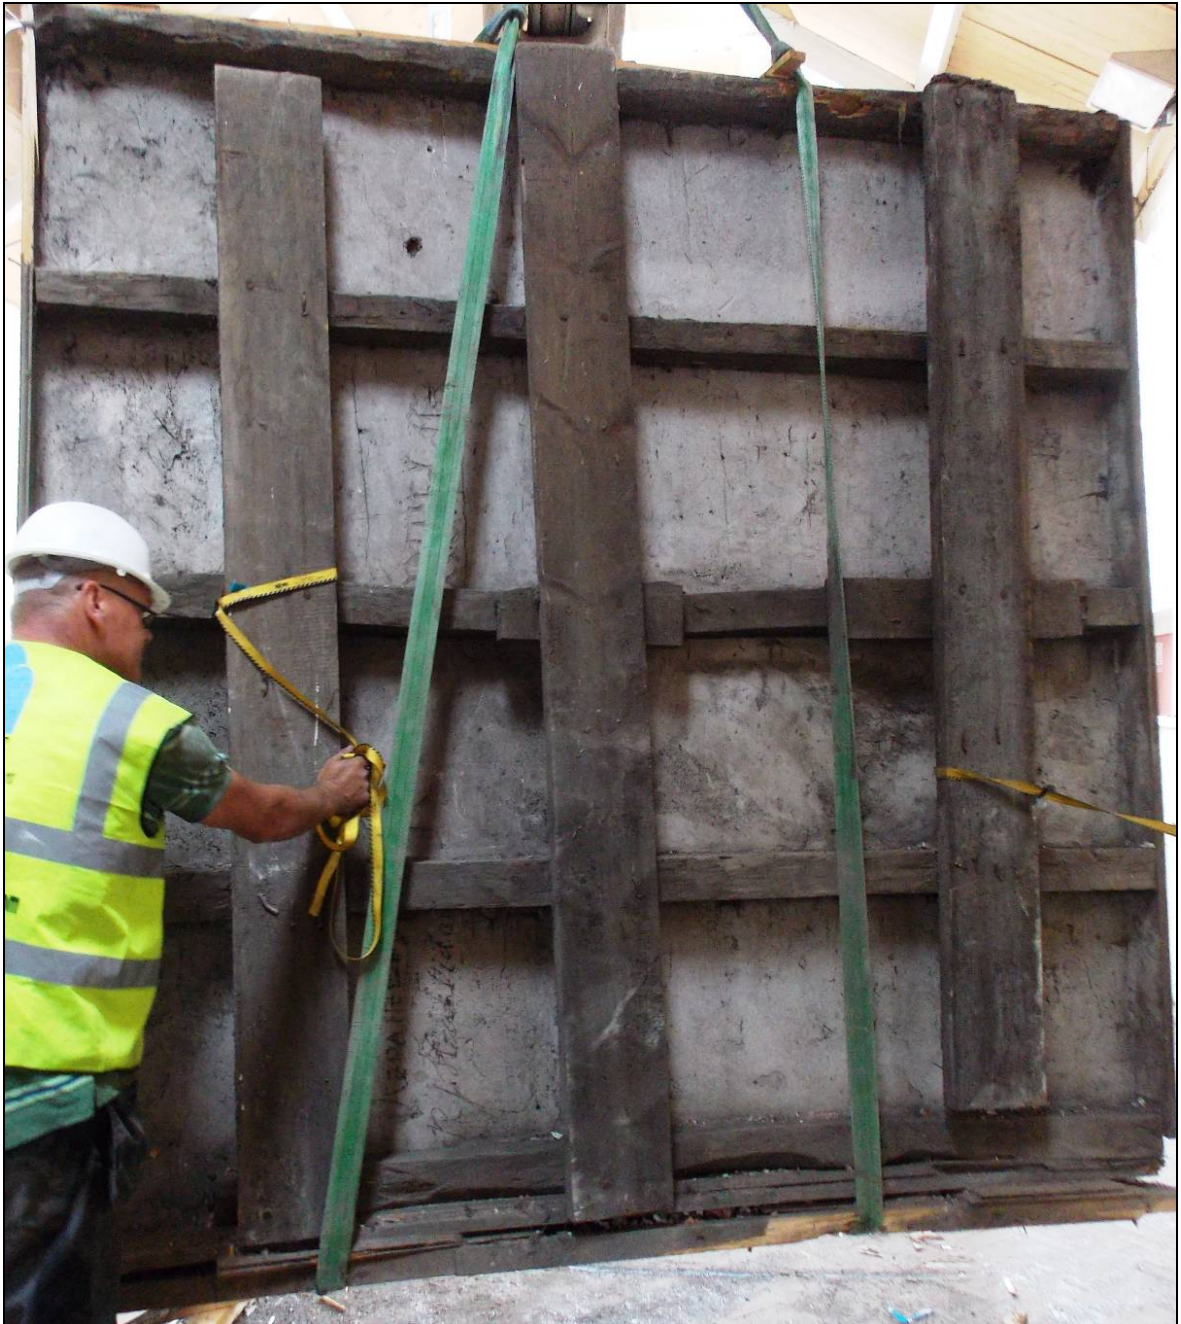
5.5.10 The reverse side was also examined whose construction was comparable to the one of Panel 1 (Fig. 43). This also includes a thick lime ash veneer between the side of the joists with similar incised inscriptions within both upper and lower sections of the panel. The upper inscription reads 'R. J. Holliday' and the lower is very similar and reads 'Repaired By R. J. Holliday' (Figs 44 and 45). An additional 'R' (possibly for Repaired) is also inscribed above the lower inscription although this once again appears to have been an abandoned note due to its large calligraphy (Fig. 46).

Figure 43: Reverse side of Panel 2.

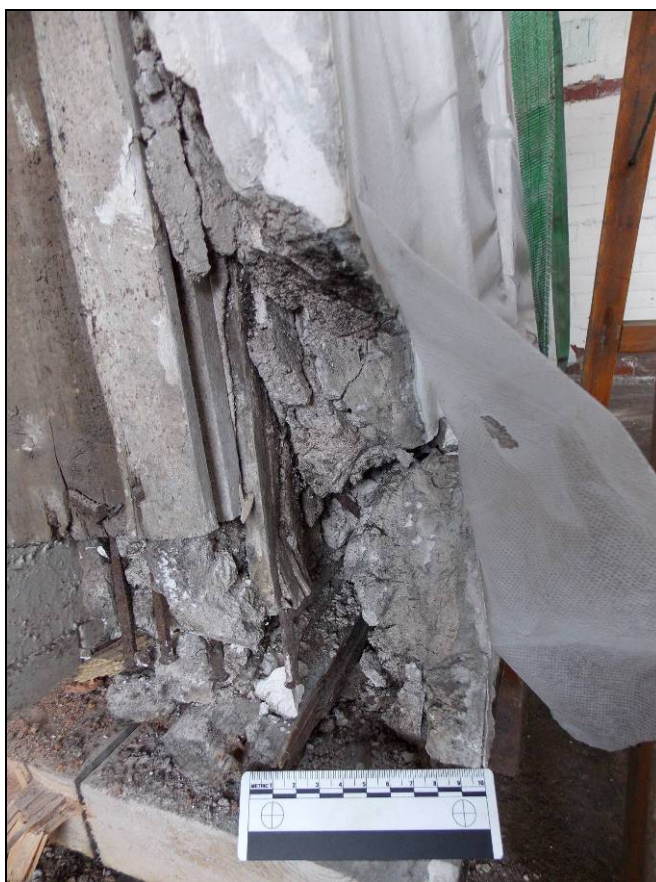
5.5.11 One of the lateral edges was not concealed by later planks, thus showing the original superimposition of joists, riven laths and plaster coating (Fig. 47). Indeed, the original plaster application was discerned consisting of three-coats plaster applied to riven laths nailed across the ceiling joists. The first render coat (≈ 8 mm thick) was squeezed throughout the spaces between the laths so it spread out behind them to form keys that, when set, held the plaster in

place. The render coat would have been scored to create a key for the second layer often called the floating coat (*c.*6mm thick) which provided an even surface for the final layer. This also was keyed. The final or setting coat (*c.*3mm thick) was trowelled smoothly to provide a suitable surface for decoration. The composition appears to be of lime and sand mixed with water. Animal hair was applied to the first two coats in order to bind the material together.

Figure 47: Detail of plaster coats and laths (scale 100mm).
