**Buxton and Leek College Campus, Leek,
Staffordshire**

**Archaeological building recording and
watching brief (Volume 2)**

ARS Ltd Report 2014/44
June 2014
OASIS ID: archaeol5 – 174831

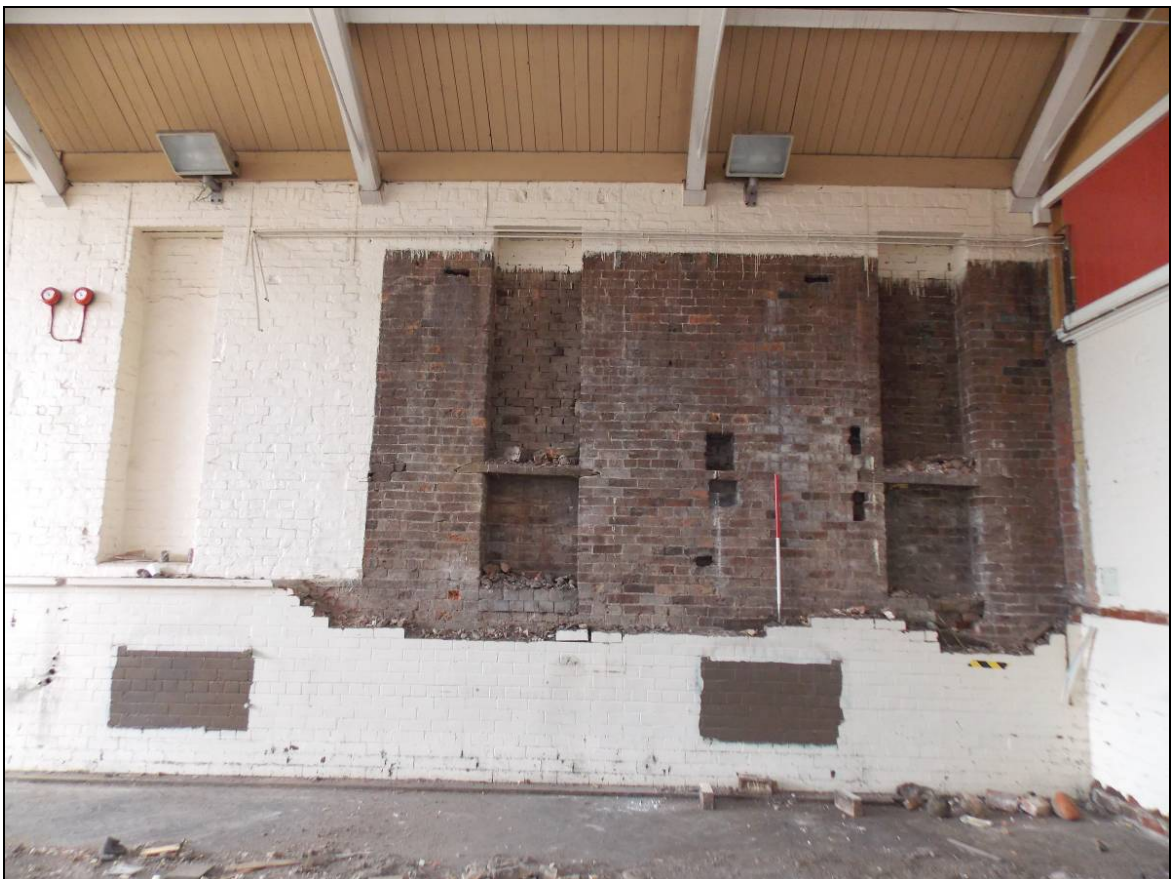
5.5.12 This panel was also safely carried to the Hirst Conservation lorry (Fig. 48). The dismantlement of the panels enabled viewing the brickwork behind them containing two long recessed niches equivalent to another one to the north forming a regular layout (Fig. 49). These were recognized during the building recording of the Gymnasium (Mora-Ottomano 2013), but it was not known that each niche contains a wooden shelf, and so it is likely that the uncovered one might have also contained a similar feature for storage as part of a mid to late 19th century structure associated with a timber yard workshop as identified on the aforementioned previous archaeological building recording (*ibid.*). Moreover, the sequential development of the construction of the Carr Gymnasium proposed on the building recording was further elucidated through the identification of a clear construction break/joint between the east and south walls of the Gymnasium (Fig. 50).

Figure 49: Southern end of the east wall following the dismantlement of the ceiling (scale 1m).

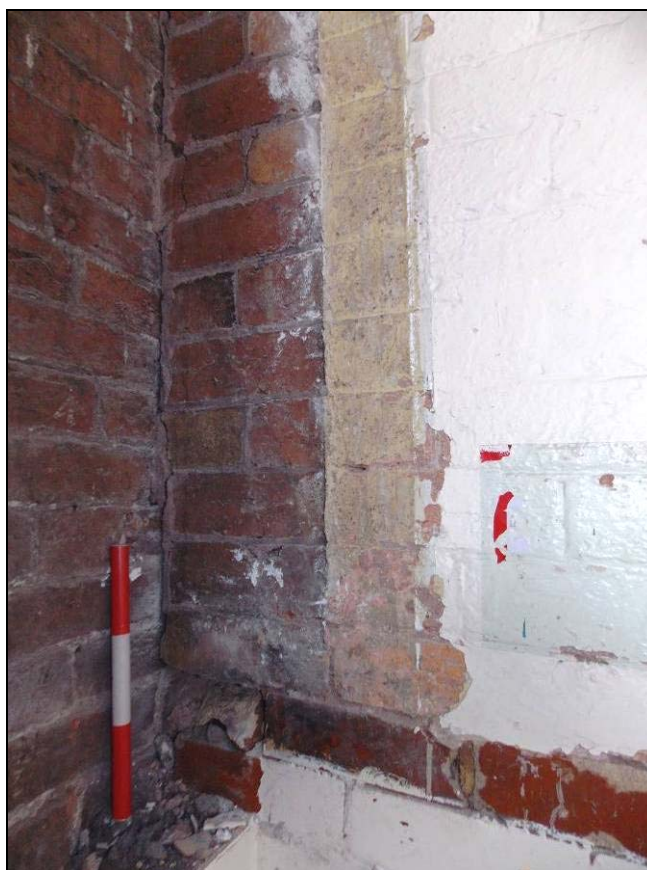
The final dismantlement of the plaster ceiling revealed additional evidence of the proposed phase of construction of the Carr Gymnasium, establishing that the eastern wall where the ex situ plaster ceiling was mounted was part of a mid to late 19th century structure associated with a timber yard workshop.

Figure 50: Detail of construction break/joint between the east and south walls (scale 300mm).
