**The Queen's Head Hotel, Buxton,
Derbyshire**

Archaeological Watching Brief

ARS Ltd Report 2014/45

March 2014

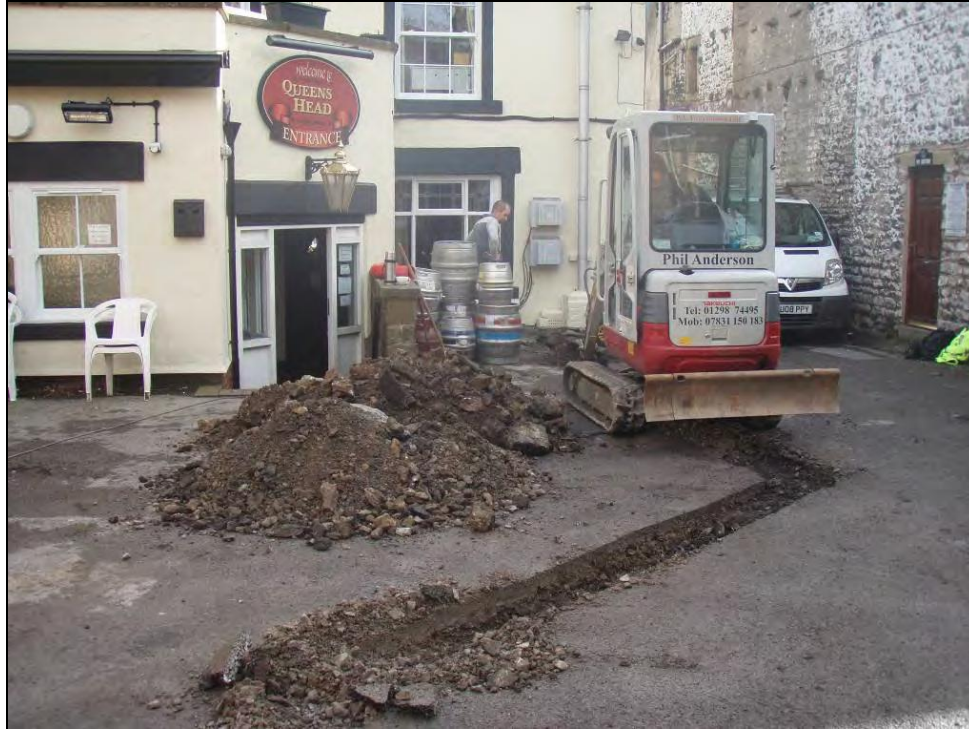
- 4.1.1 Trench 1 comprised a service trench for electrical cables to be laid and connected to the new building. The trench measured approximately 8.6m east to west, turned a 45 degree angle on a north west to south-east alignment for 3.7m and finally turned back on an east to west alignment for a further 2.1 m. The trench measured 0.35m in width and reached a maximum depth of 0.45m, with a minimum depth of 0.2m.

Figure 3. Trench 1 mid-excavation. Facing south-east.

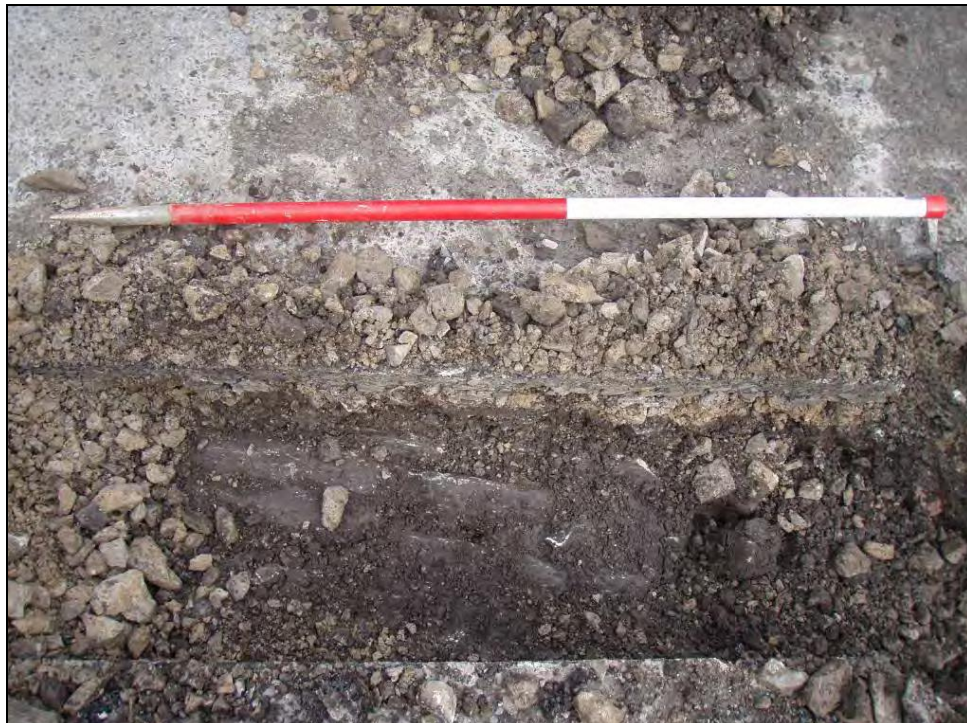
- 4.1.3 At the very eastern end of the trench a small spread of cobbles (109) was observed (figure 4), measuring approximately 0.6m in length and exceeding the width of the trench. These were placed on top of a bedding/levelling deposit (104) of very dark reddish-brown fine silty clay with limestone inclusions. Each cobble measured approximately 0.2m in length by

0.06m in width and was slightly rounded. It is likely that these cobbles represent part of an outdoor surface, possibly a courtyard area of the stables that are known to have existed on the site. The cobbles appeared to continue beyond the eastern end of the trench.

Figure 4. Cobbles (109). Scale = 1m.

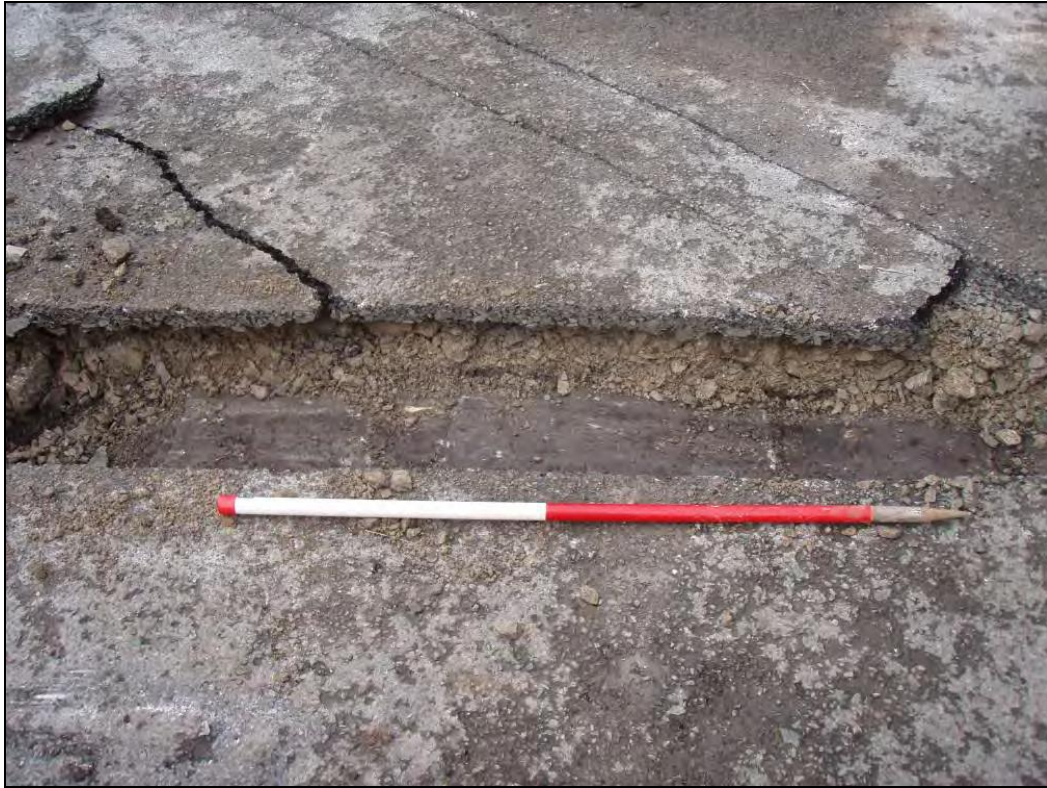
4.2.2 The stratigraphic sequence of Trench 2 comprised a layer of tarmac (100) and hardcore (101) as seen in Trench 1. In the north/south alignment of the trench, a layer of roughly squared flagstones (103) (Figure 5) was observed, present for 1.5m in length. Each flag measured between 0.5m and 0.6m in length and were 0.1m thick, with the width exceeding the confines of the trench. These were observed to be sitting upon levelling deposit (104), as observed with the cobbles (109) in Trench 1. A small amount of 18th and 19th century pottery and clay pipe stem fragments were recovered from the levelling deposit (104) in Trench 2.

Figure 5. Flagged surface (103). Facing west. Scale = 1m.

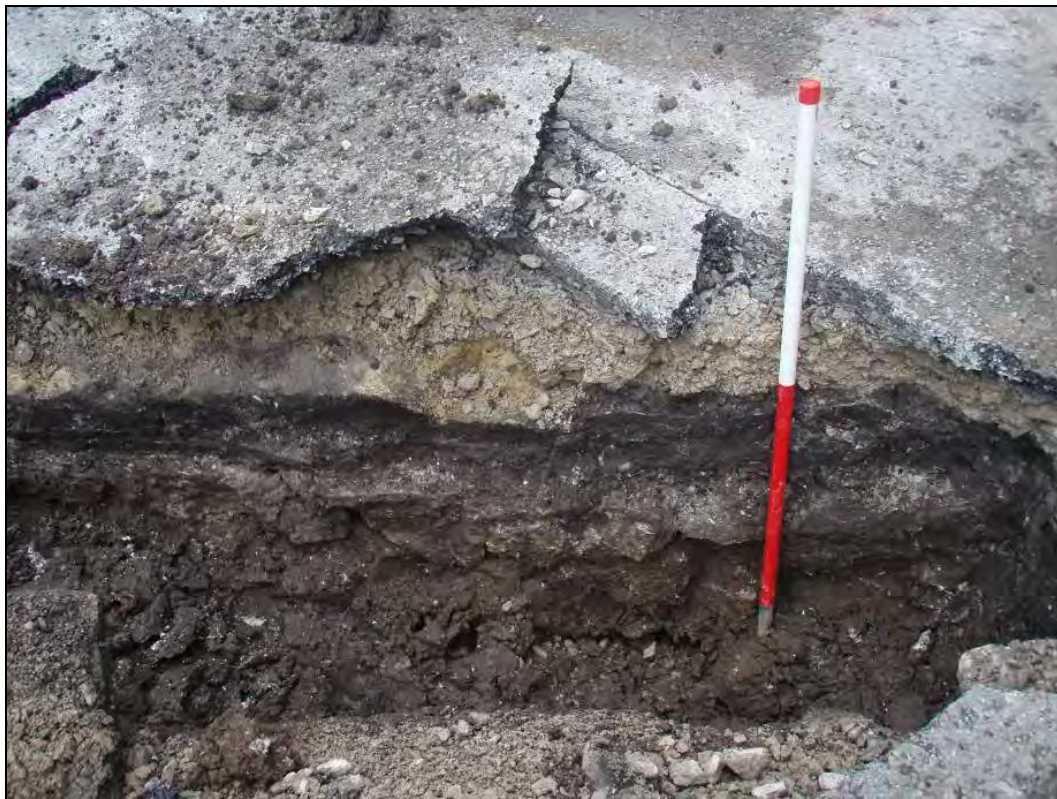
4.2.3 Upon removal of the flagged surface (103), it became clear that it was abutting the outside face of a gritstone wall (106) (Figure 6) comprising roughly squared gritstone blocks, each measuring approximately 0.4m in length, 0.2m in depth and 0.35m in width. This was constructed upon a bedding of roughly squared limestone blocks (107), approximately 0.4m in thickness, which was cut into levelling deposit (104) and subsoil (105), and sat upon the natural limestone bedrock (123). The wall measured, in total, 1.5m in length, and continued beyond the confines of the trench.

4.2.4 The north-east to south-west alignment of Trench 2 exposed the entire width of wall (106), proving to be 0.65m in width. Beyond the wall an inner floor surface (108) was observed, which was identical in material and construction to surface (103). Surface (108) abutted the inner face of wall (106), and was constructed upon the bedding/levelling deposit (104), which directly overlay subsoil (105) and the natural limestone bedrock (123).

Figure 6. Wall (106) and limestone bedding (107). Facing west. Scale = 1m.

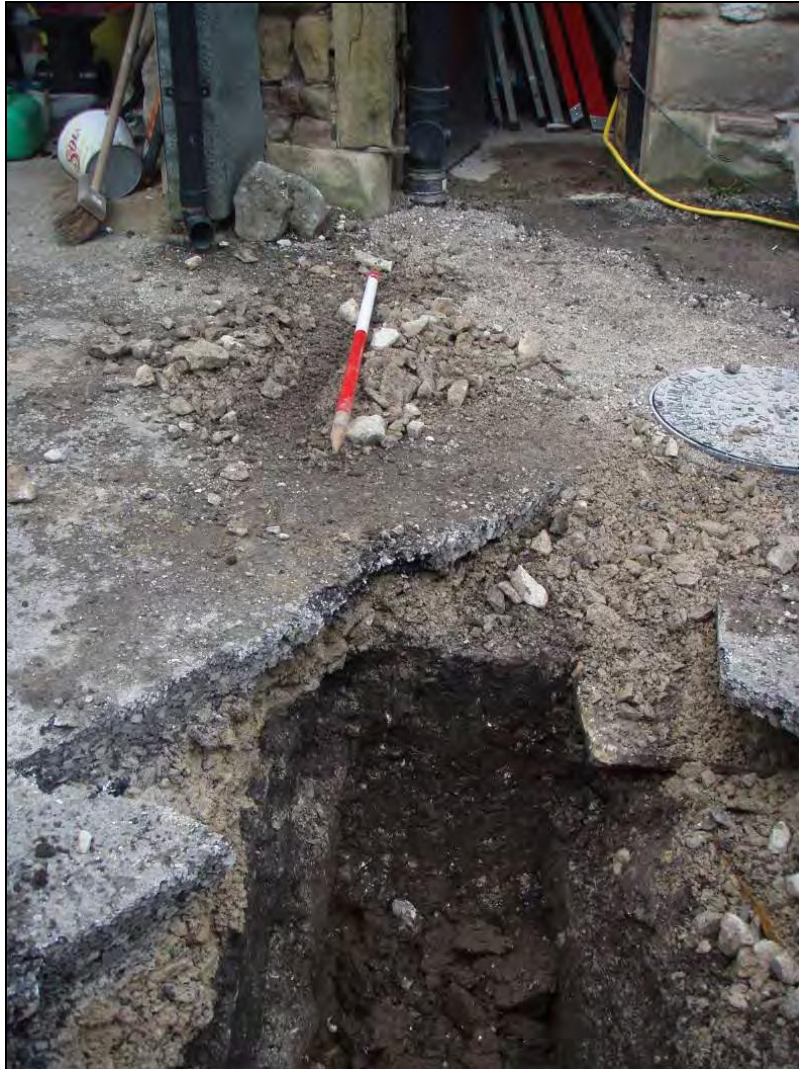
4.2.5 The wall in Trench 2 (106) was found to be in direct alignment with the existing wall of part of the old stable block (Figure 7), hence it is highly probable that the wall (106) was once part of the stable block. Flagged surface (103) appears to be located outside the stable building, and is likely to represent a yard surface, and may be a later repair to the cobbled surface (109) observed in Trench 1. Flagged surface (108) appears to be located inside the building, and is identical in construction and material to flagged surface (103).

Figure 7. Wall (106) shown in alignment with the existing stable block wall. Facing north. Scale = 1m.

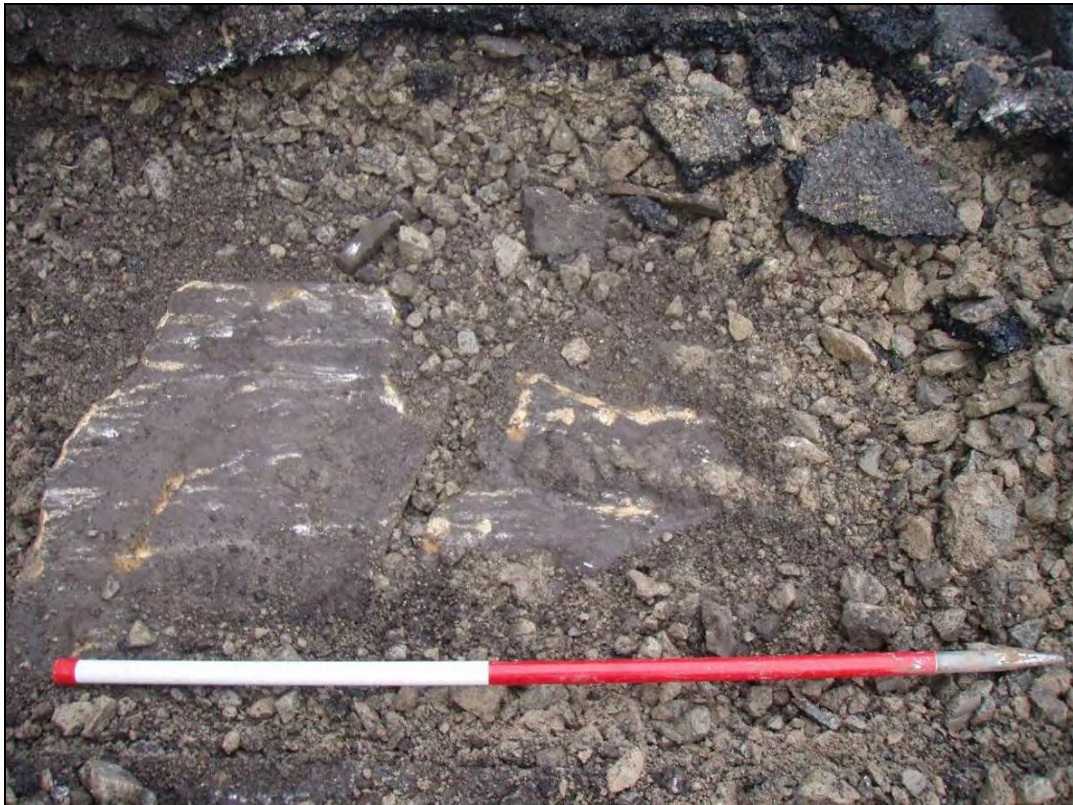
4.3.2 The stratigraphic sequence consisted of a layer of tarmac (100) and hardcore (101) as observed in Trenches 1 and 2. Immediately beneath the hardcore an intermittent surface of flagstones (112) was observed in the south-east facing section of Transect 1, measuring 1.30m in length. These were not present for the whole length of the transect, however in the south-west facing section of Transect 2 they were observed again, and continued for 2.2m. The flags were approximately 0.1m in thickness and were placed upon the bedding/levelling layer (104) as observed with the cobbled and flagged surfaces observed in Trenches 1 and 2. These flagstones appear to be located inside the stable building, hence are likely to represent a floor surface.

Figure 9. Transect 1 of Trench 3. Flagged surface (112), immediately underlying hardcore (101).

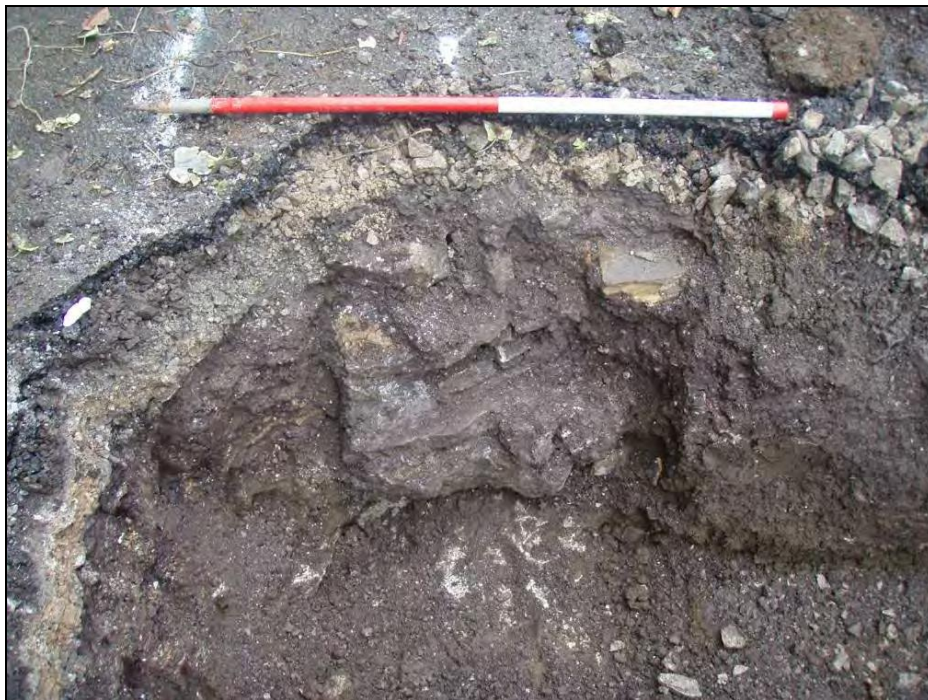
4.3.3 In Transect 2 it was apparent that flagstones (112) abutted the inner face of wall (111), a north-west to south-east aligned gritstone structure measuring 0.6m in thickness and 0.65m in width, present along the entire length of the transect. The wall was cut into bedding (104) and subsoil (105), allowing the wall to sit upon the natural limestone bedrock (117). This is markedly different to wall (106) observed in Trench 2, which rested upon limestone that appeared to have been deliberately placed as a bedding.

Figure 11. Wall (111). Facing north-west. Scale = 1m.

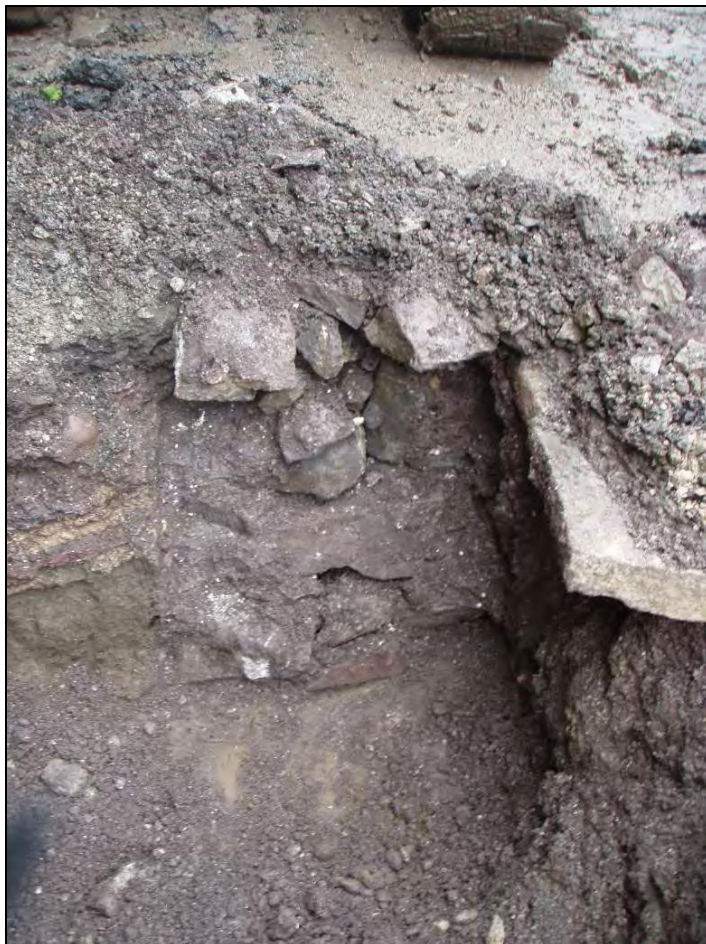
Figure 12. Flagged surface (112) abutting the inner face of wall (111). Facing north-west.

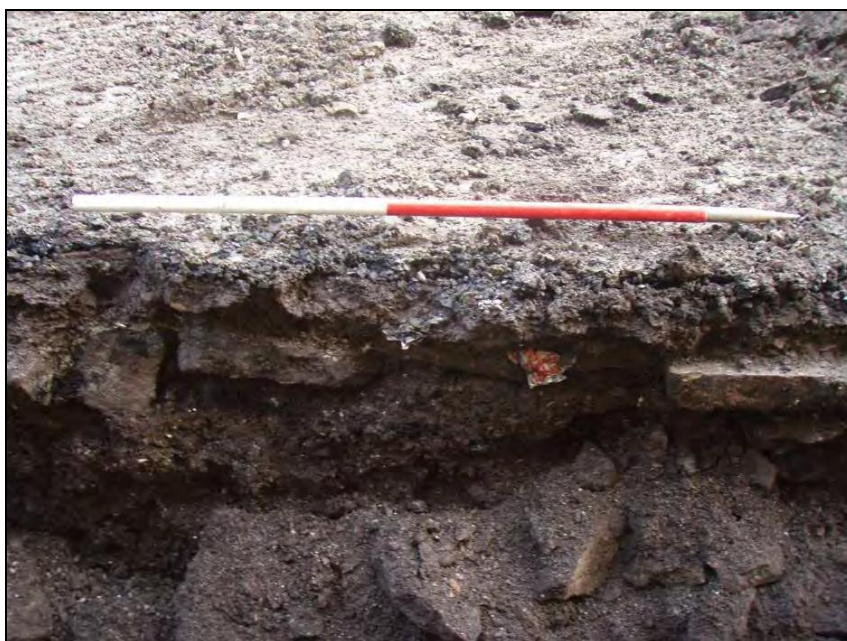
Figure 13. Transect 2 of Trench 3, section 2. Flagged surface (112) (right) and wall (111) (left). Facing north-east.
Scale = 1m.

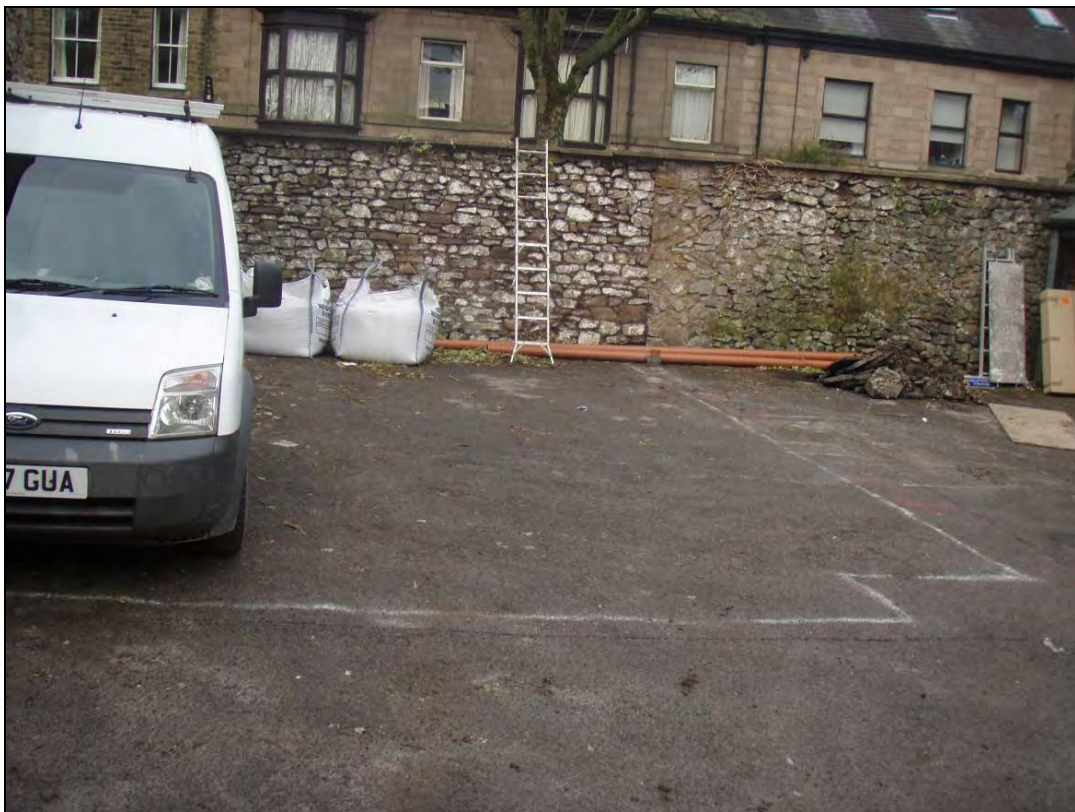
4.3.4 Wall (111) was found to meet wall (116) at the interface of Transect 2 and 3 of Trench 3. Wall (116) was aligned north-east to south-west. No clear relationship was apparent between the two walls but they were clearly joined, indicating that they were constructed at the same time and are part of the same structure. In addition, the construction of the two walls was identical, comprising large gritstone blocks sitting directly upon the limestone bedrock (123), and cut into levelling deposit (104) and subsoil (105).

4.3.5 At the interface of transects 3 and 4 of Trench3, wall (116) was observed to continue on a north-east to south-west alignment, beyond the confines of the trench. The course of this wall is known as it was still standing at the commencement of the site (Figures 12 and 13), but was knocked down before the ground works began.

Figure 14. Wall (116) as observed intact before the commencement of ground works. The left hand side of the wall has clearly been subject to later repair/rebuilding works, however the foundations did not demonstrate any later alterations. Facing north-west.

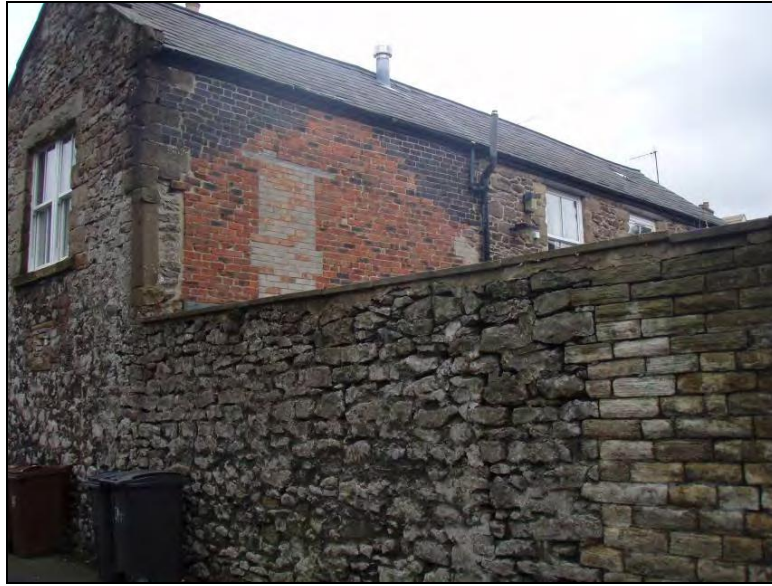
Figure 15. Wall (116), taken from Torr Street, before demolition. The wall clearly runs in a continuous line until it meets with the existing stable building. Facing north-east.

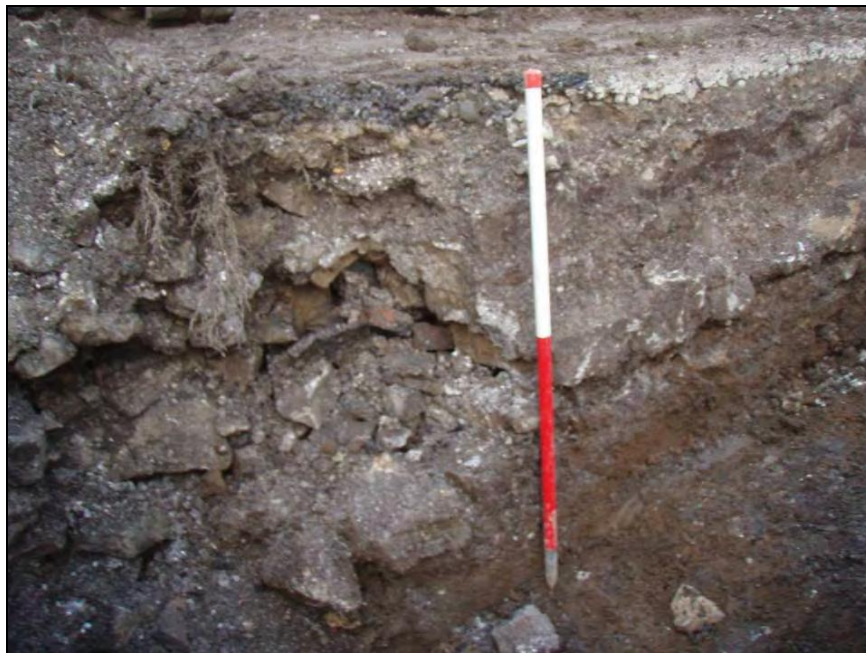
4.3.6 Wall (115) observed in Transect 4 was visible for the whole length of the transect and was observed to abut wall (116). These two walls were of identical construction, as with wall (111). The outer face of wall (115) was found to immediately abut a cobbled surface (113) at the south-western end of the trench, only observed in section, which presumably made up the outer courtyard of the stables and may be the same cobbled surface as observed in Trench 1 (109).

Figure 16. Intact wall (115) (right) abutting wall (116) (left), which continues beyond the confines of the trench, and runs up to the existing stable building as demonstrated in figure 13. Scale = 1m.

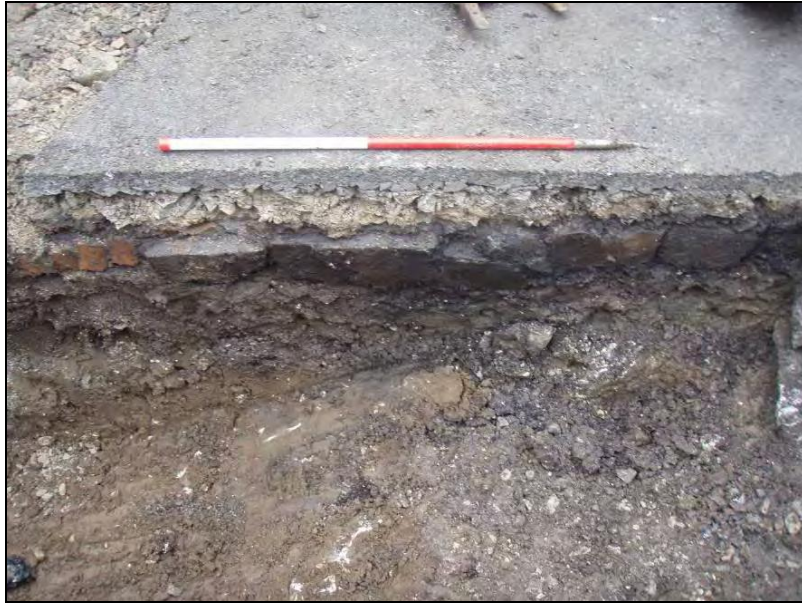
Figure 17. Cobbled surface (113) with wall (115) visible in the extreme right of the photograph. The red bricks (118) to the left of the picture represent a possible drain or service trench [119]. Facing north-west. Scale = 1m.

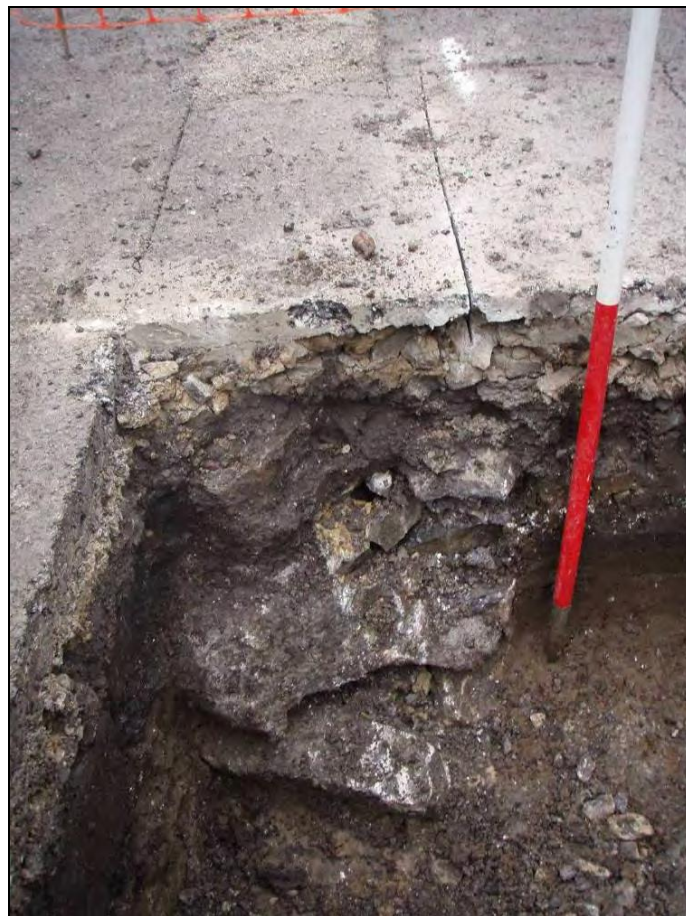
Figure 18. Wall (115) continuing beyond the confines of the Trench 3 at the south-eastern end. As no front wall was present in Transect 1 of Trench 3, and wall (115) continues beyond the trench, it seems likely that the front of the stable lies just outside the trench edge. Facing south-east. Red portion of scale = 0.5m.

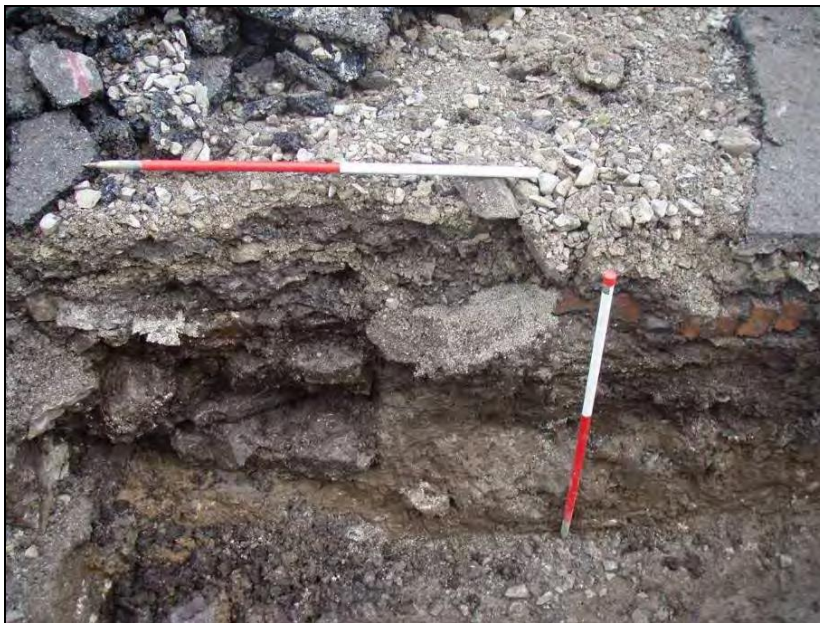
4.3.7 Cut through the cobbles (113) was an apparent drain [119], lined by red bricks (118) on either side. The service pipe is no longer extant and the cut has been filled with gravel/hardcore (117), presumably when the building was destroyed.

4.3.8 Abutting the outer face of wall (115) was wall (122), a north-east to south-west aligned wall. This was on the same alignment with wall (106) observed in Trench 2, and is likely to be indeed the same wall.

Figure 20. Brick lining (118) of drain [119]. Wall (122) is visible at the left of the photograph where it runs in a north-easterly direction, towards wall (106) in Trench 2. Facing north-east. Scale = 2x1m.

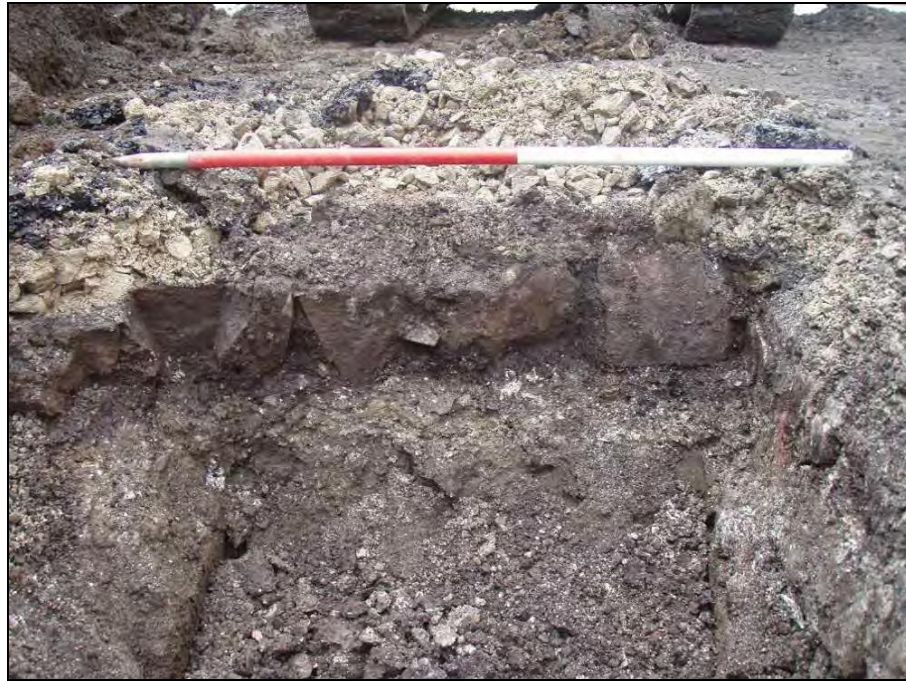
4.3.9 Abutting the inner face of wall (115), a cobbled surface (121) was observed which was apparent for the entire length of transect 4 beyond wall (122), up to the inner edge of wall (116) in Transect 3. The cobbles were constructed out of red gritstone, which suggest it may have been sourced out of the immediate local area at a locality further south than Buxton, such as Leek or Ashbourne where red gritstone is common, in comparison to the pale yellow gritstone found around Buxton from which the walls are constructed. The composition of the surface was irregular, with some stones placed end on, and some laid flat.

Figure 21. Internal cobbled surface (121) of the stable. Scale = 1m.

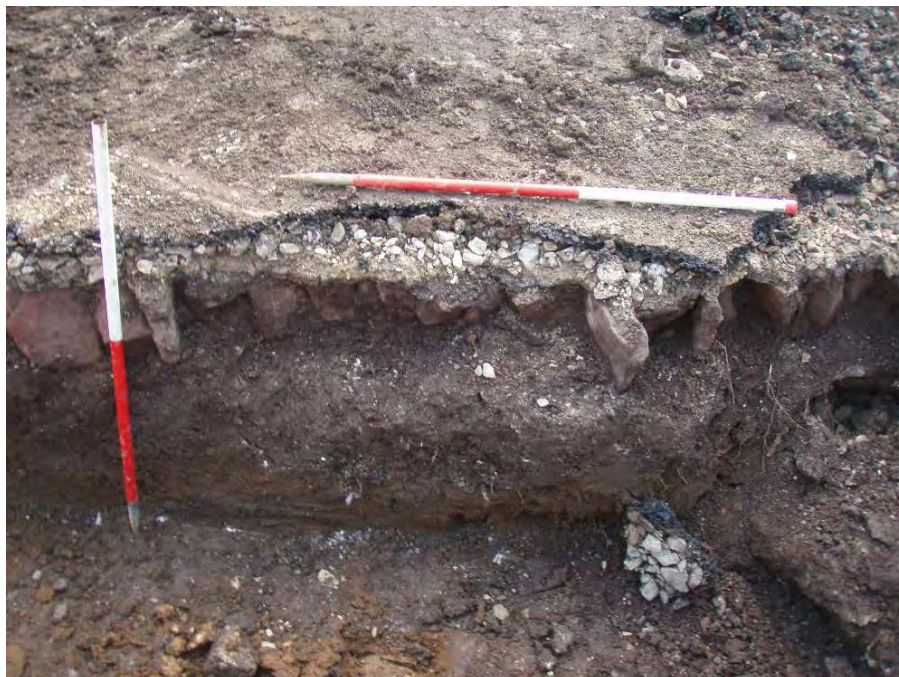
Figure 22. Cobbles (121) inside walls (115) and (116) (removed). Scale = 2x1m.

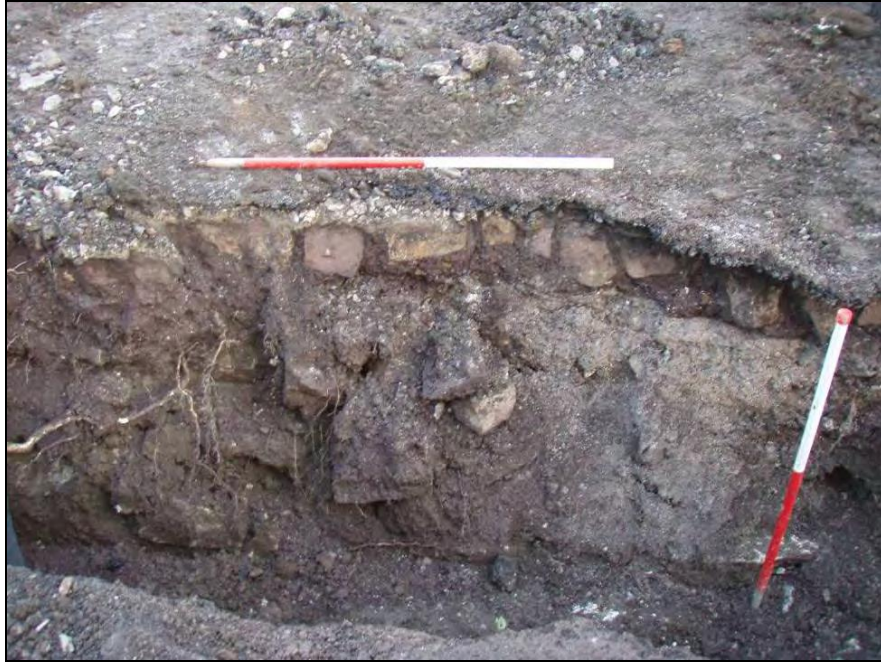
Figure 23. Internal cobbled surface (121) of the stable abutting the inner face of wall (115). Scale = 2x 1m

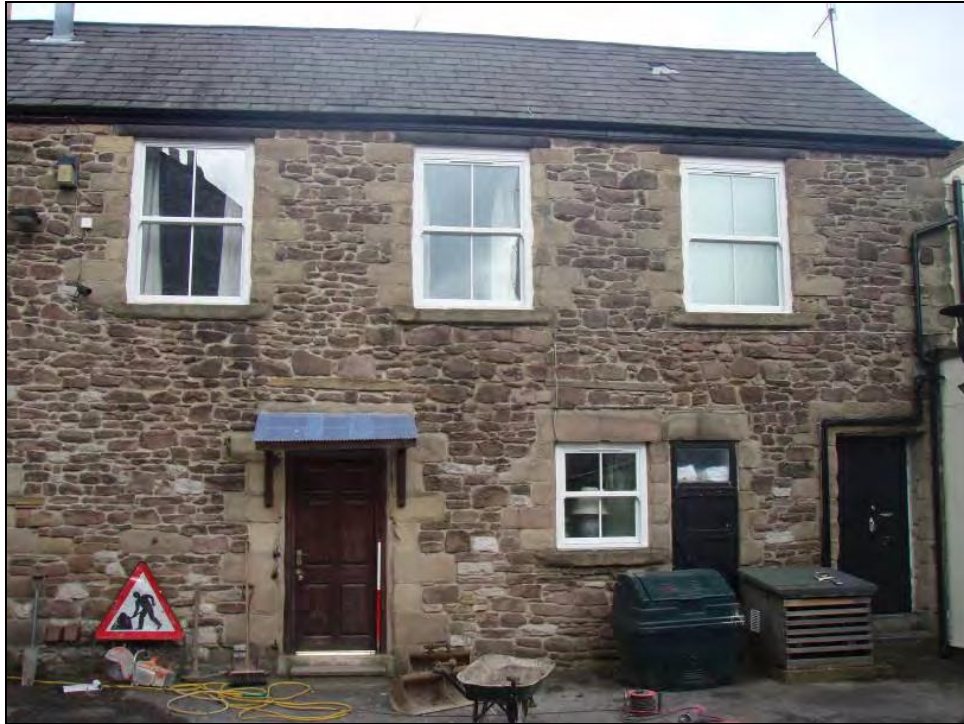
6.3 It is highly likely that the structural remains and associated artefacts relate to a known stable building that once stood on the site, which was partially demolished in the late nineteenth century. The perpendicular alignment of the stable block still exists on the site (Figure 25, below), and is of identical construction to the walls identified in Trenches 2 and 3 of the watching brief. In addition, two of the walls recorded during the watching brief are in precise alignment with one of the existing stable walls, indicating that they were once joined.

Figure 26. The existing stable in the Queen's Head car park. The walls identified during the watching brief are thought to belong to a perpendicular wing of this stable block that was demolished due to poor condition in the 1970s. Scale = 1m.
