An Archaeological Watching Brief at Brynmor, Hill Street, Corbridge

ARS Ltd Report No. 2014/76
May 2014

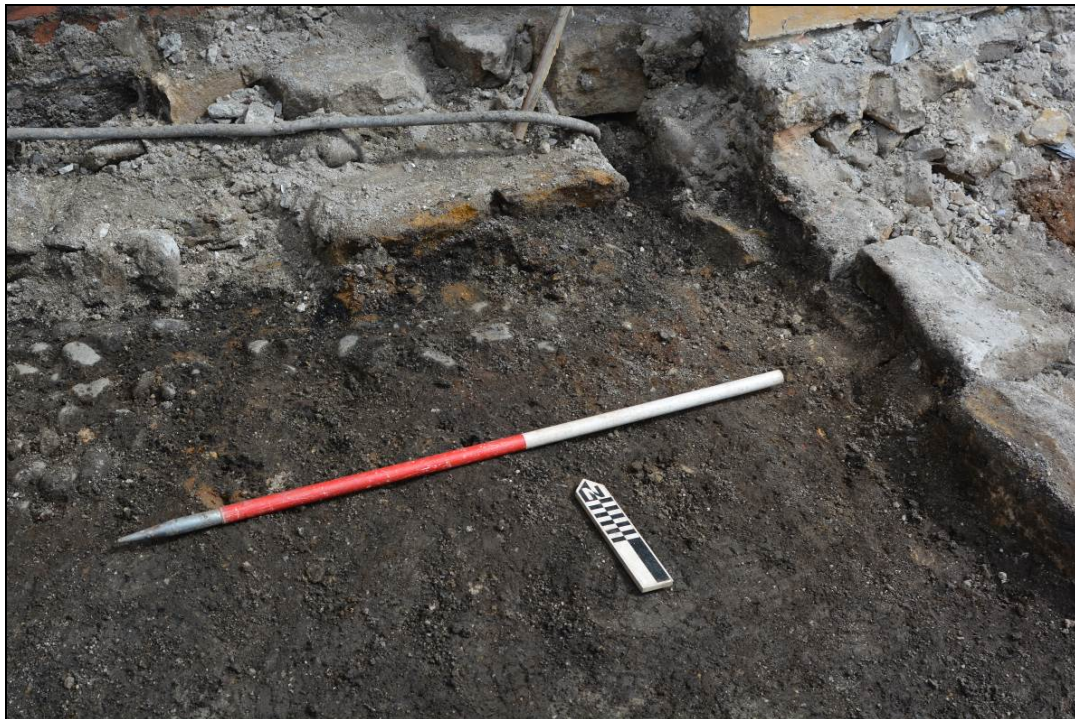
Figure 3. Remnants of a possible cobbled surface.

A narrow strip of what appeared to be a cobbled surface was found at the very northern extent of the excavation area. No other archaeological finds or features were found.

6.1. A narrow strip of possible cobbled surface was found at the northern extent of the excavation area sitting amongst deposit (005), which produced Victorian pottery. This means that the cobbles are either contemporary with or post-date the Victorian period. No other finds or features of archaeological significance were encountered during the watching brief.

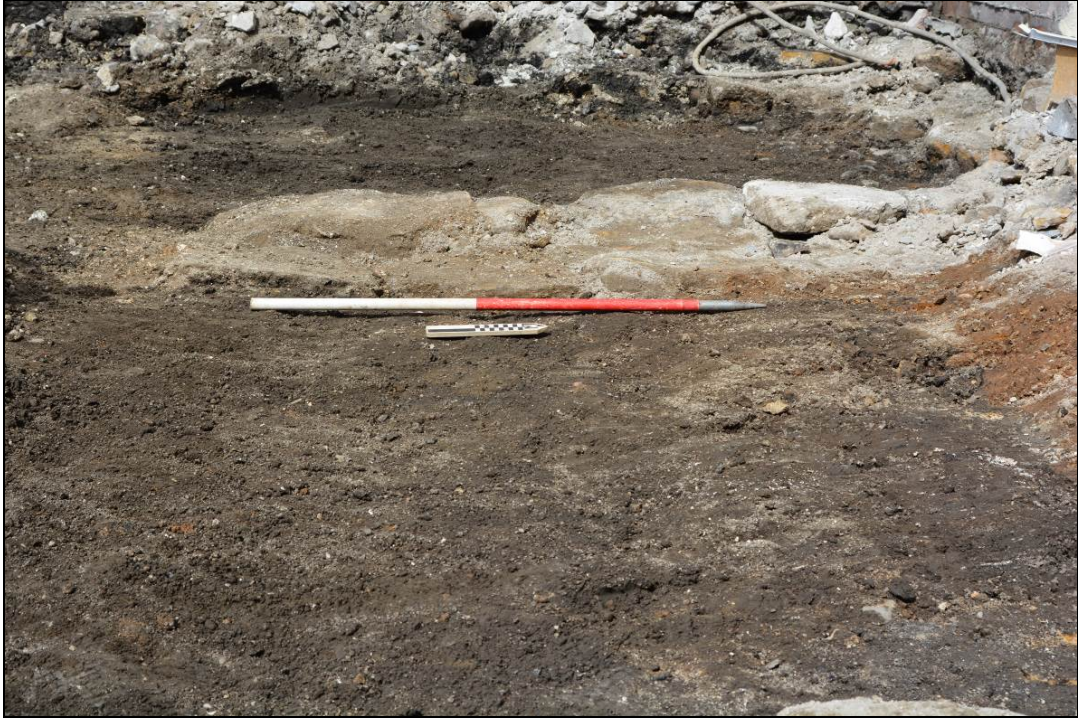
Figure 4. Wall (003), looking west. Scale = 1m.

5.1 The excavation area was covered by a concrete slab which had already been removed by the time that an archaeologist arrived on to the site. The excavation area had been partially excavated to reveal the foundation courses of three of the walls from the previous building (003), (004) and (010). Beneath the concrete and its bedding layers, and between the walls, was a layer of very dark brown clayey silt, (005), containing sherds of Victorian pottery. A small area of possible cobbled surface, (008), was encountered at the northern extent of the excavation area, running underneath the foundations of the previous building (Figures 3 and 7). The cobbles covered an area of approximately 0.4m² and were sat amongst deposit (005), which produced Victorian pottery.

5.2 The wall foundations were removed before excavation of the new foundation trenches commenced. Each of the four trenches were dug through (005) into the natural orange/brown clay (011) beneath. The natural clay began at an average depth of 0.56m below current ground level. Deposit (005) had a maximum depth of 0.6m. The natural clay continued beyond the limits of the excavation. The current ground level of the site was at 42.3m aOD.

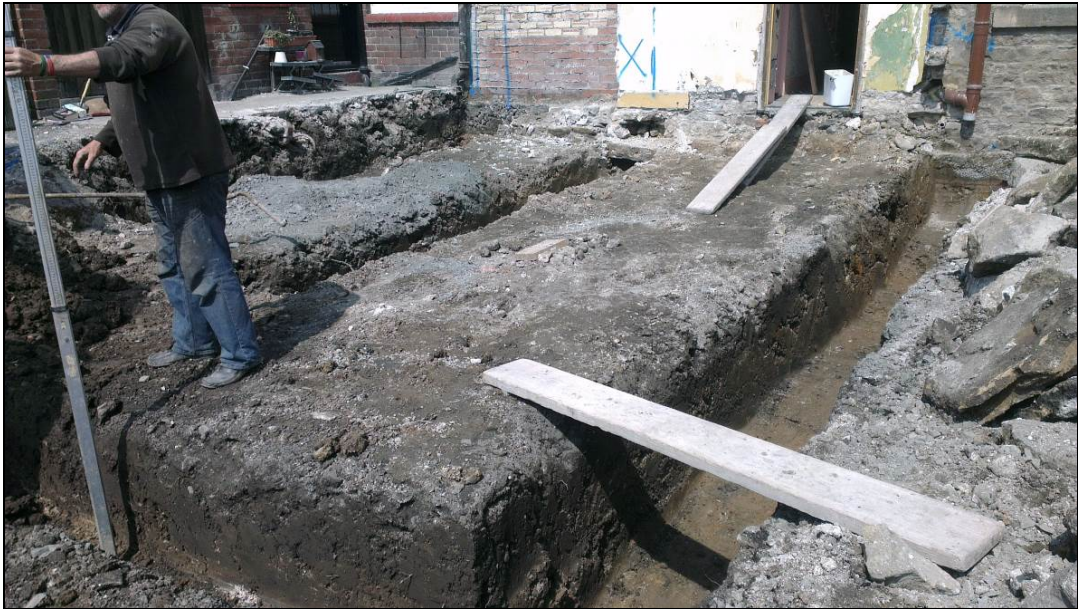
Figure 5. The excavation area and excavated foundation trenches, looking north.

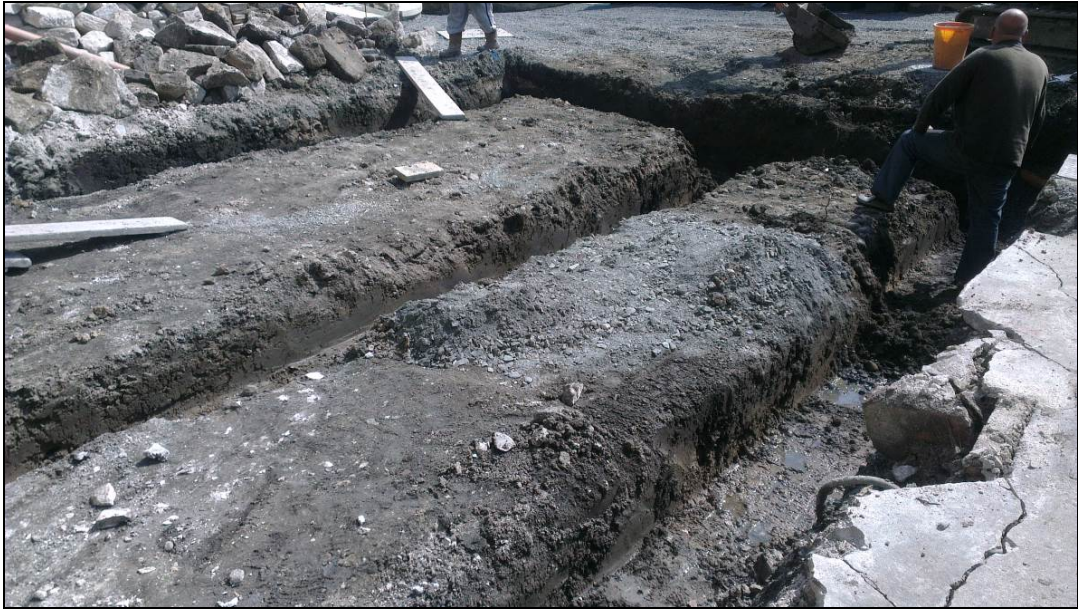
Figure 6. The excavation area and excavated foundation trenches, looking south.
