An Archaeological Watching Brief at Cresswell Tower House, Northumberland

ARS Ltd Report No. 2014/100
July 2014

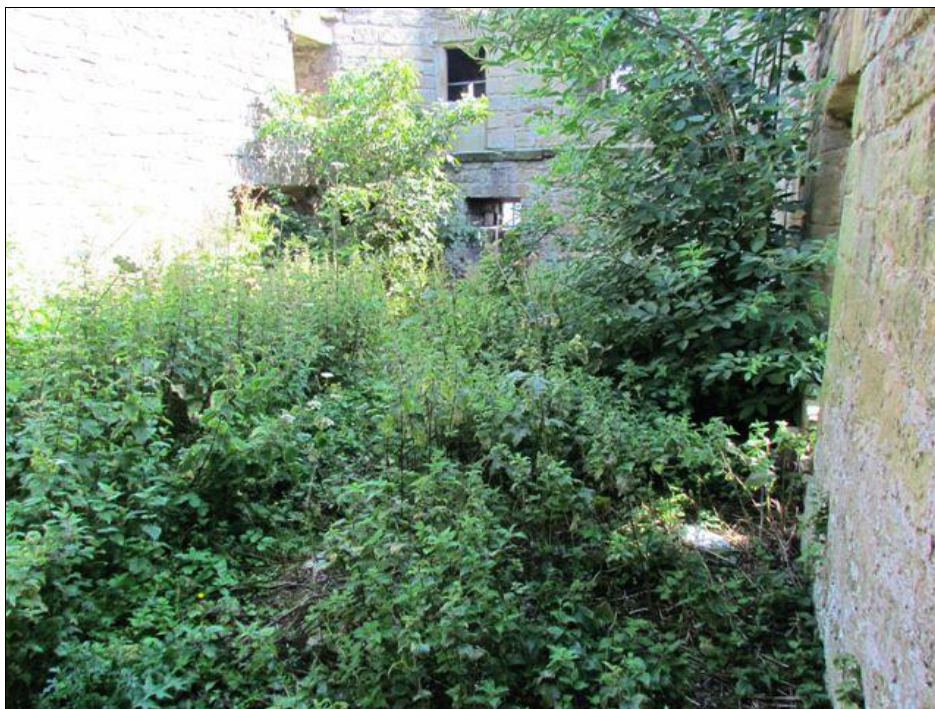
Figure 3: The appearance of the first-floor level of the tower prior to clearance works, looking west (Photograph Barry Mead).

6.1 The first floor chamber was covered with dense vegetation (Figure 3) which was cut down and removed by hand. A dark brown silty clay deposit (001), containing frequent slate roof tiles and ceramic chimney pot fragments, was removed by hand (Figures 4). This deposit (001) varied in depth from c.0.04m at the eastern entrance into the chamber, to c.0.28m at the west end of the chamber. Artefactual remains within this deposit (001) were largely limited to modern objects such as plastic bottle-tops, a spanner and glass bottles. Towards the south-west corner of the chamber, the greater depth of deposit (001) contained a collection of animal bones from horse, cow and sheep/goat (Figure 5), which were removed up to the limit of excavation. A fragment of post-medieval-modern pottery was recovered amongst the bones, indicating that they were deposited after the floor was removed in this area.

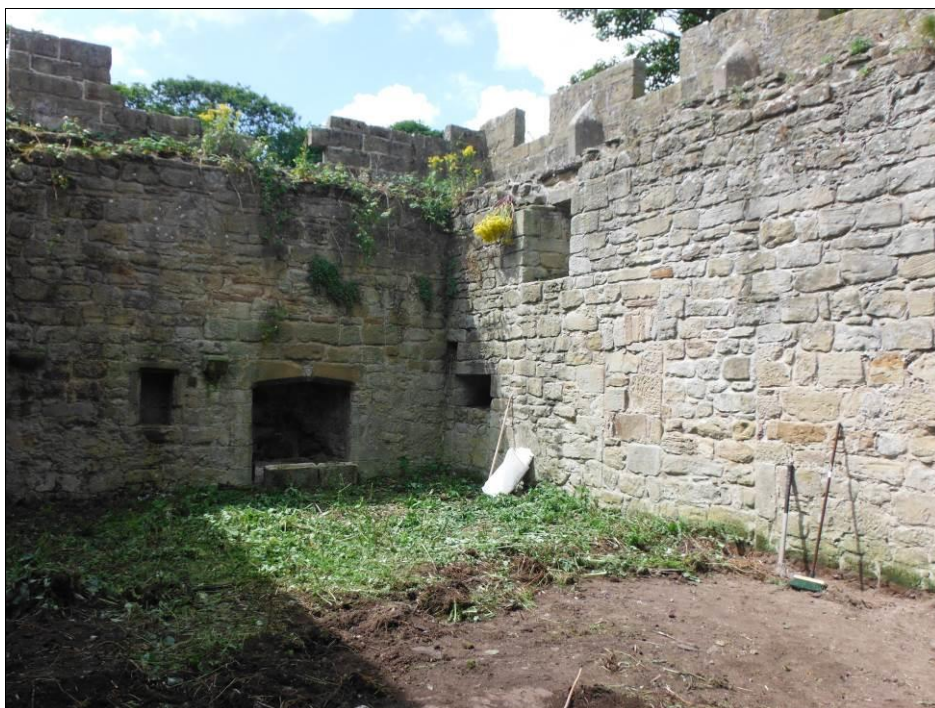
Figure 4: The first-floor during clearance of deposit (001), looking north-west.

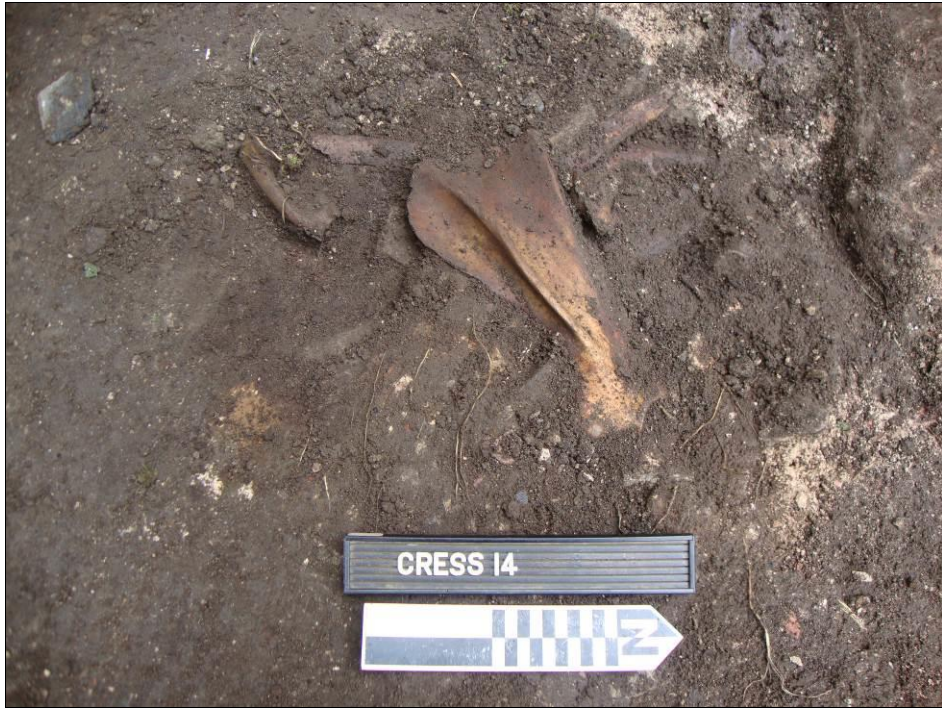
Figure 5: Pre-excavation photograph of a collection of faunal remains within deposit (001) (scale = 0.25m).

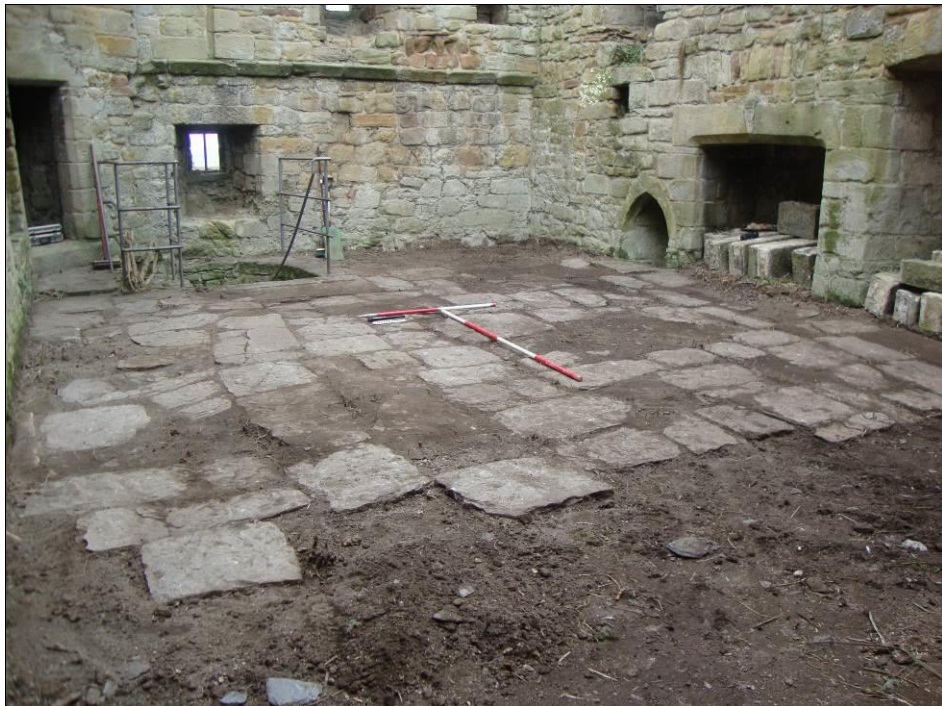
Figure 6: The first-floor level following clearance, showing the flag-stone surface (002), looking south-east (scale = 2m + 1m).

6.2 Deposit (001) overlay a flag-stone surface (002) over much of the area of the first-floor level. The surface (002) consisted of square and rectangular flag stones of sizes varying from 0.25m x 0.25m to 0.7m x 0.8m (Figure 6 and 7). The flag-stone floor (002) only

survived in part, with significant robbed-out areas noted in the south-east corner of the chamber and across the western end of the chamber. In the areas of stone robbing a nominal limit of excavation was set at the level of the flag-stones meaning that a shallow depth of deposit (001) was retained *in-situ* in these areas. Against the west wall of the tower a small area of (001) was removed in order to characterise the deposits beneath. This revealed an area of compacted sandstone blocks and chips set within a sandy matrix (003) which is likely to be the material packed in around the top of the vault to level the area and form a bedding layer for the floor. This area was immediately re-covered with a thin layer of deposit (001) for protection. The flag-stone surface (002) formed the limit of excavation elsewhere and was retained *in-situ*.

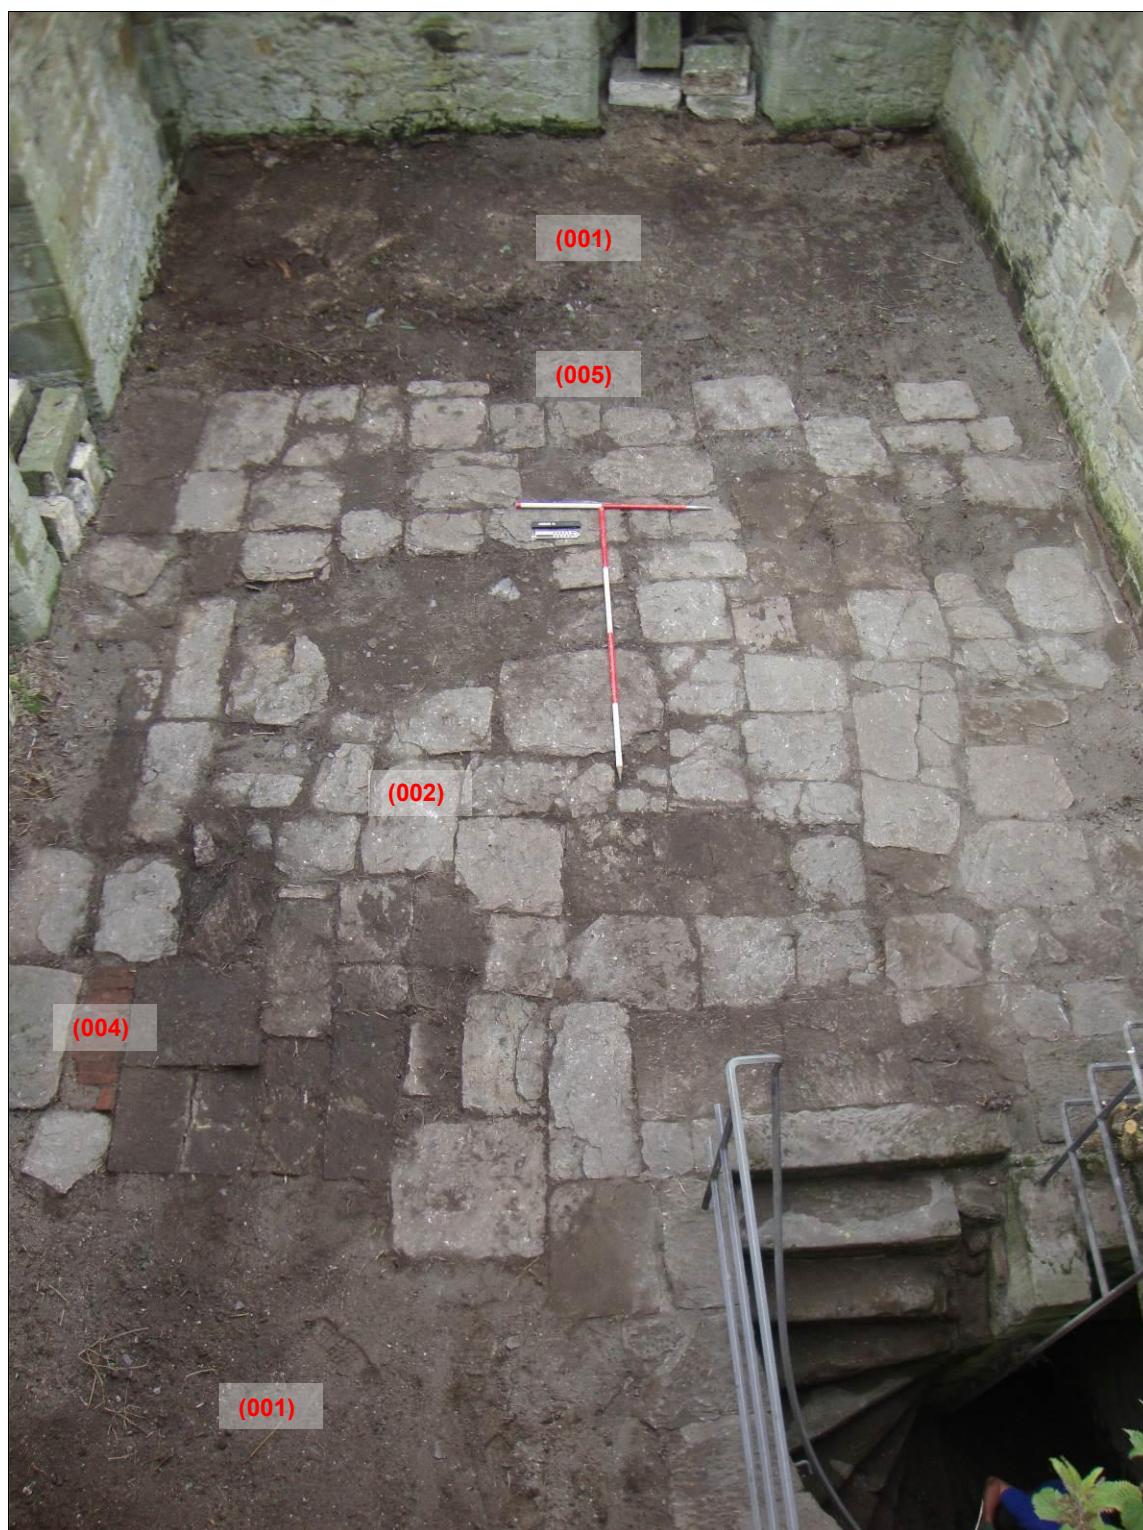
Figure 7: The first-floor level following clearance (scale = 2m + 1m).

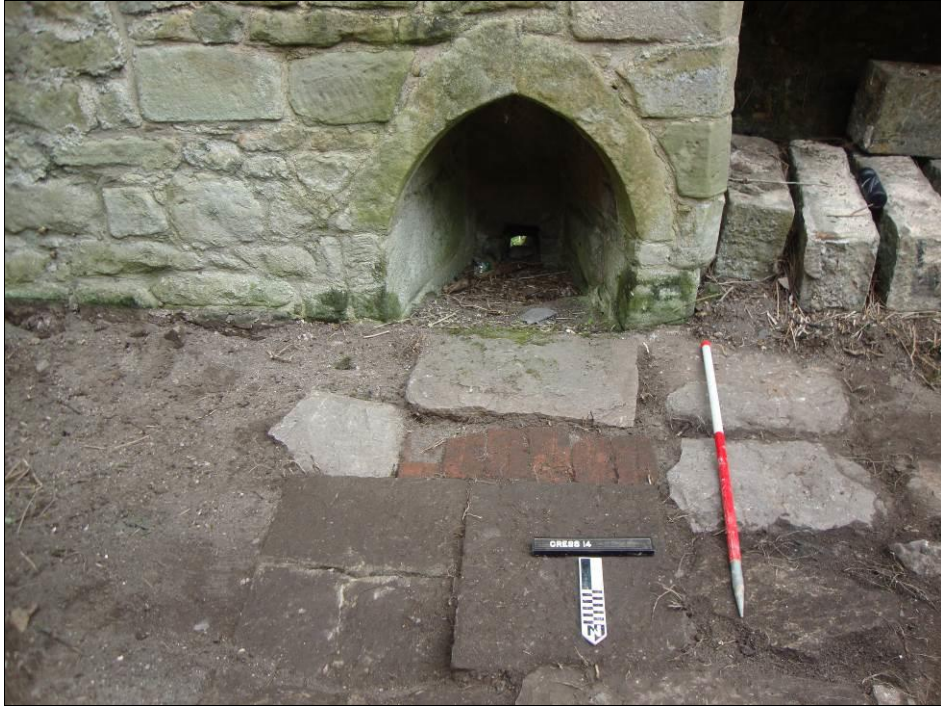
Figure 8: The brick and stone repair (004) adjacent to the slop hole in the south wall (scale = 1m).

6.3 The surviving area of flag-stone surfacing (002) contains a brick and stone repair (004) adjacent to the slop hole in the south wall. This consists of six hand-made bricks laid flat and two new or re-laid stone slabs (Figure 8). The flag-stone floor (002) and the walls of the tower also contain evidence that corroborates Ryder's argument for a partition of this level into two rooms. Ryder suggested that the westernmost 3.5m of the first floor were partitioned off using a timber screen to form a separate chamber (Ryder 2003, 77). This area corresponds almost exactly with the extent of the robbed-out area at the western end of the first-floor level (Figures 9 and 10), suggesting that the floor surfacing of the entire western chamber was removed, whilst the floor of the eastern chamber was retained. Further to this, it appears that the floor level of the western chamber was higher than the floor level of the eastern chamber (represented by the flag-stone surface 002). This is evidenced by the height of the entrance into the latrine chamber at the west end of the south wall and by the rough rubble base to the walls on the north, west and south sides of the tower (Figure 11), which must have been hidden beneath the floor level originally. There is no such rough stonework visible at this level in the eastern chamber, where the walls' facing stones continue down to the flag-stone floor (002). The final piece of evidence relating to the partition is found at the centre of the westernmost extent of the surviving flag-stone floor (002), where there is a set-back section (005) of the flag-stone floor (Figure 12), potentially marking the location of the doorway into the western chamber. This set-back section (005) would be exactly central in the partition and the recess formed by the set-back section most likely marks the location of a robbed-out stone step, which would have given access up into the higher floor level of the western chamber. No evidence survives of the form of the floor of the westernmost chamber, however, the fact that it was removed in preference to the flag-stone floor (002) of the eastern chamber suggests that it may have been of higher quality, or of more useful materials, than the flag-stone in the eastern room, possibly ceramic tiles or timber.

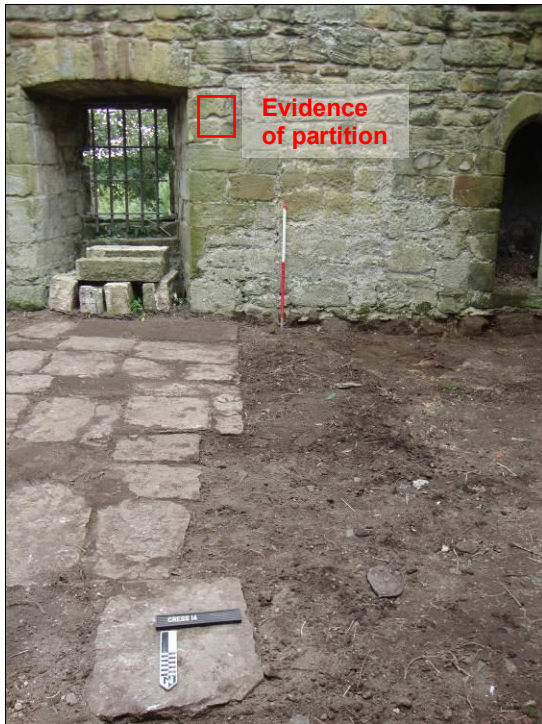
Figure 9: Extent of the surviving stone floor (002) in relation to the evidence in the south wall of a timber partition (scale = 1m).

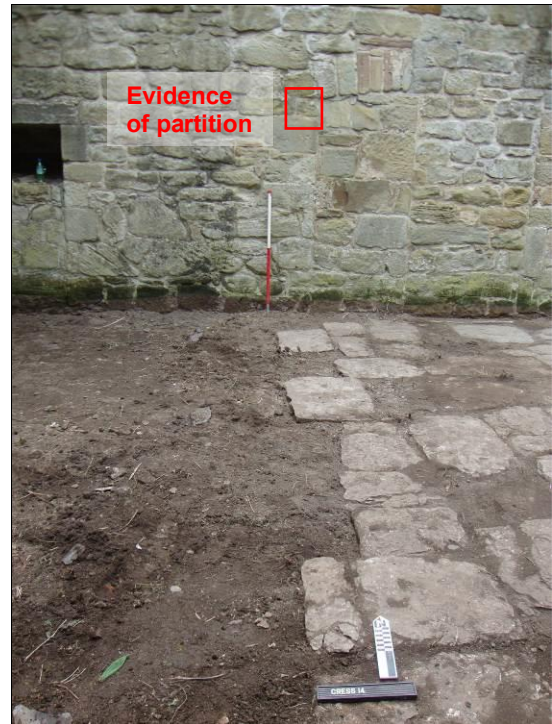
Figure 10: Extent of the surviving stone floor (002) in relation to the evidence in the north wall of a timber partition (scale = 1m).

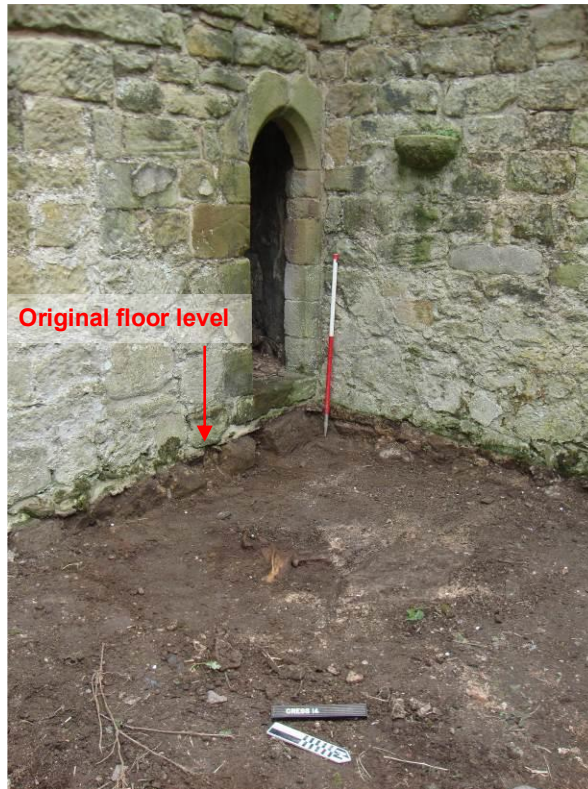
Figure 11: Rough rubble base to the west and south walls of the western chamber, marking the height of the previous floor level which must have been above the rubble section. Note also the height of the entrance to the latrine chamber. This floor level would have been higher than the level of the flag-stone floor in the eastern chamber (scale = 1m).

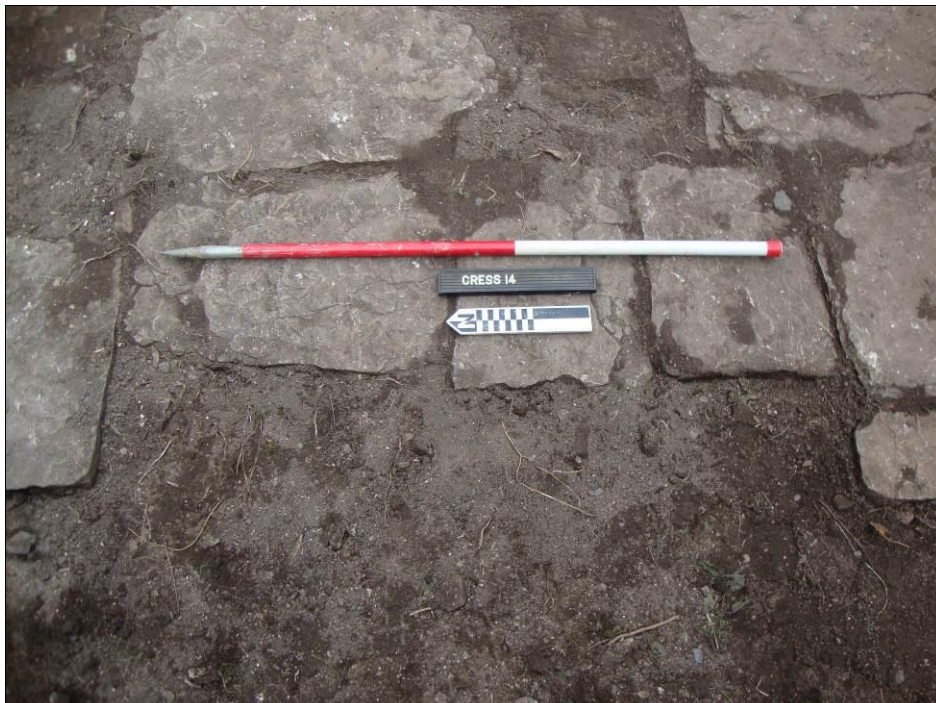
Figure 12: Set-back section (005) in the centre of the westernmost extent of the flag-stone floor (002) marking the location of a possible entrance into the western chamber which most likely original had a stone step at this point (scale = 1m).

6.4 The flag-stone surface (002) was not excavated so it has not been possible to ascertain its date. However the presence of the set-back section of flooring (005) marking the possible entrance into the westernmost chamber, indicates that the flooring (002) was in place whilst the timber partition was still in operation. It appears likely, therefore, that the flag-stone surface (002) is an original 15th century floor, however further excavation would be required to confirm this.
