Sheffield General Cemetery – Catacombs – Sheffield, South Yorkshire

Archaeological monitoring and recording

ARS Ltd Report 2015/56

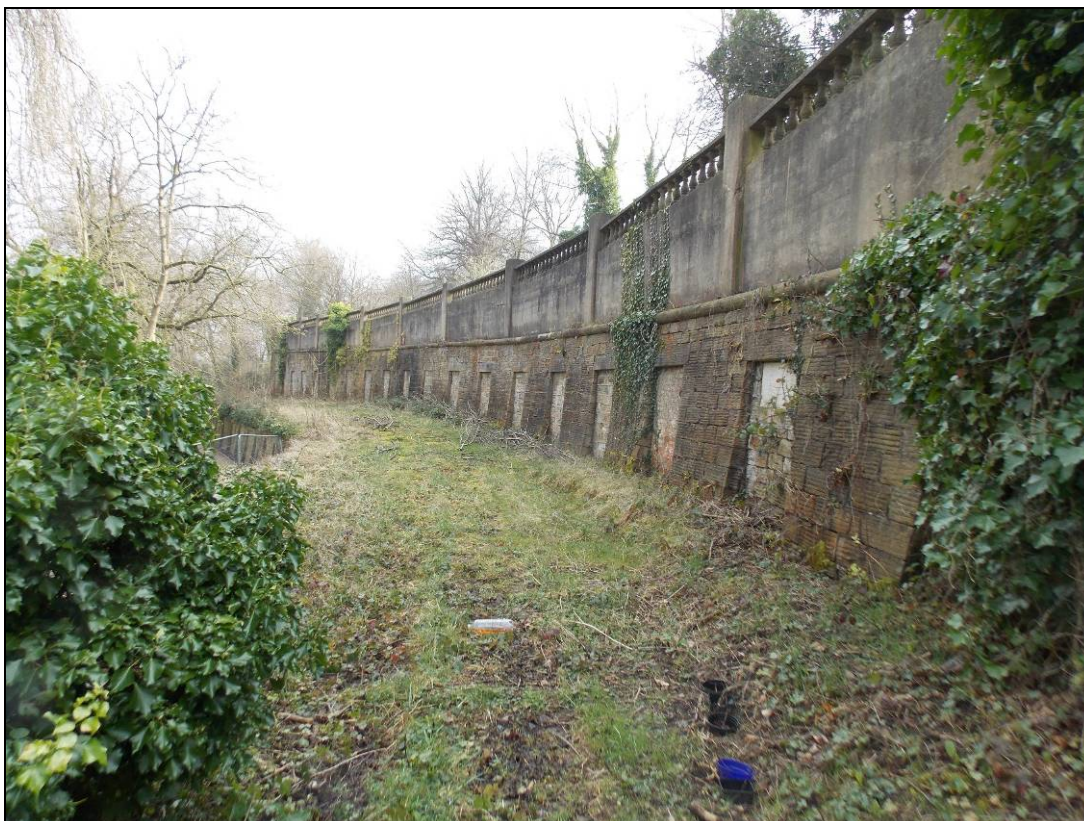
Figure 5: General view of the Catacombs, looking east.

5.2 The Catacombs are in two terraced levels (lower and upper) built with coursed sandstone squared blocks. The walls are slightly battered with doorways to each Catacomb and topped with a concrete balustraded parapet (Figs 5 and 6). Historical records indicate that the Catacombs were used for burial, although some plots may now be empty enabling appropriate inspection.

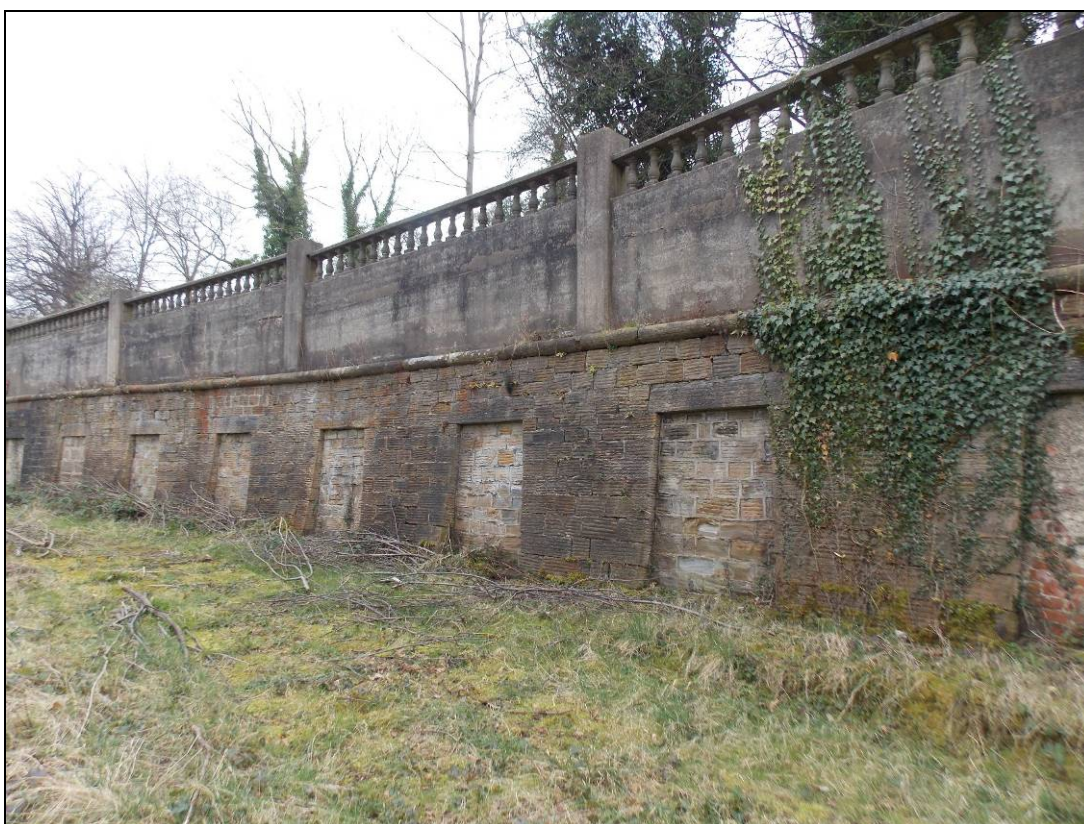
Figure 6: Westernmost end of the upper level of the Catacombs.

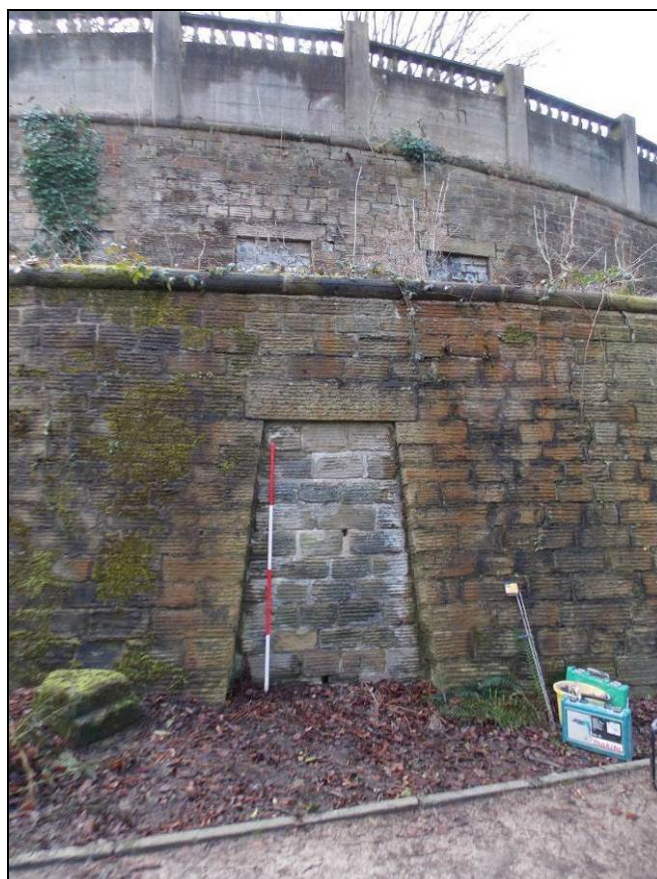
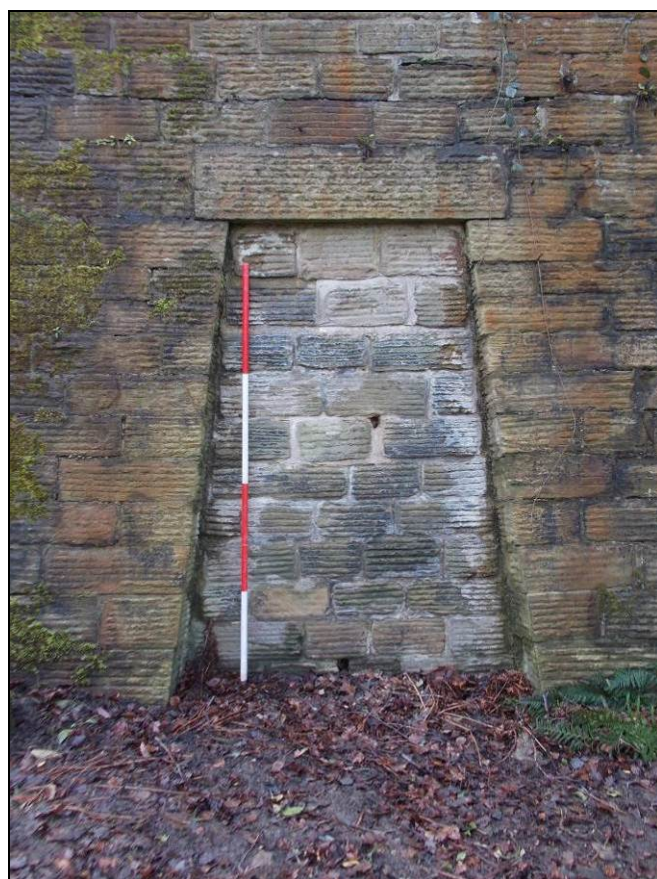
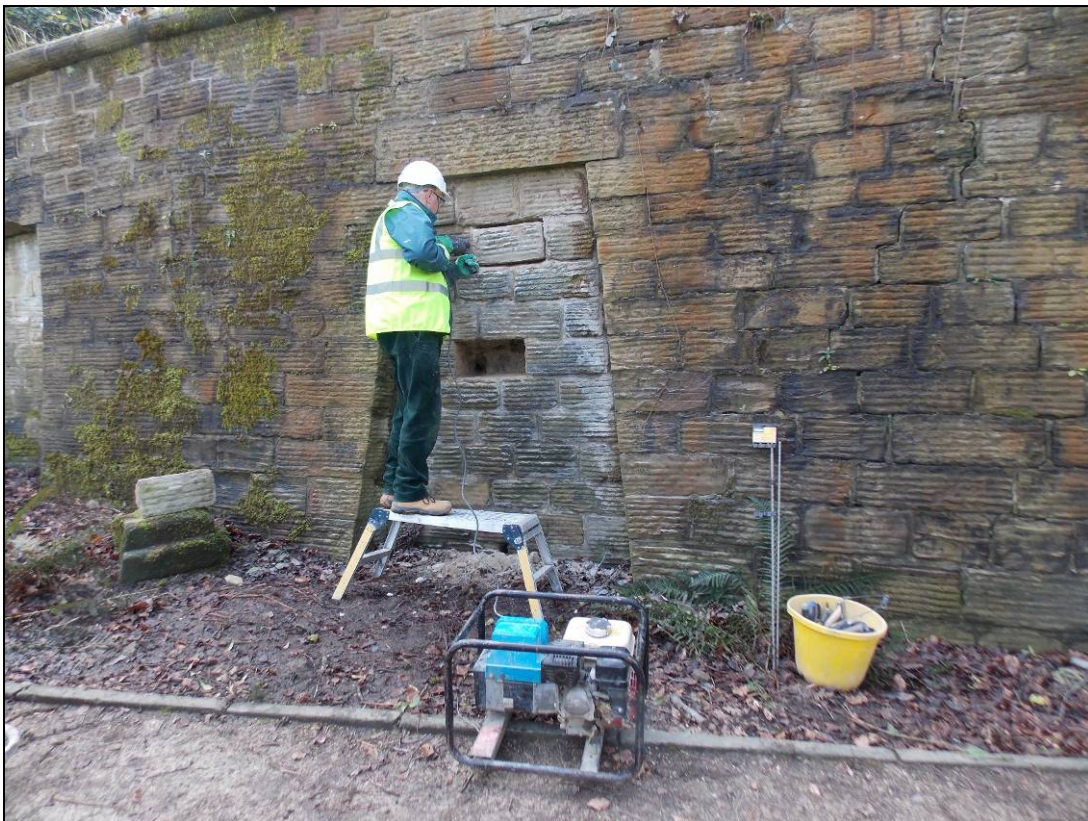
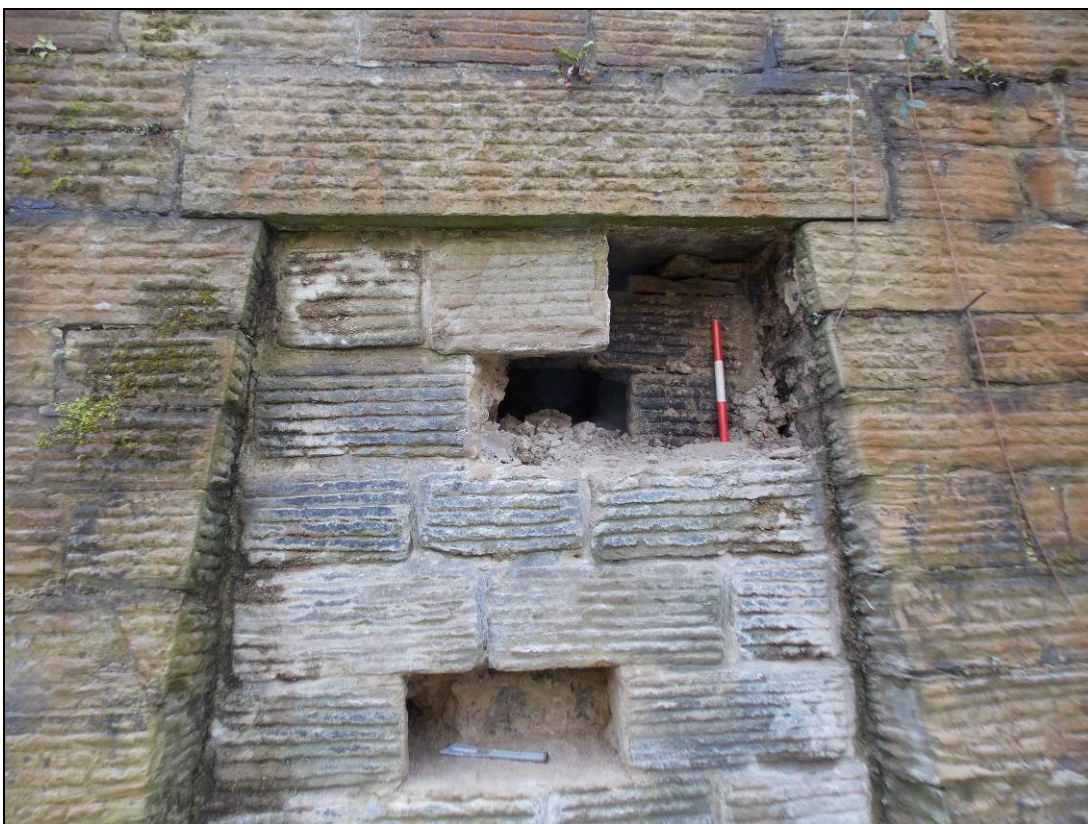
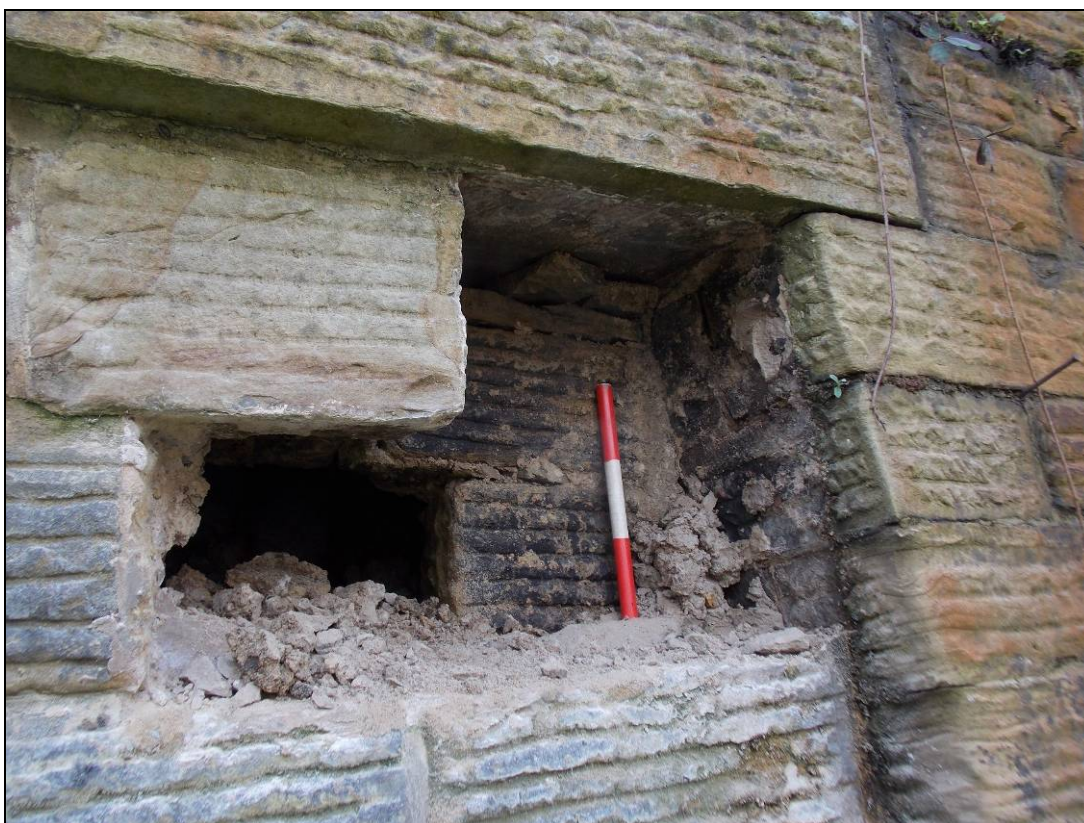
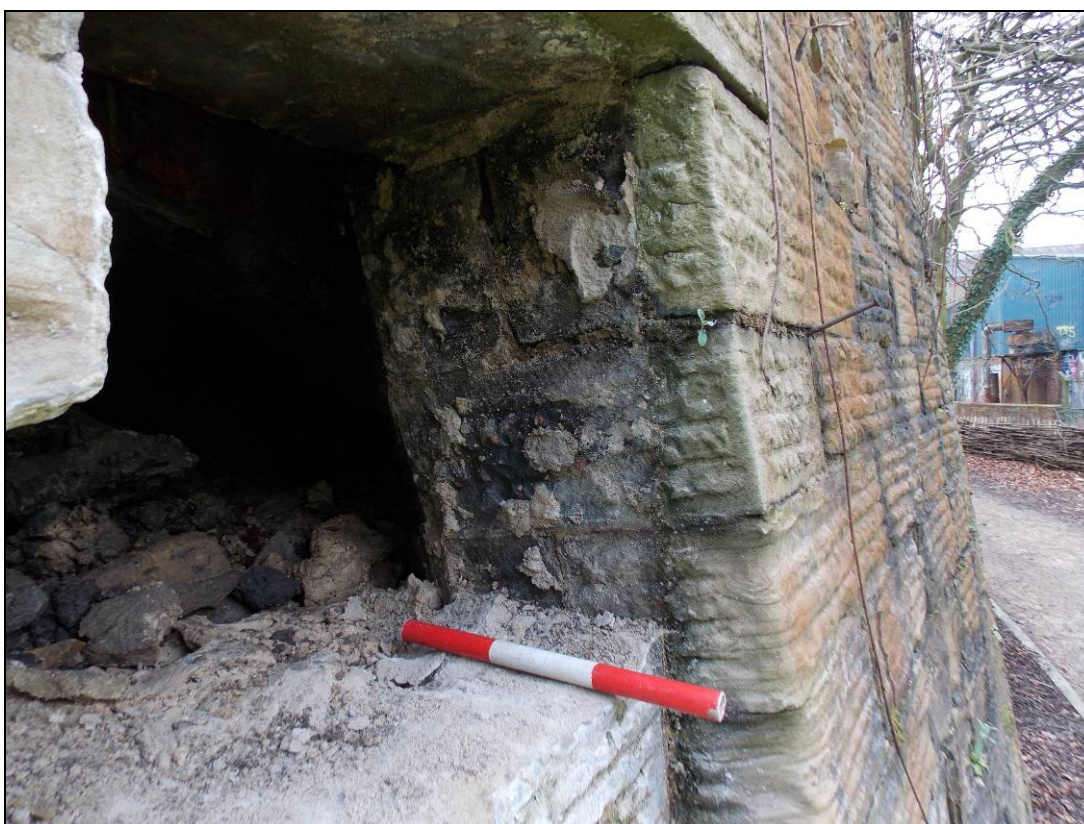
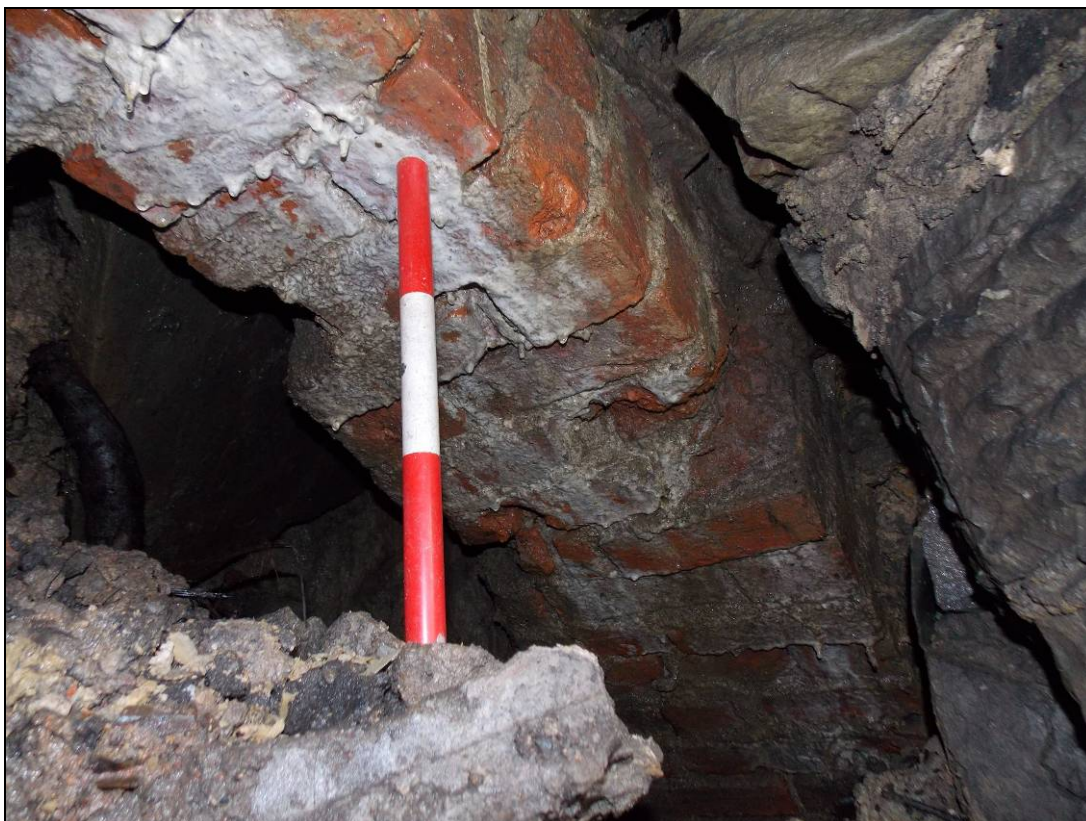
5.3 Catacomb DD, within the lower level, was the first one investigated following the removal of some of the uppermost stones blocking the doorway which was recessed 60mm from the outer side of the wall. It was revealed that the doorway had been blocked up with two separate veneer of coursed sandstone masonry decorated with furrowed tooling marks similar to the main Catacombs' wall. The thickness of the original front wall of the Catacomb measures 500mm and the doorway jambs are internally splayed (150mm wide). The interior was mostly obscured by a substantial amount of rubble which appears to have been inserted into the chamber through several large holes that perforate the ceiling. It was established, nevertheless, that the roof consisted of a brick barrel vault (225mm thick) built with hand-made orangey standard bricks bonded with lime mortar. The brick vault is not tied to the main front wall of the Catacomb as there is a gap of 100mm between them (Figs 7 – 13).

Figure 7: Catacomb DD within the lower level.

Figure 8: Detail of blocked-up doorway of Catacomb DD.

Figure 9: Inspection opening of Catacomb DD.

Figure 10: Opening into Catacomb DD.

Figure 11: Detail of blocking veneers.

Figure 12: Detail of wall thickness of the lower Catacombs.

Figure 13: Brick barrel vaulted chamber.

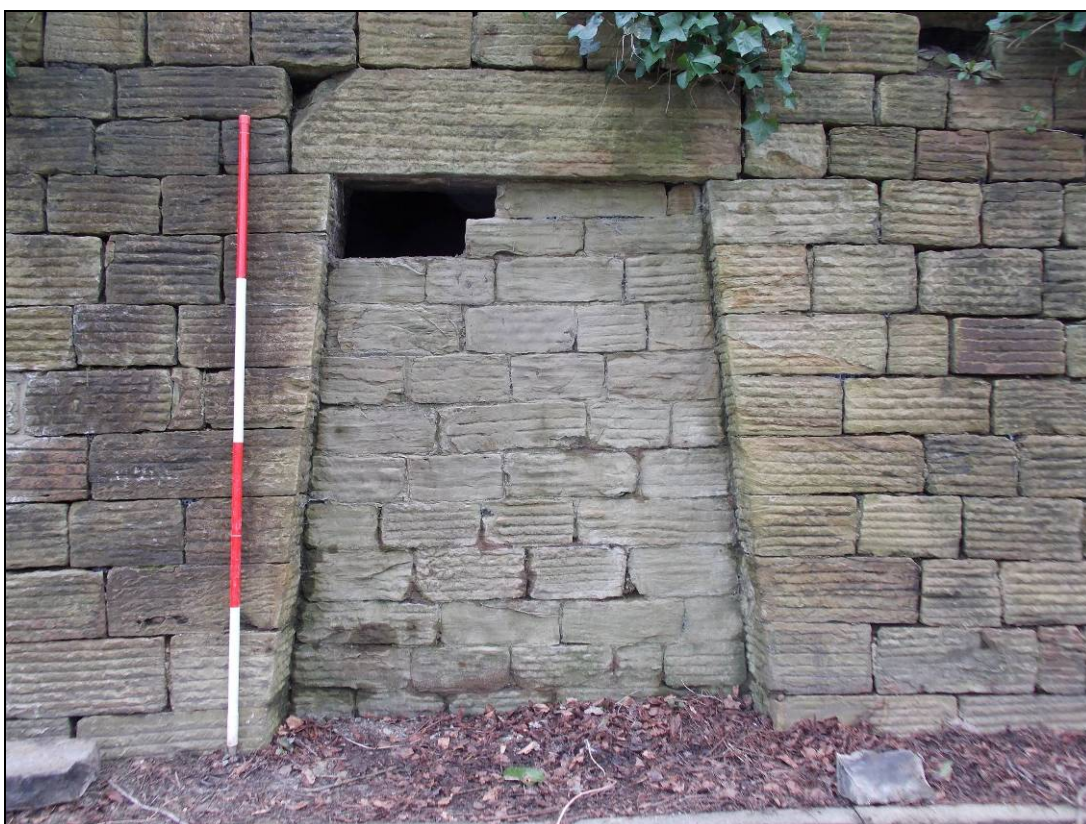
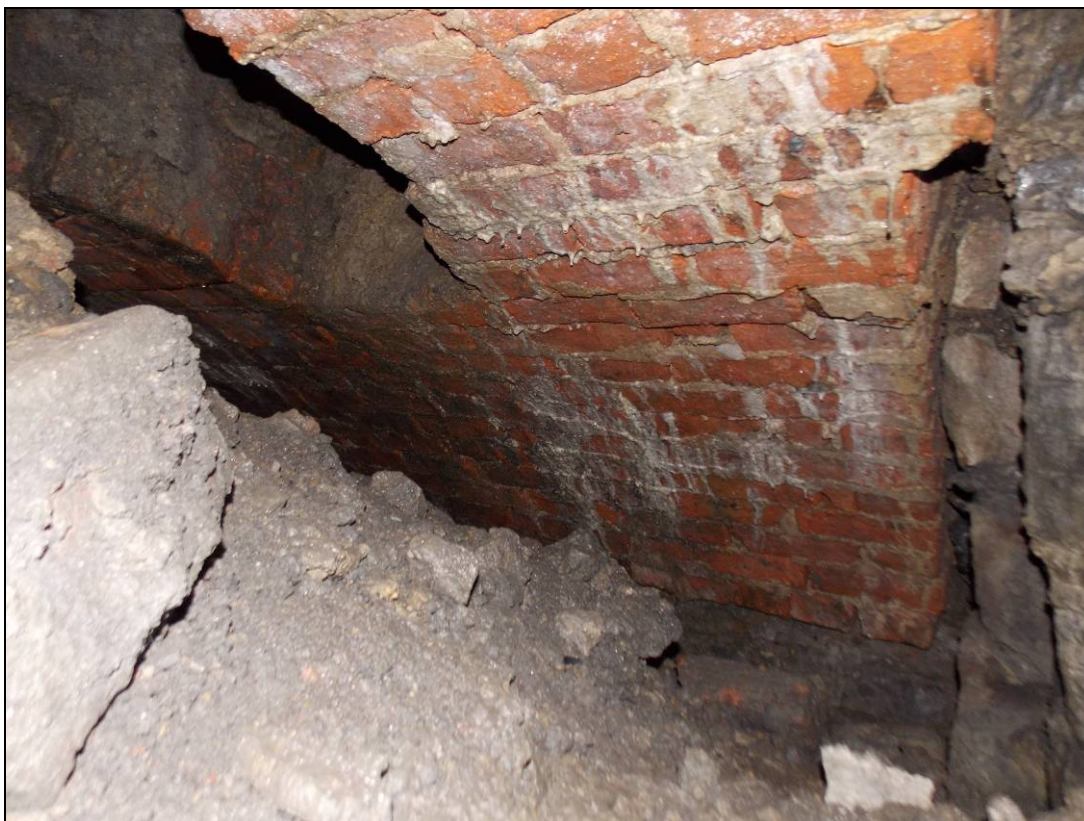
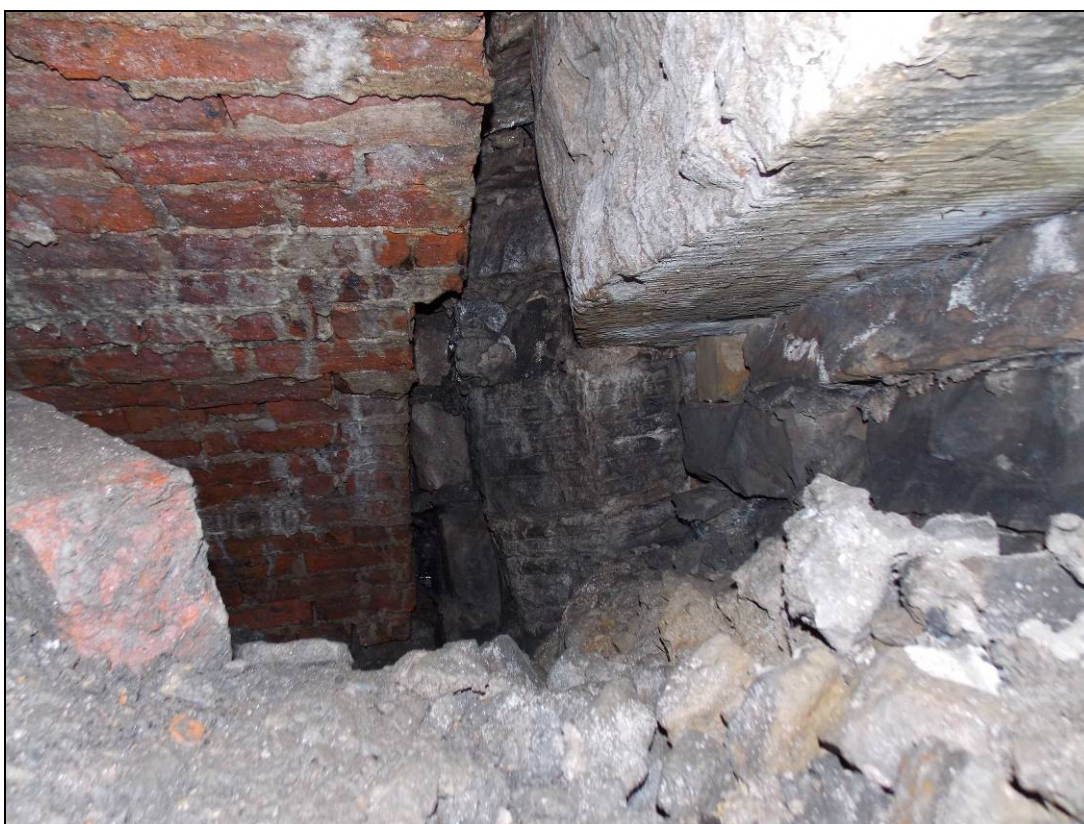
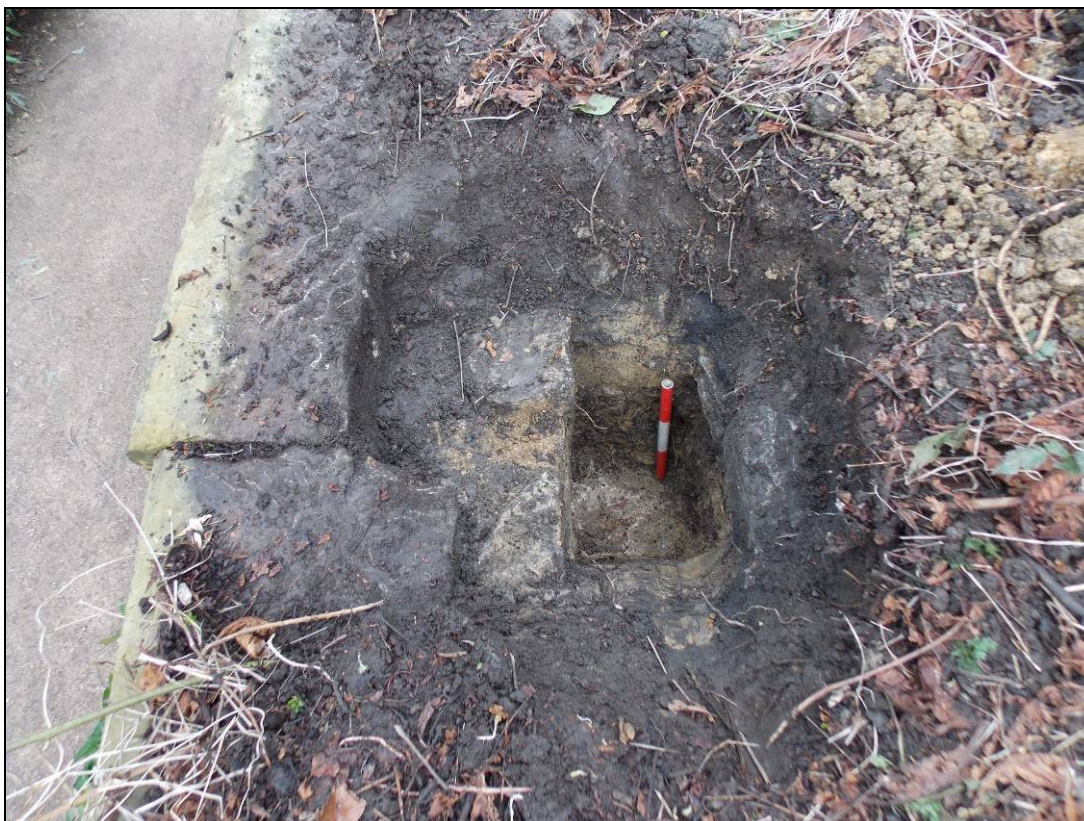
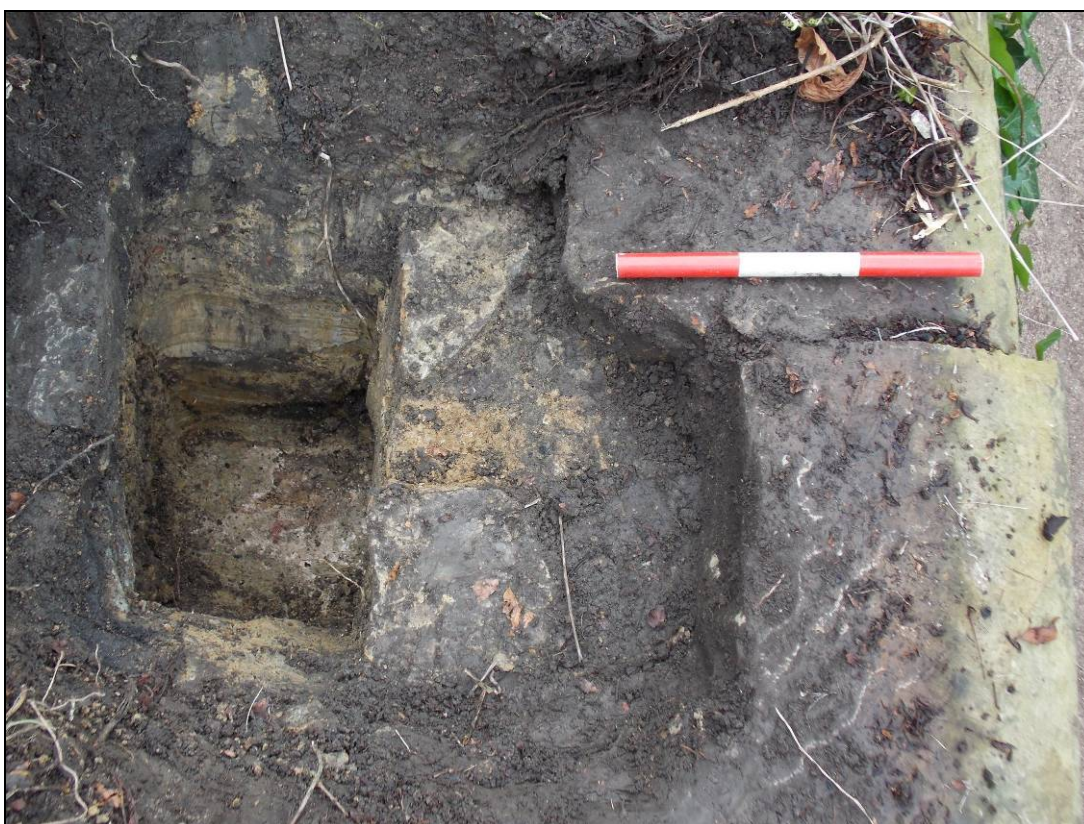
5.4 Catacomb OO, within the lower level, was also the subject of a similar investigation removing a few stones from the upper left corner of the blocked-up doorway which was recessed 80mm. The blocking here consisted only of a single leaf. The internal character of this Catacomb was comparable to its counterpart although it was better observed as the rubble deposit did not filled in the entire the chamber. Indeed, the springing course of the barrel vault was discerned over a stone cross wall. The brick vault is also detached from the front wall of the Catacomb although a secondary infill between them was also discerned which may represent the result of an improvised reinforcement. A small trial pit was subsequently excavated over the roof of the Catacomb through a thin topsoil layer which in turn overlay the natural sub-stratum composed of light yellowing clay. The *intrados* of the barrel vault was established at 650mm below the topsoil of the terraced platform above. This excavation also showed that the rolled moulding coping stones of the lower Catacombs have no fittings and/or scars of any railings or similar type of fence protection (Figs 14 – 18).

Figure 14: Doorway of Catacomb OO.

Figure 15: Brick barrel vault springing from a stone cross wall.

Figure 16: Detail of secondary infill between the brick vault and the external stone masonry of Catacomb.

Figure 17: Excavation over the brick vault.

Figure 18: Detail of excavated area showing brick vault *extrado*.

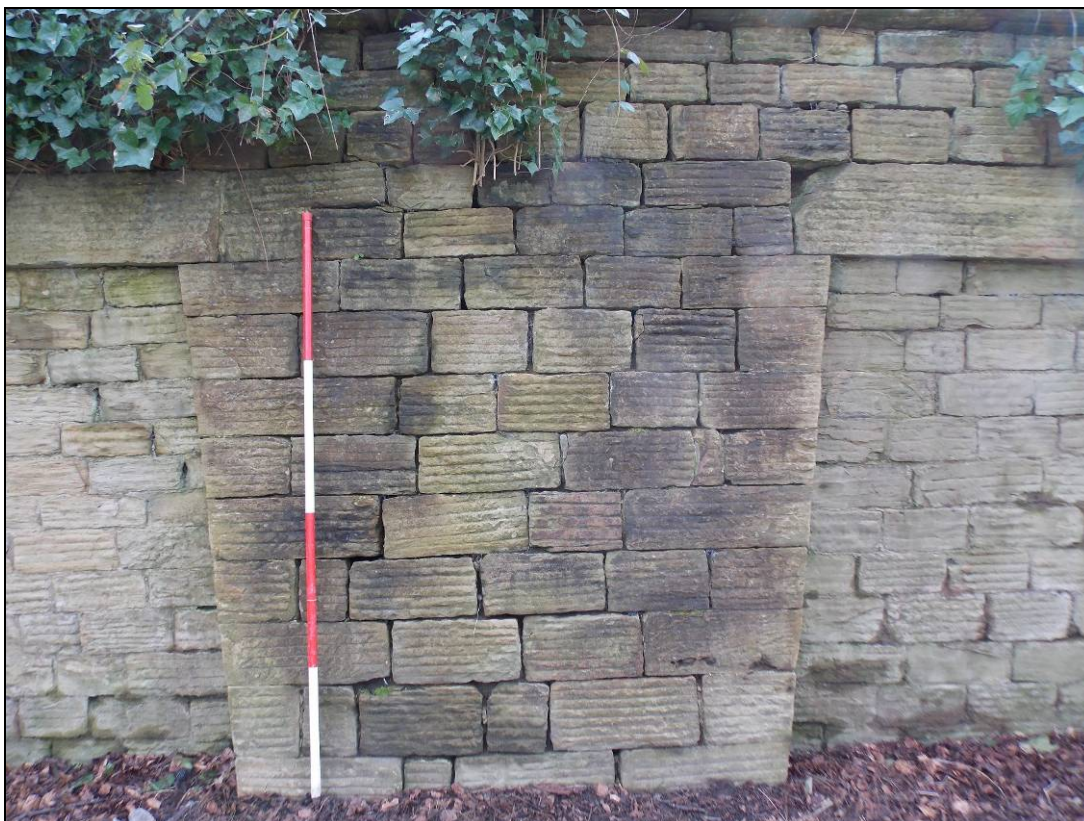
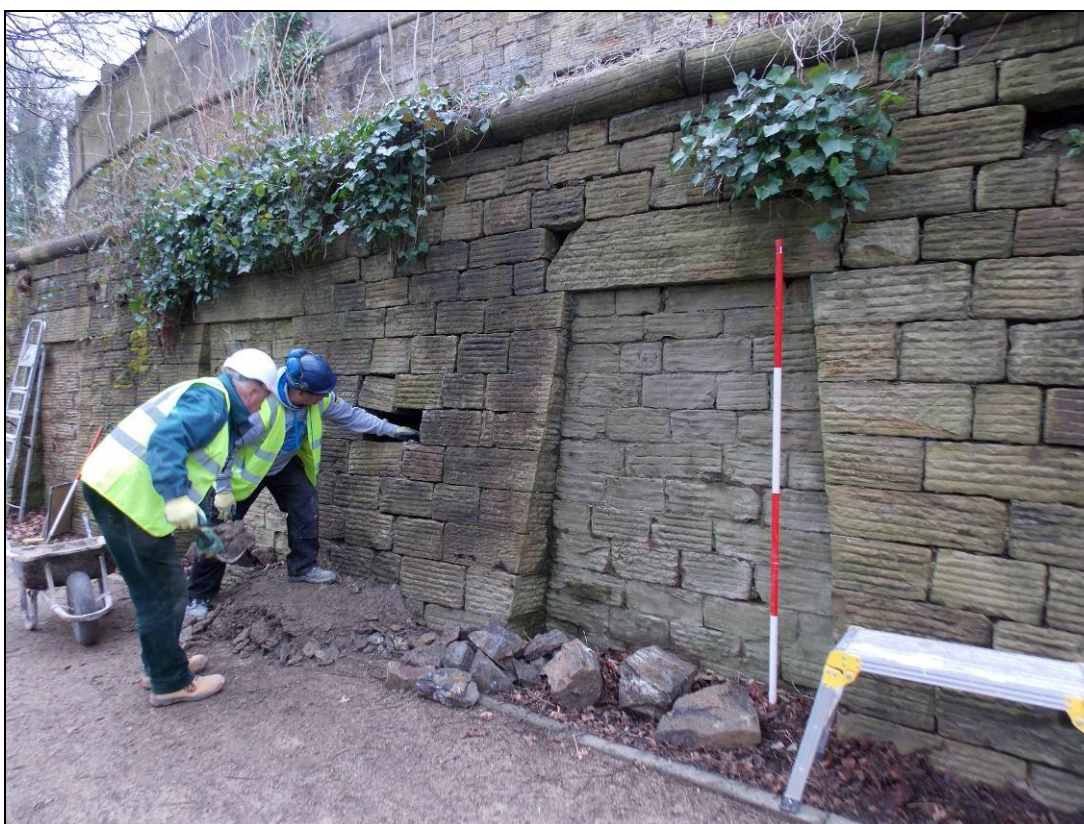
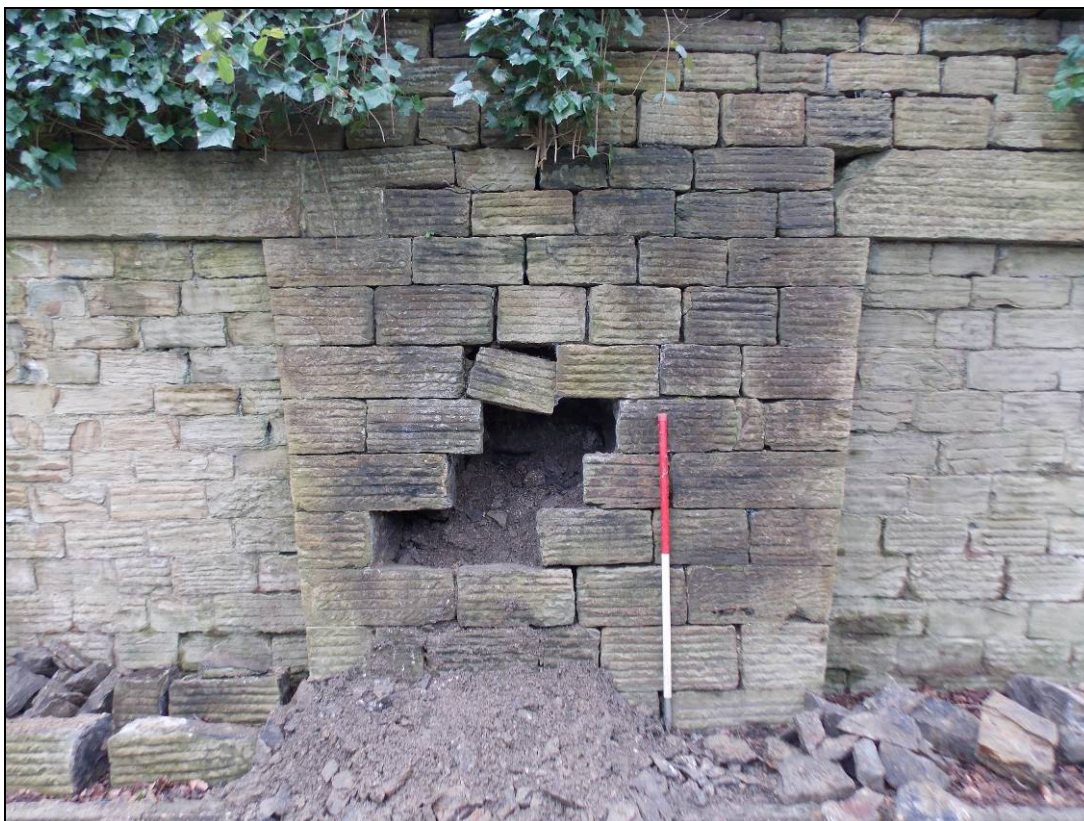
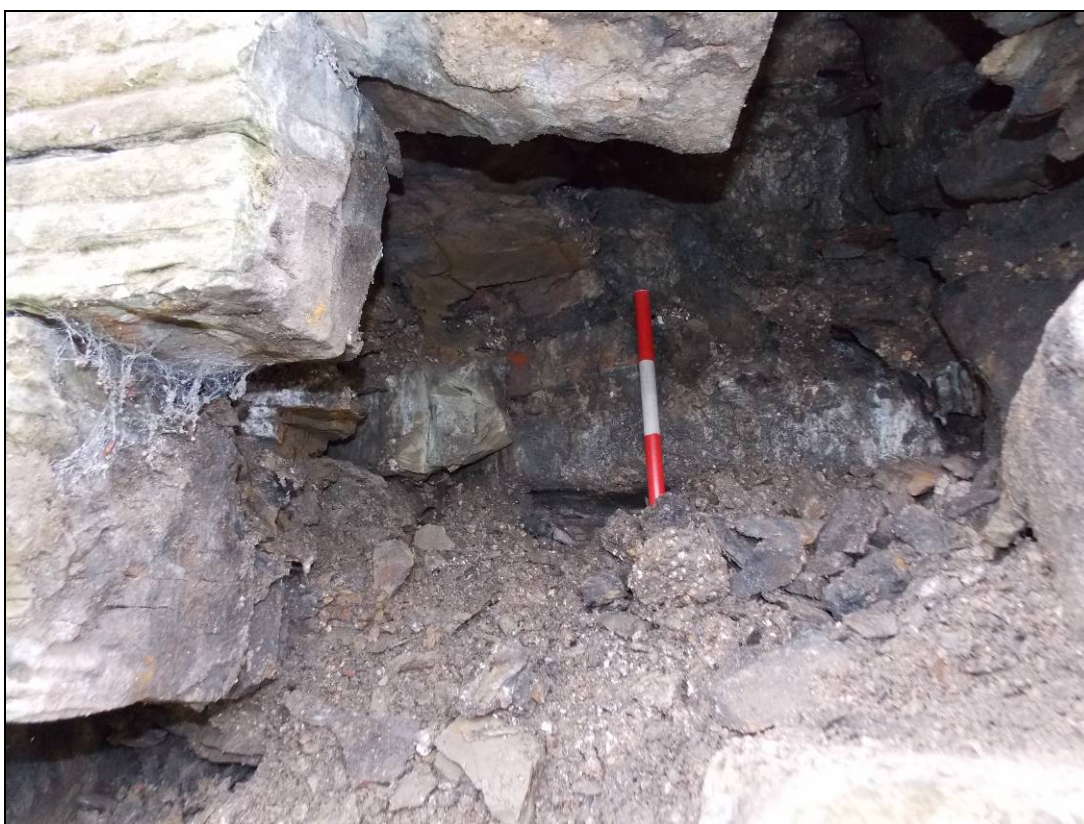
5.5 A loose section of stonework between the doorways of Catacombs NN and OO was removed establishing the springing course of the brick barrel vault and stone cross wall recessed approximately 600mm from the face of the wall. There was loose rubble infill between the brick/stone and the inner face of the façade wall (Figs 19 – 22).

Figure 19: Wall between Catacombs NN and OO.

Figure 20: Opening within wall between Catacombs NN and OO.

Figure 21: Detail of the opening.

Figure 22: Internal view showing the external masonry, rubble infill and masonry of the Catacomb inside.

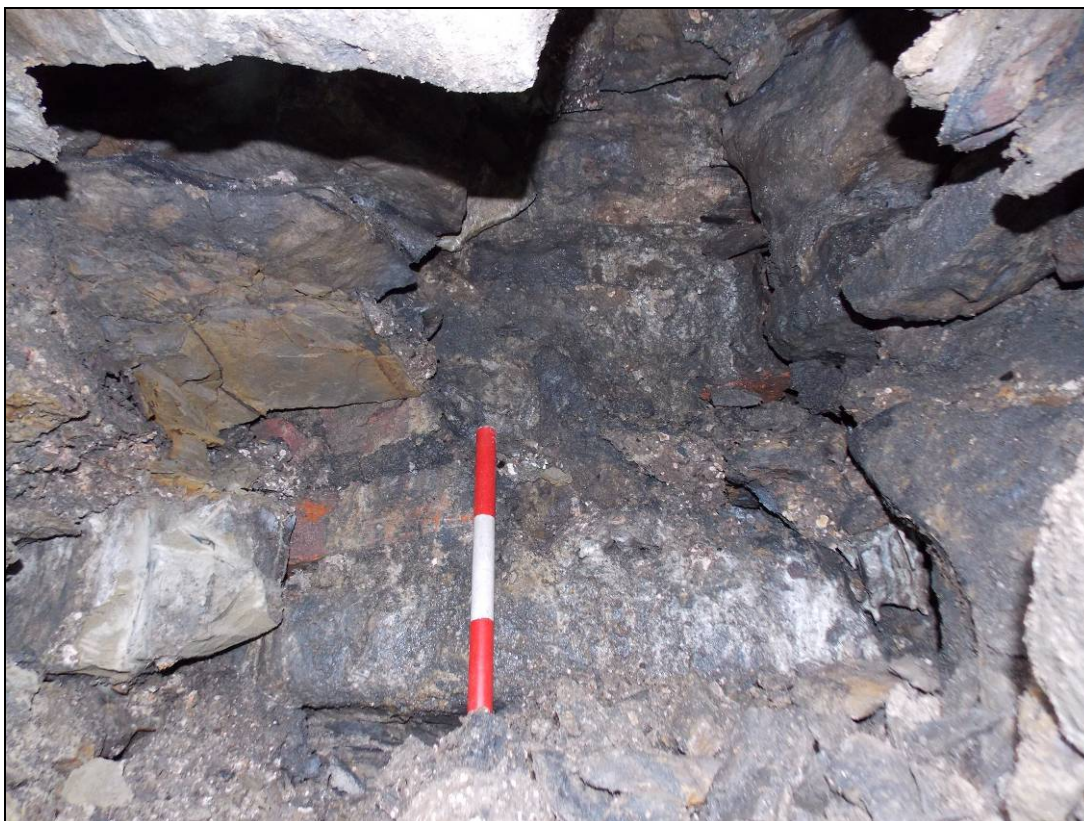
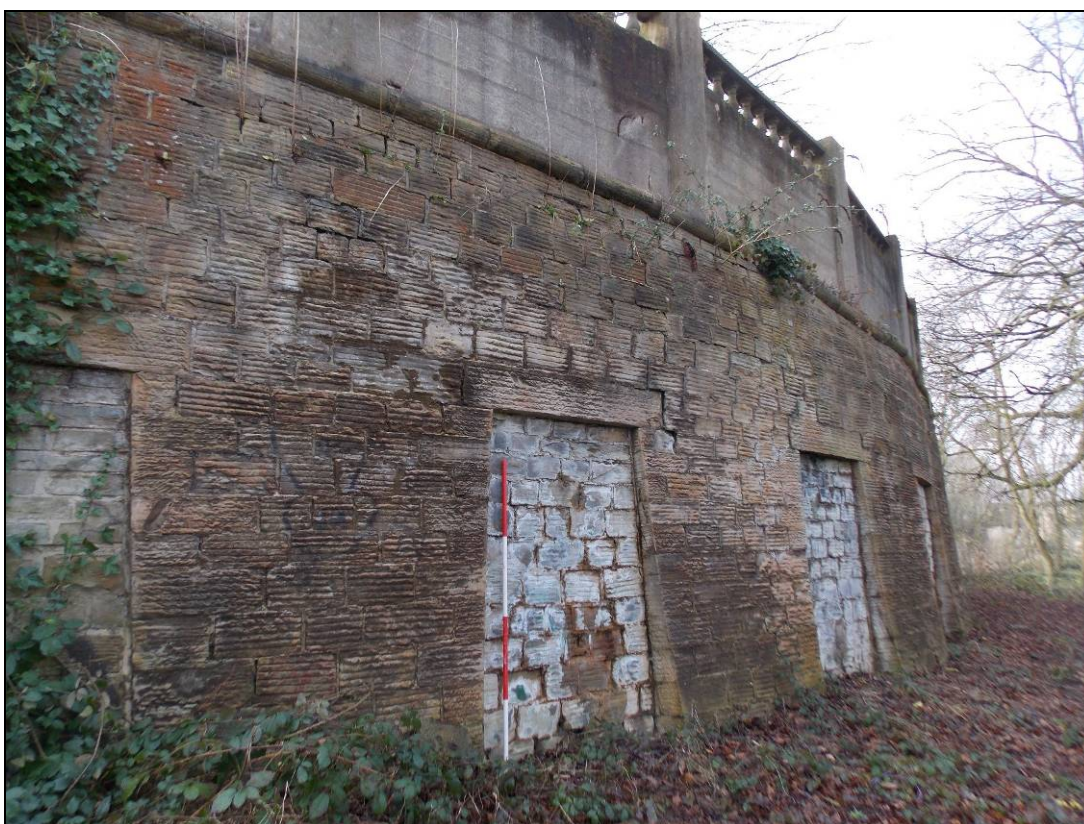
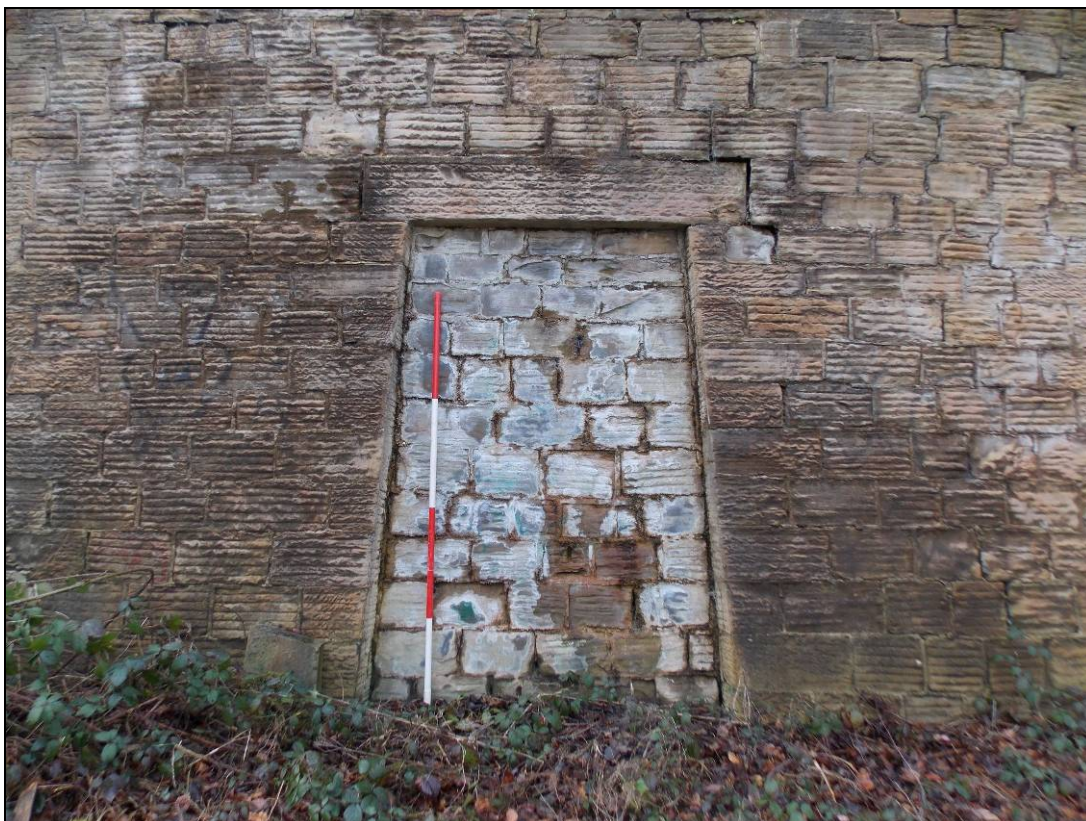
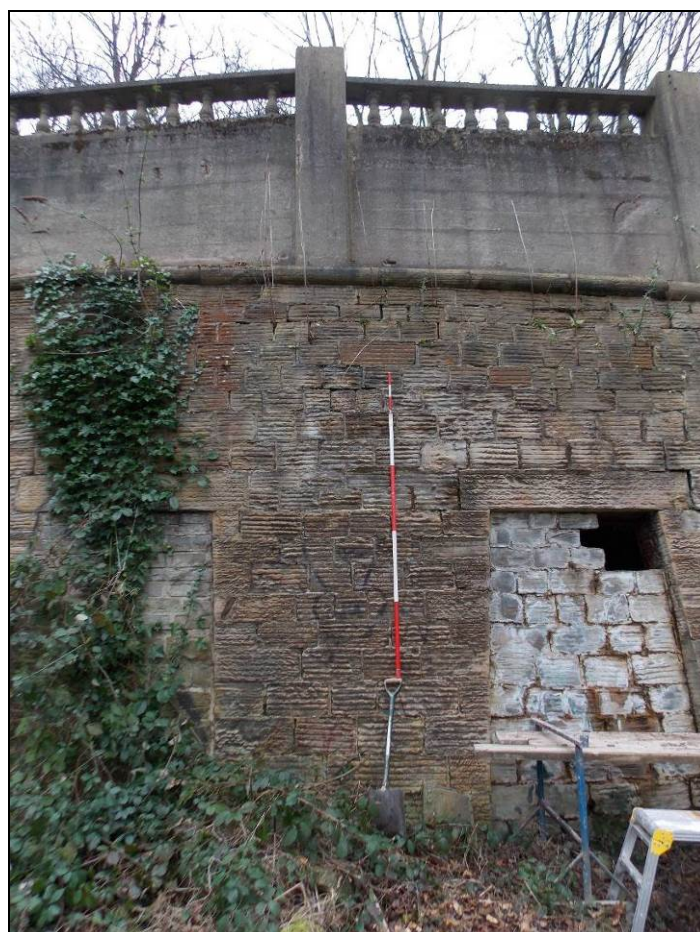
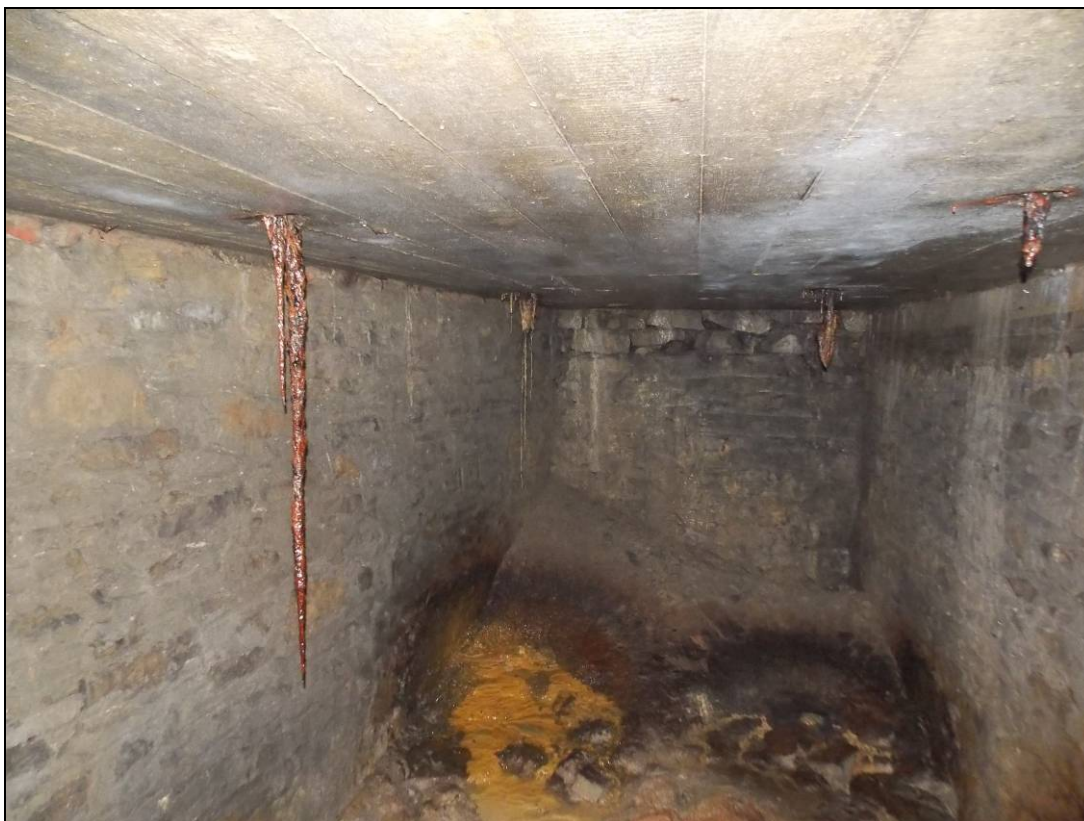
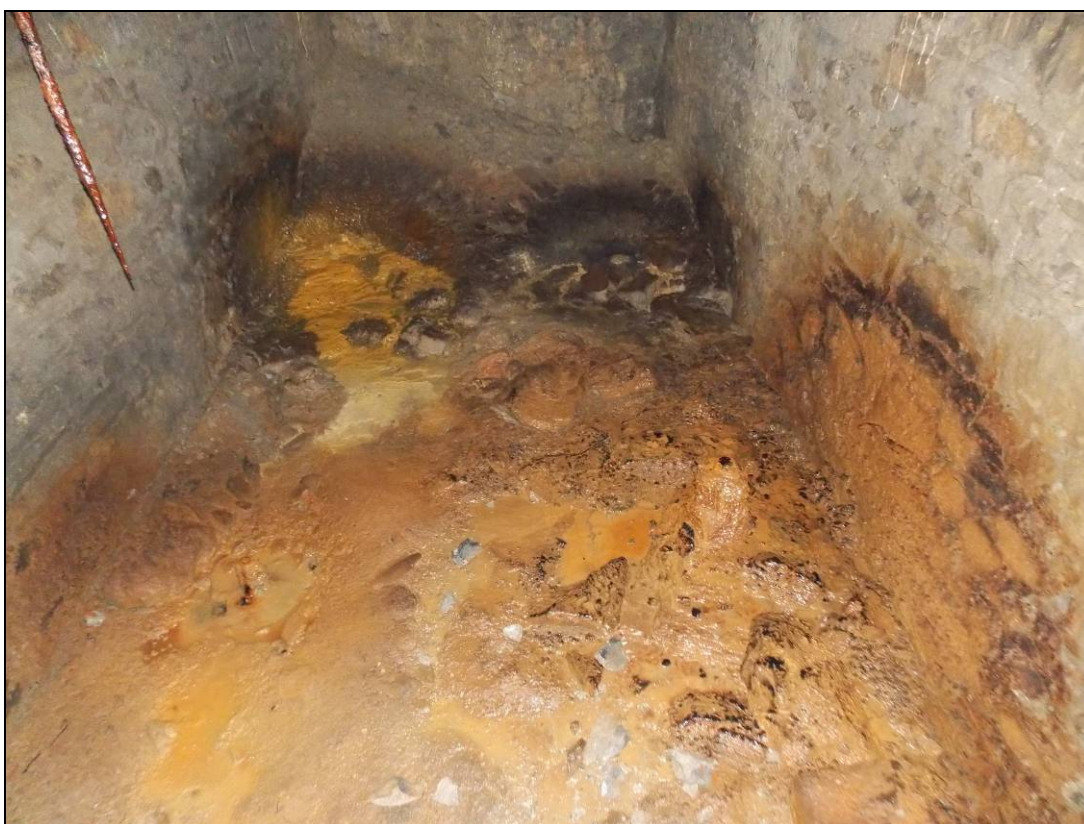
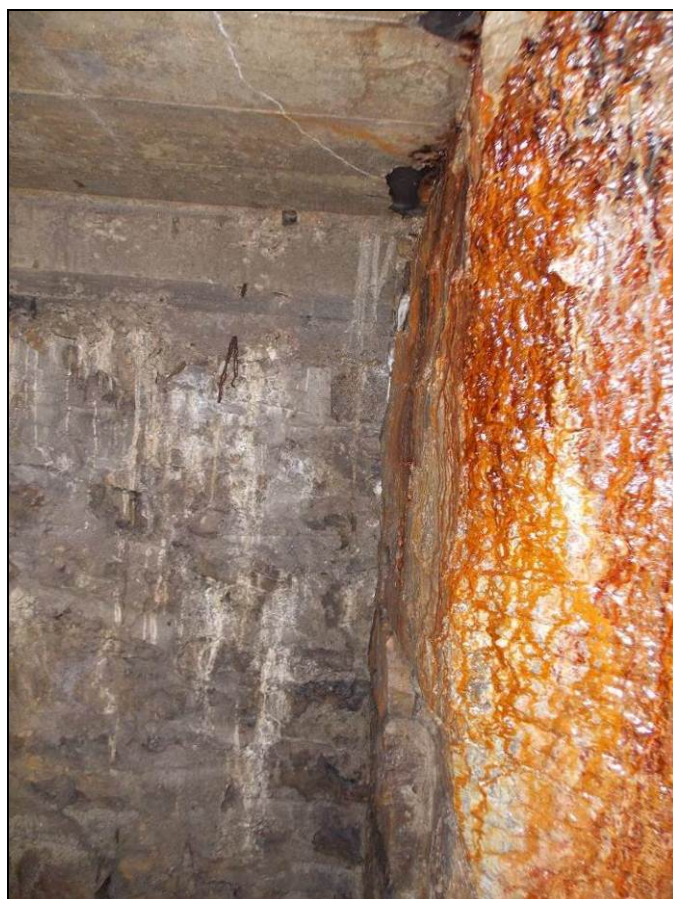
5.6 The upper level of the Catacombs was also studied by means of several inspection holes through the main front wall and blocked-up doorways. Several stones of the top three courses of the blocked-up doorway of Catacomb D were removed which were

recessed approximately 100mm from the face of the wall. The construction of the front wall is equivalent to the lower level with an overall thickness of 500mm. However, the interior of the chamber was different from the vaults encountered within the lower level, consisting of tall stone walls supporting a concrete ceiling. The concrete construction is clearly a later insertion thought to have taken place in the 1930s. However, the tall stone walls built with roughly hewn sandstone rubble built to courses without any sign of vault construction may indicate that the upper Catacombs might have encompassed flat ceilings, possibly supported by bridging beams or similar elements. The Catacomb is a complete void but with some rubble deposited across the floor. The chamber measures 5.05 metres in length by 2 metres in width and the height is approximately 2.20 metres. Traces of four equidistance iron columns/posts were discerned within the floor and projecting out the ceiling, despite severe oxidation and decay. These posts would have originally extended vertically through the timber shuttering and spans which facilitated the initial concrete casting process and thus they may be regarded as reinforcing rods of the basal area of the balustraded parapet. Further oxidation stains caused by decomposed iron rods/poles or a reinforcing cage of the above concrete structure were observed along the inner side of the blocked-up doorway (23 – 29).

Figure 23: Detail of the stone wall and brick vault of the Catacomb inside.

Figure 24: Doorway of Catacomb D within the upper level.

Figure 25: Detail of doorway of Catacomb D.

Figure 26: Inspection hole within the blocked-up doorway of Catacomb D.

Figure 27: General view of the interior.

Figure 28: Basal area of Catacomb D with oxidised residues.

Figure 29: Further oxidation along the inner side of the blocked-up doorway.
