Sheffield General Cemetery – Catacombs – Sheffield, South Yorkshire

Archaeological monitoring and recording

ARS Ltd Report 2015/56

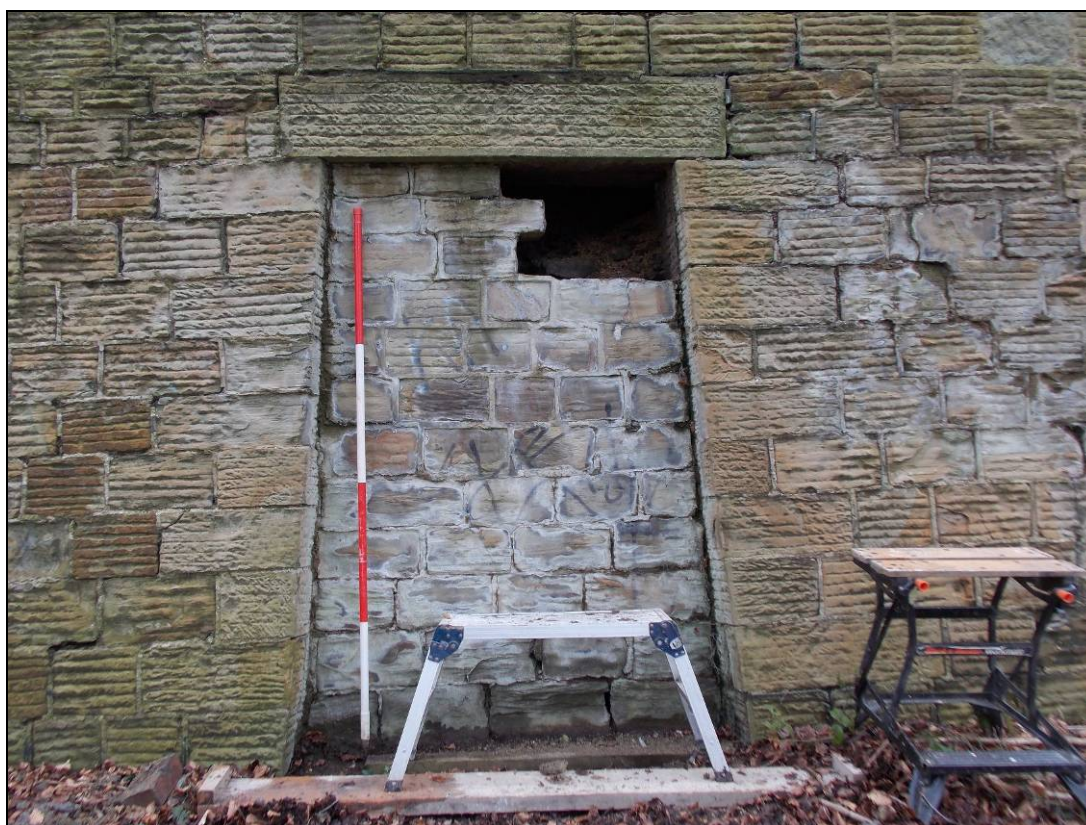
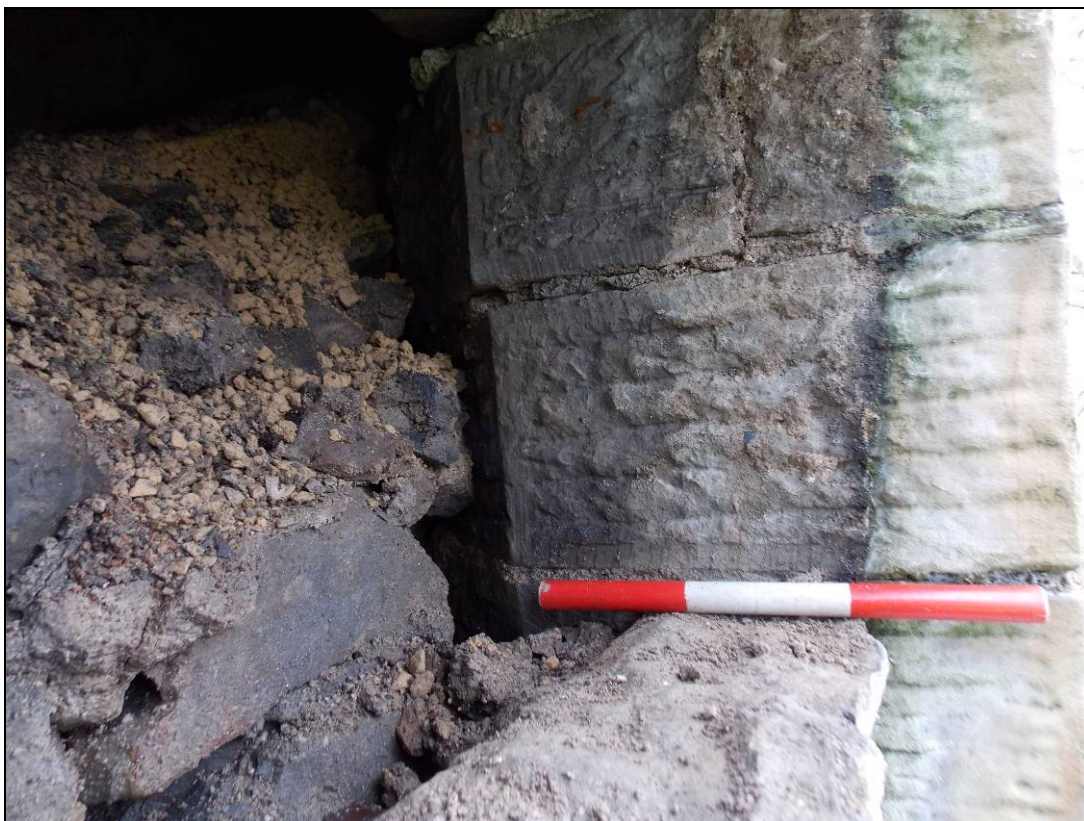
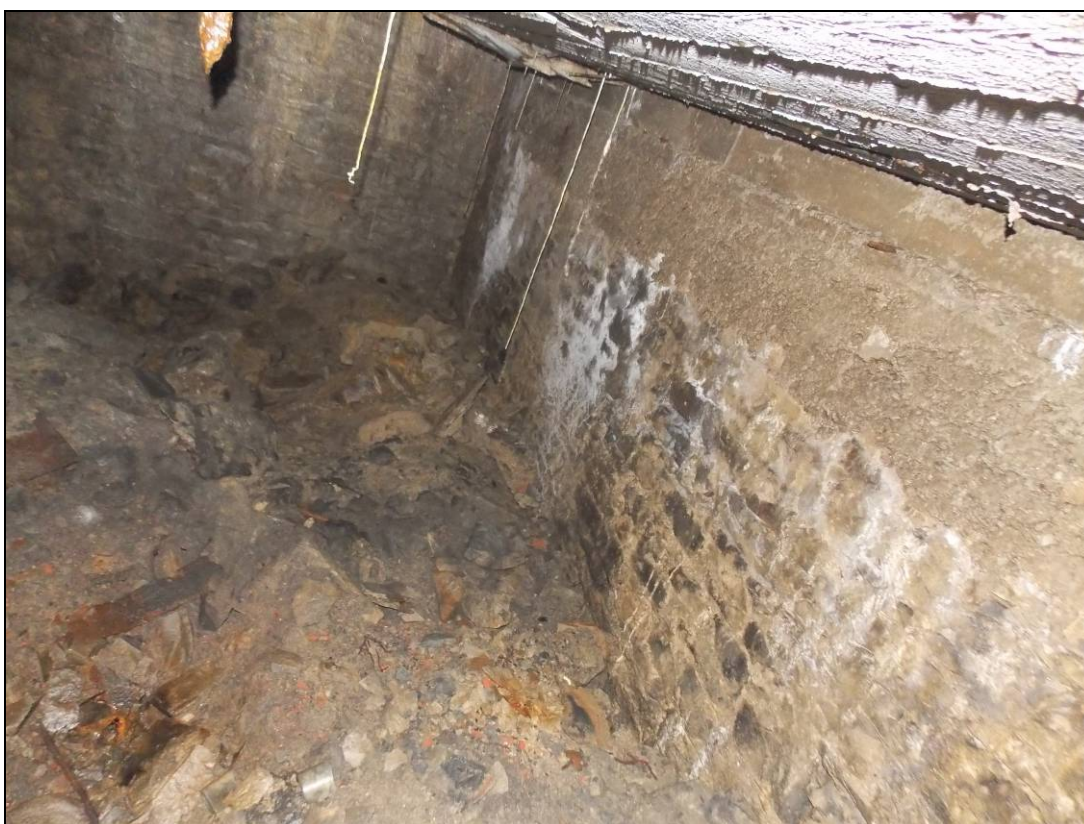
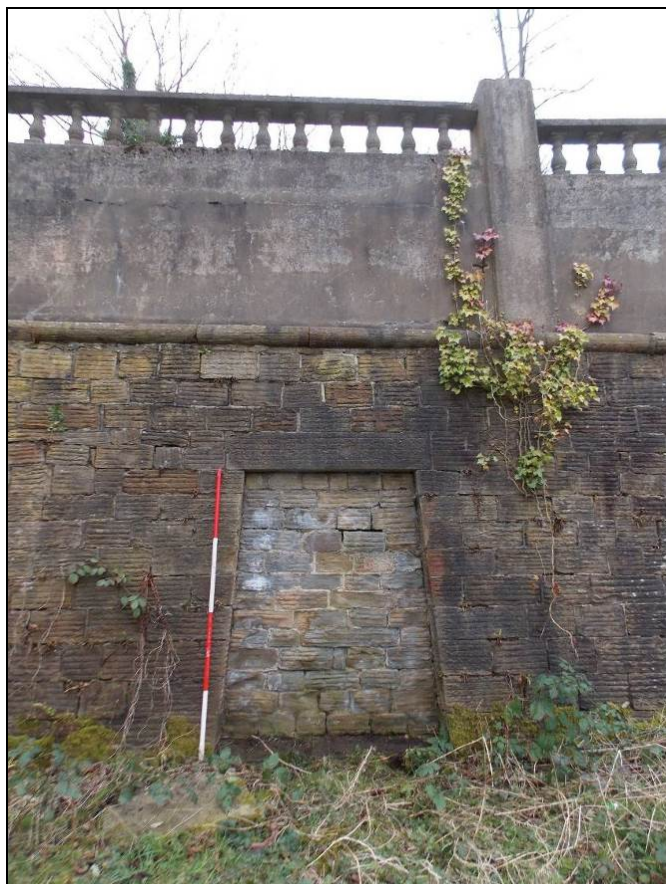
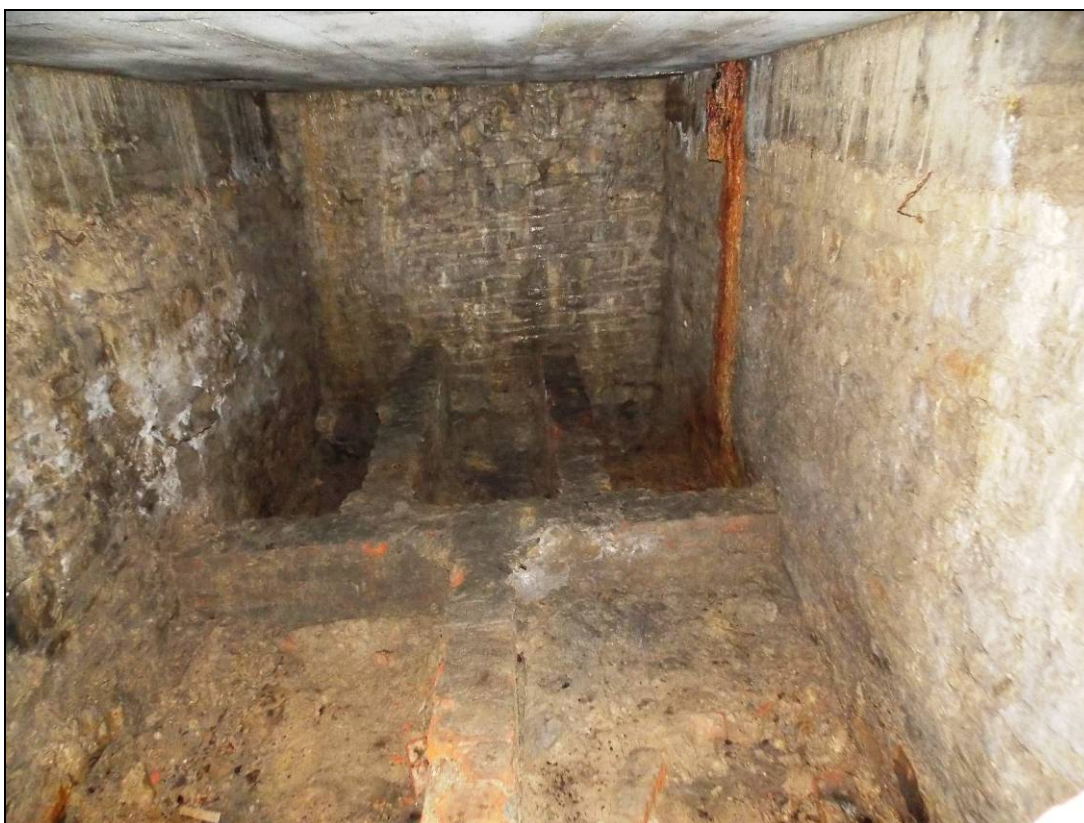
5.7 Catacombs I and R were opened up on the basis that the inspections would be made from the opening and no intrusion into the Catacombs would take place. The findings were similar to Catacomb D although it appears that the concrete deck reduces in level in line with the sloping path over the Catacombs. Indeed, the concrete soffit of Catacomb I is 450mm lower than the *intrados* of the original doorway lintel; and the soffit of Catacomb R is 620mm lower than the *intrados* of its doorway's lintel. In both Catacombs there is a concrete wall built off the front edge of the concrete deck which extends up to support the high level concrete balustrade parapet on top of the Catacombs. There are no ties between the concrete wall and the inner face of the façade stone wall. The floor of Catacomb I is covered with a substantial amount of rubble debris, whereas Catacomb R contains well-preserved brick-built sub-divisions which would have acted as separate burial chambers within the Catacomb (Figs 30 – 34).

Figure 30: Doorway of Catacomb I.

Figure 31: Original doorway jamb with internal splayed edges.

Figure 32: Internal view of Catacomb I with substantial deposited rubble.

Figure 33: Doorway of Catacomb R.

Figure 34: Catacomb R with brick burial chambers.

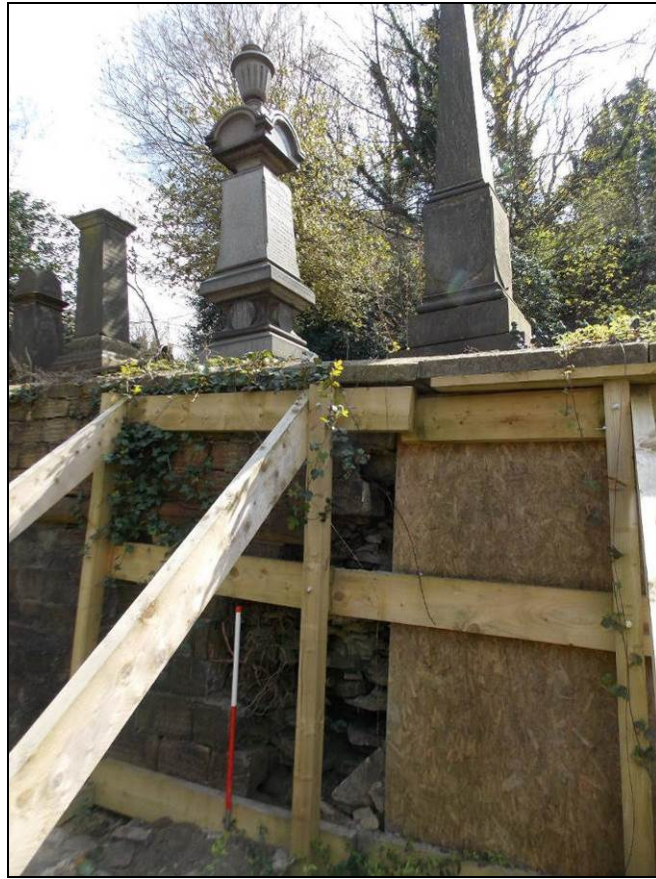
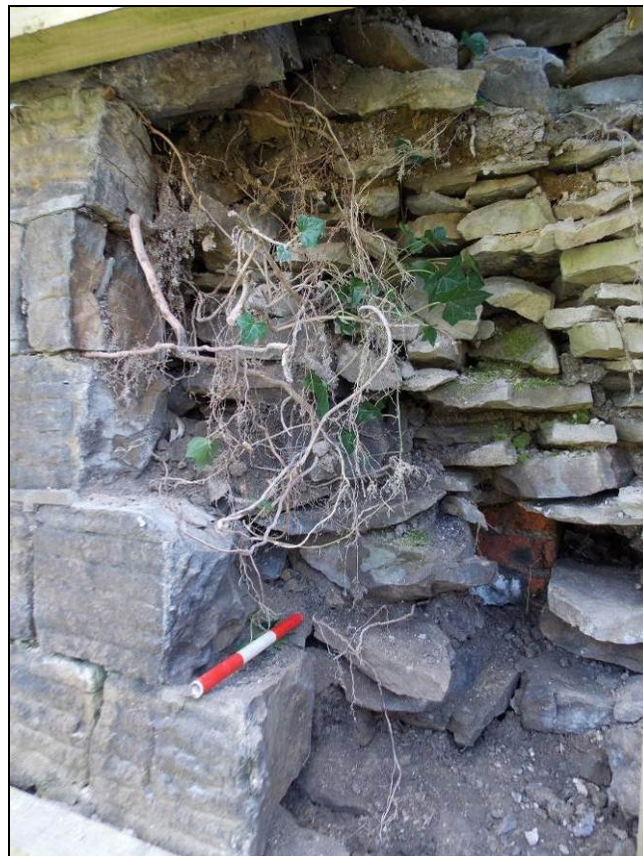
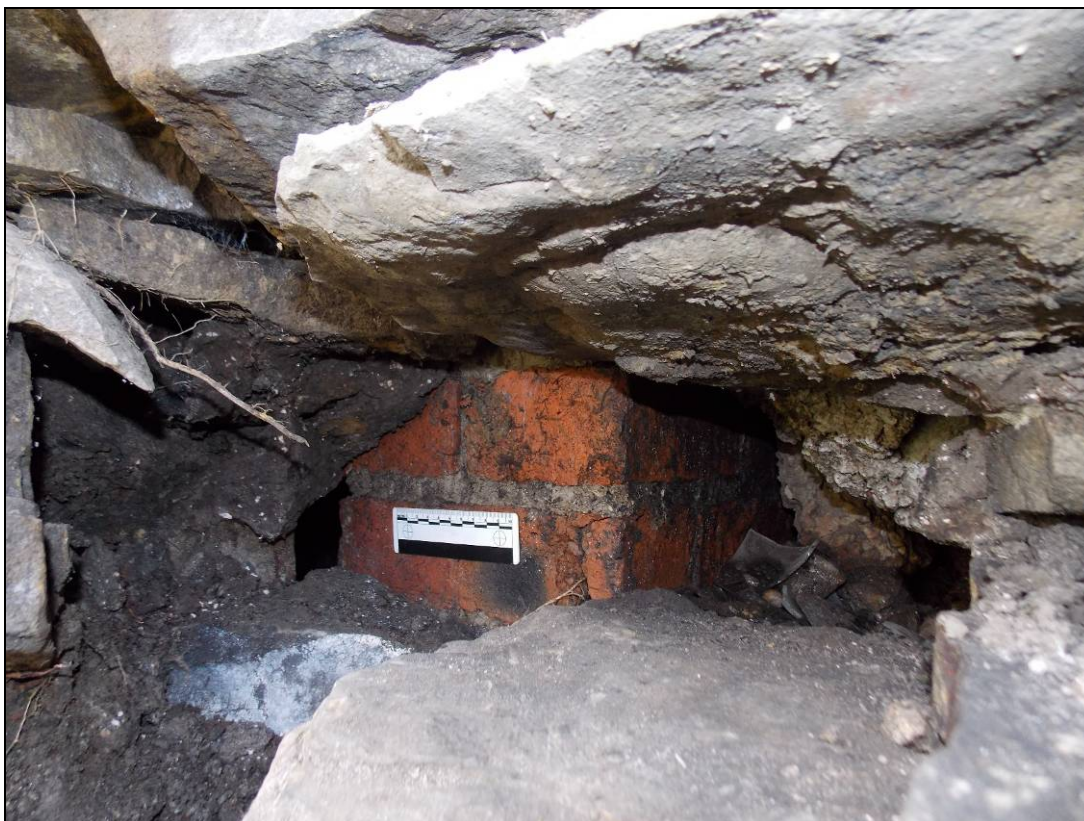
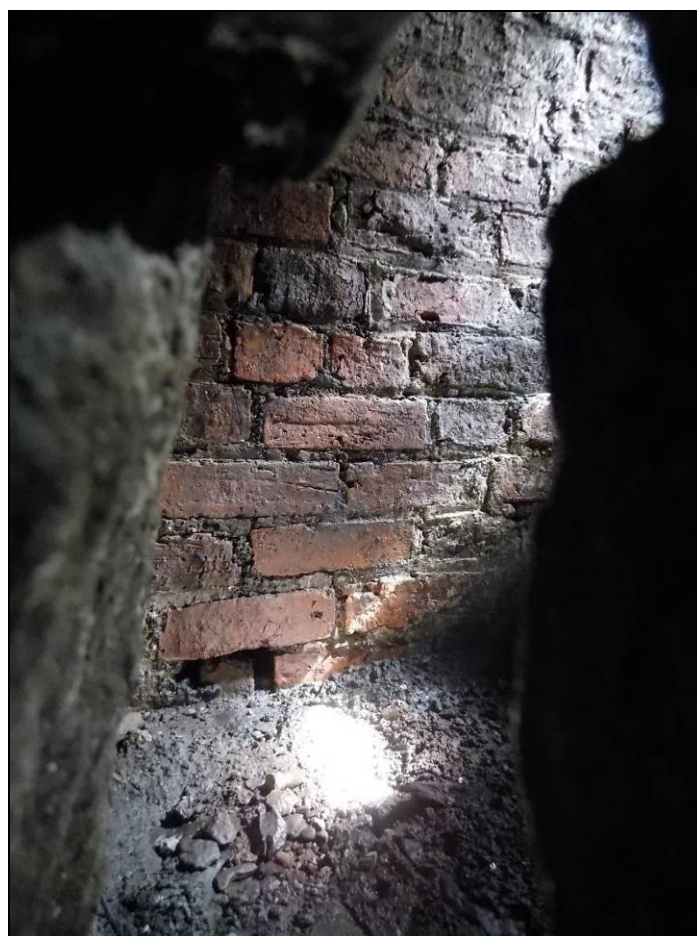
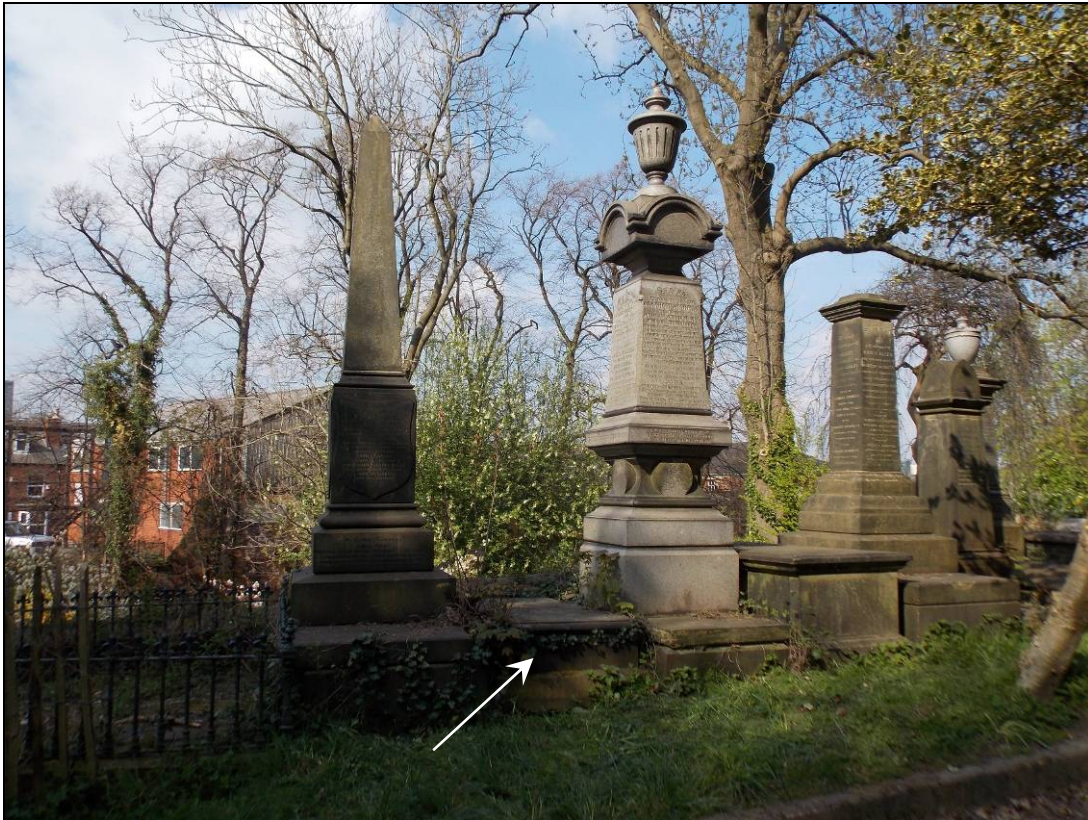
5.9 The first inspection took place within the upper level at approximately 18 metres from the western end of the wall where a large amount of dressed stones of the outer face of the wall have tumbled and is currently shored with timber joists, planks and boards. The missing outer skin has revealed rubble infill composed of elongated and fairly flat sandstone rubble laid slightly irregular and bonded with coarse lime mortar. The removal of several rubble exposed a brick wall at 830mm from the face of the retaining wall which appears to be a U-shaped chamber built against the inner side of the retaining wall. The brick wall extends further down. The interior of chamber measure approximately 750mm in width and its inner face appears to be slightly lime washed. The brickwork consists of hand-made orangey standard size bonded with lime mortar. The base of the chamber contains soil which could be covering an interment. The tomb stone of this burial chamber was identified above the retaining wall (Figs 35 – 39).

Figure 35: Upper retaining wall with missing outer stone veneer boarded up.

Figure 36: Inspection hole through the exposed rubble infill.

Figure 37: Brick wall abutting the rubble infill of the retaining wall.

Figure 38: Internal view of the brick vault.

Figure 39: Tomb stone (arrow) of the brick vault partially observed below.

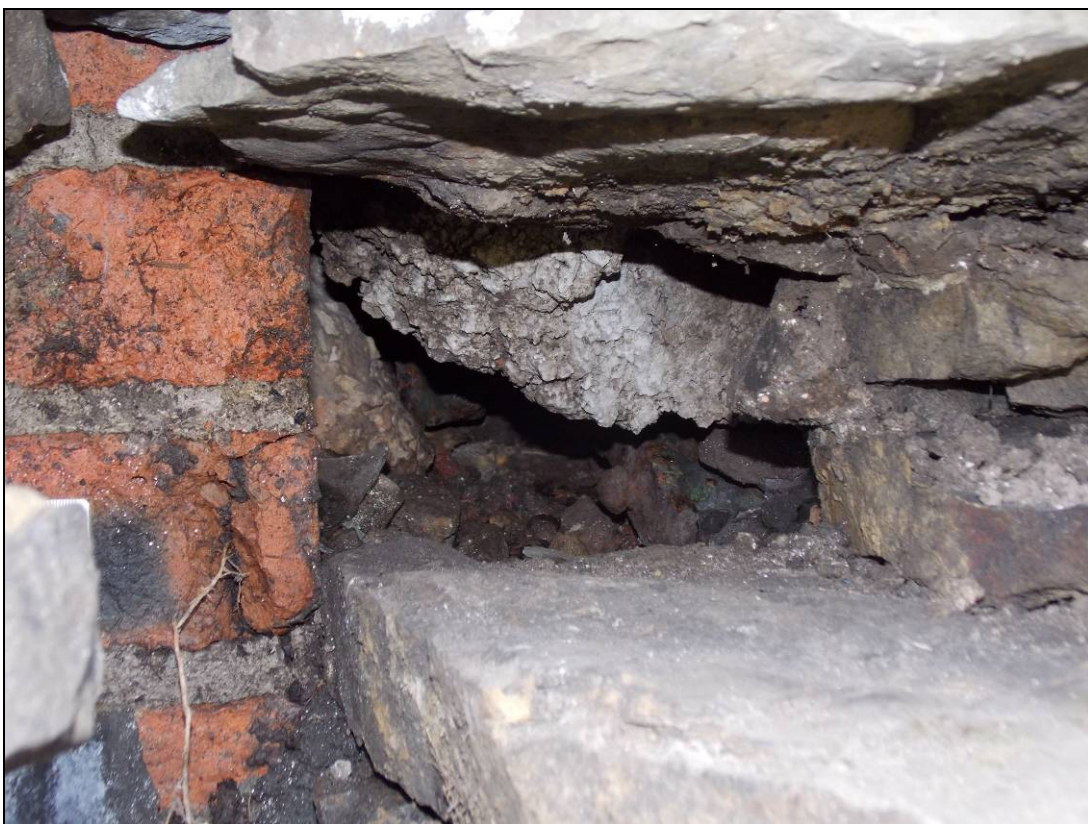
Figure 40: Basal section of adjacent concrete structure with metal and glass aggregate/packing.

5.10 Immediately to the right of the outer side of the exposed wall, a basal section of an adjacent concrete burial chamber was viewed (Fig. 40). This is rather intriguing as the memorial monument above refers to burials dating from the late 19th century onwards,

although the concrete construction is more likely to date from the first quarter to mid 20th century instead. It is likely that later re-interments had taken place within the entire cemetery, particularly along the driveway above the Catacombs, as indicated by a inscribed plaque (Fig. 41) situated within a blocked-up doorway of the western side of the upper Catacombs which reads:

5.11 The construction of these burial chambers might have undermined the upper retaining wall although the chambers themselves probably act as a convenient revetment for the present driveway.

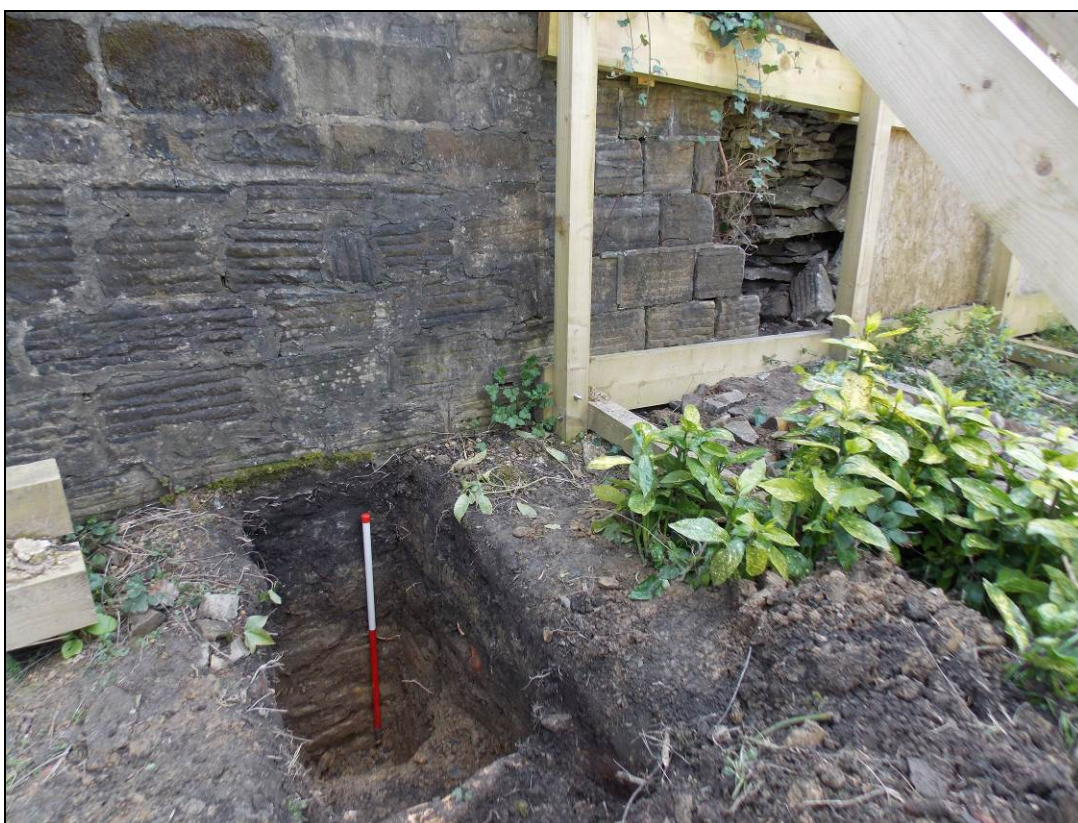
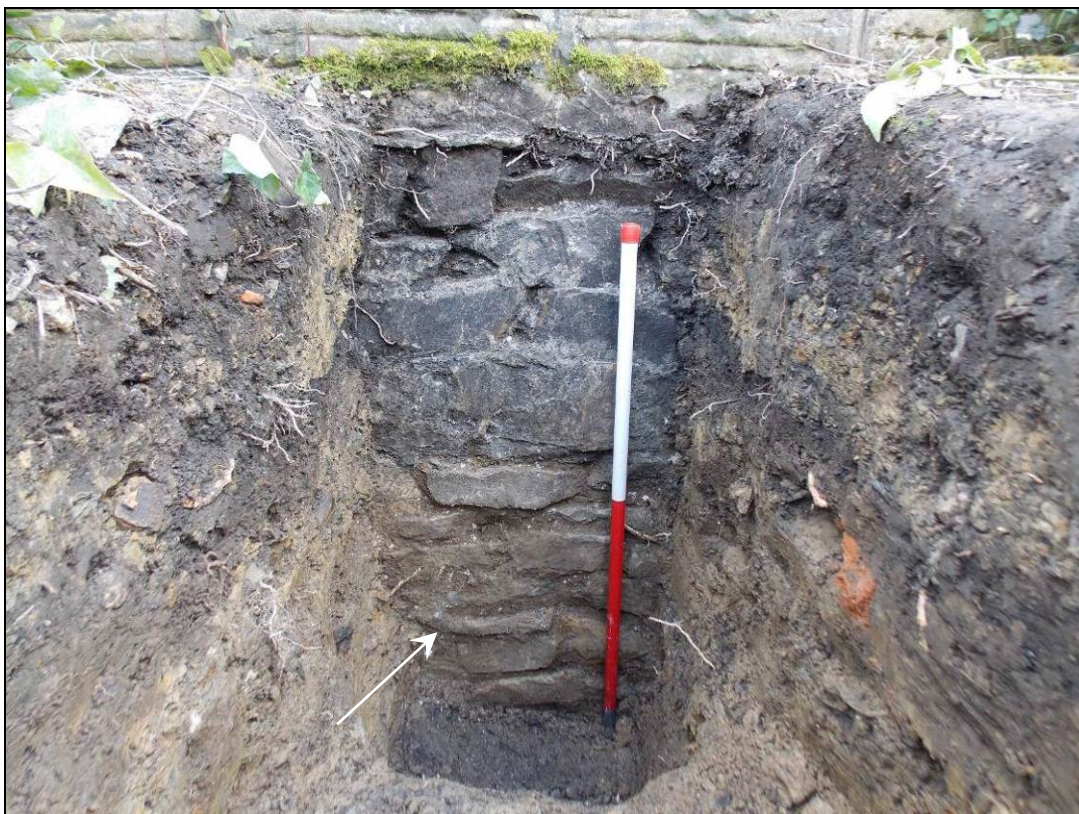
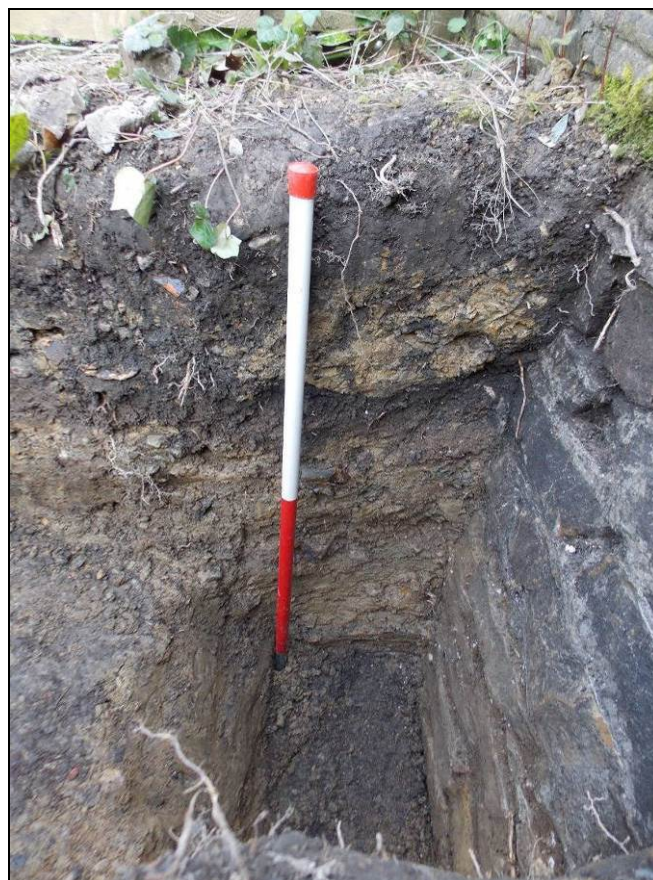
5.12 Approximately 2 metres east of the inspection hole, a test pit was dug to expose the foundation of the retaining wall. This was excavated to a depth of 1.3 metres although the exposed wall continues downwards. Nevertheless, it was established that the upstanding retaining wall, with furrowed dressed squared blocks, sits over a foundation wall, consisting of four slightly irregular courses (with an overall thickness of c.600mm) of large sandstone rubble bonded with hard mid grey lime mortar, which in turn overlies a lower wall, composed of smaller sandstone fairly flat and elongated rubble bonded with a rather thick matrix composed of light reddish brown sandy silt with occasional specks of whiteish lime mortar. The section across the test pit shows that the lower wall cuts through the natural clay sub-stratum (Figs 42 – 44). It is possible that the lower wall may be associated with an earlier structure, such as a boundary wall, as indicated by the 1832 Tayler's map (Fig. 2).

Figure 42: Test pit adjacent to the partially demolished retaining wall of the upper level.

Figure 43: Test pit showing an earlier phase of construction beneath the foundation of the retaining wall.

Figure 44: West facing section through the test pit.

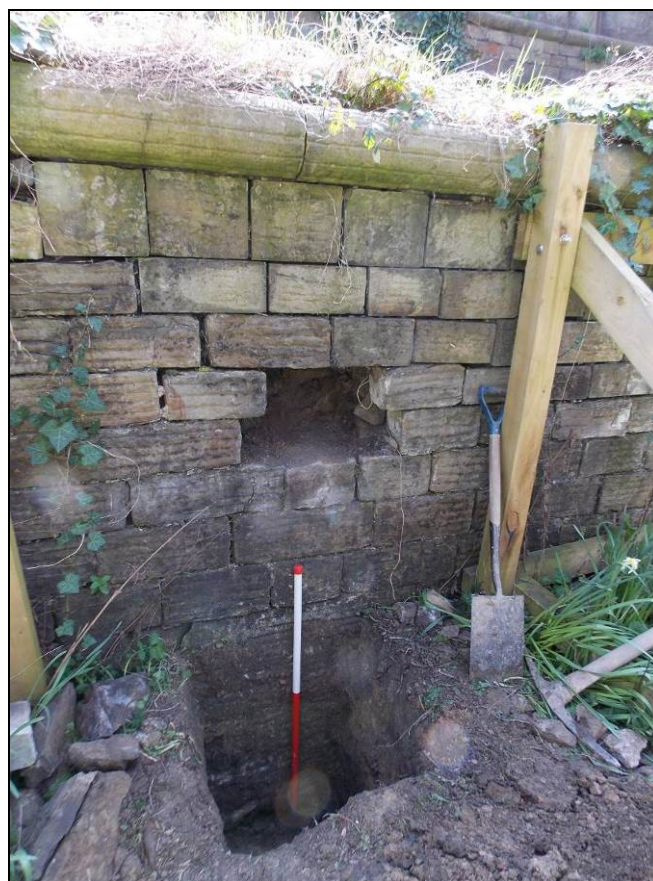
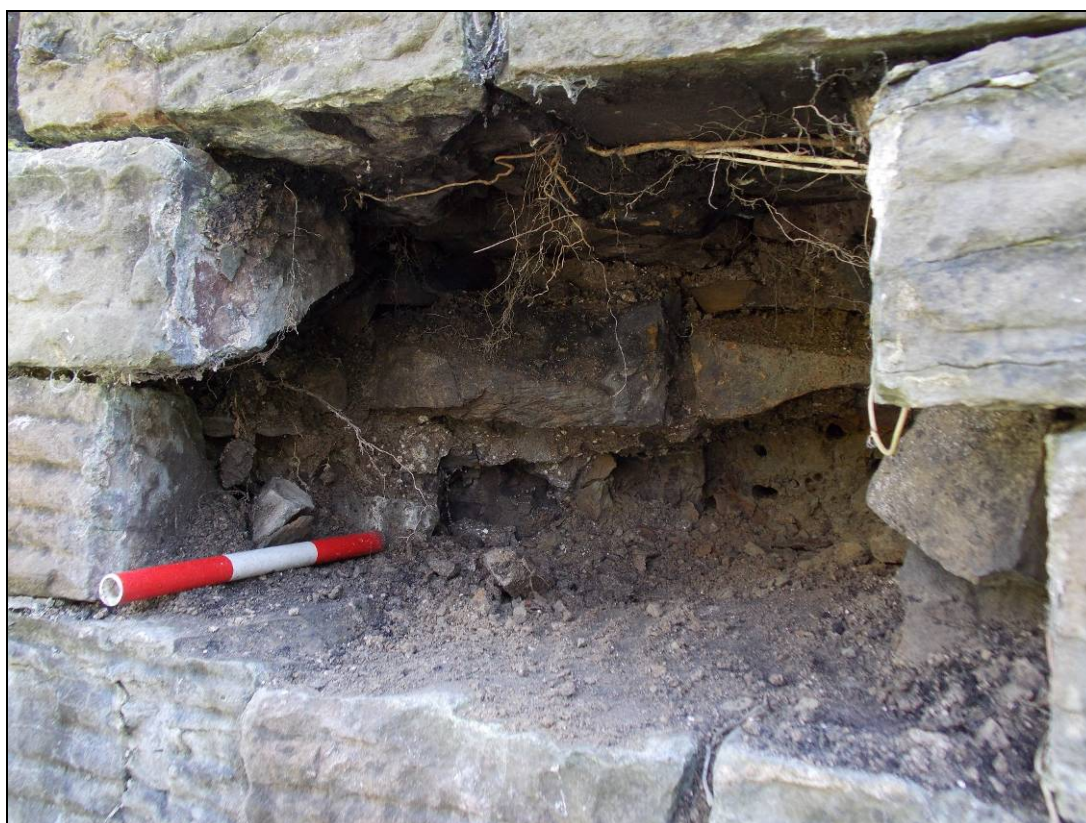
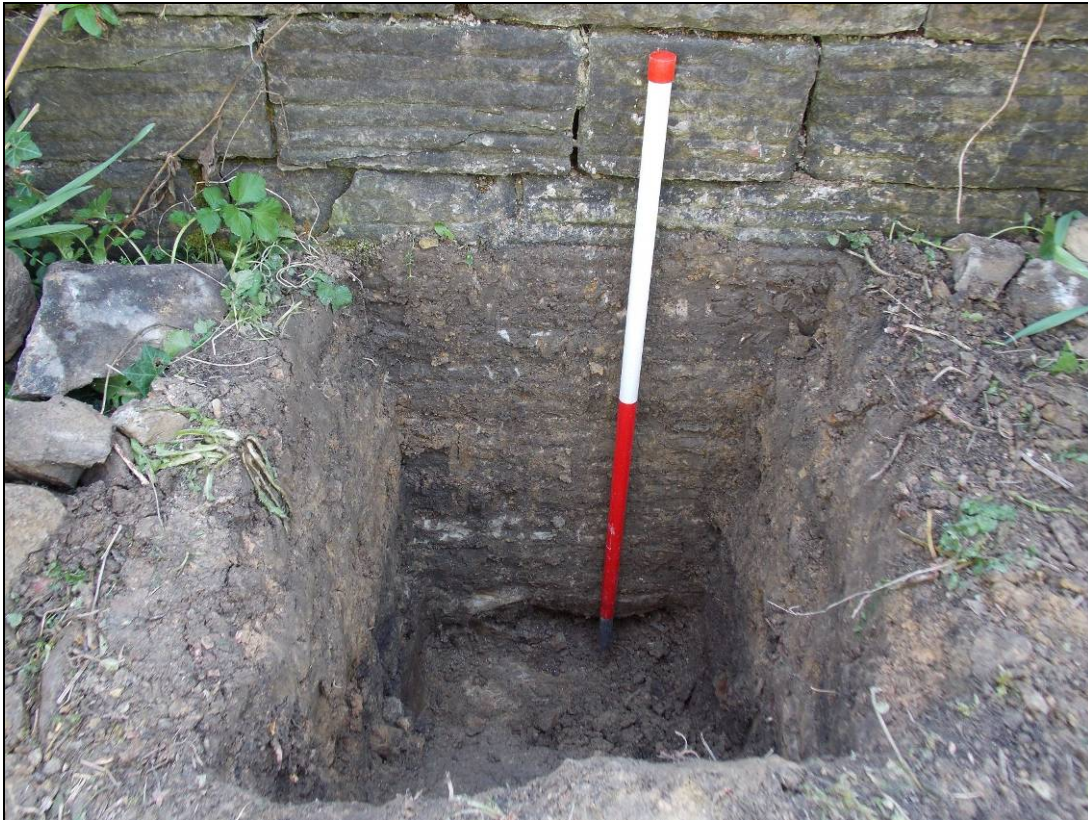
5.13 A similar inspection consisting of a small hole and test pit was also undertaken within the lower retaining wall of the Catacombs at 11 metres from the western end of the wall. The construction of the wall was similar to its counterpart consisting of a single skin of squared dressed sandstone with rubble infill yielding an overall width of 650mm. The rubble infill of this level is smaller and slightly more regularly laid. The natural clay sub-stratum was identified behind the wall. The test pit reached a depth of approximately 900mm, establishing the natural bedrock. The entire exposed wall appears to be a single phase of construction whose squared blocks are decorated with furrowed dressing (Figs 45 – 47).

Figure 45: Location of trial hole and pit within the lower retaining wall.

Figure 46: Detail of trial hole.

Figure 47: Detail of test pit showing the wall over the natural bedrock.

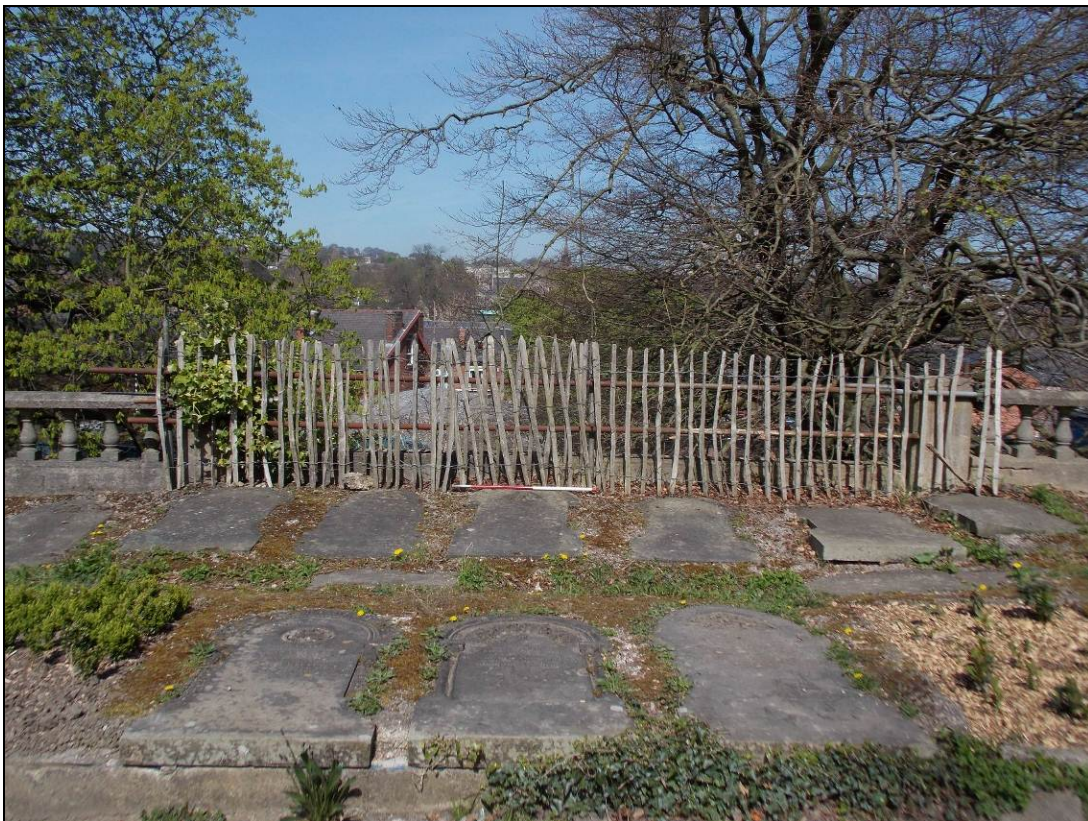
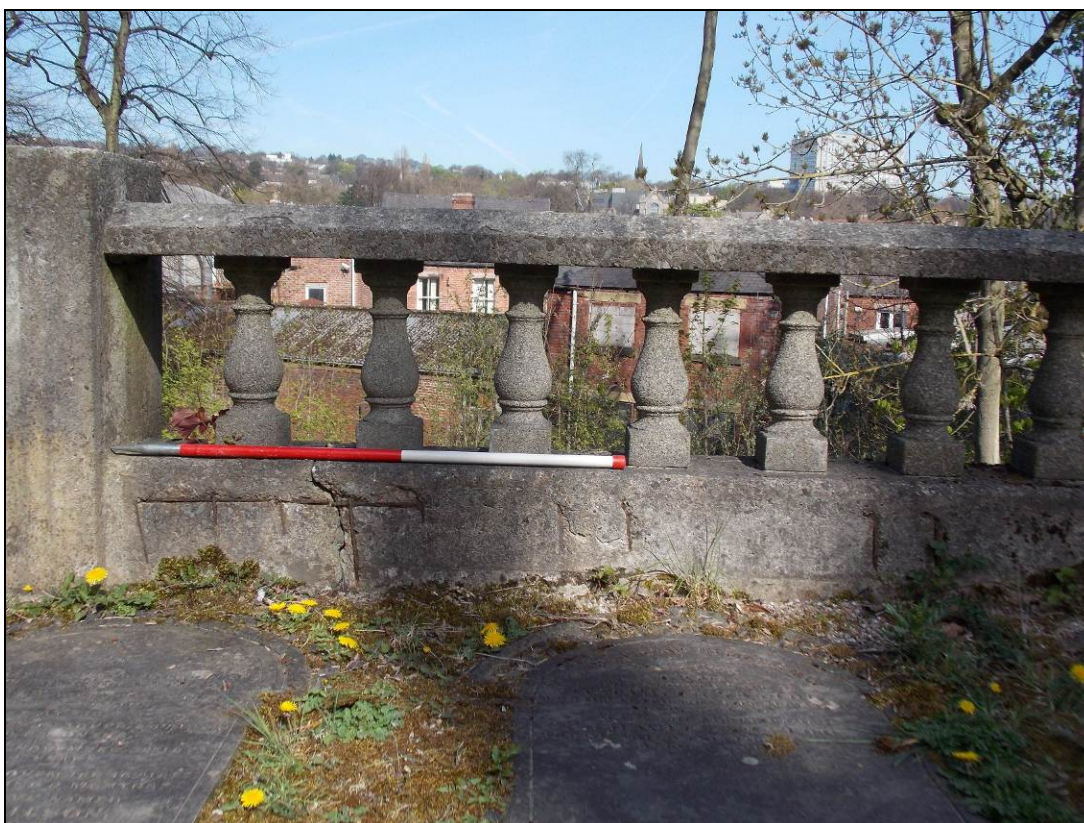
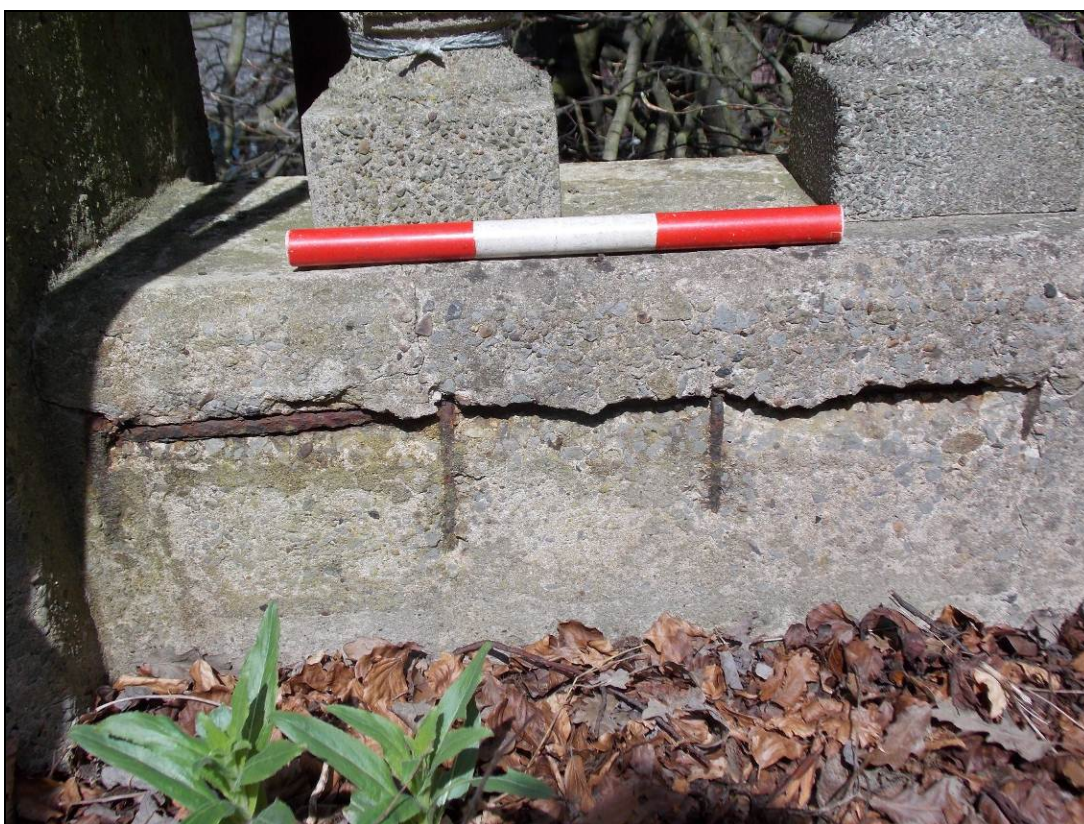
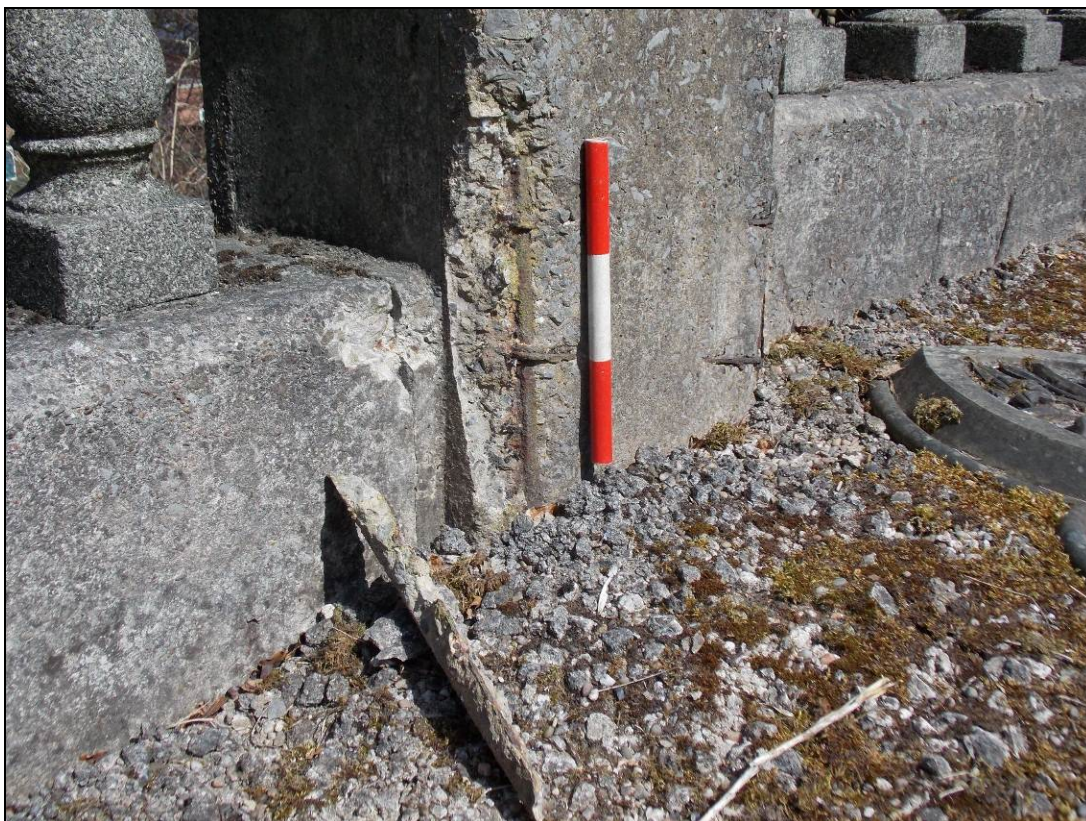
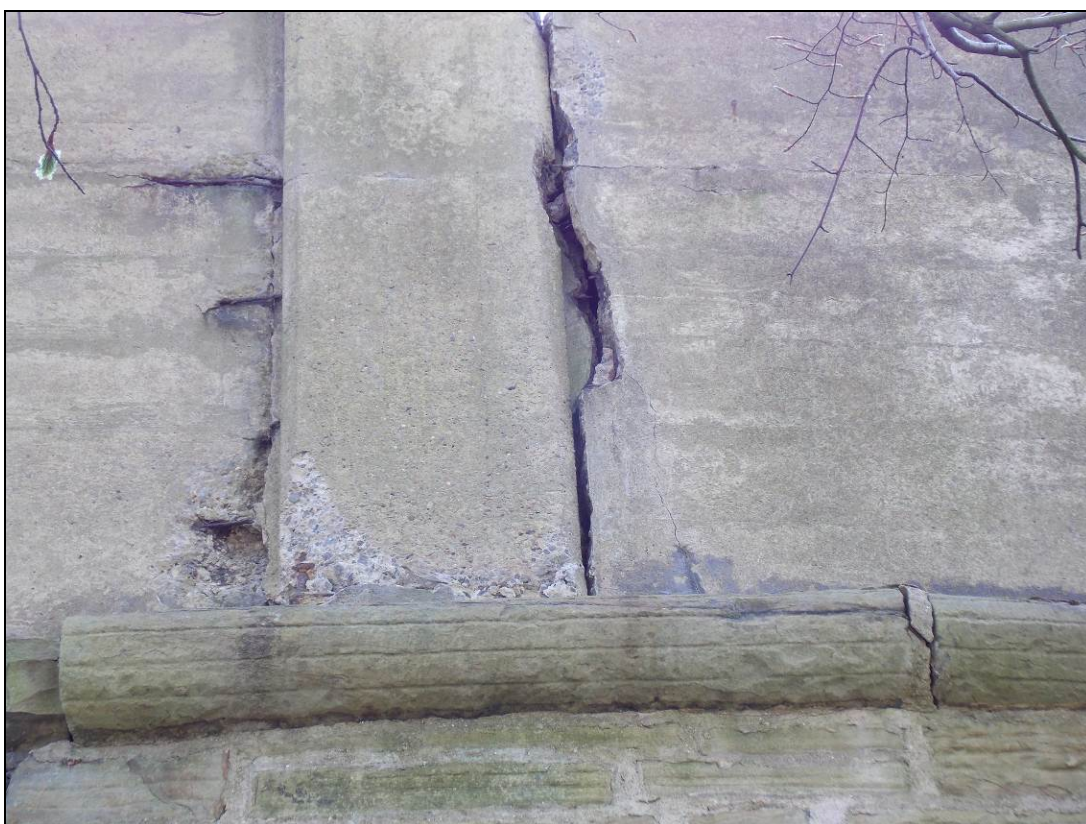
5.14 The concrete balustrade parapet capping the upper Catacombs appears to have been a later insertion replacing an original and integral parapet. The secondary concrete structure intruded into the Catacombs substituting the original roof structure as well as the actual parapet. The state of the concrete feature will be the subject of further structural studies as deterioration of the feature has been noted. Although this will not have an impact on the archaeological work, a photographic record of the damaged areas within the entire concrete parapet was undertaken on 22nd of April 2015 which will form part of the project archive. A selection of photographs illustrating the damage is provided below (Figs 48 – 52).

Figure 48: Section of the concrete parapet with missing balusters.

Figure 49: Plinth of balustrade showing exposed iron reinforcing cage.

Figure 50: Detail of exposed reinforced cage and fracture.

Figure 51: Exposed reinforced rod as a result of spalling.

Figure 52: Severe fracture within the parapet.
