## Erewash Museum and Gardens, Ilkeston.

### An Archaeological Excavation.

**ARS Ltd Report No. 2015/60**

May 2015

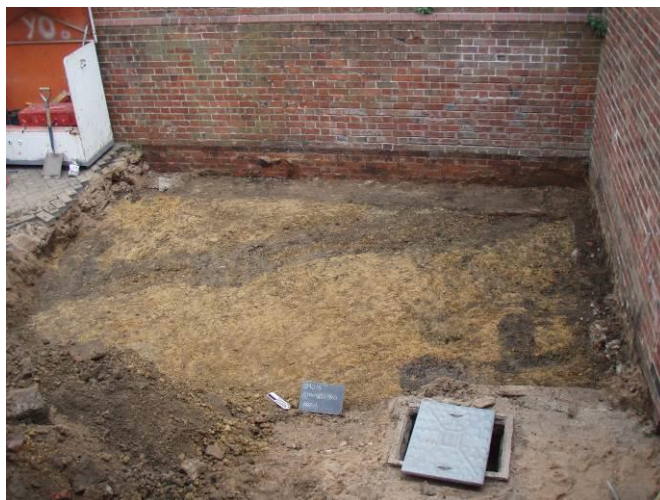
Drain running east-west across the site with manhole cover in the foreground.

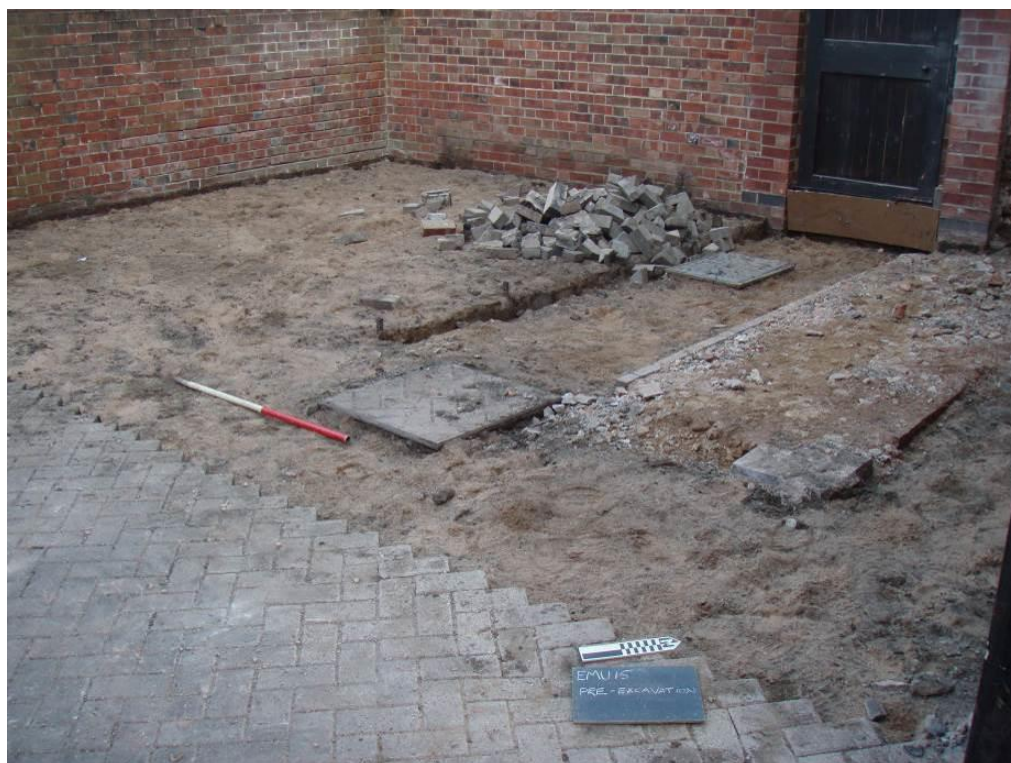
Figure 3. Pre-excitation photograph showing the excavation area facing west. The herringbone paving bricks were removed prior to excavation, exposing the levelling sand deposit (101), and manhole covers. To the right is the base of a brick staircase which was also removed prior to excavation. Scale 1m.

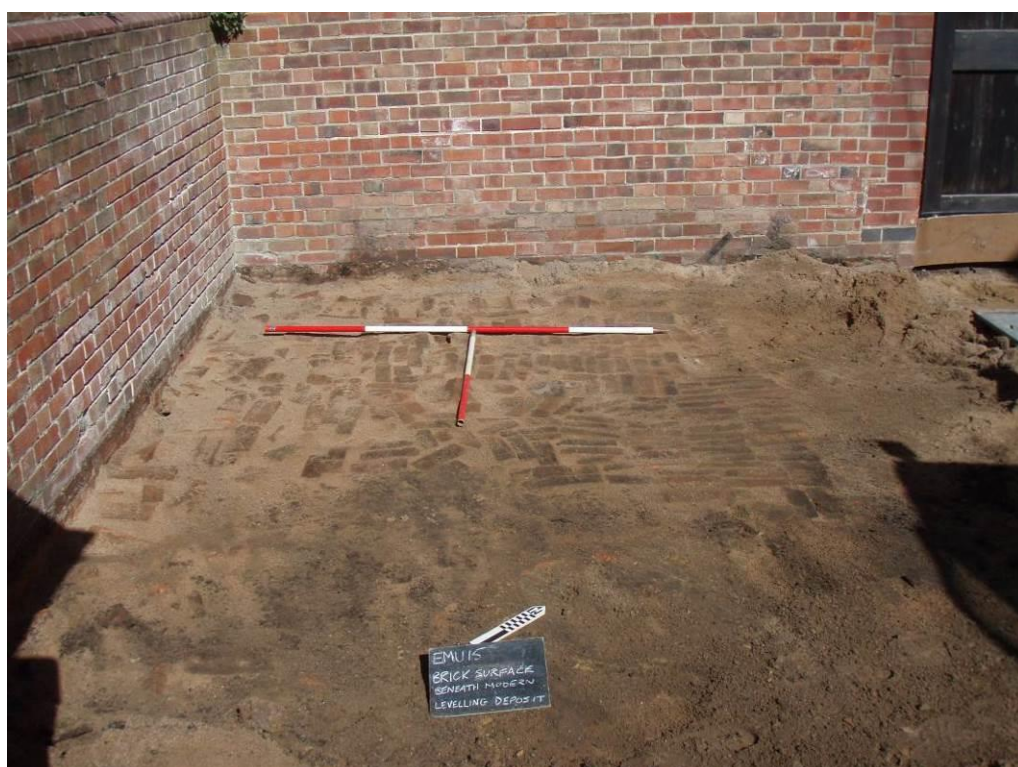
Figure 4. Buried brick surface (F104) facing north-west. Scale 2m x 1m.

- 5.2 In the south-western portion of the site, a herringbone paved surface of unmortared bricks was removed prior to archaeological monitoring. Beneath this was a deposit of sterile sand (101), probably a levelling deposit spread prior to the laying of the herringbone brick surface. Beneath this levelling deposit, at a depth of 0.18m, a buried brick surface was uncovered (F104). This surface extended over much of the western corner of the excavated area, and became less consolidated nearer to cuts for modern water and sewer services. The surface was composed of several types of brick and occasional irregular pieces of sandstone (Figure 6).

- 8.3 The buried brick surface, (F104) in the south-western corner of the excavated area lay directly above context (102). This brick surface represents a previous surface of the stable yard, likely laid in the late 19<sup>th</sup> or early 20<sup>th</sup> centuries. This feature was directly overlain by the modern levelling deposit and herringbone paved surface.

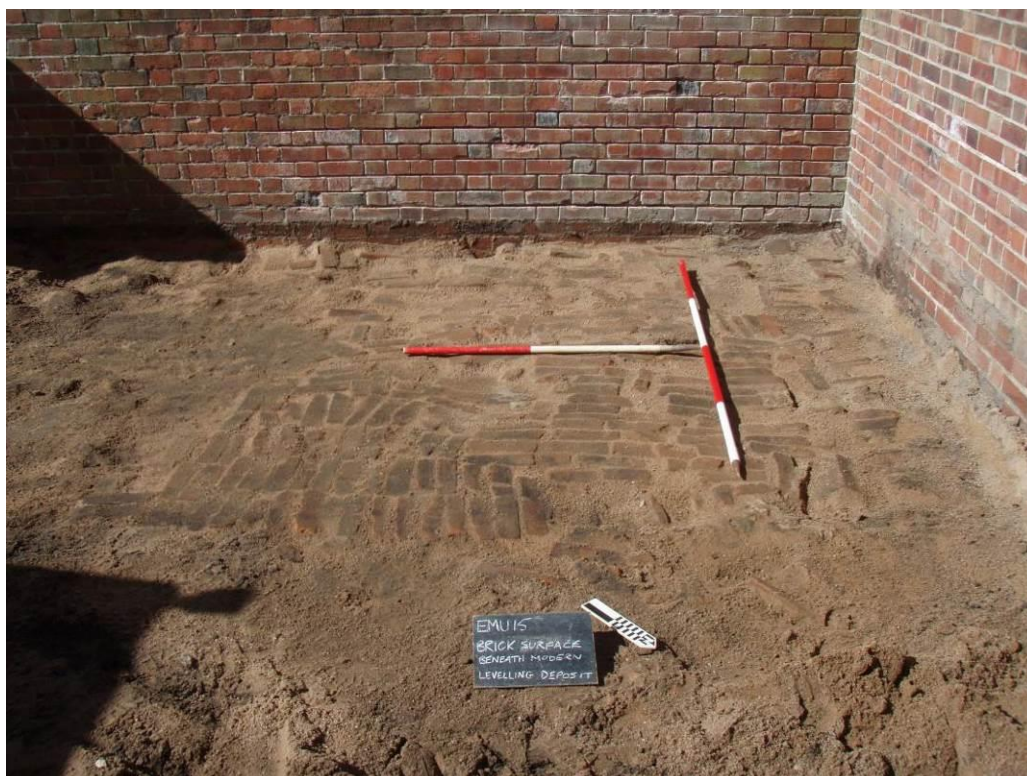
Figure 5. Buried brick surface (F104) facing south-west. Scale 2m x 1m.

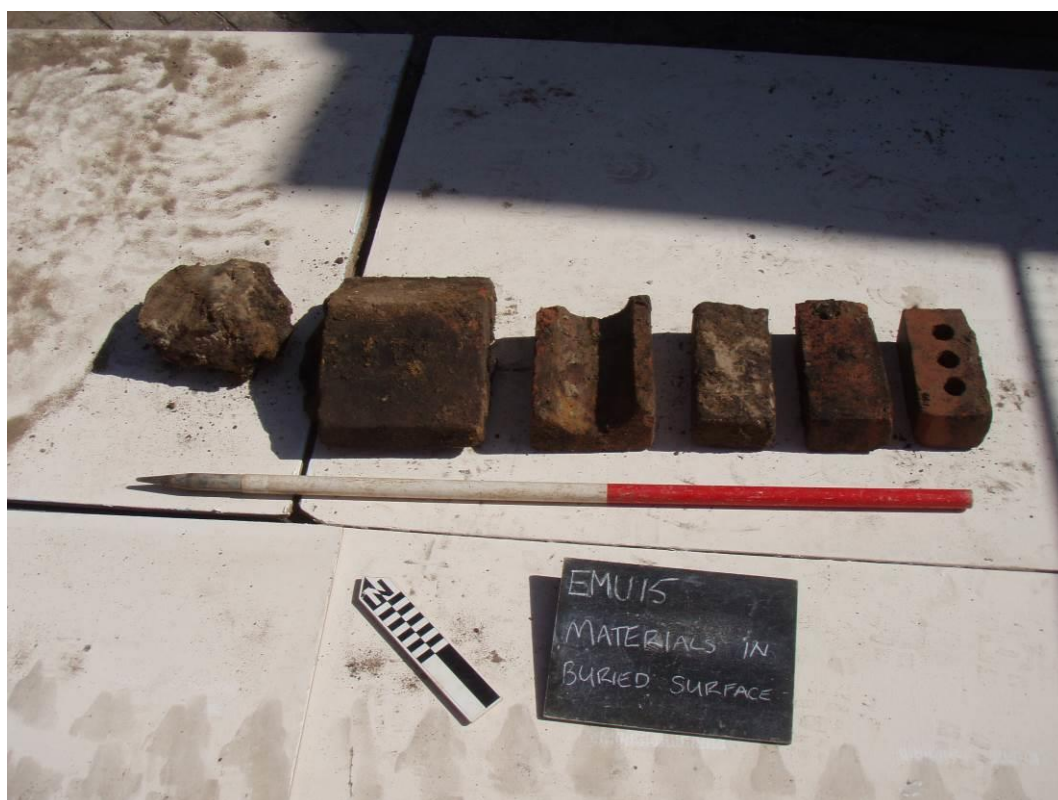
Figure 6. Types of coarse building material used in F104. From left to right: sandstone, saddleback coping bricks, curved drainage bricks, grey and red unfrosted bricks and red machine-made bricks.

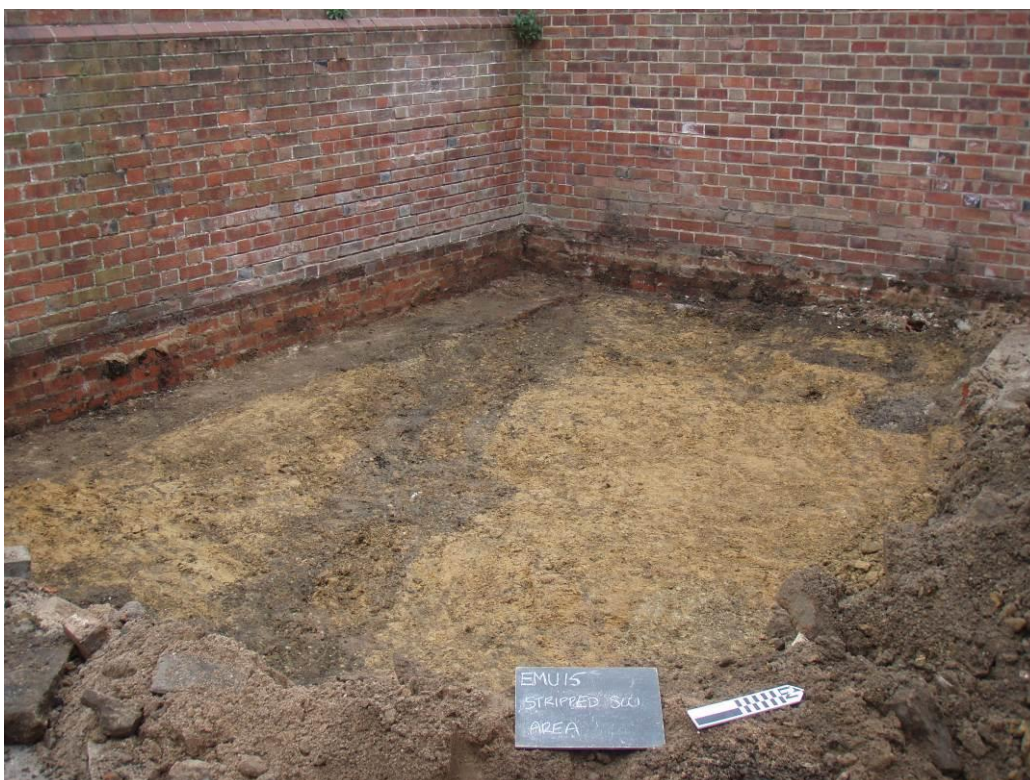
Figure 7. Archaeological features cut into natural deposits in the south-western portion of the site. To the left is a concrete wall footing, a linear feature is visible in the centre (F105) and two small pits (F107) and (F115) are present in the upper right corner.

- 5.3 Directly beneath the buried brick surface (F104) was a dark grey sandy silt deposit (102) which contained pottery, ceramic building material, animal bone and glass. This context (102) was directly above the natural yellow clay (109). Several features were cut into the natural (109) and filled with deposits which resembled context 102 (Figure 7).

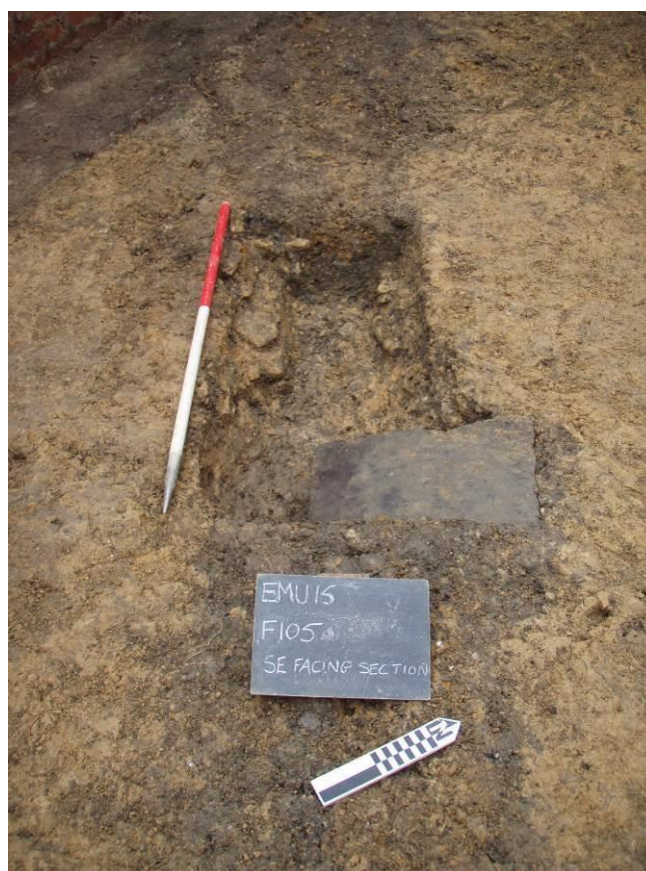
Figure 8. South-east facing section of the slot dug across feature 105. The possible capstone may be seen to at the bottom right of the slot. Scale 1m.

- 5.4 A linear feature, *c.*0.45 m in width, ran east to west across the excavated area. A 1.2m long slot was excavated across the feature. The slot was 0.24m deep and contained semi-decomposed leaf litter in addition to brick, pottery and glass similar to that found in context 102. The fill of F105 was similar to context 102 except for the presence of semi-decomposed leaf litter, which was only found in the fill of F105. A possible cap stone was encountered and left *in-situ* (Figure 9). The base of the linear feature was cut into the natural sandstone bedrock. The shape and presence of semi-decomposed leaf litter suggests this feature represents a drain cut into the natural sandstone.

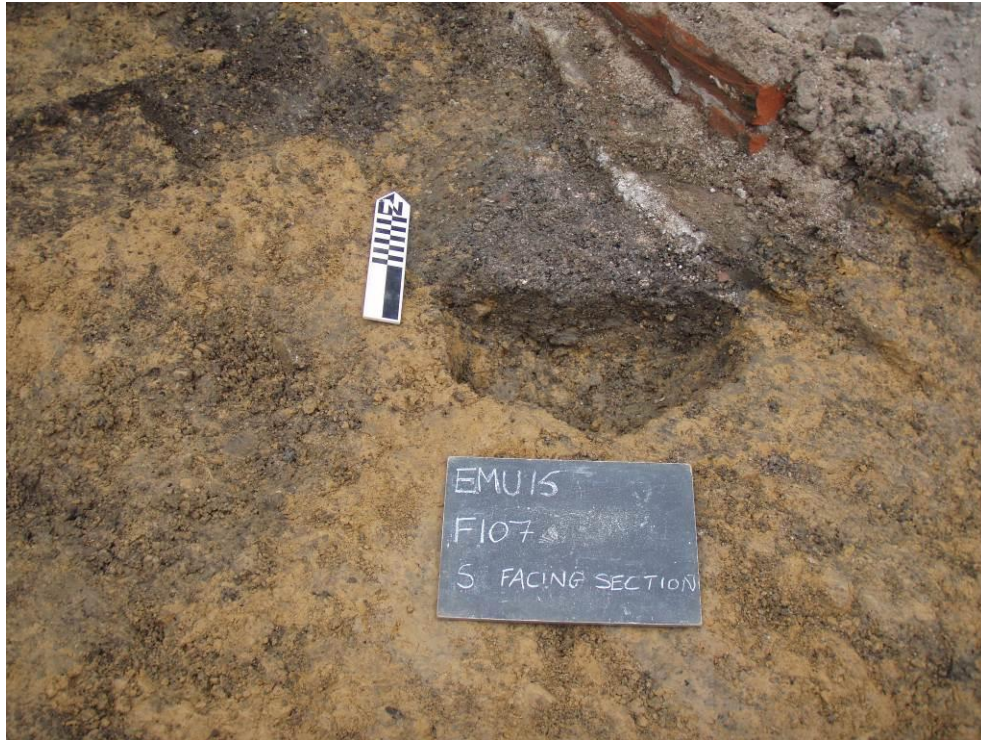
Figure 9. South facing section of F107. Scale 0.25m.

- 5.5 A small pit (F107), 0.45m in diameter, was also cut into the natural sandstone. The northern corner of this pit was partially truncated by the concrete footing of a modern brick path boundary wall (Figure 9). The pit was 50% sampled. The pit contained a grey silt deposit similar to context (102) with some patches of ashy sand. No archaeological material was recovered from this feature.

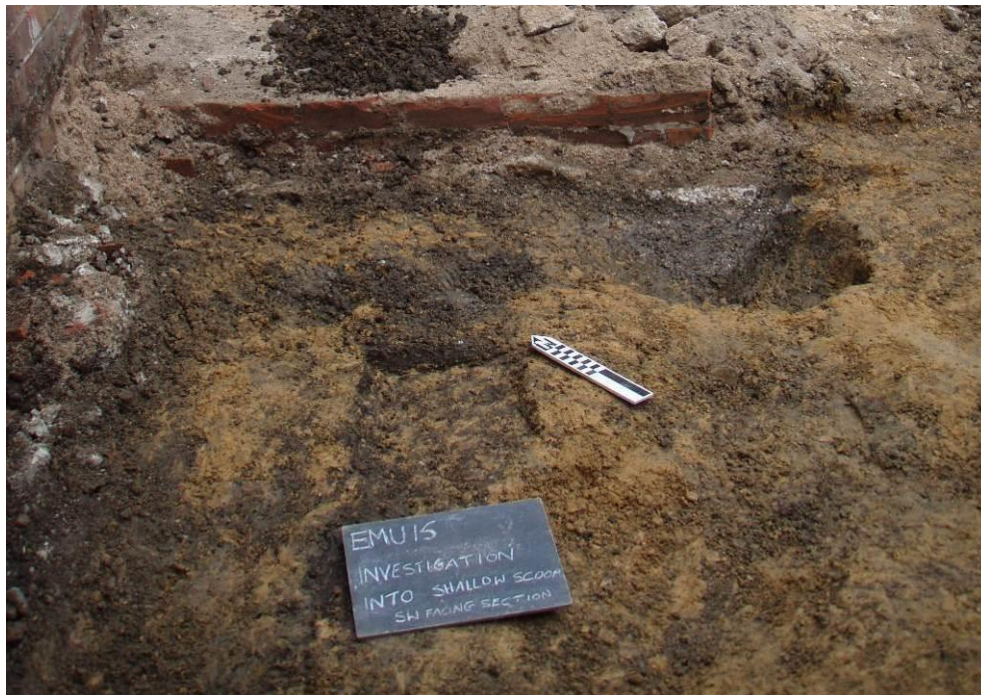
Figure 10. Investigation slot into F115. The patch was very shallow and likely the result of a naturally occurring depression in the underlying deposit.

- 5.6 Another small patch oval patch of darker soil was identified within the natural clay next to F107. The fill of this patch (115) was a dark grey clay very similar to (102). The fill was extremely shallow, and this feature may represent a naturally occurring hollow in the natural deposits (Figure 10).

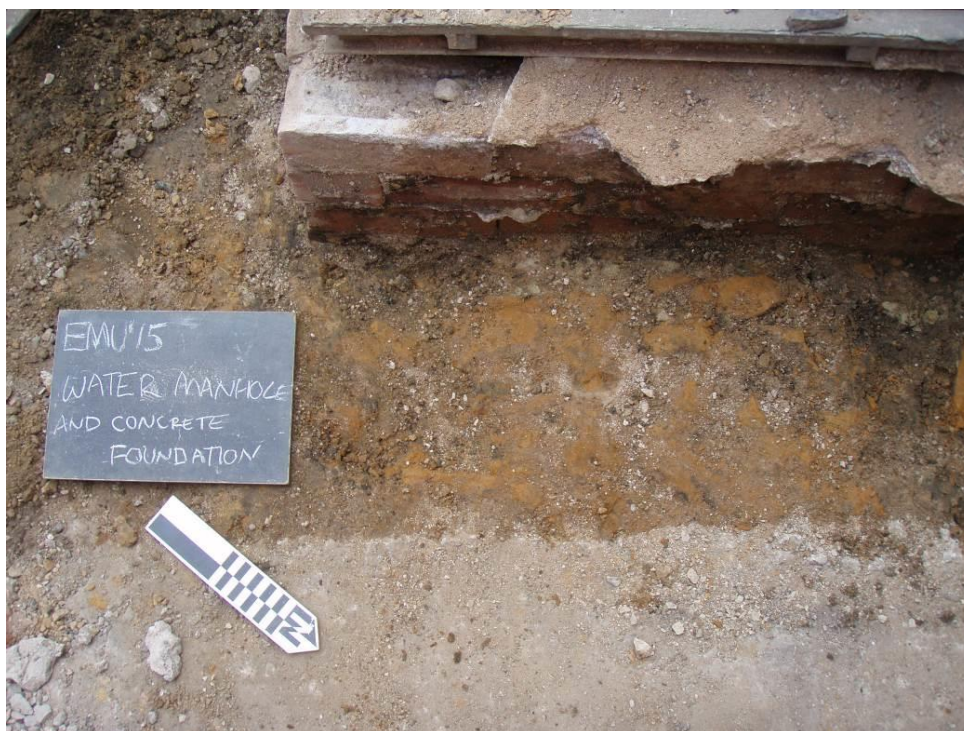
Figure 12. Manhole for water service and the concrete staircase foundation, cut into yellow natural clay (109).

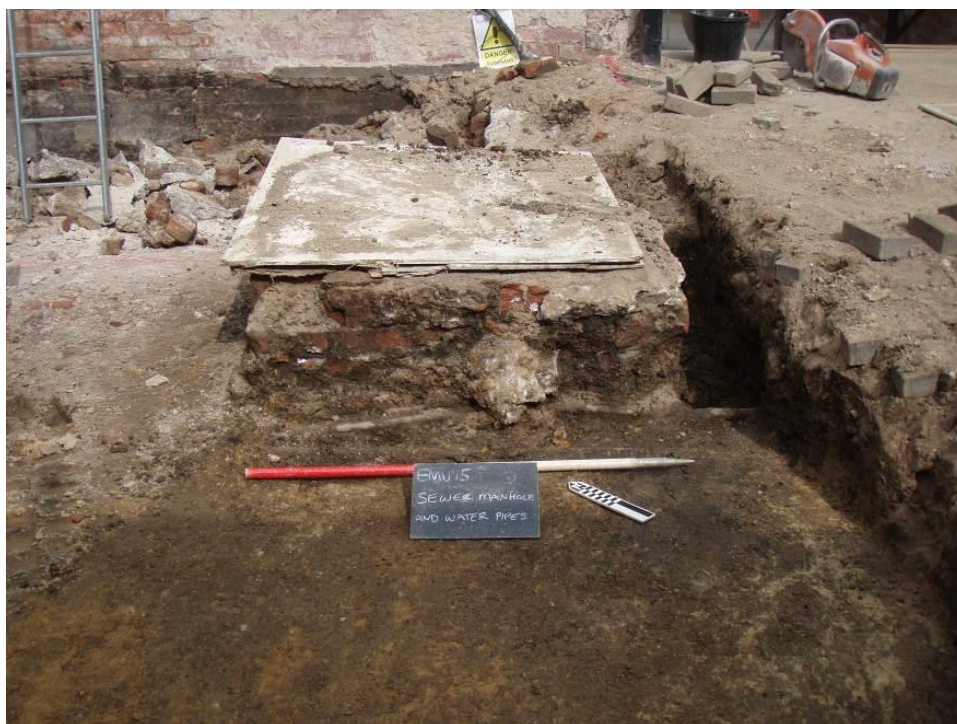
Figure 13. The manhole for sewer maintenance, post-excitation to a depth of 0.5m. The manhole was left *in-situ*, along with the water pipes visible just to the fore of the manhole.

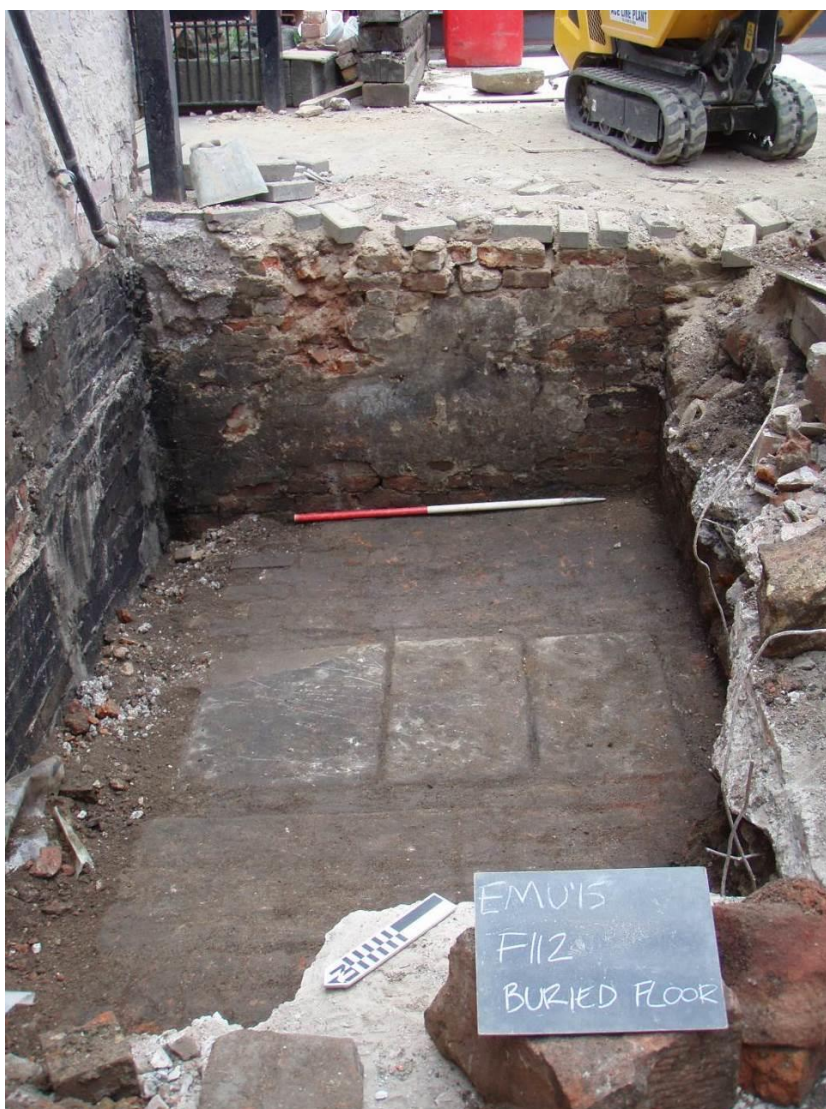
Figure 14. The buried stone and brick floor (F112) in the eastern corner of the excavated area. A brick wall can be seen extending from the stone and brick floor up to the current herringbone paving bricks. A second brick wall, to the right, has been partially truncated by the sewer manhole and concrete staircase foundation.

them, at a depth of 0.5m from the original herringbone brick surface, was a large concrete foundation which extended over the entire north-eastern portion of the excavated area. Due to the difficulty posed by removing this concrete foundation, the concrete was only removed in areas where the foundations for the building extension required further excavation. Where no further excavation was required, the concrete was left *in-situ*. Where removal was necessary, the concrete foundation was broken and removed by machine. Beneath the concrete foundation was a 0.6m thick deposit of brick and stone rubble mixed with soil (110). Beneath this rubble deposit, at a depth of 1.05m, a buried archaeological surface was identified (F112). This feature consisted of a buried surface of several large rectangular stones surrounded by laid, unfrogged bricks with no evidence of mortar. The removal of the rubble deposit (110) also revealed the existence of two buried brick walls on two sides of the buried stone and brick floor (F112). The rubble deposit (110) seems to have been used to fill this buried structure. Various ceramic building material was present in (110, including red bricks (some of which were unfrogged) and sandstone blocks (Figure 16).

- 8.4 The buried stone and brick surface (F112) in the eastern corner of the excavated area, at a depth of 1.5m, was likely associated with the stable building. The brick walls on two sides suggest this was an extension of the stable building. An Ordnance Survey map surveyed in 1879-1880 and published in 1884 shows buildings where the stable appears to extend further south-west (Figure 18). F112 and the two buried walls may be related to this past extension. The soil and rubble fill of this structure (110) contained a copper alloy door knob of late 19<sup>th</sup>-early 20<sup>th</sup> centuries date, providing a time period for the in-filling of this buried structure. The concrete slab and brick staircase laid above it are a modern construction related to the current use of the site as a museum.

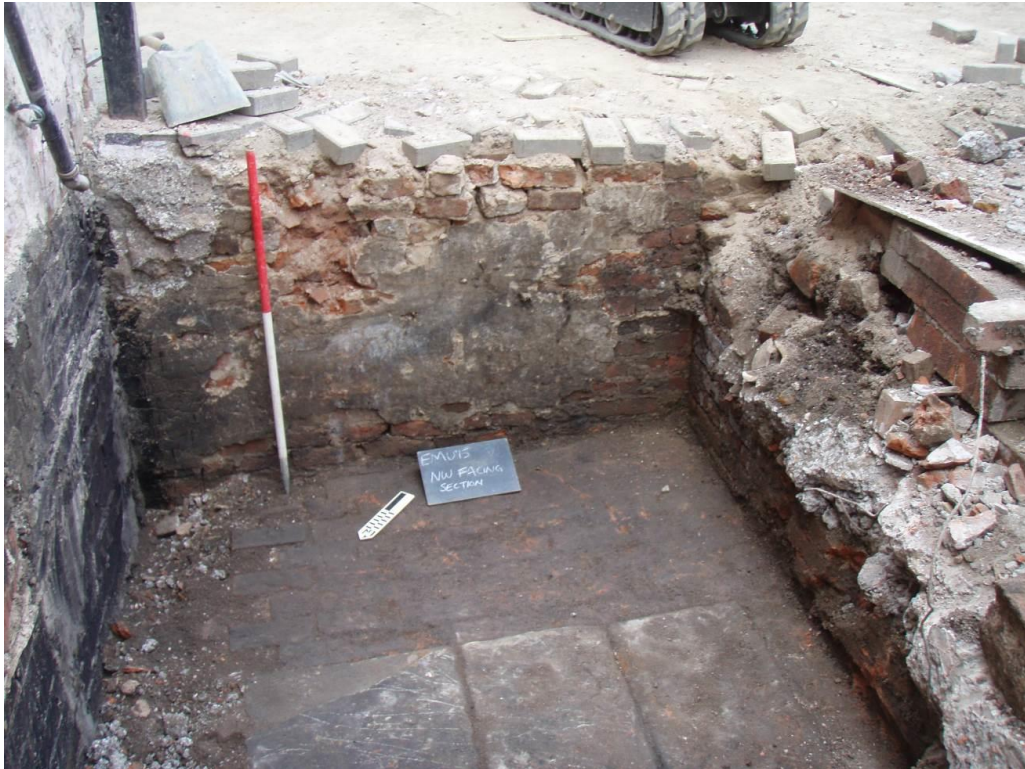
Figure 15. F112 showing the cut and removed bricks to the left, along the current stable wall. Scale 1m.

- 5.10 A cut was present along the current stable wall. This cut was made for the modern installation of asbestos boards along the base of the wall. Monitoring was not possible during the removal of the boards. The trench dug for the installation of the boards had cut into the buried floor surface (F112) and the bricks from F112 nearest to the stable building wall had been removed (Figure 16).

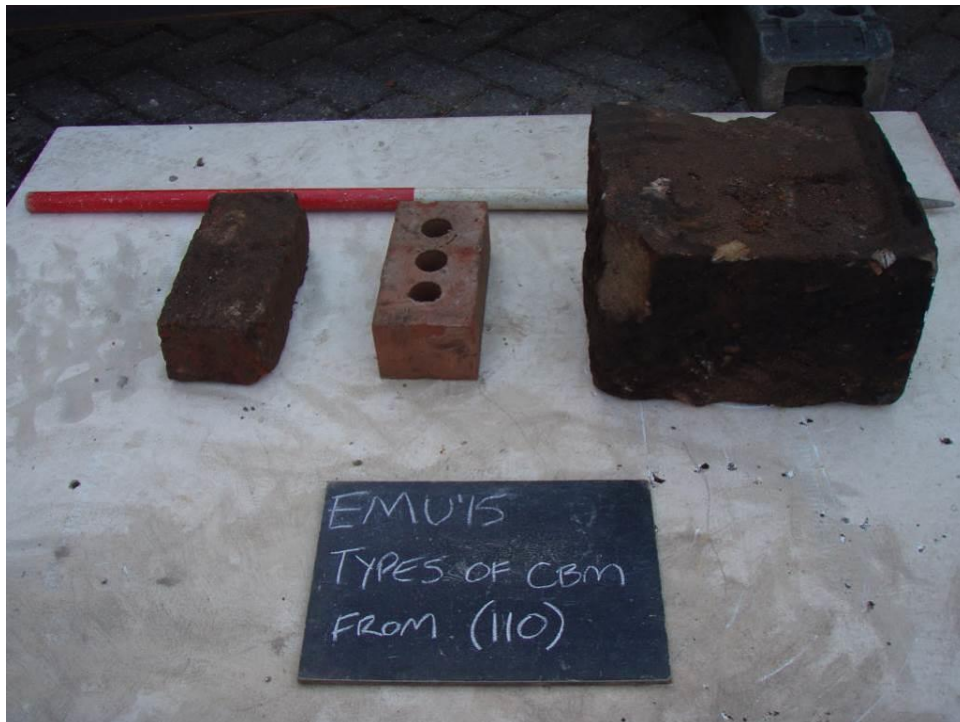
Figure 16. From left to right: unfrosted red brick, potted red brick and a shaped sandstone block, representative of the types of coarse building material present in context 110.

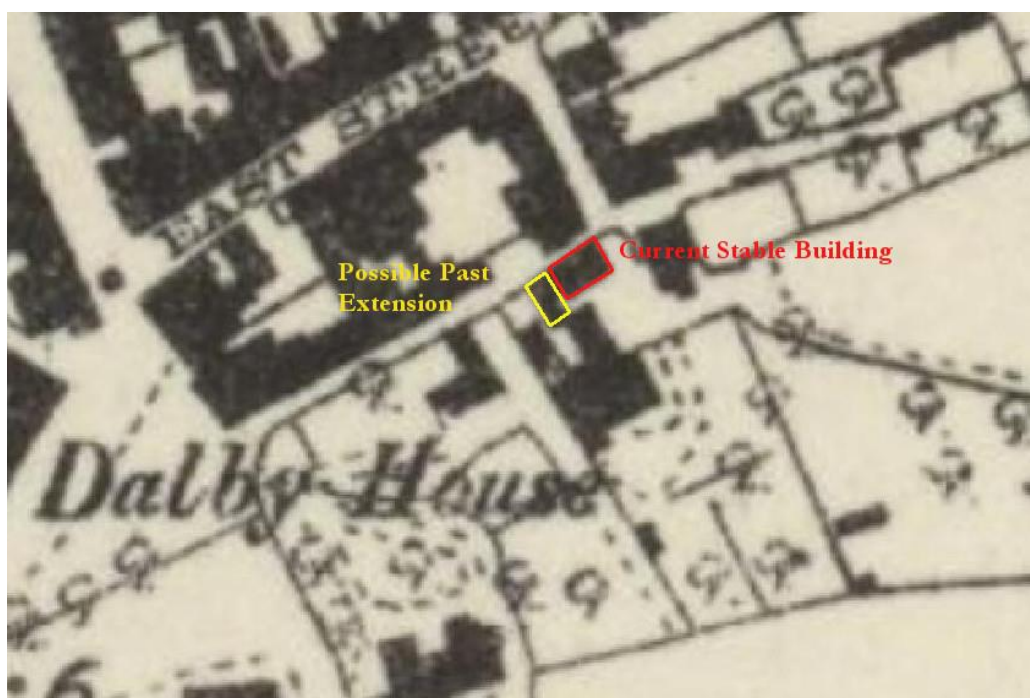
Figure 17. Ordnance Survey map surveyed in 1879-1880 and published in 1884, showing a possible past extension to the current stable building.

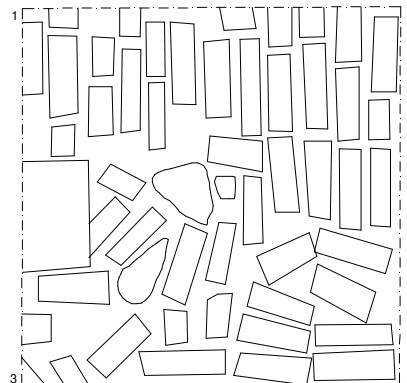
Title: Erewash Museum and Gardens  
Scale: Excavation at 0.18m depth  
Plan at 1:50  
Brick detail at 1:20

F104 Detail of laid brick

A pre-excavation site plan was drawn at 1:50, and subsequent plans were drawn at 0.18m, 0.4m, and 1.05m.

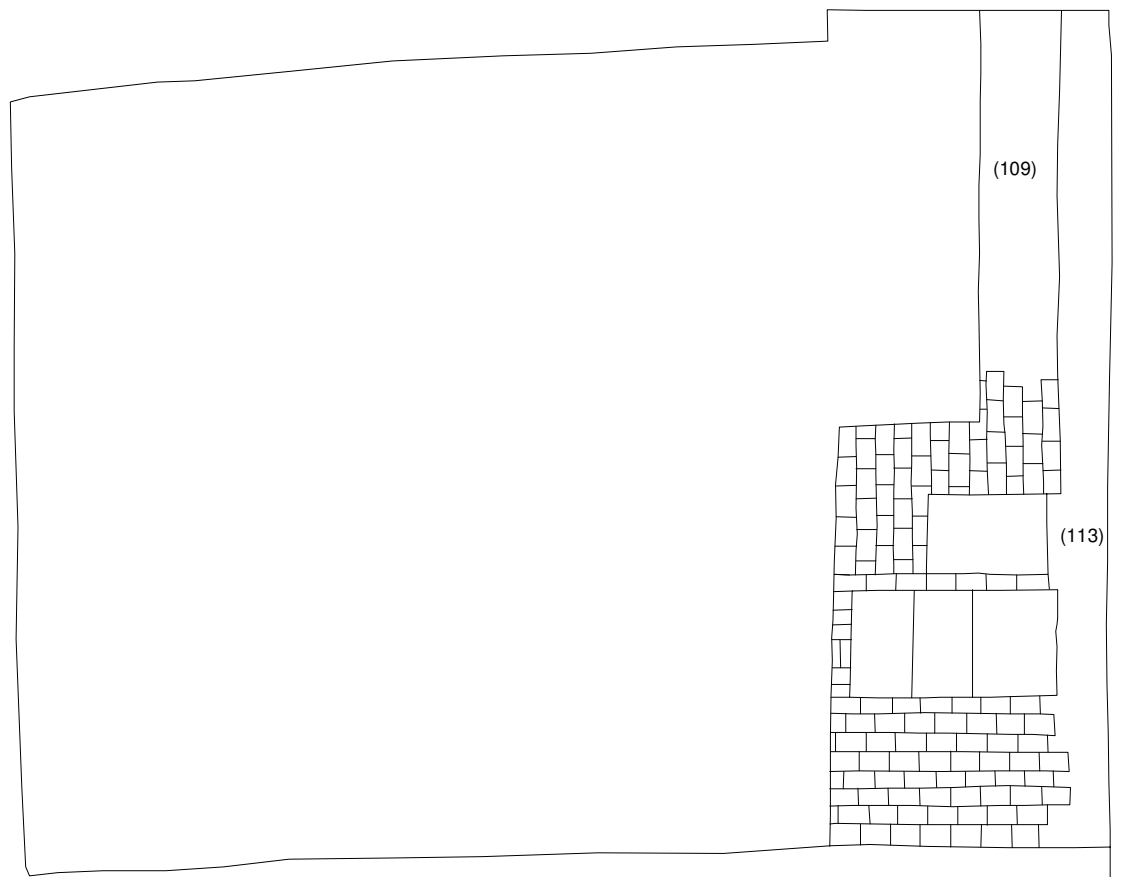
Title: Erewash Museum and Gardens  
Depth 1.05m

Area excavated to a depth of 1.05m.

Brick and stone floor (F112).

Natural (109) and disturbed (113) deposits.

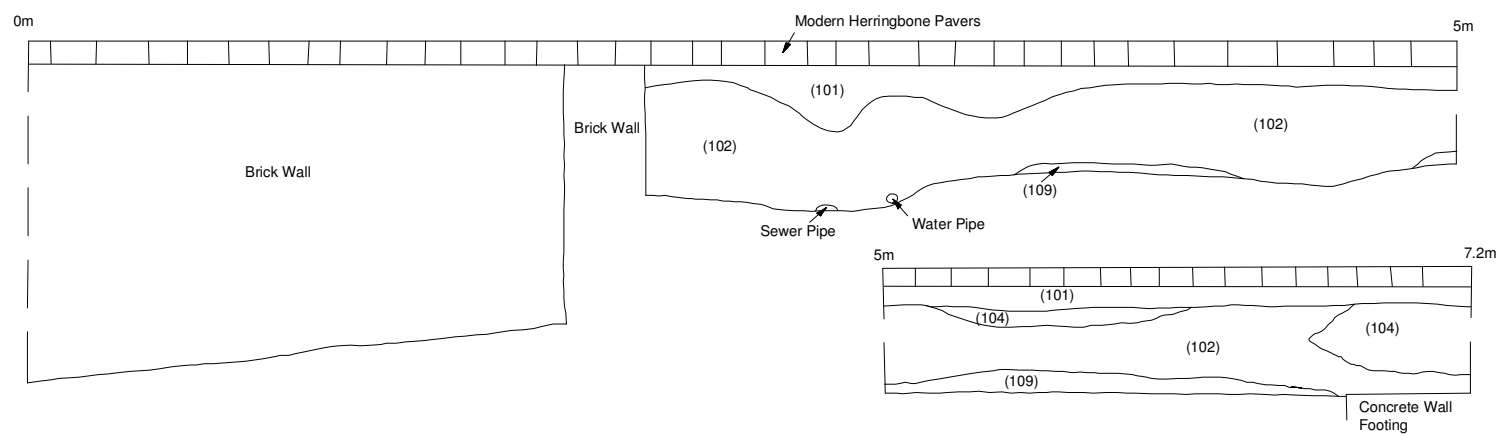
Title: Erewash Museum and Gardens  
Northwest Facing Section  
Scale: 1:50

The north-west facing soil section was drawn at 1:50.
