# St Michael and All Angels Church, Taddington, Derbyshire: An Archaeological Watching Brief

ARS Ltd Report No.2015/117

*Project Name: St Michael and All Angels Church, Taddington, Derbyshire: An Archaeological Watching Brief*

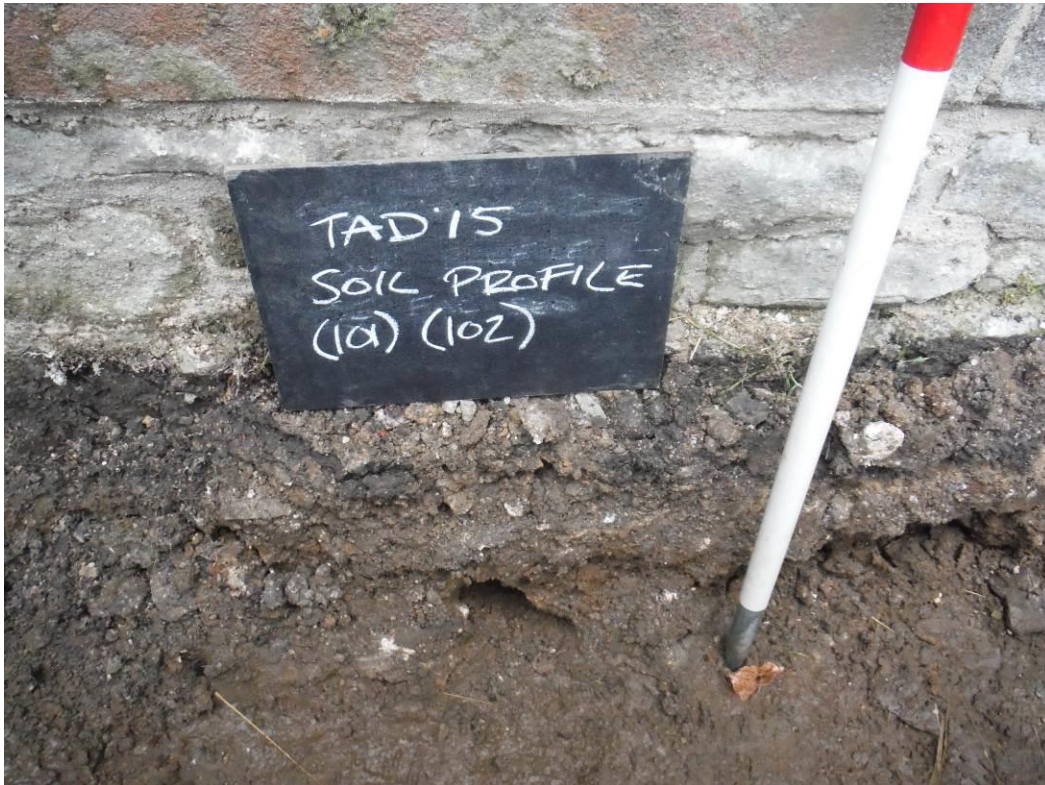
6.1 A 0.5m wide trench, 21m in length, was dug along the north side of the church, which then turned northeast away from the church (see Appendix 1 – Site Plan). A second shorter trench, 6.4m in length, was dug from the northeast corner of the church to the main trench. Both trenches were 0.3-0.4m deep along the side of the church (Figure 1), becoming deeper further from the church with a maximum depth of 1.4m.

Figure 1. Trench depth along church wall. Scale 0.5m.

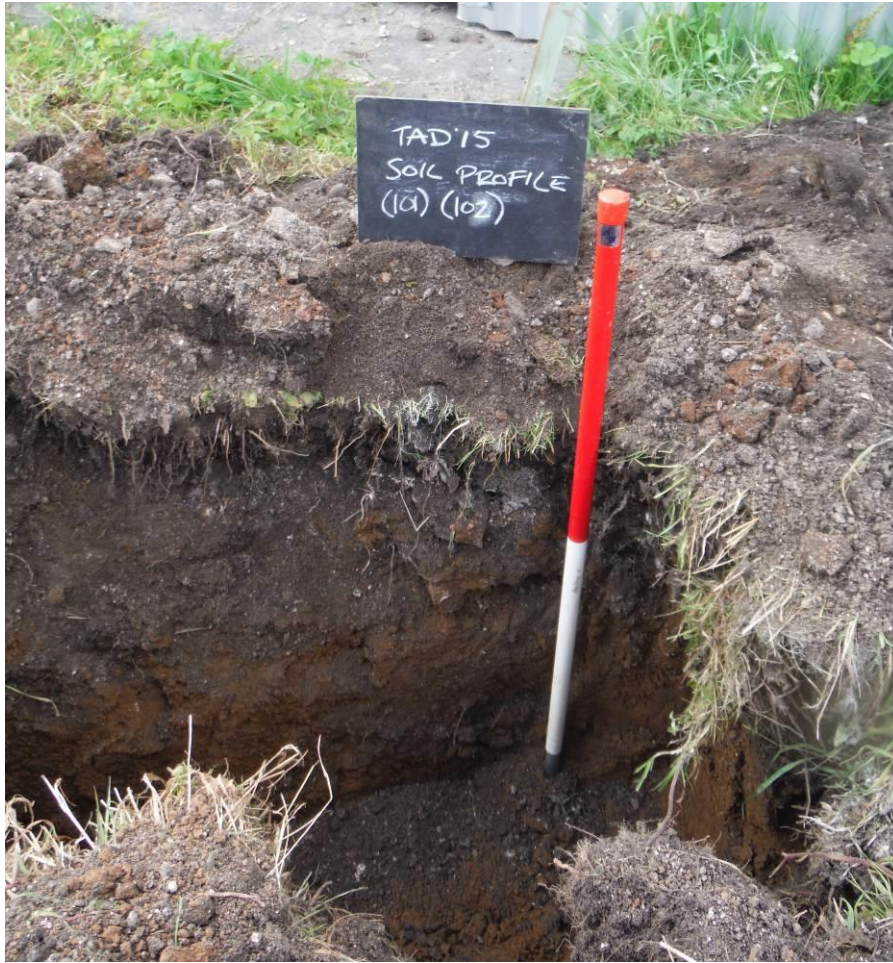
6.2 The undisturbed soil stratigraphy consisted of 0.25-0.4m of dark grey-brown silty topsoil (101) over a reddish brown clay subsoil(102). The reddish brown clay subsoil continued past the maximum depth of excavation (Figure 2).

Figure 2. Soil profile of (101) and (102). Scale 1m.

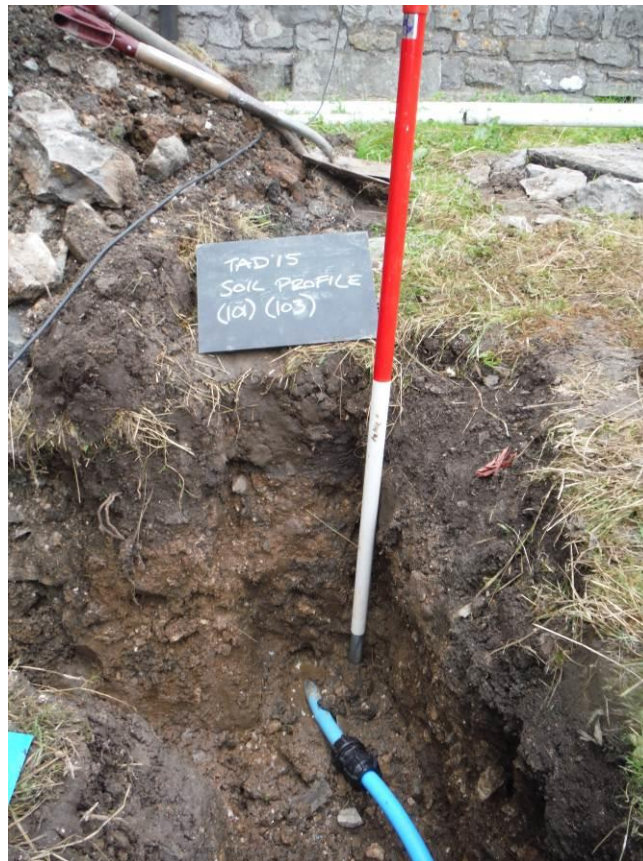
6.3 A grey silty sand fill (103) was present in the main trench (Figure 3) in association with a modern plastic water duct and a retaining wall located 0.6m from the wall of the church. The retaining wall formed a part of the previous drainage system. The grey silty sand (103) was cut into the reddish brown clay subsoil (102). It was unclear whether this cut was made as a part of the construction of the retaining wall or the installation of the water pipe. The wall foundation was not exposed during the excavation.

Figure 3. Soil profile of (101) and (103), containing modern water pipe. Scale 1m.

6.4 66 fragments of previously disturbed human remains were recovered from context (103). These remains were not in-situ, and were likely disturbed during the construction of the retaining wall or the installation of the water pipe. This is supported by find of modern pottery and iron nails in the same context.
