All Saints Church, Elton, Derbyshire.

**Report on a watching brief
undertaken during drainage works.**

ARS Ltd Report 2007/5
February 2007

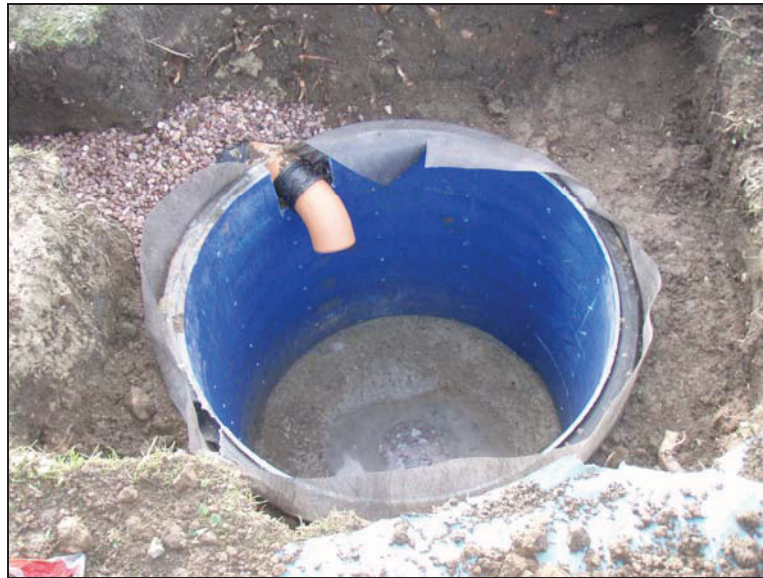
Figure 3. View of completed soakaway four.

- 5.1 The drainage trenches were dug manually with a spade to a maximum depth of 0.53m and a width of 0.4m to accommodate pipes with a diameter of 0.1m. The drainage pipes connected to existing down pipes from the church and were attached to four soakaways that were 1.2m in width and varied in depth up to 1.5m deep (Fig. 3).

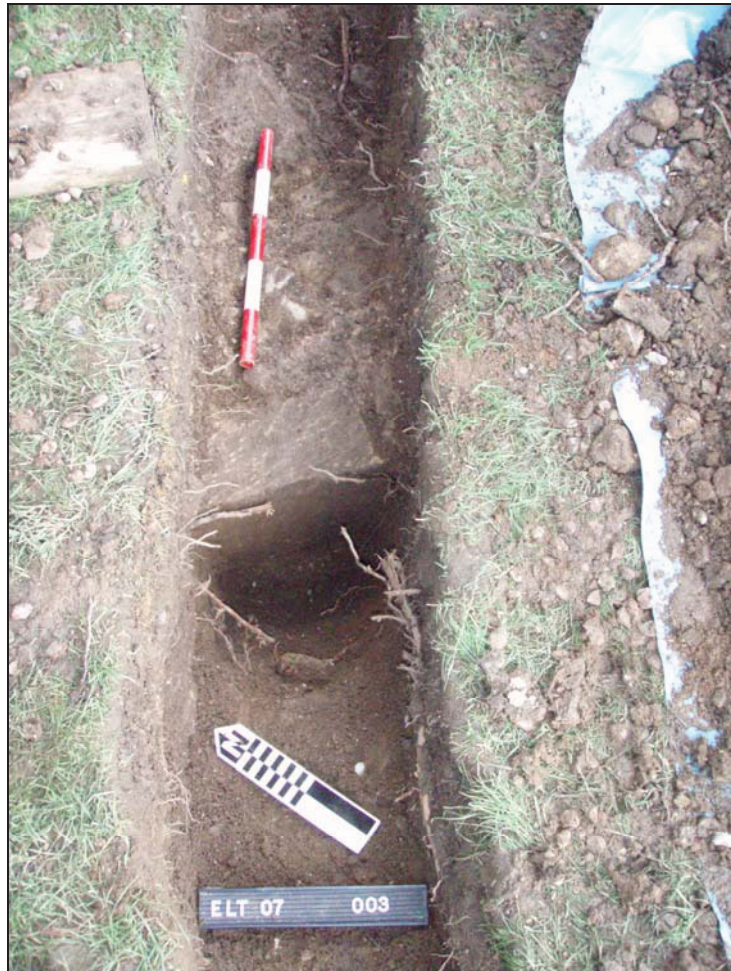
- 6.5 A substantial sandstone wall (003) was uncovered within trench four, 0.85m from the west corner of the tower (Figs. 4 and 5). The wall appeared to run parallel with the present tower wall suggesting that it could be the remains of an earlier

church tower. Only a 0.4m wide section of the wall was exposed as this was the maximum extent of the trench (Fig. 4). The width of the wall, which was 0.96m and consisted of two outer courses of ashlar sandstone blocks with an inner core of smaller stones. The extent of the wall below the ground was undeterminable but at a depth of 0.44m below the surface of the ground the blocks were angled slightly outwards. This chamfering technique was used to aid the drainage of rainwater on external walls (Parsons 1998, 52).

Figure 4. View of wall discovered within trench four looking east (Scale: 0.5m).

- 8.2 The discovery of a substantial sandstone wall on a similar alignment as the present tower suggests that it could be the remains of the previous tower. Its size and construction implies it was an exterior wall. However, plans of the old church do not correspond with the position of this wall but rather show that the new tower directly overlay the old towers foundations. The discovery of the wall may mean that the plans were not totally accurate, which is not uncommon, or that the wall found represents part of an unrecorded construction of an unknown date.

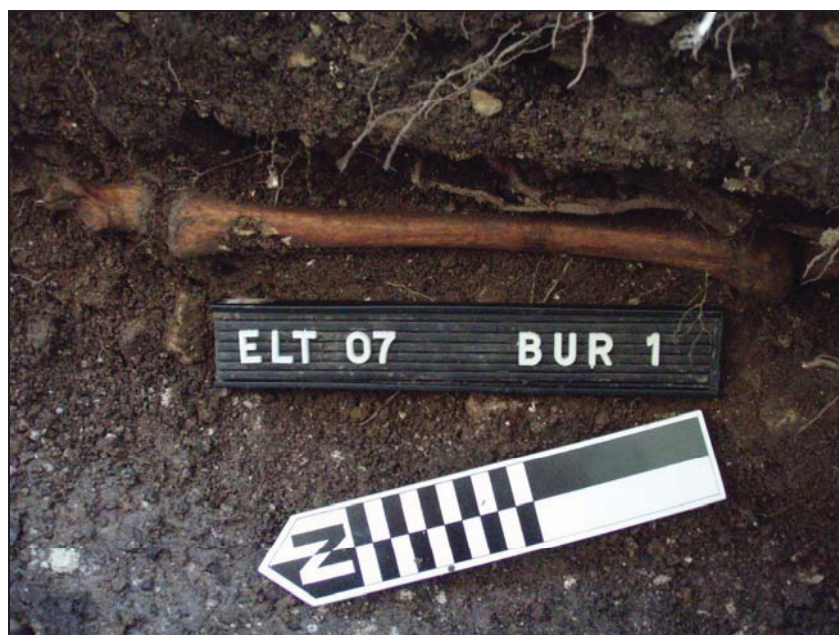
7.1 Burial one (005) was located within trench four, 0.48m south from the west corner of the main church building and 7.72m west from the west side of the porch. The remains were positioned in the side of the trench and could not be fully excavated without extending the trench (Fig. 6). The remains uncovered consisted of the left tibia and fibula and the bones from the left foot. The tibia's epiphyseal ends were not fused which happens during puberty. This suggests that the remains were from a juvenile under the age of 16 years old. Part of a disarticulated female pelvis was found close to the burial but it was not possible to state whether it was connected. The burial was recorded and left *in situ*.

Figure 6. View of burial one (Scale: 0.25m)

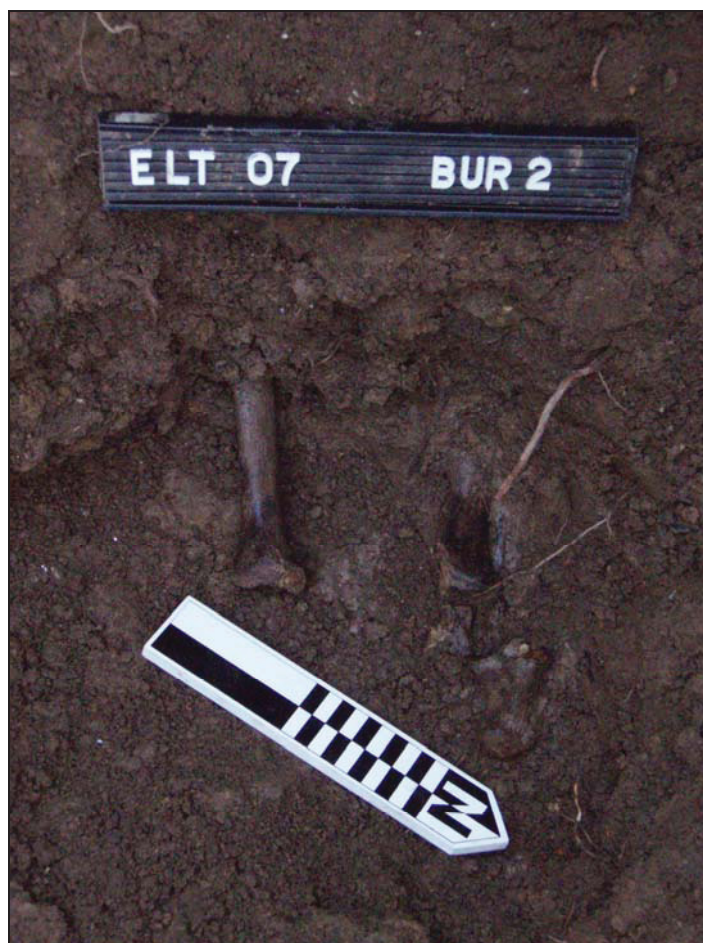
7.2 Burial two (007) was located in the north-west corner of soakaway three. The position of the skeleton suggested that the headstone for this burial had been lost as the remains were in line with other headstones close by. The remains were supine and extended and consisted of the distal ends of both tibia and fibula, the bones from the right foot and left calcaneus and talus of an adult. The remains were found within a clay deposit (006) (Fig.7). Related to these remains a metal

artefact, probably a coffin handle, was uncovered. The remains were covered with a wooden box and left *in situ*.

Figure 7. View of burial two (Scale: 0.25m).

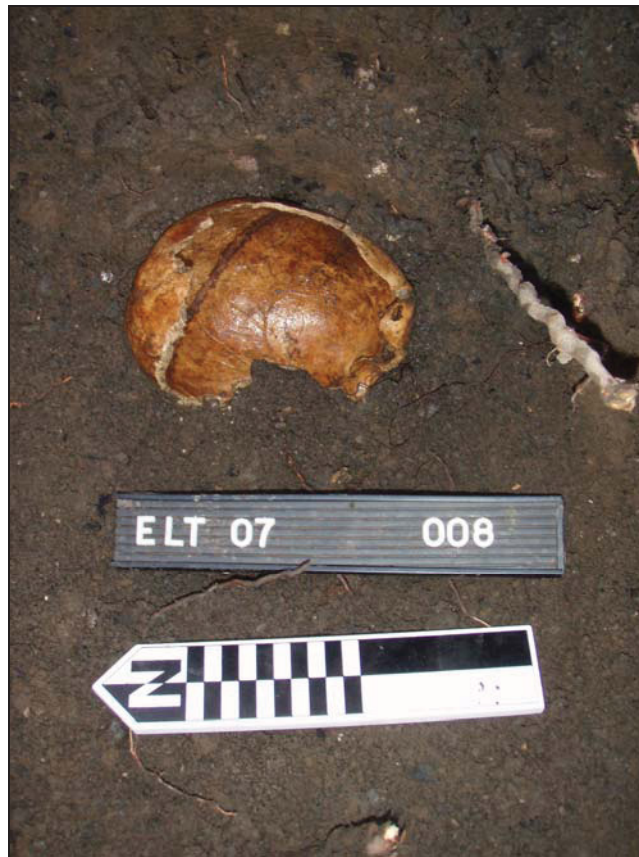
- 7.3 Whilst digging soakaway four a disarticulated skull (008) was uncovered 0.72m below the surface of the ground. Further excavation revealed articulated remains, directly beneath the skull (Burial 3), at a depth of 1.1m below the surface of the ground. It was impossible to state whether the skull was related to the burial as it could have been deposited at a later date. The skull was aligned north-south and was laid on its' left side, partially face down (Fig. 8). Some disarticulated pieces of jaw with teeth were located close by and were possibly related to this skull.
- 7.3.1 Burial three (009) consisted of both the left tibia and femur of an adult (Fig. 9). The remains were located within the side of the soakaway and could not be uncovered without extending the trench. Both the skull (008) and burial three were located within the topsoil (002).

Figure 8. View of skull (008) (Scale: 0.25m).

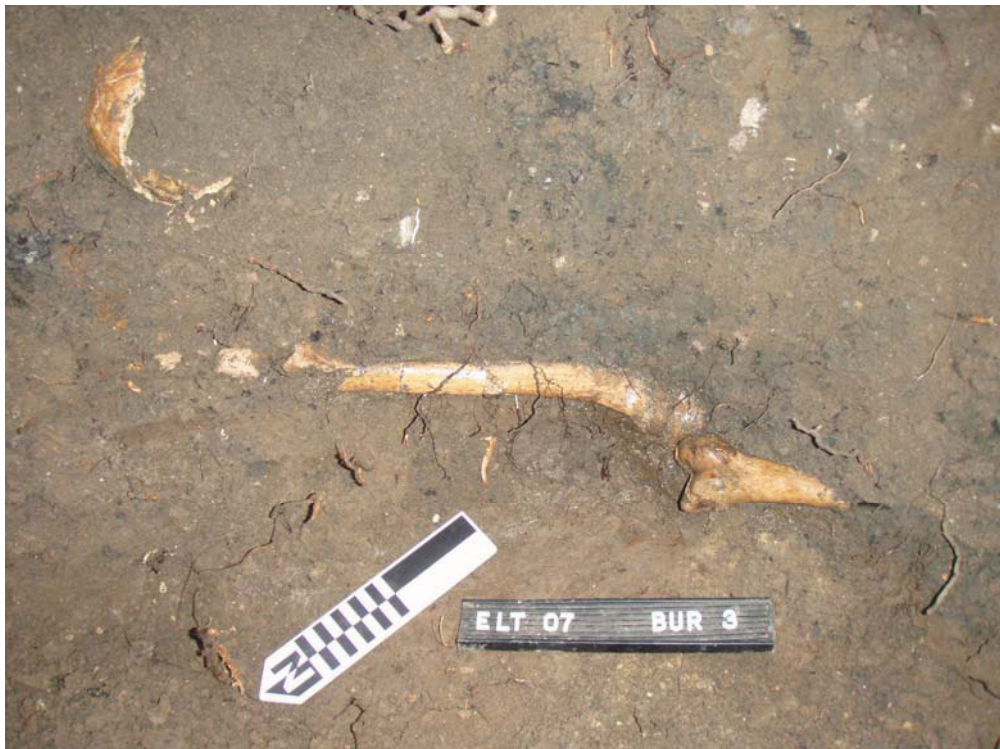
Figure 9. View of burial three (Scale: 0.25m).

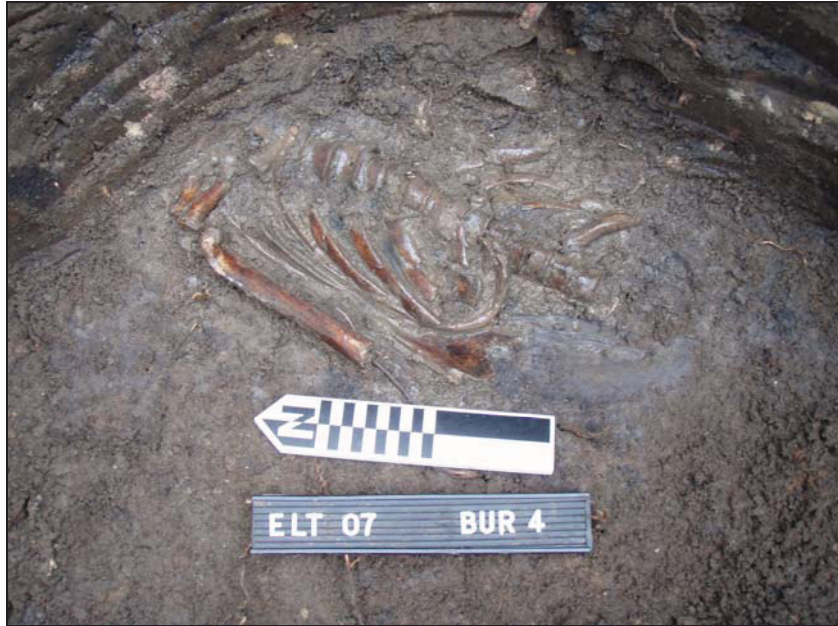
- 7.4 Burial four was located in the south-east corner of soakaway four, 1.46m below the surface of the ground (Fig. 10). The remains were supine and extended and consisted of 13 vertebrae, ribs, the left humerus and radius and part of the pelvis of an adult. The arms were extended up and across the face which is an unusual position and suggests the possibility that the remains had been moved. The remains were located within a clay deposit (010) found at 1.4m below the surface of the ground. The remains were covered with a wooden box and left *in situ* (Fig. 11).

Figure 10. View of burial four (Scale: 0.25m).

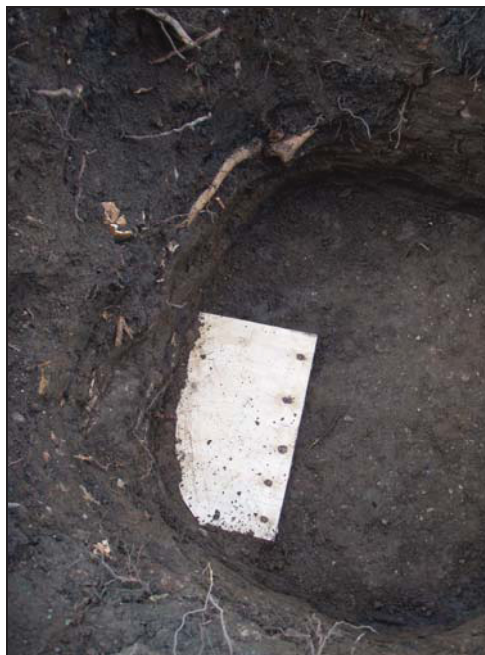
Figure 11. View of burial four covered by the wooden box - shows proximity of burial three above.

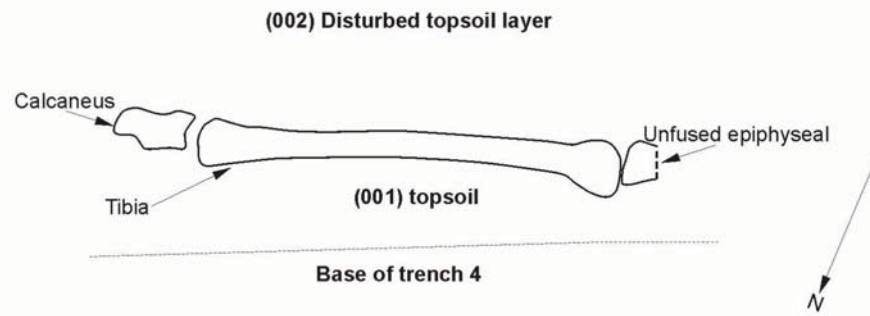
Plan of Burial 1

Figure. 12
Plans of burials 1 and 2.

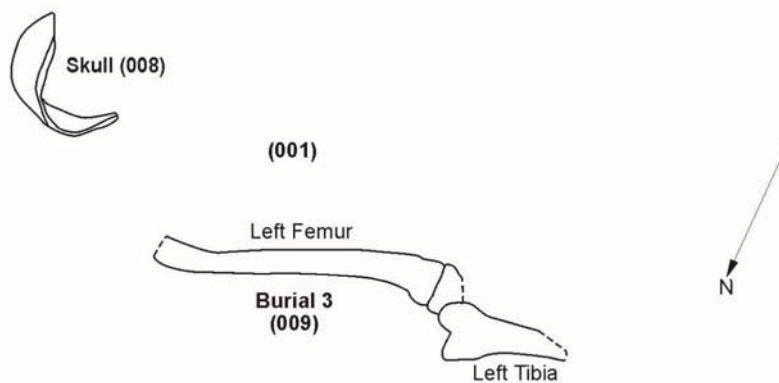
Figure. 13
Section of Burial 3 with (008).
Plan of Burial 4.

Section showing skull (008) and Burial 3 in soakaway 4.

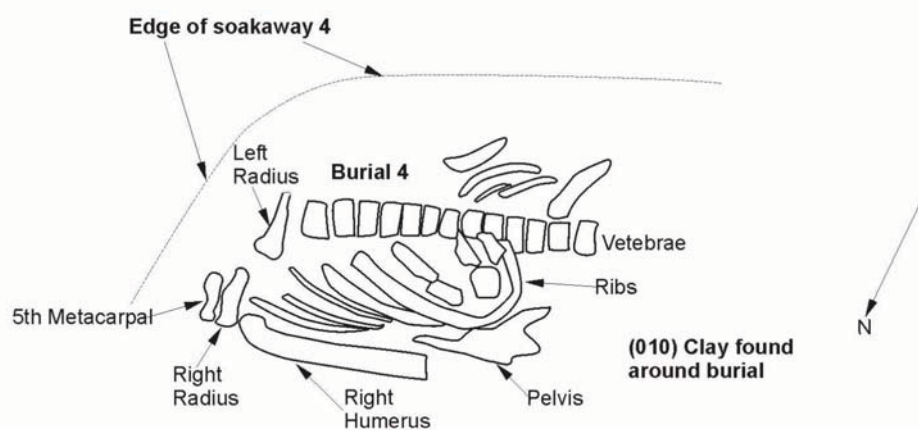
Plan of Burial 4 in soakaway 4.
