Provincial House, Solly Street, Sheffield: An Archaeological Field Evaluation

ARS Ltd Report No. 2015/149

Project Name: Provincial House, Solly Street, Sheffield: An Archaeological Field Evaluation

Location: Provincial House, Solly Street and 90 Garden Street, Sheffield

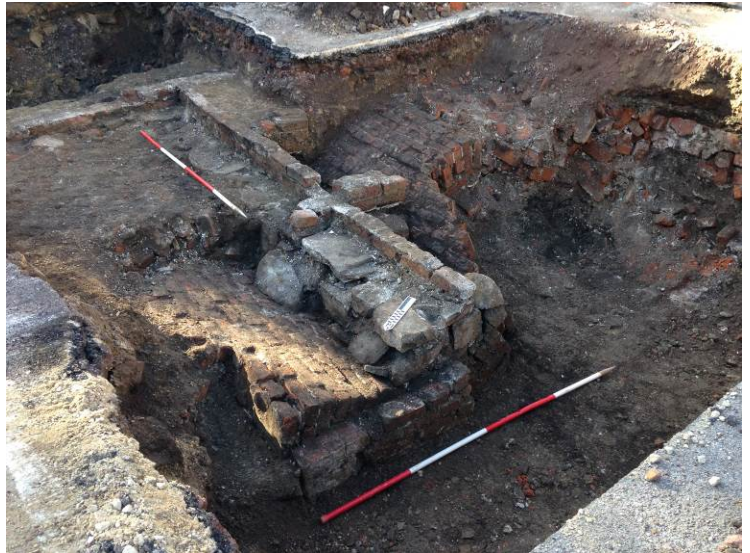
Trench 3 looking south.

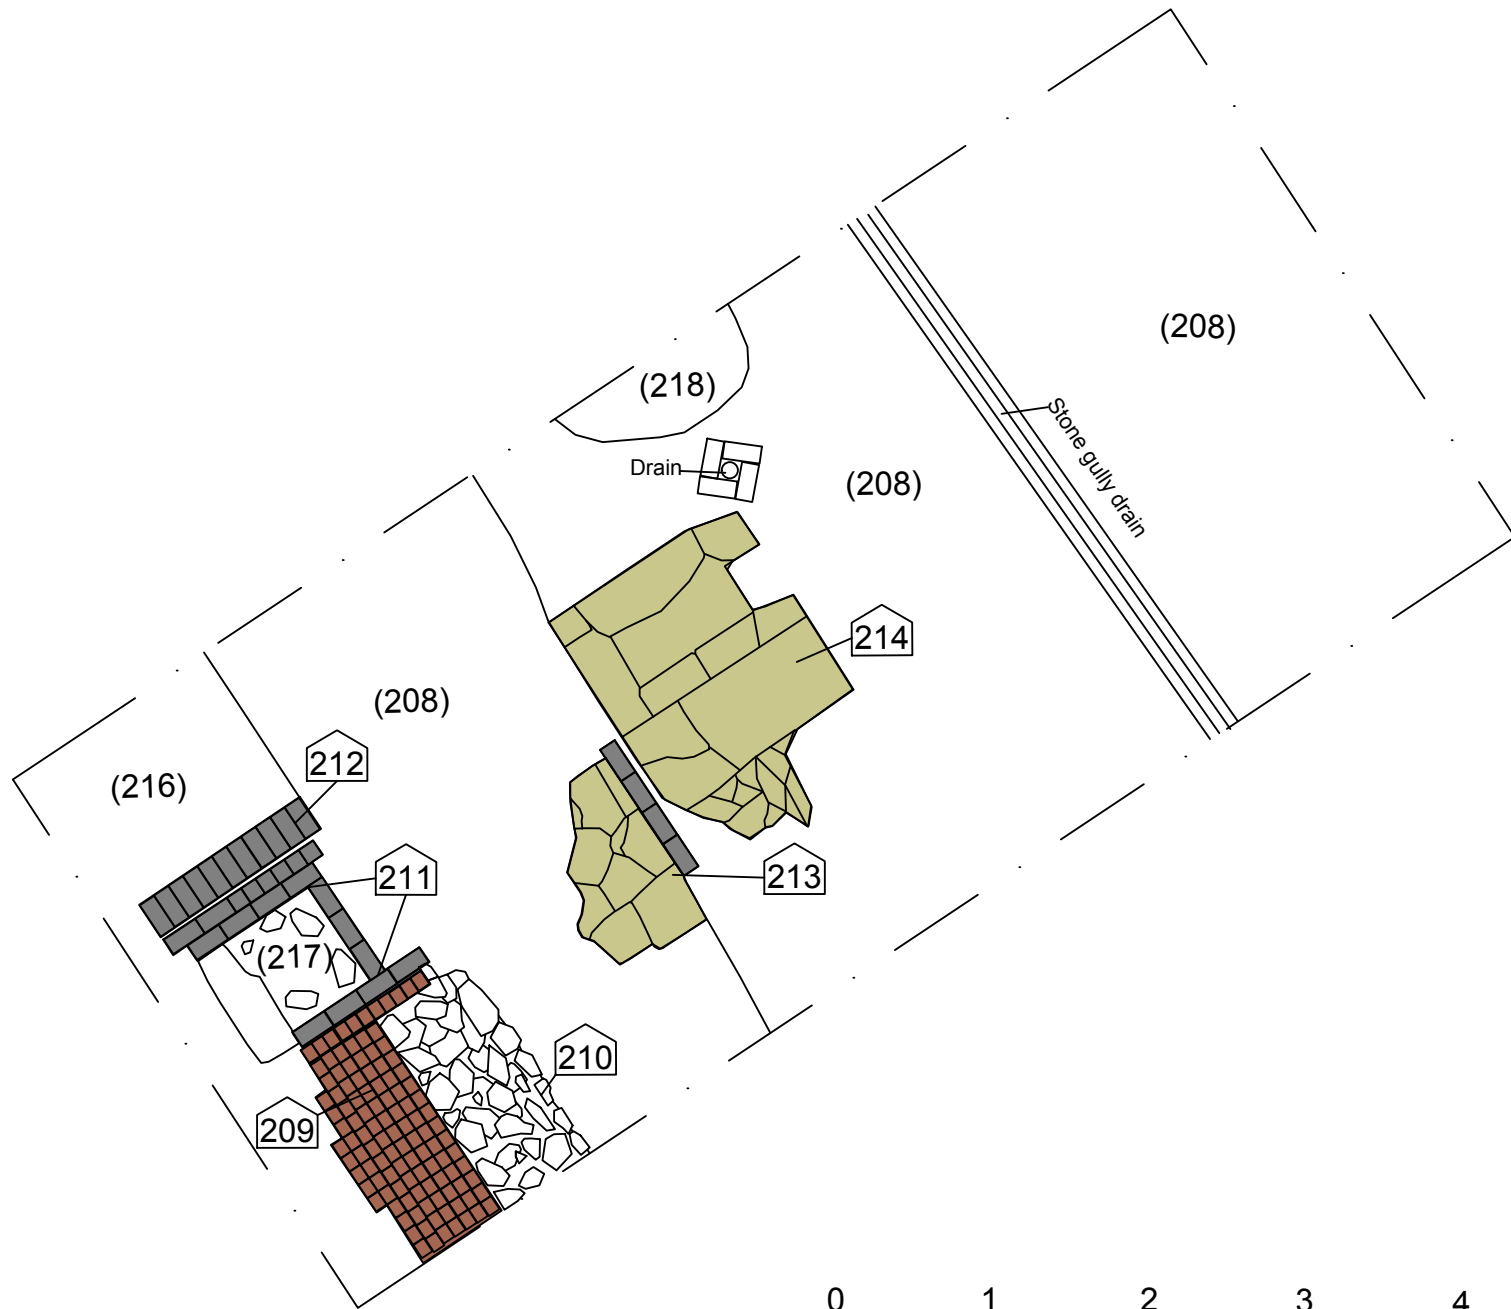
Figure 4. Trench 2 plan.
Scale: 1:50 @A4

5.7 Trench 2 (Fig. 4) was located at the western end of the upper car park and was intended to assess the preservation of the housing at Red Place and associated courtyard. Initially this trench was planned to be 10m by 4m but following discussion

with the local planning archaeologist this was reduced to 8.5m by 4m and moved approximately 1.5m to the west.

5.8 The modern concrete surface (201) overlay loose yellow-grey levelling gravel (202) throughout the trench. A layer of poorly sorted demolition rubble with fragmentary brick (206) was also present across most of the trench although the thickness of this layer varied. Degraded red sandstone composed the natural substratum throughout the whole trench (208).

5.9 In the eastern end of the trench the rubble layer came down onto an older concrete layer with stone inclusions (204). This was removed and found to sit on dark grey sand (205) which overlay the degraded red sandstone natural substratum (208). The concrete was bounded by a stone gully drain which ran across the trench along a northwest-southeast orientation. To the west of the drain the degraded red sandstone natural substratum (208) was visible without an equivalent concrete layer. An area of stone flagging F214 (c. 2m by c. 1.5m), directly overlying the natural substratum, was present in the middle of the trench. An adjacent drain to the north of this area was outlined with a square of bricks. A dark slag rich deposit (218) to the north of this drain may represent the backfill of a trench cut for the pipe.

5.10 A single skinned brick wall F213 bounded the paved area F214 on the west. A second paved area adjacent to this wall had a dark brown-black coating/fill. A single metal door latch was recovered from this material. The second paved area had a step down c.450mm.

5.11 In the west end of the trench a series of walls F210, F211, F212 and a brick-built vaulted cellar F209 were uncovered. The cellar walls F210 comprised mortared brick on top of generally unmortared irregular stone. A sharpening wheel stone was visible within the irregular stone. Finds from the interface between the irregular stone of the cellar wall F210 and the irregular sandstone backfill (216) included pottery sherds of late 18th- to early 19th-century Pearlware type and a fragment of clay pipe dating from a similar period. The vault F209 was backfilled with rubble including irregular stone and brick (217). A void to the north of the vaulted cellar was also filled with irregular stone (217).

5.12 An interruption of the natural red sandstone natural substratum (218) was seen in the north and south sections. This is likely to have been a construction cut [215] for the building of the cellar. It was not initially obvious as it was being excavated as the back fill around the cellar structure was also of irregular sandstone. The back fill (216) was, however, less compact. Wall F212 may have been a retaining wall for the irregular sandstone backfill which was packed up against it.

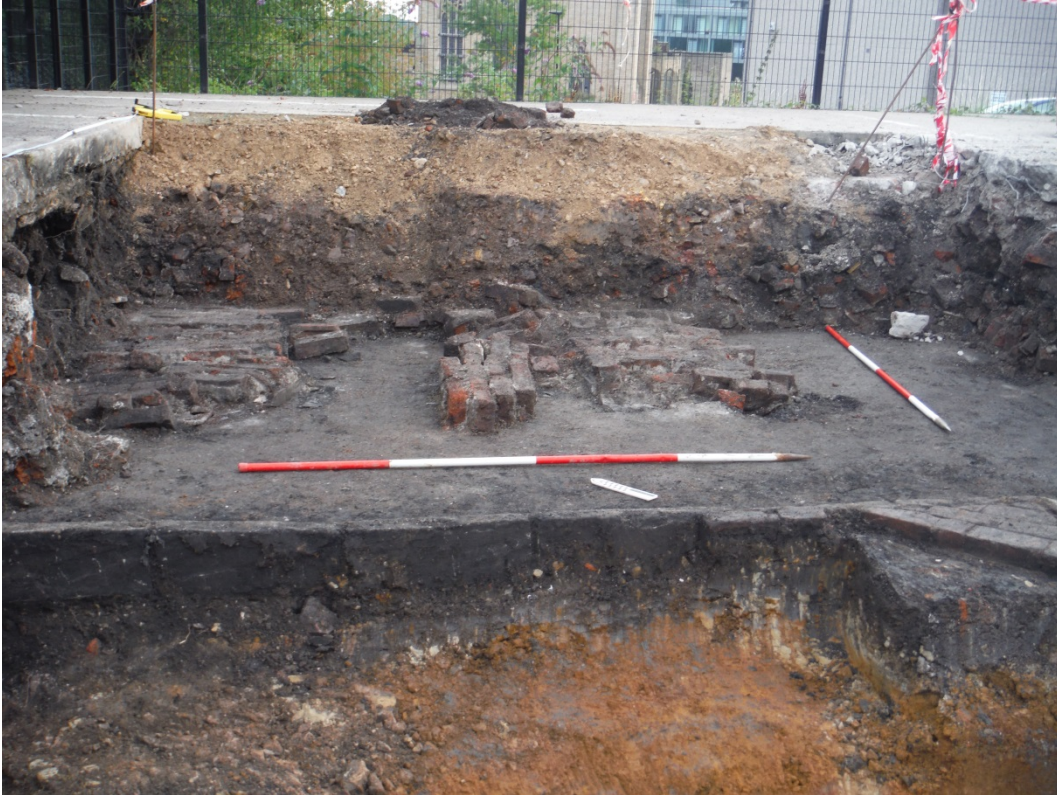
Figure 8. Eastern end of Trench 1 looking east showing collapsed wall F108, compact path surface (109) and sandstone edging of F107. Scales = 2 x 2m.

5.3 In the eastern edge of the trench the demolition rubble (103) came down onto remains of a tumbled brick wall F108. This had maintained some cohesion, most likely the result of a 20mm layer of mortar rendering on the inside wall. Two corroded metal hanging hooks were found below the remains of this wall. The rendering gave the impression of linear edging along part of the collapsed wall (see Fig. 3) possibly indicating an entrance way. This brick overlay a black compacted slate-like surface (109) which was generally in a good state of preservation but which was broken around the areas of the collapsed wall, most likely the result damage sustained when the wall was tumbled.

6.1 The remains in Trench 1 suggest that this area was used as a garden. The organic rich soil present within sandstone edging along with the decorative brick-built corner piece and the compact black pathway point to this interpretation. The tumbled walls, which in other circumstances might be more ambiguous, can also be interpreted as corresponding to this function as there were decorative metal hangers between the wall and dark compacted pathway. These were likely to have been attached to the walls prior to collapse. The damage sustained by the path was almost certainly caused by the wall collapsing or being tumbled.

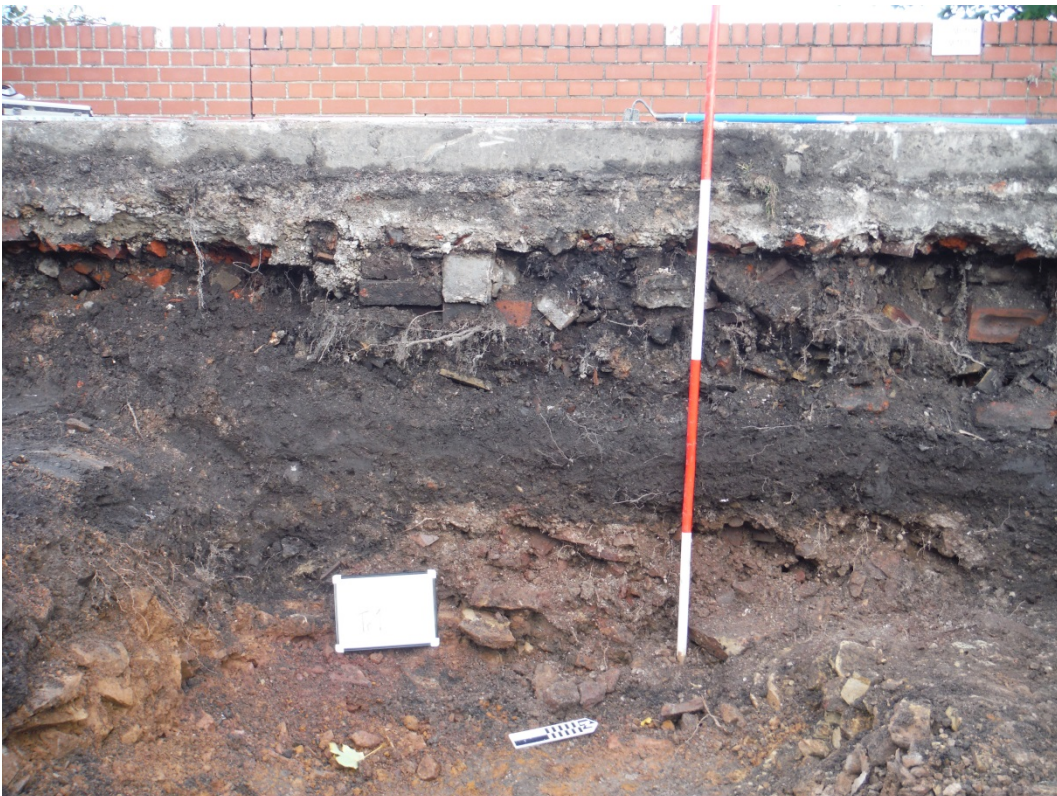
Figure 9. Middle of Trench 1 looking north-west showing dark organic rich garden soil (104) overlying degraded sandstone and mortar (105). Scale = 2m.

5.5 Sandstone edging F110 contained an area filled with dark brown-black organic-rich soil (104). The south-east corner of the sandstone edging had a brick-built corner platform built diagonally across the internal corner. The organic rich soil within the sandstone edging ran from the corner detail to the north and west edges of the trench. The organic nature of the soil and the nature of the sandstone edging suggest that this is a garden feature.

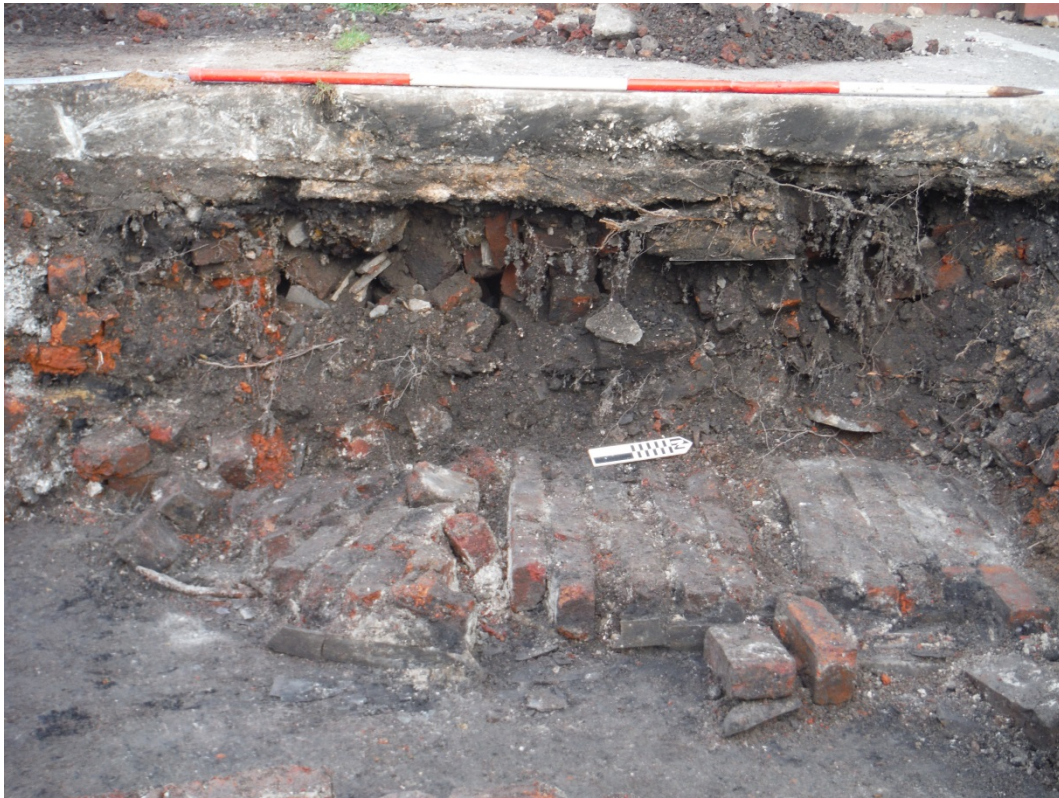
Figure 10. Eastern end of Trench 1 looking north-west showing collapsed brick wall F108. Scale = 2m.

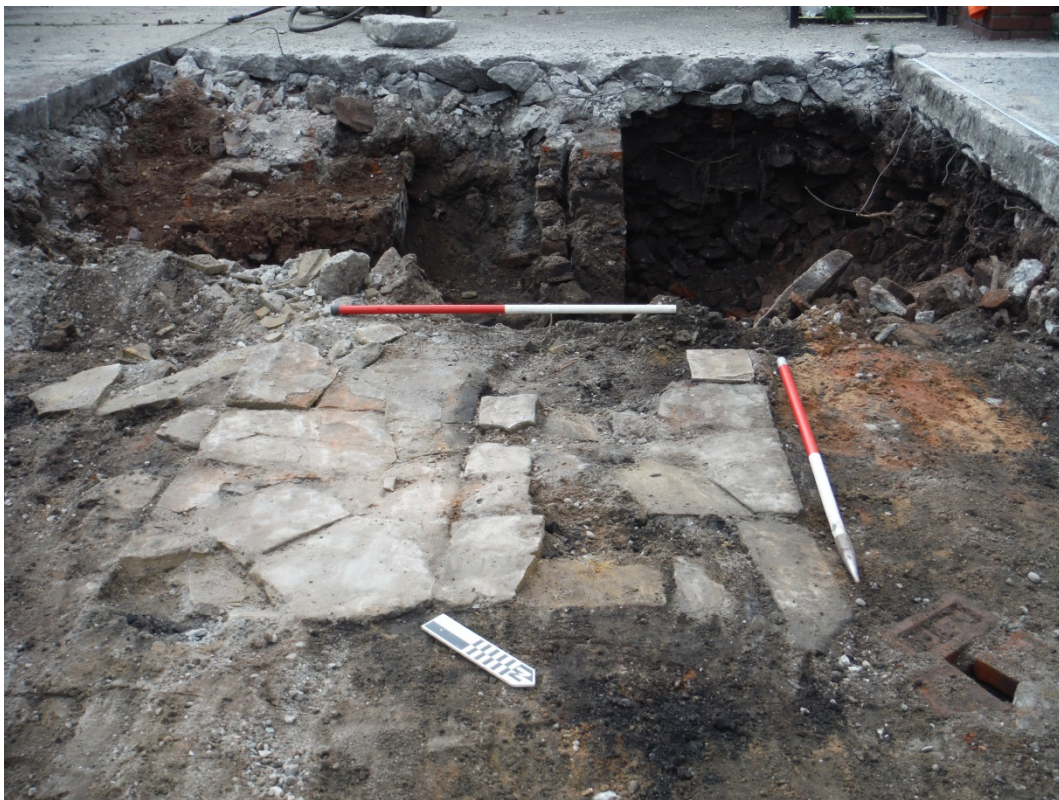
Figure 11. Middle of Trench 2 looking south-west showing paved area F214 and drain. Scales = 2 x 1m.

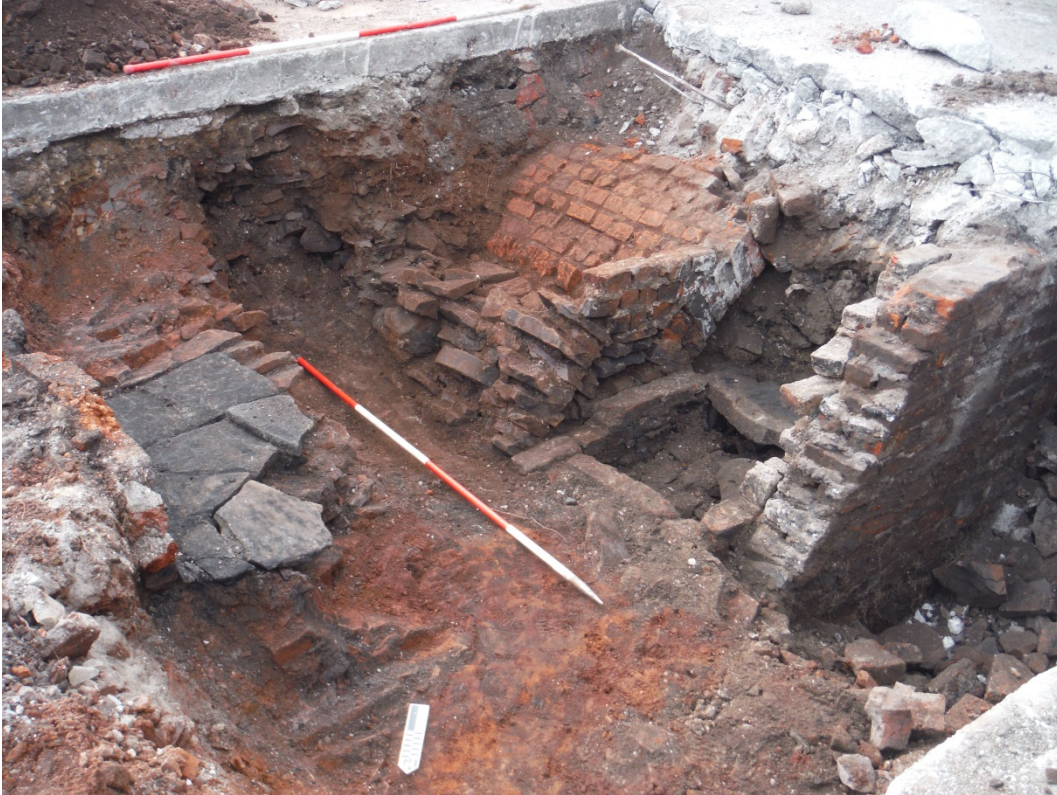
Figure 12. Western end of Trench 2 looking south showing vaulted cellar (F209 and F210) and associated walls (F211 and F212). Also showing construction cut [215] and backfill (216) in section. Scales = 2 x 2m.

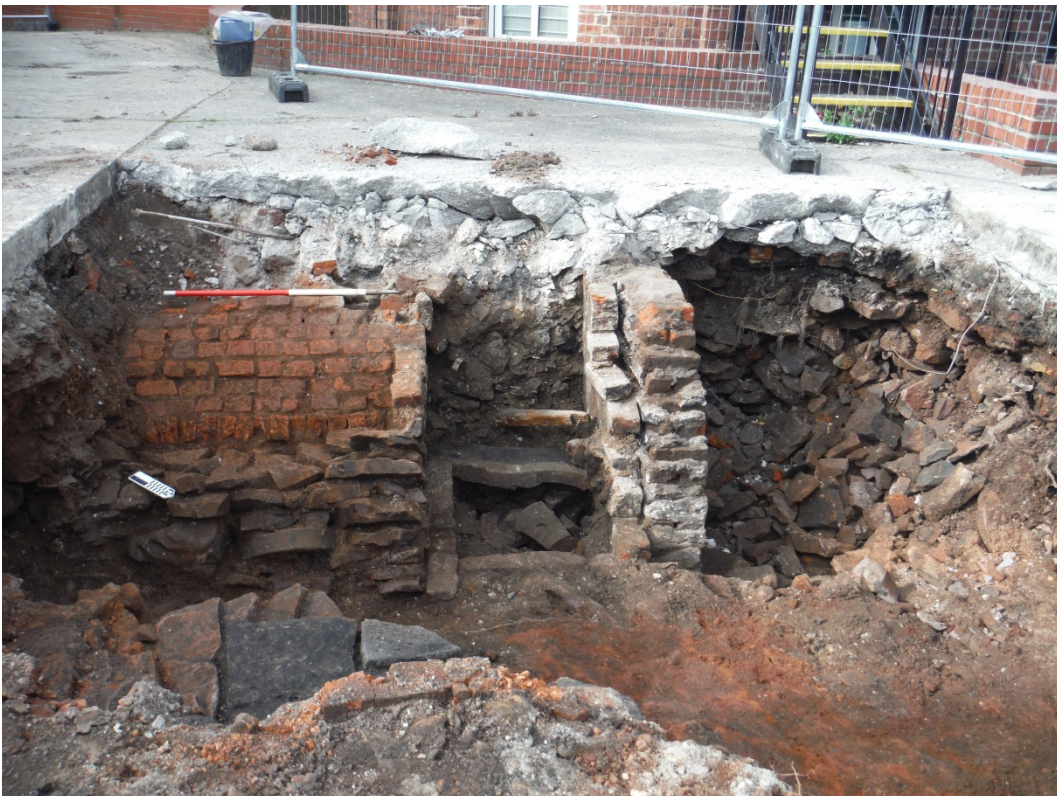
Figure 13. Western end of Trench 2 looking south-west showing vaulted cellar (F209 and F210) and associated walls (F211 and F212) in relation to Provincial House chapel. Scale = 1m.

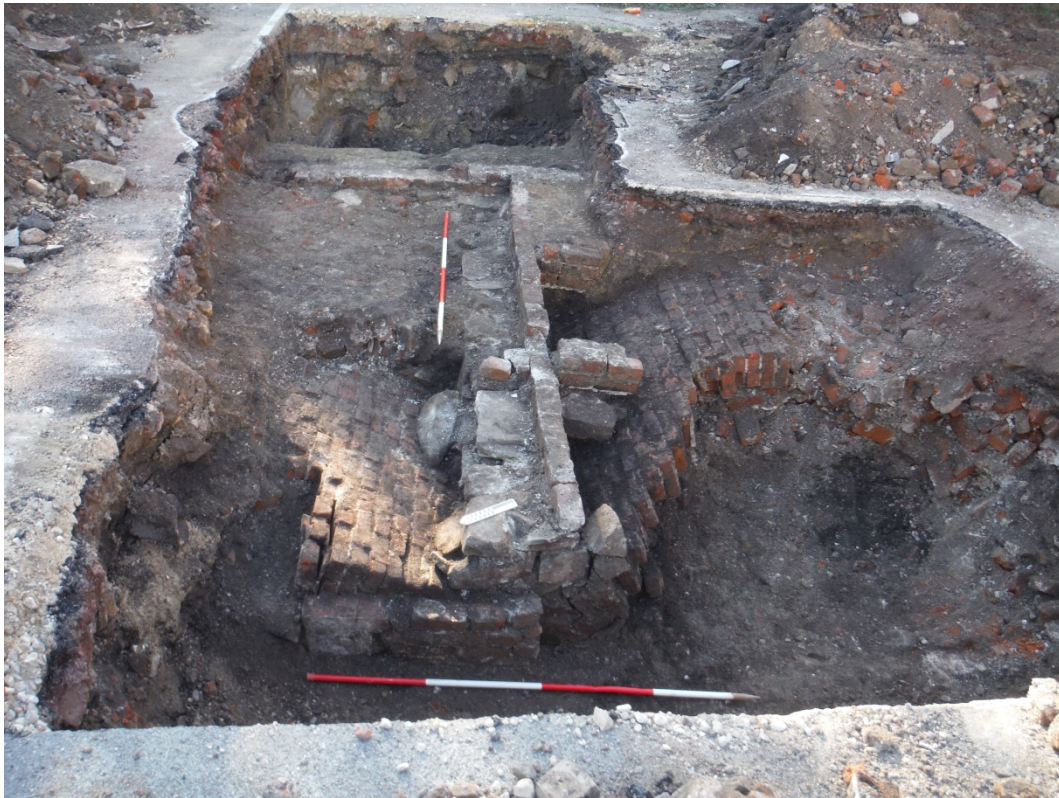
Figure 14. Trench 3 looking south-east showing vaulted cellars (F308 and F309) and walls F307 of back-to-back houses. Scales = 2 x 2m.

5.19 The northern test pit had encountered two brick-built cellar vaults. These vaults were again encountered and cleaned back to reveal limited survival. Diagrams produced in the site investigation report suggest that survival had been better than what was observed when the area was excavated. The two cellar vaults F308 and F 309 were encountered but both were partially collapsed and backfilled with poorly sorted rubble from the collapsed vault (310). The material removed from the area of the test pit was unsorted backfill including brick and other demolition rubble. The partial remains of wall corner F313 in the northern part of the trench was whitewashed and suggested a narrow access way to cellar F308. The depth of the remains and the loose nature of the

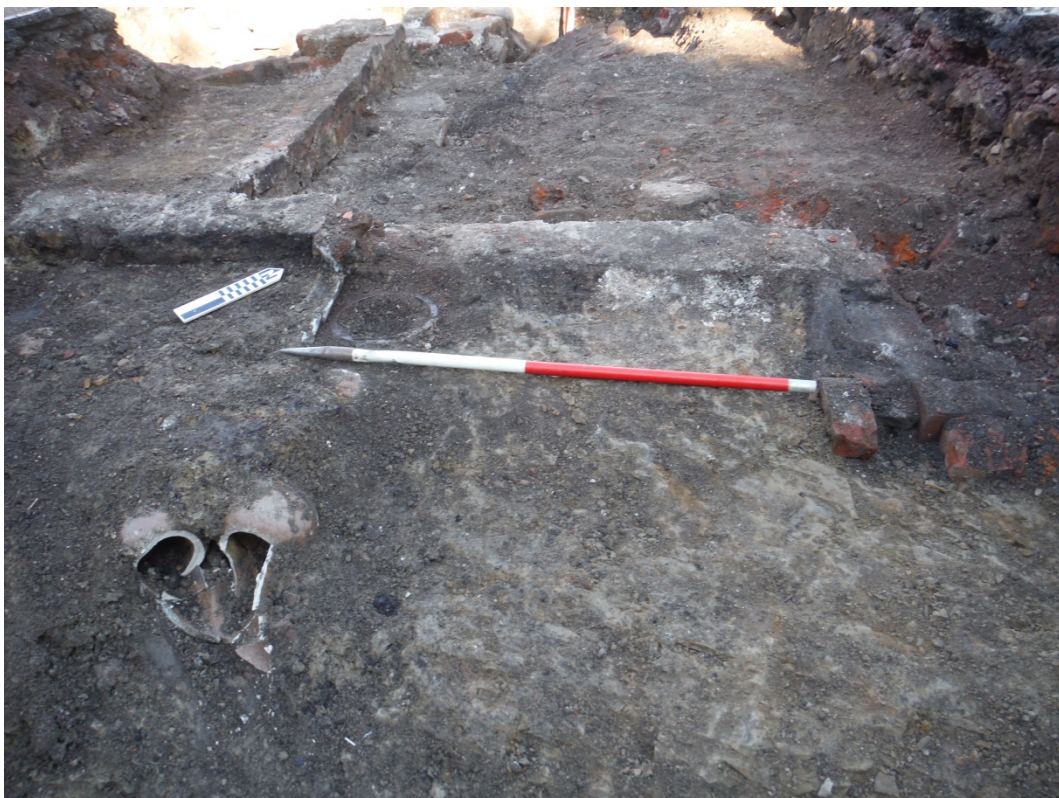
Figure 15. Southern end of Trench 3 looking north-west showing wall of back-to-back houses F307 and drains. Scale = 1m.

5.17 A double skinned brick wall F307, running parallel to and c. 1.2m north of the cistern wall, marks the outside of 19th-century back-to-back housing. Three drains were visible on the outside of this wall, although the easternmost drain appears to be within a small projecting annex. Two glazed ceramic pipes leading from these drains joined together and then continued into the southwestern facing trench section. An additional pipe from the drain within the projecting annex was not discernible. Both the wall and the drains were within compact pale yellow sandy clay (305).

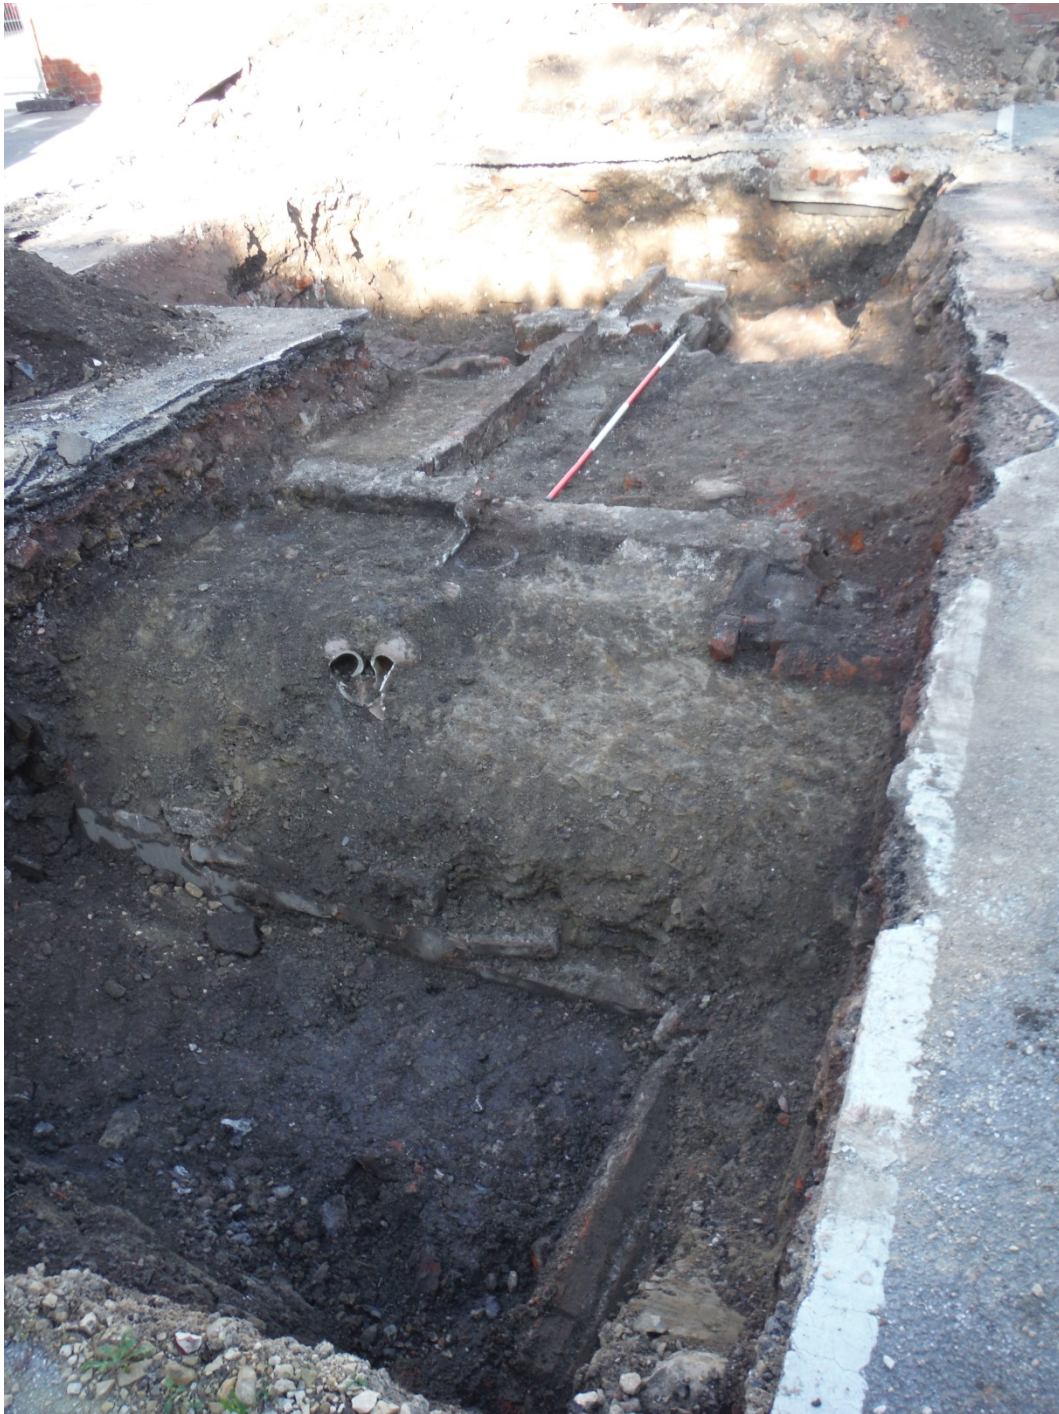
Figure 16. Trench 3 looking north-west showing remains of well cistern F306 and walls of back-to-back houses F307. Scale = 2m.

5.16 Starting at the southern part of the trench the remains of a vault and a wall F306 most likely relate to the wider vault encountered by the site investigators. This vault had sustained damage during the excavation of the test pit and only the eastern-most part of the vault remained intact. The dark brown-black silty gravel fill of the vault was wet and had an unpleasant odour. There were also fragments of brick throughout the fill reflecting the disturbance that this area has sustained. Excavation by machine revealed that the wall extended down to beyond 2.7m from the ground surface and had a rendered finish on the south facing side. The floor was not found to be intact as the site investigation test pit had continued through to c. 4m below the ground surface. The rendered finish of the brick wall suggests that this vaulted structure was a water cistern rather than a cellar. The cistern was abutted by and appeared to be built into compact pale yellow sandy clay (305).

6.10 The vault on the side of the houses furthest from the street would fall within what is described as courtyard 3 on the 1890 OS town plan. This vault was uncovered during site investigation work and sustained some damage during the excavation of a test pit, compromising the stratigraphy that may have been present in the backfill. It is likely that this feature is the remains of a cistern. The rendered wall surface would also fit with this interpretation. The 1853 OS town plan shows a well in this courtyard which would have been supplied by water from this cistern. The construction of this well would most likely have taken place during the early- to mid-19th century, at the same time as the construction of the houses.

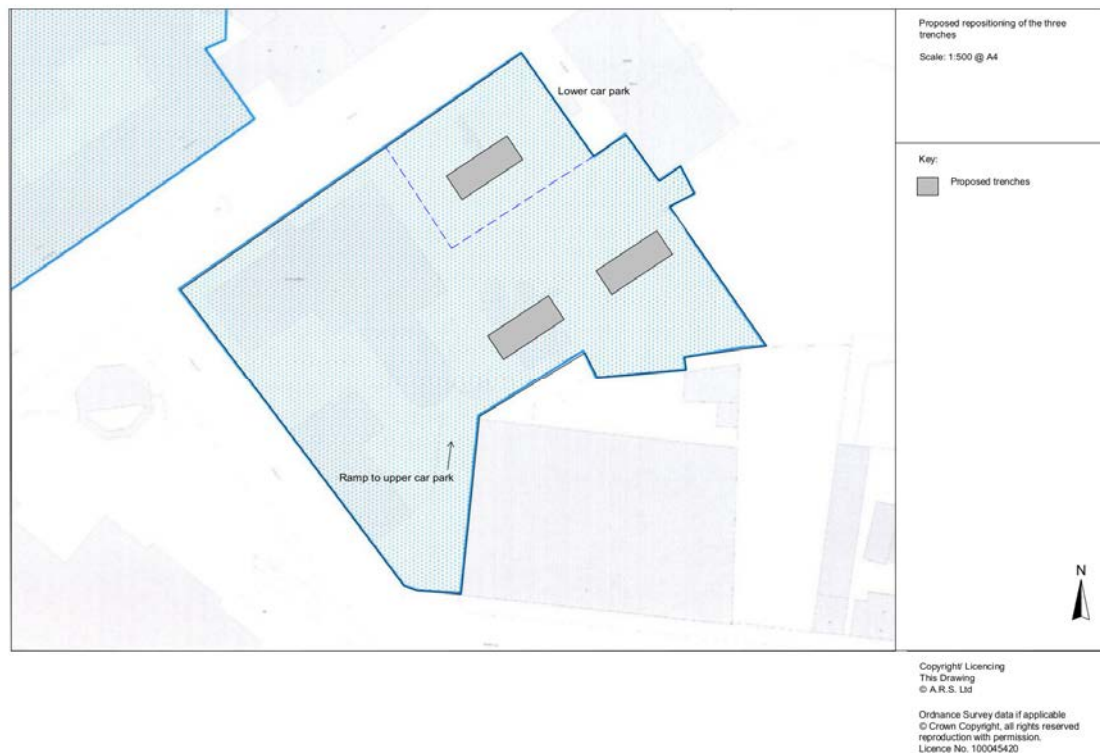
Figure 2. Location of trenches.

- 4.1. Following consultation with the South Yorkshire Archaeology Service (SYAS) the scheme of archaeological works involves excavating three trenches each c.10m by 4m in size (Figure 2) in the first instance. Any or all trenches may require extension in order to meet the aims and objectives of the evaluation.
- 4.2. The first trench is located in the lower car park and is designed to determine the level of

preservation of the back-to-back houses and their associated courtyard following demolition and levelling for the car park. The second trench is situated at the eastern end of the upper car park and is intended to determine the level of preservation of a former building here and associated courtyard(s), as well as to assess the impact of the construction/demolition of St Vincent's Club and levelling for the car park. The third trench, at the western end of the upper car park, is to determine the level of preservation of buildings of the former Red Place and associated courtyard(s), along with assessing the impact of levelling for the car park on the remains. Whilst the Garden Street frontage is also of interest, access to the upper car park makes it currently impracticable to investigate this area.
