# An Archaeological Watching Brief at the Camping and Caravanning Club, Culzean Castle, Ayrshire

**ARS Ltd Report No. 2015/175**  
**OASIS ID - archaeol5--233779**

ARS Ltd Report 2015/175

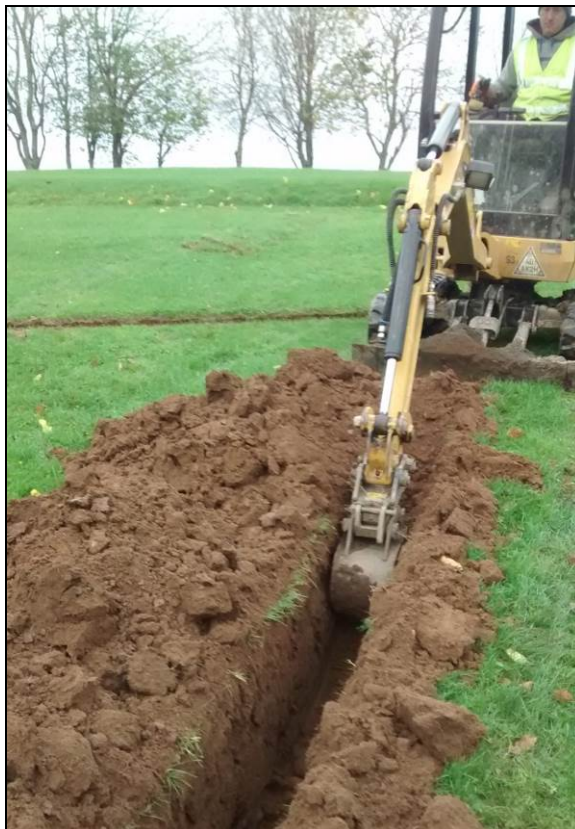
Figure 3. Excavation of electricity cable trenches. Phase A.

0.1m. A layer of pale brown subsoil (004) was located beneath the topsoil (003) with a depth of 0.15m (Figure 3).

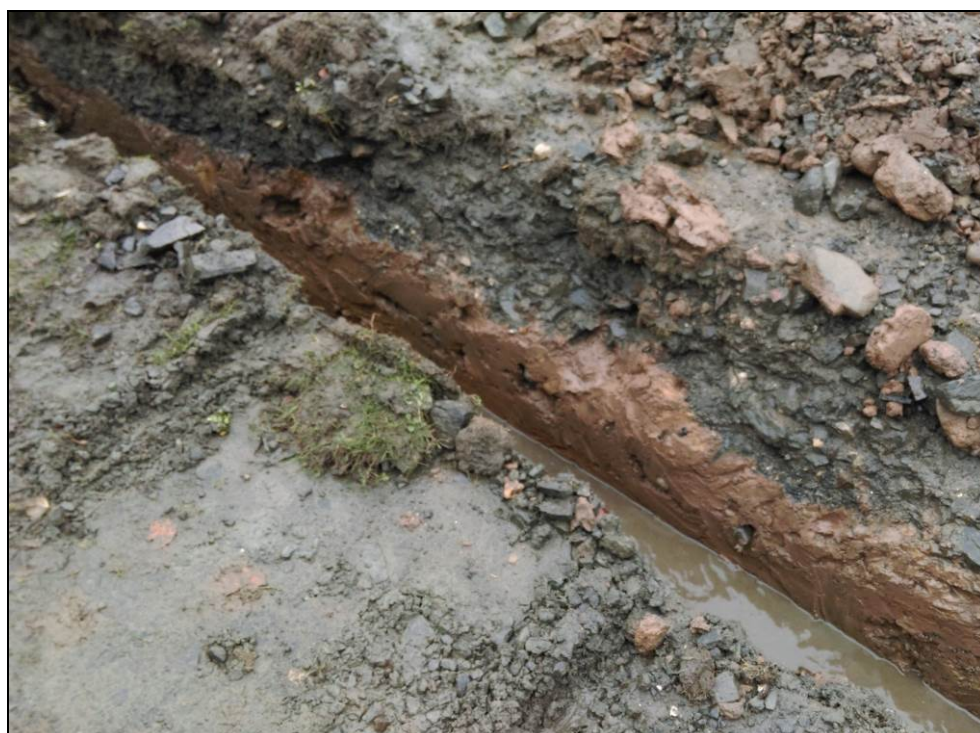
Figure 4. Excavation of a trench across a road showing tarmac with grey chippings (007) beneath. Orange/brown natural clay can be seen in the base of the trench. Phase A.

6.3. Natural clay (005) was encountered across the site to an average depth of 0.4m. The clay, where seen, varied in colour from brown to orange and in places graded into soft sandstone bedrock. A number of additional deposits were recorded during the watching brief although none were of archaeological significance. These deposits included layers of crushed modern brick (006) and grey chippings within sand (007) (Figure 4). No archaeological features or finds were encountered during this phase of the watching brief.

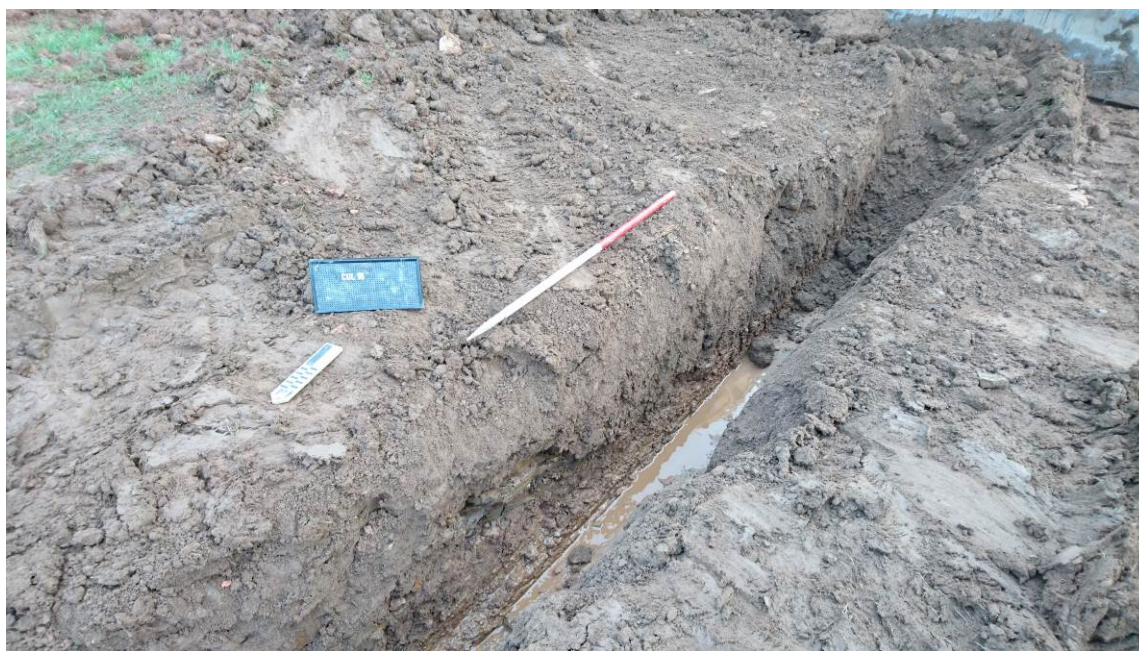
Figure 5. View looking south east showing a representative section of Trench 1 through topsoil (104). Phase B (scale 1 x 1m).

6.5. Trench 1 (Figure 5 and 6) was excavated across grass and woodland areas of the site with an average width of 0.3m. Where the trench crossed the grassed areas it was dug through turf and topsoil (104) which had an average depth of 0.26m. Where the trench was excavated across woodland, it was dug through a layer of undergrowth and decaying woodland material (101) which had an average depth of 0.16m. Woodland floor (101) and topsoil (104) overlay a light brown silty loam subsoil deposit (105) with an average depth of 0.15m. Natural clay (103) was encountered across the trench at an average depth of 0.48m below the surface.

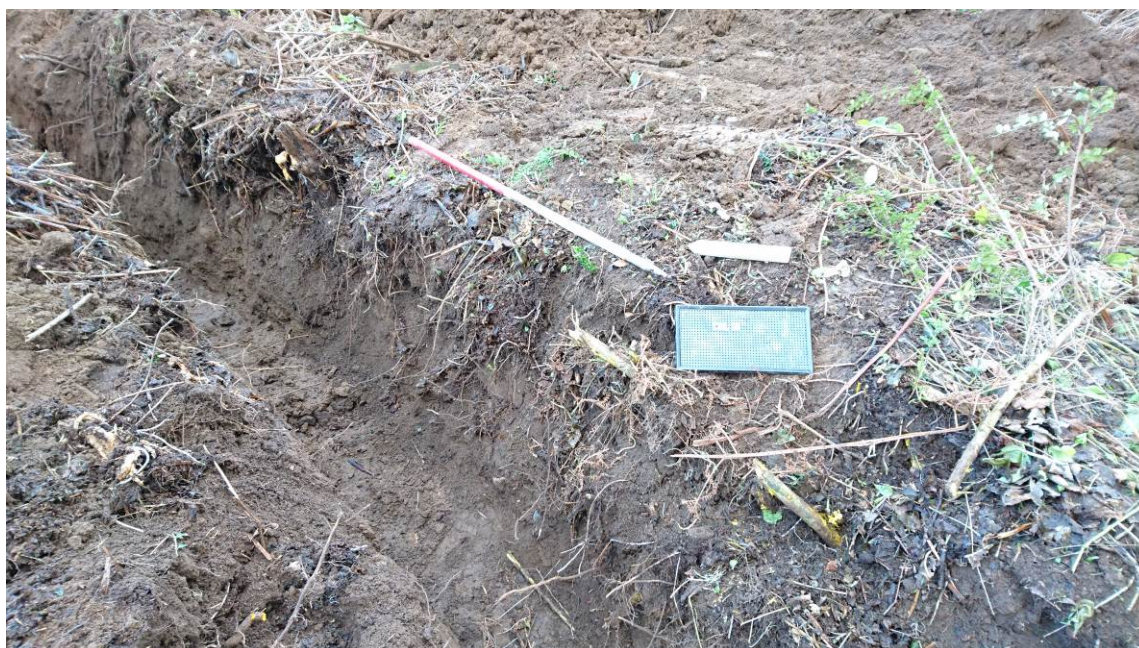
Figure 6. View looking north east showing a representative section of Trench 1 through woodland floor (101). Phase B (scale 1 x 1m).

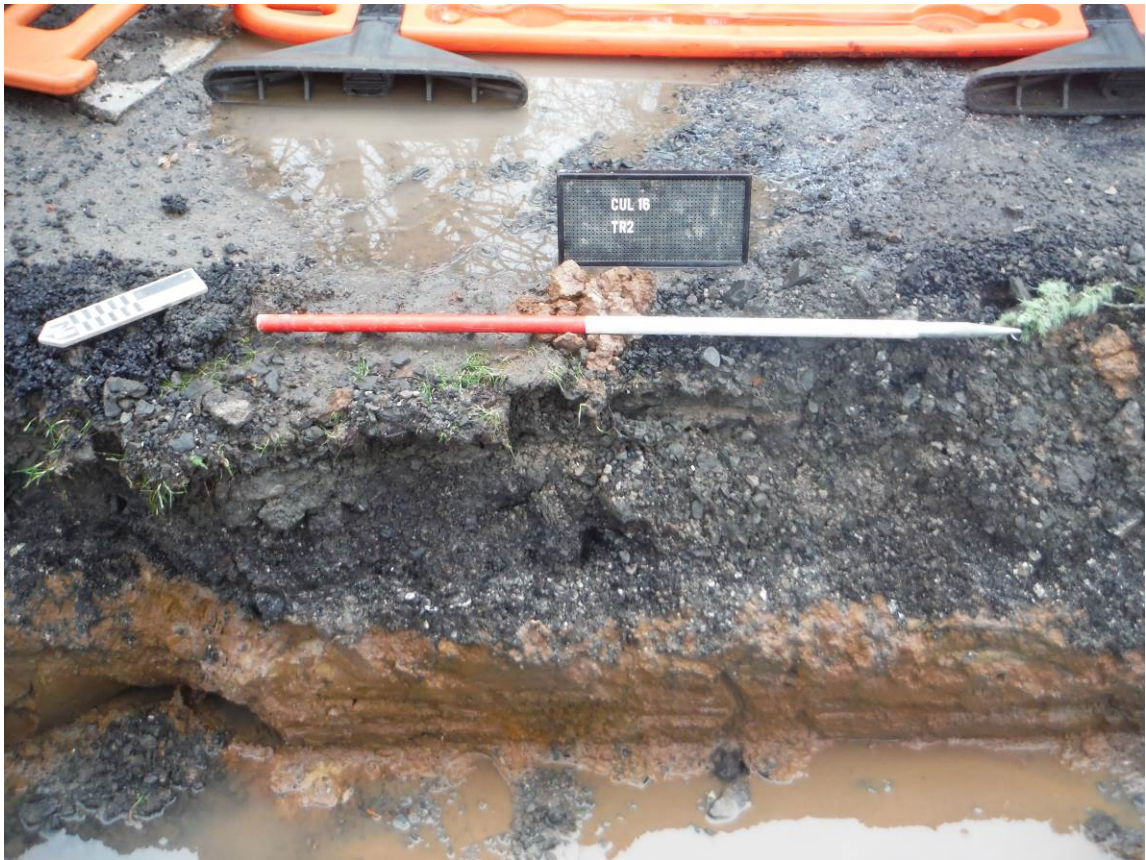
Figure 7. View looking south east showing a representative section of Trench 2 through Tarmac (106) Phase 2 (scale= 1 x 1m).

6.6. Trench 2 was excavated across a grass turfed area of the site with an average width of 0.3m. This revealed turf and topsoil deposit (104) which had an average depth of 0.19m. Towards the western extent of the trench topsoil (104) overlay a 0.5m thick asphalt surface (106) which sat upon a 0.34m thick stone sub-base deposit (107) (Figure 7). Towards the eastern extent of the trench topsoil (104) overlay a grey stone crush (108) which had a depth of 0.18m and was interpreted as the remnants of a former railway embankment. Below (108) was a 0.33m thick stone bedding deposit (109) (Figure 8). Bedding deposit (109) and sub-base deposit (107) overlay the clay natural substrate (103), seen at an average depth of 0.56m from the surface.

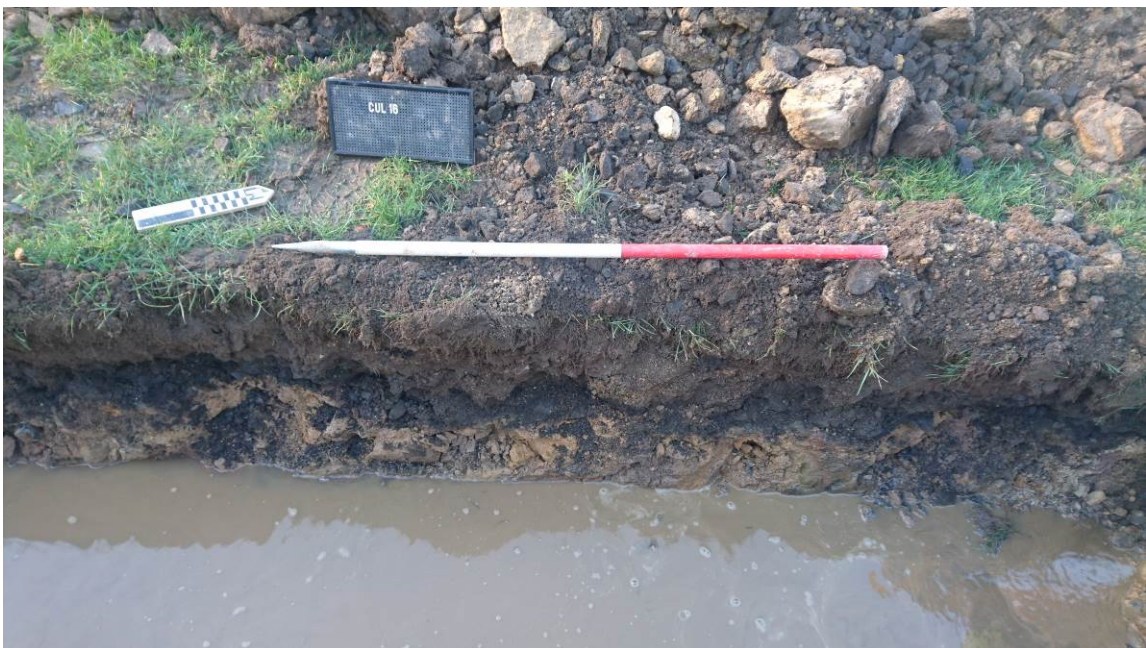
Figure 8. View looking north west showing a representative section of Trench 2 through (108). Phase B (scale= 1 x 1m).

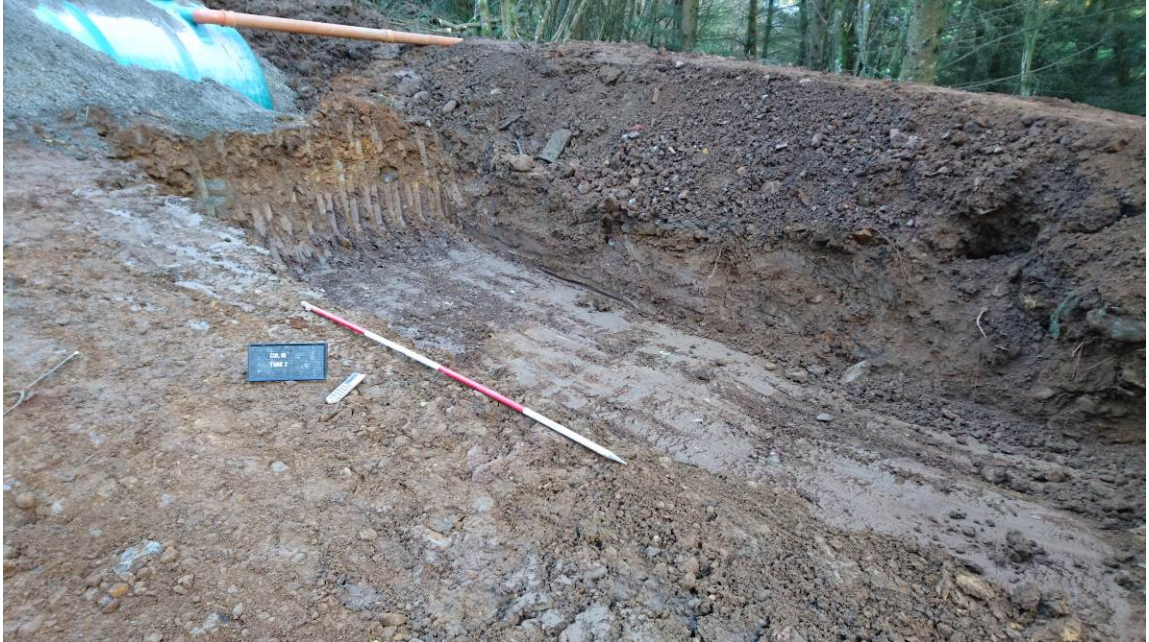
Figure 9. View facing south-east of septic tank area 1. Phase B (scale= 1 x 2m).

6.7. Two rectangular areas, both approximately 10m x 5m in area were stripped prior to the installation of new septic tanks. The excavation revealed a woodland floor deposit (101) with a depth of 0.15m and overlay a 0.12m thick sub-soil deposit (105) (Figure 9). Within the septic tank 1 area, sub-soil (105) sealed a redeposited natural clay (102) with a depth of 0.29m and this was interpreted as deliberate deposition of material associated with the construction of the railway embankment. Redeposited material (102) overlay clay natural (103) at a depth of 0.46m from the surface. Within the septic tank 2 area, sub-soil (105) overlay natural clay (103) which was exposed at a depth of 0.27m from the surface.
