An Archaeological Watching Brief at St. Mary's Church, Crich, Derbyshire

ARS Ltd Report No. 2016/8

Project Name: St. Mary's Church, Crich, Derbyshire

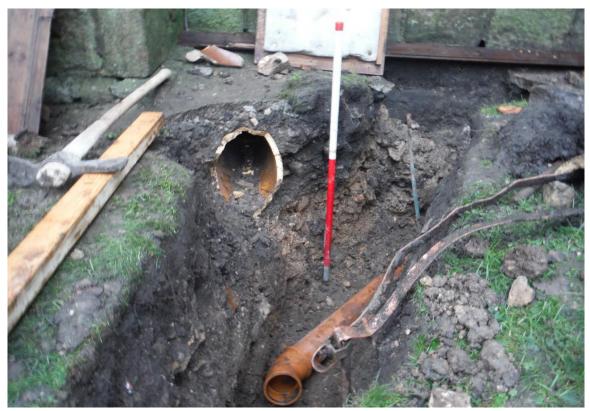
Figure 3. Photograph showing organ pipe exiting the church within the topsoil layer in a wide pipe trench (scale = 1m).

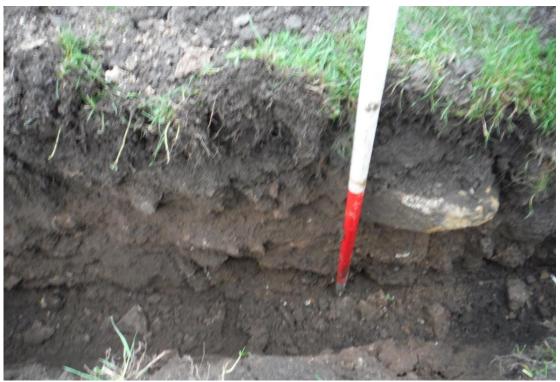
- The dark grey-brown loam which comprised the topsoil (001) was removed by machine to a maximum depth of 300mm. The topsoil overlay a mid orange-brown sandy clay (002) substratum or 'subsoil'. Overlying topsoil (001) in places overlain by a path (009). In parts of the site where topsoil had been paved over with repurposed gravestone slabs, only a small lens of topsoil was extant beneath before deposit (002) was encountered.

Figure 4. Soil Profile showing the dark grey brown topsoil overlying the mid orange-brown substratum (scale = 1m).

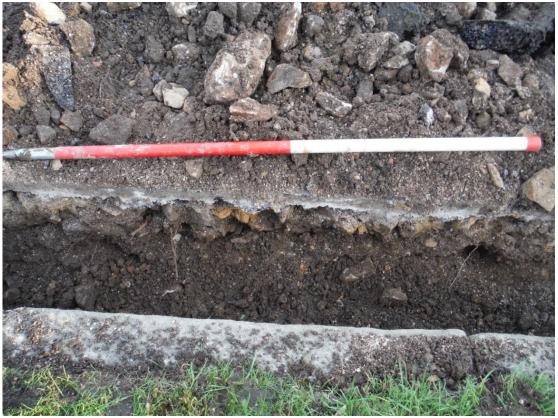
Figure 5. Tarmac pathway overlying bedding deposit (scale = 1m).

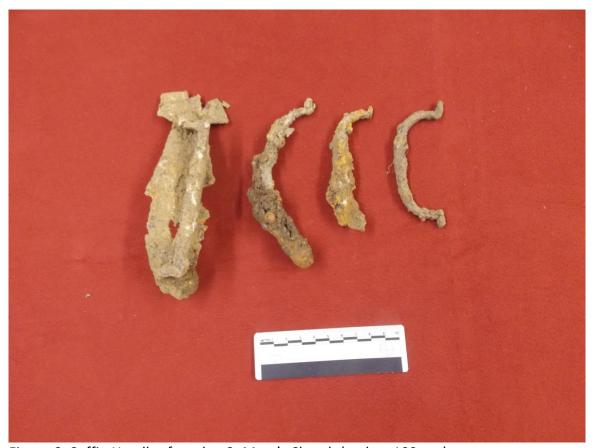
Figure 6. Coffin Handles found at St Mary's Church (scale = 100mm).

Four coffin handles and five iron nails were recovered and are summarised below. These handles represent coffin furniture from four different coffins and the nails are also likely residual finds from disturbed burials.

Handle 1 (Far left) This represents the best-preserved handle featuring a rectangular bail grip attached to a single decorative lug by a pair of brackets. Although quite heavily corroded the lug appears roughly cut and features a small 'heart shaped' cut close to one of the grips. This is a fairly generic swing handle, with slight moulding of the grip ends to ensure the handle would not swing far past 90 degrees. This seems to indicate that it is probably quite a late example of this handle type, probably from the mid 19th century, as early handles of this type are generally known to have been manufactured without this moulded brace and would have been able to swing a full 180 degrees.

Handle 2 (Centre left) This handle represents another bail grip, this time without any of the associated parts. It is again heavily corroded, particularly at one end where the attachment to the brackets is no longer visible. This handle does not show any sign of a moulded grip and would have been able to swing a full 180 degrees, indicating that this is likely an earlier handle than 1 and 3.

Handle 3 (Centre right) This handle is also a bail grip found without associated brackets or lug(s). It has, however, got a moulded end to ensure its swing could not exceed 90 degrees, putting it into a likely later phase of manufacture and use than handles 2 and 4.

Handle 4 (Far right) Another bail grip swing handle, this time without moulded ends. This likely precedes handles 1 and 3 although its exact dating is uncertain. None of these handles are likely to be later than the early 20th century, however, iron handles have been mass manufactured in England since the mid 18th century and in use since long before that. As a result, and because of the generic designs represented here, the earliest date for these handles is difficult to state, although handles 1 and 3 seem unlikely to predate the mid 19th century.

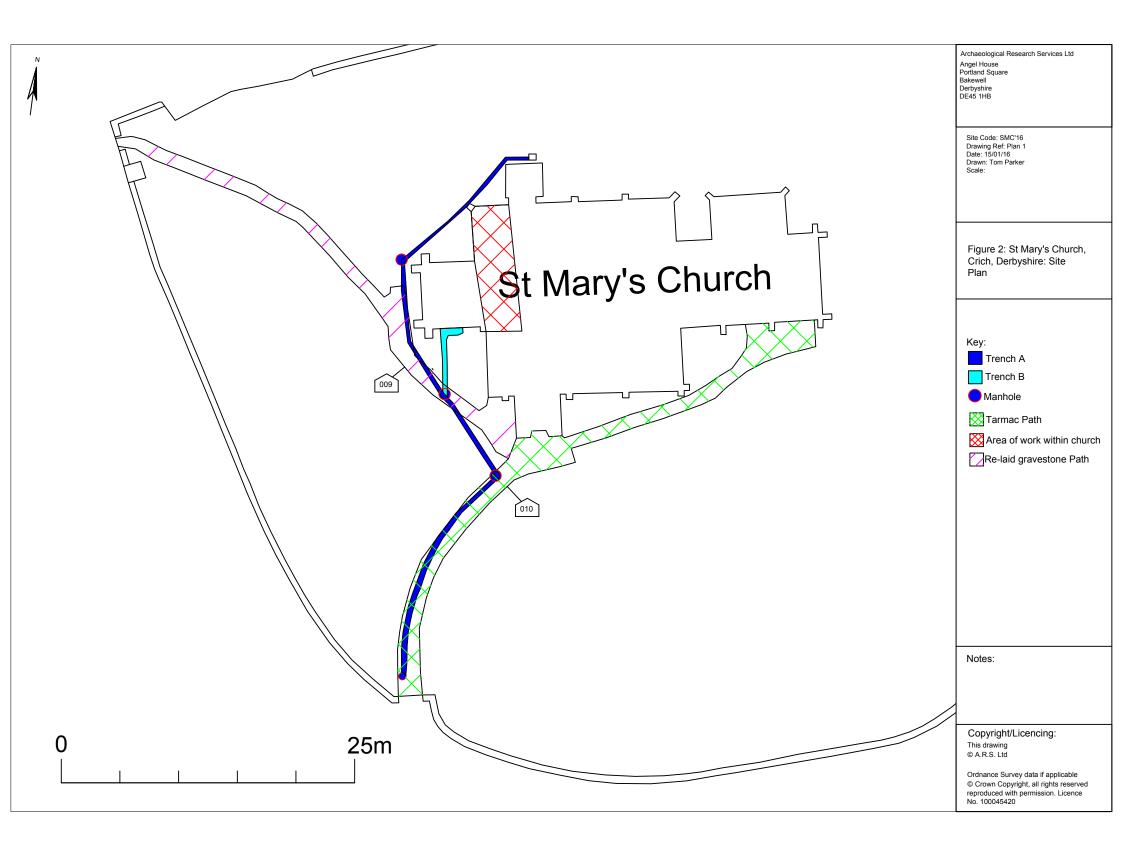
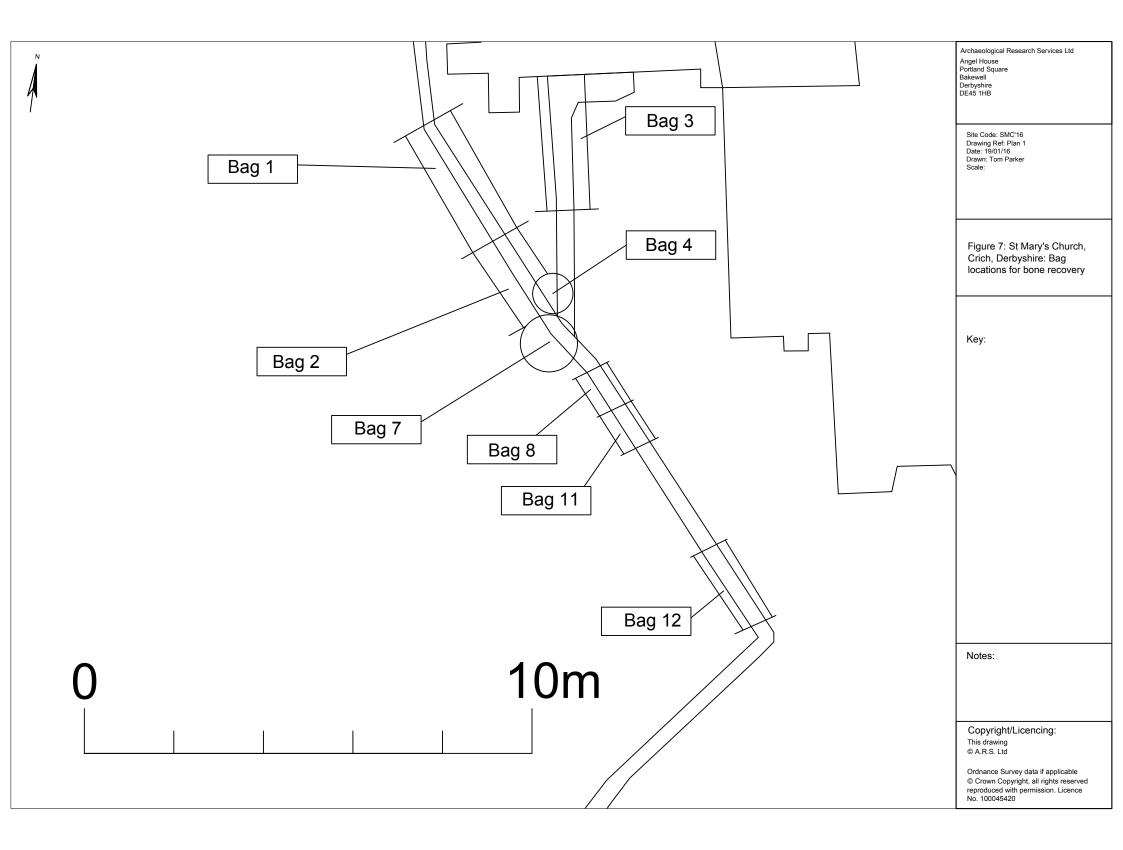
(see figure 7). This allowed further analysis of volume of bone by area rather than ascribing all bones to the one context in which the most were found.

- Deposit (002) contained frequent angular limestone cobbles and occasional disarticulated human bone fragments, which are thought to be present across the site. Both modern and less recent pipe and service trenches have cut into deposit (002) (Figure 3). To the north-west of the church numerous pipes and services are visible that are likely to be associated with the 20th century extension of the vestry, and to the south of the church there is truncation of this layer by large clay pipes associated with providing air for the organ, as well as a substantial tarmac pathway joining the church's main entrance with Cromford Road (see Figure 7).
