Scholes Mill, Tansley, Matlock

**Desk Based Assessment and Building
Recording**

ARS Ltd Report No. 2007/9
Planning Application No. 06/00974/FUL
February 2007

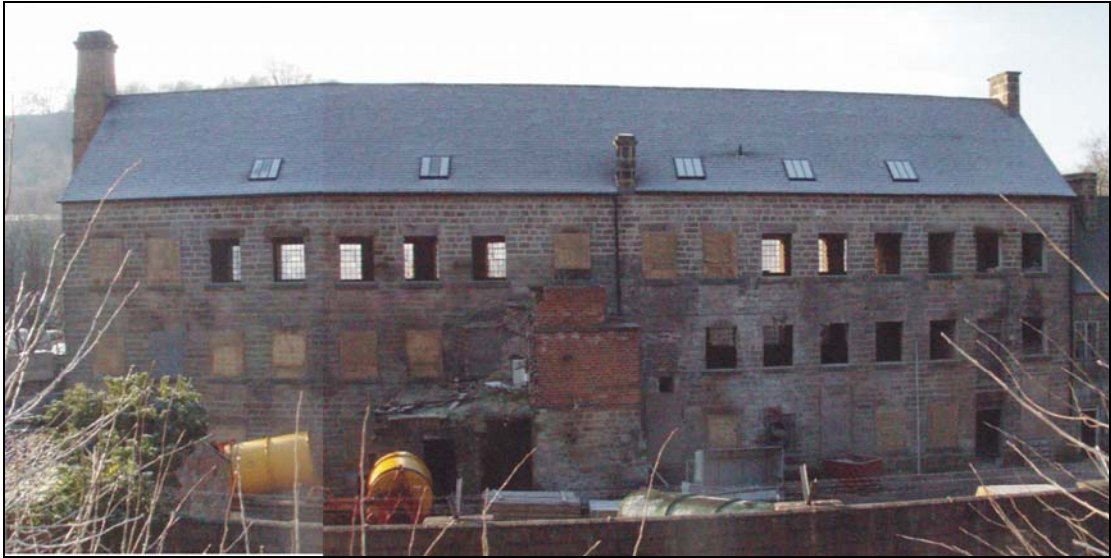
- 6.1.1 The mill is made from dressed gritstone and consists of three storeys of visible windows and an attic storey which has windows on the ends of the building only (Fig. 3). The lowest four courses of stone blocks stand proud of the stonework by c. 0.55m and the top is an average of 0.86m above ground level (Fig. 4). In places, a rougher course can be seen as a foundation below these protruding lower courses (Fig. 5).

Fig. 3. Photograph of the windows in north-east façade of the mill (facing south-west) (scale = 5m).

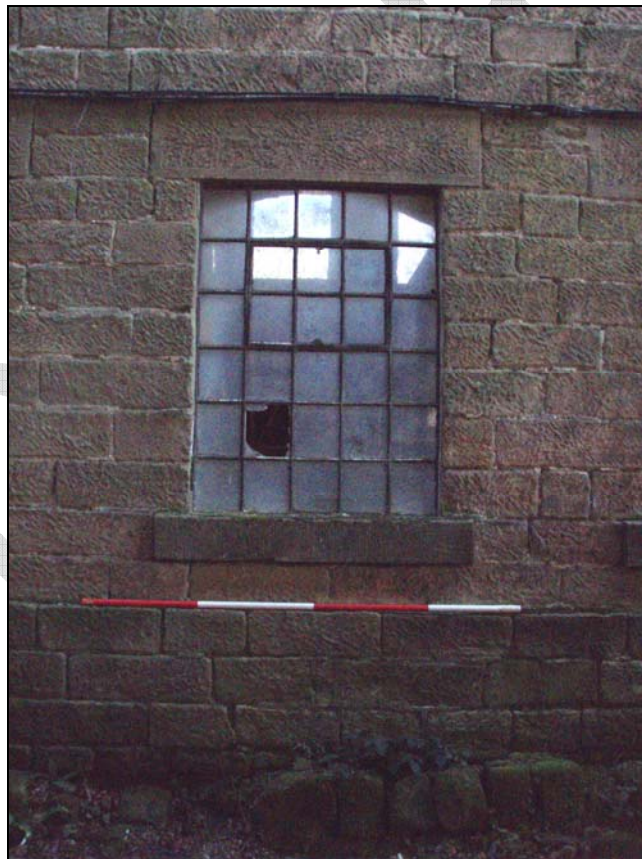
Fig. 4. Photograph of the lower course blocks of stone, the foundations and a standard window in the south-west façade of the mill (facing north-east) (scale = 2m).

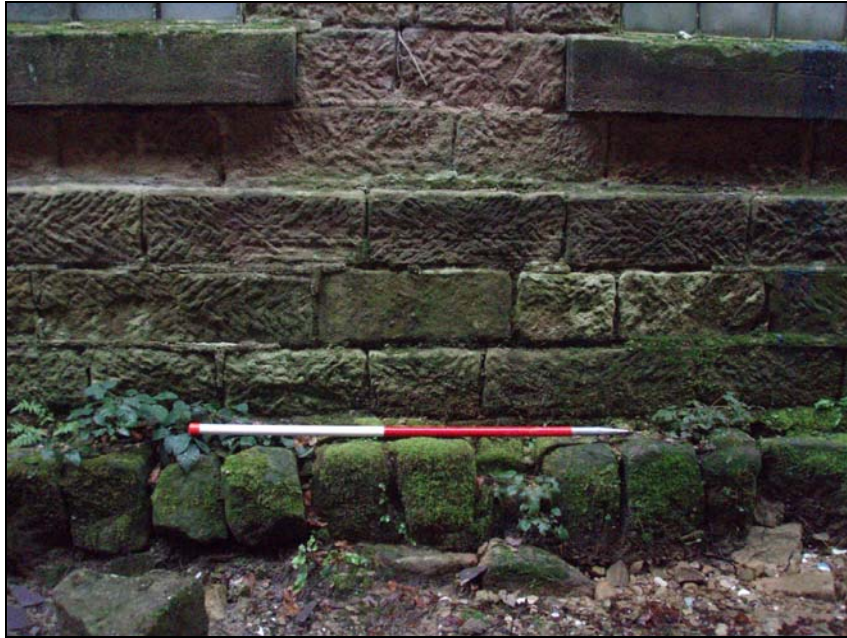
Fig. 5. Photograph of the rougher courses of stone forming the foundations (facing north-east) (scale = 1m).

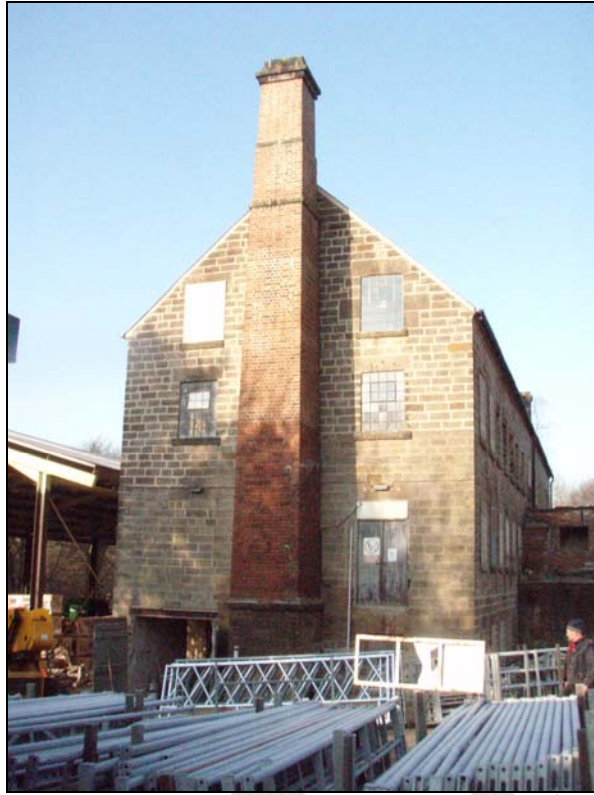
- 6.1.2 The window frames on both the north-east and south-west façades are 30-paned (six high and five across) on all three floors. The ground and first floors have 14 standard windows, with the first floor having one extra, smaller (eight pane) window above the main entrance, whilst the second floor has 15 standard windows (Fig. 3). A standard window measures 1.1m wide by 1.52m high (Fig. 4). Each has a gritstone lintel measuring 1.6m wide by 0.4m high and a stone sill of measurements 1.45m wide and 0.18m high. On the south-east façade, there are four standard windows (Fig. 6).

Fig. 6. Photograph of the standard windows in the South-east façade of Scholes Mill, Tansley (facing north-west).

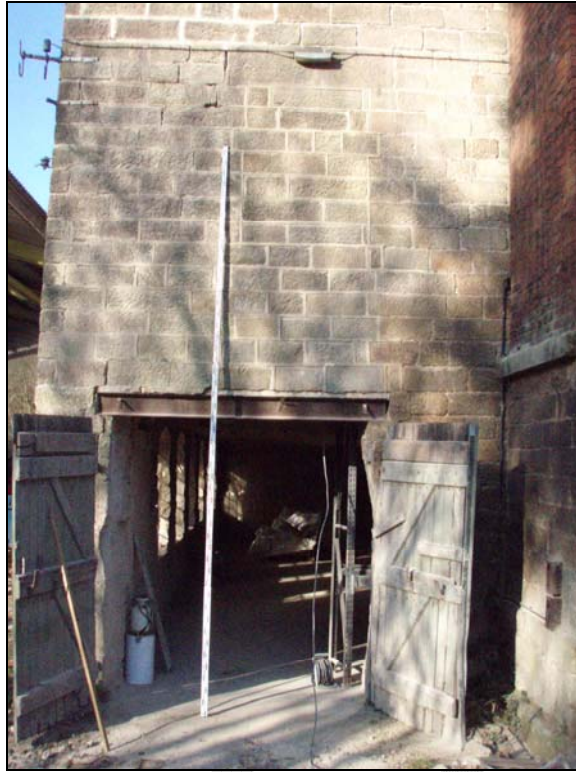
- 6.1.3 A doorway has been created in the south-east façade of the mill at a later date than the original construction of the mill, located just below an infilled window (Fig. 7). A steel girder was used to form the lintel of the doorway suggesting that these changes may have taken place when the Army occupied the mill. This doorway probably provided access to the canteen and cookhouse. A red brick chimney was built on this façade after the original construction of the mill but prior to the First Edition Ordnance Survey Map (1878).

Fig. 7. Photograph of infilled window and doorway of later construction than the mill in the south-east façade of the mill (facing north-west) (scale = 5m)

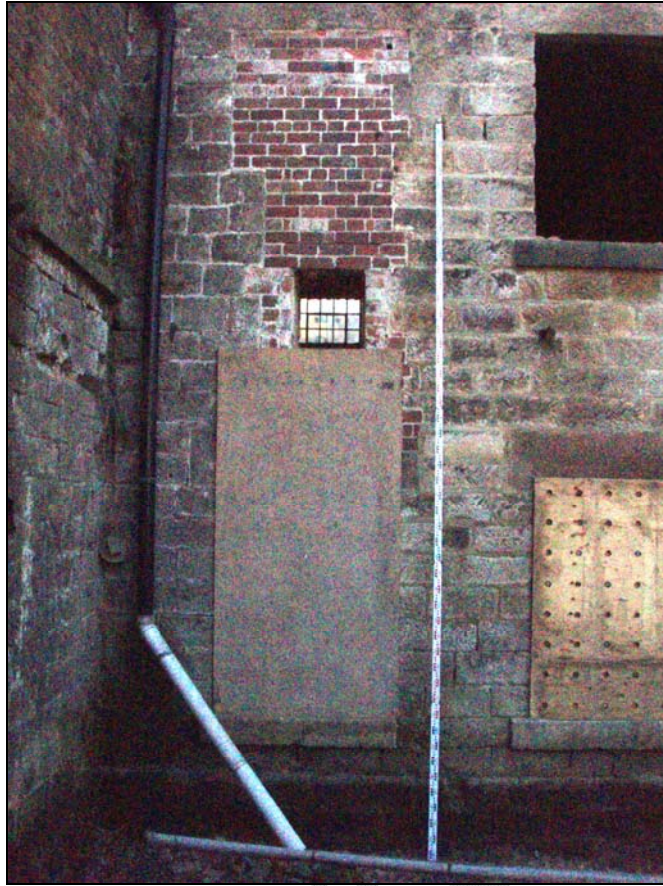
- 6.1.4 A vertical section of the north-east façade of the mill has been removed, but for what purpose, it is unclear. Subsequently, this section and the window above it have been infilled with red brick, possibly when the mill was converted to steam power (Fig. 8). The haphazard nature of the infilled bricks suggests that this vertical gap was not constructed when the mill was built.

Fig. 8. Photograph of infilling of the wall and one of the windows in the north-east façade of Scholes Mill, Tansley (facing south-west).

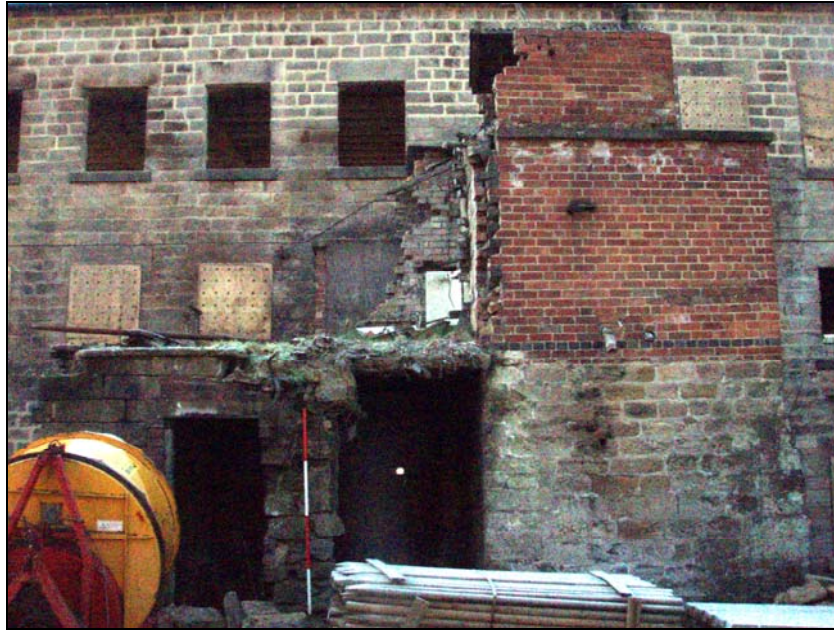
- 6.2.1 A stone extension, now known as the 'boiler house', was added to the room initially used to house the water wheel prior to the conversion of the mill to steam power. It is possible that the extension was built when the water wheel was blocked off to replace it with the boiler. The boiler house was built from the same gritstones as the mill but they have weathered differently to the original build, indicating the later construction of the extension (Fig. 9). The windows of the mill were infilled in this portion of the wall in order to accommodate for the build but are not original to the construction of the mill (Fig. 10, 11 and 12).

Fig. 9. Photograph of the boiler house and red brick extension (facing south-west) (scale = 2m).

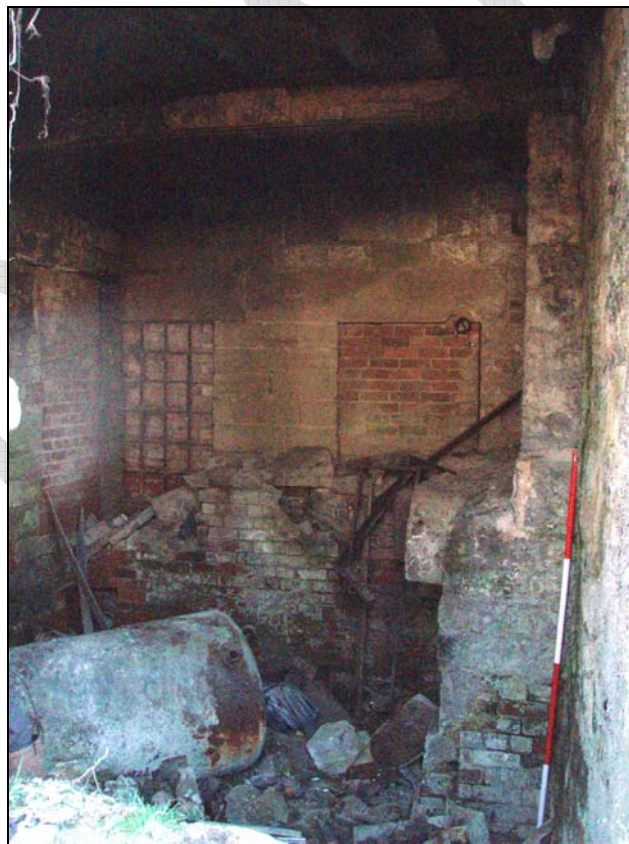
Fig. 10. Photograph of the interior of the boiler house and the infilled windows in the mill wall (facing south-west) (scale = 2m).

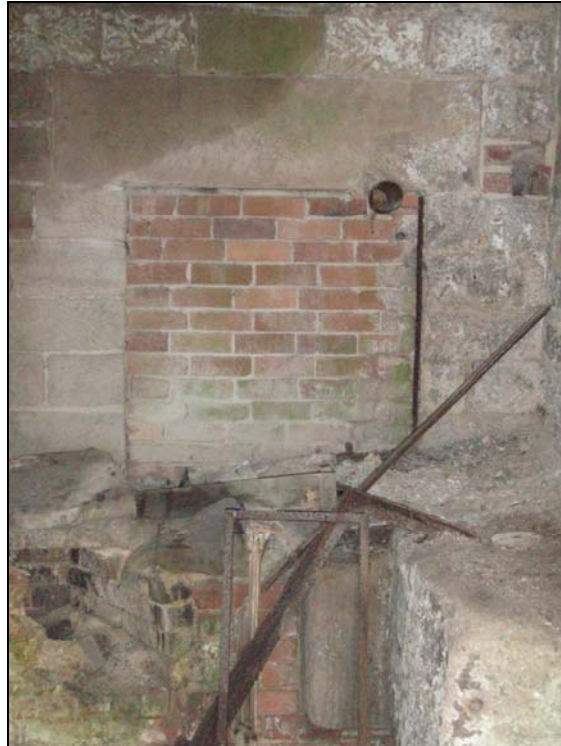
Fig. 11. Photograph of an infilled window on the south-east interior wall of the boiler house (facing south) (scale = 1m).

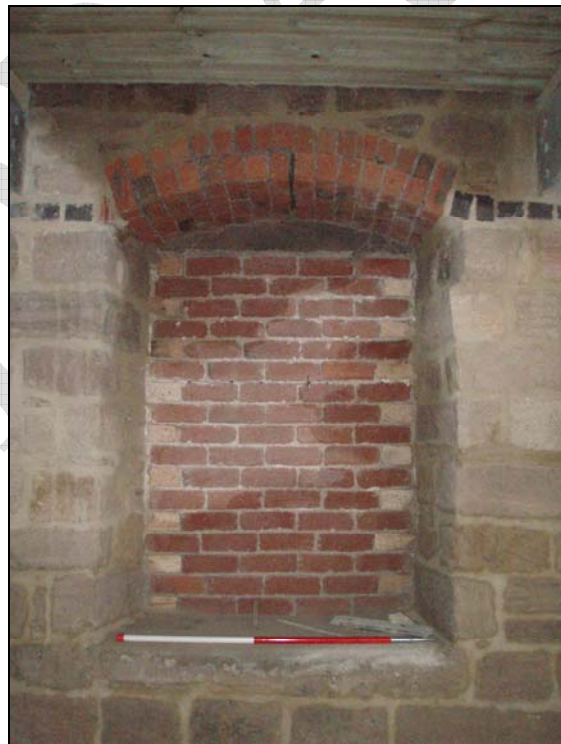
Fig. 12. Photograph of an infilled window on the north-east façade of the mill which abuts the boiler house (facing north-east) (scale = 1m).

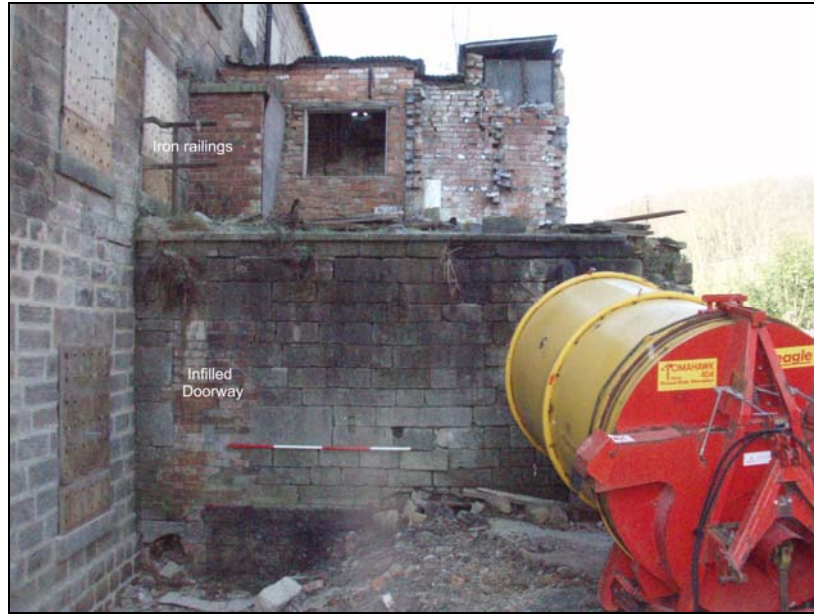
- 6.2.2 A red brick structure with a corrugated iron roof was built on top of the stone extension of the boiler house at a later date than the mill's construction (Figs. 9, 13 and 15). It was probably built and used as toilet or shower facilities during the occupation of the mill by the Army (Wardman, G. 2007, pers. comm.), but is currently in a poor state of repair. Iron railings surround the flat roof of the boiler house, located south-east of the red brick addition (Fig. 14). These railings suggest that the roof may have been constructed by Army.

Fig. 13. Photograph of infilled doorway and iron railings in south-east wall of extension (facing north-west).

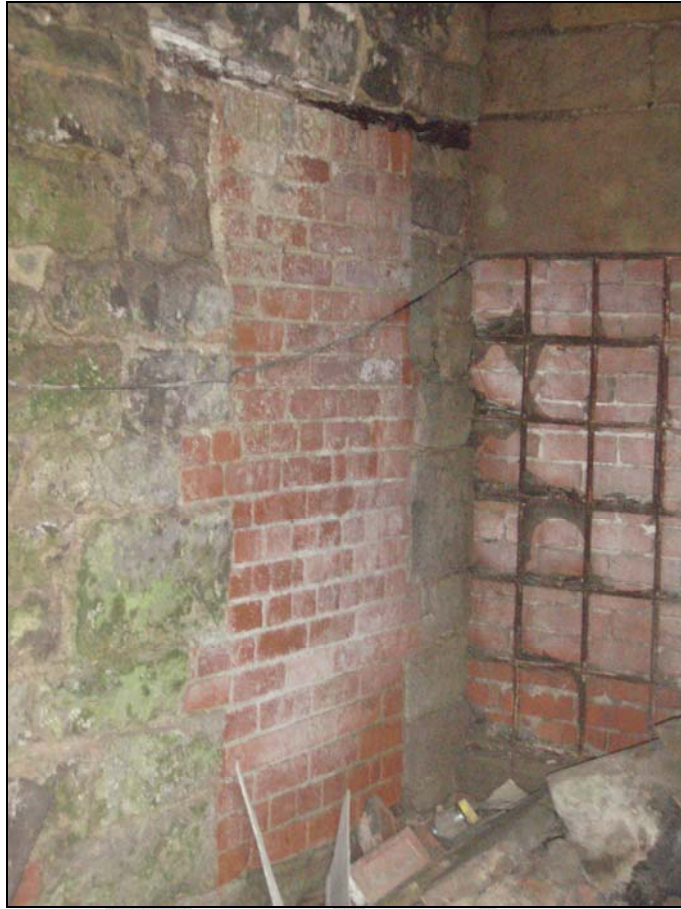
Fig. 14. Photograph of an infilled doorway on the interior south-east wall of the boiler house (facing south) (scale = 1m).

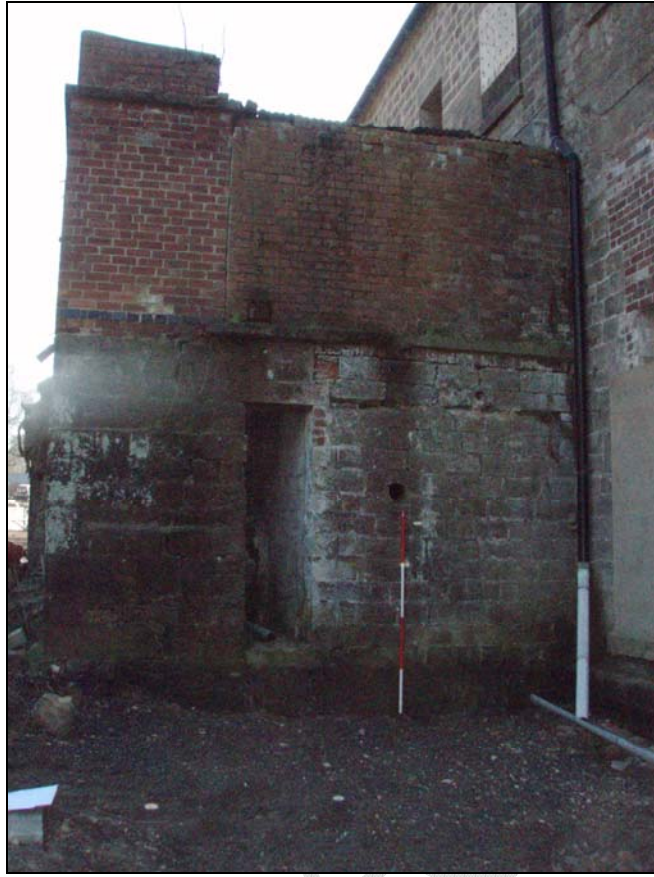
Fig. 15. Photograph of the brick extension located on top of the boiler house (facing south-east) (scale = 2m).

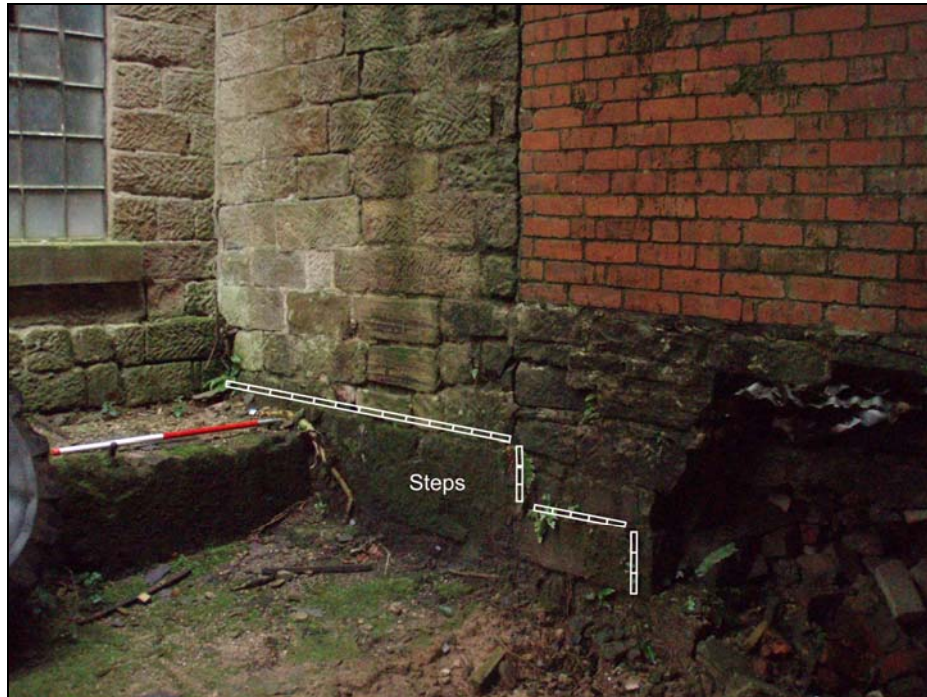
- 6.4.1 The original entrance lies on the south-west façade of the mill and was constructed of dressed gritstone. Initially, there were a series of steps (Fig. 16) running up to the arched doorway (Figs. 16 and 18), surrounded by an iron gateway (Fig. 19). In the second phase of extension to the entrance, a gritstone porch was added to the archway (Fig. 18 and 19). This porch has a straight line joint and is not keyed into the original mill building, both indications that this is a later addition (Fig. 16). This stone has weathered to the same degree as the original mill suggesting that the porch was constructed soon after the mill. The third phase consisted of the building of a brick extension onto the porch (Figs. 17, 18 and 19). This structure contained a window in the south-west wall, blocking any opening, which suggests the structure was used as an outhouse rather than a doorway (Fig. 21). At this stage the walls of the porch were partially plastered (Fig. 22). Finally, the arch and entranceway were infilled with red brick and corrugated iron was used as roofing, thus completing the fourth stage of alteration of the entranceway (Figs. 18 and 19). This final stage was probably completed by the Army as the same type of 20th Century brick was used in this area of the mill as the brick extension on top of the boiler house.

Fig. 16. Photograph of the original steps which led up to the arched entranceway in phase one (facing north-east) (scale = 1m).

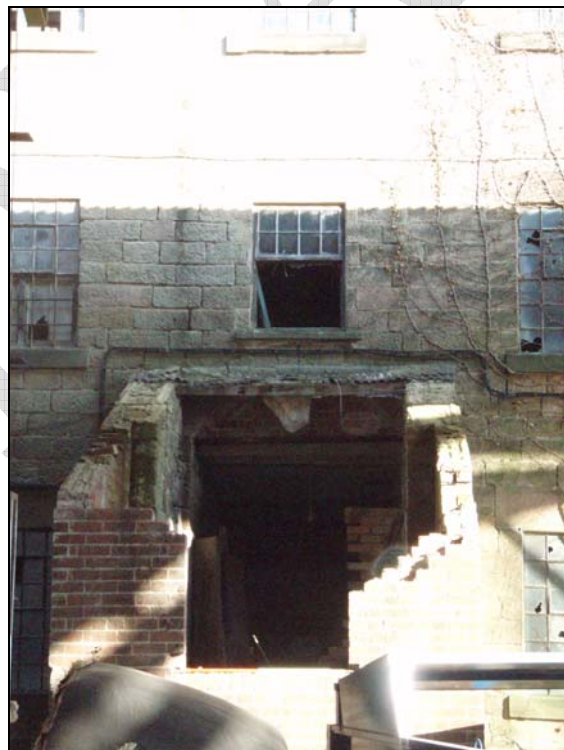
Fig. 17. Photograph of the phases of construction of the original entrance on the south-west façade of the mill (facing north-east) (scale = 1m).

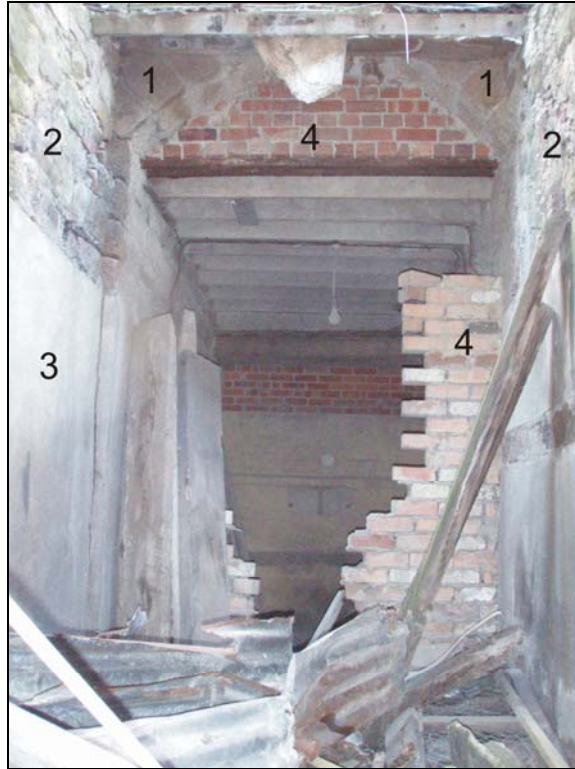
Fig. 18. Photograph of the phases of construction of the entrance including the original arch (1), the porch (2), the plastering of the porch (3) and the infilled arch and porch (4) (facing north-east) (scale = 1m).

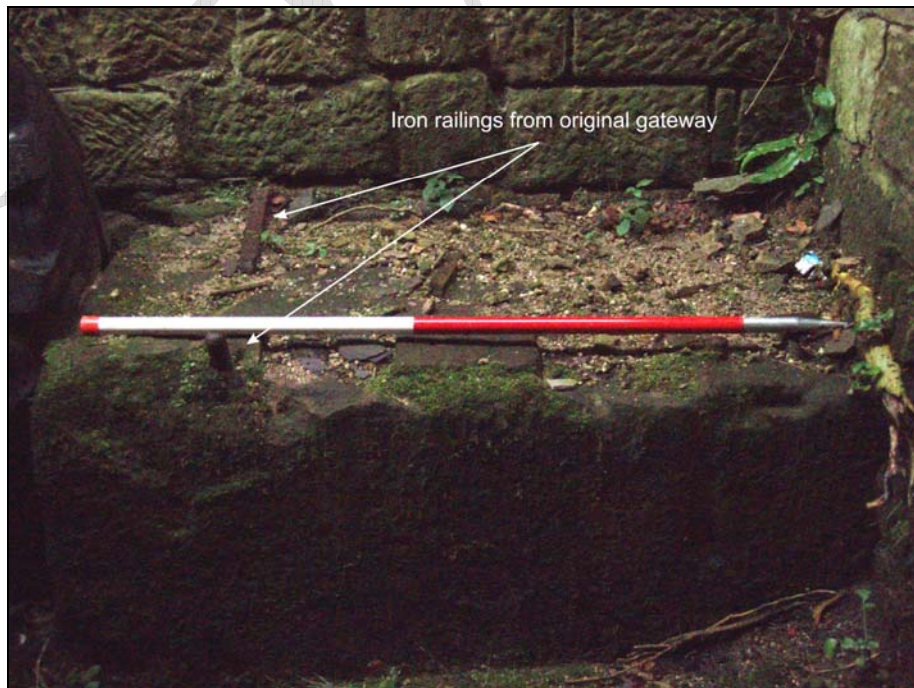
Fig. 19. Photograph of the remains of the iron gateway from phase one of the construction of the entrance to Scholes Mill (facing north-east) (scale = 1m).

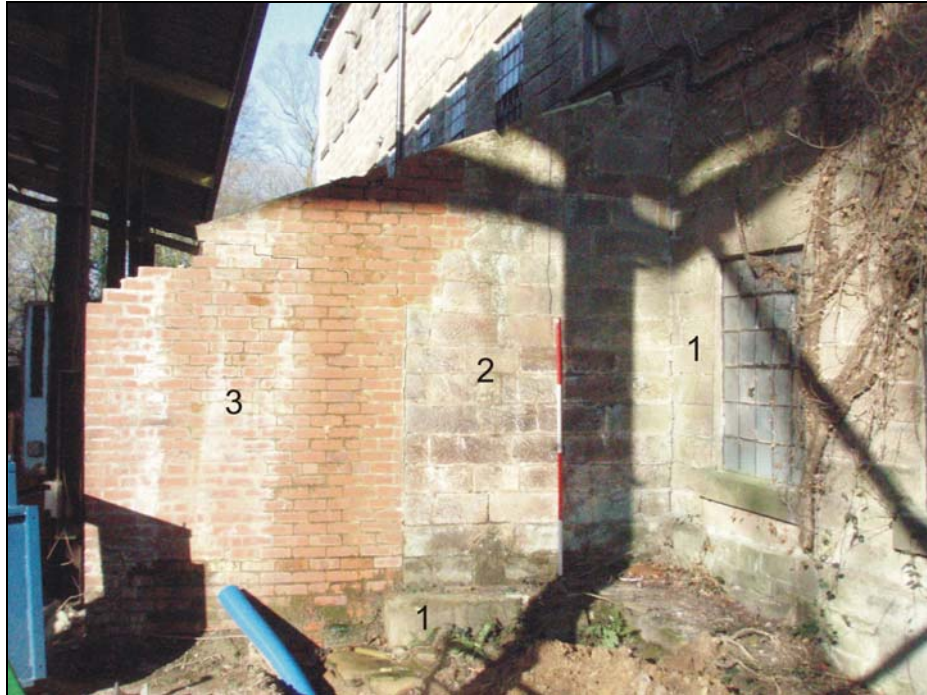
Fig. 20. Photograph of the phases of extension to the entrance, including the original mill (1), the porch addition (2) and red brick extension onto the porch (3) (facing north-west) (scale = 2m).

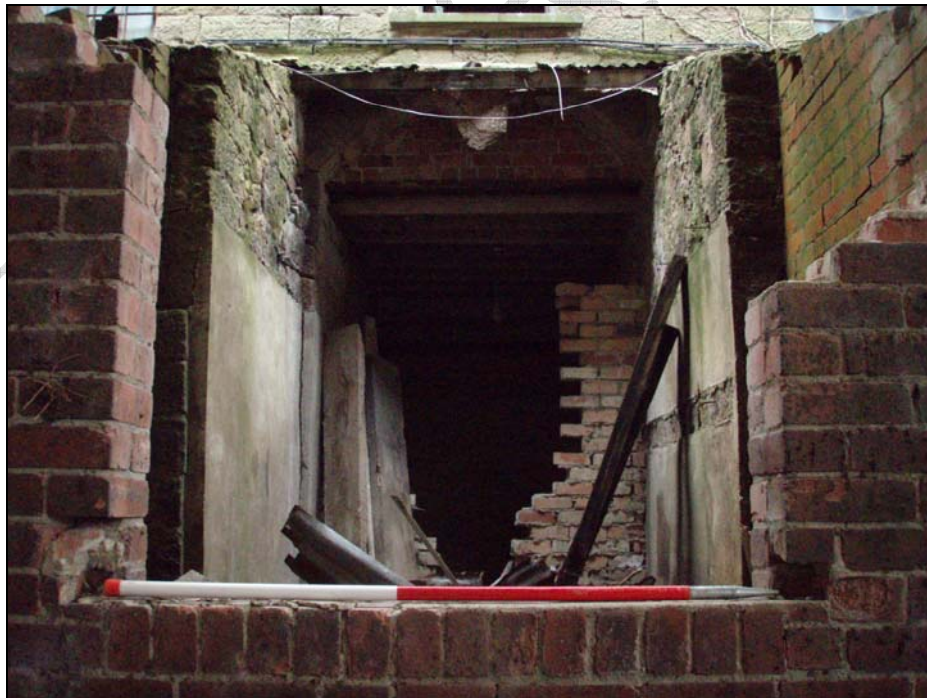
Fig. 21. Photograph of the window in the brick extension of phase three of the alteration of the entrance (facing north-east) (scale = 1m).

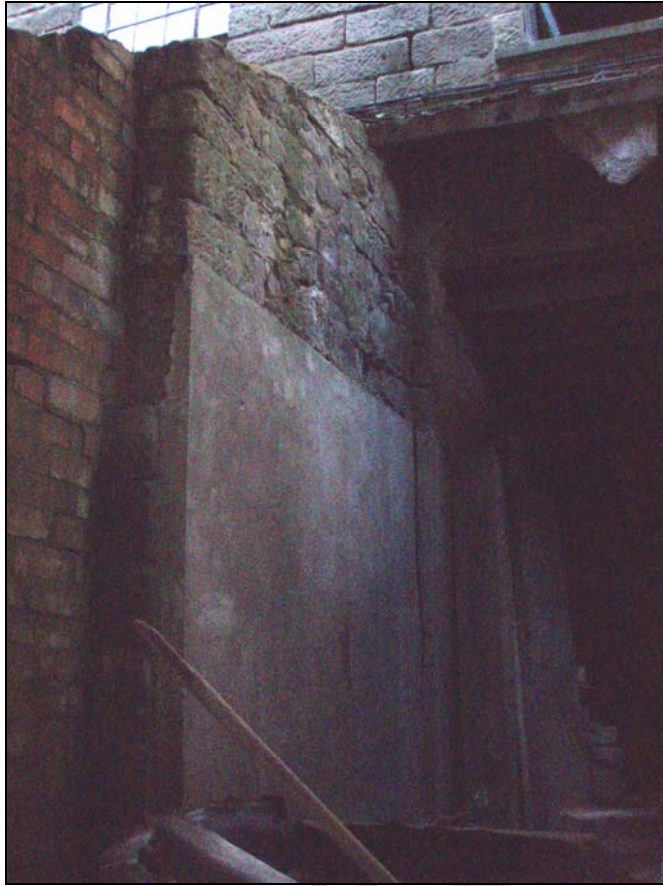
Fig. 22. Photograph of the plastered section of the porch (facing north) (scale = 1m).

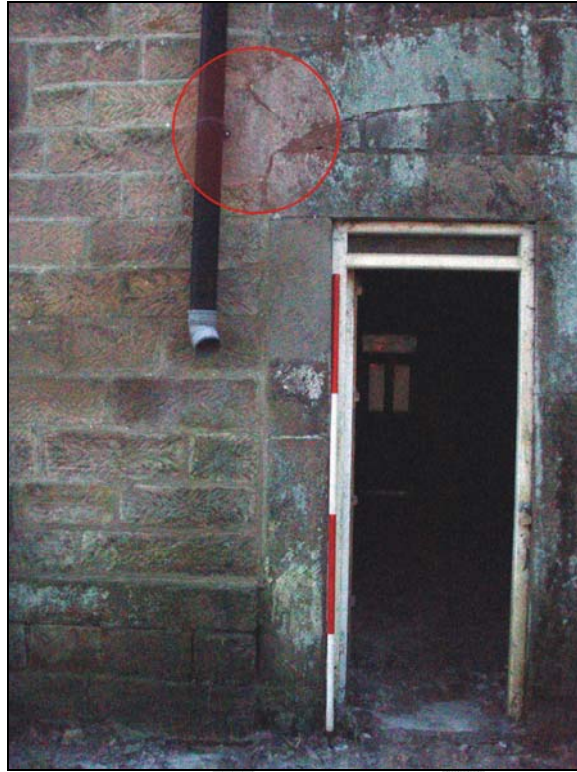
Fig. 23. Photograph of the stones of the arch which have been keyed into the construction of the mill (facing south-west) (scale = 2m).

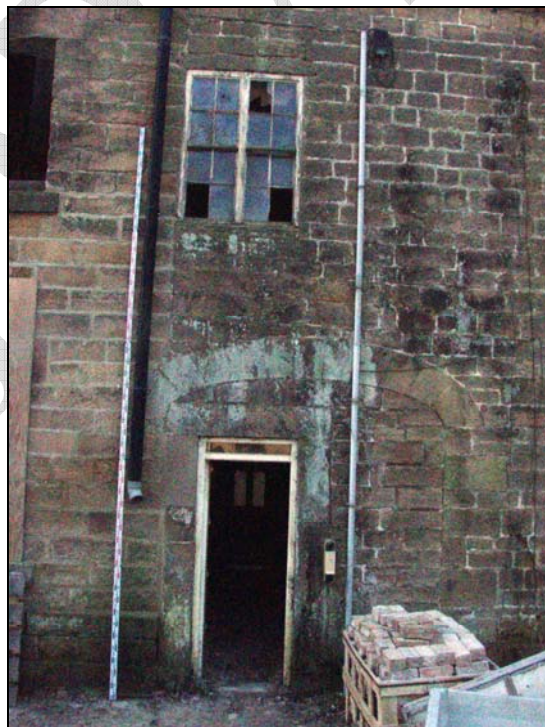
- 6.4.1 There is no documentary or archival evidence to confirm the ownership of the house but in view of the location and grand nature of the house, it was probably the manager's house. The building abuts the north-western end of Scholes Mill and was added after the construction of the mill. The same gritstone was used for the build, suggesting the house may have been built shortly after the mill. Upon construction of the house a tunnel was built for vehicle access to and from the front and the rear of the buildings. It is clear that the arch of the tunnel is contemporary to the house build as the stone was keyed into the original brickwork of the mill (Fig. 23). The archway was infilled at a later date with gritstone bricks and a doorway was added at both the front and rear of the house (Fig. 24).

Fig. 24. Photograph of the join between the mill and the house and the infilled archway on north-east façade of the house (facing south-west) (scale = 5m).

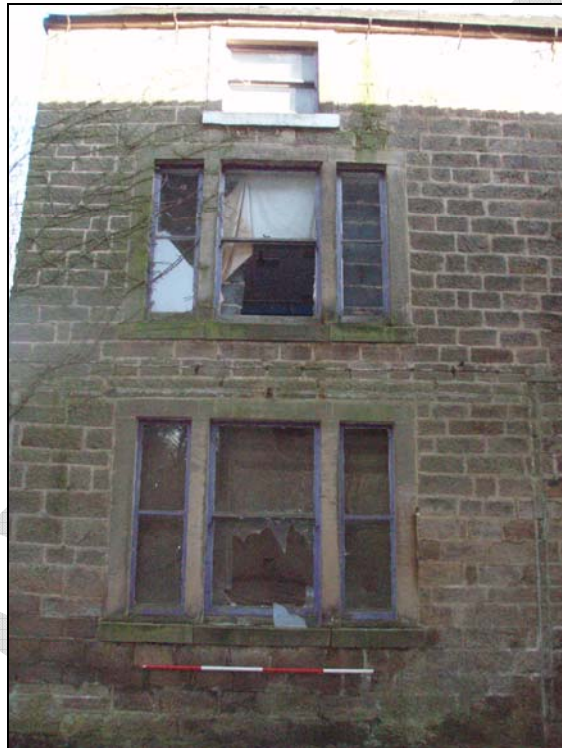
Fig. 25. Photograph of a standard window (ground and first floor) and small window (second floor) of the south-west façade of the house (facing north-east)

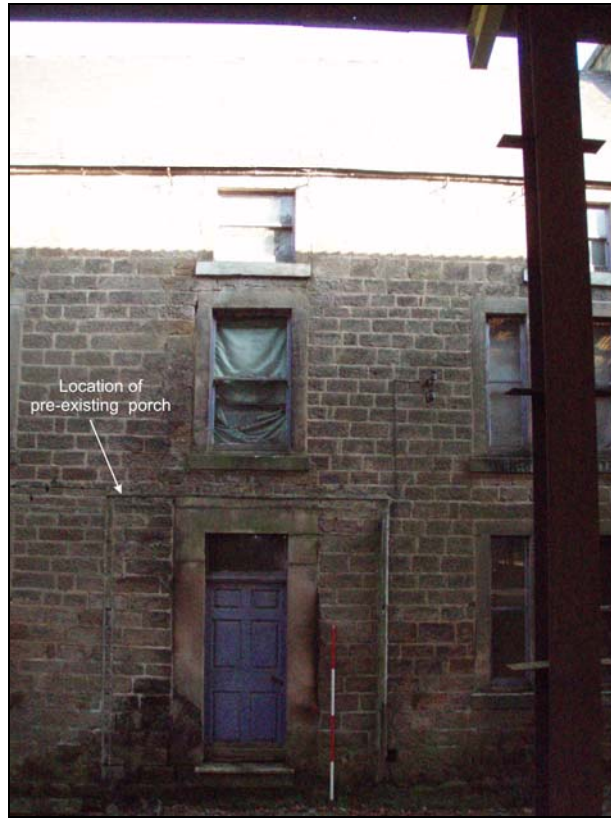
Fig. 26. Photograph of the main entrance to the house on the south-west façade with evidence of a pre-existing porch (facing north-east) (scale = 2m).

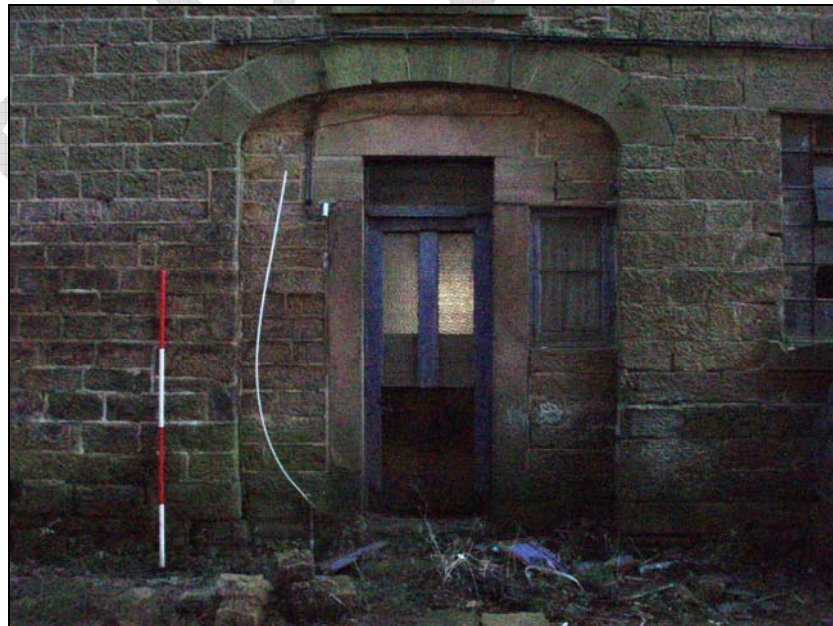
6.4.2 The house has three storeys with windows on each storey. On the ground floor of the south-west façade, which is grander in appearance than the north-east rear façade, there are two large windows, a main entrance door, second door and a small window. The large windows have six panes separated by two stone mullions and three wooden transoms, which are surrounded by a dressed stone lintel and sill (Fig. 25). The main doorway is surrounded by a large stone lintel (Fig. 26). A series of mortared, but broken, joins surround the doorway suggesting that a porch may have been constructed after the house was built (Fig. 26). The other doorway and small window were built when the tunnel was infilled with bricks (Fig. 27). The small window is situated to the right of the doorway and is made of two panes of glass (Fig. 27).

Fig. 27. Photograph of the doorway created within the original tunnel on the south-west façade of the house (facing north-east)

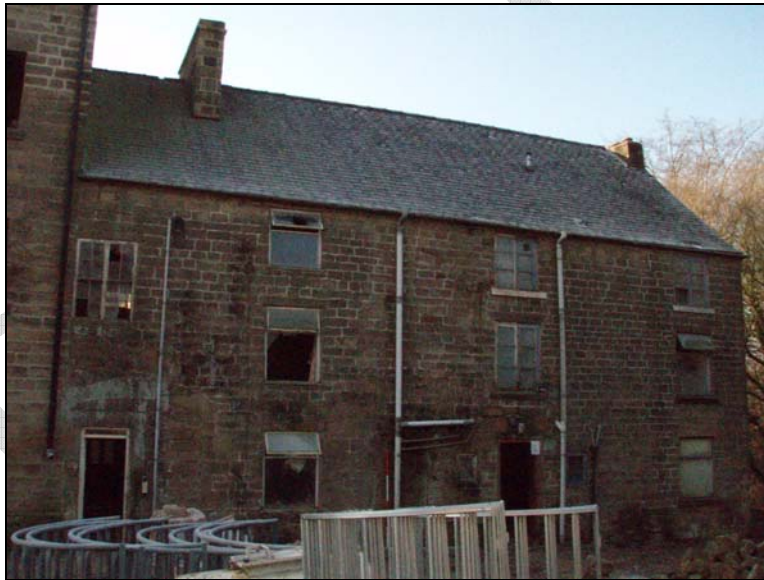
- 6.4.4 The north-east façade of the house is less grand than the south-west façade as the windows and doors are simpler in style with smaller lintels and no mullions (Fig. 27). The ground floor consists of a door situated within the old tunnel (Fig. 27), two standard windows, both with two panes and another door with two very small windows on either side (Figs. 29 and 30). This floor also has an infilled door, possibly occurring when the house was divided into two, with a large stone lintel. This was probably the original back door to the house (Fig. 31). The first floor has three standard windows, two with two panes and one with six. The second floor contains three standard windows, two with six panes and one with two and is possibly on a staircase. Above the door within the old tunnel is another standard window with 16 panes which appears to be between the first and second floors. The windows on the right hand side of the building have stone lintels and sills, whilst those on the left hand side, have smaller lintels and no sill.

Fig. 28. Photograph of the windows and doors on the north-east façade of the house (facing south-west) (scale = 2m).

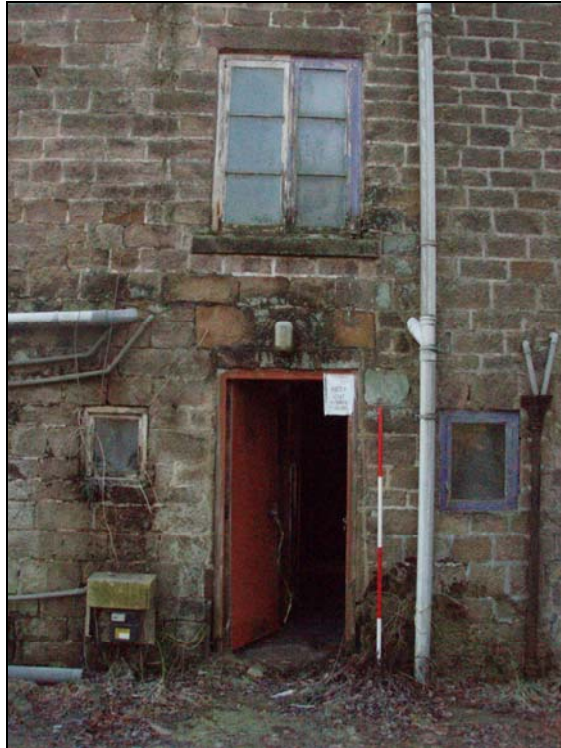
Fig. 29. Photograph of the second doorway and very small windows in the north-east façade of the house (facing south-west) (scale = 2m).

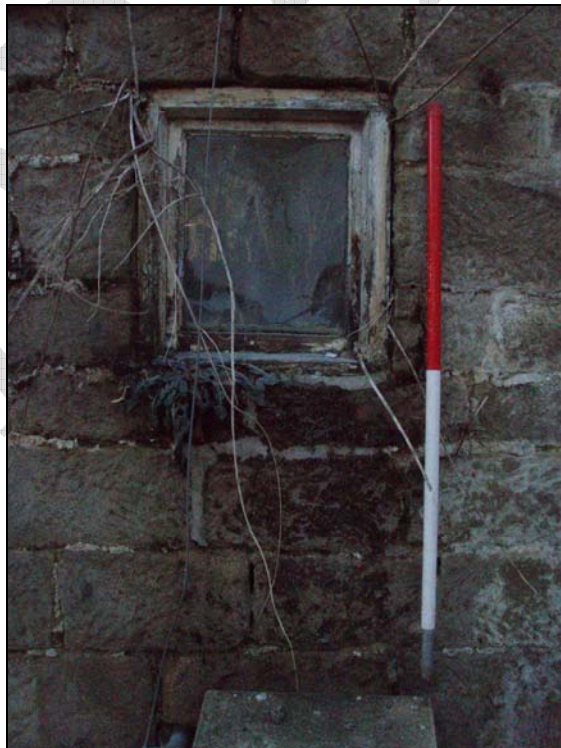
Fig. 30. Photograph of the small window located on the left of the second doorway (facing south-west) (scale = 1m).

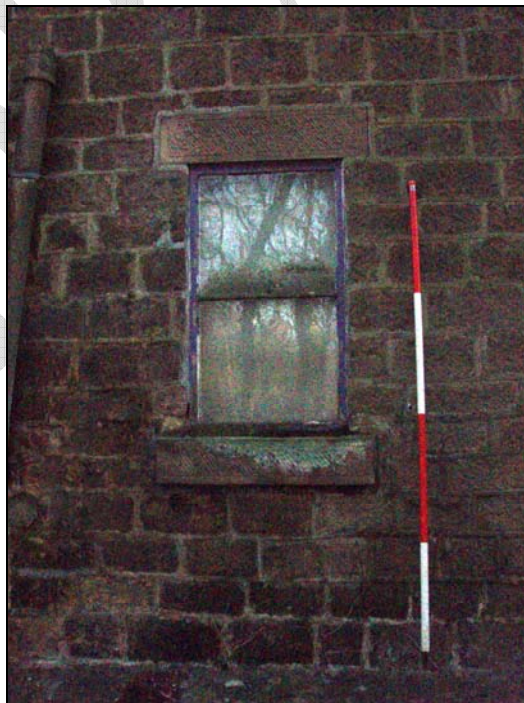
Fig. 32. Photograph of the window in the north-west façade of the house (facing south-east) (scale = 2m).

- 6.4.5. The north-west façade of the house is comprised of one small window with two panes and a stone lintel and sill (Figs. 32 and 33).

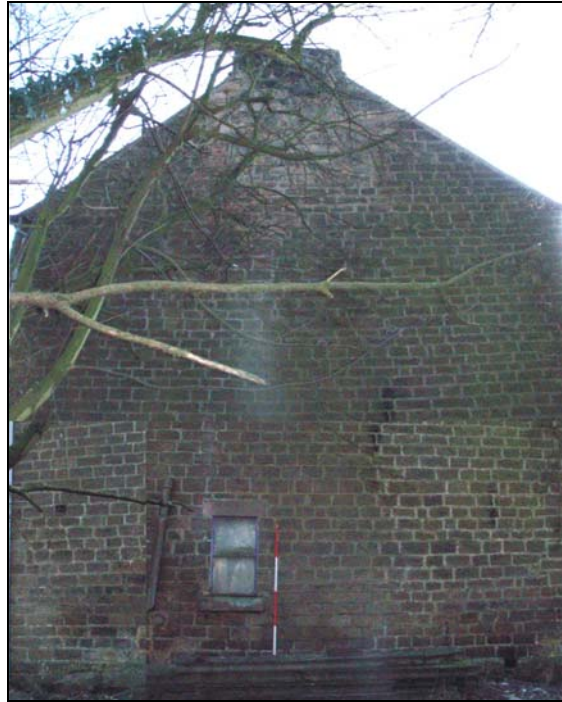
Fig. 33. Photograph of the north-west façade of the house (facing south-east).

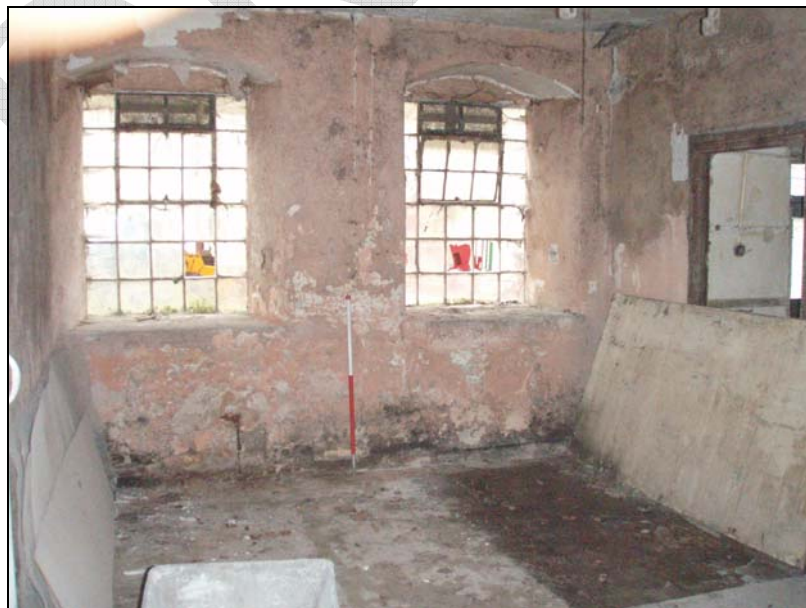
Fig. 34. Photograph of ground floor back room showing windows (facing south-west) (scale = 2m).

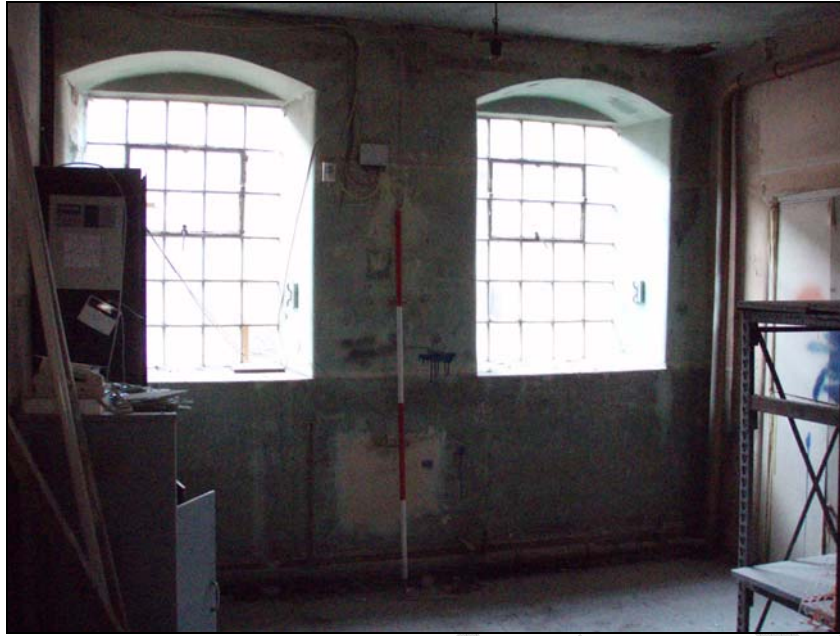
- 6.5.1 The floor plans of the ground, first and second floors of the Mill are all similar, consisting of a long single hall which is divided into two by a partition wall or two partition walls. At the north-west end of each of the floors is a back room with an entrance doorway in the north-east internal wall, two windows and no other original features (Figs. 34 and 35).

Fig. 35. Photograph of second floor back room showing windows (facing south-west) (scale = 2m).

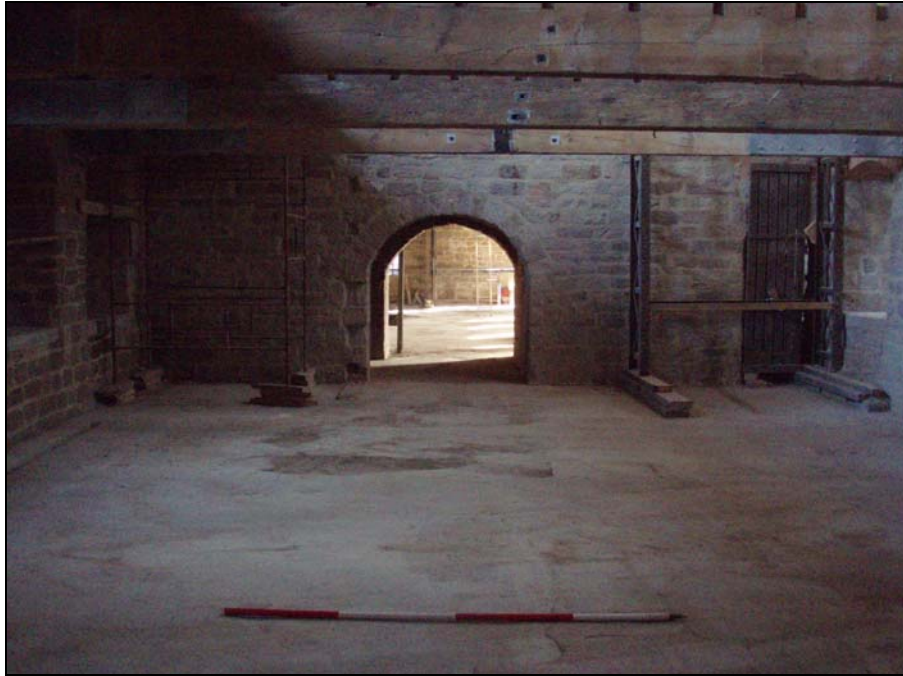
- 6.5.2 The ground floor of the mill is divided by two central walls and two keystone arches (Fig. 36). The south-east wall of the partition wall is load bearing and continues to the roof the structure, whilst the north-west wall of the partition continues to the first floor. A doorway is located on the south side of the north-west partition wall on the ground floor of the mill (Fig. 37). Originally, the entrance to the mill from the south-east façade would have led through a narrow hallway towards the water wheel and the two arches in the partition walls. This doorway was added either when the water wheel was replaced or when the hallway was blocked off with brick (Fig. 38) by the Army in order to create a room from the original entrance to the mill. There is no doorway on the opposite, south-east partition wall (Fig. 39).

Fig. 36. Photograph of the partition wall and arches on the ground floor of the mill (facing south-east) (scale = 2m).

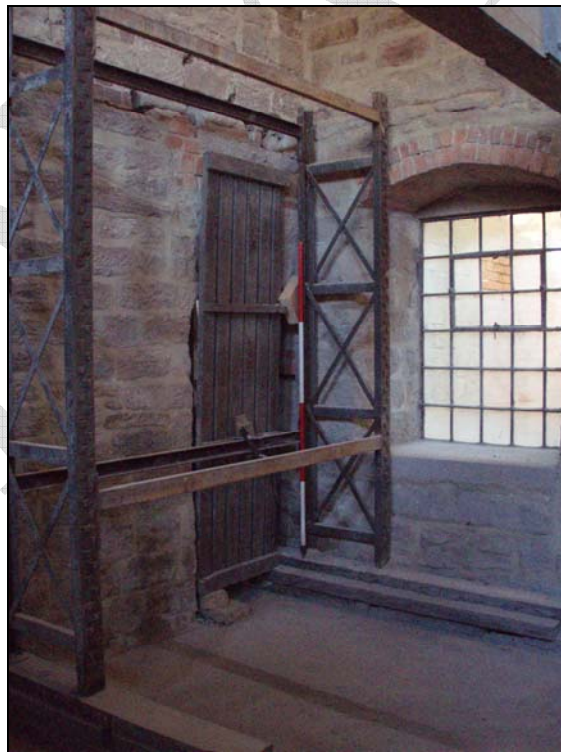
Fig. 37. Doorway in the north-west partition wall of the ground floor of the mill (facing south-east) (scale = 2m).

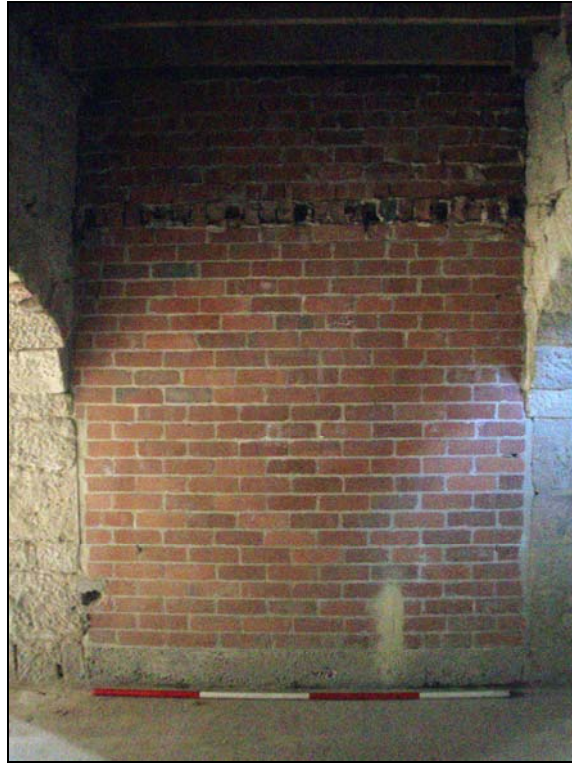
Fig. 38. Photograph of the hallway and entrance which was infilled during the Army's occupation of the mill (facing south-west) (scale = 2m).

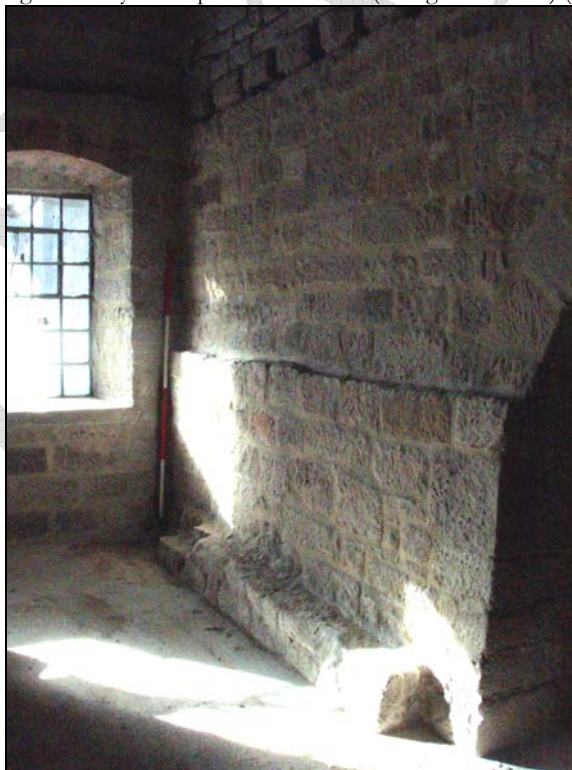
Fig. 39. Photograph of the south side of the south-east partition wall (facing west) (scale = 2m).

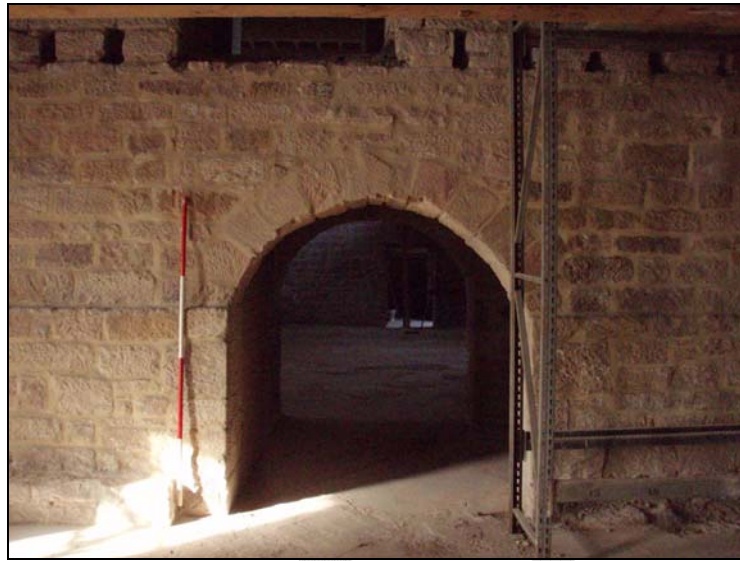
Fig. 40. Photograph of the south-east partition walls and arch on the ground floor of the mill (facing north-west) (scale = 2m).

6.5.3 The arches are made of dressed gritstone with mortared joints (Fig. 40). The interior windows on the three floors are the same as the exterior but with angled stonework surrounds and brick arched lintels rather than the exterior stone rectangular lintels (Figs. 41 and 42).

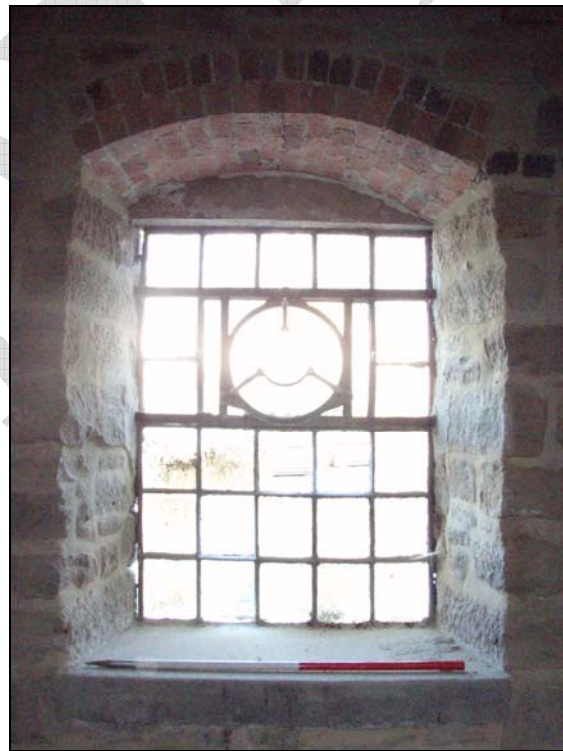
Fig. 41. Internal window with arched lintels and angled brick surrounds on the ground floor of the mill (facing north-east) (scale = 1m).
