Scholes Mill, Tansley, Matlock

**Desk Based Assessment and Building
Recording**

ARS Ltd Report No. 2007/9
Planning Application No. 06/00974/FUL
February 2007

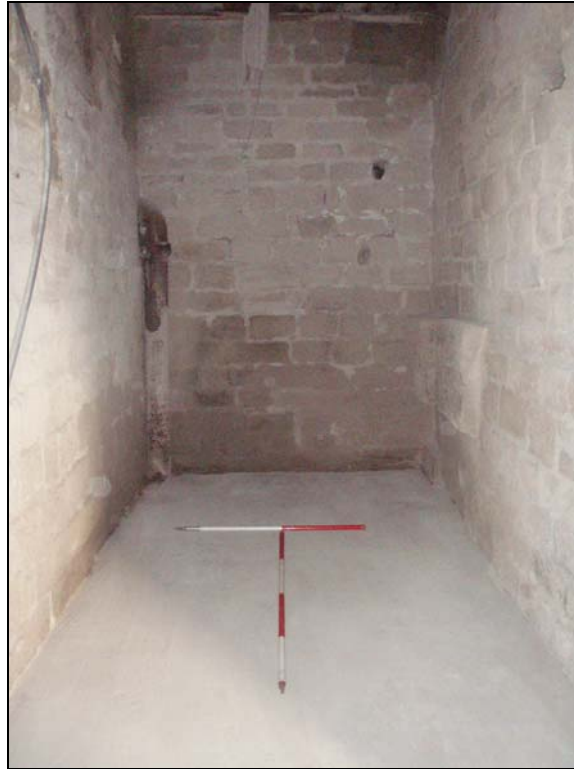
- 6.5.4 The water wheel was originally located between the two partition walls on the ground floor on the north-east side of the mill (Fig. 43). It was a vertical wheel, 41 ft in diameter and thus one of the largest wheels in England at that time (Taylor 2005: 63). Water was transported by a pipe from the mill pond directly to the water wheel (Taylor 2005: 60). The water pipe at Scholes Mill would have extended north-east to south-west down from the mill pond to the water wheel. The mill pond is situated on higher ground than the mill suggesting that the water wheel was an overshot wheel (Fig. 44). The wheel received the water from above, thus harnessing the water flow and the impetus of gravity for power (Munro 2002: 10-12). Opposite the wheel was the original main entrance to the mill, which was infilled with red brick possibly when the mill was occupied by the Army (Fig. 45).

Fig. 43. Photograph of the original position of the water wheel (facing north-east) (scale = 2m).

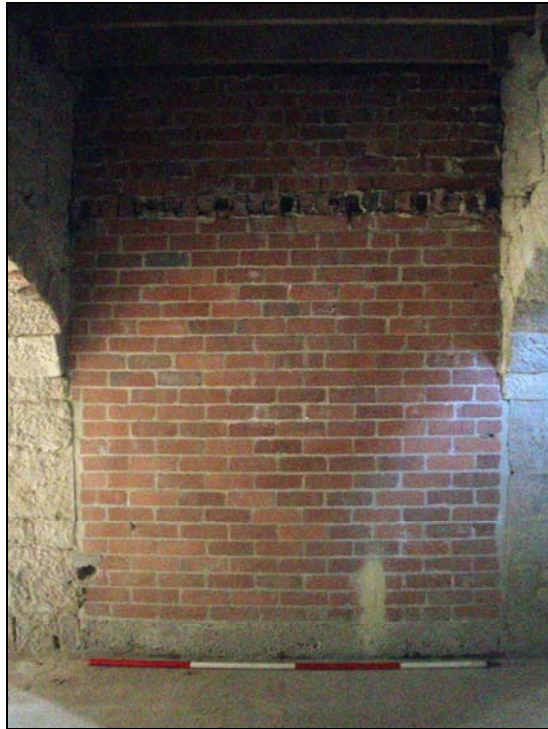
Fig. 45. Photograph of the brick wall which blocks the original entrance to the mill (facing south-west) (scale = 2m).

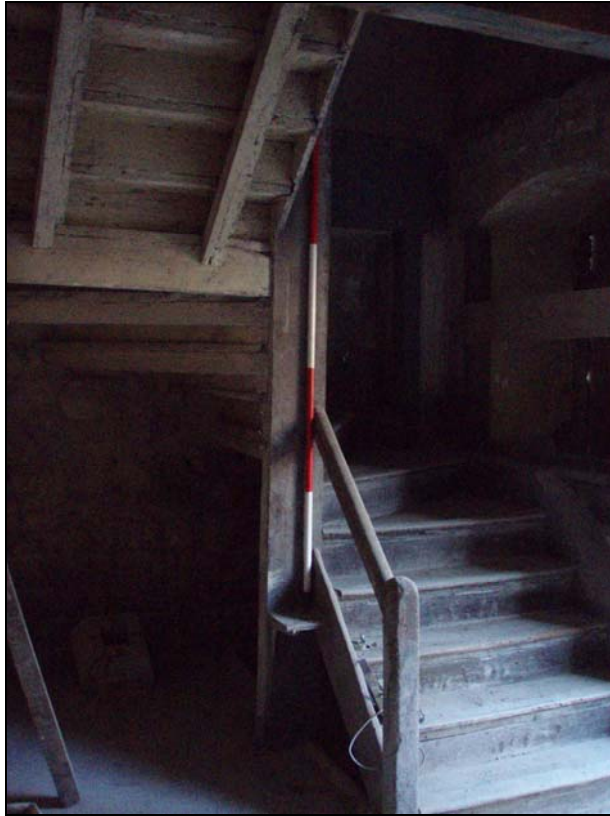
- 6.5.5 Access to the first floor is via a spiralled staircase in the northern corner which runs to the attic of the mill (Fig. 46). This staircase was inserted into the mill after its original construction as it covers some of the windows of the original north-west façade prior to the construction of the house (Fig. 47).

Fig. 46. Photograph of the staircase in the mill (facing north) (scale = 2m).

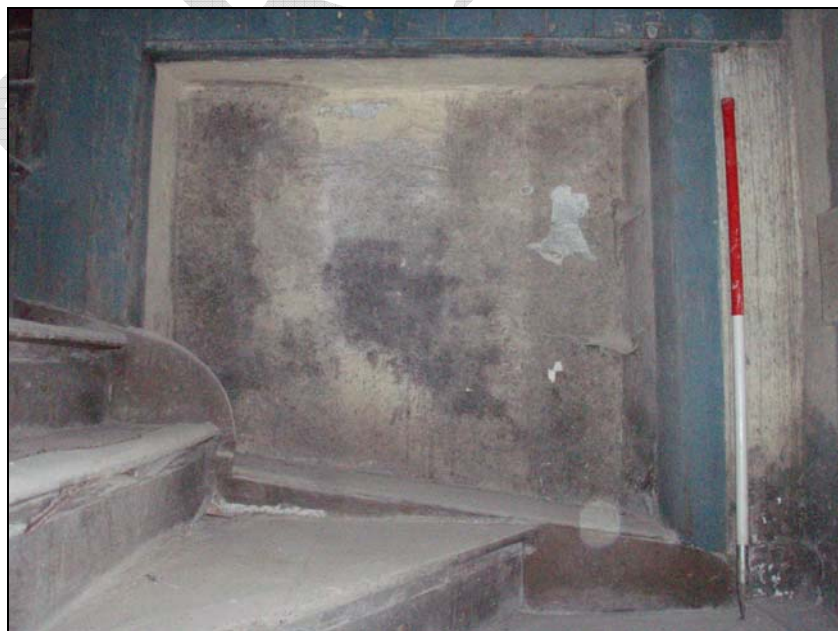
Fig. 47. Photograph of an infilled window which was covered by the staircase of the mill (facing north-west) (scale = 1m).

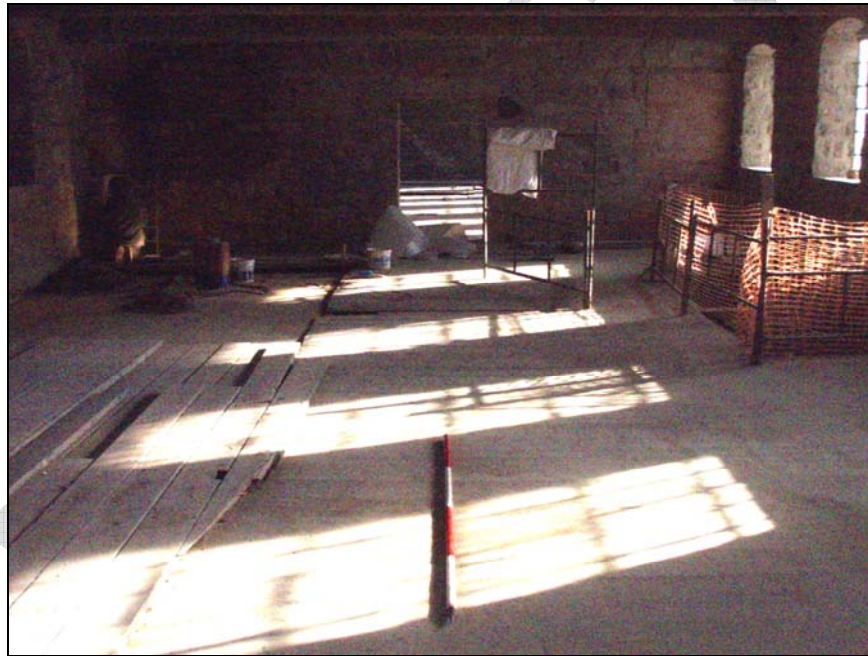
Fig. 48. Photograph of second floor of mill and doorway (facing south-east).

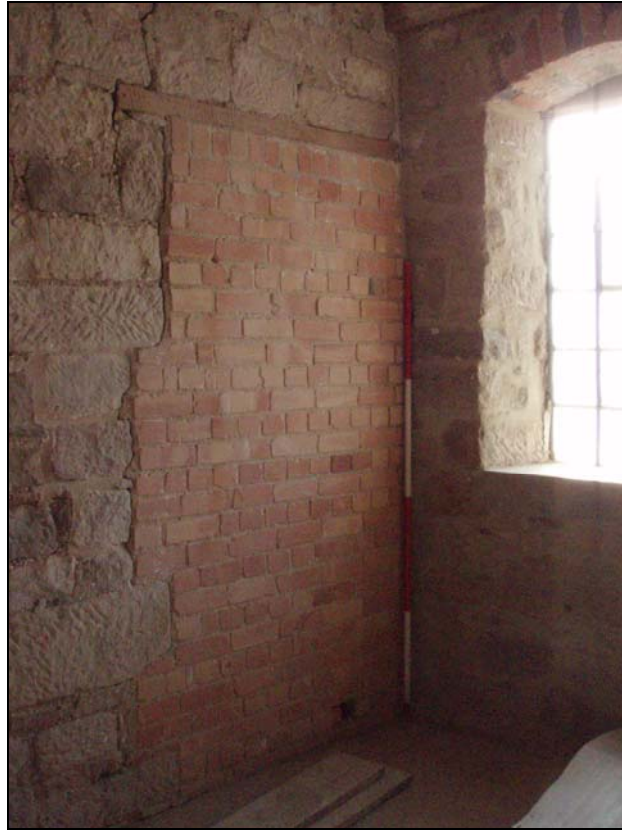
Fig. 49. Photograph of infilled door on second floor of mill (facing south).

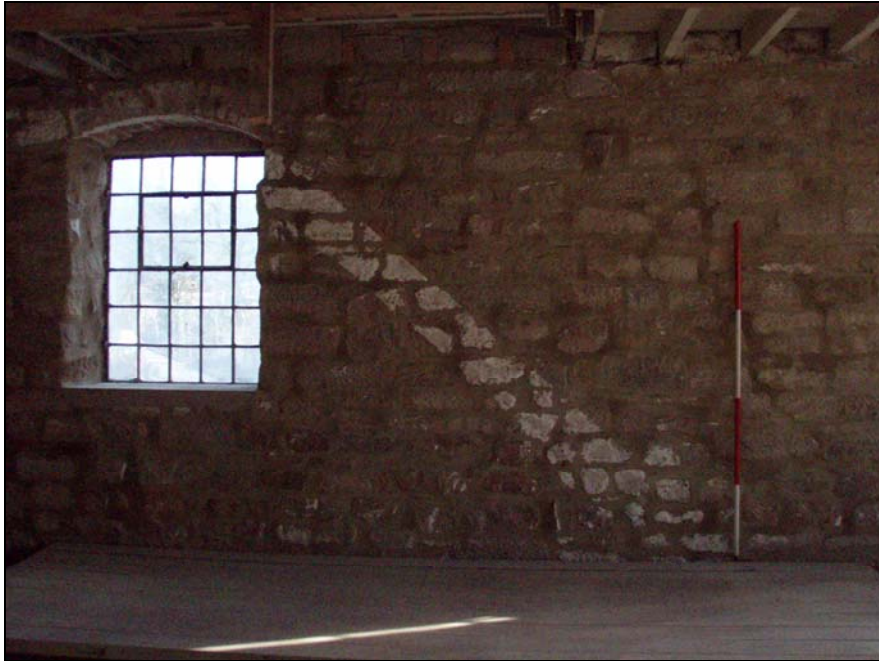
- 6.5.8 A window in the south-east wall of the mill was partially covered by a staircase, which provides access to the attic, suggesting that the staircase was built after the original construction of the mill (Fig. 50). This staircase has been removed for refurbishment and will, once repaired, be replaced in its original position (Fig. 51). There is no evidence that a staircase existed on the south-east wall of the ground floor (Fig. 52).

Fig. 50. Photograph of position of stairway which overlies a window in the south-east façade of the mill (facing south-east).

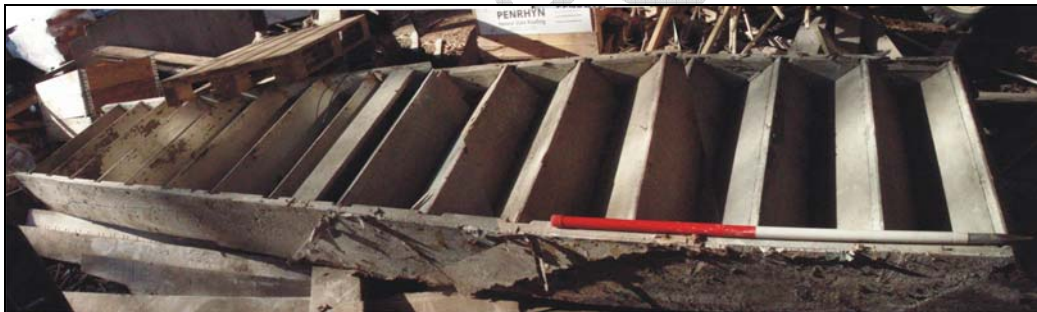
Fig. 51. Photograph of original staircase from the second floor of the mill (facing south-west) (scale = 1m).

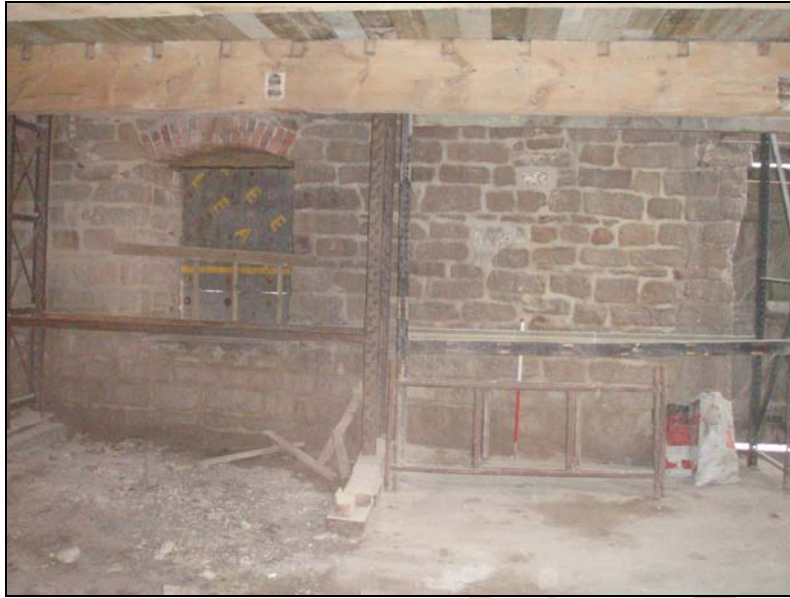
Fig. 52. Photograph of the south-east wall of the ground floor of the mill (facing south-east) (scale = 1m).

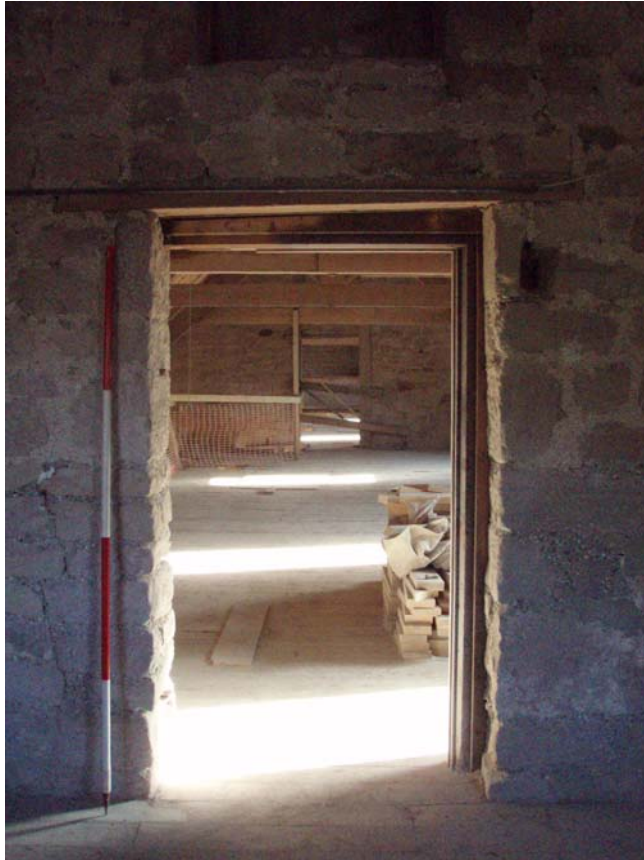
- 6.5.9 The attic level of the mill consists of two rooms; the first being at the top of the staircase (Fig. 53). The second lies through the doorway of the first room and is a long hall with a partition wall across the centre containing a door (Fig. 54). The roof of the mill was replaced by Wardmans (Matlock) Ltd with king post truss rafters when the original collapsed in 2005. A lift from the second floor to the attic is located in the south-eastern section of the attic and was built after the mill became a storage unit in the mid 20th century (Fig. 55). Two standard windows are located in the south-eastern façade of the mill (Fig. 56).

Fig. 53. Photograph from the first room at the top of the staircase in the attic of the mill (facing south-east) (scale = 2m).

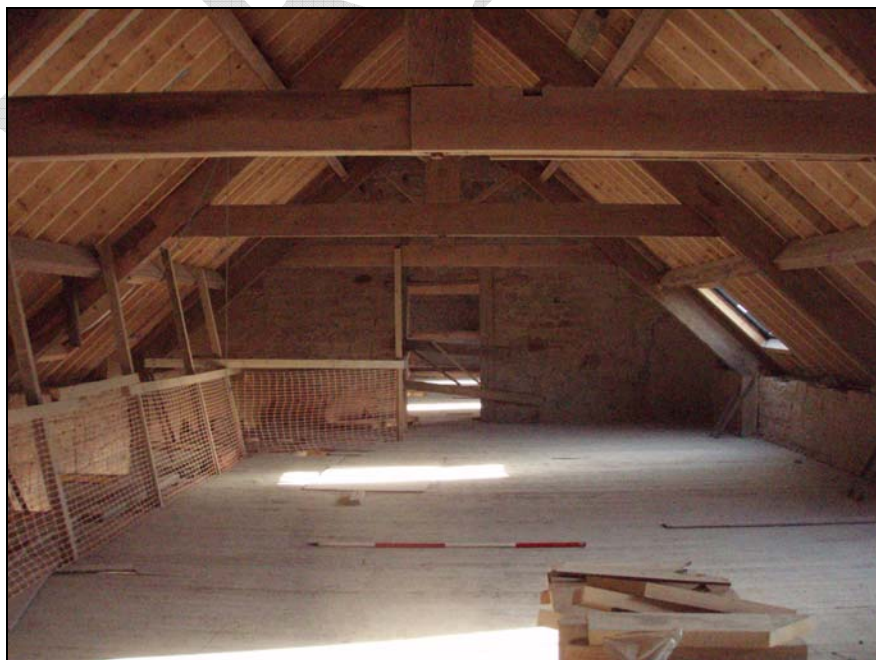
Fig. 54. Photograph of the attic of the mill (facing south-east) (scale = 2m).

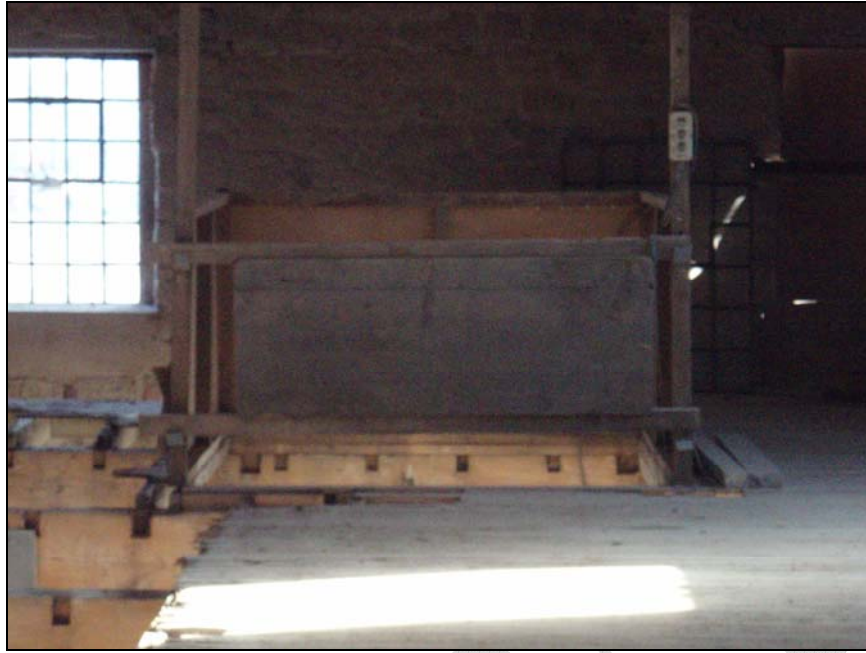
Fig. 55. Photograph of lift connecting the second floor with the attic (facing south-east) (scale = 2m).

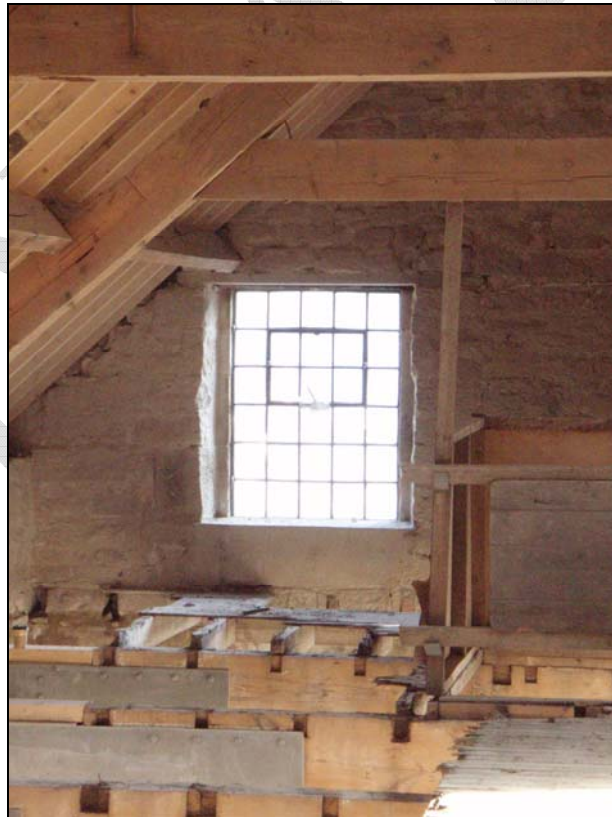
Fig. 56. Photograph of a window in the south-east façade of the mill (facing south-east) (scale = 2m).

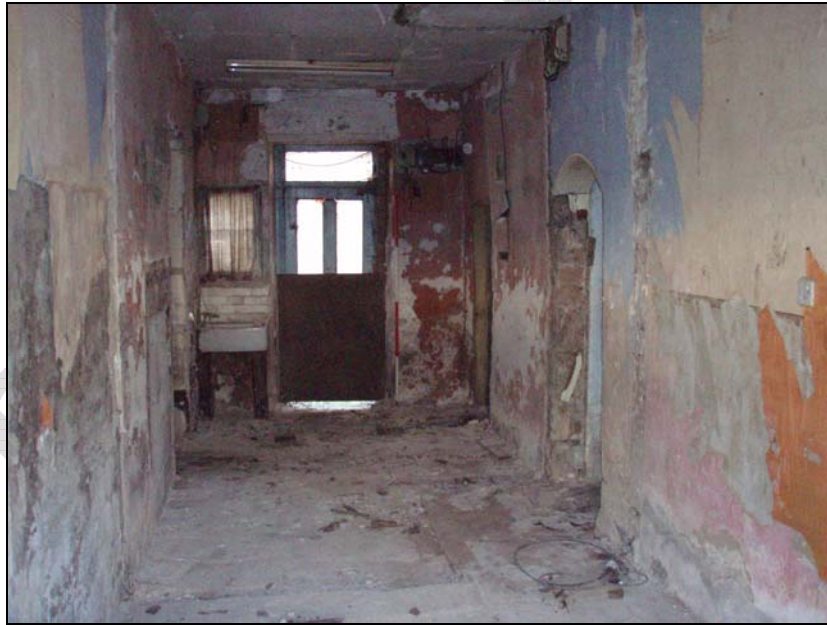
6.6.2 The ground floor of unit one consists of a hall which was originally the tunnel providing access from the front to the rear of the mill (Fig. 57), with an infilled fireplace in the south-east wall, a kitchen to the east and a front room to the west of the building. The first floor consists of a room with an internal wall which was built when the houses were split into two as it partially blocks an original window (Fig. 58). The rest of unit one was deemed structurally unsafe to survey, but three other rooms and a staircase were visible (Fig. 59).

Fig. 57. Ground floor hall of Unit one (facing south-west) (scale = 2m).

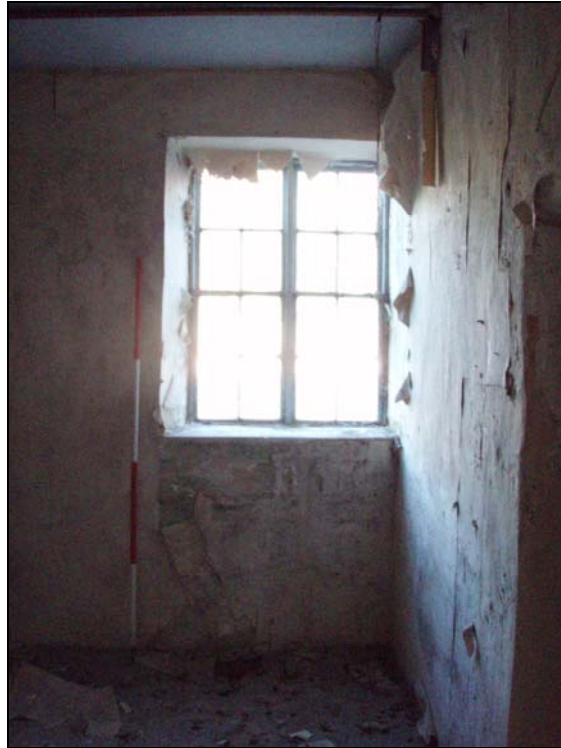
Fig. 58. A partially covered window in the first floor room of unit one (facing south-west) (scale = 2m).

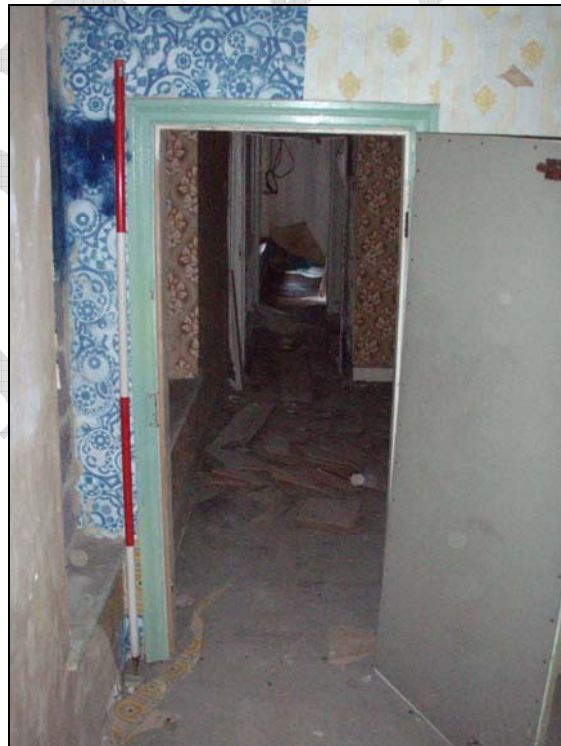
Fig. 59. A doorway on the first floor of unit one into the rest of the structure (facing north west) (scale = 2m).

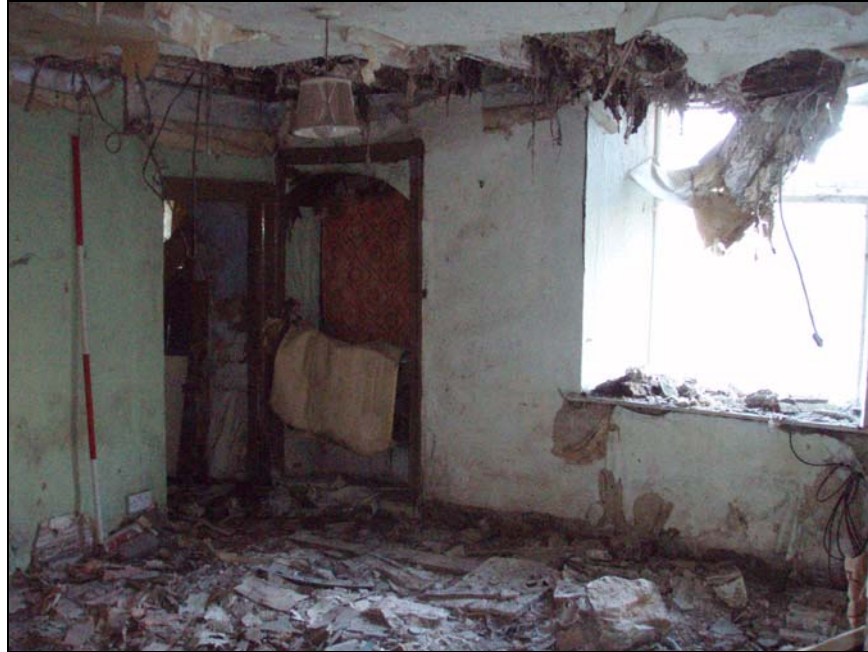
- 6.6.3 The stairs and floors of unit two were deemed structurally unsafe. This, coupled with the extensive decoration, including wallpaper and wood panelling covering most of the original features of the rooms which were safe, resulted in most of the structural survey of unit two being conducted from the exterior and the front room. The rear back door of the original house had been made into an alcove in the front room of unit two, probably when the house was split (Fig. 60).

Fig. 60. Photograph of the front room of unit two showing the infilled back door (facing north) (scale = 2m).

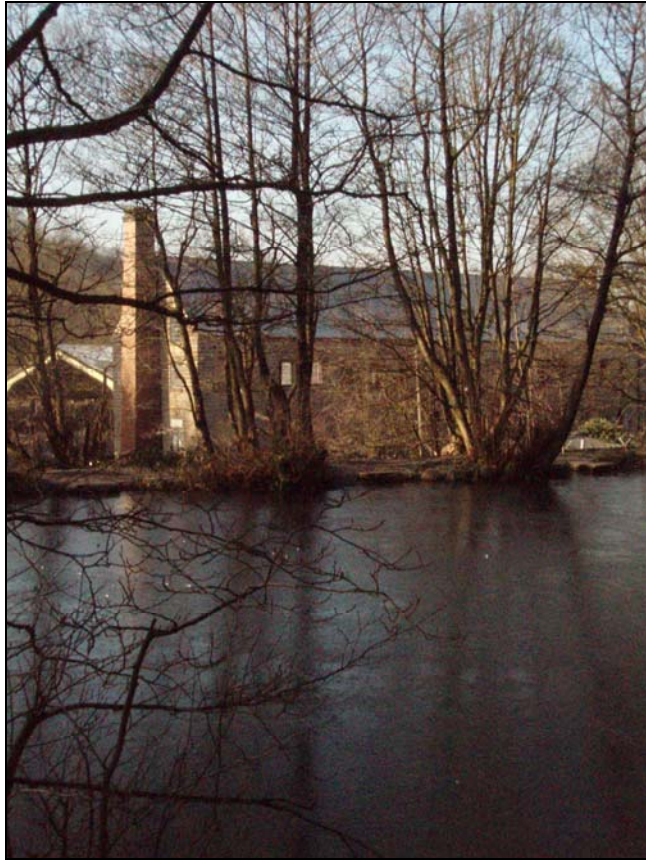
Fig. 61. View across the millpond looking south back towards the mill complex.

- 6.7.1 To the north-east of the mill complex, there is a large millpond which constitutes part of the Conservation Area of Lumsdale. In this region, there remains evidence of the sluice machinery which controlled the flow of the water to the water wheel (Figs. 61, 62, 63 and 64). Five lakes and dams originally fed all the Tansley Mills, including Scholes Mill. The water was transported by pipes or aqueducts from the lakes directly to the water wheels (Taylor 2005: 60) (Fig. 65). The water wheel at Scholes Mill was so large that it would have reached to the second storey of the mill despite being sunk below ground (Taylor 2005: 63).

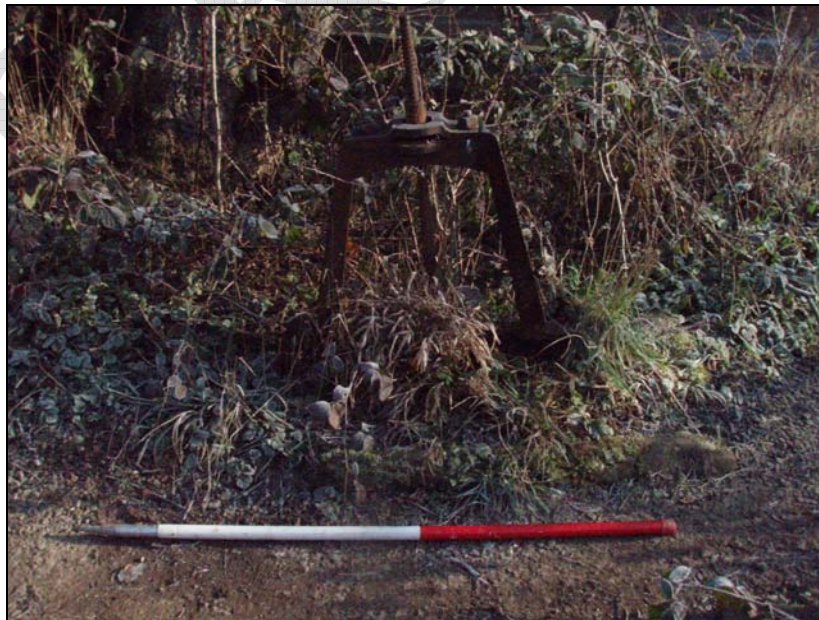
Fig. 62. Photograph of sluice machinery associated with the Mill pond at Scholes Mill (facing north).

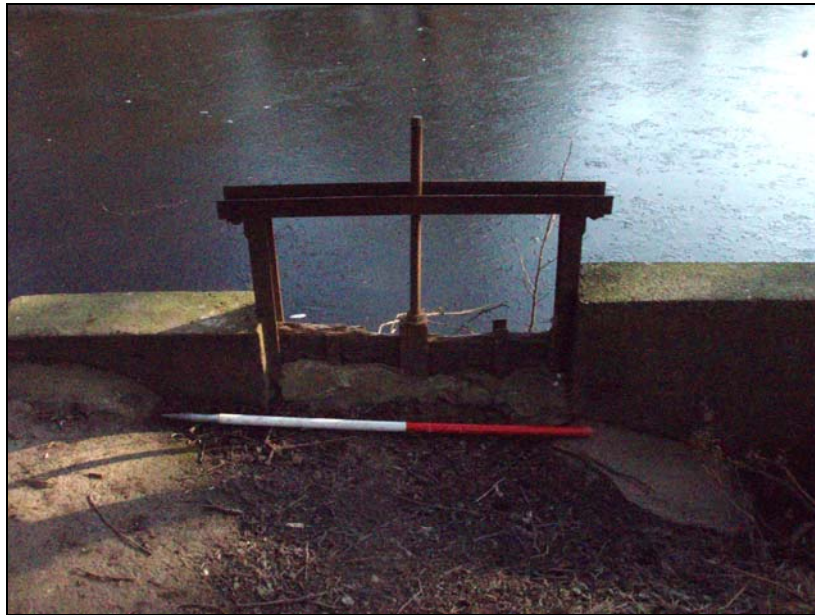
Fig. 63. Photograph of the sluice gate and the Scholes Mill pond (facing north-east).

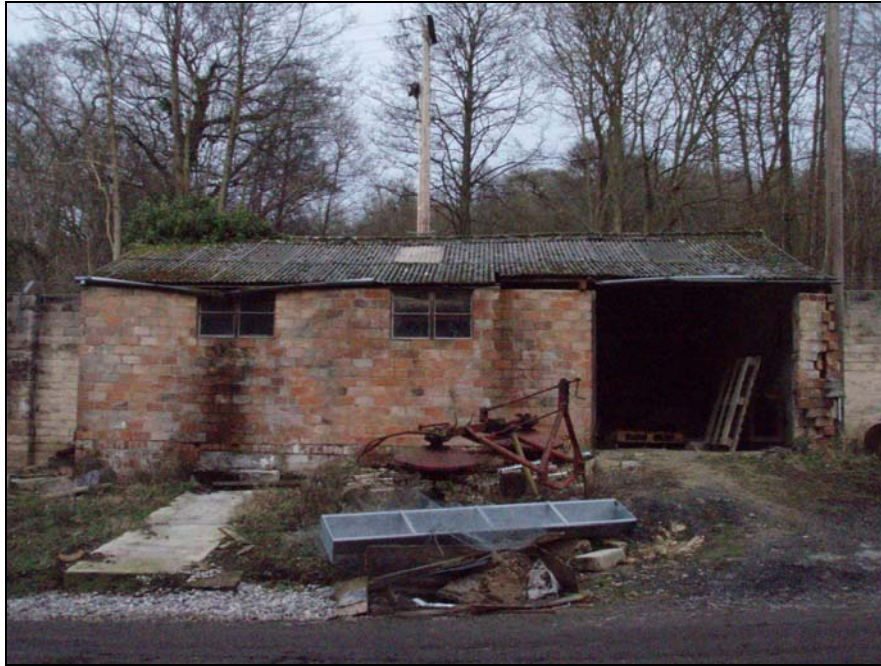
Fig. 66. Photograph of the outhouse (facing north-east) (scale = 2m).
