Grimesthorpe Road, Burngreave, Sheffield. An Archaeological Watching Brief on the 'Roman Ridge'.

ARS Ltd Report 2007/11

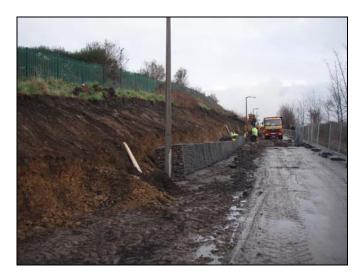
3.3 Grimesthorpe Road, which runs through Burngreave, is a very old road that follows the course of the 'Roman Ridge'. Excavations by Leslie Butcher in 1948 revealed the remains of the ridge lay just below the crest of the natural bank on Grimesthorpe Road (Fig. 2). Where the road bends in a more easterly direction the ridge turns north towards what used to be Wilkinson's Spring Wood, now a housing estate (Cronk 2004, 23). It was during work to widen the road in 1948 that excavations revealed the internal structure of the bank, with the variation in material suggesting that the ditch material had been used to create the bank (Butcher 1957, 96). There appears to have been no attempt to make a uniform structure when creating the ridge (Cronk 2004, 25). One commentator (Cronk 2004, 25) has suggested that rather than being a status symbol the dyke was thrown up in haste as a defence against immediate danger. Unfortunately, it seems all traces of the dyke were destroyed during the road widening.

Figure. 2 View of Grimesthorpe Road looking east.

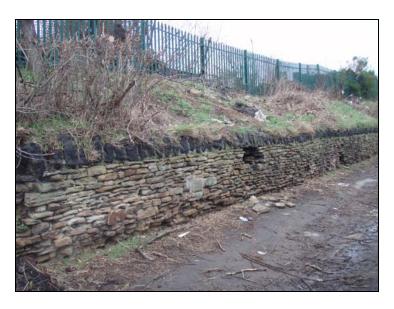
Fig. 3 View of the sandstone revetment wall looking west.

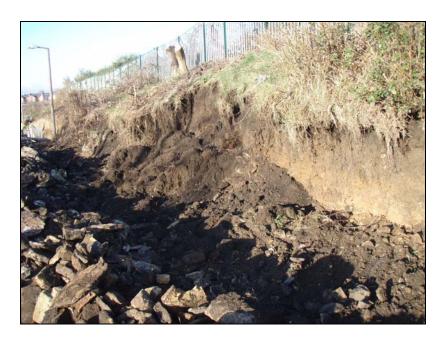
Fig. 5 View of the wall after demolition, looking north-west.

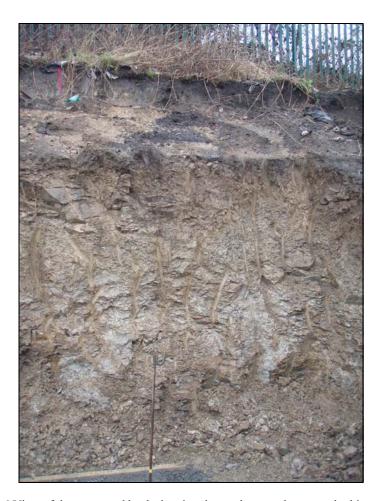
- 6.2 The results of the watching brief suggest that rather than being an artificial bank, the 'Roman Ridge' in this area may have predominately been a natural sandstone scarp (Fig. 6). It is possible that the ridge builders deposited some of the ditch material on top of the scarp, as well as taking advantage of its natural height, but no evidence for this was found during this intervention. It is likely that the road widening in 1948 destroyed any remaining traces of an artificial ridge. However, it is possible that some of this ridge still survives on the very top of the bank but the watching brief did not require the ground to be stripped at this level.

Fig. 6 View of the excavated bank showing the sandstone substratum, looking north.

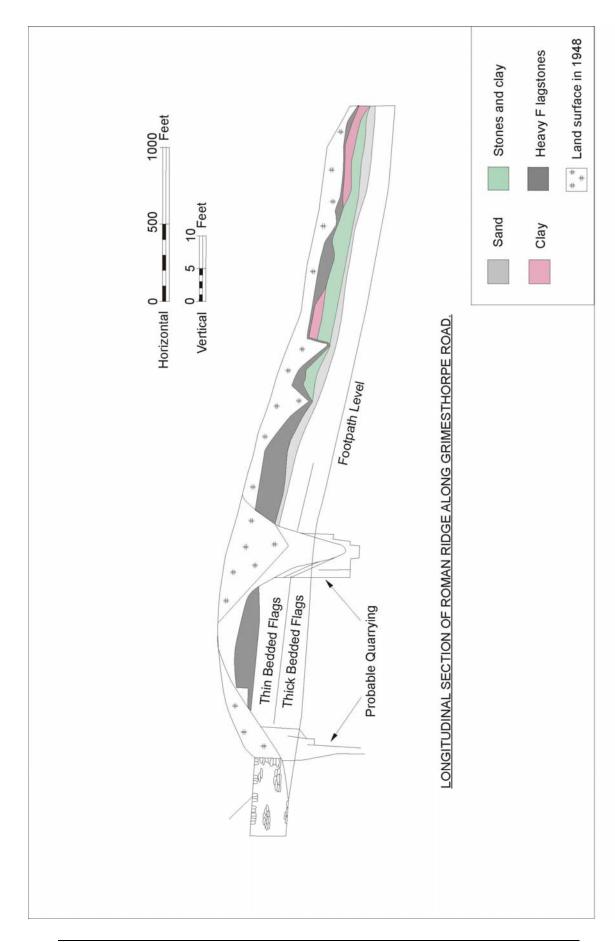
- 6.3 The archaeological work undertaken by Butcher during the road widening is informative, as the section drawing reveals the internal structure of the bank (Fig. 7). The drawing shows that the construction of the bank involved layers of heavy sandstone blocks that Butcher described as 'flagstones', together with smaller stones, sand and clay (Butcher 1957, 96). It is unlikely that he meant flagstones as cut sandstone blocks, but rather broken slabs of the natural sandstone from the rock-cut ditch that can be won by prizing off along the bedding planes. However, there are inconsistencies with Butchers work that need to be explained. It appears that the scale bar used on Butchers section is the same as the scale bar used on his corresponding plan of Grimesthorpe Road. This is clearly inaccurate, as it would make the section over several thousand feet long. The mistake means that a precise length for this section cannot be obtained. A further inconsistency is that the section, according to Butcher, was aligned along a length of Grimesthorpe Road, rather than being perpendicular to it. The drawing is clearly a cross-section view of the bank and the only cross-section of the bank made during these works was when a new road, Margate Drive, was constructed (Fig. 4). It can be concluded then, that the location of the section is incorrectly located on Butcher's plan. The most likely position of this section is shown on Fig. 4. It is along this part of the natural ridge that the scarp is less steep and therefore more likely to have been artificially banked up, a detail that is consistent with Butcher's drawing.

An alternative, however, is that if Butcher's location of the section is correct, then it must have cut across the bank at a very oblique angle and Butcher has used this stretched profile as the basis for his drawing that appears to show a section cut to the line of the monument. Despite this latter possibility it is still thought most likely that Butcher's section was taken from the monument in the Margate Drive area.

Figure. 7 Section of the 'Roman Ridge' along Grimesthorpe Road redrawn from Butcher (1957).

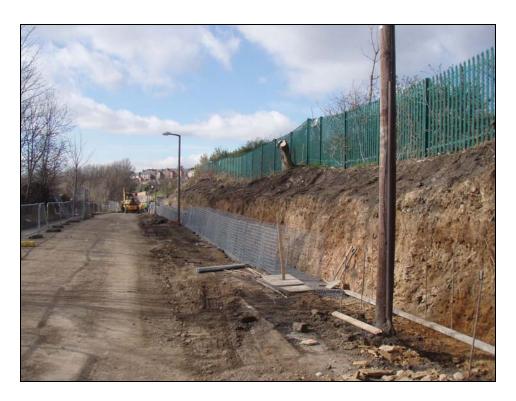
Fig. 8 View of work in progress. (The streetlights show the original width of the bank before it was excavated to accommodate the gabions).

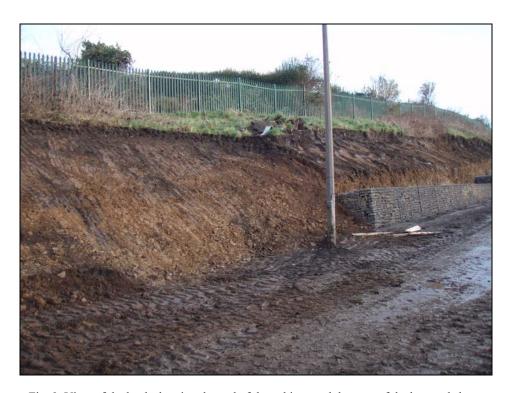
Grimesthorpe Road was demolished for a length of 270m and the stones reused in the gabions (Fig. 8 and 9). The gabions were not used at the north-west end of the road. In this area the bank was battered to a gentle slope (Fig. 9). The exposed area behind the wall revealed that the majority of the bank was comprised of natural deposits with a layer of topsoil (Fig. 5). The topsoil (001) had a maximum depth of 0.6m and was dark brown (7.5YR 3/4) in colour. The topsoil (001) had a significant amount of modern debris included within it, probably from the allotment gardens situated at the top of the bank. Below the topsoil (001) was a natural clay substrate (002) which had a maximum thickness of 0.45m and was yellow brown (10YR 3/4) in colour. The substrate (002) had no modern inclusions and overlay the natural yellow sandstone substratum (003) which was excavated to a maximum thickness of 1.3m (Fig. 6). No archaeological deposits or artefacts were uncovered during any of these works.

Fig. 9 View of the bank showing the end of the gabions and the start of the battered slope.
