An Archaeological Watching Brief at Radbourne Hall, Radbourne, Derbyshire.

ARS Ltd Report No. 2016/42 OASIS ID - archaeol5-247182 NHLE No: 1334517 Listed Status: Grade 1

Project Name: An Archaeological Watching Brief at Radbourne Hall, Radbourne,

Date of Fieldwork: February 2016

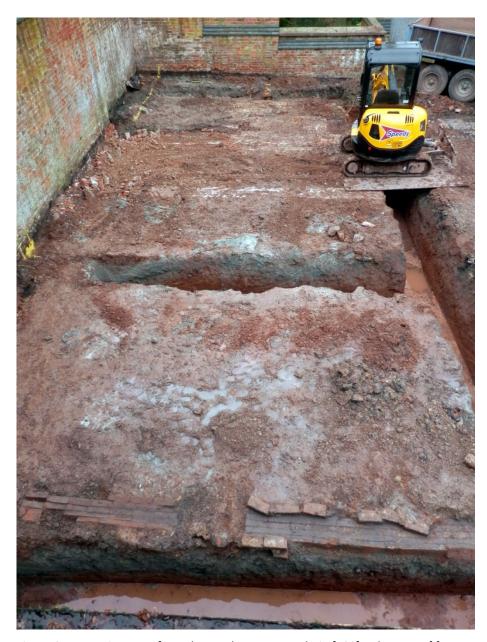
- The excavated area was initially stripped to a depth of c.0.18m with deeper trenches excavated to a depth of c.0.8m for the foundations of the new boiler house (Figure 2).

Figure 2: Excavation Area from the south-east, Note drain [120] at bottom of frame.

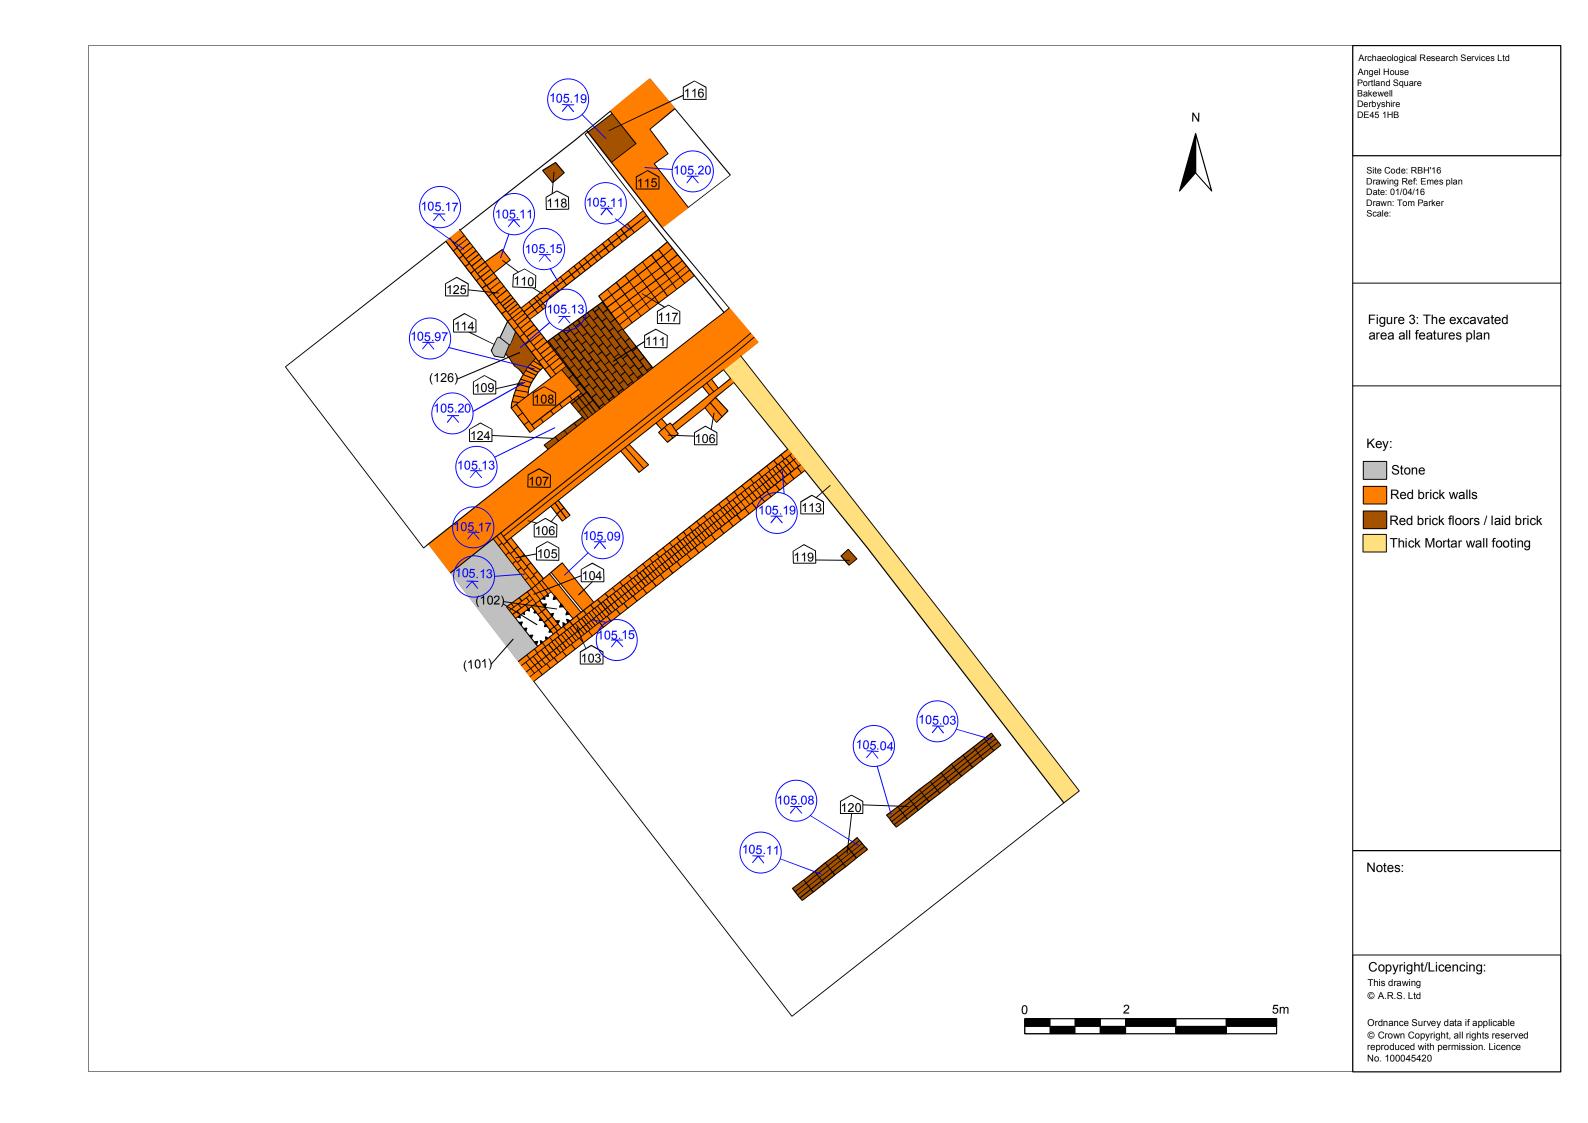
- 6.2 The archaeological features uncovered confirm a structural sequence of construction and demolition attested in historical map sources represented by the Emes Estate map of 1790 (Figure 10), the Ordnance Survey Map of 1888 (Figure 11) and the R.W. Chandos-Pole map of the house drawn in 1892 (Figure 12). Much of this sequence, however, was revealed in the section of the foundation trenches for the installation of the boiler room and was below the depth of development (Figure 6).

- 6.8 To the north only the north-east corner of an ancillary building [115] evidenced in the 1790 map was present (Figure 3, Figure 8).
- 6.9 Immediately to the south an interior basement room of the hall was defined by wall [103]. Wall [103] was also built of handmade, unfrogged, bricks, it abutted wall [113] and created a room 4.9m long and 1.85m. The room was floored with lime washed bricks [128] (Figure 6).

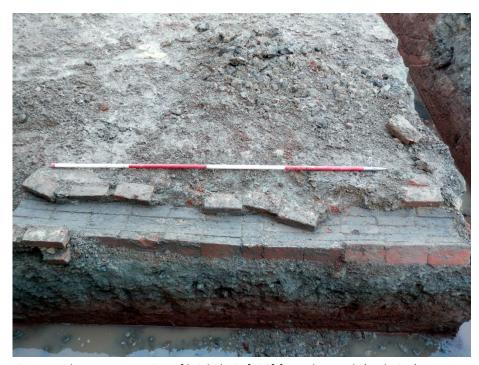
The earliest feature on site appeared to be the remains of a demolished brick drain [120] which drained from south-west to north-east (Figure 4). This drain, which was made of unfrogged handmade bricks, was represented entirely by its basal courses with no trace of its foundation trench or the level from which it was built.

Figure 4: The eastern section of brick drain [120] from the south (scale 2m).

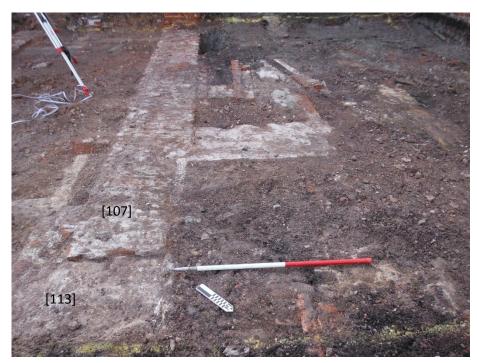
- 6.5 Drain [120] was truncated to the east by wall [113] which was represented entirely by the base of foundation trench (127) and the truncated remains of a rubble and mortar raft foundation [113] (Figure 5).
- 6.6 To the north the wall footings of the hall [107] and an ancillary building to the north-east [115] extant at the time of the Emes estate map of 1790 were clearly represented (Figure 2 and Figure 8). Substantial brick walls [107; 115] were made of unfrogged handmade bricks and were preserved to a height of 0.6m.
- 6.7 Wall [107] appeared to abut wall foundation [113] as evidenced by the straight mortar joint in (Figure 5) where [107] had been built against [113] at this course.

Figure 5: Detail of external wall [107] and relationship with [113] from the north-east (scale 1m)

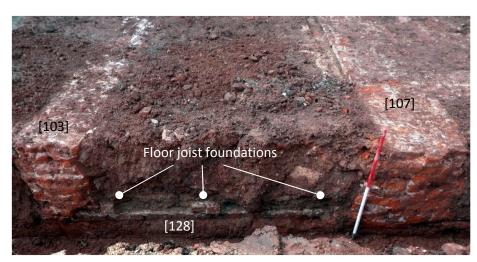
Figure 6: Walls [103] left and [107] right with basement floor [128] in section (scale 1m).

6.13 The basement room defined by [107; 103] had a shell wall [105; 106] of brick inserted into it which was contiguous with the construction of the foundations for a fireplace (104) and ashpit (102) (Figure 3) that also appeared to incorporate the foundations for a back boiler. It is likely that this room, at this point, had a wooden floor some 0.4m lower than this foundation as brick pad foundations for floor joists were apparent in section (Figure 6).

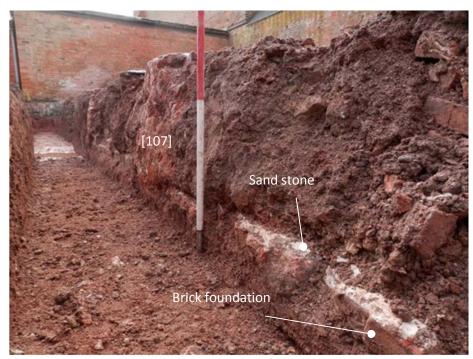
6.11 The most easterly of these rooms was provided in its earliest phase with a flagged floor on a brick foundation (Figure 7) and its interior faced with limewashed mortar (Figure 8).

Figure 7: The internal floor of the north-eastern room inserted in the 1865 rebuild (foreground). Note broken sandstone slab above brick floor with wall [107] in the background (scale graded in divisions of 0.5m).

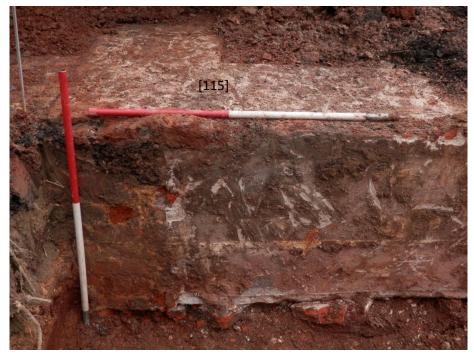
Figure 8: Limewashed mortar on the south-west facing elevation of [115] (scale 1m).

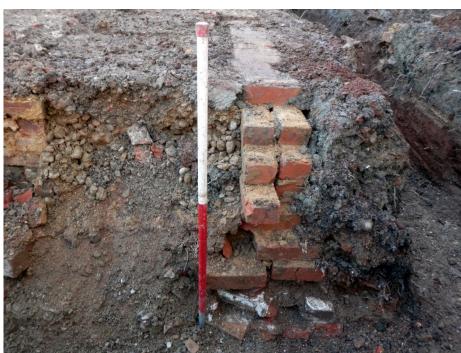
- 6.14 Subsequent addition in the northwest corner of the excavation area witnessed the insertion of a brick floor [111] against wall [125] possibly also intimating a threshold communicating to the west. It appears that, following the disuse of this room, a buttress [108] was inserted over brick floor [111] probably signifying the reuse of wall [125] as a garden wall (Figure 3).
- 6.15 The corner of wall [107; 113] also appears to have been buttressed at some point after the disuse of the earliest floor of is room with a substantial brick foundation [117] established over [111]. This wall and wall [110] were relatively modern insertions (Figure) having been built freestanding on the flagged brick floor of this room it having been backfilled and levelled up with lean-mix floor substrate.

Figure 9: Modern wall [110] and levelling up of lean mix floor substrate.

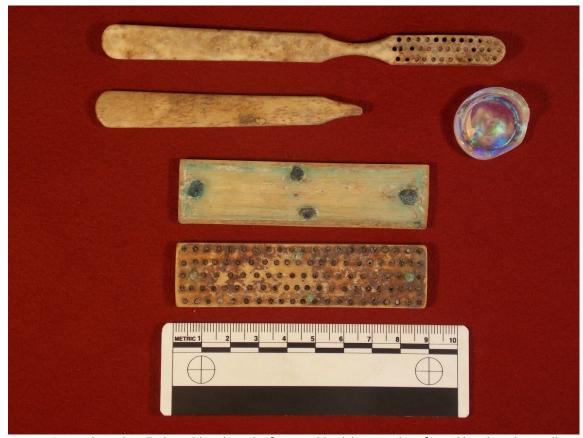
7.4 Two toothbrush handles and one scrubbing brush handle of animal bone dating to the 19th-early 20th centuries date, were recovered from (120).

Figure 13: Two bone handled toothbrushes, the front and back bone scales of a nail brush and a small bottle base fragment likely to represent a perfume bottle, all from context (120).
