## The Winery, Burton upon Trent, Staffordshire: An Archaeological Watching Brief

**ARS Ltd Report 2016/57**  
April 2016

# **The Winery, Burton upon Trent, Staffordshire: An Archaeological Watching Brief**

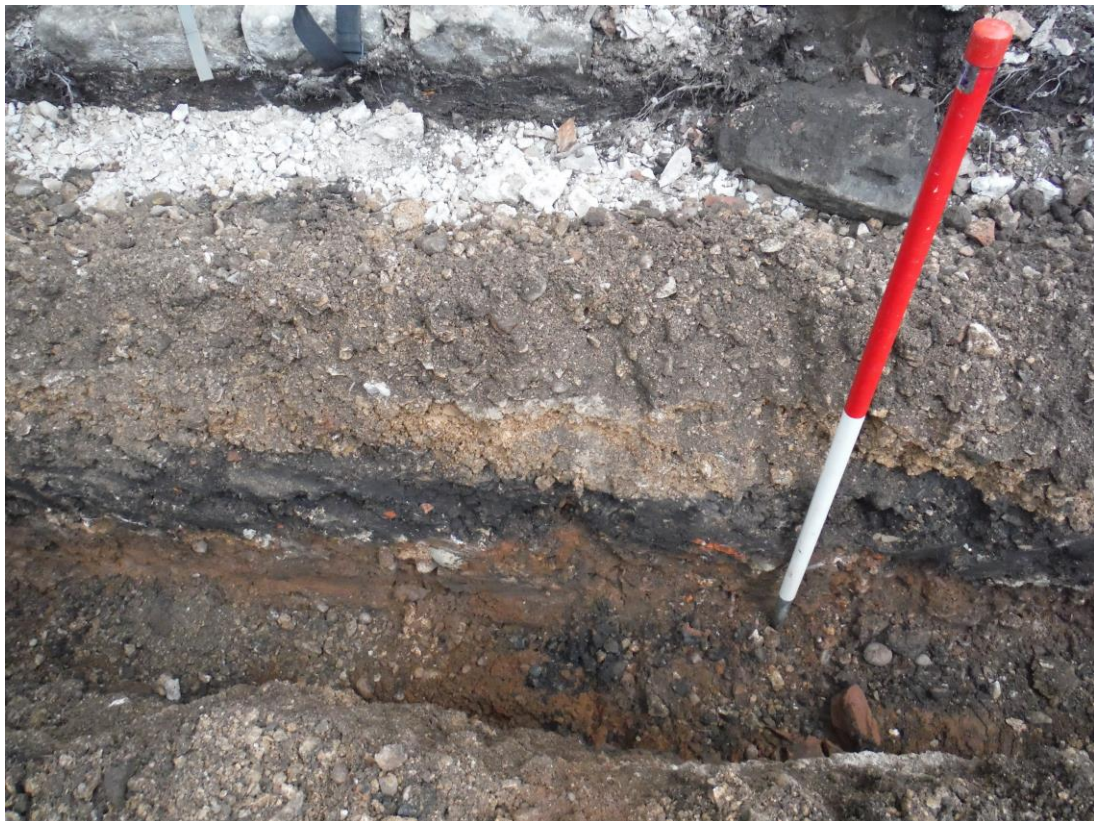
3.2 The stratigraphic sequence consisted mainly of a series of made ground and levelling deposits (Figure 3). The development area is currently in use as a pathway and storage area behind the kitchen, and the two upper contexts (101 and 102) consist of modern spreads of sand and gravel to a depth of 0.3m. These seal a redeposited black organic silt deposit (103) with frequent brick inclusions which was c.0.2m thick, potentially representing another levelling deposit or a demolition layer. The ground level in the development area has been significantly reduced in the past (Figure 4), potentially for the construction of the current restaurant which is evident on OS maps from 1923 onwards. The redeposited black silt (103) context may originate from this period when the ground was reduced and the current restaurant building was constructed. Throughout most of the trench the redeposited black silt (103) overlies an orange brown clay (106) at a depth of 0.9m (Figure 3).

Figure 3. Stratigraphy in west-facing trench edge

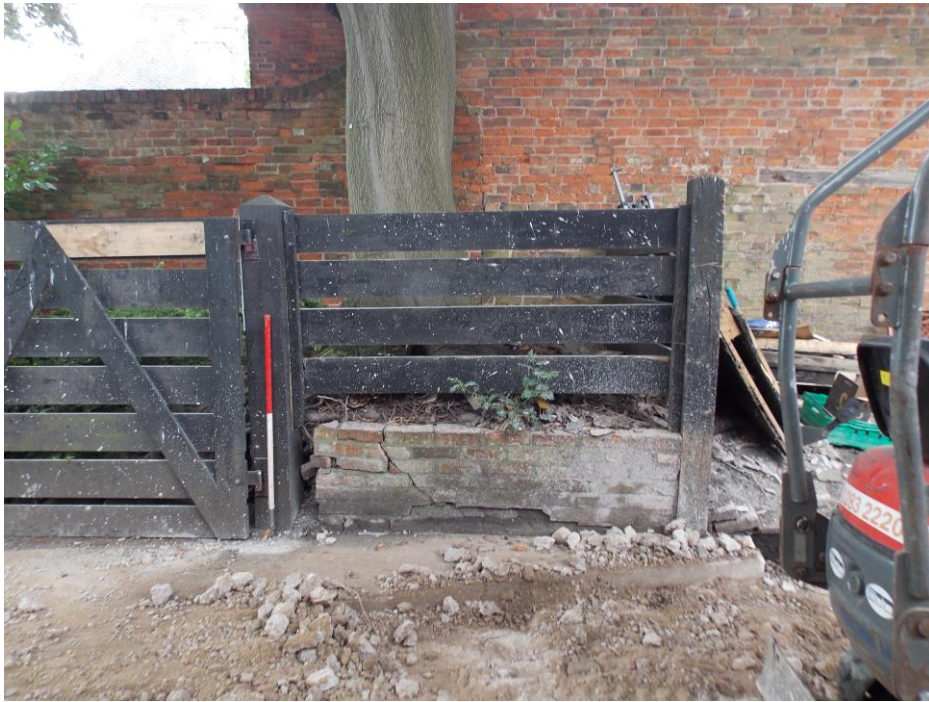
Figure 4. Ground level around the tree adjacent to the development area shows a previous reduction in the ground level, prior to the deposition of made ground deposits.

4.1 Excavation of a single trench at The Winery exposed a sequence of mainly made ground deposits which identify a sequence of changes to ground level and ground-making activities which took place at The Winery over the course of the 20<sup>th</sup> century. The first phase of identified activity is the reduction of the ground level in comparison to adjacent trees, potentially during the construction of the current restaurant building, which map regression analysis of OS maps place between 1901 and 1923. The orange-brown clay deposit (106) 0.9m below the current ground level may represent the ground level reduction which took place when the current building was constructed.

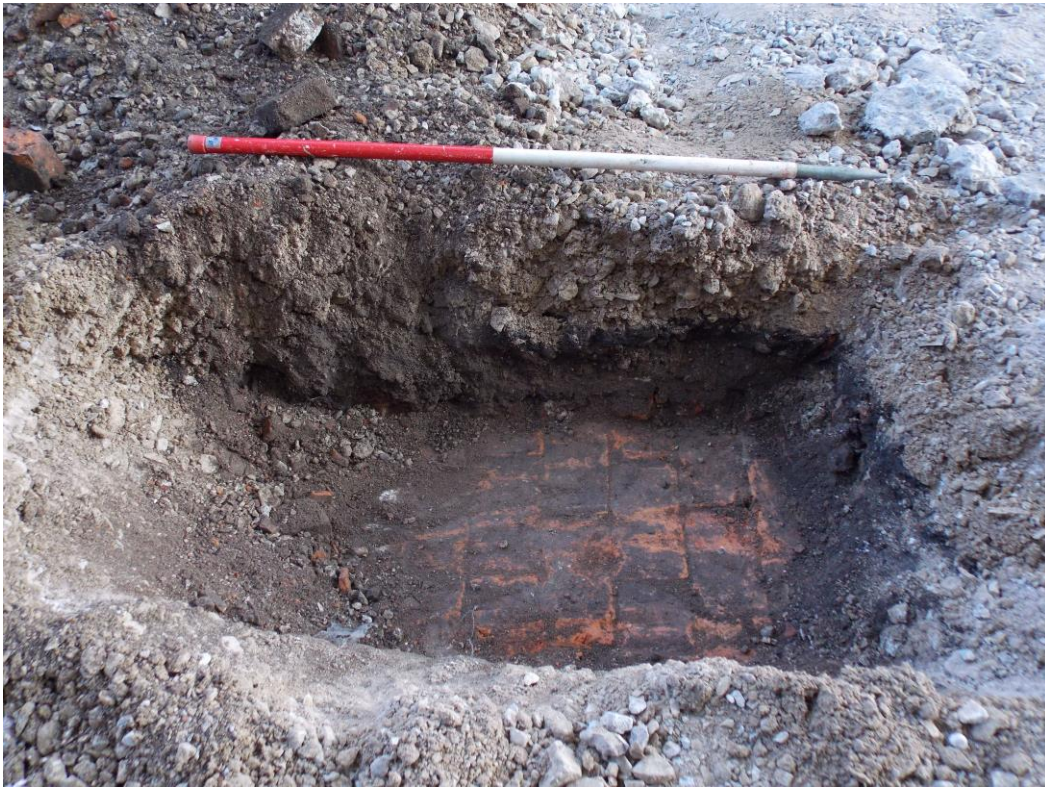
3.3 At the northern end of the excavated trench, a floor section or path surface (104) was encountered (Figure 5) at a depth of 0.5m. The surface consisted of handmade dry-bonded bricks which measured 220x120x70mm. The surface was roughly 0.8m in width, and continued to the east and west of the excavated area, suggesting it may form part of a buried footpath. The surface was located directly below the redeposited black organic silt (103), and therefore predates that episode of made ground deposition. The brick surface was removed to reach the depth necessary for development (Figure 6). The brick surface (104) overlay a grey sand deposit (105); it was probably a levelling deposit laid down under the brick surface, as it was not observed elsewhere in the excavated area.

Figure 5. Exposed surface of the brick floor or path (104).

4.2 A brick floor section or path (104) was identified, constructed at this lower ground level. The stratigraphic position of the floor section or path suggests it was related to the construction of the current building following the reduction of the ground level. The possible path or floor of an outbuilding would therefore also have been laid between 1901 and 1923, which is consistent with the form and characteristics of the bricks. A black organic silt made ground (103) with frequent brick inclusions was subsequently deposited over the entire excavated area.

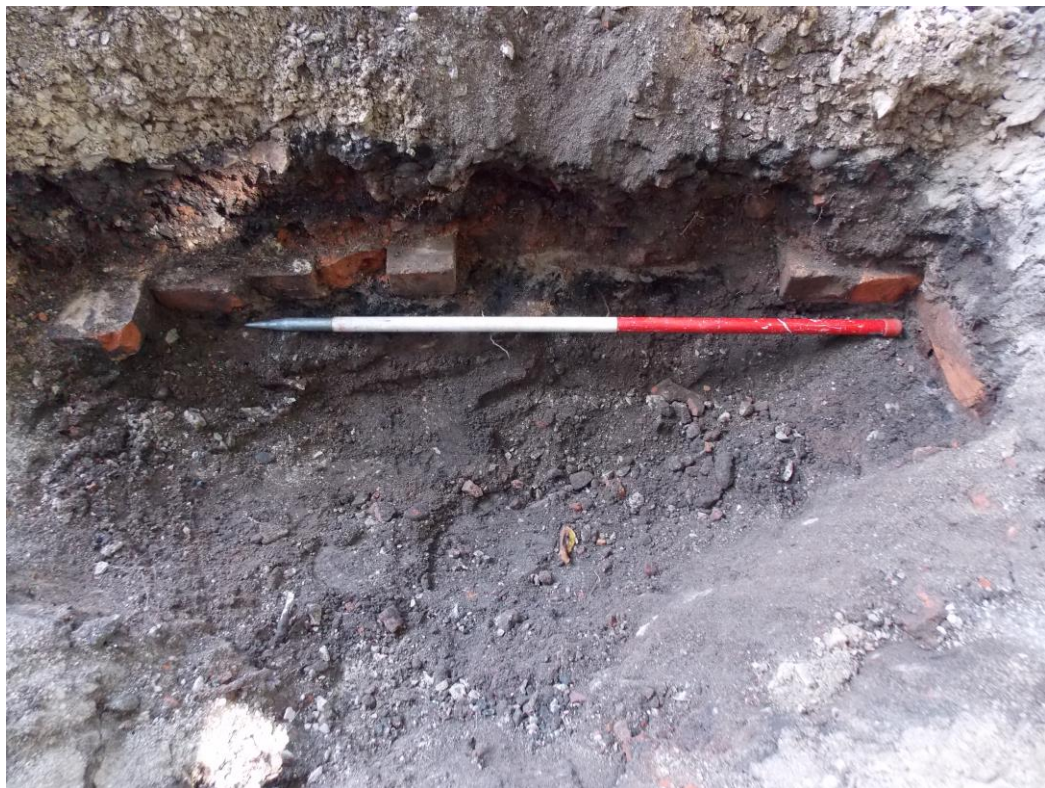
Figure 6. Stratigraphy above and below the brick floor or path (104).
